Your Inspection Report

Nice Town, MN

INSPECTION DATE:
Friday, December 20, 2013

RE: Report No. 1140, v.4

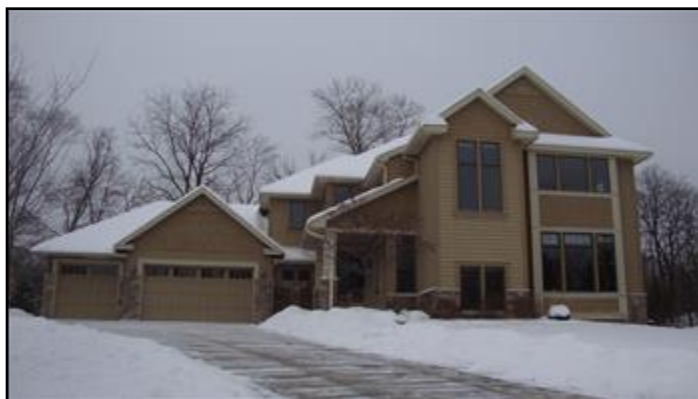
Difficult to assess grade and paved surfaces due to snow cover. Limited areas were visible.

Snow

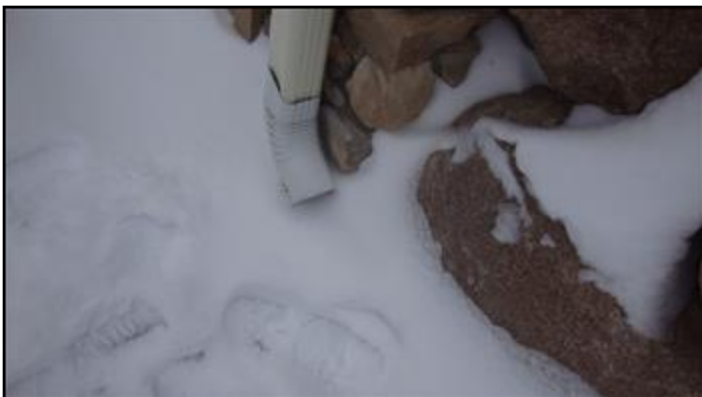
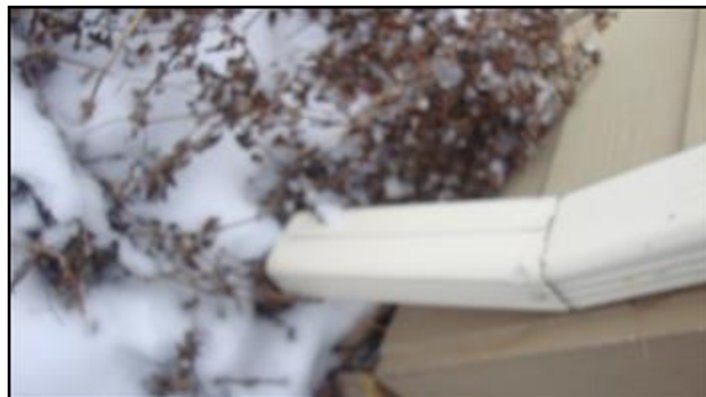
Condition: • [Downspouts end too close to building](#)

Downspouts end too close to building

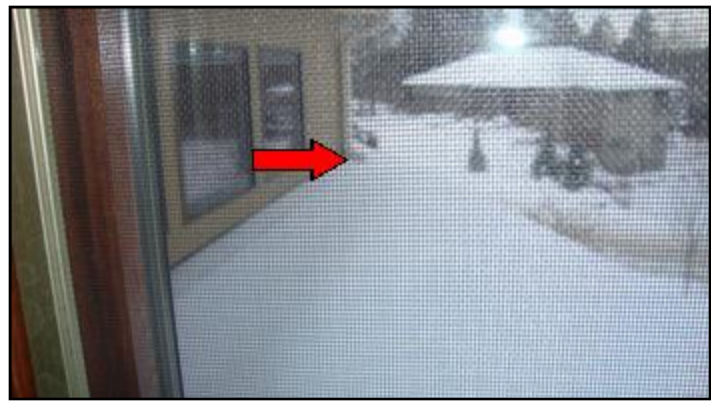
Condition: • [Downspouts discharging onto roofs](#)

Downspouts discharging onto roofs

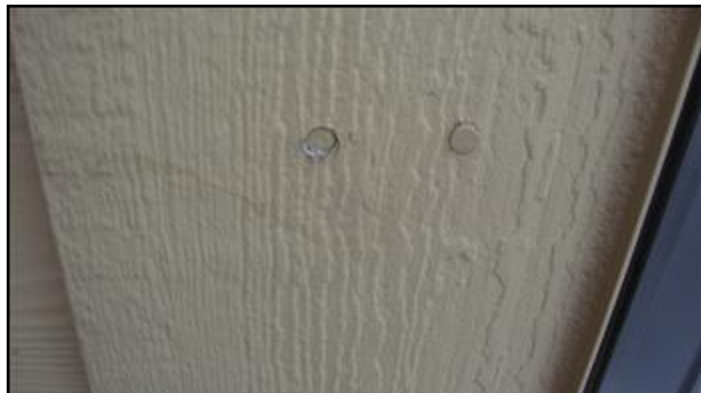
8. Condition: • [Caulking missing or deteriorated](#)

It is essential that all voids and gaps are filled to prevent water from contacting unprotected siding. Fiber cement siding and trim may delaminate and will rapidly deteriorate if not painted or caulked. Minor deterioration was observed in a few small areas. The siding was in good overall condition but will require maintenance repairs in the spring.

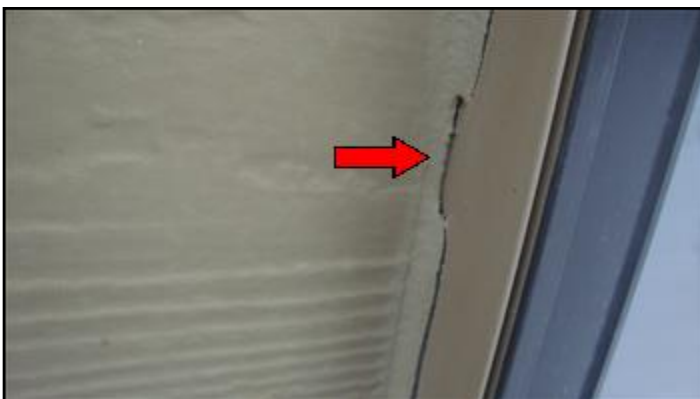
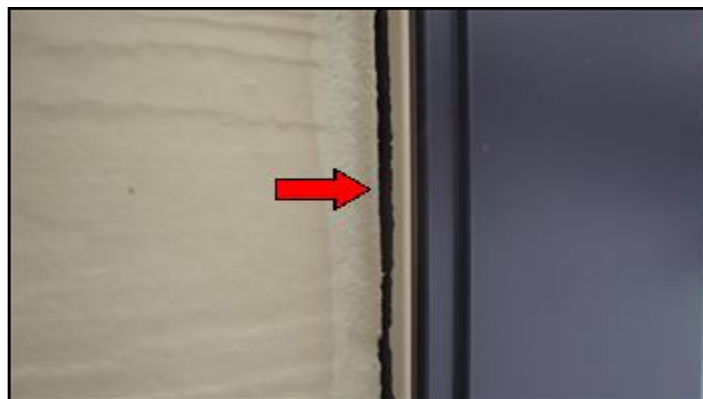
Caulking missing or deteriorated

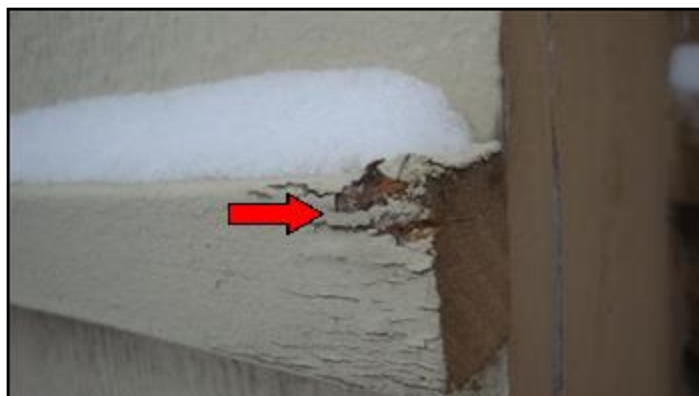
Delaminating at exposed edge. Seal or replace.

9. Condition: • Rot

Rot

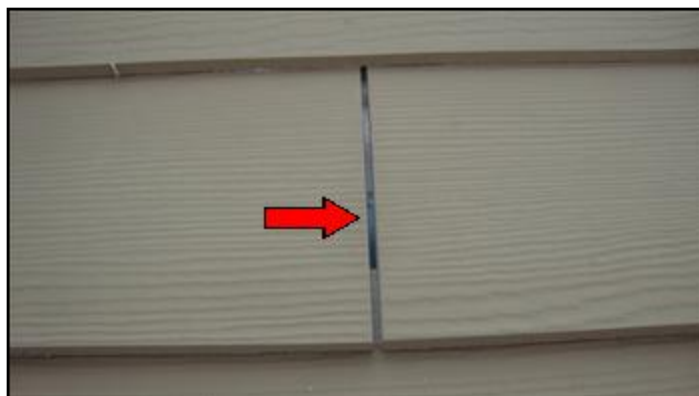
Condition: • [Flashings missing](#)

Flashings missing

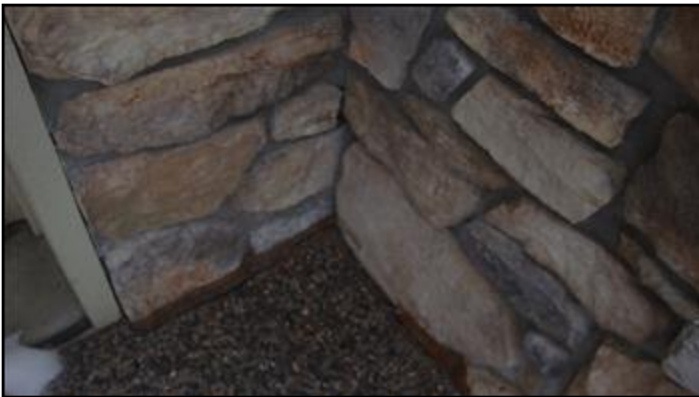
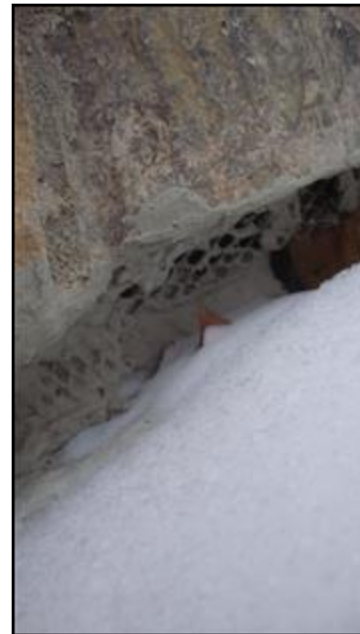
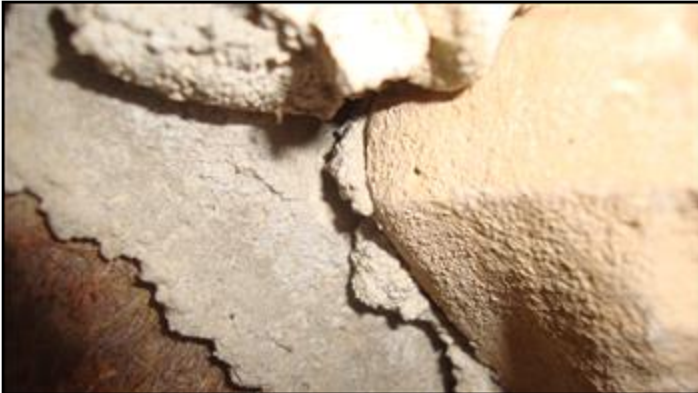
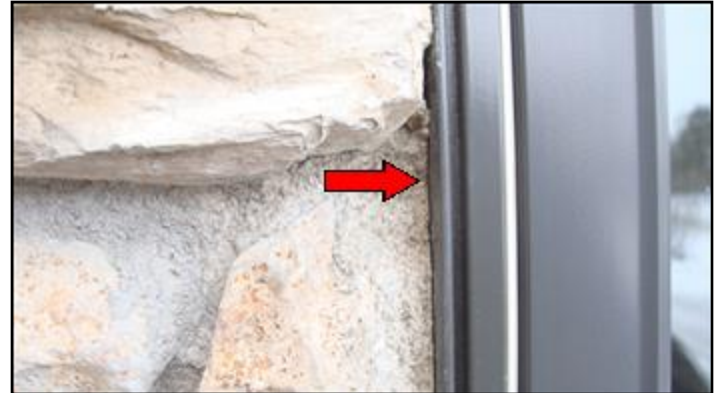
13. Condition: • [Missing, ineffective weep holes or flashings](#)

Potential source of water intrusion. Monitor condition of exterior and interior surfaces. Mortar is contacting windows, is not sealed and missing caulk gap. Seal voids with quality caulk engineered for this application. Link to article: http://www.cement.org/masonry/cc_al_frames.asp

Missing, ineffective weep holes or flashings

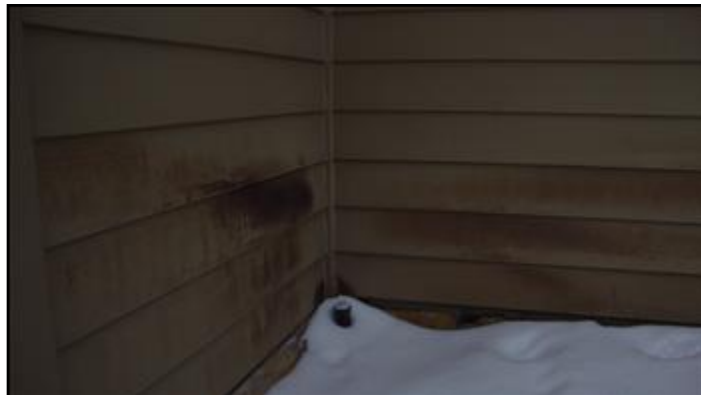
16. Condition: • Minor damage. Repair and paint exposed areas.

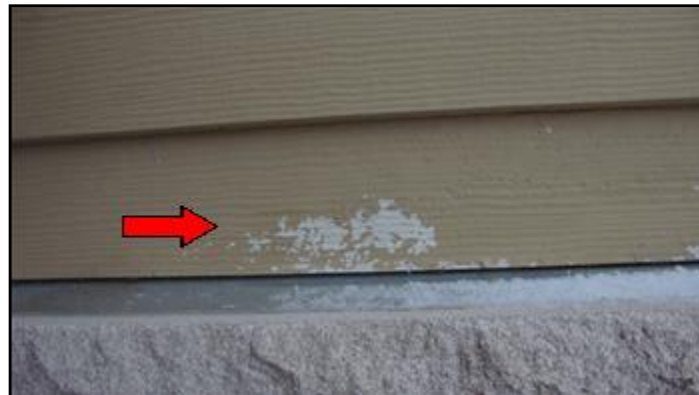
17. Condition: • [Missing paint or caulking](#)

Missing paint or caulking

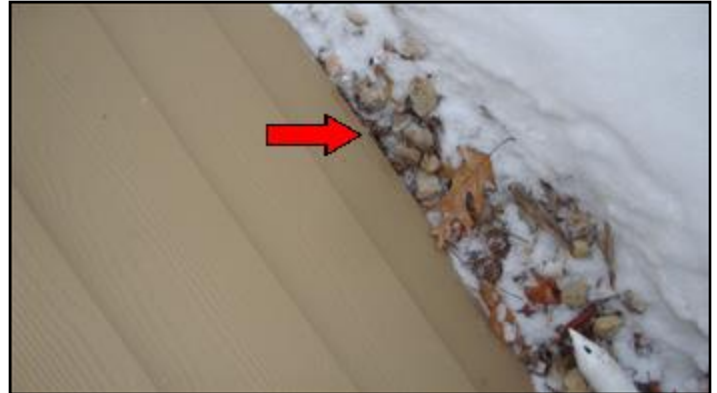
Fiber cement siding that is too close to grade has a high potential for premature decay. Monitor or replace with PVC or Cedar grade board.

Too close to grade

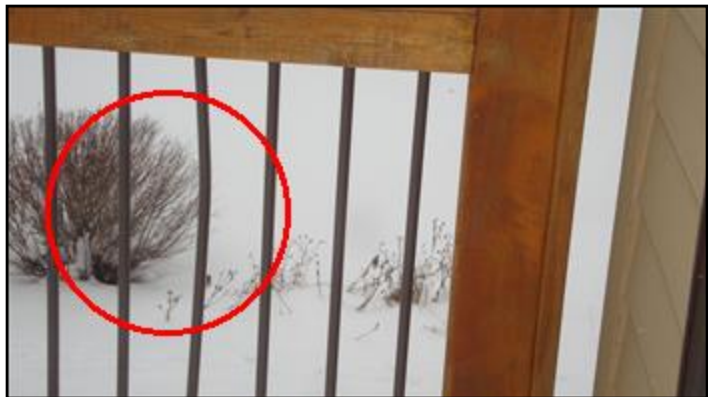
Condition: • [Spindles too far apart](#)

Spindles too far apart

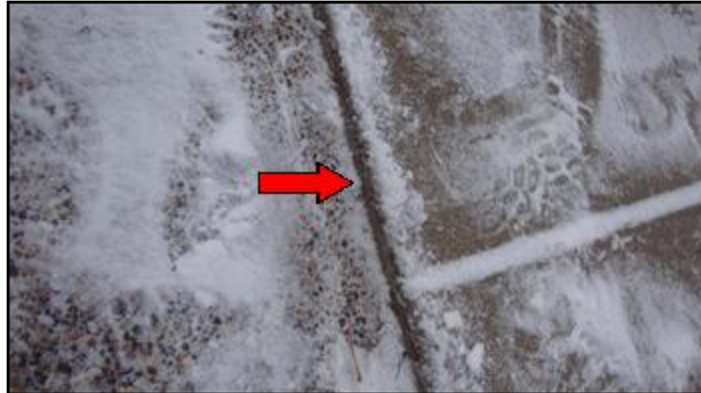
Condition: • [Uneven \(trip hazard\)](#)

Uneven (trip hazard)

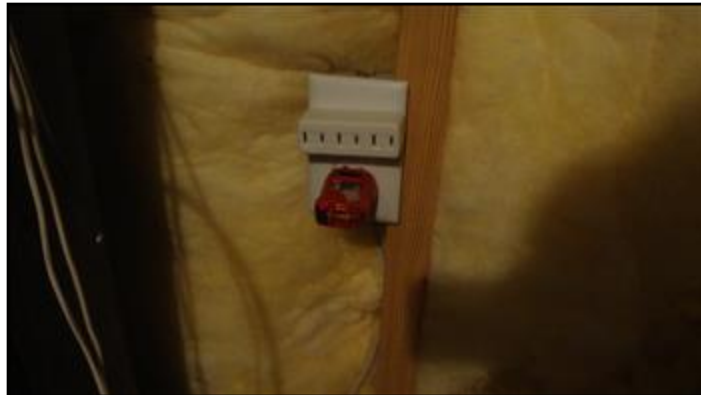
Inoperative

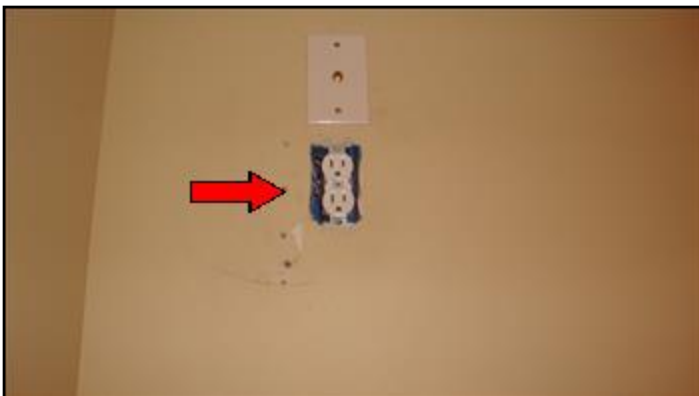
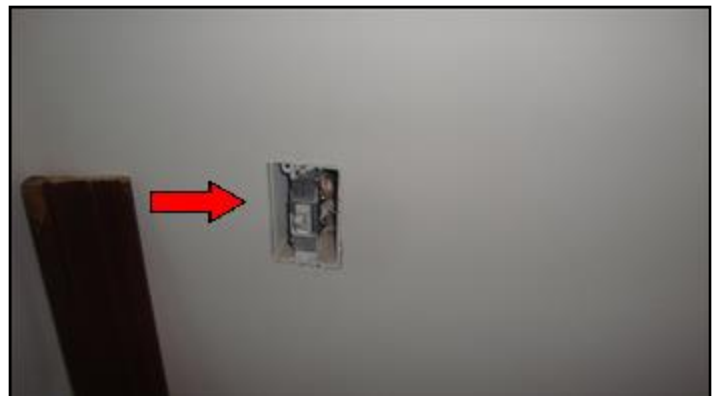
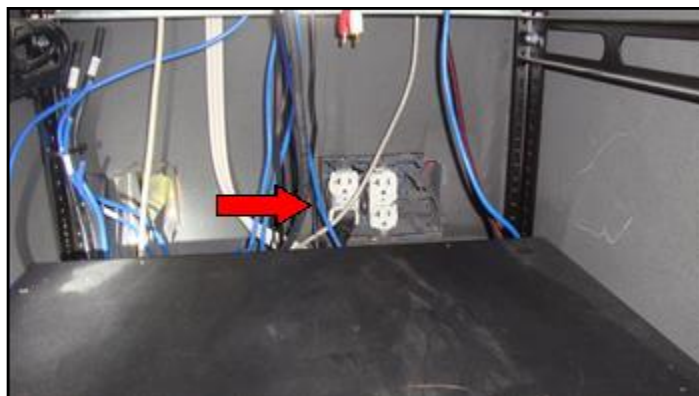
Missing

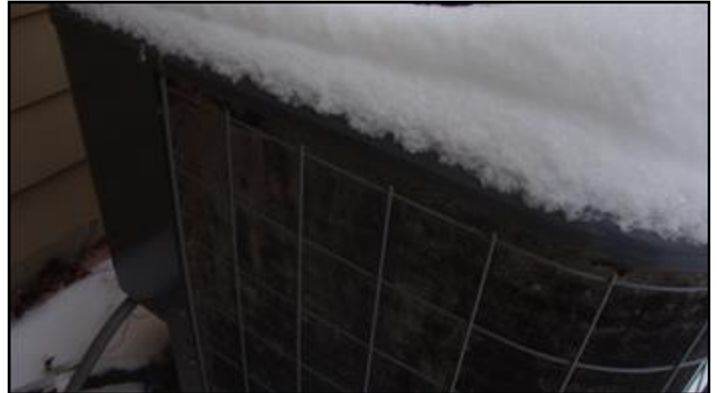
Dirty

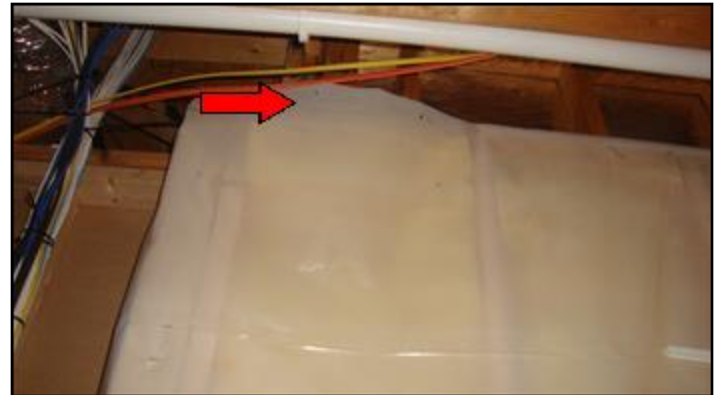
41. Condition: • [Incomplete](#)

Incomplete

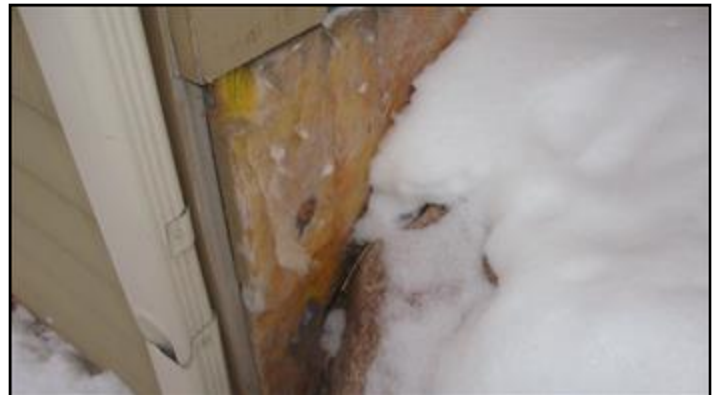
Condition: • [Not protected at top](#)

Exposed, missing and deteriorated. Protect and repair. Link to article:

Not protected at top

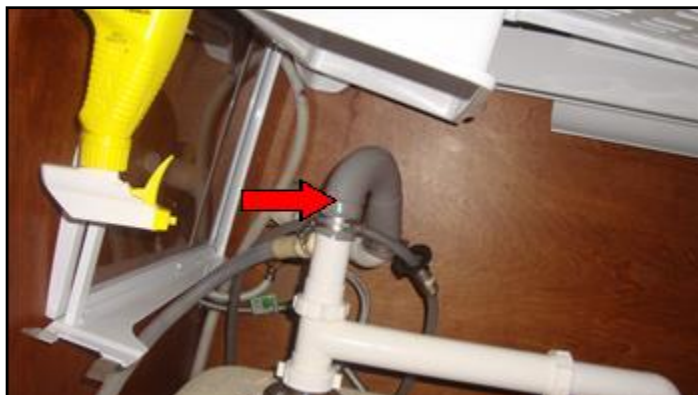
Nonstandard shape or material

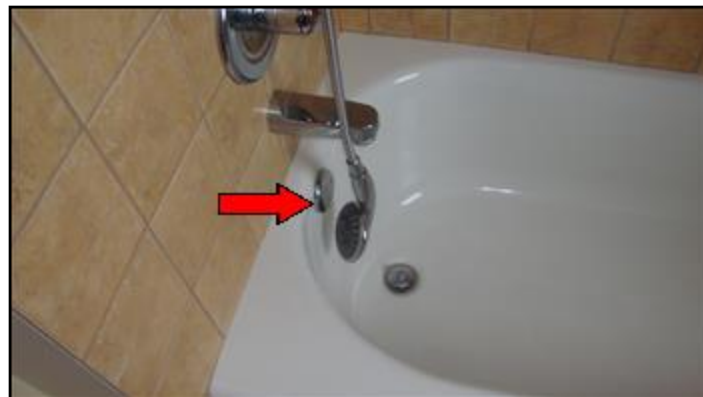
Cross connections

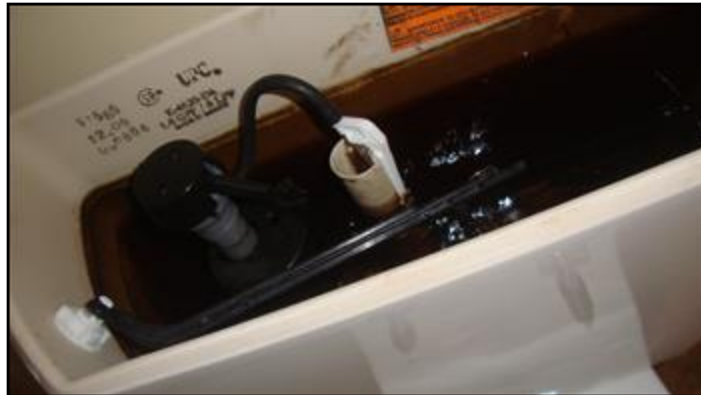
Cross connection

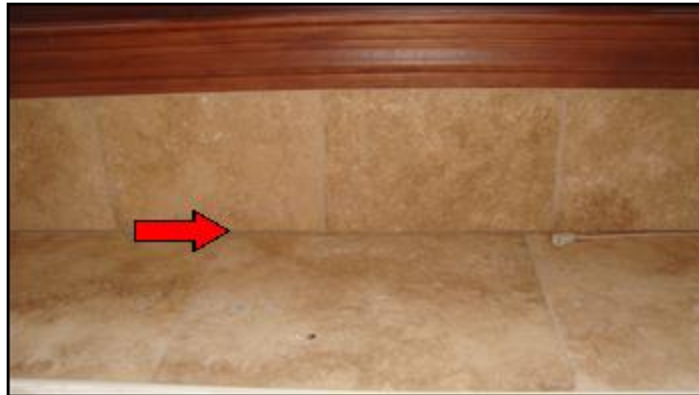
Grout cracked.

Grout loose, missing or deteriorated

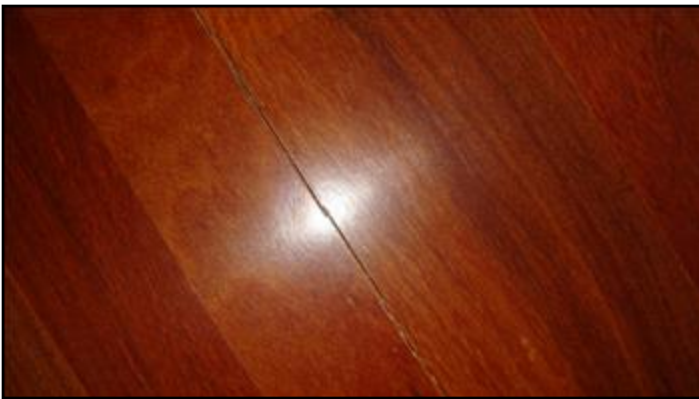
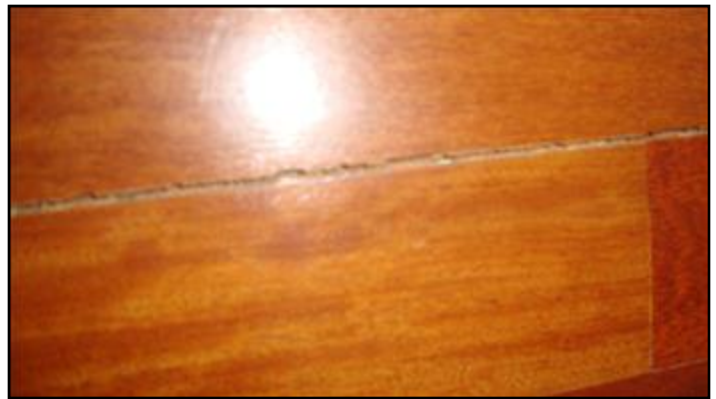
Exposed tongues

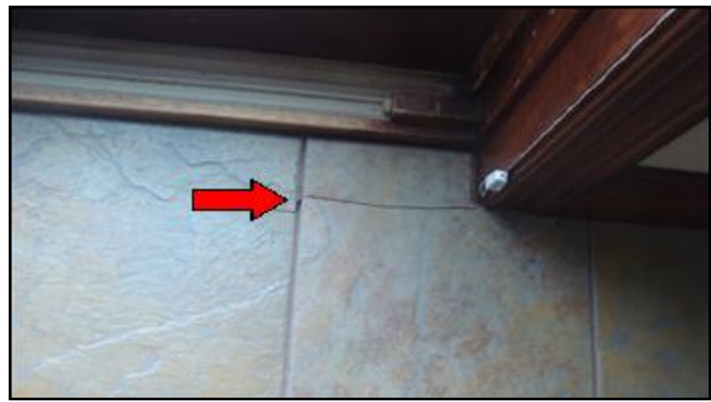
Tiles cracked

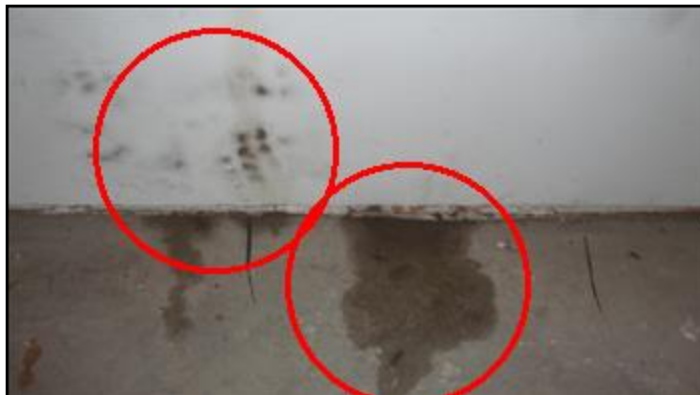
57. Condition: • [Water damage](#)
 Potential water damage.
Implication(s): Cosmetic defects
Location: Garage
Task: Monitor - Repair
Time: Immediate

Water damage

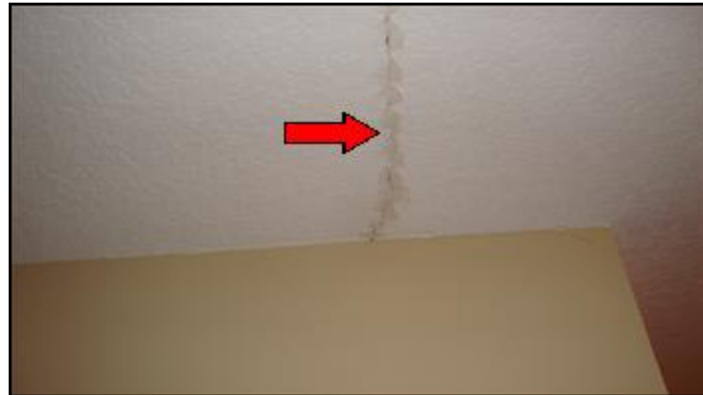
Cracked

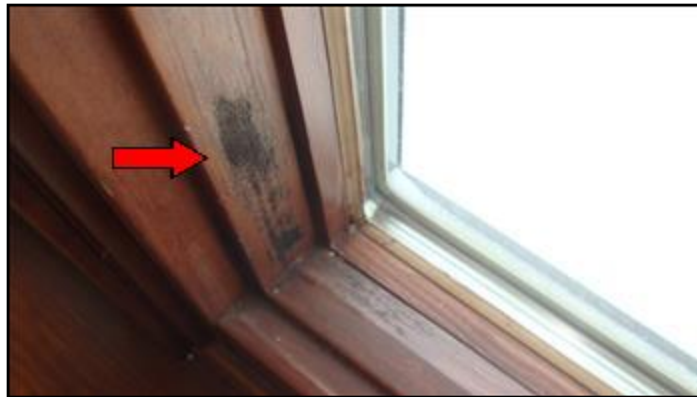
Paint or stain needed

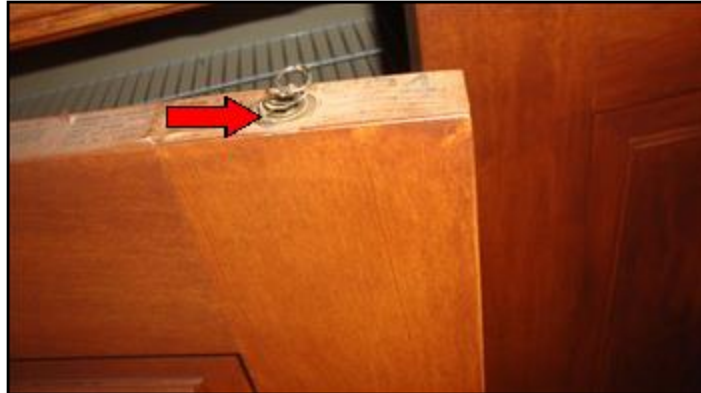
Ineffective

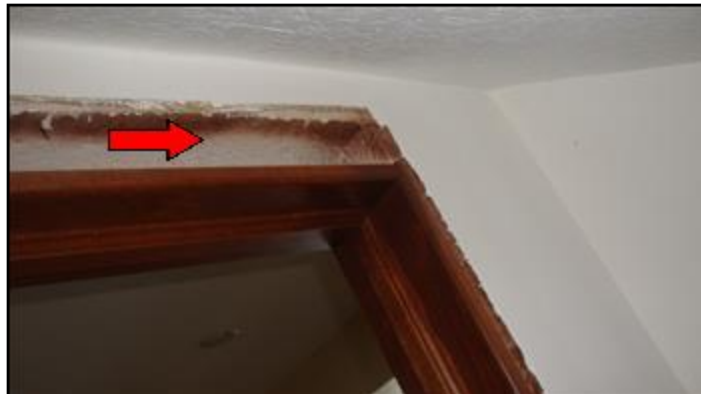
Missing
