PROPERTY CONDITION ASSESSMENT REPORT

Sample Report
Minneapolis, MN

Wednesday, October 21, 2015

RE: Report No. 1480, v.2
Sample Report
Minneapolis, MN

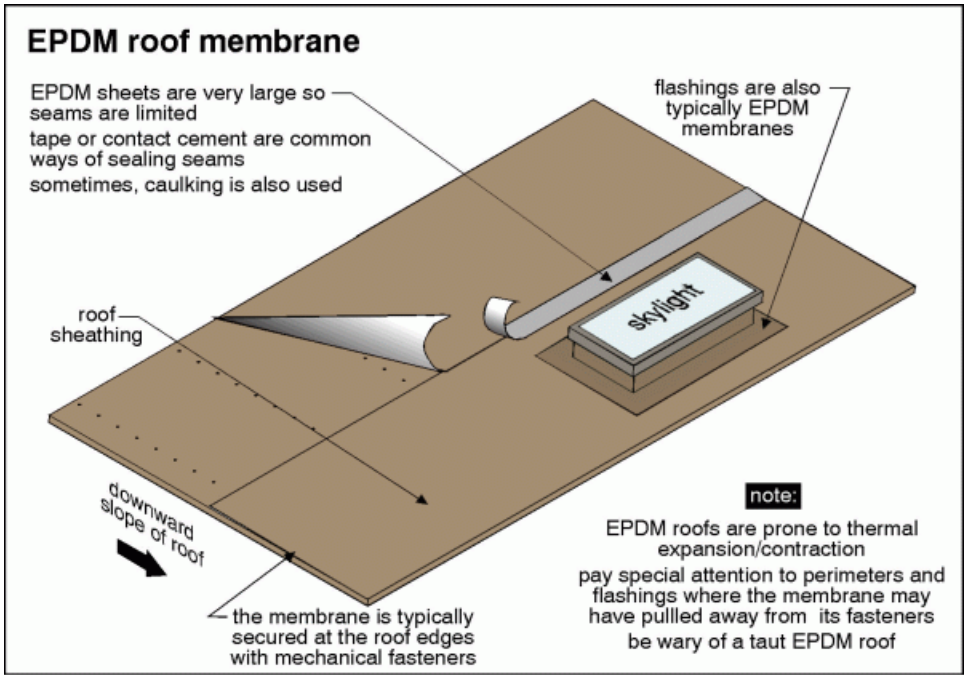
7. Taut, tenting

Condition: • [Taut, tenting](#)

Roof is aging with minor tenting observed. Recommend annual service to prolong life of roof .

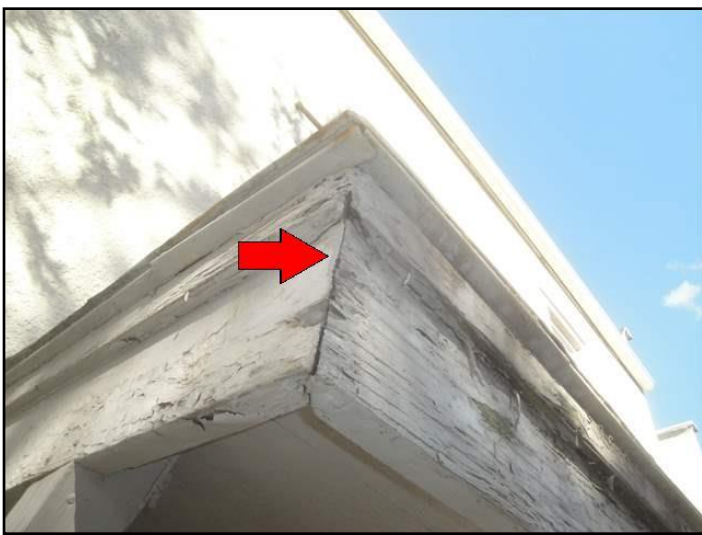
25. *Paint or stain needed*

Condition: • [Paint or stain needed](#)

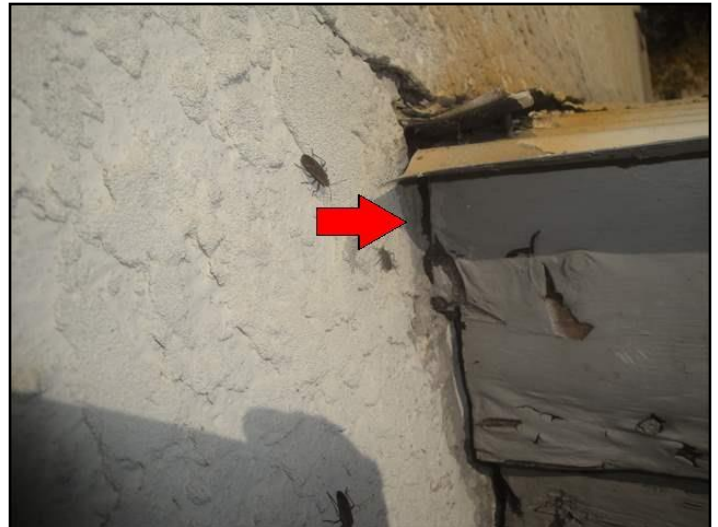
29. *Caulking missing or ineffective*

Condition: • [Caulking missing or ineffective](#)

Missing at front and rear entry framing details. Caulk is also beginning to shrink in a small number of areas. Monitor and repair as necessary.

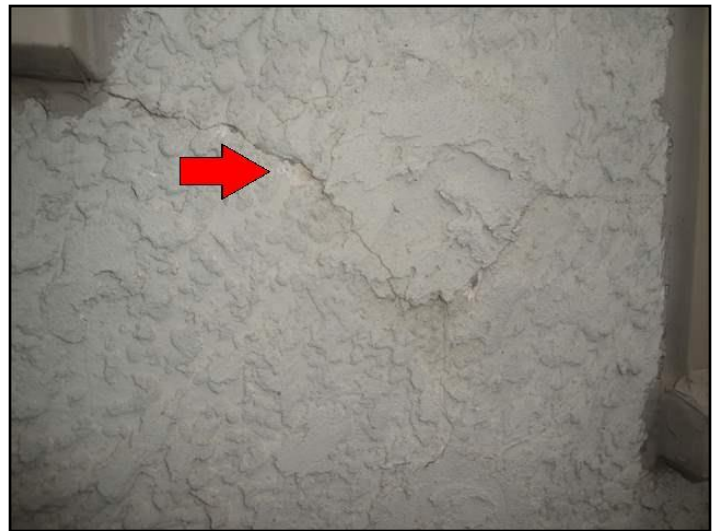
33. Cracked

Condition: • [Cracked](#)

A small number of minor cracks were observed in various areas of the buildings. There is a potential for moisture penetration. Seal cracks and voids.

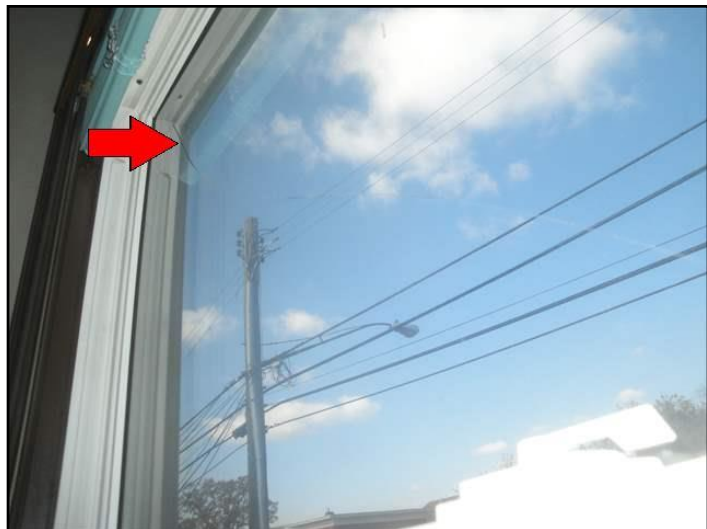
39. Cracked

21. Condition: • [Cracked](#)

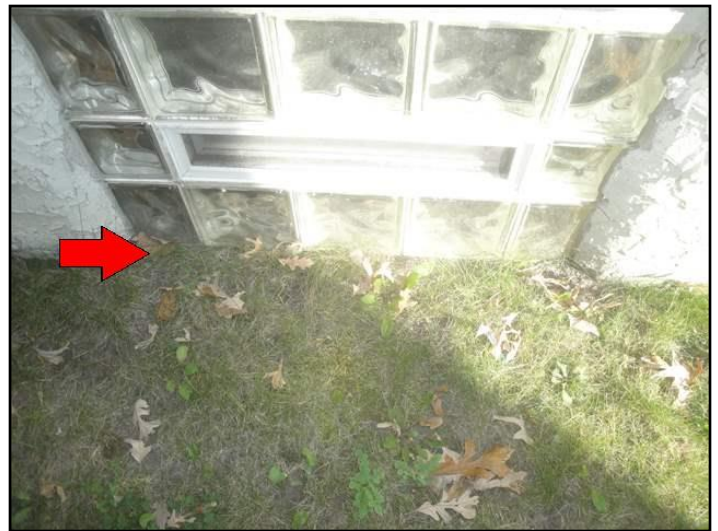
43. Improper slope

Condition: • [Improper slope](#)

Settled areas and areas of flat grade observed near foundations. Window sills were at or below grade. Evidence of significant moisture intrusion on interior basement walls.

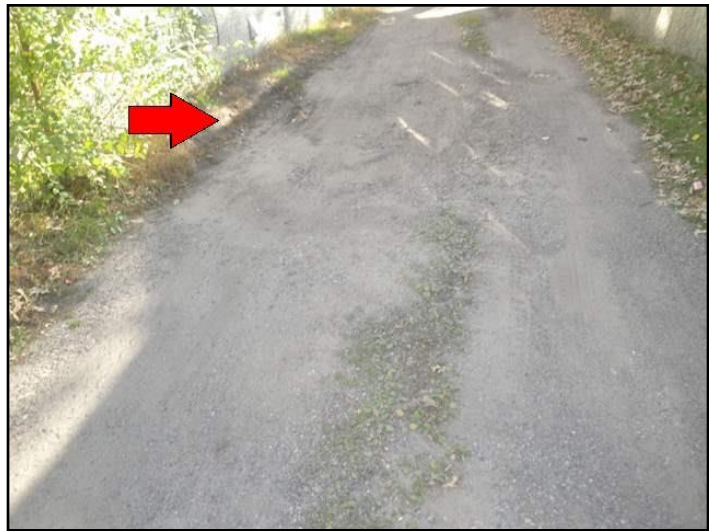
47. Improper slope or drainage

Condition: • [Improper slope or drainage](#)

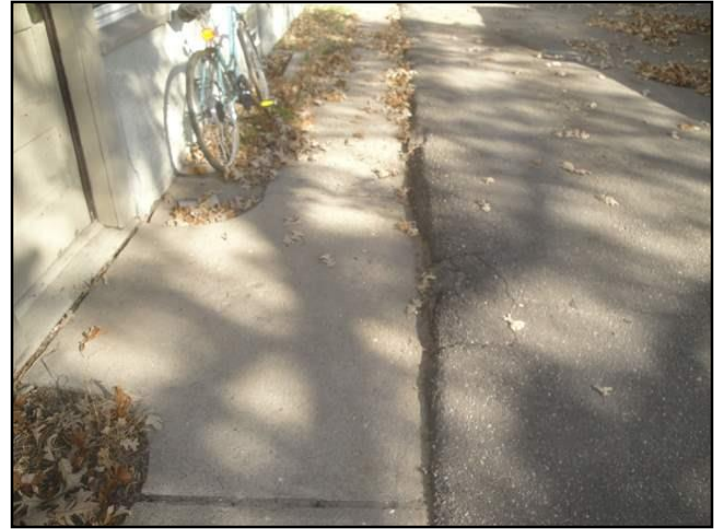
49. Improper slope or drainage

Condition: • [Improper slope or drainage](#)

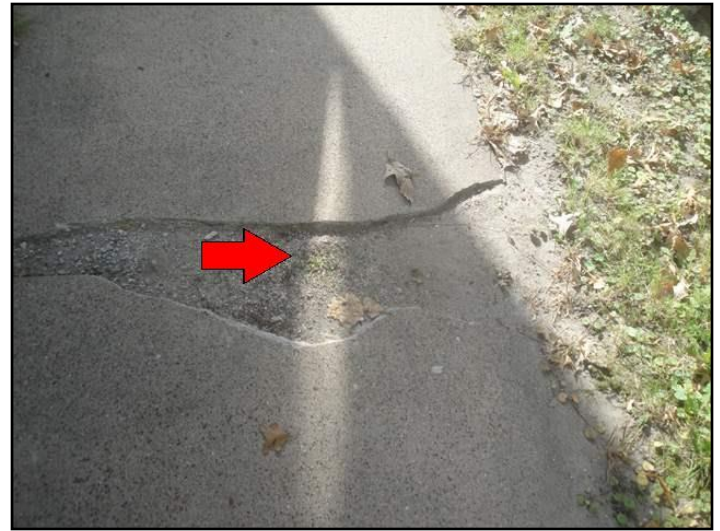
51. Uneven (trip hazard)

Condition: • [Uneven \(trip hazard\)](#)

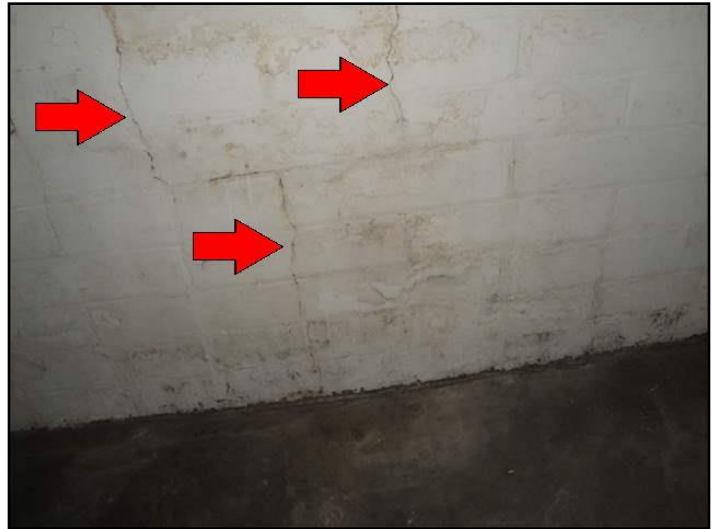
56. Cracked

Condition: • [Cracked](#)

Minor to moderate cracks were observed. Poor grading and water damage are contributing factors. The cracks are not an immediate structural concern however grading improvements and mortar repair or crack sealing are recommended to prevent further damage and moisture intrusion.

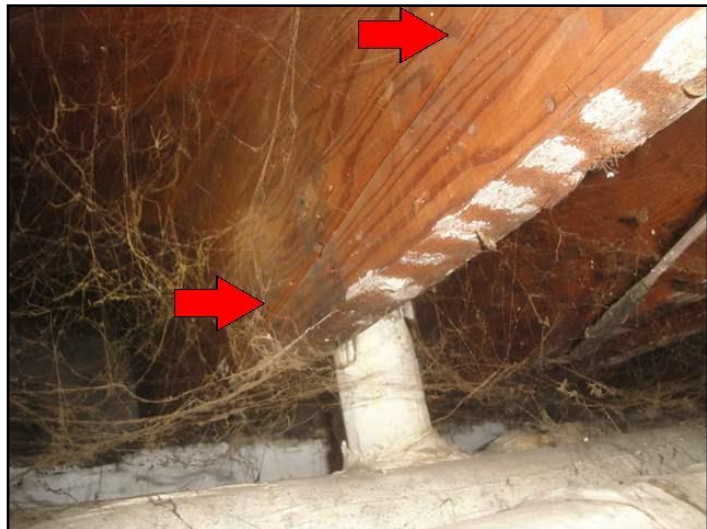
65. Split or damaged

Condition: • [Split or damaged](#)

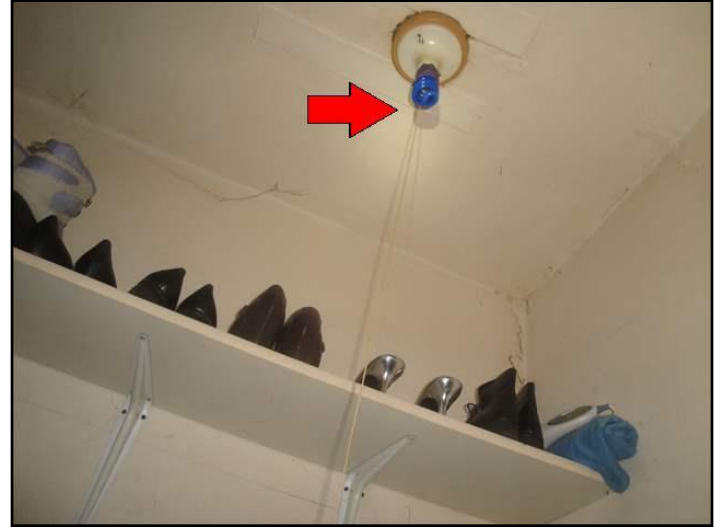
69. Improper closet lighting

Condition: • [Improper closet lighting](#)

Provide a globe or replace the fixture to reduce the risk of fire when items in the closet have the potential to come into contact with or have little clearance from hot exposed bulb.

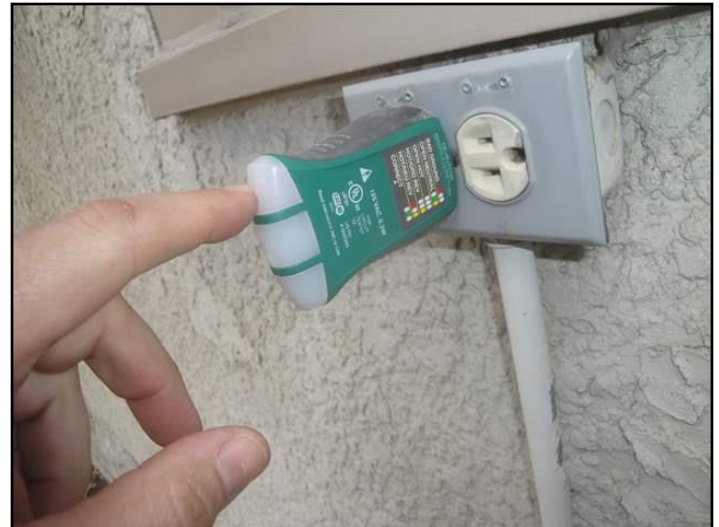
71. Inoperative

Condition: • [Inoperative](#)

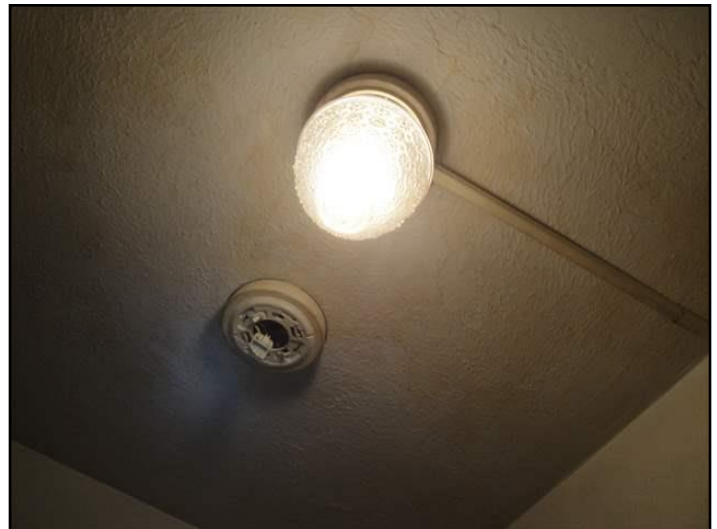
74. Missing

Condition: • Missing

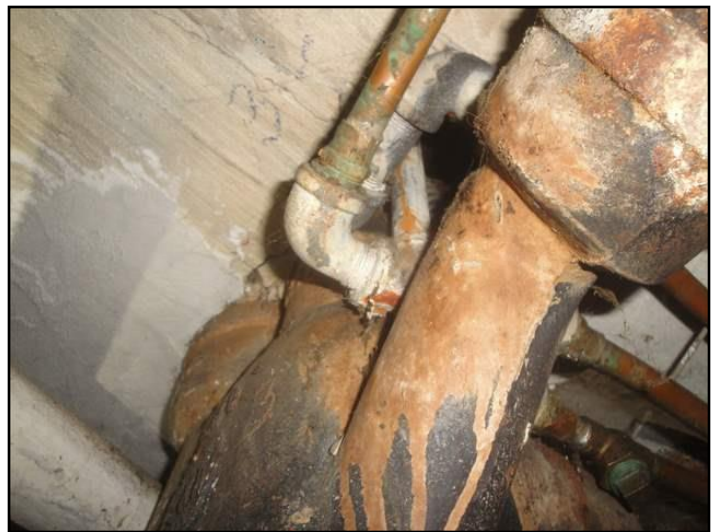
93. Rust

Condition: • [Rust](#)

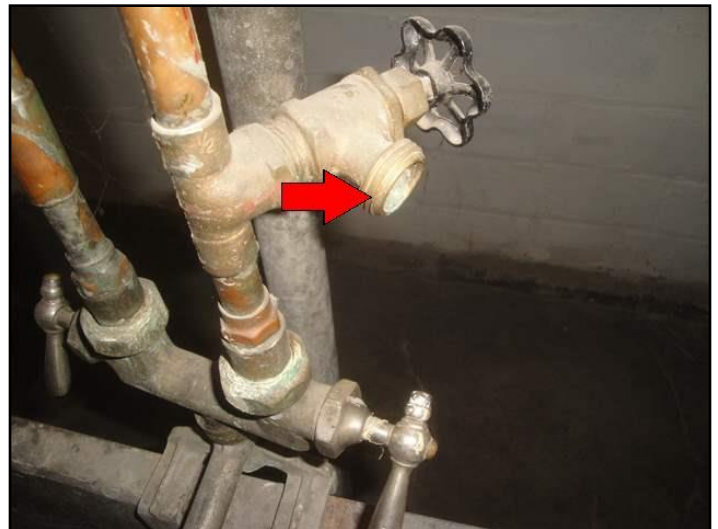
101. Backflow prevention missing

Condition: • [Backflow prevention missing](#)

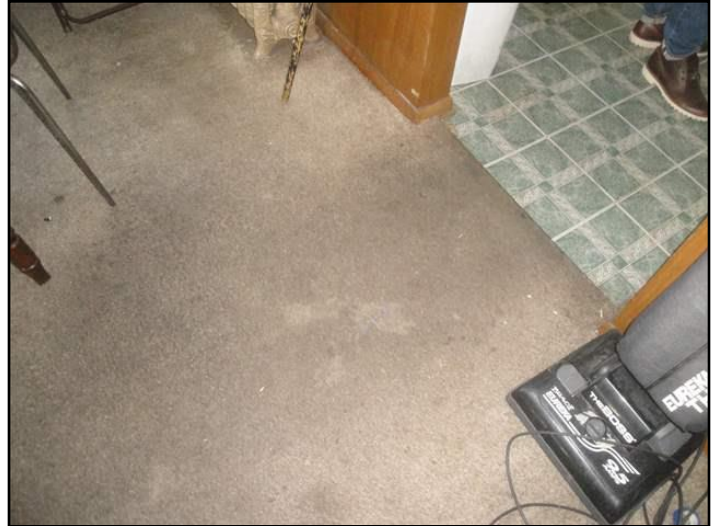
106. Worn

Condition: • Worn

The floors were generally in poor condition with damaged, stained and worn surfaces, stained carpet and cracked grout observed. The floors were in fair to good condition in unit 3 @ both 960 & 962.

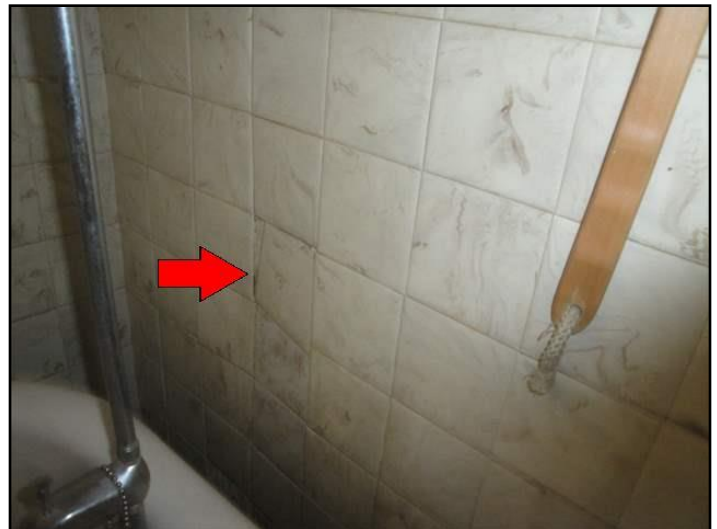
109. Damaged

Condition: • Damaged

Damaged wall tiles

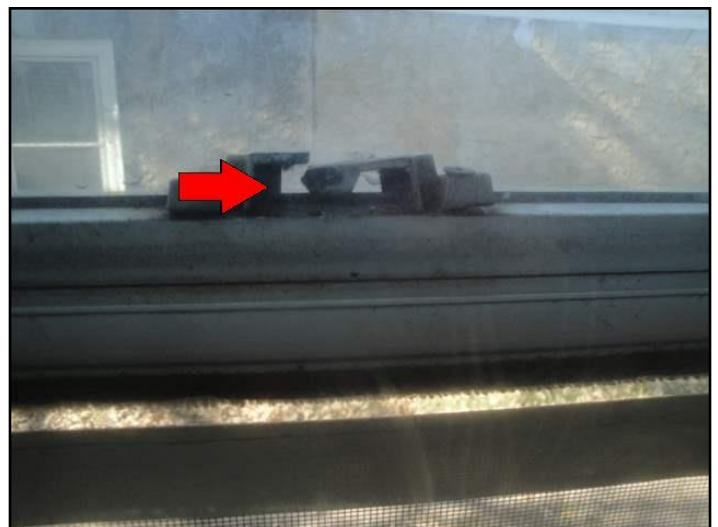
120. Broken

Condition: • [Broken](#)

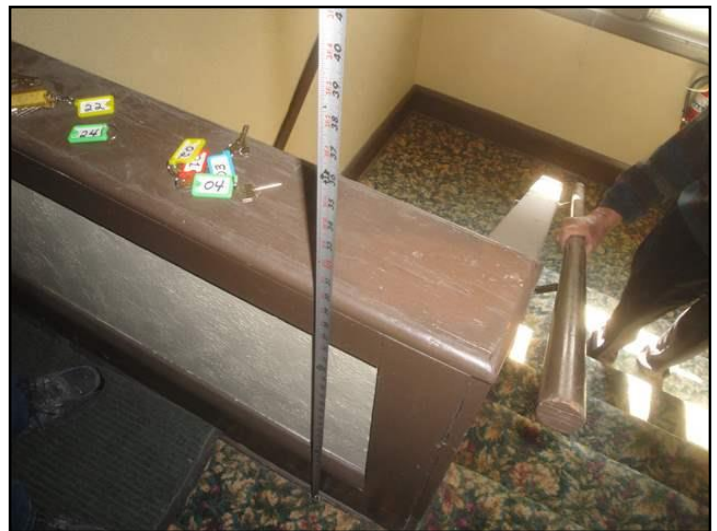
128. Too low

Condition: • [Too low](#)

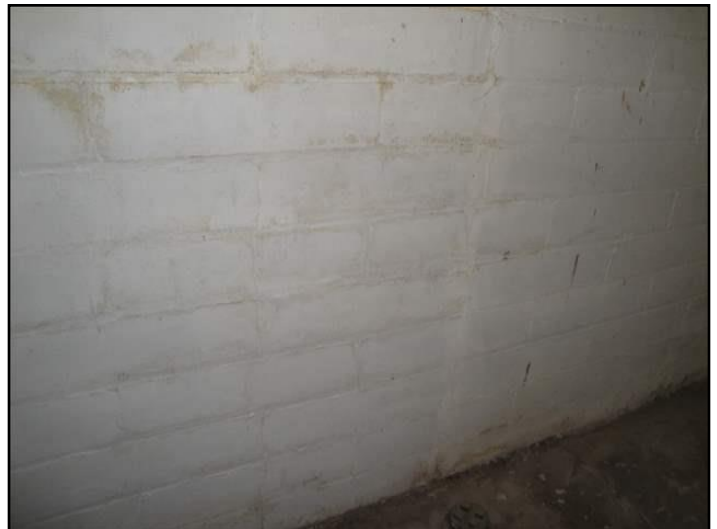
133. Efflorescence

Condition: • [Efflorescence](#)

Grading improvements and mortar repair or crack sealing are recommended to prevent further damage and moisture intrusion.

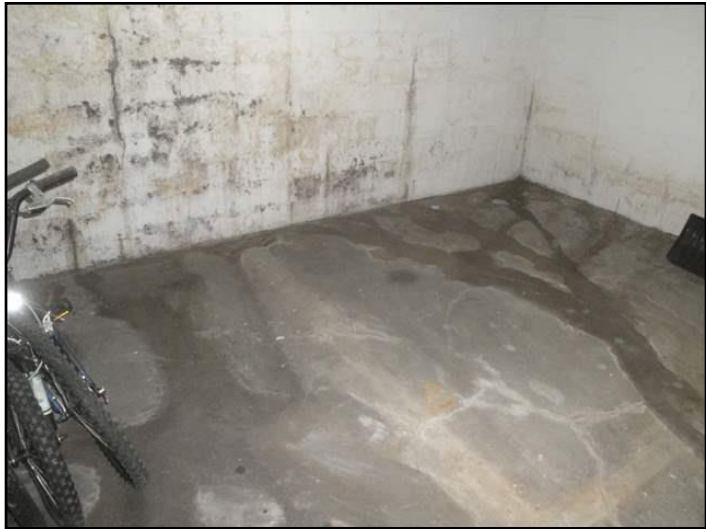
135. Stains

Condition: • [Stains](#)

Grading improvements and mortar repair or crack sealing are recommended to prevent further damage and moisture intrusion.
