PROPERTY CONDITION ASSESSMENT REPORT

999

Minneapolis Area, MN

Friday, March 6, 2015

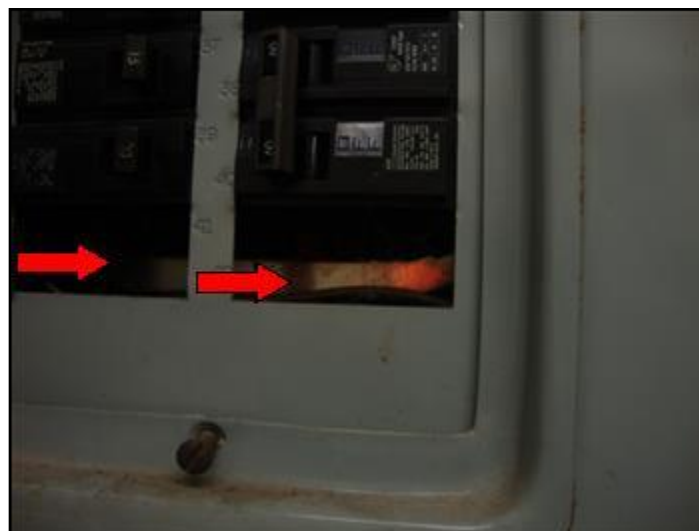
3. Condition: • Unprotected openings
Location: Basement
Task: Repair
Time: Immediate

1. Unprotected openings

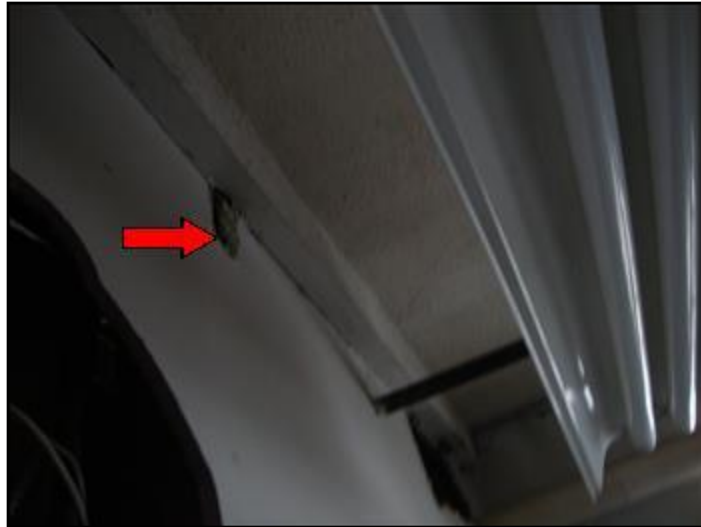
2.

6. Condition: • Missing

Task: Repair

Time: Immediate

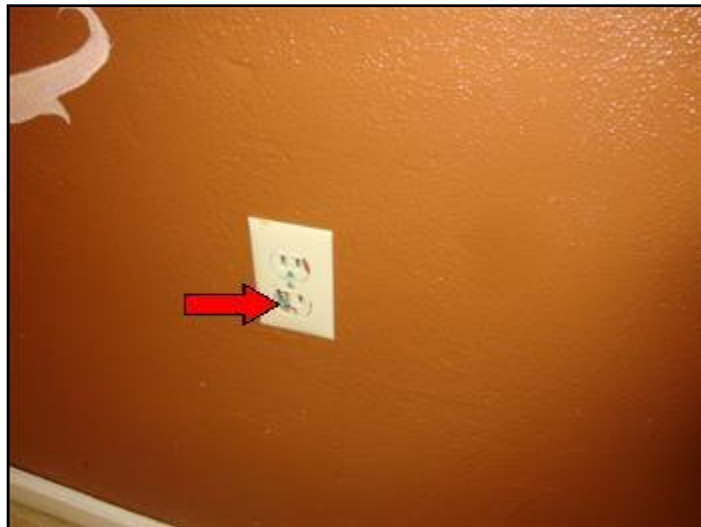
3.

7. Condition: • Damaged outlet

Task: Repair

Time: Immediate

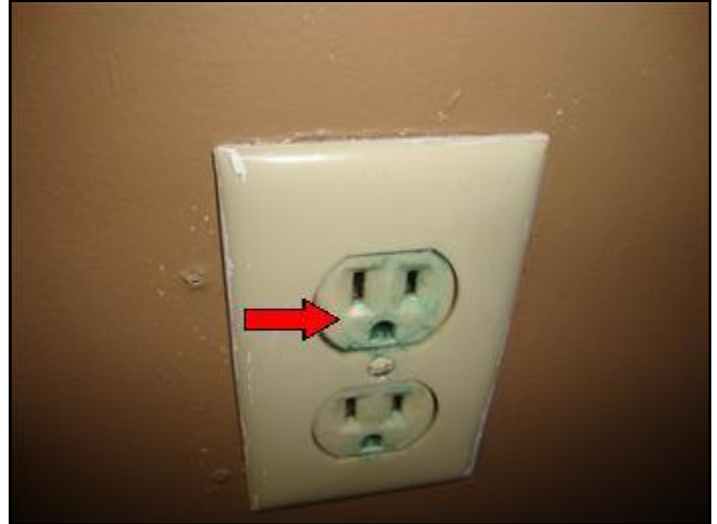
5.

8. Condition: • Corroded outlets. Green oxidation of copper suggests evidence of past flooding or water damage. Recommend receptacles are assessed by a licensed electrician and replaced if necessary.

Task: Further evaluation - Replace

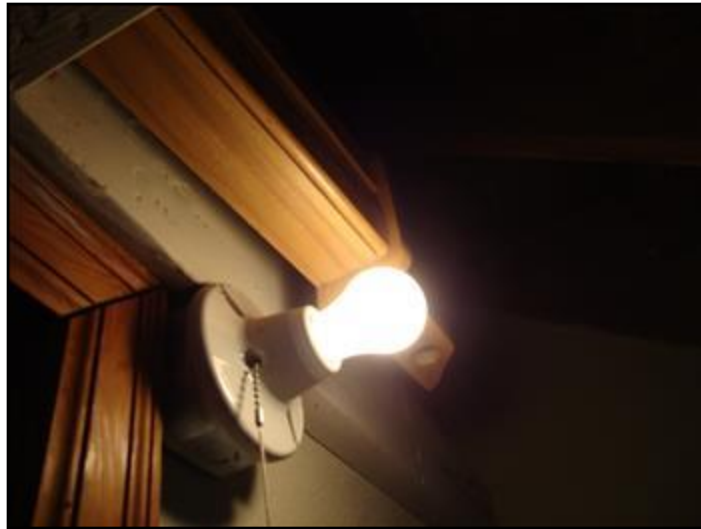
6.

12. Condition: • Improper closet lighting. Keep combustibles away from open lamps, add globes to lamps or replace fixtures.

Task: Below current standards

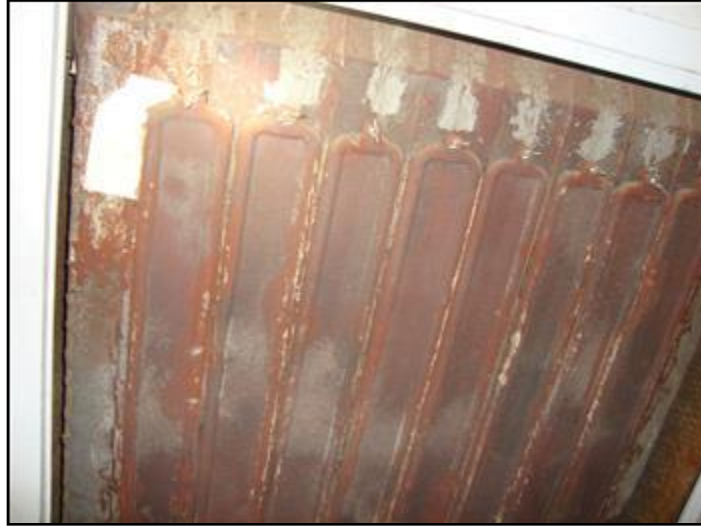
18. Condition: • Corroded casing

7. Corroded casing

Task: Service annually

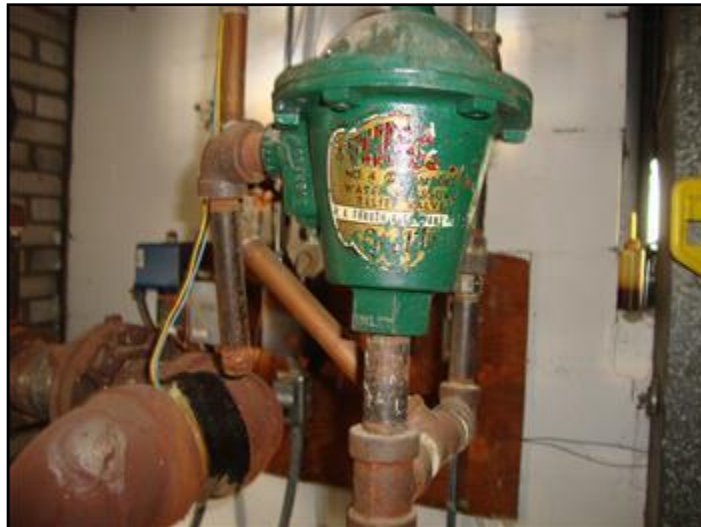
9.

22. Condition: • Corrosion observed on boiler pipes

Task: Monitor

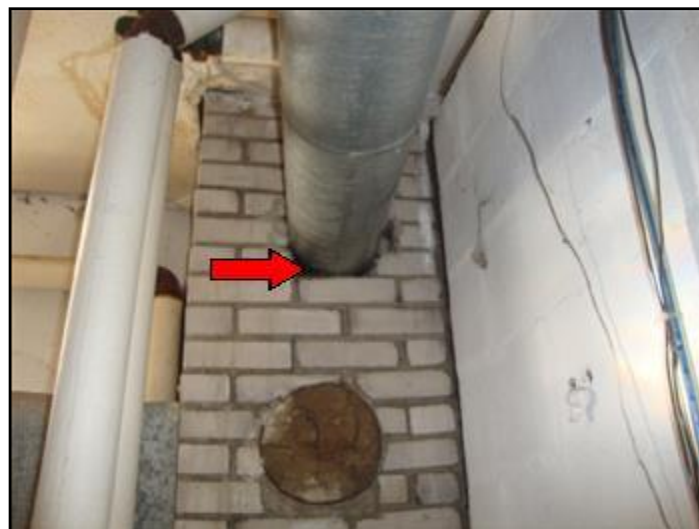
28. Condition: • Poor seal

Vent connector loose at chimney

12. Poor seal

Task: Repair

Time: Immediate

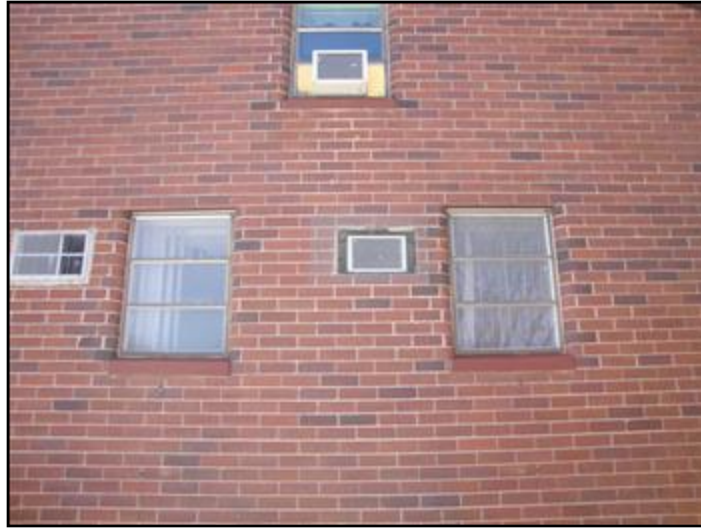
13.

30. • Air conditioner missing window sleeve. Potential for water intrusion.

Task: Repair

Time: Less than 1 year

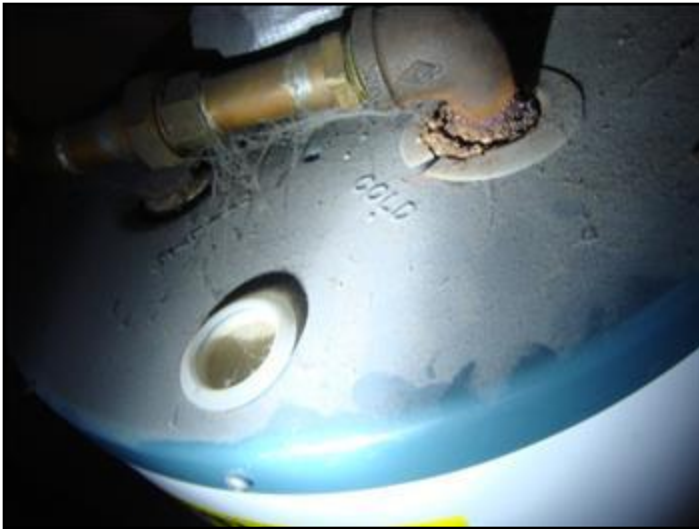
41. Condition: • Evidence of past leakage noted

Corrosion observed at multiple locations. Galvanized to copper connections which promote corrosion of these dissimilar metals.

15. Evidence of past leakage noted

Task: Repair

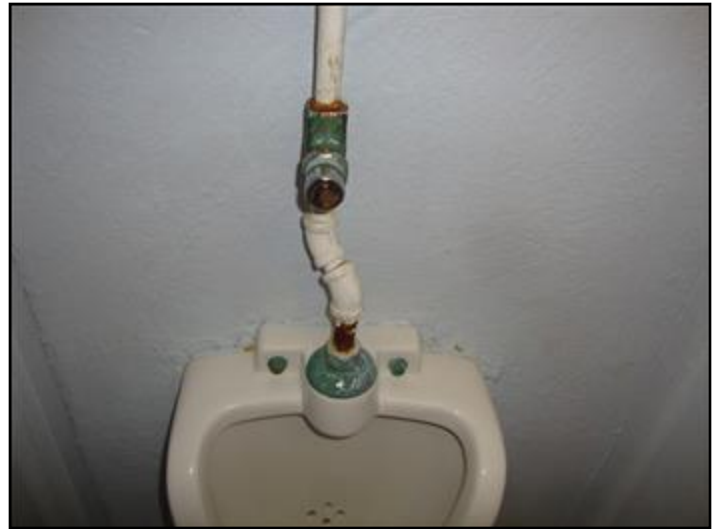
16. Evidence of past leakage noted

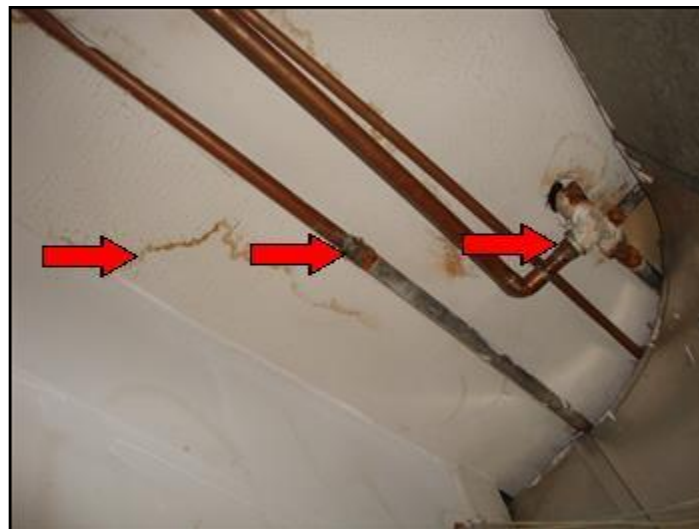
17. Evidence of past leakage noted

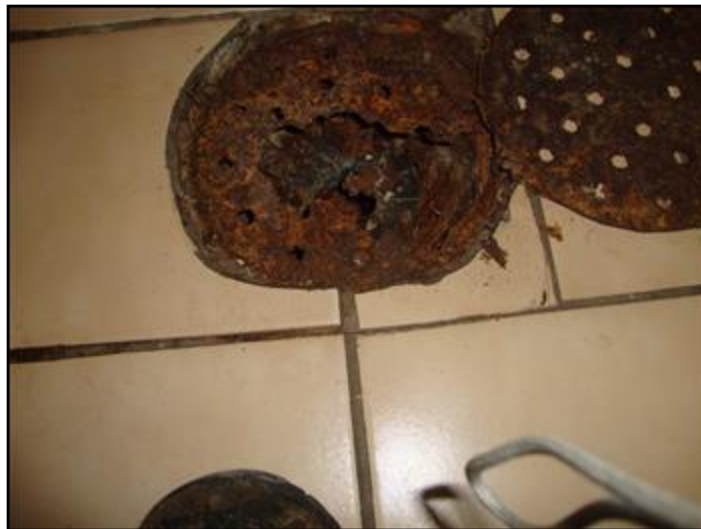
18.

43. **Condition:** • Rusted floor drain covers

Task: Repair

Time: Less than 1 year

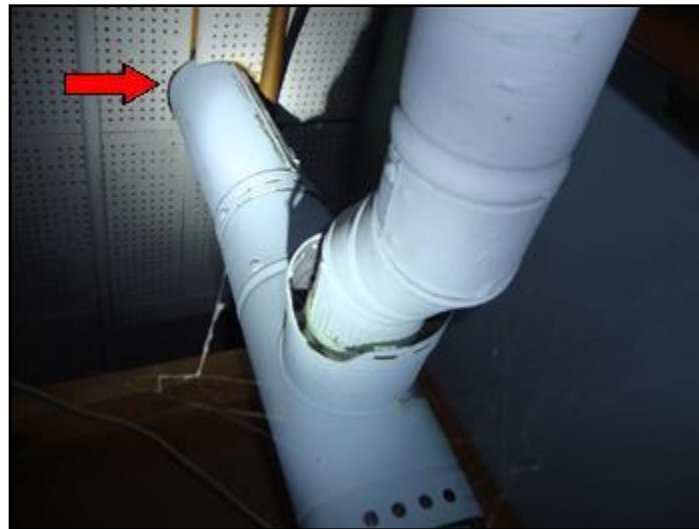
19.

48. Condition: • Combustible clearance to vent pipe does not meet current standards

Metal chimney combustible clearances

Task: Repair

Time: Immediate

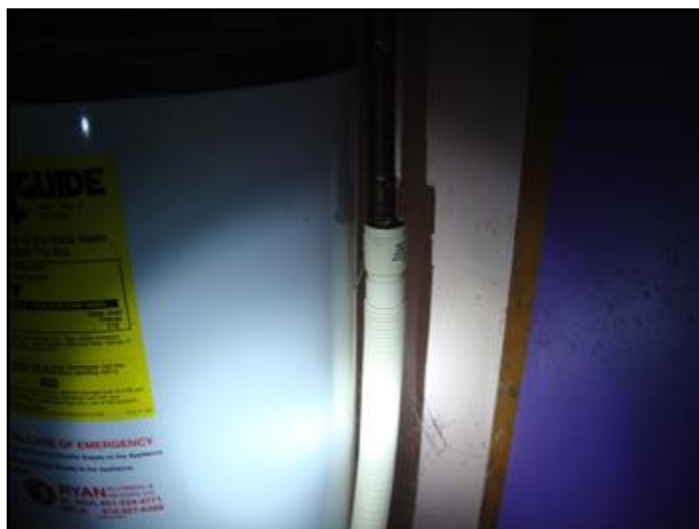
51. Condition: • Missing discharge from the pressure relief valve

21. Missing discharge from the pressure relief...

Task: Repair

Time: Immediate

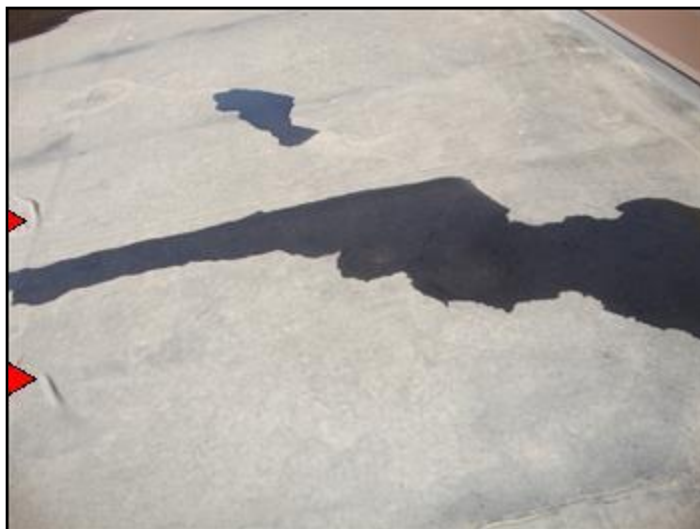
61. Condition: • Wrinkling noted

23. *Wrinkling noted*

Task: Monitor

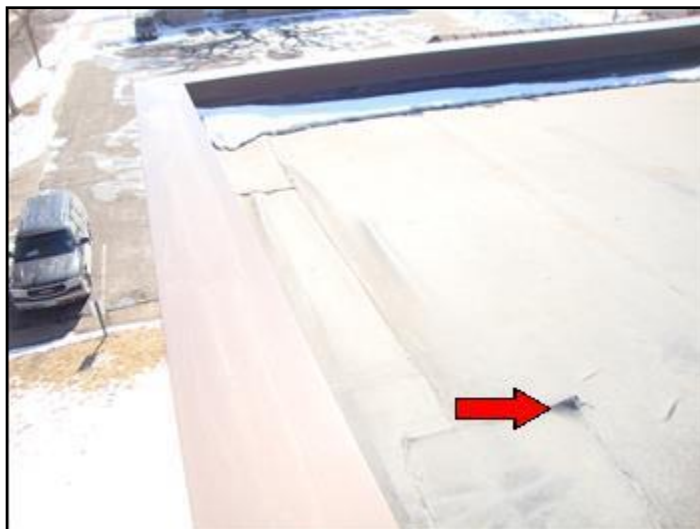
62. Condition: • Open seams at lap joints

24. *Open seams at lap joints*

Task: Repair

Time: Immediate

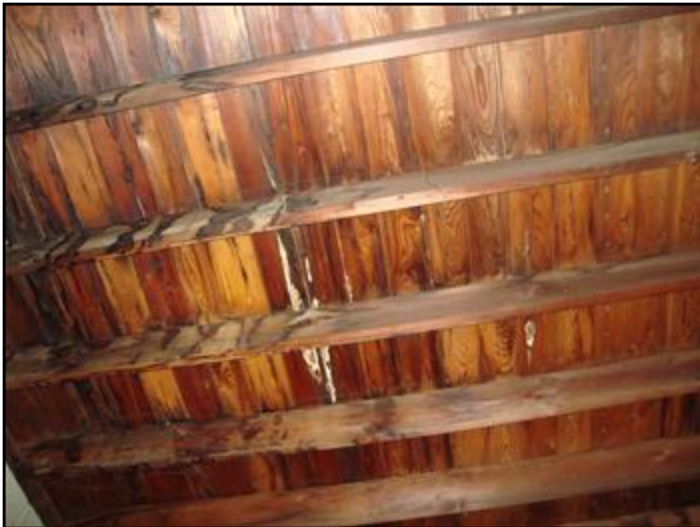
63. Condition: • Leakage noted

Evidence of past leaks. It could not be determined if active leaks are present.

25. Leakage noted

Task: Monitor Request disclosure

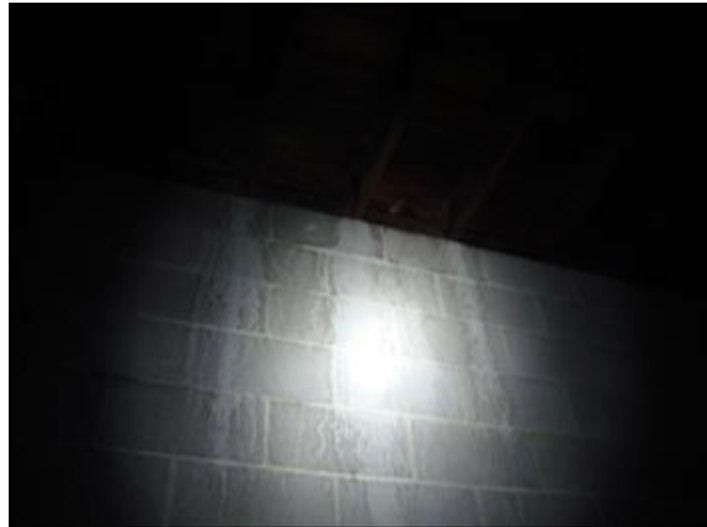
26. Leakage noted

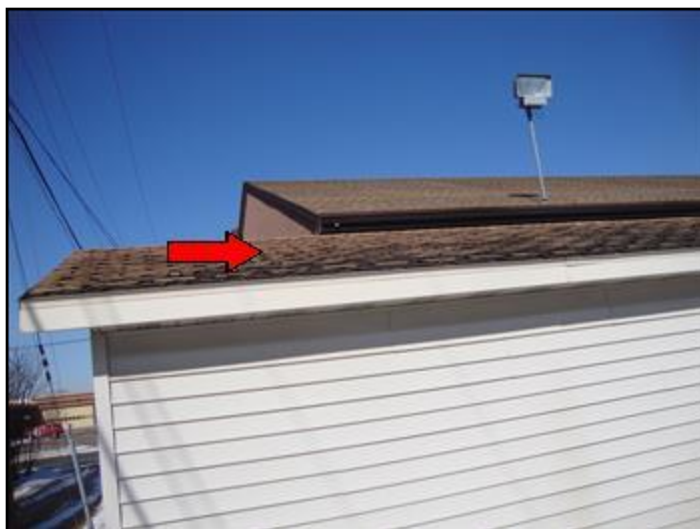
65. Condition: • Curled

27. Curled

Task: Repair

Time: Less than 1 year

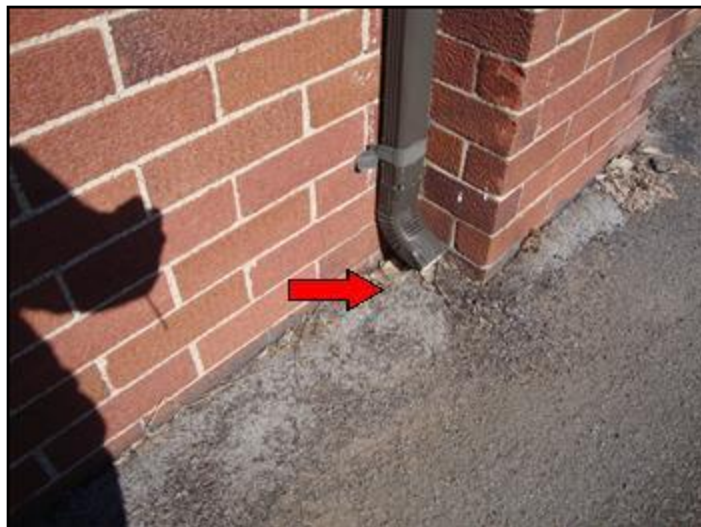
67. Condition: • Discharging too close to building structure

29. *Discharging too close to building structure*

Task: Repair

Time: Immediate

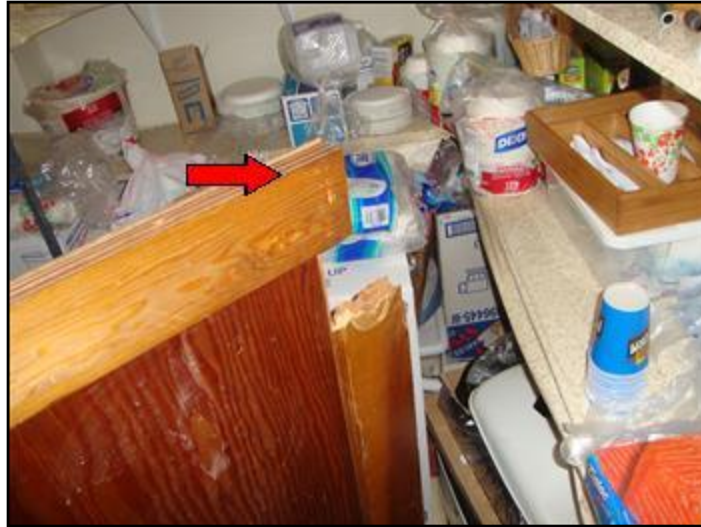
30.

71. Condition: • Broken door

Task: Replace

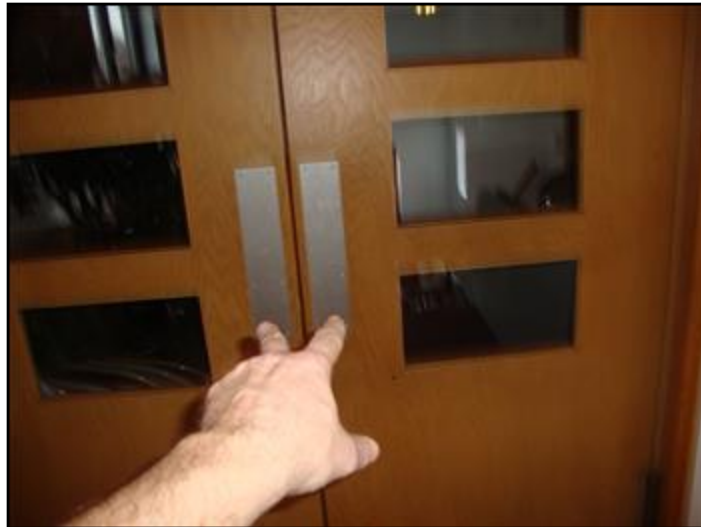
31.

72. Condition: • Two way doors at sanctuary

Task: Below current standards

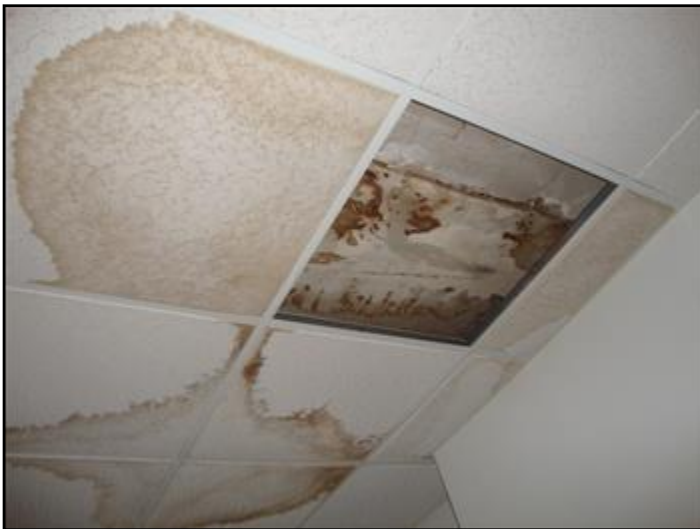
76. Condition: • Water stain

33. Water stain

Task: Monitor Repair

Time: Less than 1 year

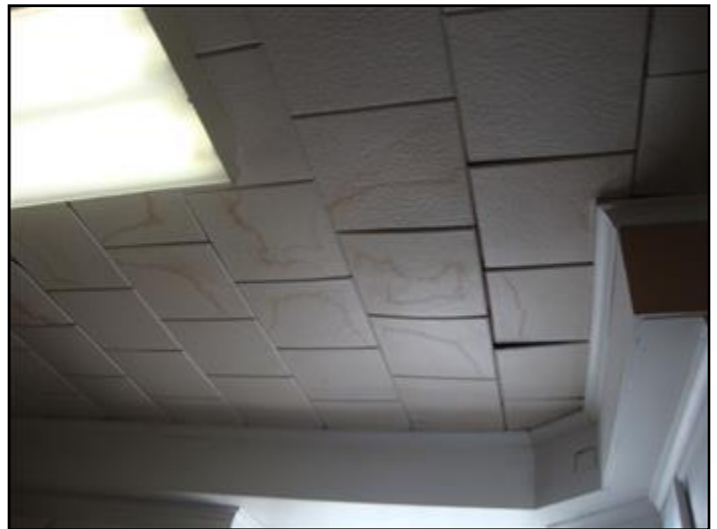
34. Water stain

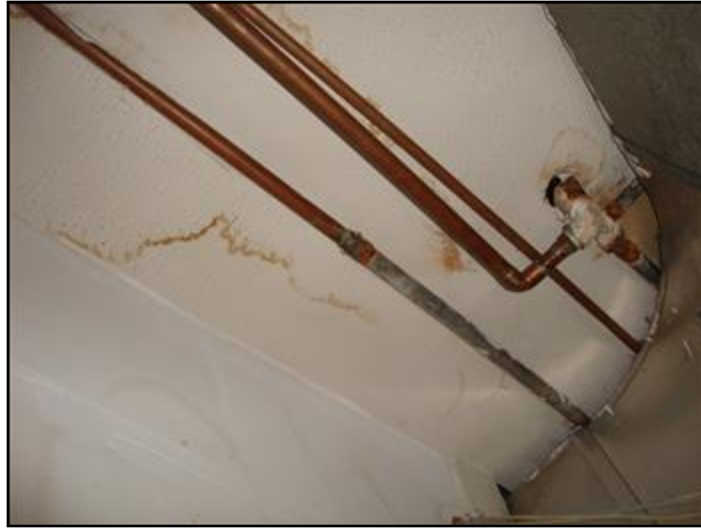
35. *Water stain*

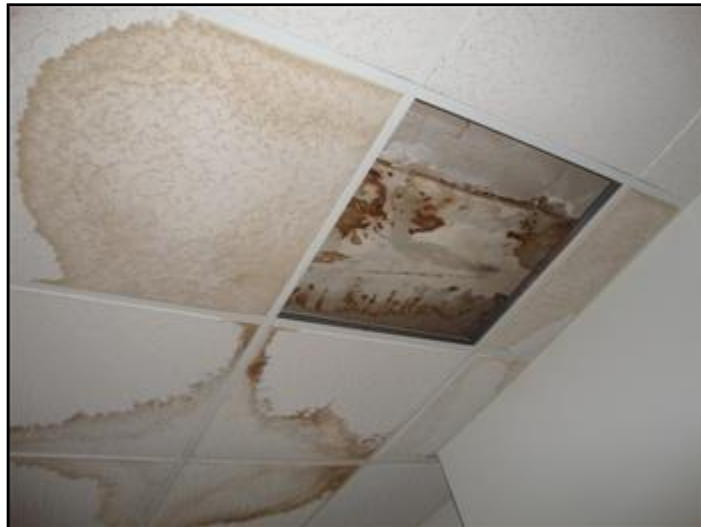
77. Condition: • Damaged

36. *Damaged*

Task: Repair

Time: Less than 1 year

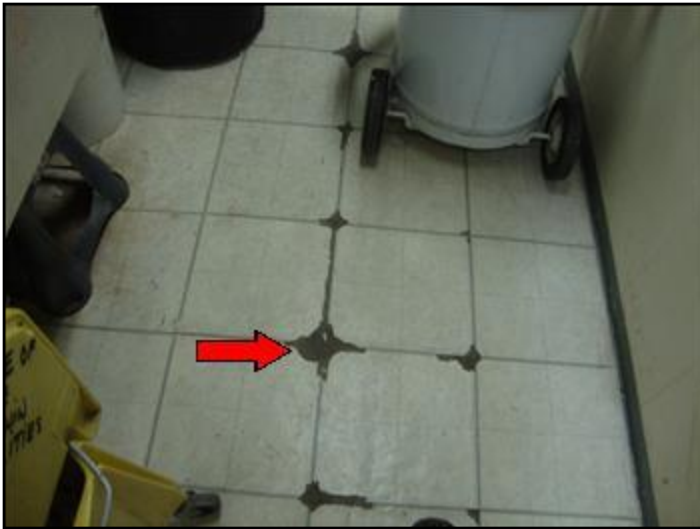
78. Condition: • Cracked tiles

37. Cracked tiles

Task: Repair or replace

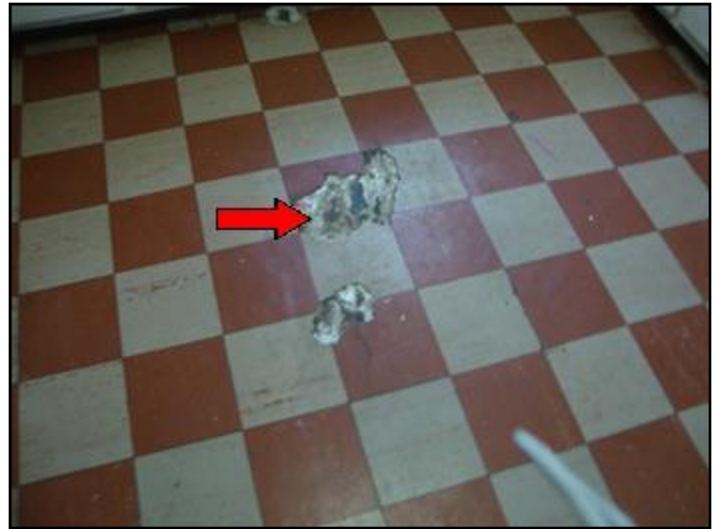
38. Cracked tiles

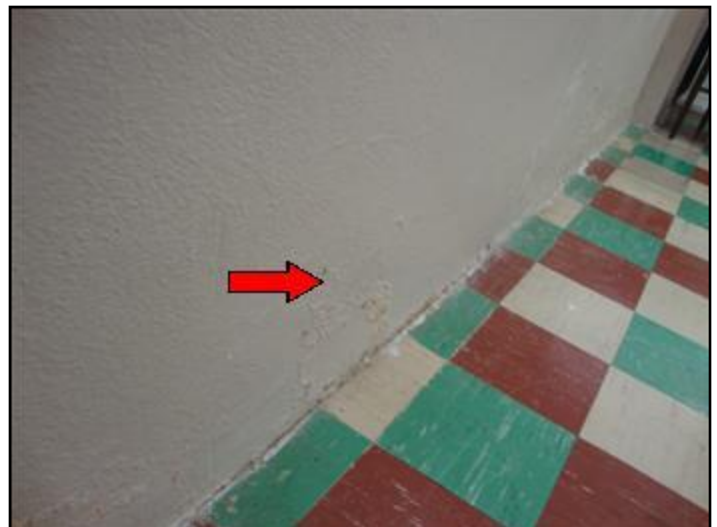
80. Condition: • Efflorescence

39. Efflorescence

Task: Monitor - Repair

Time: Less than 1 year

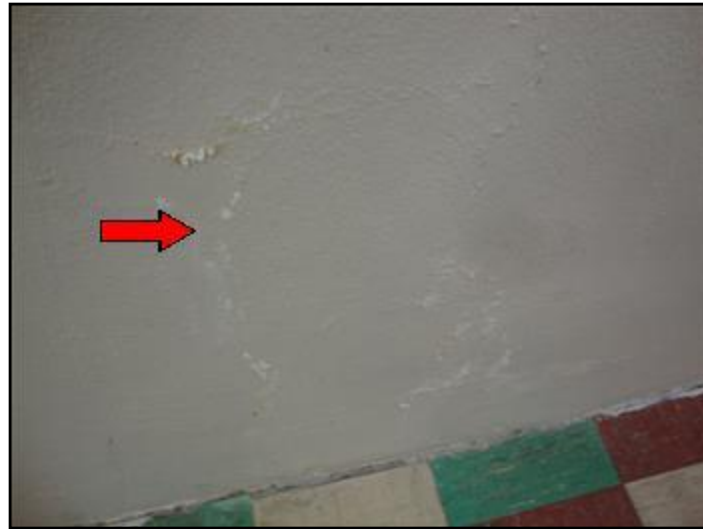
41. Efflorescence

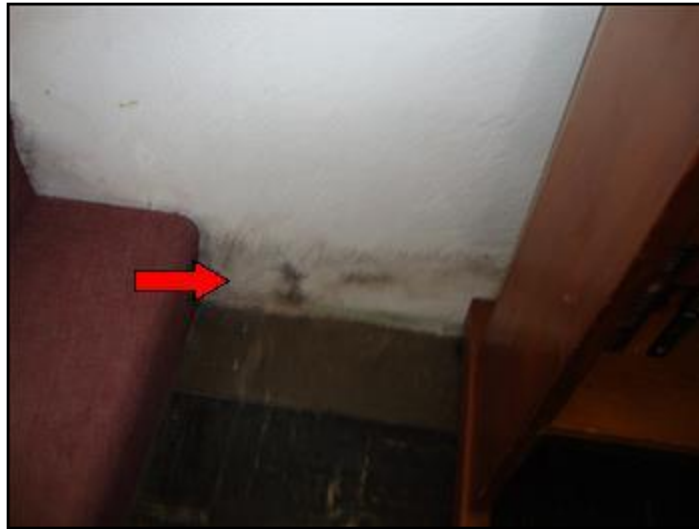
81. Condition: • Staining

42. Staining

Task: Monitor - Repair

Time: Less than 1 year

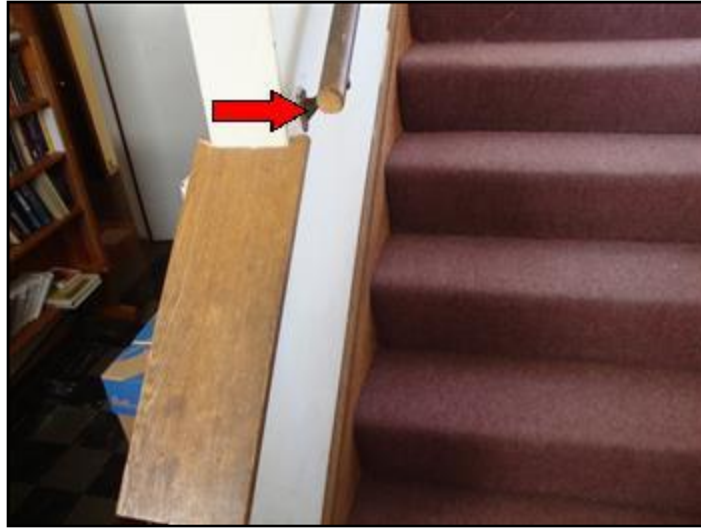
43.

88. Condition: • Too short. Does not extend to nose of first tread.

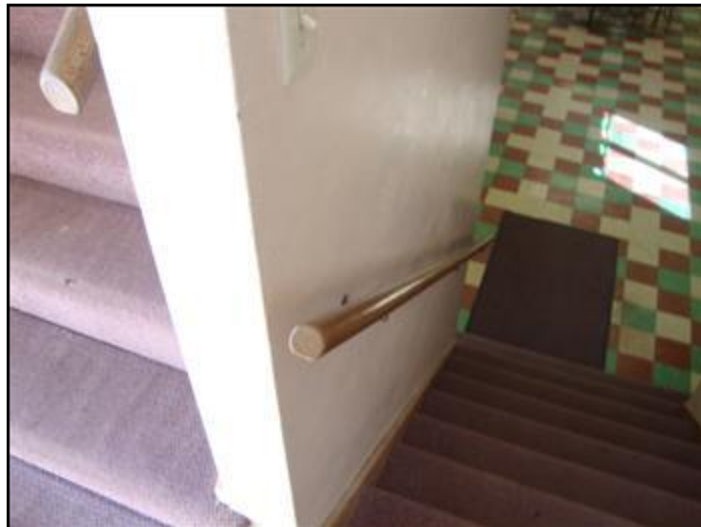
90. Condition: • Loose

44. Loose

Task: Repair

Time: Immediate

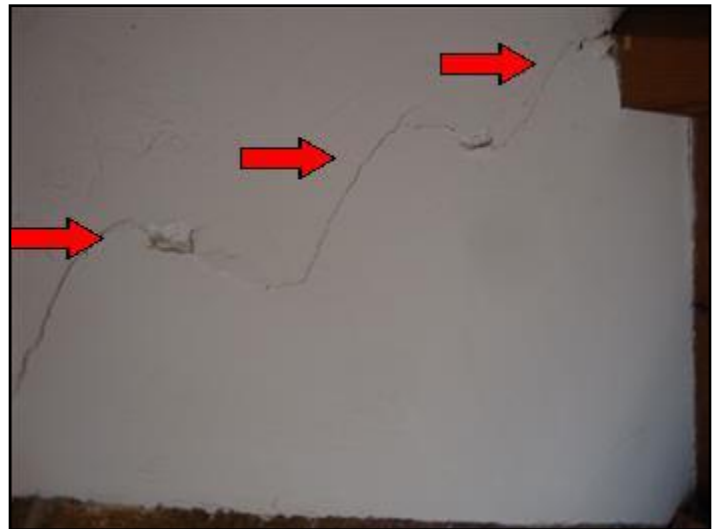
47. Settlement cracks noted

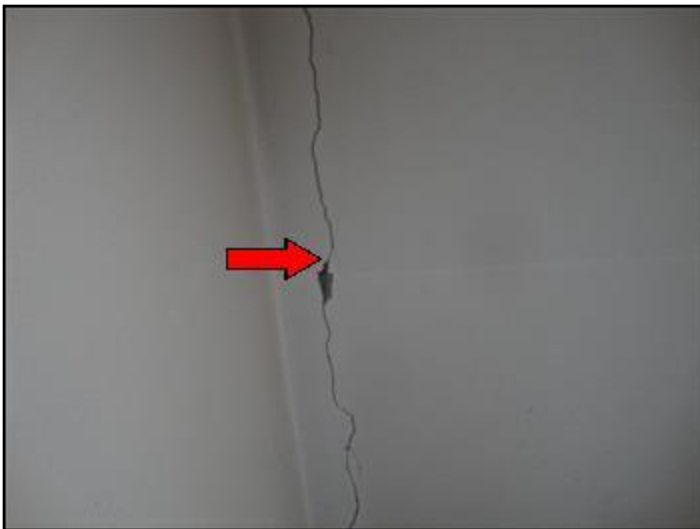
48. Settlement cracks noted

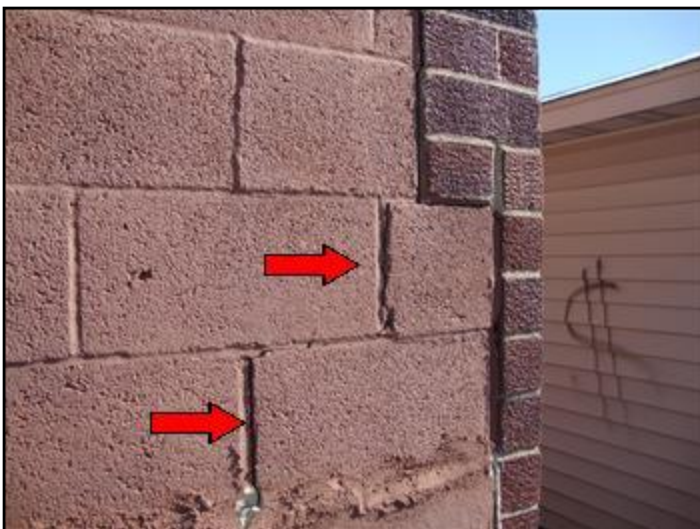
50. Settlement cracks noted

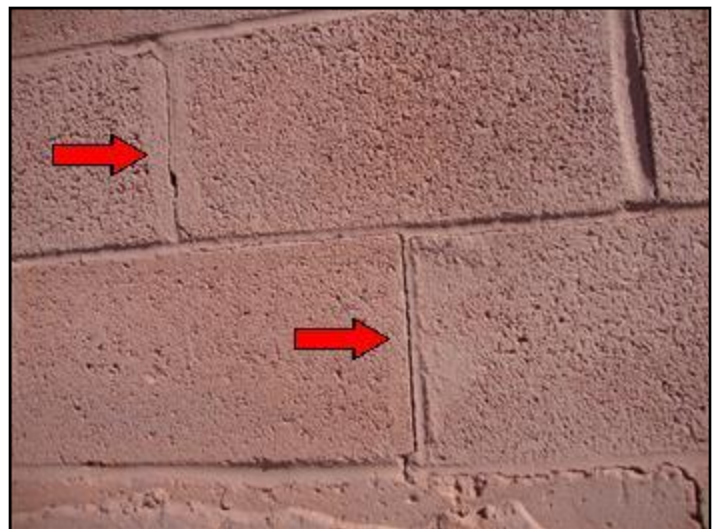
51. Settlement cracks noted

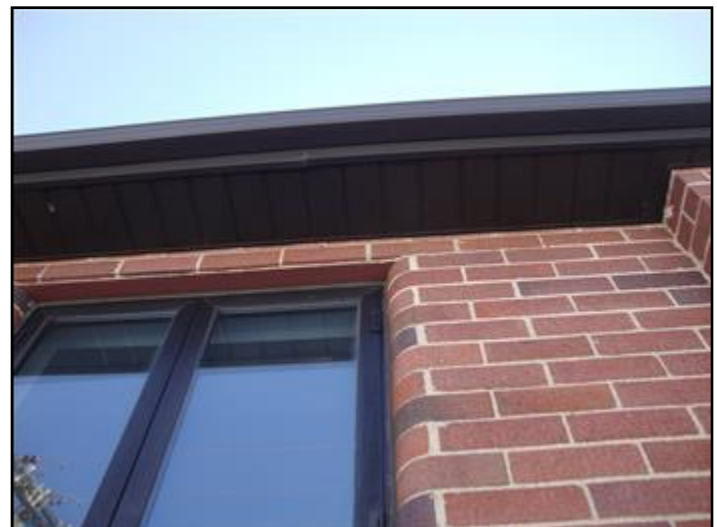
54. Corroded

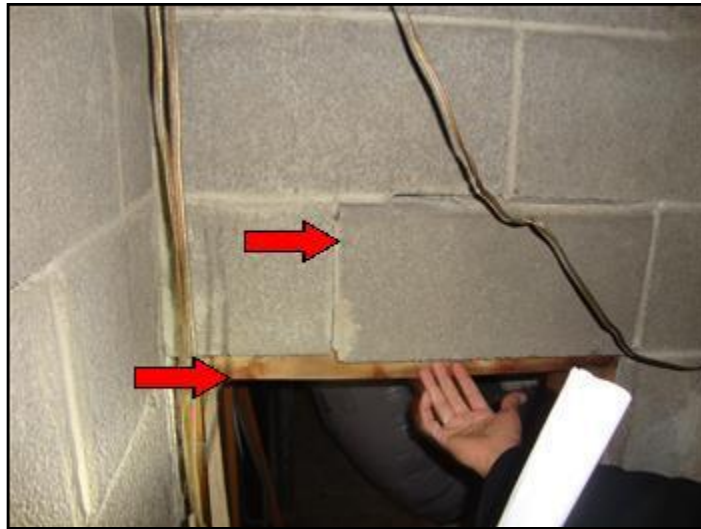
99. Condition: • Missing

55. Missing

Time: Less than 1 year

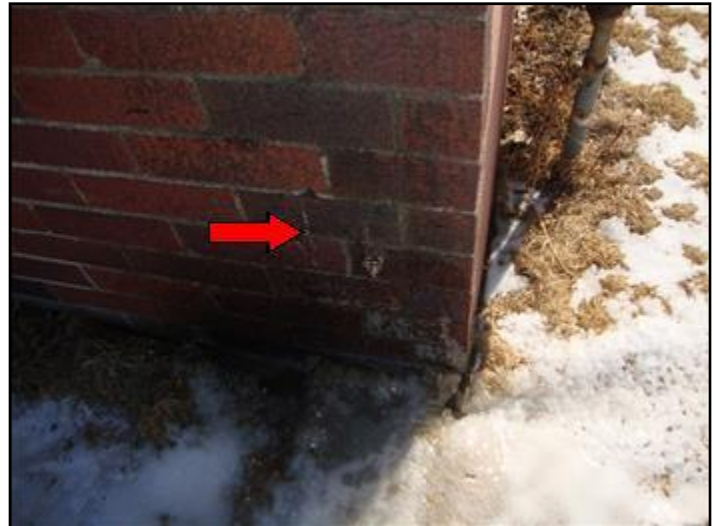
57. Water damage

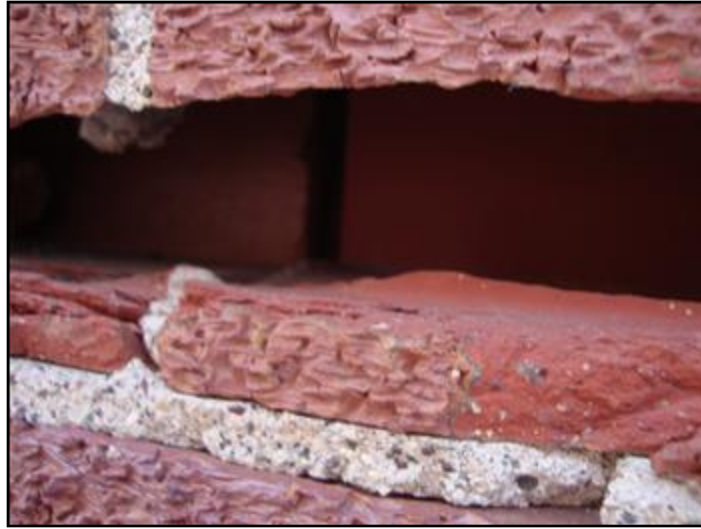
58. *Water damage*

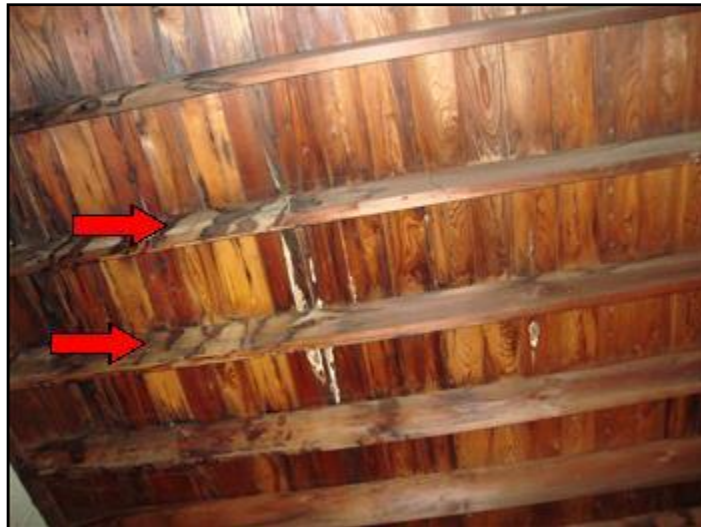
59. *Water stains*

Task: Monitor

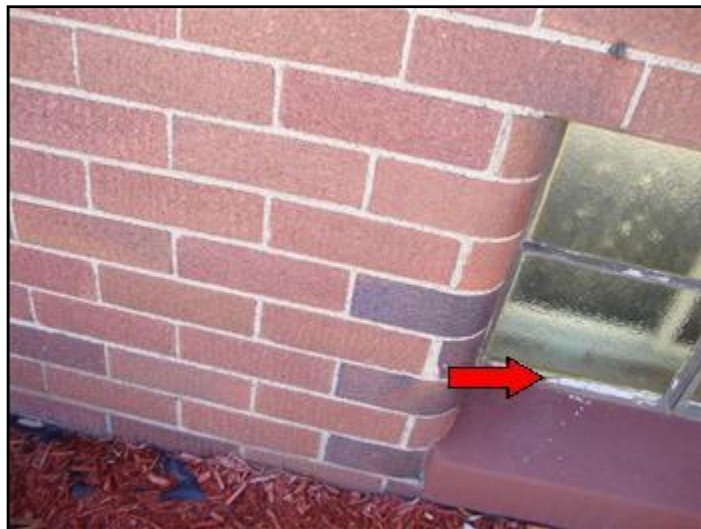
116. Condition: • Old single-glazed, metal-frame
Deteriorated glazing putty.

68. *Old single-glazed, metal-frame*

Task: Repair

Time: Less than 1 year

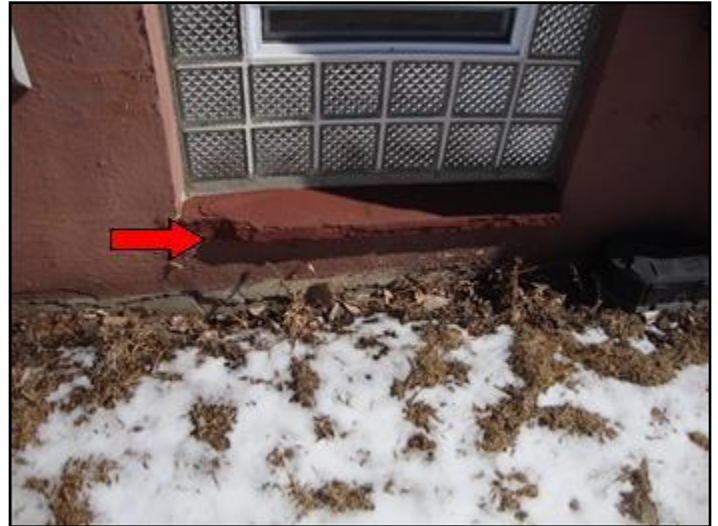
70. Deteriorated

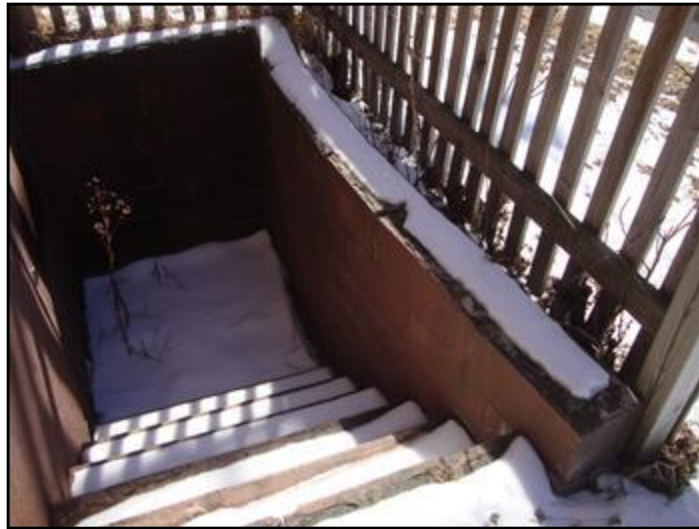
120. Condition: • Missing drain

73. Missing drain

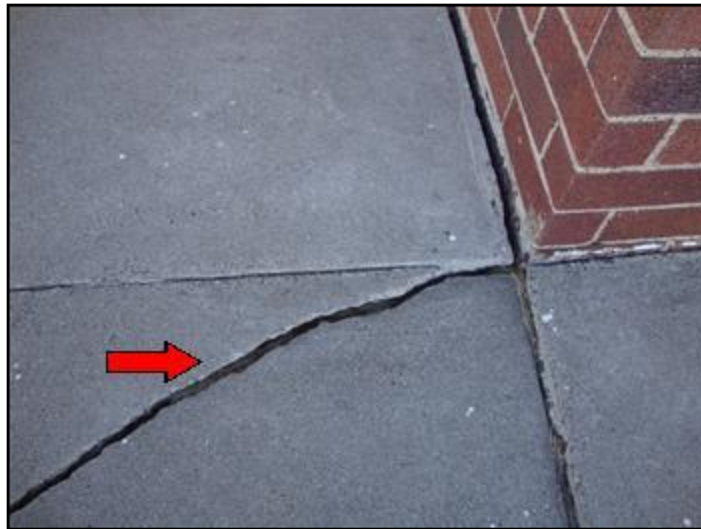
74. Cracked

Task: Repair

Time: Less than 1 year

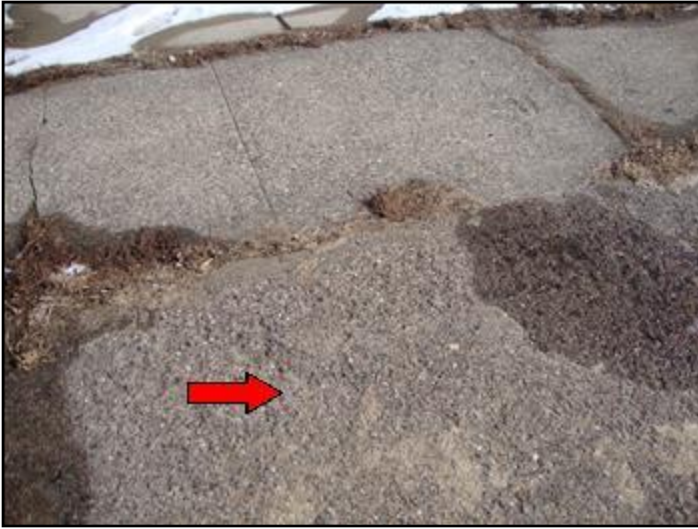
124. Condition: • Deteriorated

75. Deteriorated

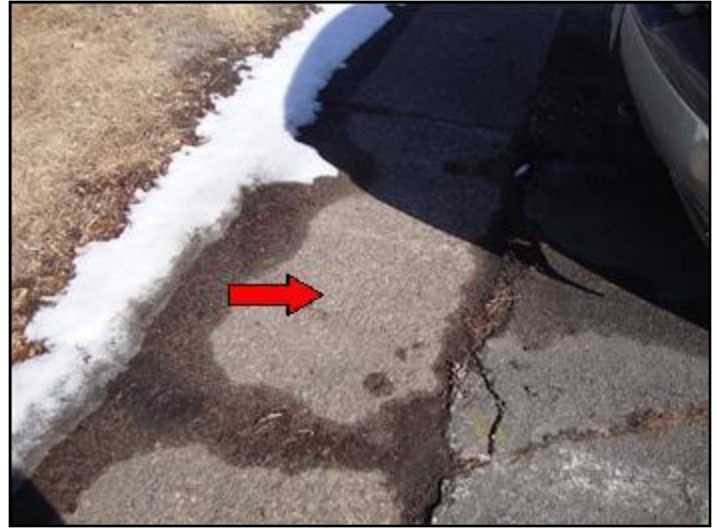
76. Deteriorated

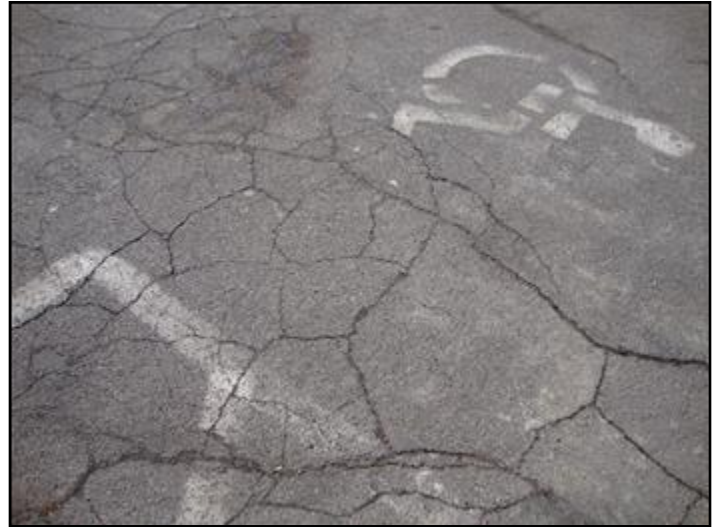
77. Poor overall condition

Task: Repair or replace

Time: Less than 1 year

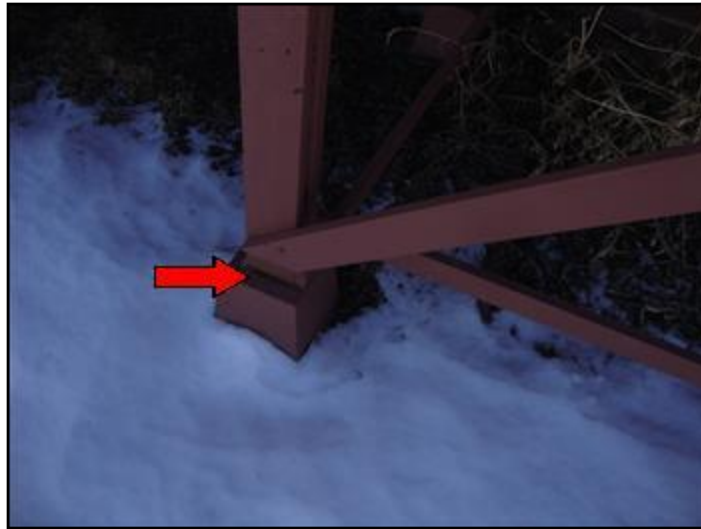
82. *Loose support at the base*
