**Daniels Loft COA**  
**104 – 108 Tejon Street**  
**Colorado Springs, CO 80903**

**Level 1 Reserve Analysis**

**Report Period – 01/01/11 – 12/31/11**

**Second  
Draft**

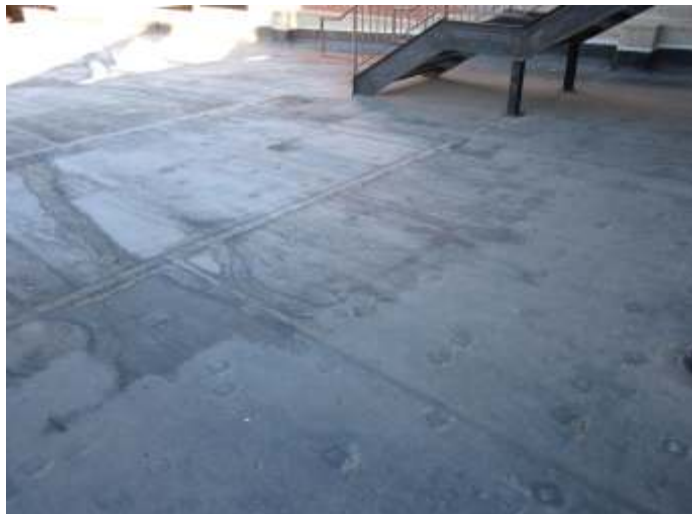
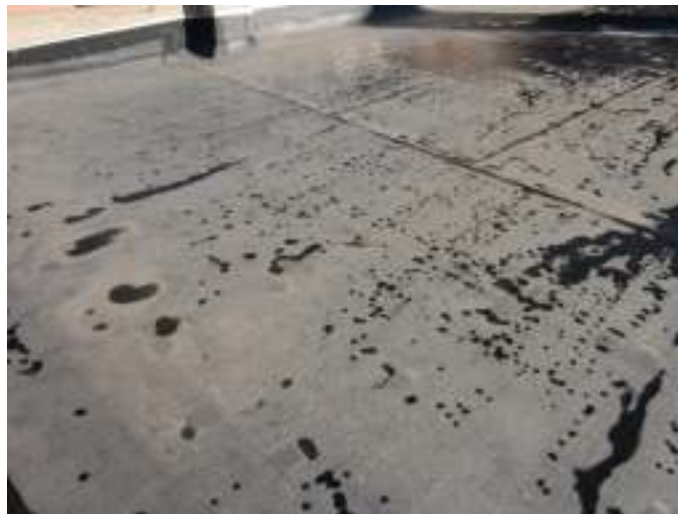
Comp #: 103 EPDM Flat Roof - Replace

Unable to access the upper roof at time of inspection due to access and safety measures. The middle and upper roofs are assumed to be similar to the upper roof as far as conditions and type of material. Middle and lower roofs were in good condition with no lifted or loose seems. Some of the roofs were covered in ice and snow, so we were unable to check these areas. No other unusual conditions observed or reported during inspection. There were no reports of leaks or problems. This type of material has a life expectancy of 18 - 22 years with proper maintenance and limited exposure to foot traffic.

\$750/square; Estimate to replace

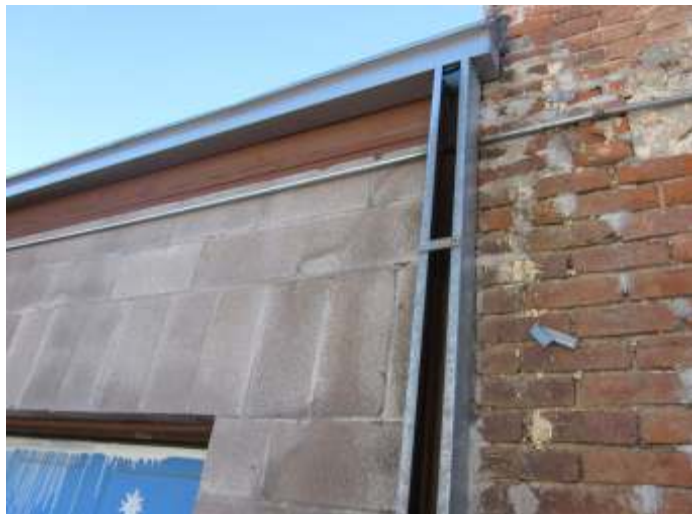
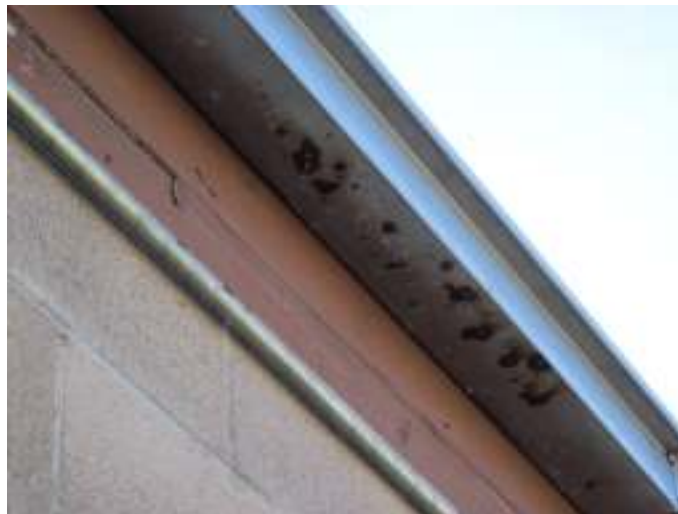
Comp #: 120 Gutters/Downspouts - Replace

The raingutter along the top of the garage entrance/exit is rusted and corroded through and water is leaking through the pinholes. The downspout is also slightly damaged. Due to the small area of gutters and downspouts, we recommend treating repairs on an as needed basis with general operating funds. Therefore, separate Reserve funding is not required for this component at this time.

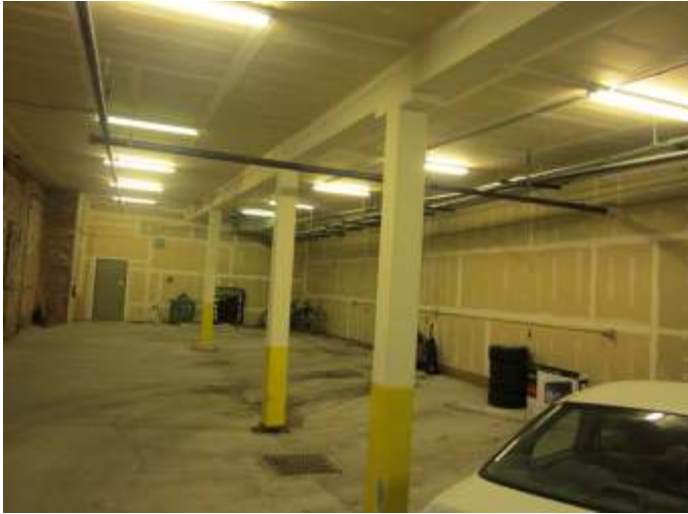
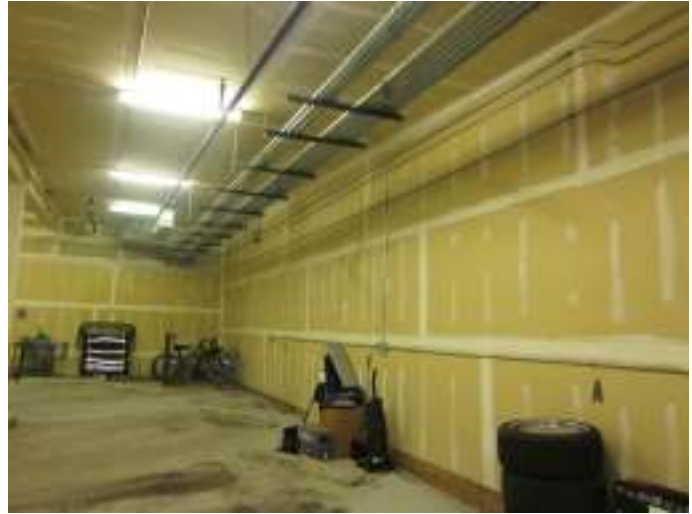
Comp #: 203 Garage Walls/Surfaces - Repaint

Surfaces are not currently painted, so Reserve funding is not required at this time. If association decides to paint these surfaces, expect to spend between \$4000 - \$4500 for the work and repaint every 10 - 15 years.

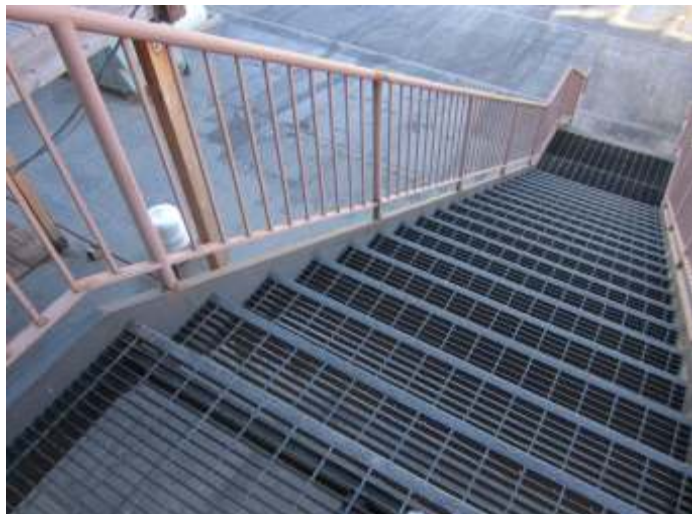
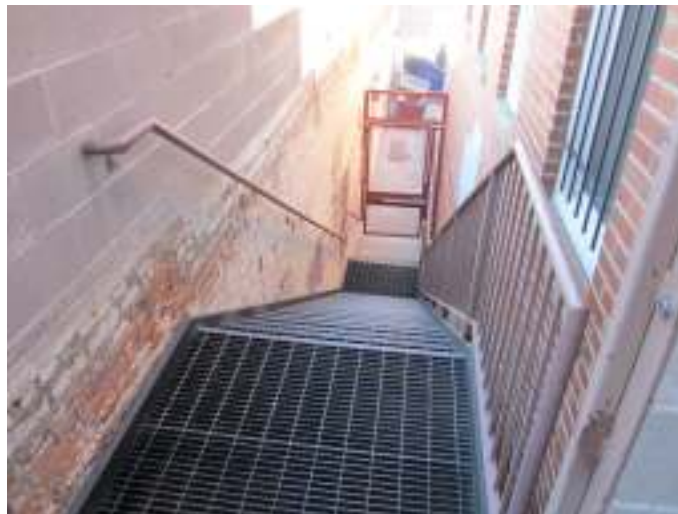
Comp #: 212 Metal Surfaces - Repaint

Paint was faded and dull in appearance, as well as showing a few signs of rust. We originally recommended painting these railings on an as needed basis as an operating expense to protect the materials from further rusting and deterioration. However, it was requested by the current Board of Directors to add Reserve funding for periodic painting of these surfaces. Therefore, we have established painting every 5 years to these surfaces at this time.

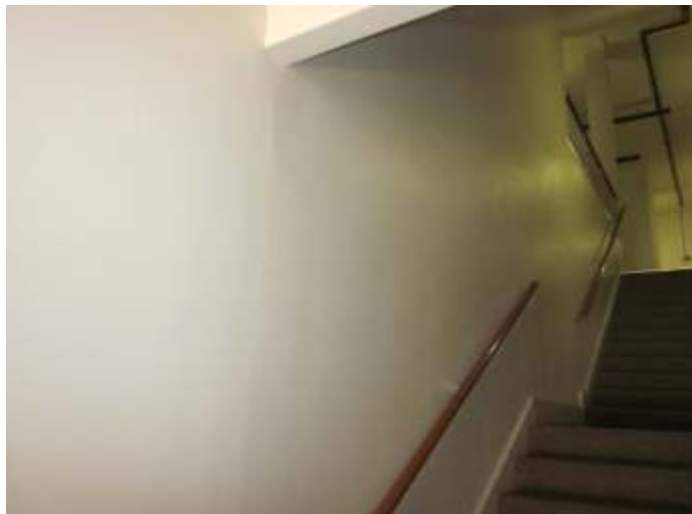
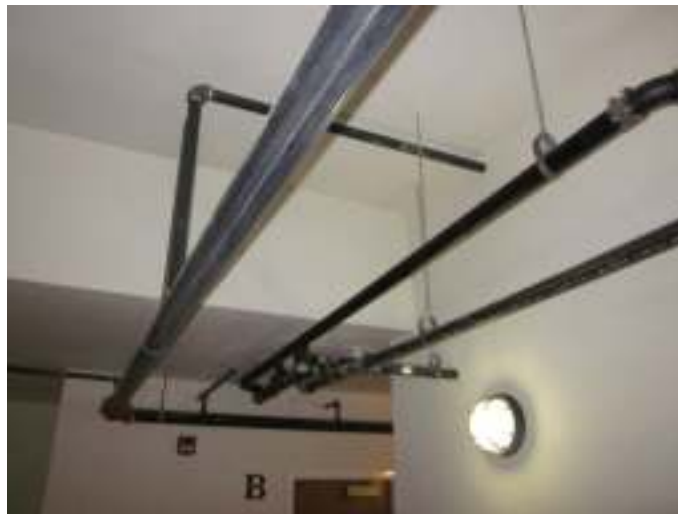
Comp #: 216 Interior Surfaces - Repaint

Surfaces are generally in good to fair condition with no major signs of wear or marks. Depending on the level of use and abuse, expect to repaint these surfaces every 10 - 15 years. The remaining life is based on the observed conditions and age of the surfaces. In between painting cycles, we recommend touching up areas on an as needed basis with general operating funds.

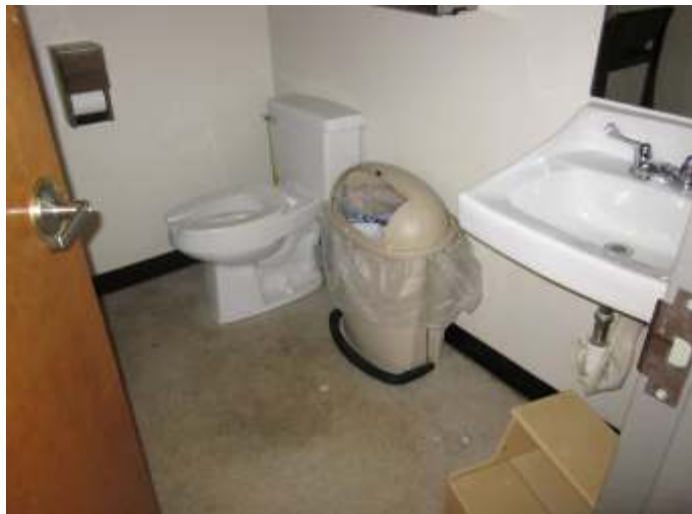
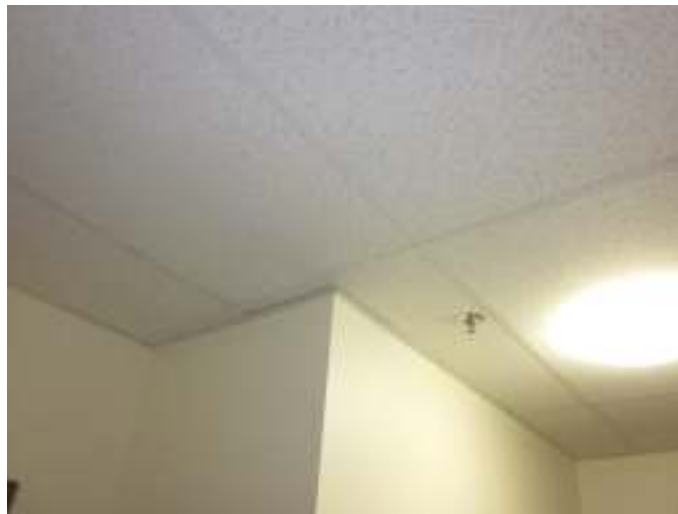
Comp #: 217 Restrooms and Hallway - Repaint

The paint was nicked and marked up and in need of a fresh coat of paint. It was originally recommended that touch up painting was to occur as needed with general operating. However, it was requested that Reserve funding be included for periodic painting. Due to the observed conditions, we recommend establishing funding to repaint these surfaces every 5 years.

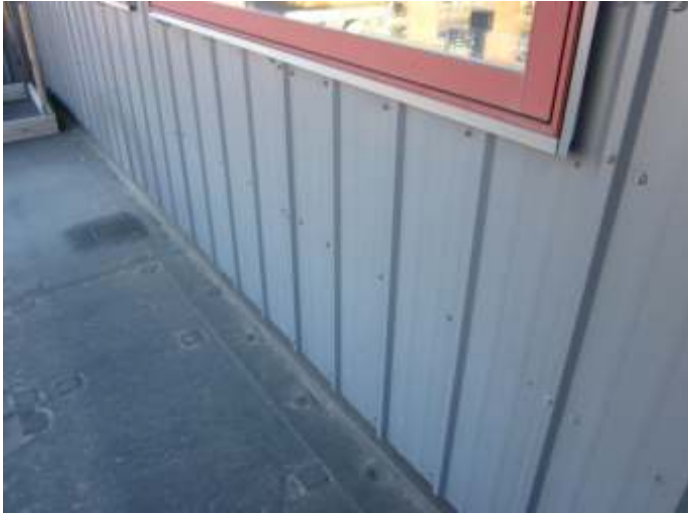
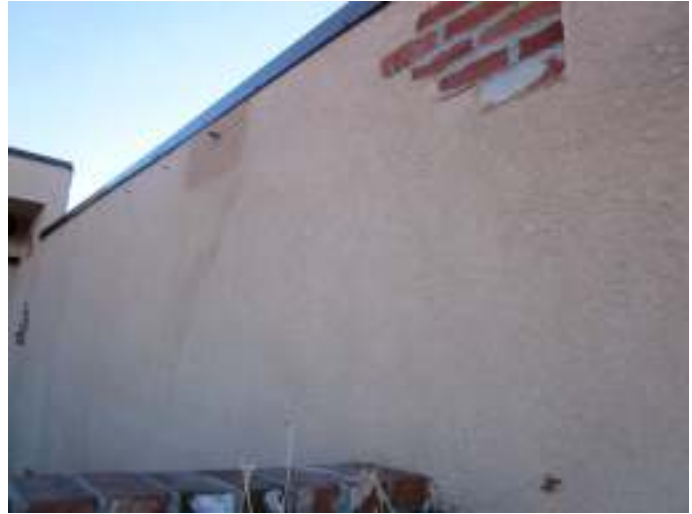
Comp #: 305 Miscellaneous Siding - Replace

No unusual conditions observed during inspection. The overall area is too small for separate Reserve designation. Include repairs with brick siding, or treat on an as needed basis with general operating funds.

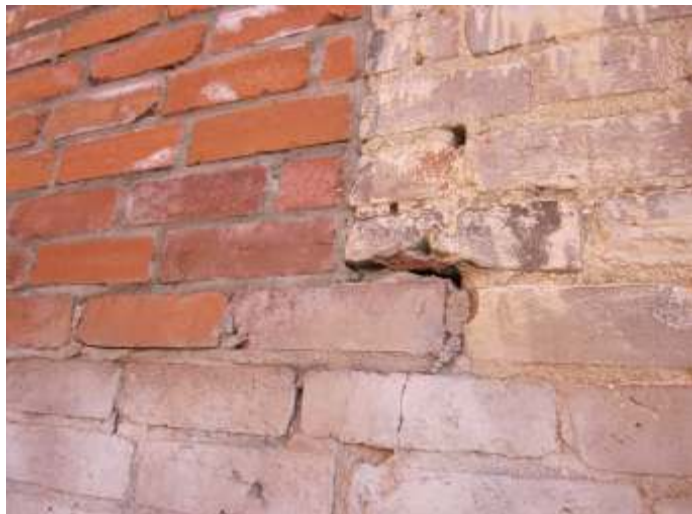
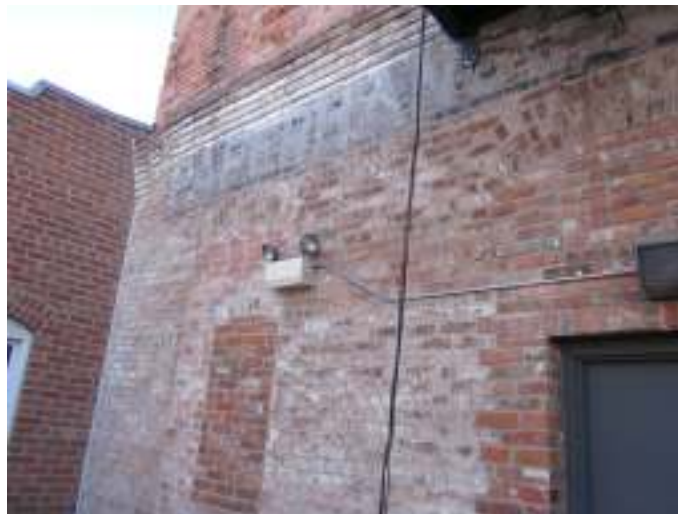
Comp #: 306 Brick - Major Repairs

This brick work is very old, original to the date of construction of the building back in the late 1800's. Over the years, there have been numerous repairs and sections of the walls that have been replaced. Due to the age of the building, we recommend establishing a Reserve allowance for periodic repairs to the brick work every 7 years. The remaining life is based on overall observed conditions during property inspection.

Allowance for major repairs every 7 years

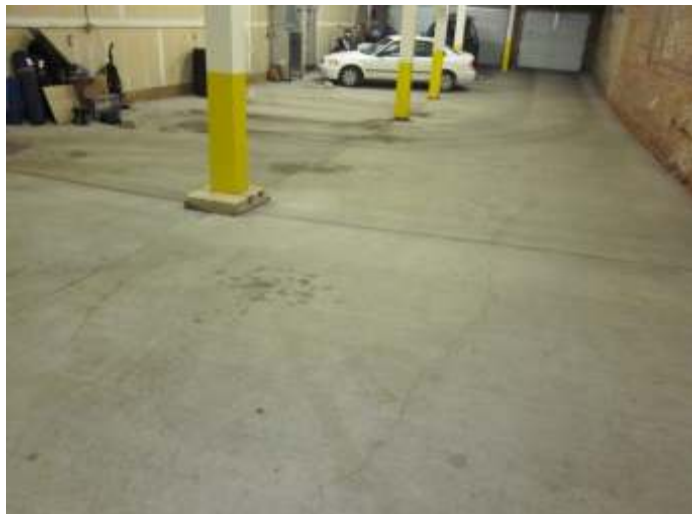
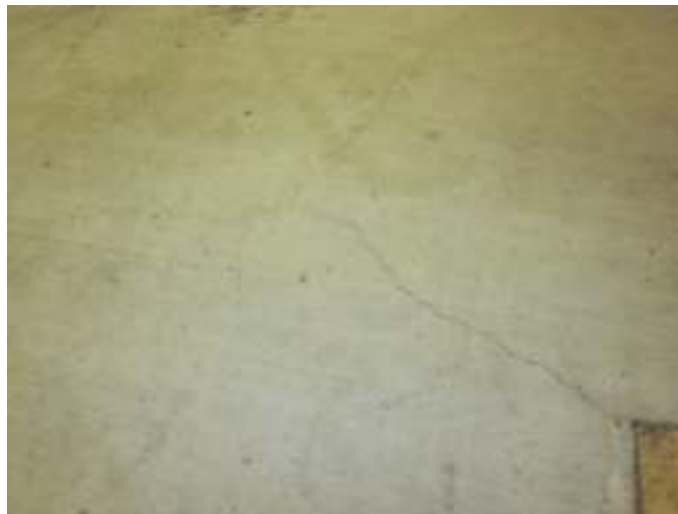
Comp #: 403 Concrete - Repair/Replace

It was observed there was a few hairline cracks noted at time of inspection. These surfaces are not exposed to elements (freeze/thaw and ice) that will cause these surfaces to worsen. Continue to monitor and repair on an as needed basis with general operating funds. At this time, separate Reserve funding is not required for this component.

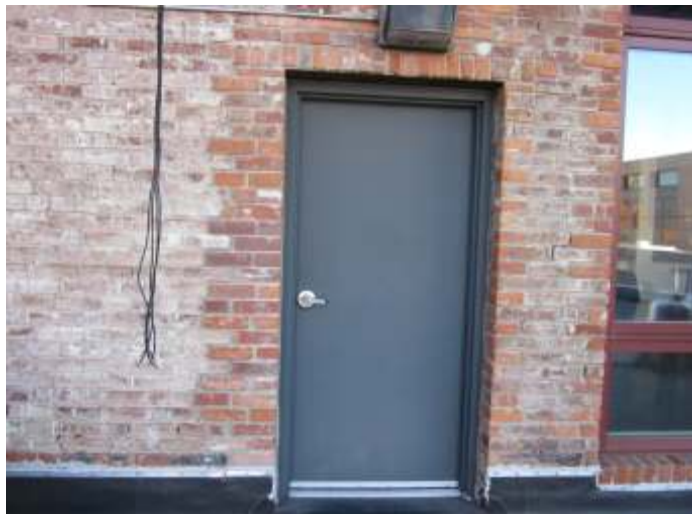
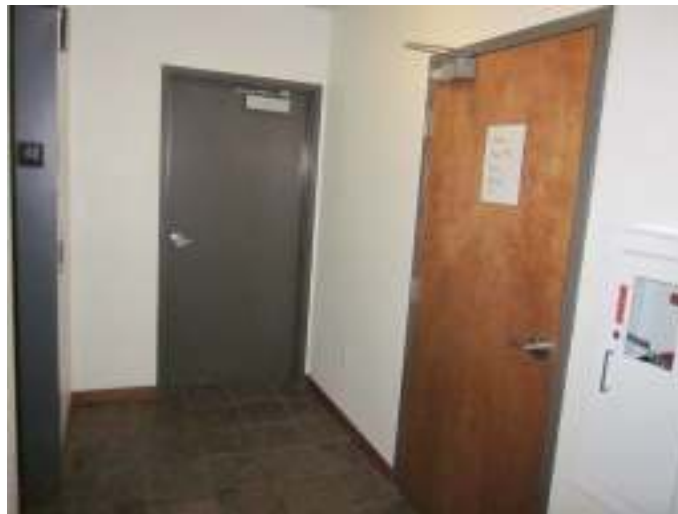
Comp #: 501 Common Doors - Replace

Under normal conditions, these doors should have a very long life expectancy with proper maintenance. Most of these doors are located inside and not exposed to elements. We originally recommended treating replacement on an as needed basis with general operating funds. However, per the clients request, we have added Reserve funding for eventual replacement of the doors. On average, these last 20 - 30 years before replacement is necessary, depending on the level of use and care.

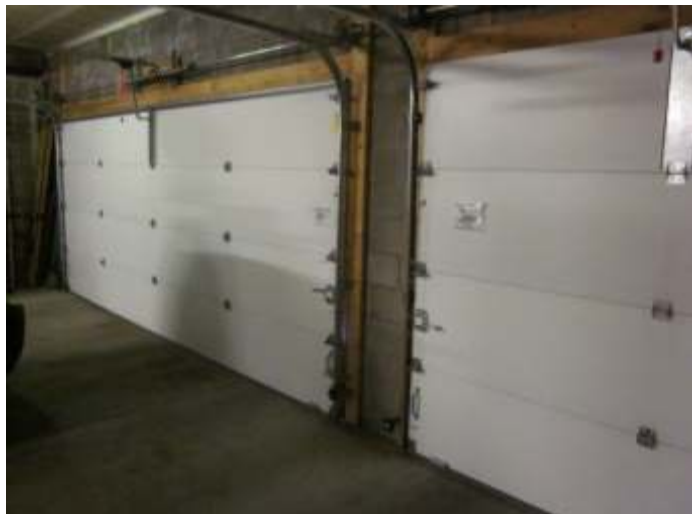
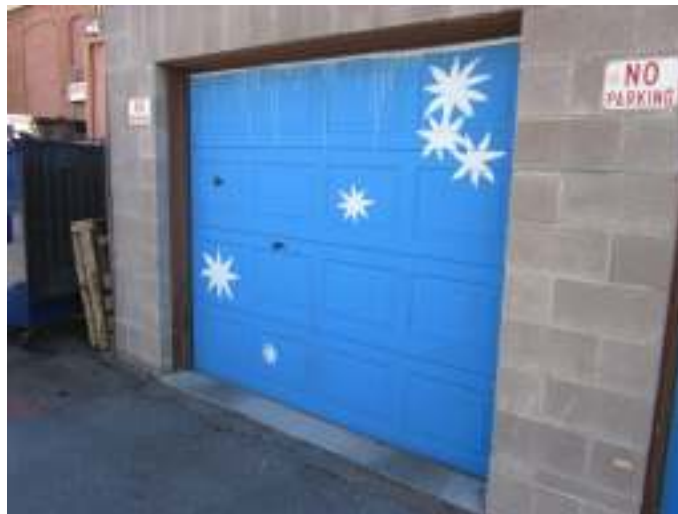
Comp #: 502 Garage Doors - Replace

Doors were functional and in good operating condition at time of property inspection. According to a local contractor, insulated doors of this quality typically lasts 15 - 20 years under normal conditions. The remaining life is based on the age of the building since renovation as it is assumed these were installed at that time.

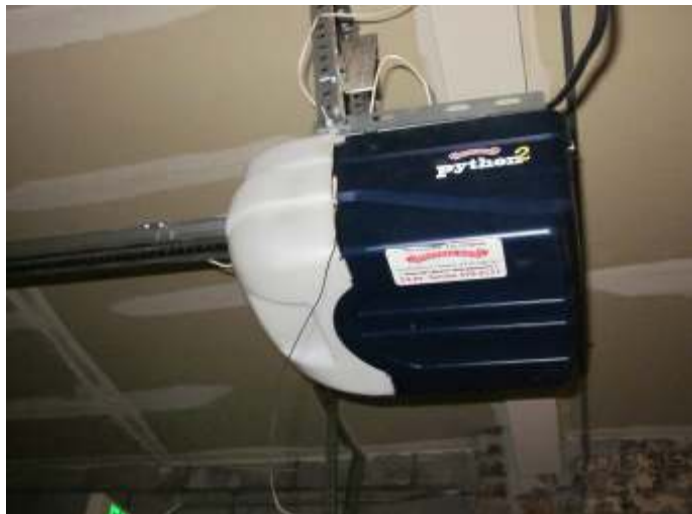
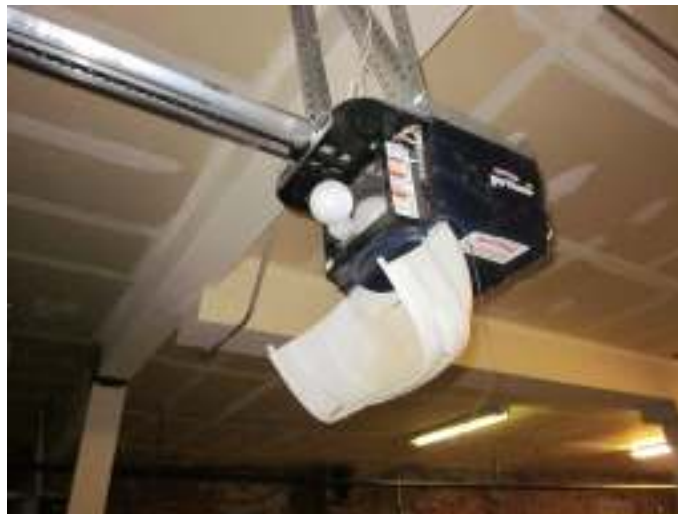
Comp #: 507 Garage Door Openers - Replace

Both operators were functional with no unusual noises coming from the units at time of inspection. According to a local contractor, these units typically last 10 - 15 years depending on the frequency of use and quality of the unit. However, this recommendation is for a residential setting, as opposed to a commercial setting. While we understand there are only 8 units that use this garage, the potential is there for many uses during the day that exceeds a residential setting. Therefore, we recommend replacing with a more durable unit when replacement is required.

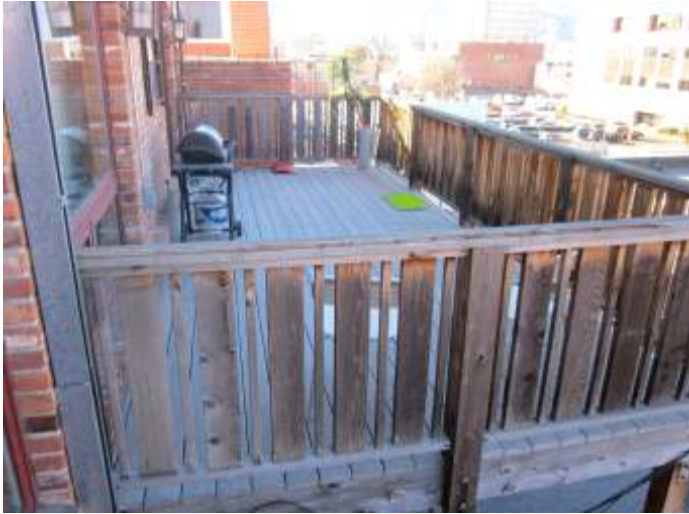
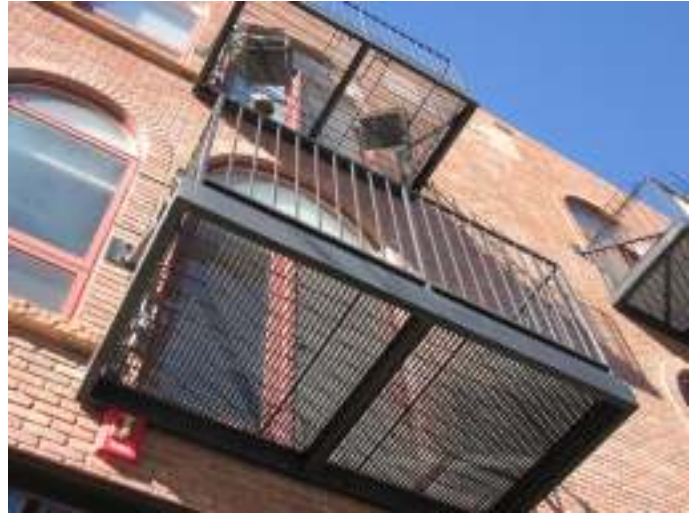
Comp #: 606 Unit Decks/Balconies - Replace

Per section 12.1B of the association declarations, the unit owner shall be responsible to maintain the Limited Common elements, which shall include the deck, balcony, patio, and porch and the railings. Therefore, separate Reserve funding is not included for this component.

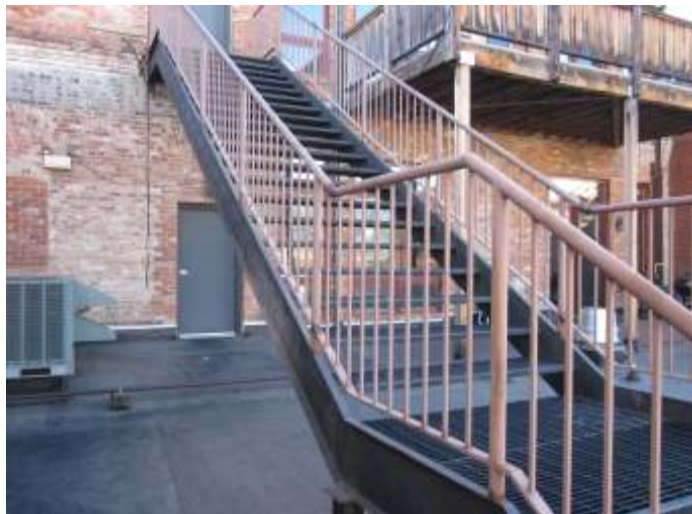
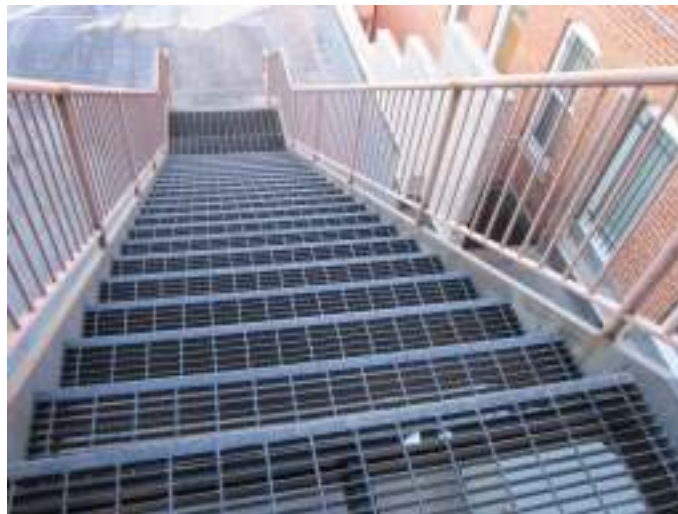
Comp #: 610 Steel Stairs - Replace

Stairways were stable and in good condition at time of property observation. The railings are showing a few signs of rust, but no major corrosion or structural issues were noted. We recommend painting the railing as an operating expense to protect the materials from further rusting and deterioration. In normal conditions, these stairways should have an indefinite life expectancy and complete replacement is not likely. Therefore, at this time, separate Reserve funding is not required for this component.

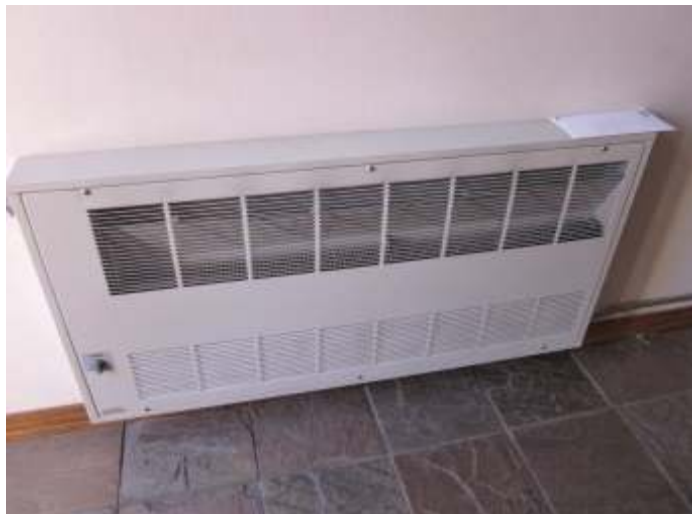
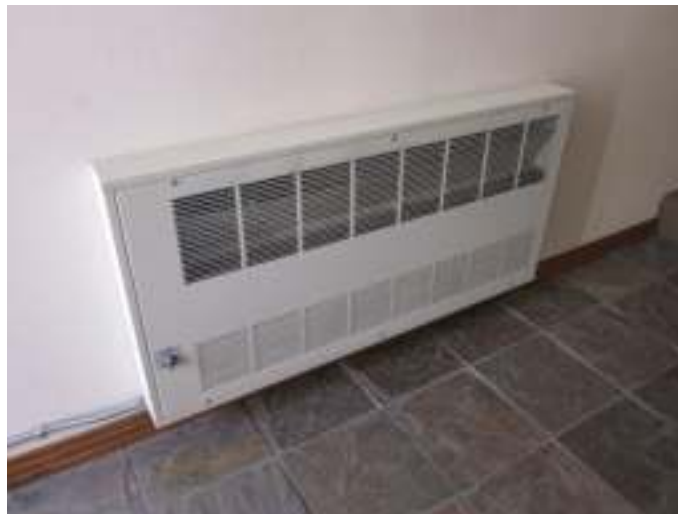
Comp #: 706 Cabinet Unit Heaters Replace

No unusual conditions observed or reported at time of report preparation. In our experience, we have seen the need to replace these types of units every 15 - 20 years, depending on the level of use and maintenance. The remaining life is based on the age of the units.

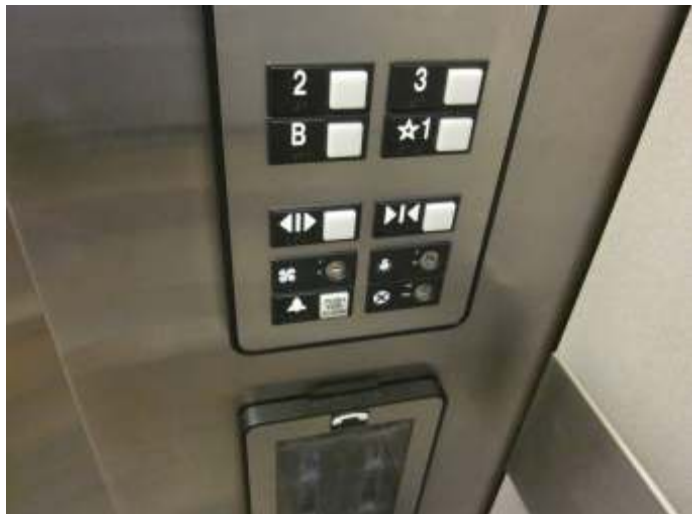
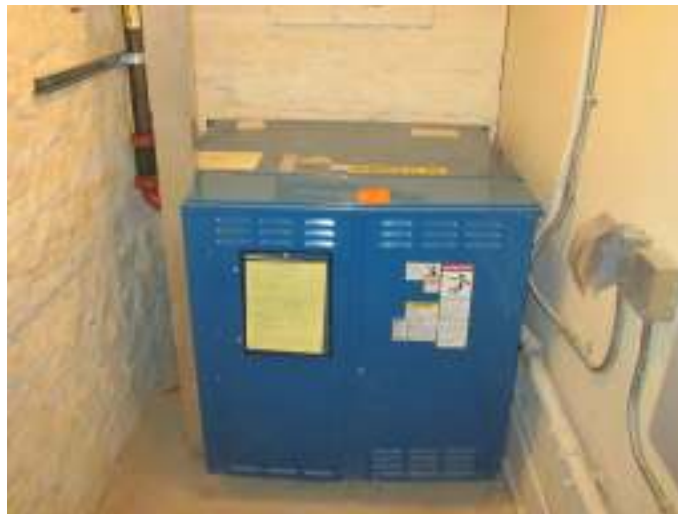
Comp #: 707 Elevator - Rebuild/Upgrade

The elevator was operating smoothly with no problems noted. The inspection and maintenance records on site did not report any unusual problems. Elevator should be inspected annually by a professional to ensure proper operation and detect any safety concerns. The equipment that will eventually fail and need to be replaced include the control system (brain of the unit), door operator and tracks, and the pump unit. Eventually, parts of the system become obsolete and replacement will be necessary. Due to average use facility, Reserve to replace this equipment every 25 years.

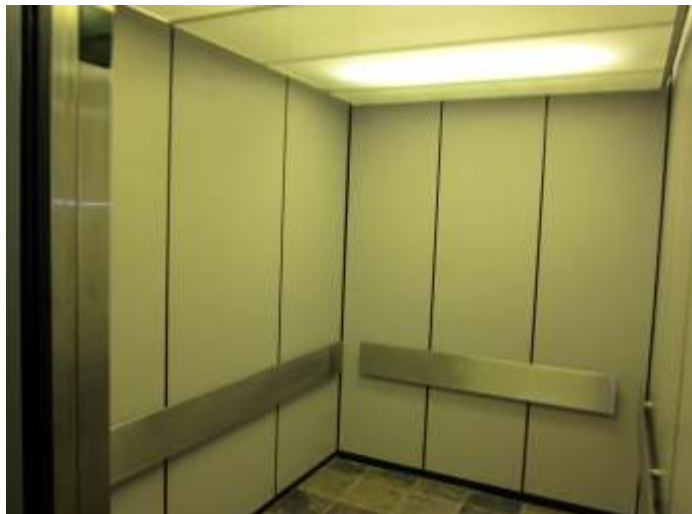
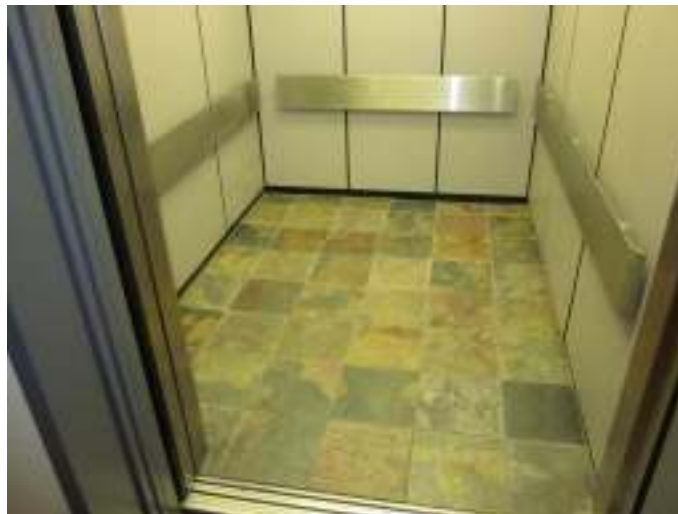
Comp #: 709 Elevator Cab - Remodel

It was reported that new tile was installed in 2009. The walls are original back to the date of the conversion, but are still in good condition. Moving pads should be used to protect the sides when moving large pieces of furniture and equipment. Depending on the decorative tastes of the association and trend development, the average remodeling cycle ranges from 15 - 20 years. Cost could vary depending on extent of décor chosen at time of remodel.

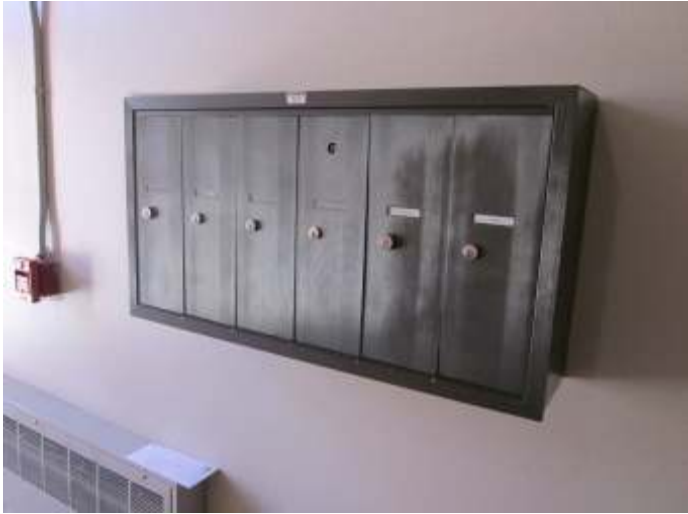
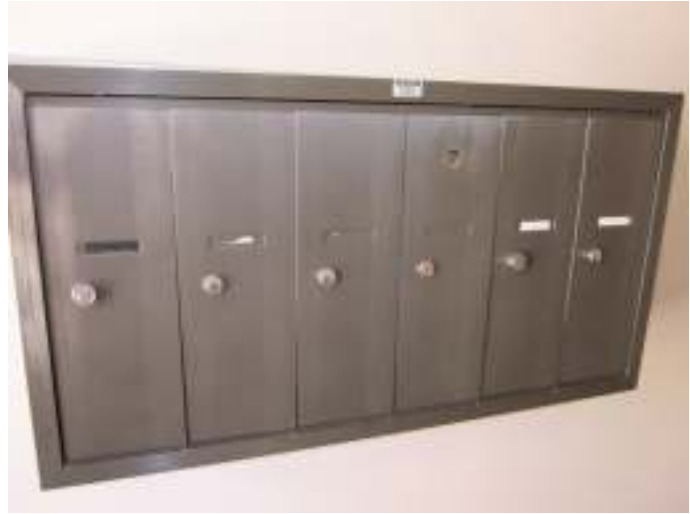
Comp #: 803 Mailboxes - Replace

No unusual conditions observed at time of inspection. These are installed inside and protected from the elements. According to the manufacturer, these boxes will have a life expectancy of 20 - 30 years due to location and quality. Due to the long life expectancy and low replacement cost (less than \$500), we recommend replacing on an as needed basis with general operating funds. Therefore, at this time, separate Reserve funding is not required for this component.

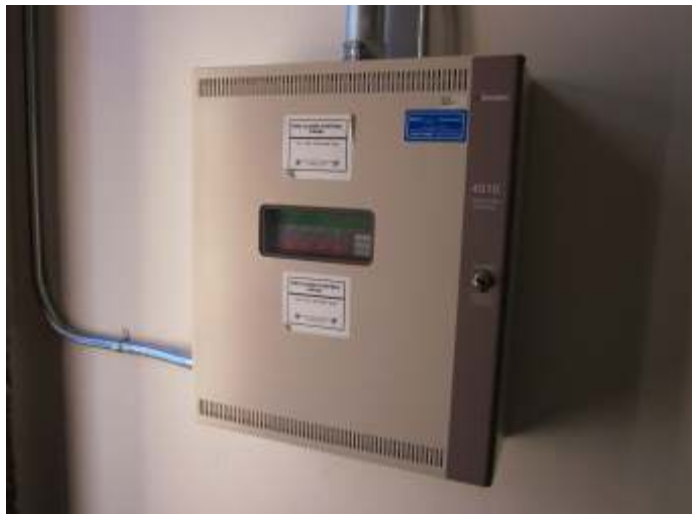
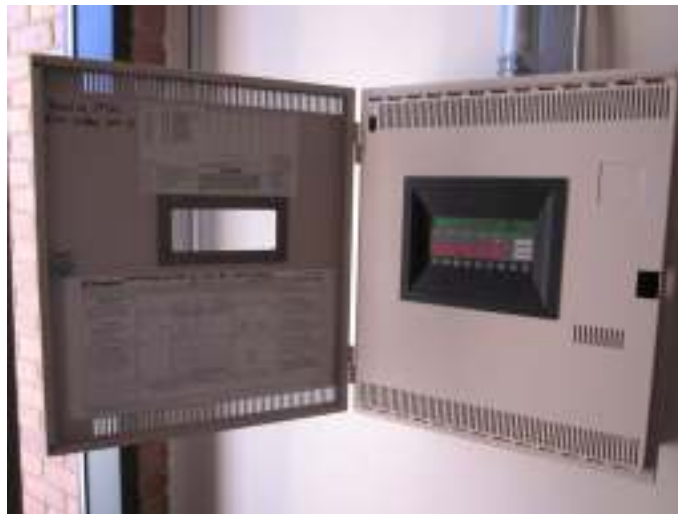
Comp #: 901 Fire Protection System - Replace

System was not tested during inspection. There were no reports of system malfunctioning recently. System is relatively new and no problems should exist. System should be tested at least once a year by a professional. Advances in technology will require the panel to be replaced every 18 - 20 years. Once the wiring is installed, it should not have to be replaced in the future.

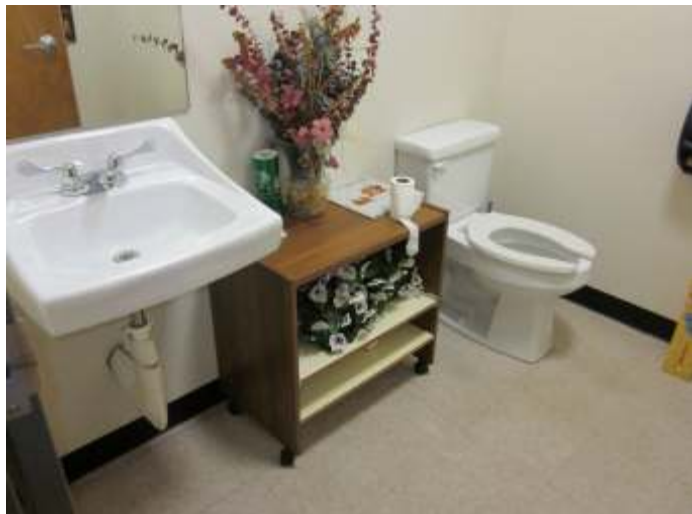
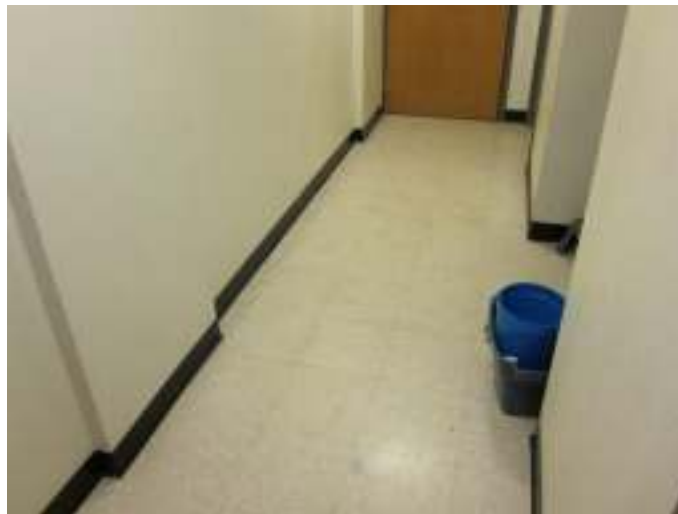
Comp #: 1413 Restrooms/Hallway - Remodel

The paint was nicked and marked up and in need of a fresh coat of paint. The rest of the area was in good to fair condition. Most associations perform a general remodel of restroom areas every 15 - 20 years to maintain appearance and keep up with current decorative trends. The final decision is up to the community members in deciding when to spend the money to perform this project since it is considered cosmetic.

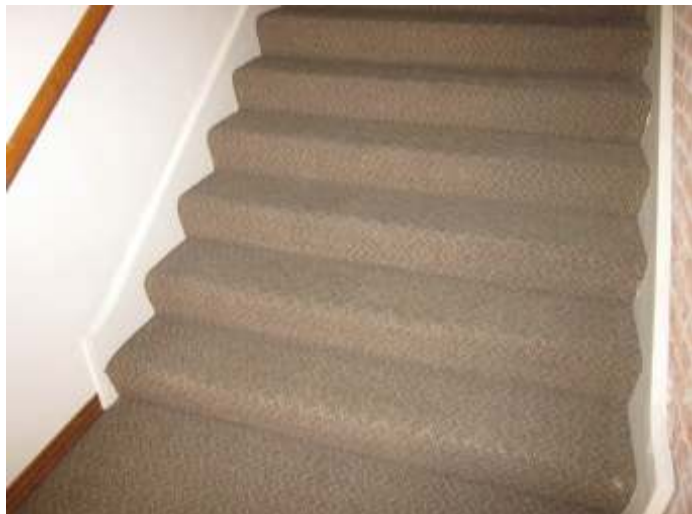
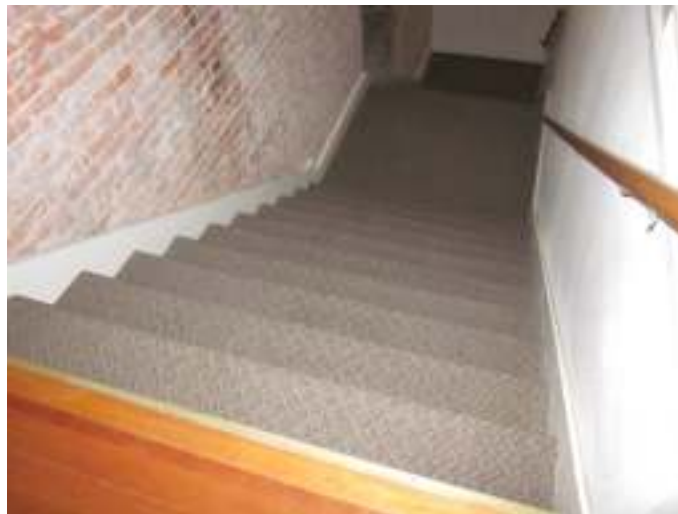
Comp #: 1501 Carpeting - Replace

Carpet is in fair condition. Some evidence of wear noted but no rips or curling seams observed at the time of inspection. Due to a low use property, expect to replace this component every 15 - 20 years assuming normal use and wear. Remaining life based on current age and condition.

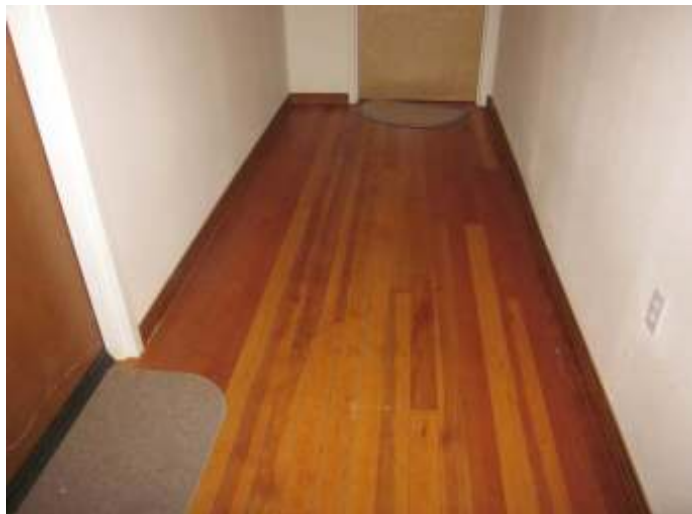
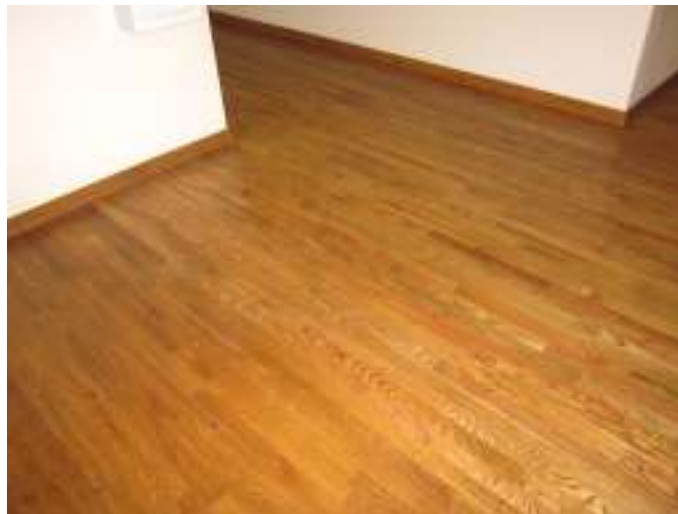
Comp #: 1505 Hardwood - Refinish

It was reported the 3rd floor was recently patched and fixed and a few areas were refinished. A few warped or uneven boards were noted on the third floor at time of inspection. Every 4 - 5 years, it is recommended that a "screen and coat" application is performed. If a screen and coat application is not performed on a regular basis, expect a full refinish every 12 - 15 years, depending on level of foot traffic.

\$2.00/GSF; Higher estimate for minor repairs

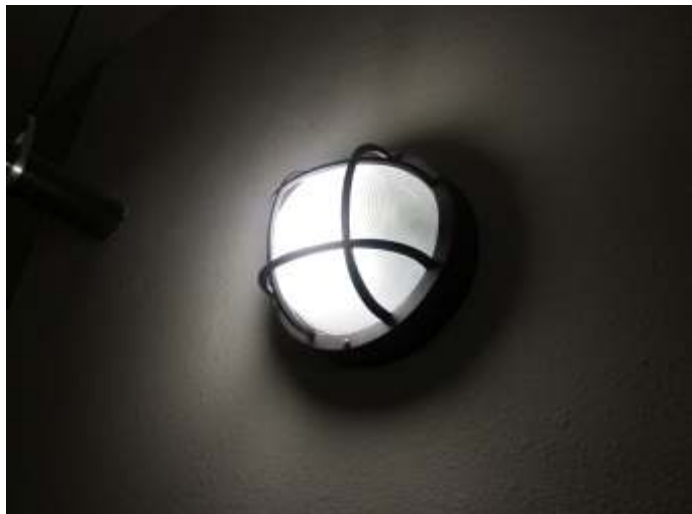
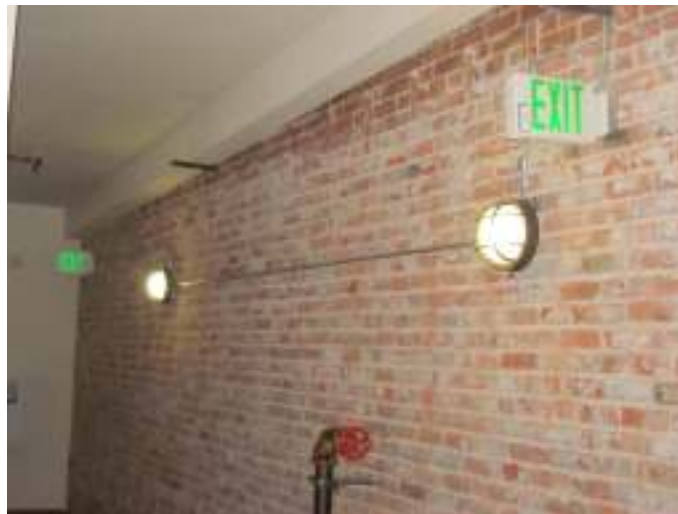
Comp #: 1601 Interior Hallway - Replace

All interior lights were functional and in good condition at time of inspection. The decorative lights match the décor of the buildings and the environment. Typically, associations prefer to upgrade and modernize lighting every 15 - 25 years, depending on changes in trends. Suggest replacing all fixtures at same time to get best cost estimate and match décor throughout all buildings. The cost estimate reflects the cost to replace the decorative lights only.

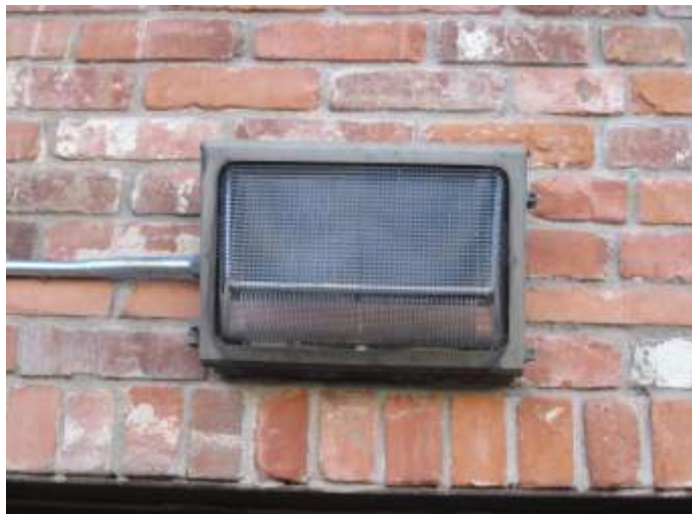
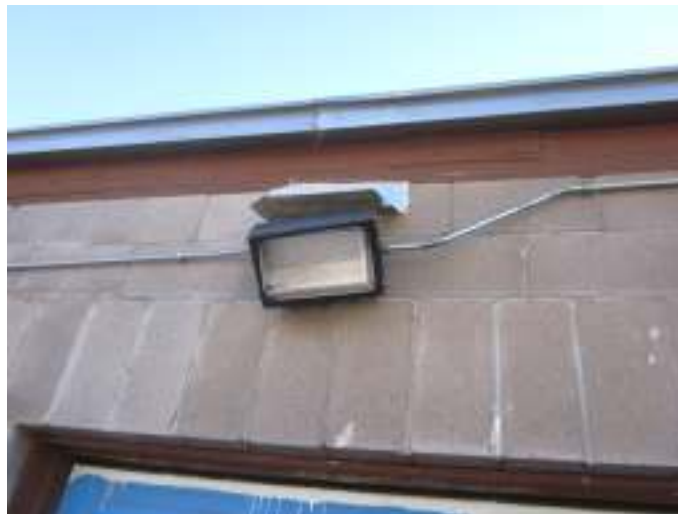
Comp #: 1602 Exterior Wall Mount - Replace

Lights are older, but no reported problems. We were unable to inspect operating conditions due to inspection taking place during daylight hours. Due to the minimal cost to replace these lights individually, reserve funding is not appropriate. Repair and replace as necessary as an operating expense.

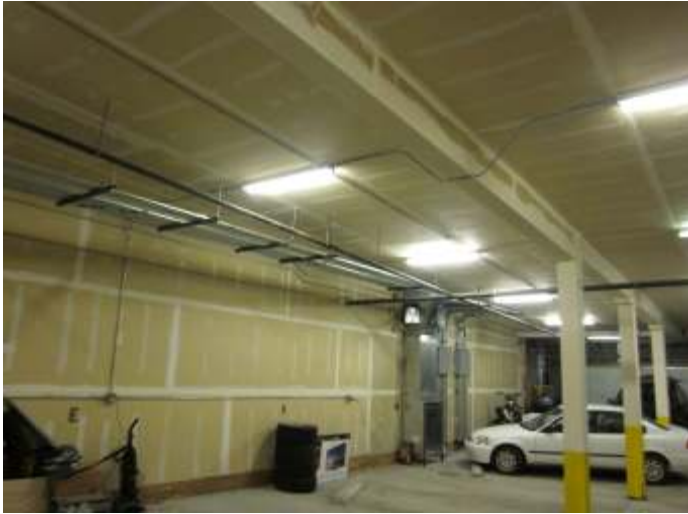
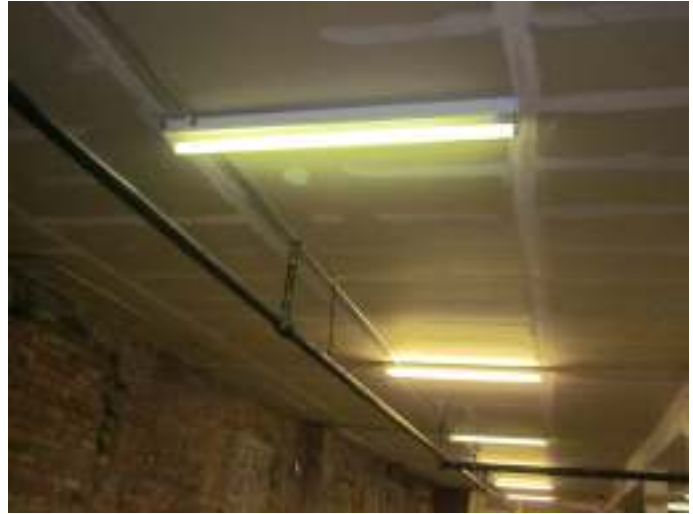
Comp #: 1610 Florescent Tube Lights - Replace

Florescent tube lights are not considered decorative and can be replaced individually as an operating expense without effecting the aesthetics of the building. Therefore, we suggest Reserve funding is not included for this component at this time.

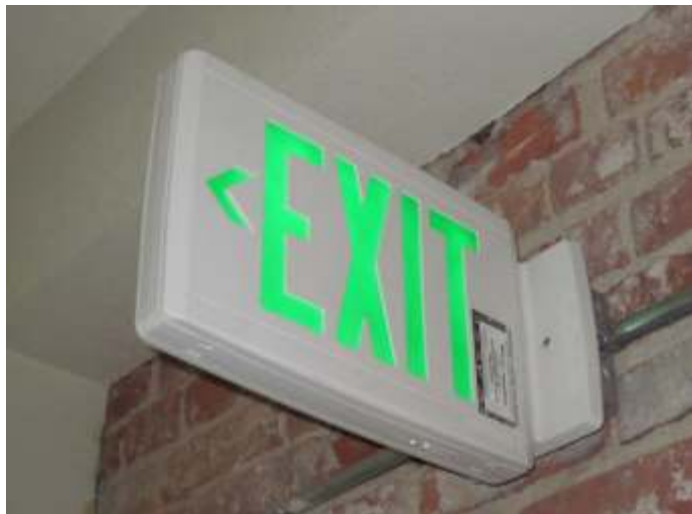
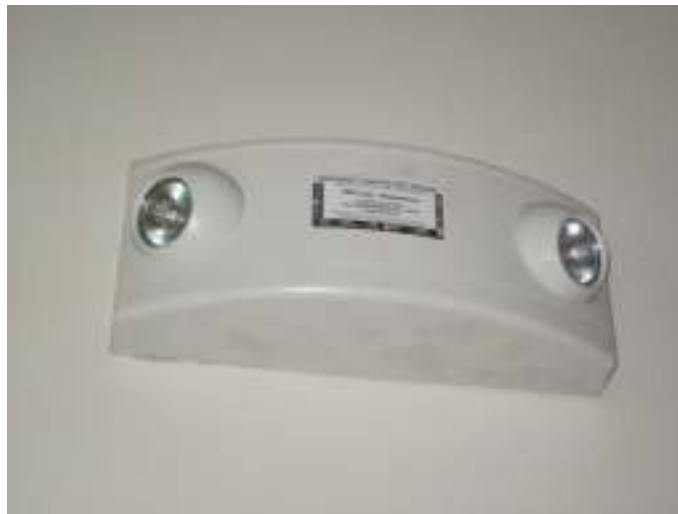
Comp #: 1611 Exit Signs/Emergency Lights - Replace

Emergency lights were not tested during property observation as this is beyond our typical scope of work. Exit signs were functional with no problems noted. Due to small replacement cost, we recommend replacing these on an as needed basis with general operating funds.
