# Inspection Report

**Beemal & Tara Vasani**

**Property Address:**  
23 Glen Eagle Dr.  
Bridgewater NJ 08807

<b>Date:</b> 1/7/2016	<b>Time:</b> 10:00 AM	<b>Report ID:</b>
<b>Property:</b> 23 Glen Eagle Dr. Bridgewater NJ 08807	<b>Customer:</b> Beemal & Tara Vasani	<b>Real Estate Professional:</b> Kevin Cary Golden Key Realty

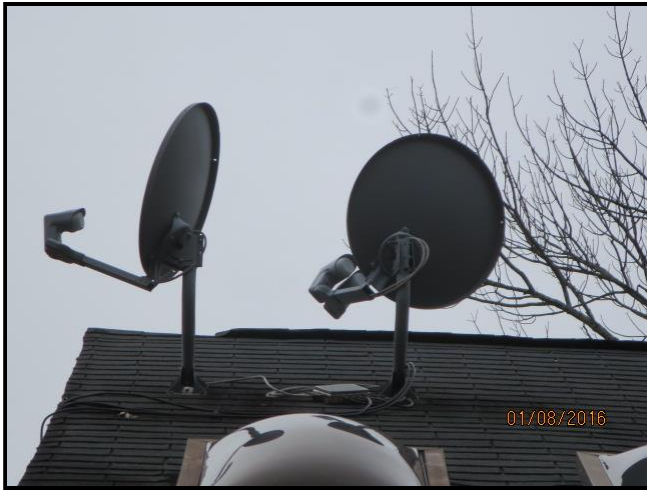
1.2 Item 2(Picture) Satellite dishes

(2) The sealant on the satellite dish at the roof needs to be maintained. Any penetration into the roof can cause water damage from leaks, This is a maintenance issue and is for your information. A qualified person should repair or replace

as needed.

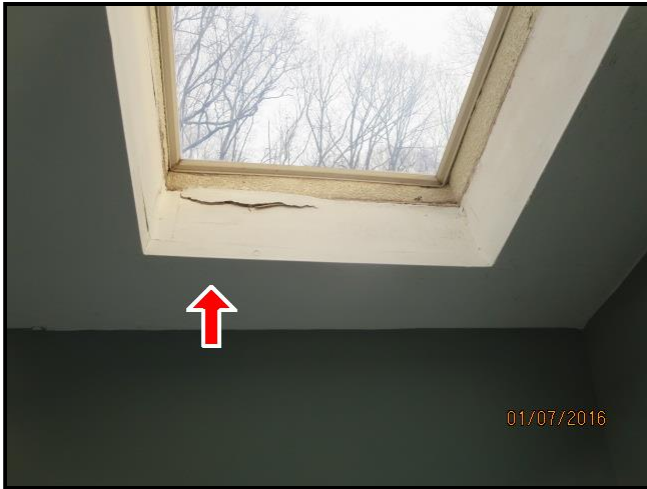
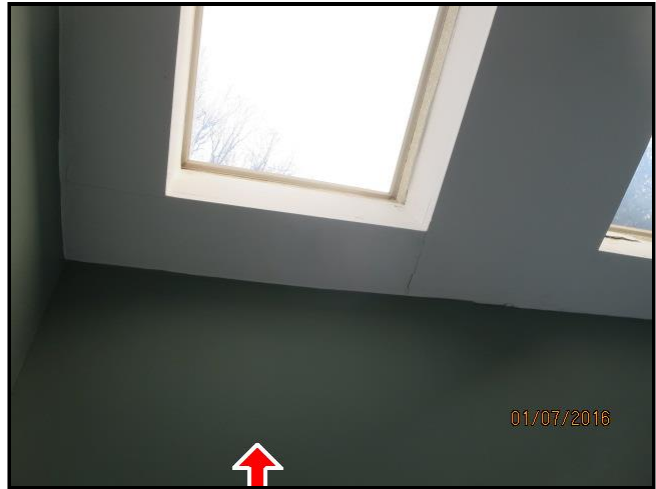
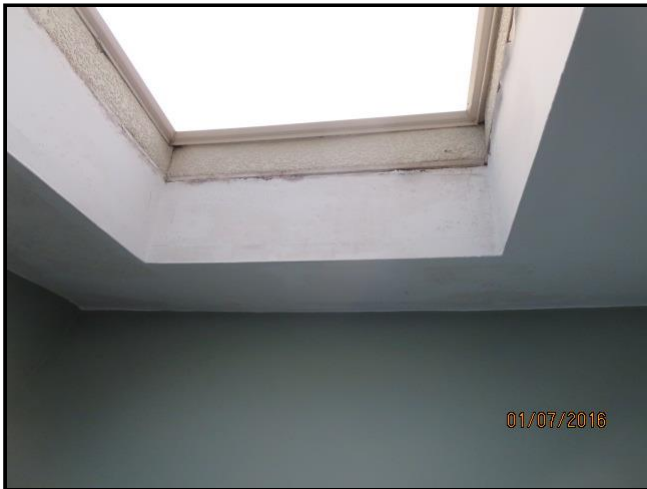
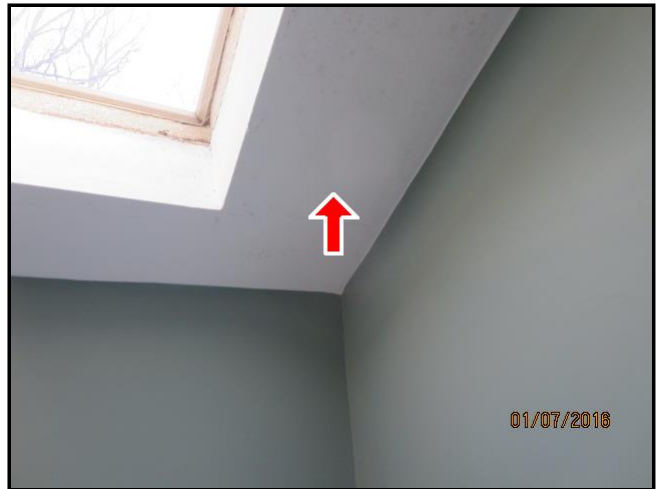
(3) Two Skylights have stains indicating a leak did or does exist at the Master Bedroom bath. Further deterioration may occur if not repaired. A qualified contractor should repair or replace as needed. Possible mold was observed at the ceiling around the skylights and may be behind the walls. Recommend a mold specialist further evaluate.

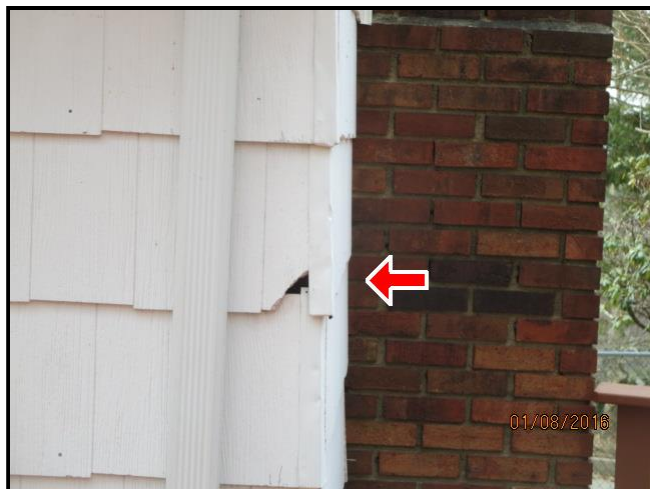
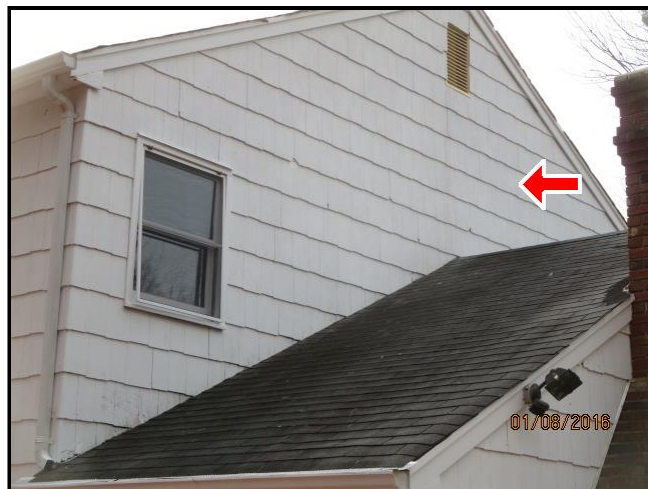
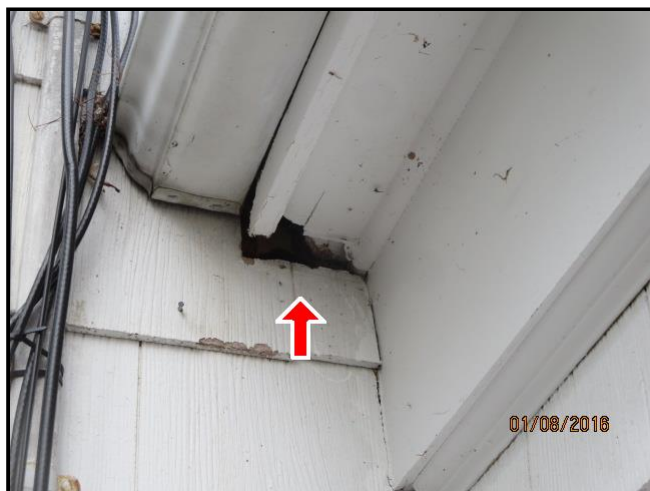
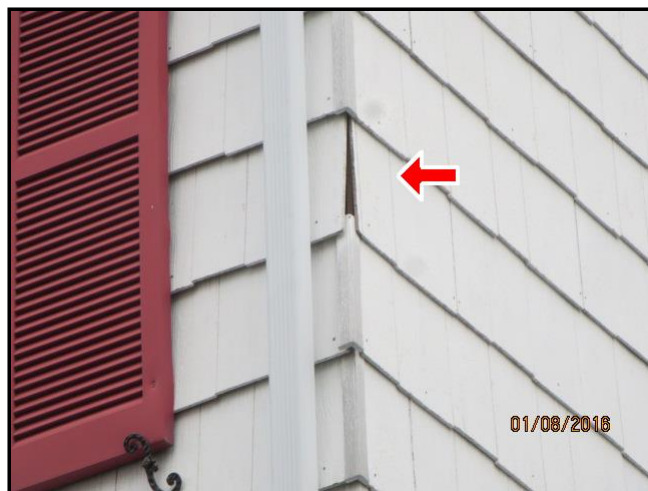
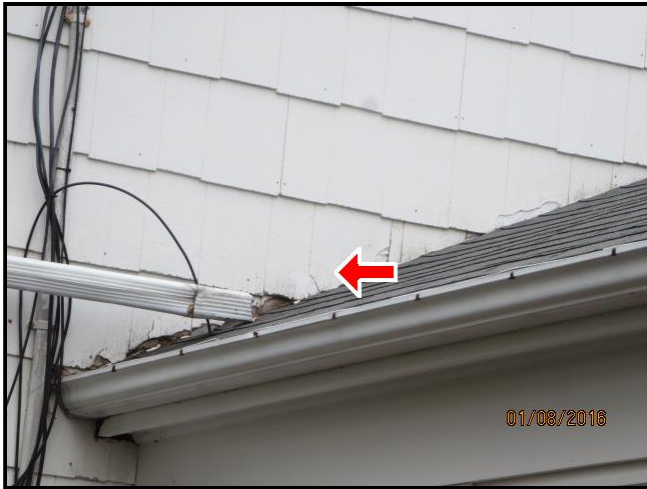
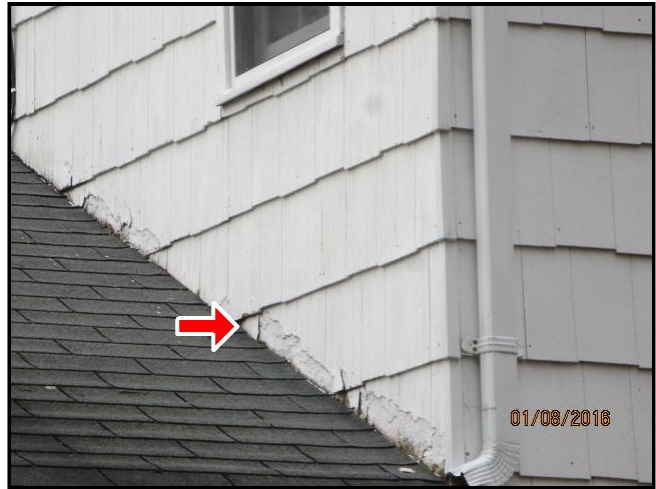
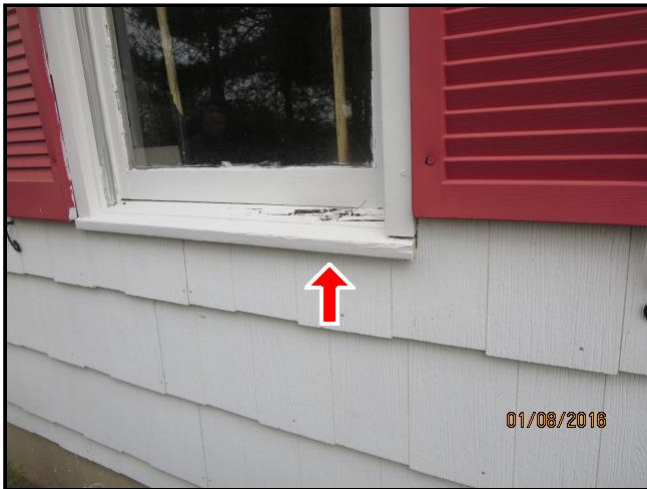
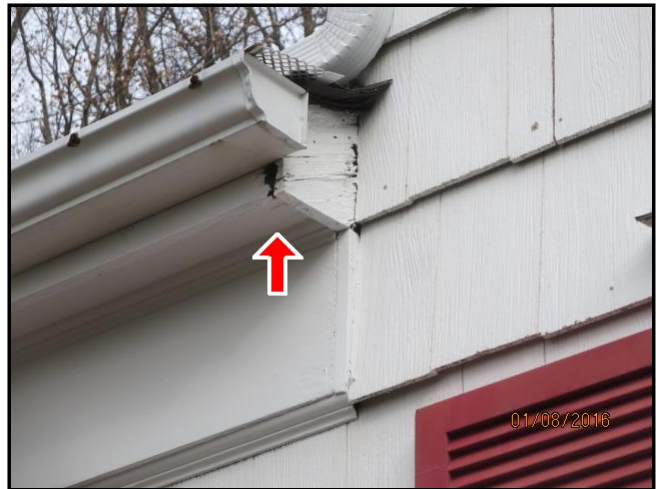
(1) The possible Asbestos slate siding at the exterior in areas is damaged, deteriorated missing and loose. Further deterioration that can lead to water and insect intrusion if not corrected. A qualified contractor should inspect and repair as needed.

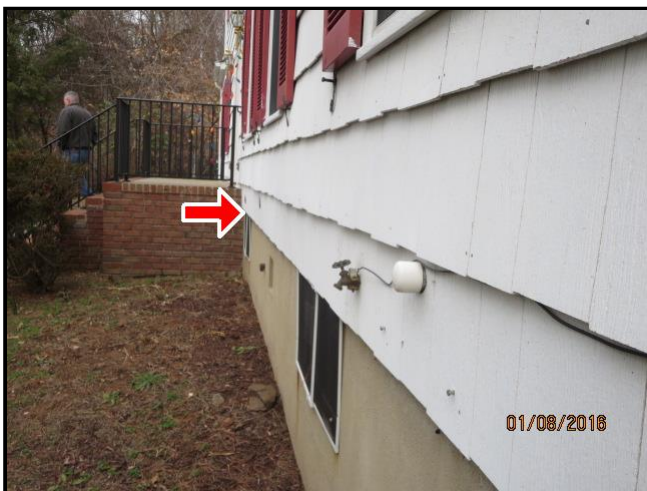
2.0 Item 9(Picture) Buckled siding

(2) The siding at the front of the home is buckled. This could be a structural problem. Recommend an structural engineer further evaluate.

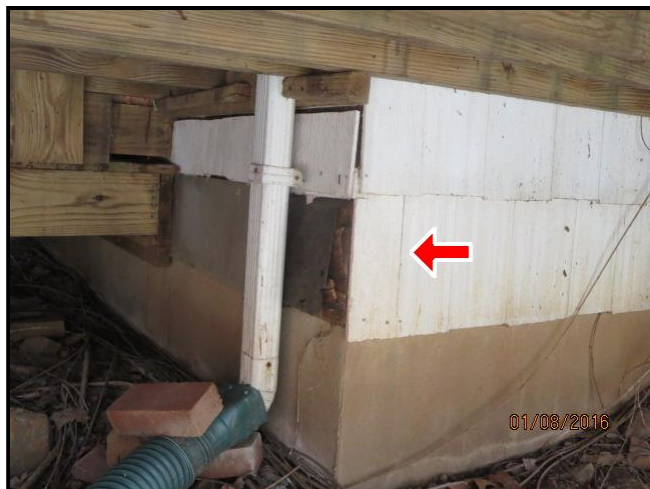
2.0 Item 10(Picture) Wood rot

(3) Rotted wood siding under deck. Further deterioration will occur that can lead to water intrusion and mold if not corrected. Recommend a GC further evaluate.

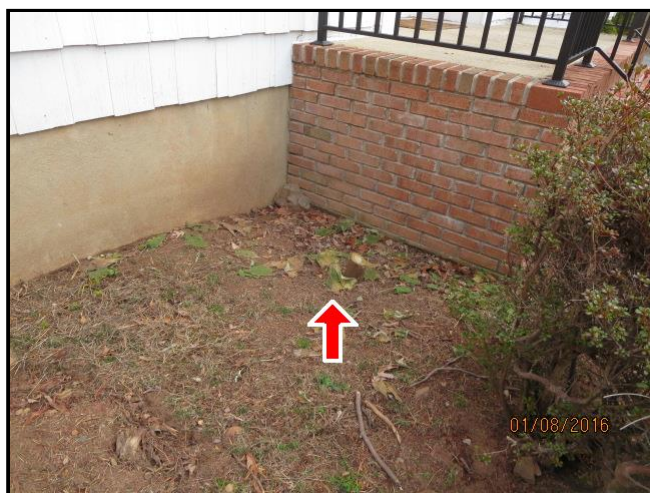
2.4 Item 1(Picture) Negative slope

There is a negative slope at the front of home and can cause or contribute to water intrusion or deterioration. I recommend correcting landscape to drain water away from home.

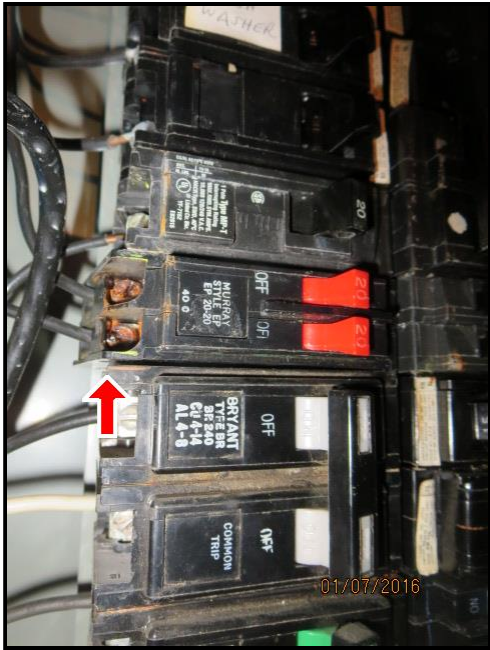
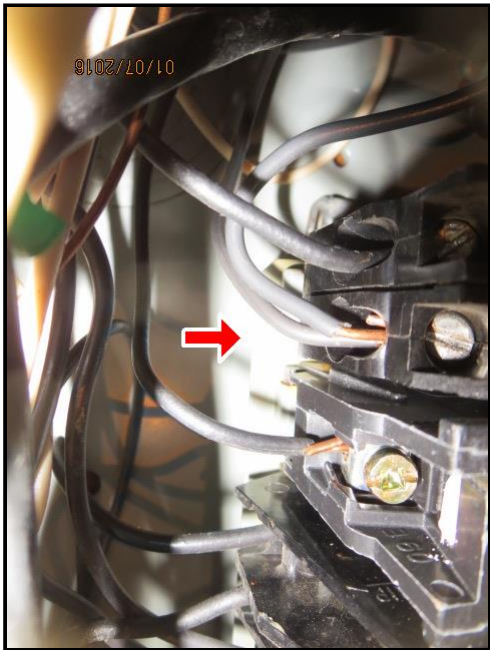
The problem(s) discovered in the panel such as doubled wiring at breakers, rust and any other problems that an electrical contractor may discover while performing repairs need correcting. I recommend a licensed electrical contractor inspect further and correct as needed. Sub Panel is not wired correctly. Neutral and ground wires are on the same bus bar.

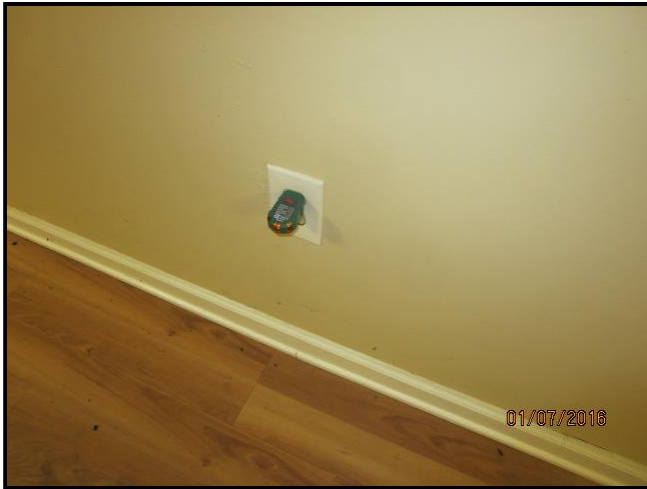
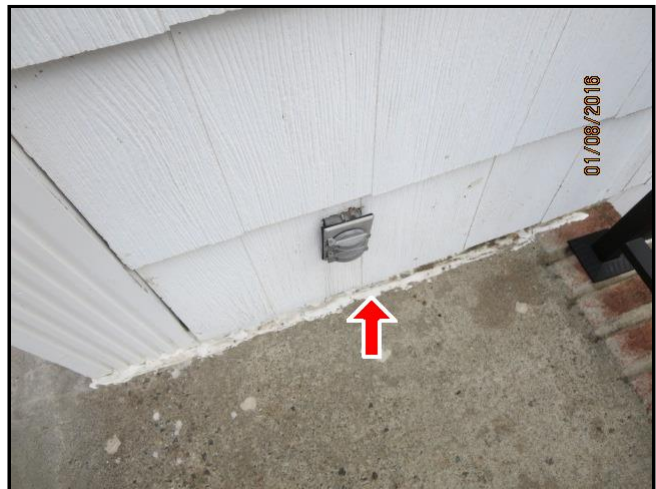
(1) At least 6 outlets in the basement and external are not grounded . This is a safety issue that needs to be corrected. A qualified licensed electrical contractor should perform repairs that involve wiring.

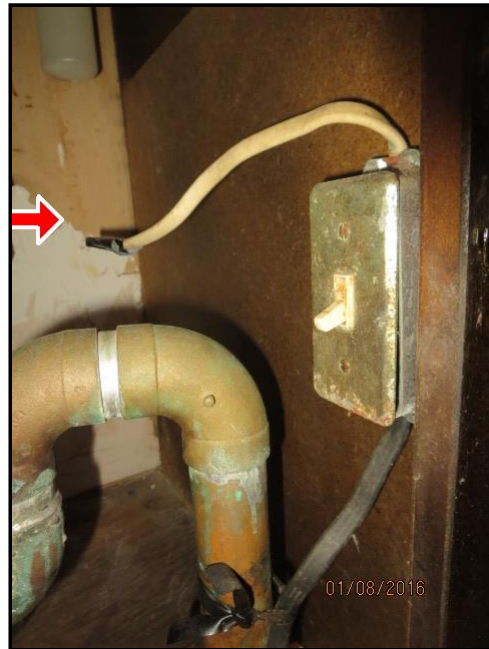
3.3 Item 9(Picture) Open splice

(3) Open splices were observed at the basement ceiling and under kitchen sink This is a safety concern that can lead to electric shock. Recommend a licensed electrician further evaluate.

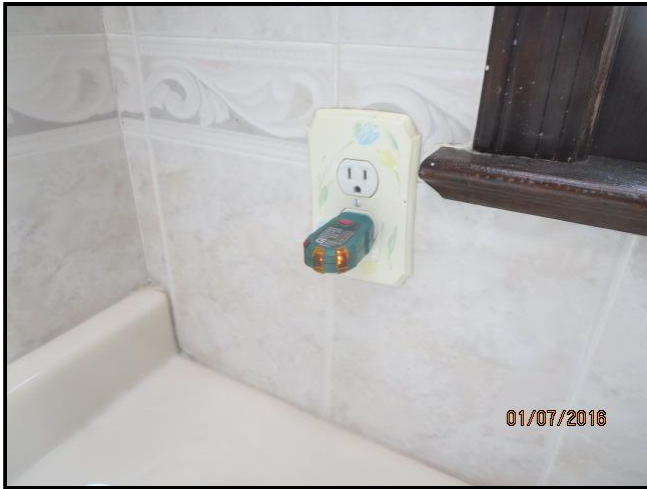
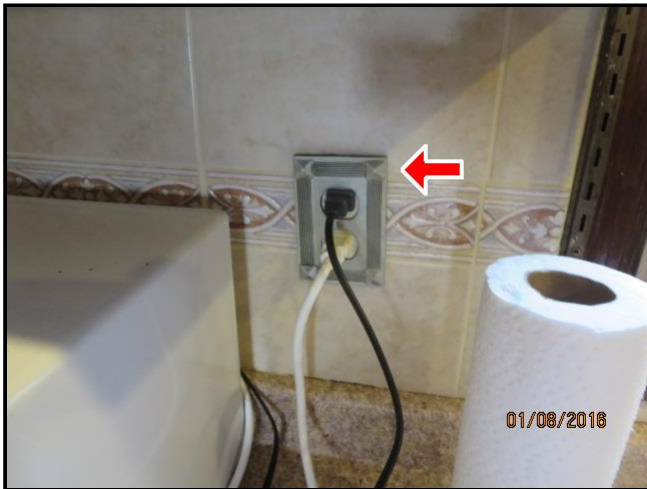
(4) All "three-prong" outlets are outdated and not a three-prong GFCI (Ground Fault Circuit Interrupt) in the kitchen and baths. These are a safety issue that needs to be corrected. A qualified licensed electrical contractor should perform repairs that involve wiring.

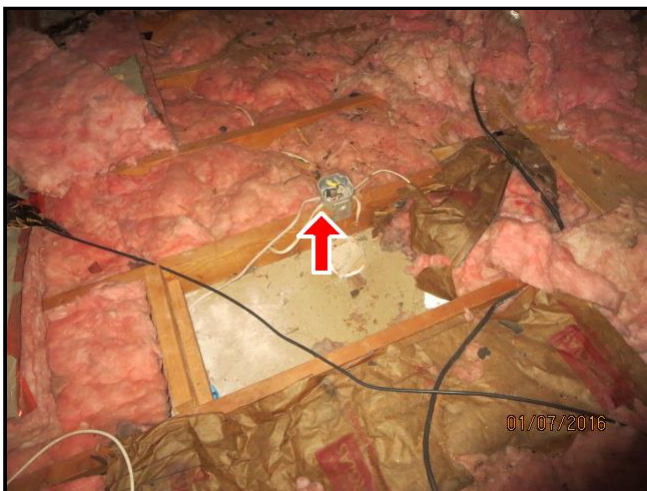
3.3 Item 13(Picture) Needs cover plate

(5) Exposed wiring at the attic needs a cover plate . This is a safety issue that needs to be corrected. A qualified licensed electrical contractor should perform repairs that involve wiring.

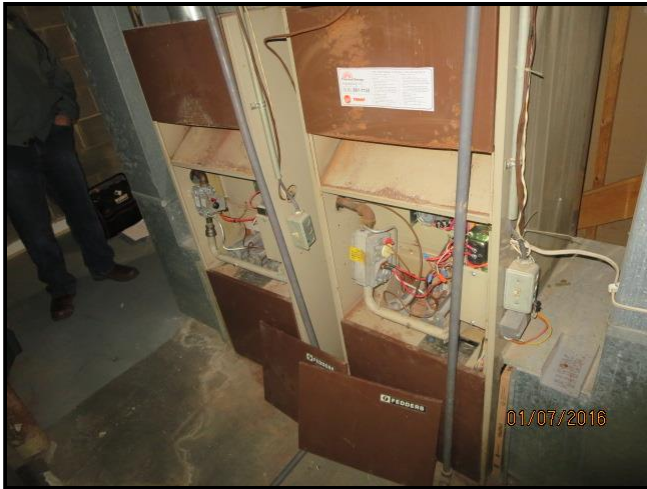
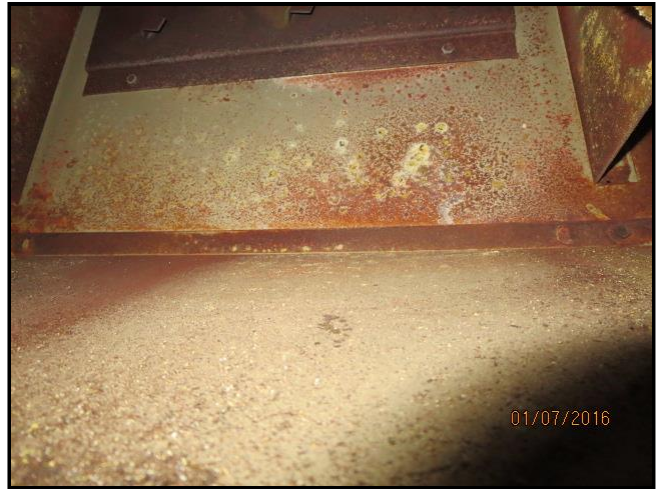
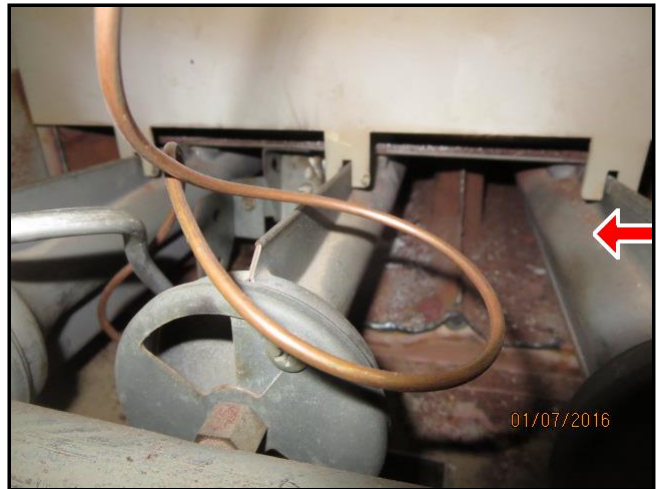
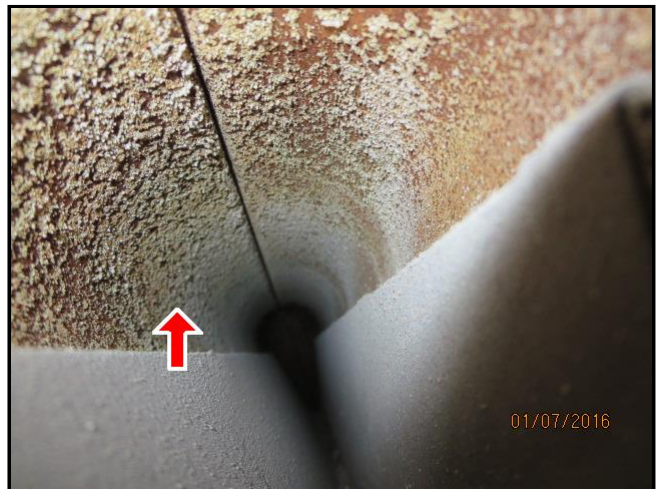
Both furnace have major heat exchanger rust conditions. A rusty heat exchanger can lead to carbon monoxide seeping into the home. This condition is a safety and health hazard issue. Recommend that the furnaces be shut down and not used till a HVAC contractor further evaluate. Both furnaces are very old and need to be replaced.

Furnaces were not inspected due to there safety conditions

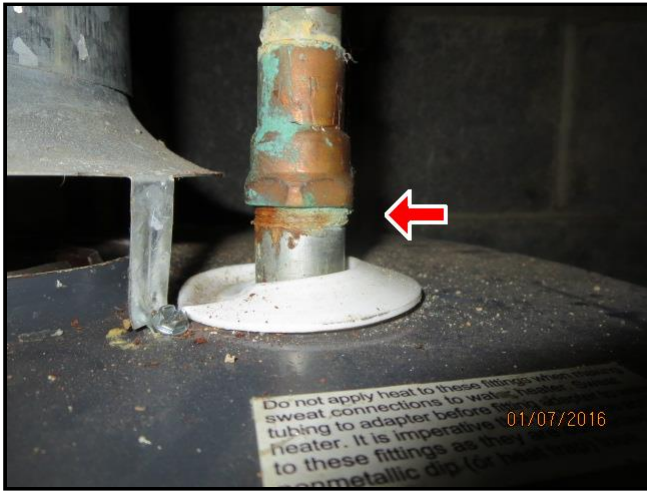
5.1 Item 1(Picture) Pipe corrosion

Plumbing connection at the water heater is corroded. Corroded pipes can lead to water leaks. Recommend a licensed plumber further evaluate and repair.

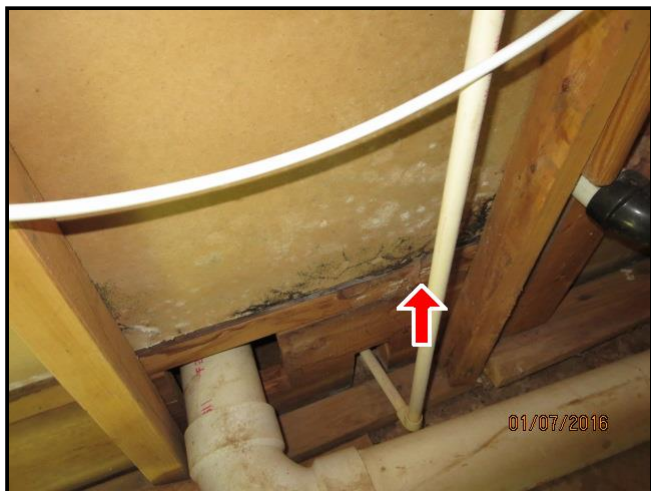
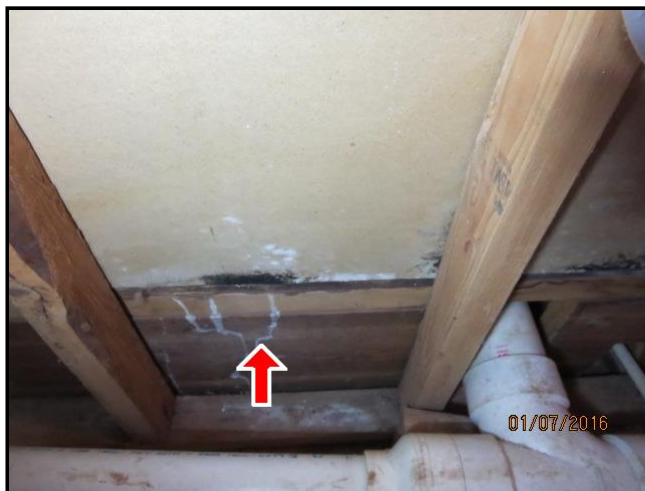
(1) Signs of fungi growth is present on the walls along basement in several areas. We did not inspect, test or determine if this growth is or is not a health hazard. The underlying cause is moisture. I recommend you contact a mold inspector or expert for investigation or correction if needed.

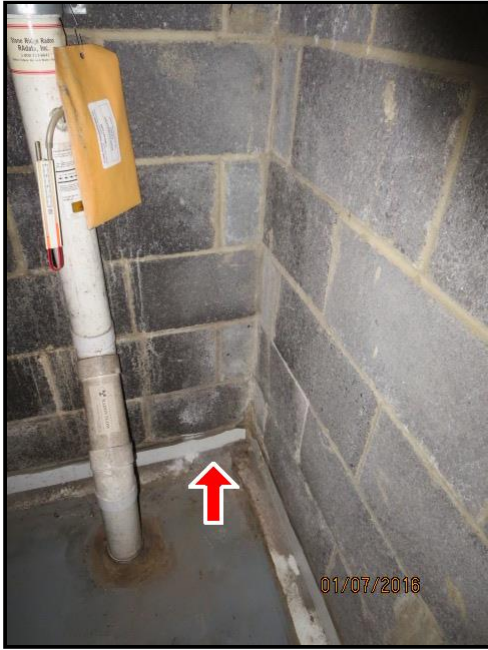
6.0 Item 3(Picture) Efflorescence

(2) White efflorescence (powder substance) on block wall indicates moisture is in contact with the masonry. This does not necessarily indicate that intrusion will occur. I recommend checking the gutters and the downspout drain lines for proper operation. Also, a water proofing paint could be applied to the

interior side of the block if necessary. Efflorescence is found on many homes without water intrusion occurring inside the home. But, it should alert you to the possibility that future steps may be needed.

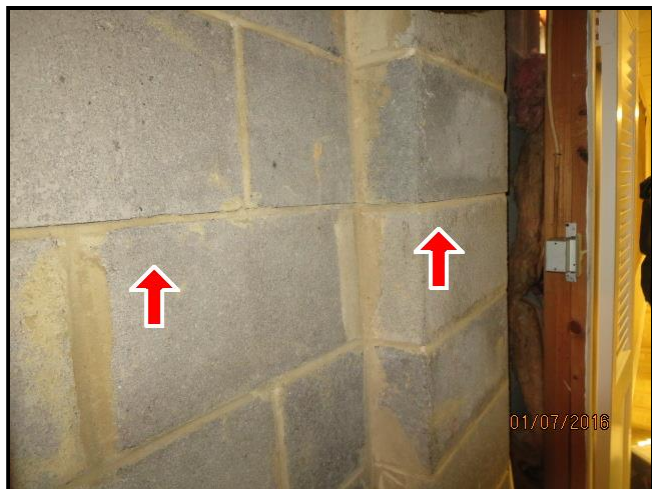
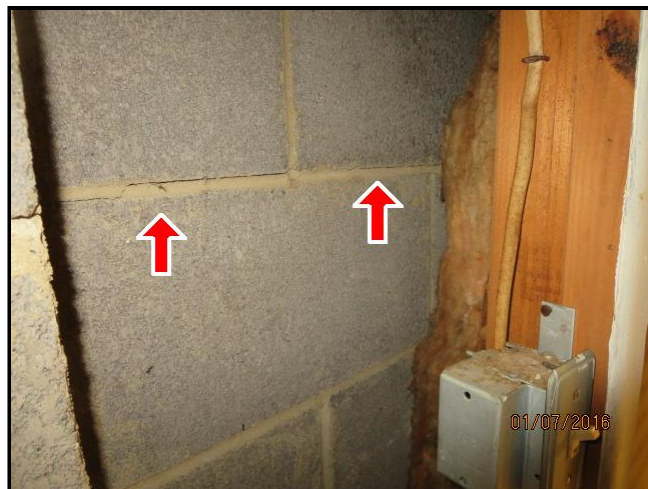
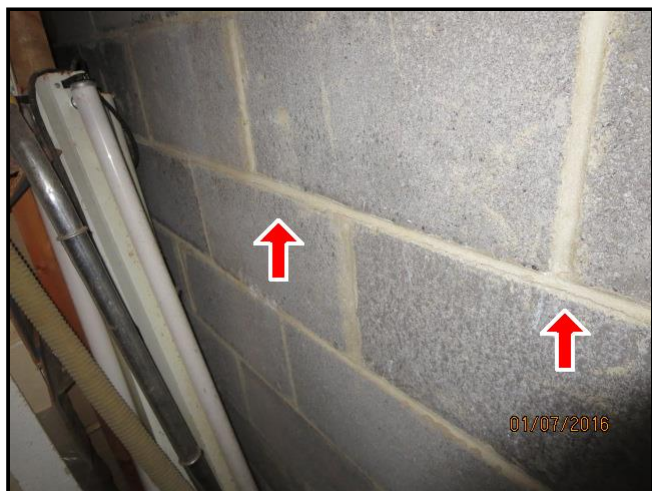
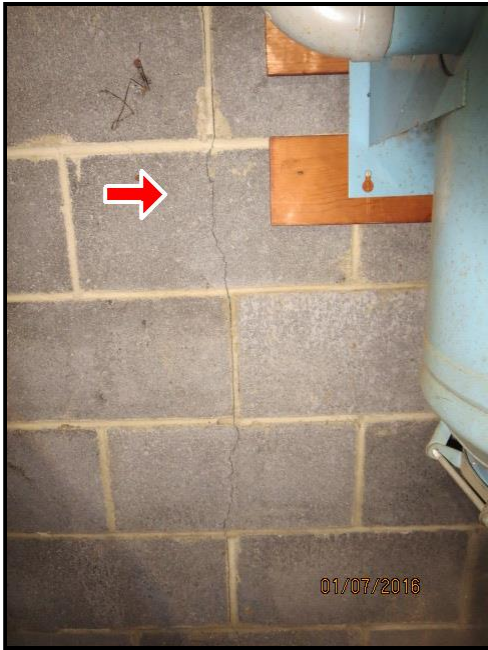
(1) The foundation walls at the front and left side (facing front) of home, has structural cracks these cracks may need reinforcement . A qualified engineer should inspect and repair or replace as needed.

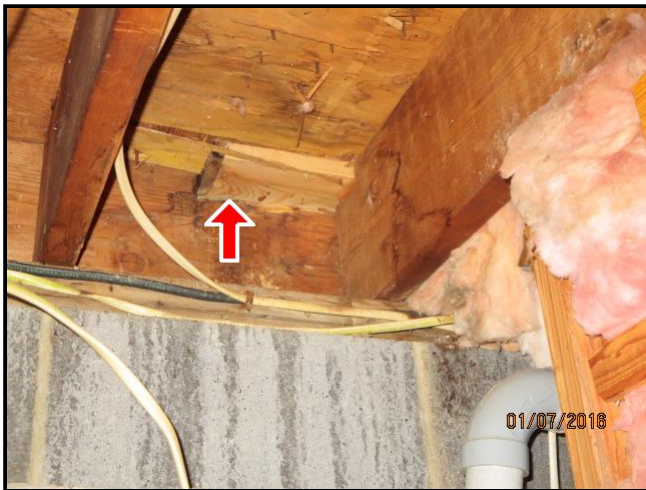
6.1 Item 6(Picture) Joist Repair

(2) Repair was made at the floor joist under rear door. Recommend that the repair be monitored and repair and replace as needed.

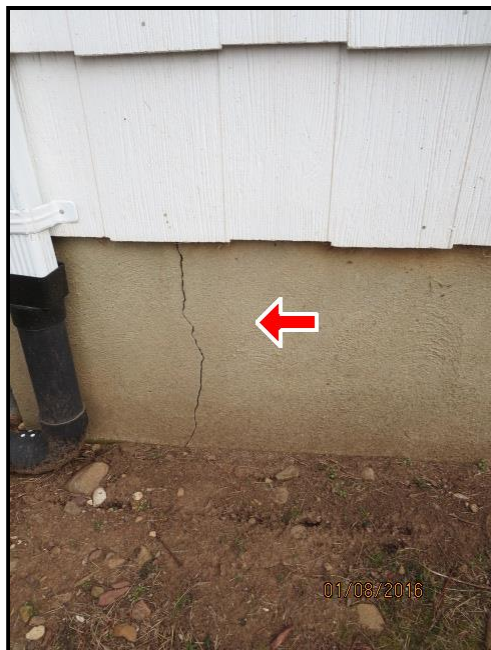
6.1 Item 7(Picture) Foundation crack

(3) The foundation wall at the front of home is damaged with a crack. This crack does not appear significant to require repairs at this time but does need to be sealed. A qualified engineer should inspect and repair or replace as needed.

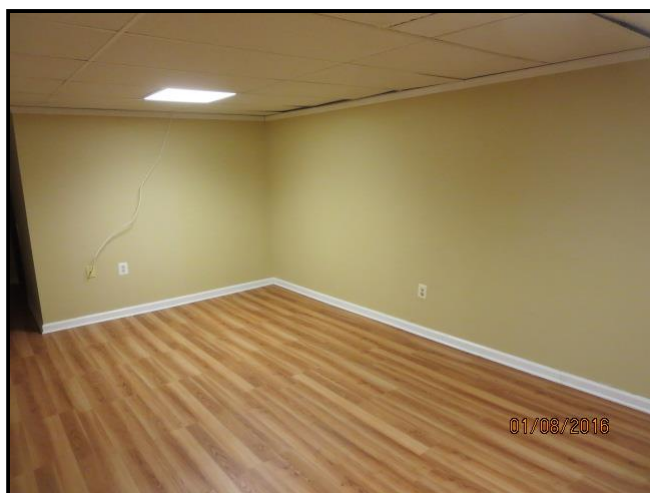
6.4 Item 1(Picture) Finished basement

Most of the walls and ceilings in the finished basement are covered and structural members are not visible. A strong mold odor was present I could not see behind these coverings. Recommend a mold specialist further evaluate.

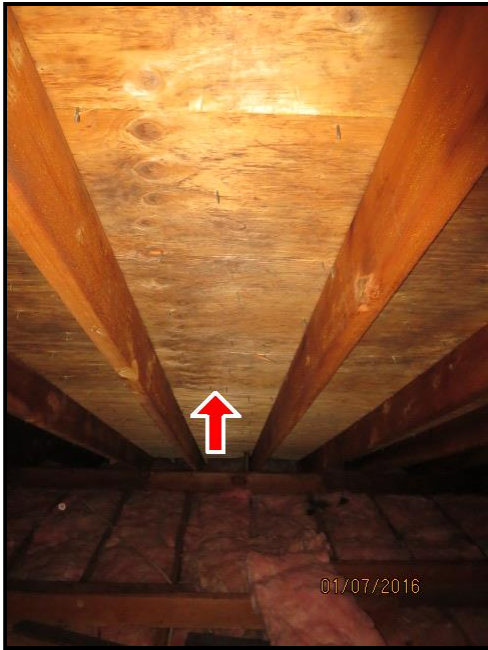
6.5 Item 1(Picture) Possible Mold

The roof sheathing in the attic may have mold. Mold can be a health hazard. Recommend a mold specialist further evaluate.

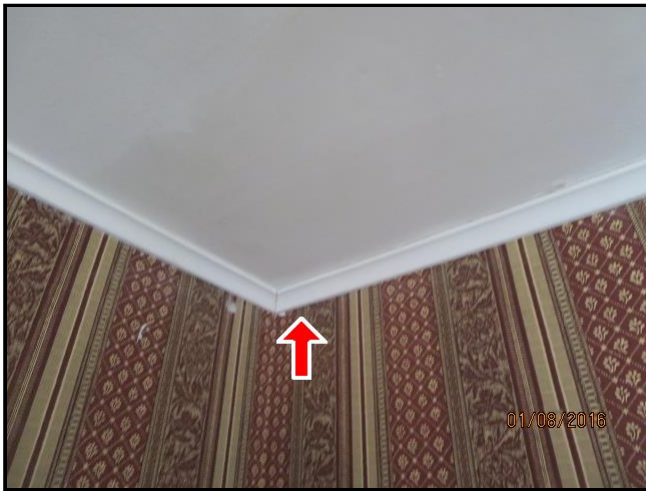
8.0 Item 1(Picture) Water stain

The Drywall on the ceiling reveals a water stain indicating a leak did or still exists at the Washer/Dryer room. Repairs were done. Water leak may be coming from vent pipe at roof A qualified contractor should inspect and repair as needed.

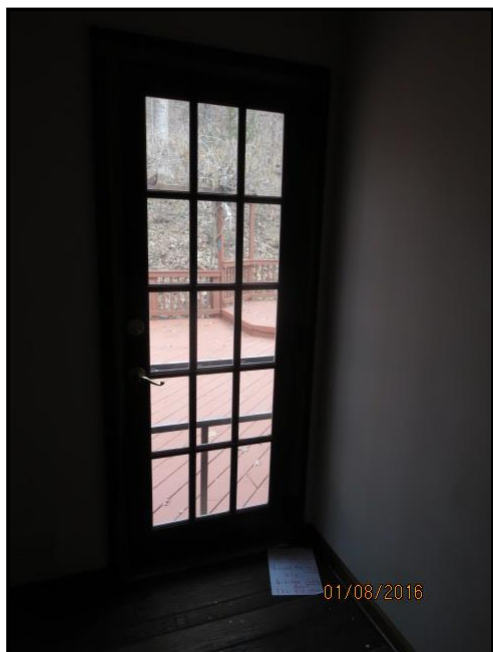
8.5 Item 1(Picture) Non working door

The Entry doors are defective at the Kitchen and family Room. This is considered unsafe and needs correcting. A qualified contractor should inspect and repair as needed.

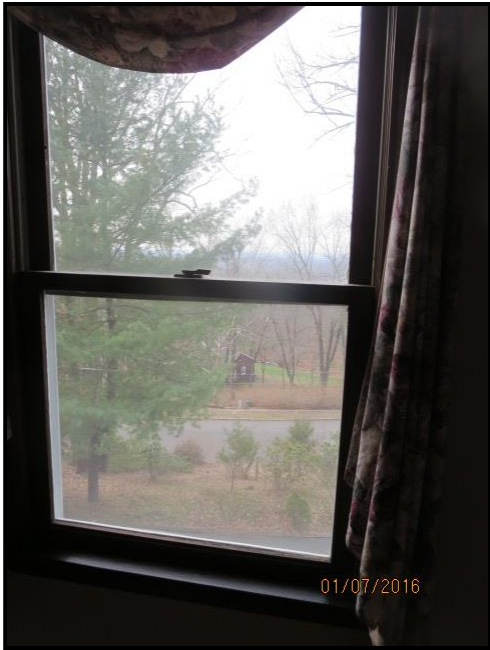
8.6 Item 1(Picture) Non working window

Four windows stuck or painted shut at the Bedroom and family Room. Further deterioration may occur if not repaired. A qualified contractor should inspect and repair as needed.

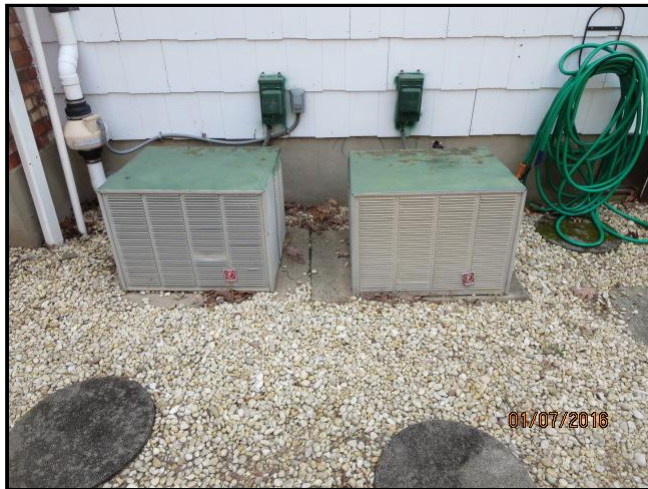
4.8 Item 1(Picture) Condensers

(1) The condenser outside (AC unit) is very old and may last a few years more, but maybe not. I have seen units fail shortly after a home inspection during the seasonal change from mild to hot weather. I cannot determine how long your AC will last before a replacement is necessary. Condenser are original life expectancy is 8-15 years
