LAKE AREA HOME INSPECTIONS

PROPERTY INSPECTION REPORT

Concerning: 134 Lakeside Dr., Mabank, TX 75156
(Address or Other Identification of Inspected Property)

By: Shawn Phares, Lic #Trec#20825 10/20/2018
(Name and License Number of Inspector) (Date)

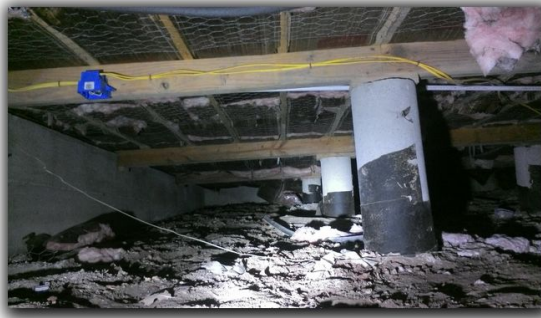
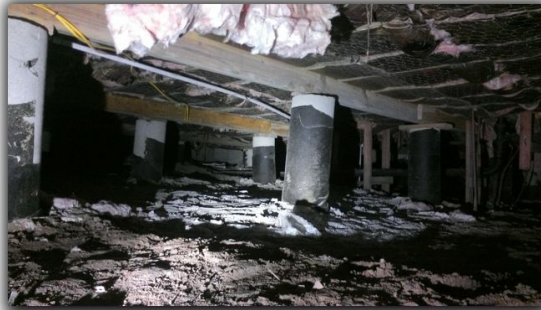
Comments: This is a foundation that is performing as intended. A careful examination showed no signs of movement in the exterior cladding beyond normal tolerance and no signs of movement in the interior walls, ceilings and floors beyond normal tolerance. The accessible crawlspace showed that there are solid, and properly spaced non-porous cement piers, correctly sized and well-placed girders as well as floor joists in good condition.

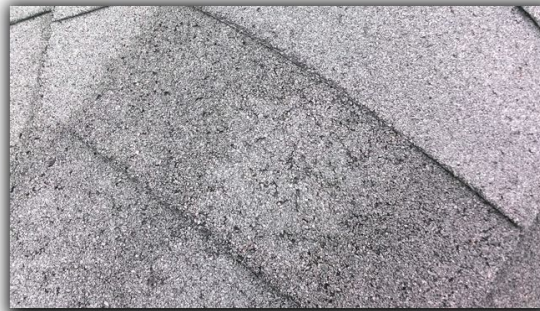
Comments: This is a 25 to 30 year asphalt shingle roof installed in the architectural style. It is my opinion, based on condition, that it is in the second third of its life. There is some granular loss. The main issue is the plumbing vent boots, these are the lead style and are prone to being chewed by rodents. All have been compromised and should be replaced. There is evidence of an active leak were the underside of the decking is wet on the backside of the house near the plumbing vent above the hall bathroom. It is my opinion that a qualified roofing contractor should evaluate this situation.

Some granular loss

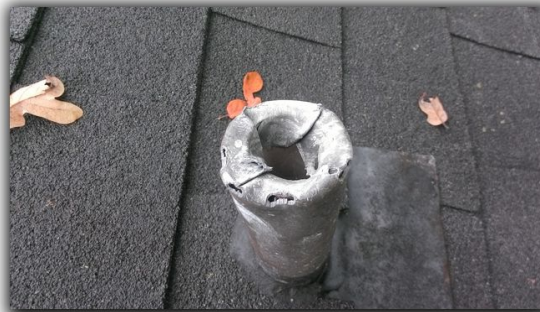
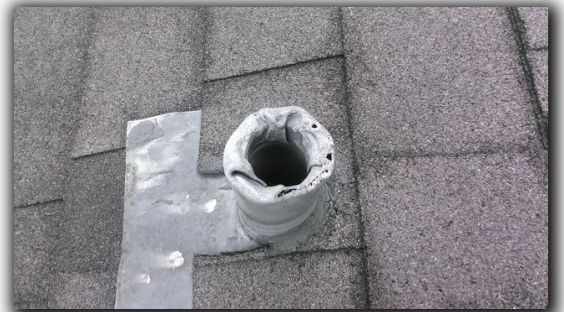
Plumbing vents are compromised

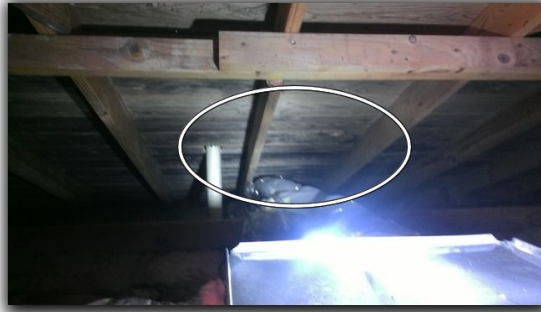
Active water leak in this area

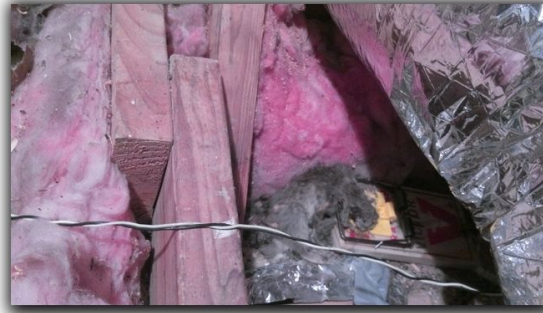
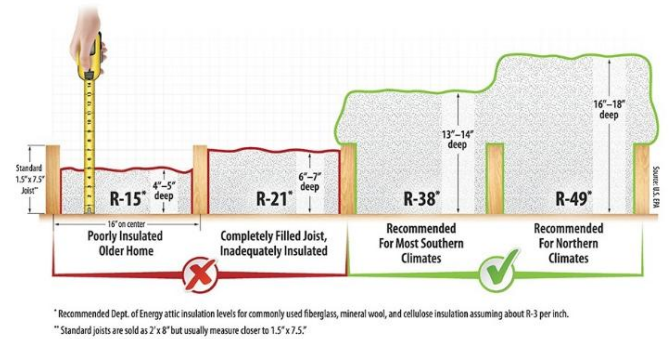
There is a dead rodent in a trap that should be removed.

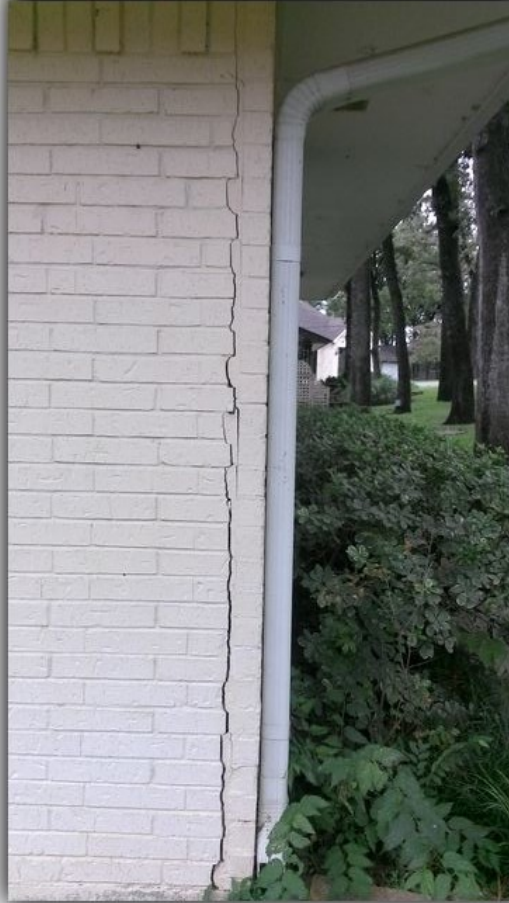
There is a vertical separation crack on the north west corner of the brick cladding. This does not appear to be associated with a foundation issue but is generally due to not having proper brick tie installation during the original construction.

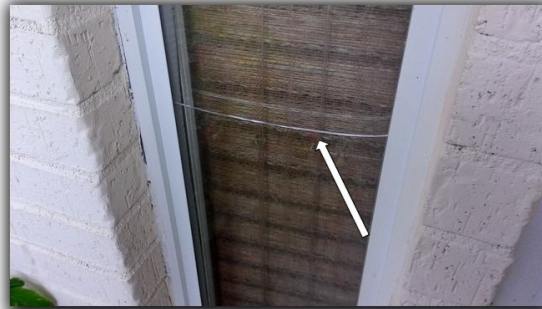
There is a broken sidelight window to the left of the front door.

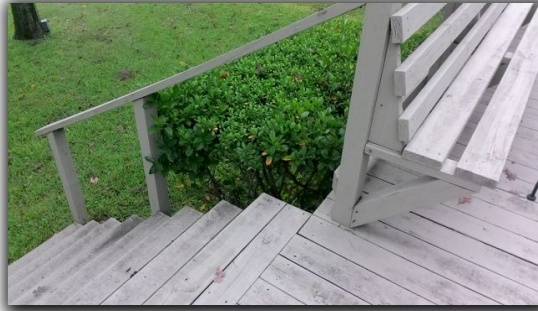
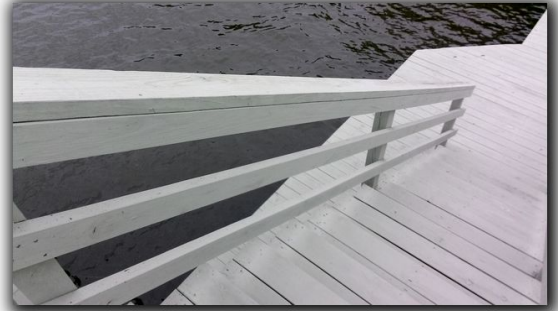
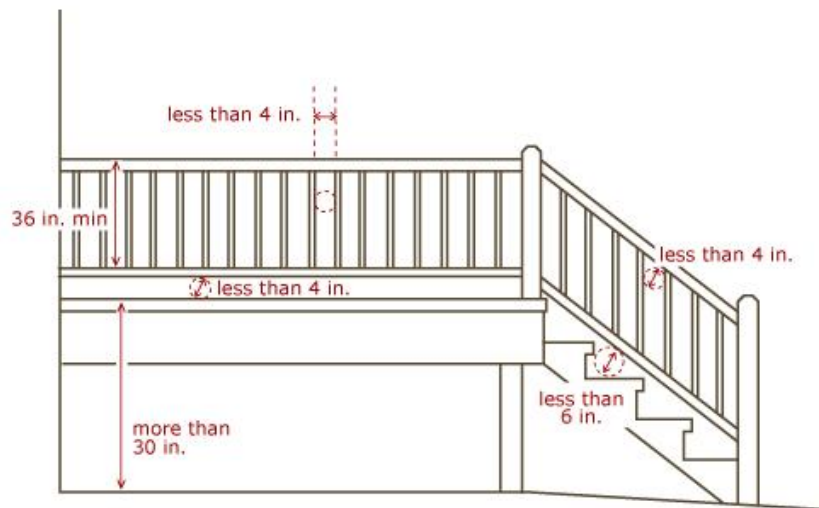
Comments: The back porch stairs and the stairs to the upper section of the dock did not comply with building safety codes. Handrails more than 30 inches above the ground require properly spaced balusters.

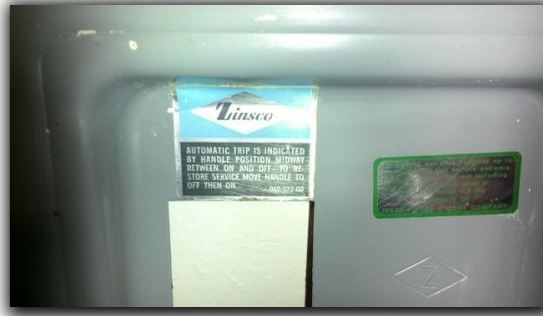
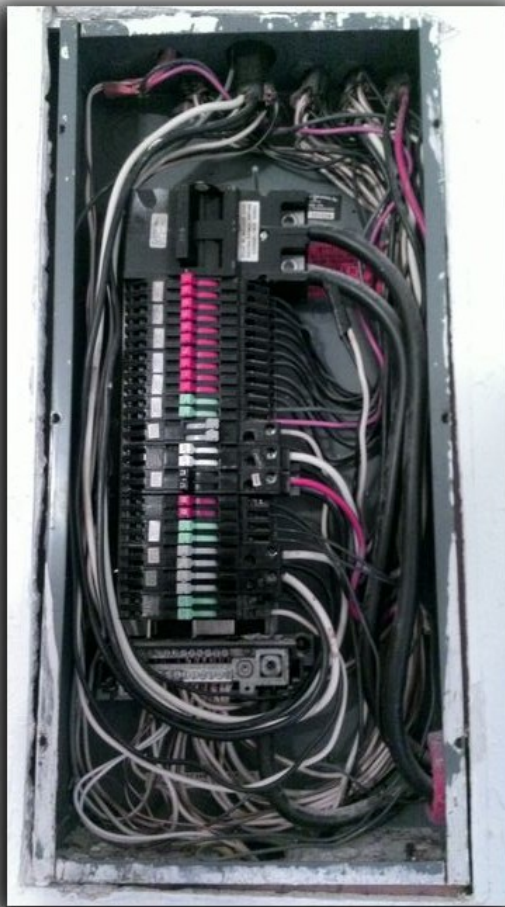
Comments: The distribution electrical panel is a Zinsco brand panel box, a company later purchased by Sylvania. This product that hasn't been manufactured for many years. There are problems with these panels that can, in some cases, be serious. Some Zinsco panels have aluminum bus bars (the bars that run down the middle of the panel to which the breakers connect). Over a period of years, oxide forms on the aluminum causing a poor connection with the breakers and can lead to arcing, overheating, breaker failure and, in some cases, electrical fires. It is my recommendation that a qualified licensed electrician should evaluate this panel.

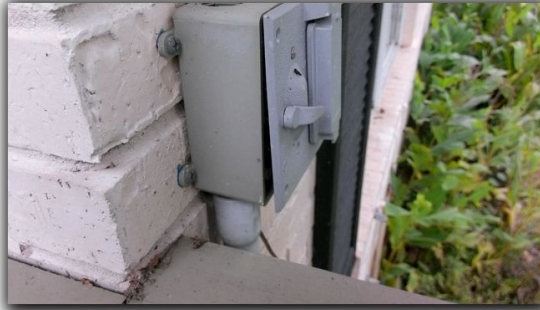
Comments: There is a broken and open exterior switch and duplex plug box on the back of the house.

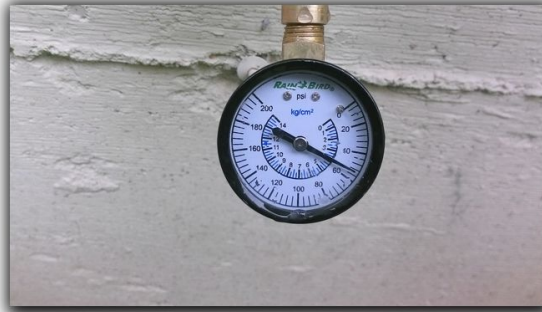
Lack of reducing valve over 80 psi

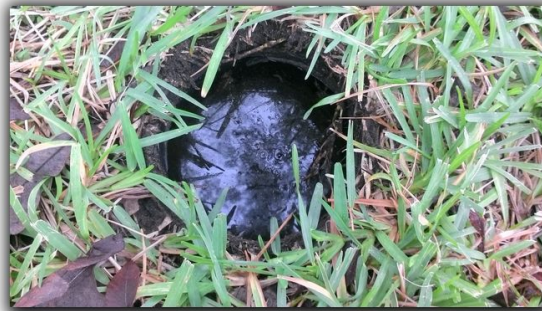
Comments: The water was off when I arrived, I turned it on at the valve just inside the meter. The box for this valve immediately filled with water indicating that there is a leak at the valve. There was also water coming up out of the ground just below the hose bib on the back south side of the house.

Private shuttle valve box filled with water

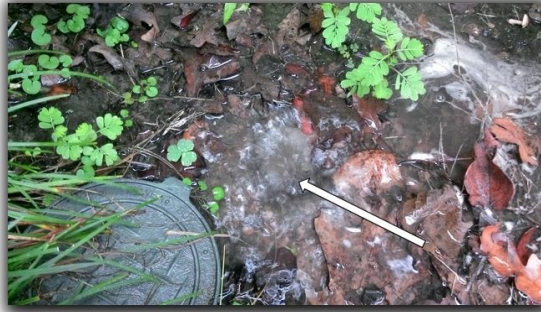
Water leak below hose bib on the south side of the house.

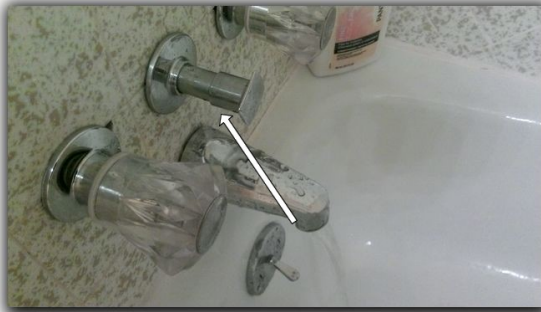
Comments: The shower diverter in the hall bath is not functioning properly and leaks.

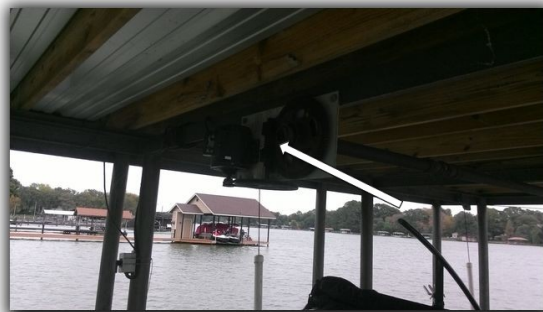
Comments: The property has a boat dock complete with a boatlift and to personal watercraft lifts. The dock itself is in very good condition, both PWC lifts were operational. The boatlift was operational but is in need of being properly lubricated.

Lift worked intermittently due to under lubrication

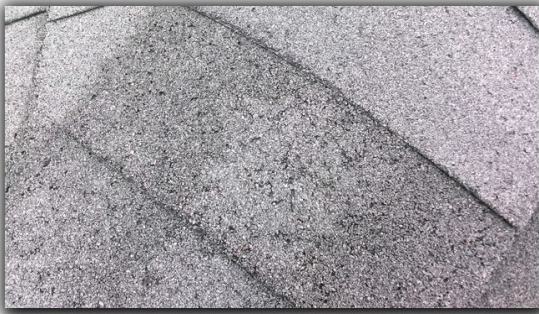
This is a 25 to 30 year asphalt shingle roof installed in the architectural style. It is my opinion, based on condition, that it is in the second third of its life. There is some granular loss. The main issue is the plumbing vent boots, these are the lead style and are prone to being chewed by rodents. All have been compromised and should be replaced. There is evidence of an active leak were the underside of the decking is wet on the backside of the house near the plumbing vent above the hall bathroom. It is my opinion that a qualified roofing contractor should evaluate this situation.

Some granular loss

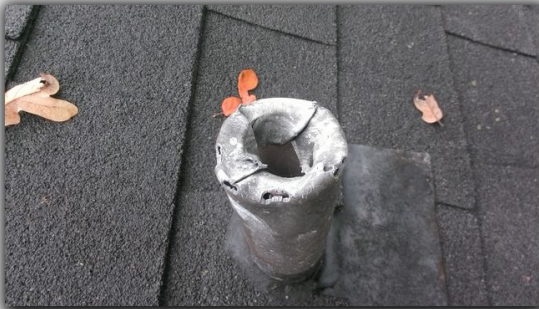
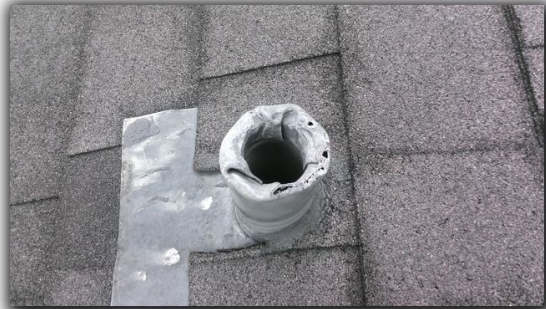
Plumbing vents are compromised

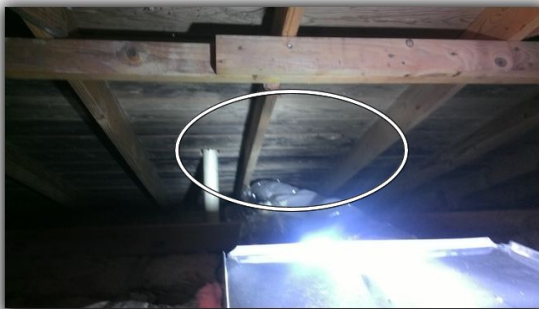
Active water leak in this area

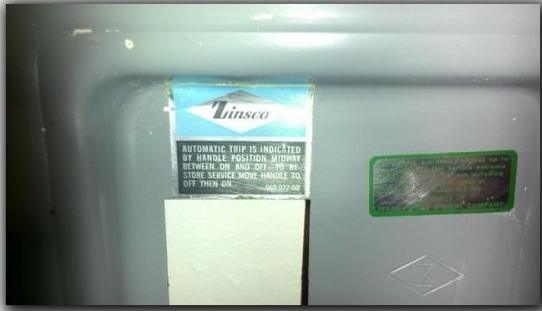
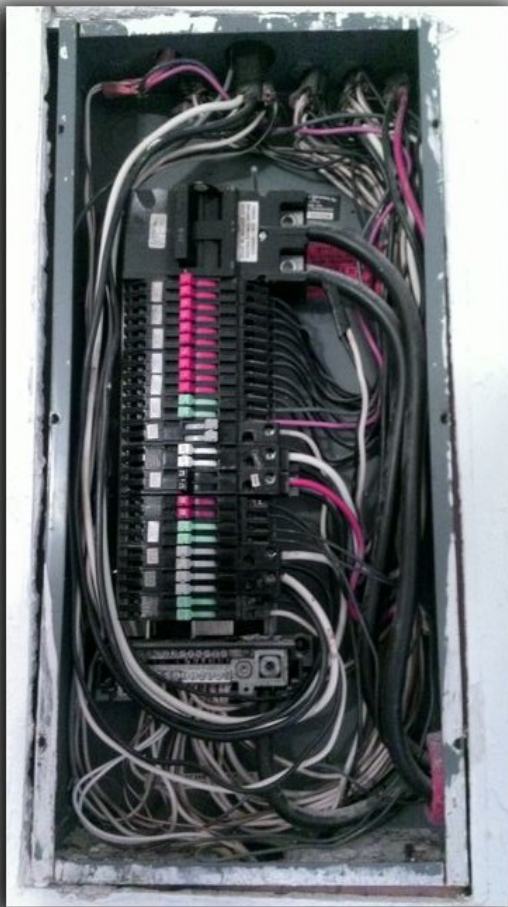
The distribution electrical panel is a Zinsco brand panel box, a company later purchased by Sylvania. This product that hasn't been manufactured for many years. There are problems with these panels that can, in some cases, be serious. Some Zinsco panels have aluminum bus bars (the bars that run down the middle of the panel to which the breakers connect). Over a period of years, oxide forms on the aluminum causing a poor connection with the breakers and can lead to arcing, overheating, breaker failure and, in some cases, electrical fires. It is my recommendation that a qualified licensed electrician should evaluate this panel.

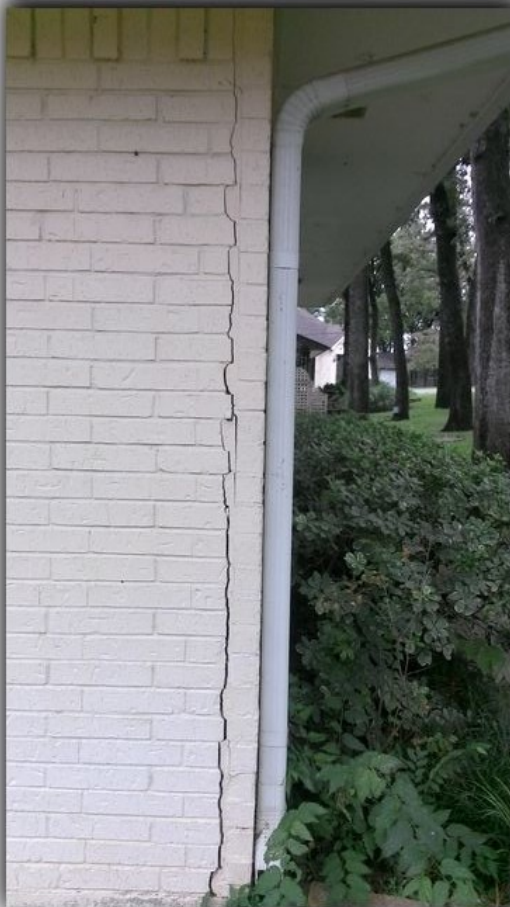
There is a vertical separation crack on the north west corner of the brick cladding. This does not appear to be associated with a foundation issue but is generally due to not having proper brick tie installation during the original construction.

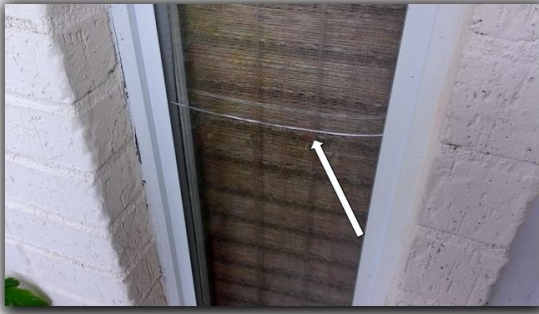
There is a broken sidelight window to the left of the front door.

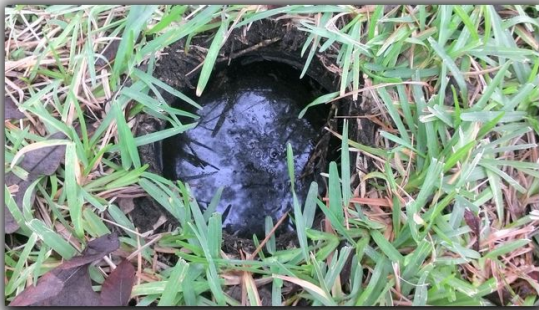
The water was off when I arrived, I turned it on at the valve just inside the meter. The box for this valve immediately filled with water indicating that there is a leak at the valve. There was also water coming up out of the ground just below the hose bib on the back south side of the house.

Private shuttle valve box filled with water

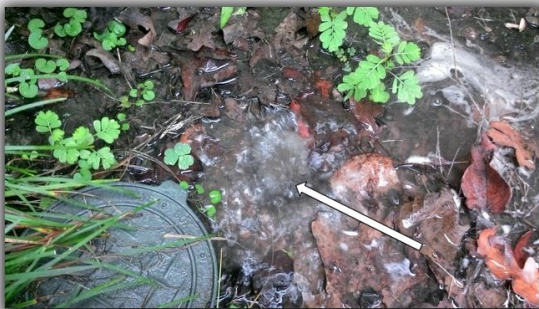
Water leak below hose bib on the south side of the house.
The shower diverter in the hall bath is not functioning properly and leaks.

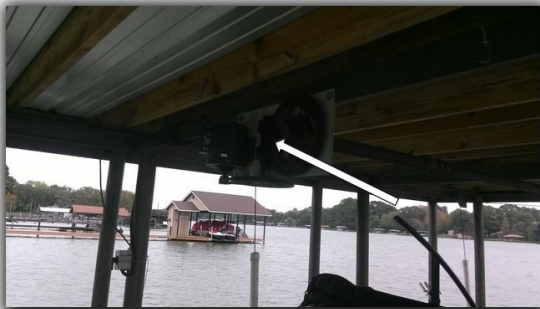
The boatlift was operational but is in need of being properly lubricated.

Lift worked intermittently due to under lubrication

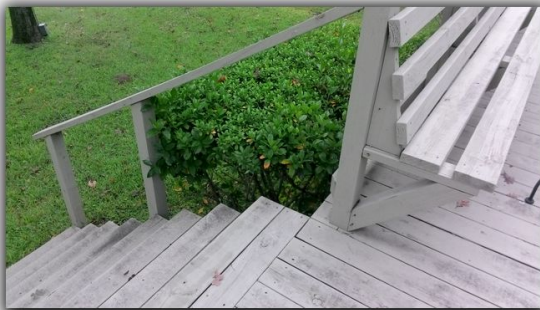
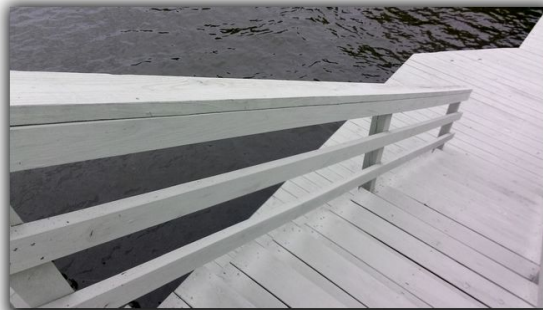
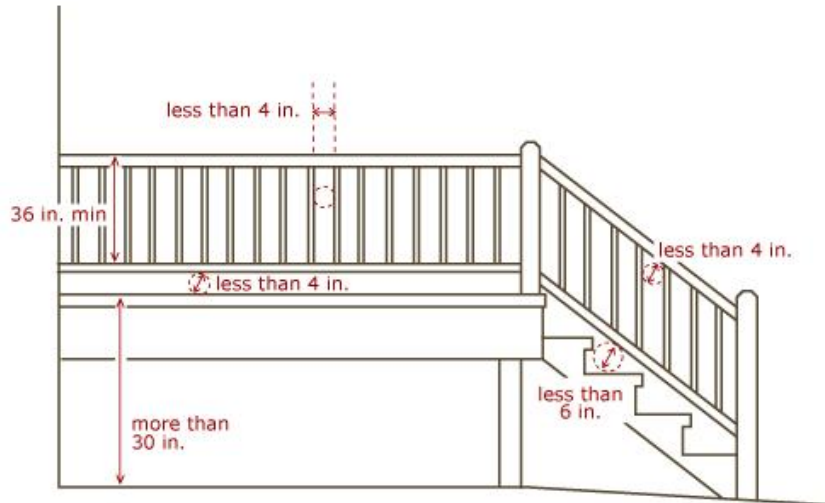
The back porch stairs and the stairs to the upper section of the dock did not comply with building safety codes. Handrails more than 30 inches above the ground require properly spaced balusters.
