INSPECTION REPORT

For the Property at:
12345 NEWHOME AVE S
SEATTLE, WA 98101

Prepared for: JOHN DOE
Inspection Date: Friday, July 24, 2020
Prepared by: Luke Chmura, WA DOL #2548

RE: Report No. 1007, v.2
12345 Newhome AVE S
Seattle, WA
98101

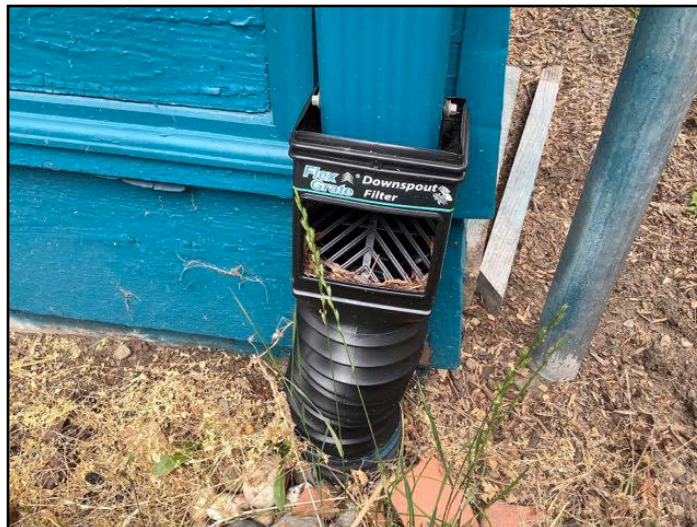
1. Discharge below grade

Condition: • [Discharge below grade](#)

Downspout discharging into below grade flexible pipe. This type of ribbed pipe is prone to clogging

Implication(s): Chance of water damage to contents, finishes and/or structure

Task: Improve

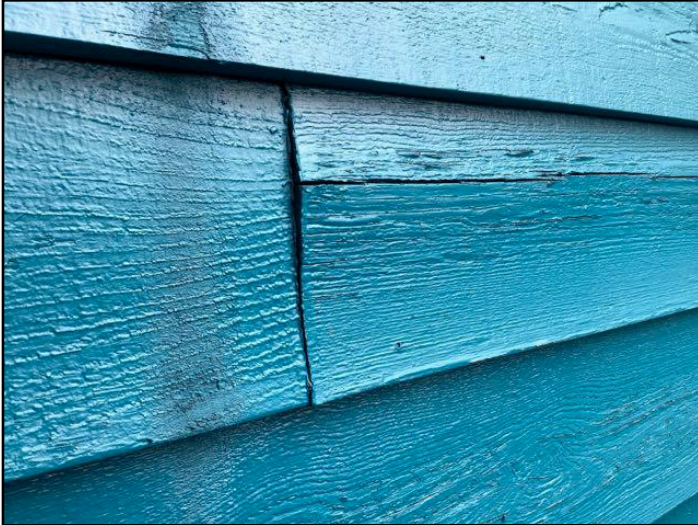
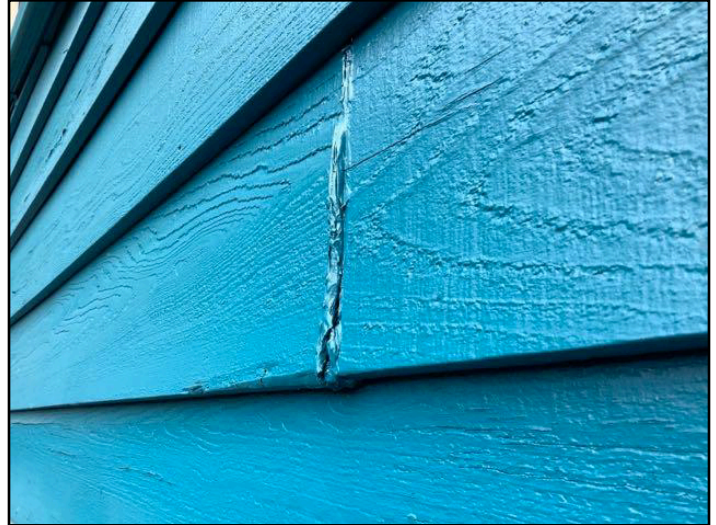
Condition: • [Cracked, split or broken](#)

Siding is loose on several locations on south side of house

Implication(s): Chance of water damage to contents, finishes and/or structure

2. Cracked, split or broken

3. Cracked, split or broken

Task: Repair or replace by qualified contractor

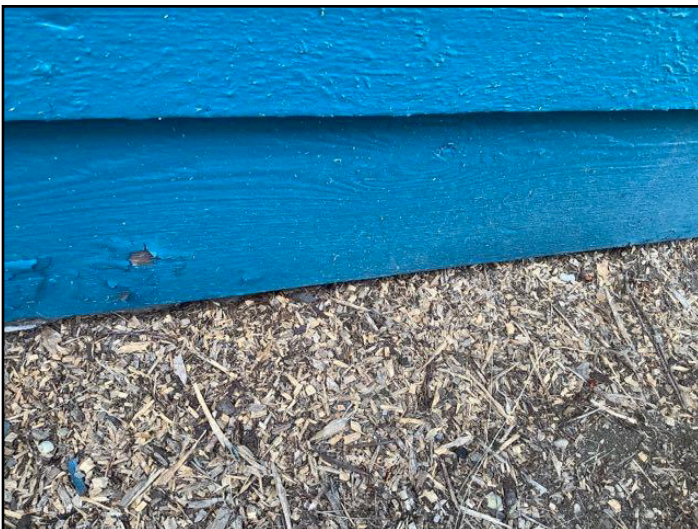
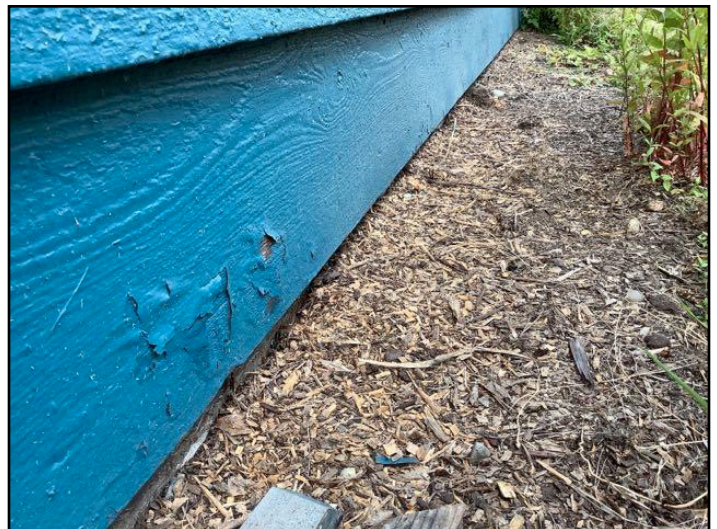
Condition: • [Too close to grade](#)

Siding should be 6 inches above grade with grades slipping away from house

Implication(s): Chance of water damage to contents, finishes and/or structure | Material deterioration | Rot | Insect damage

4. Too close to grade

5. Too close to grade

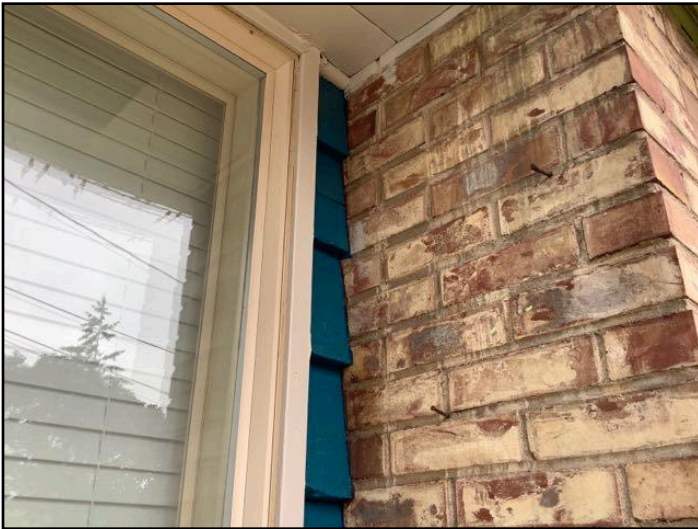
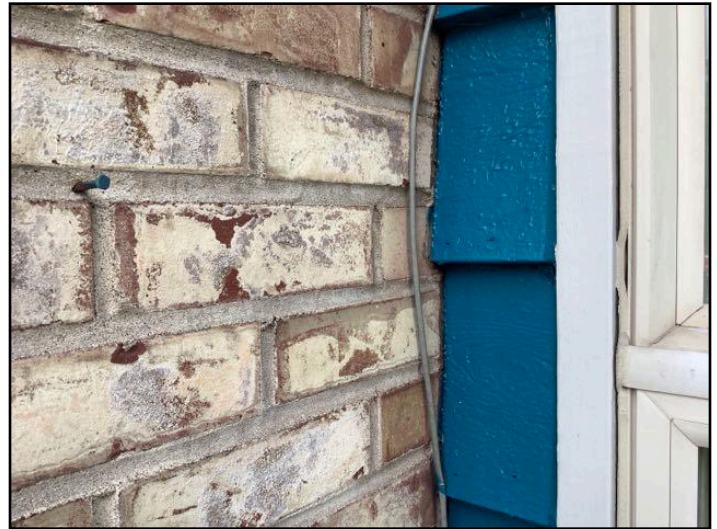
Condition: • Siding touching chimney. Possible entry point for moisture and/or insects.

Task: Improve

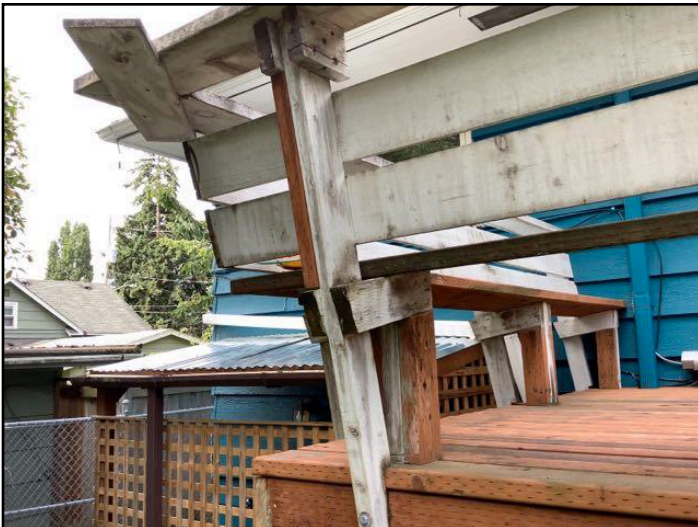
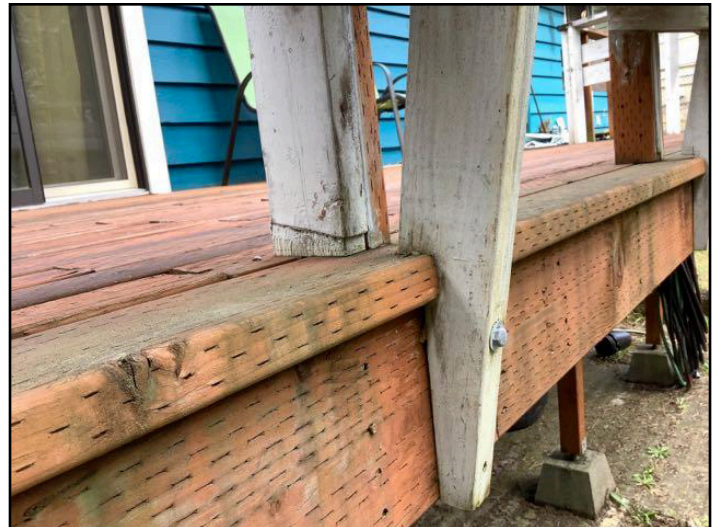
Condition: • Poorly built

Deck is unprofessionally built. Appears to be structurally unsound in seating area

Implication(s): Weakened structure

8. Poorly built

9. Poorly built

Task: Call qualified contractor or carpenter to evaluate and repair where needed

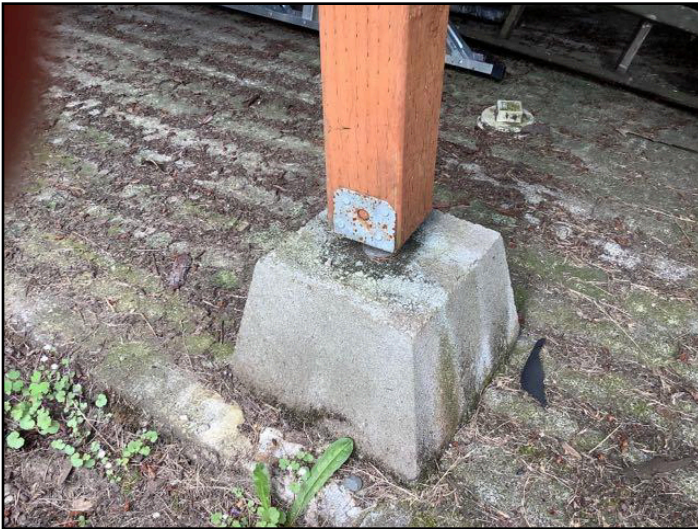
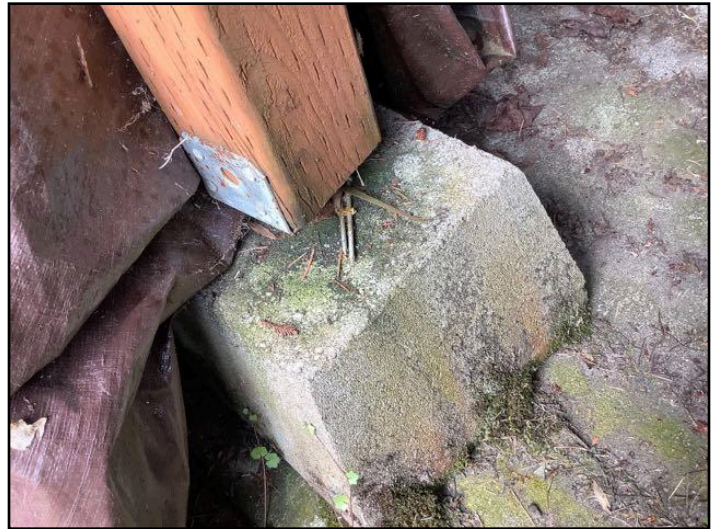
Condition: • [Connections weak](#)

Deck post supports not properly mounted in concrete

Implication(s): Weakened structure | Chance of structural movement

10. Connections weak

11. Connections weak

Task: Improve

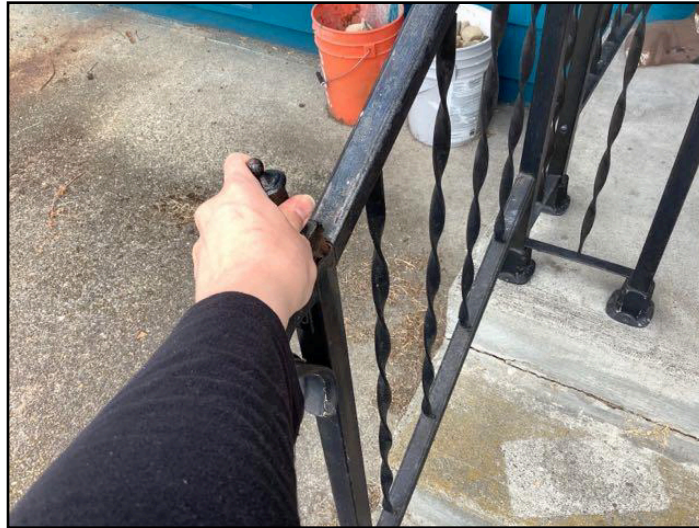
Condition: • [Loose](#)

Implication(s): Fall hazard

12. Loose

Task: Repair

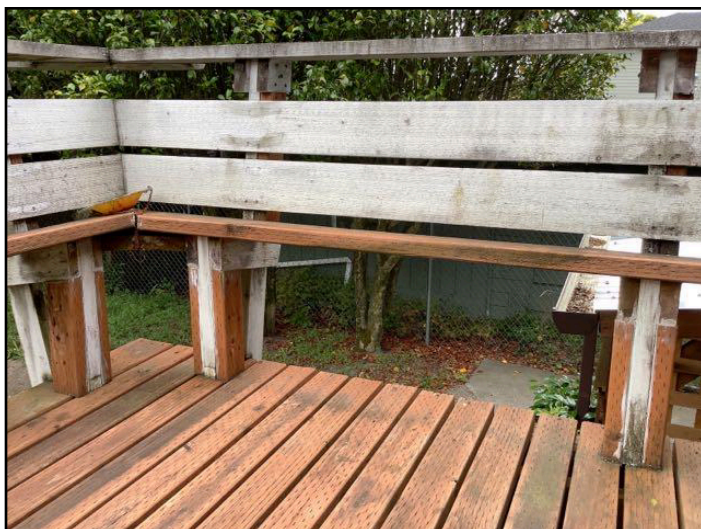
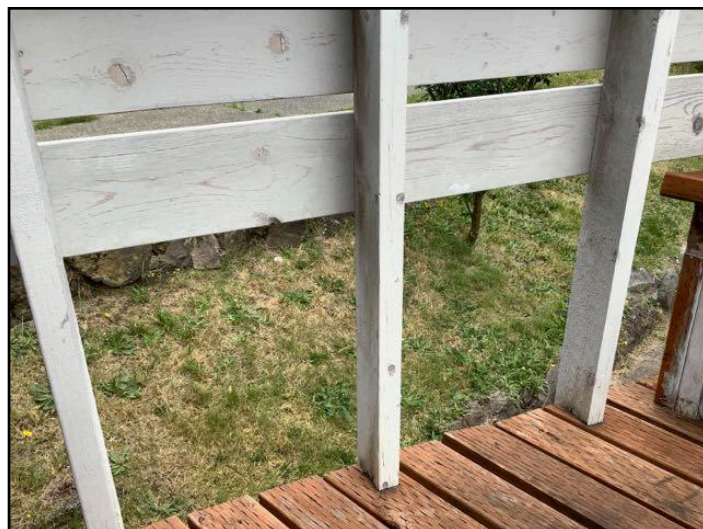
Condition: • [Openings between spindles \(balusters\) too large](#)

Implication(s): Fall hazard

13. Openings too large

14. Openings too large

Task: Correct

spindles should be spaced so that a 4" (6" in some areas) sphere cannot pass through the guard

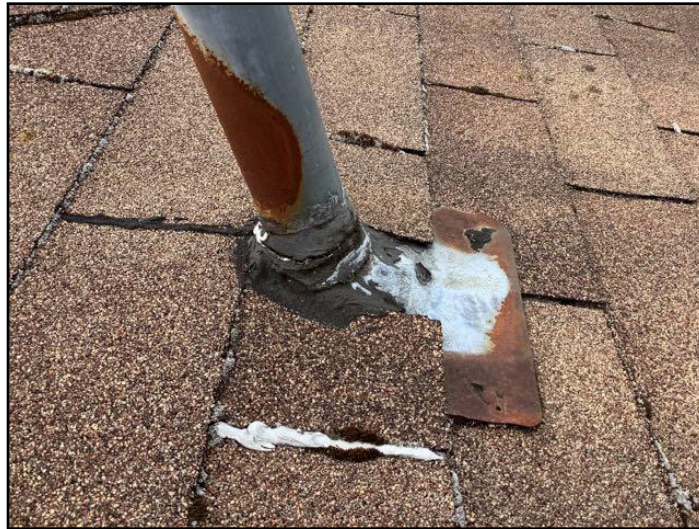
Condition: • [Mast not weather-tight](#)

The masthead flashing boot is old and worn out. This is a possible entry point for moisture.

Implication(s): Electric shock

20. Mast not weather-tight

Task: Improve

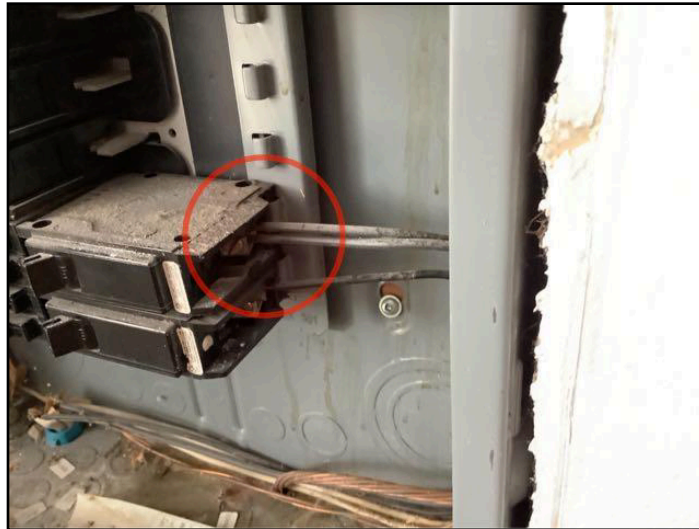
Condition: • [Double taps](#)

Implication(s): Fire hazard

21. Double taps

Task: Correct

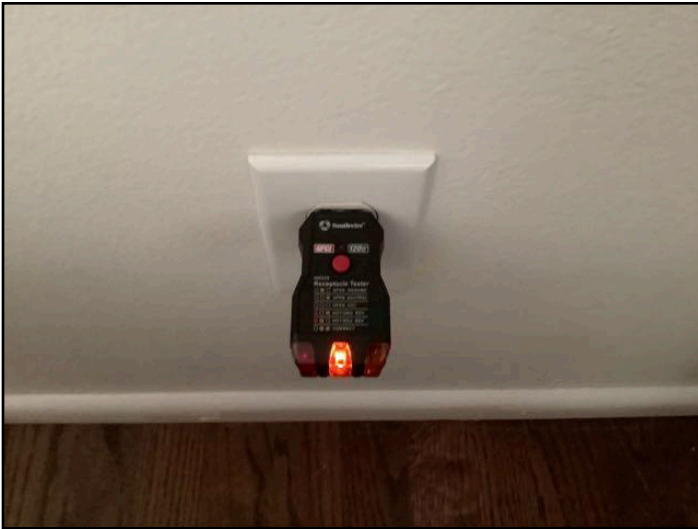
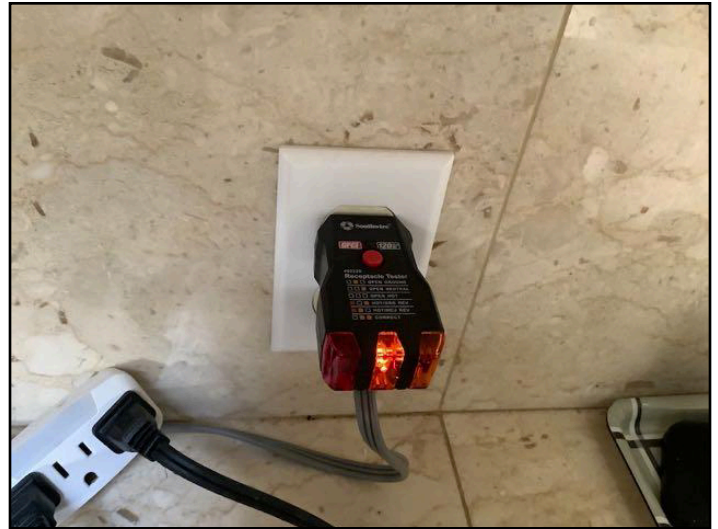
Condition: • [Ungrounded](#)

Implication(s): Electric shock

22. Ungrounded

23. Ungrounded

Task: Recommended qualified electrician to improve with grounded wires

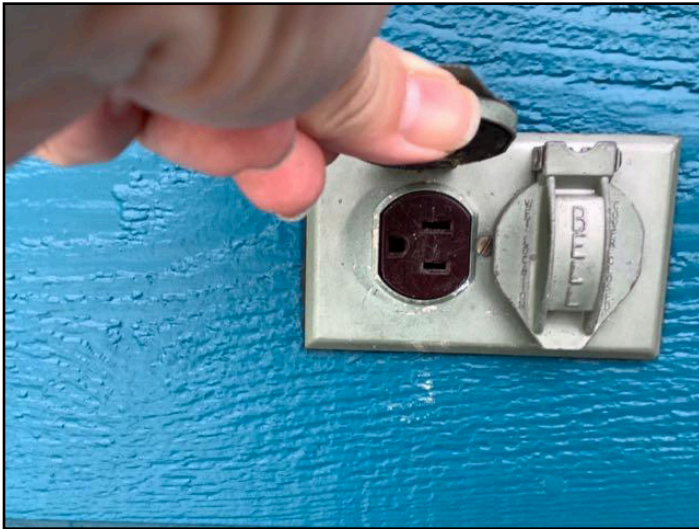
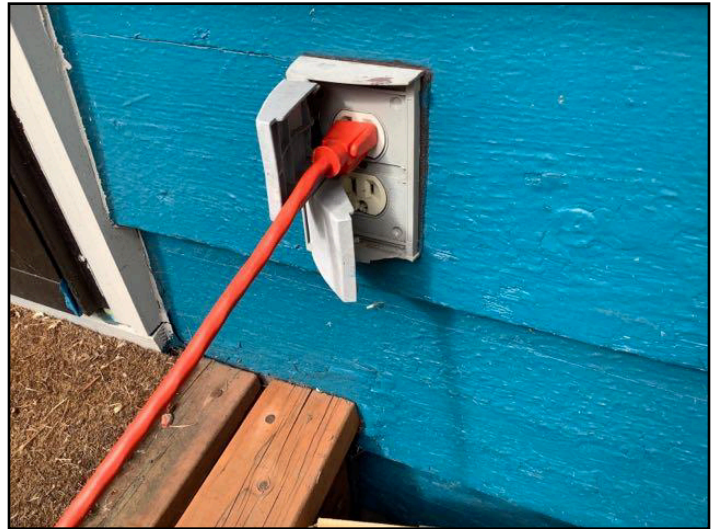
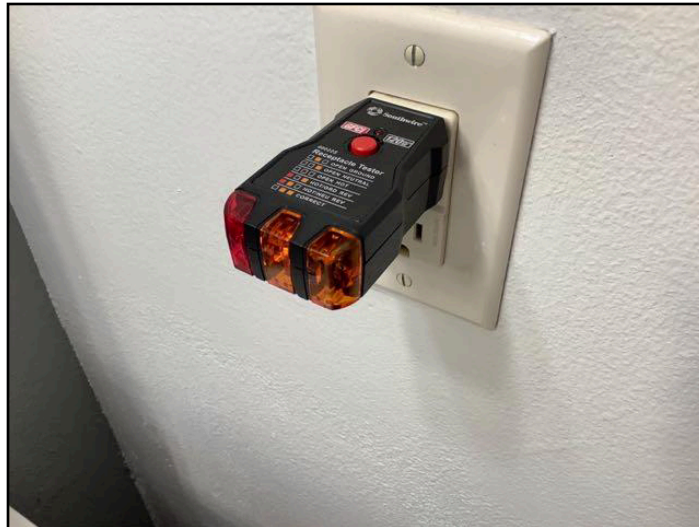
Condition: • [GFCI/GFI needed \(Ground Fault Circuit Interrupter\)](#)

No GFCI receptacles in necessary areas of house. Bathroom GFCI is ungrounded, this disables the GFCI capabilities of this receptacle.

Implication(s): Electric shock

24. GFCI/GFI needed (Ground Fault Circuit...

25. GFCI/GFI needed (Ground Fault Circuit...

26. Ungrounded GFCI in Bathroom

Task: Correct

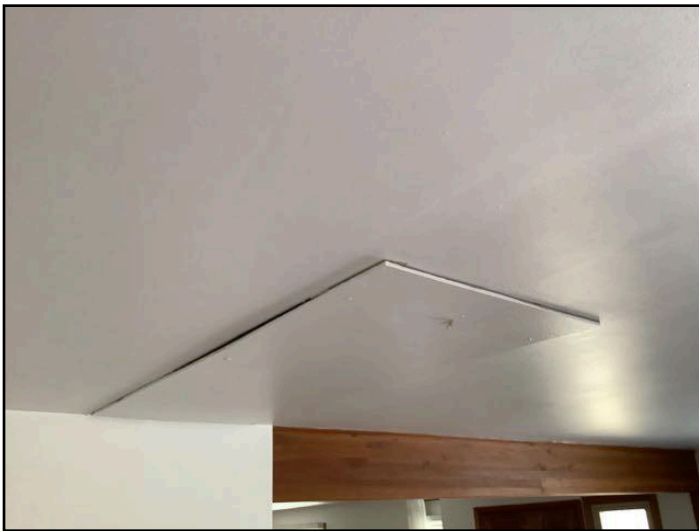
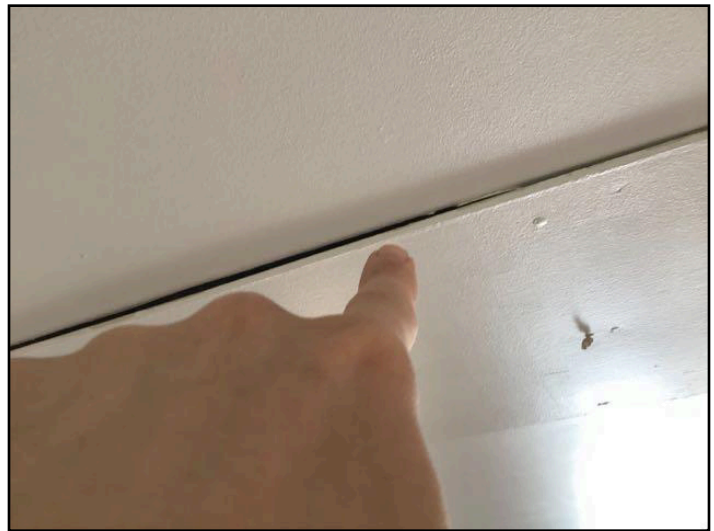
Condition: • [Inadequate insulation](#)

Insulation around attic access stairway is in adequate

Implication(s): Increased heating and cooling costs | Reduced comfort

29. Inadequate insulation

30. Inadequate insulation

Task: Improve

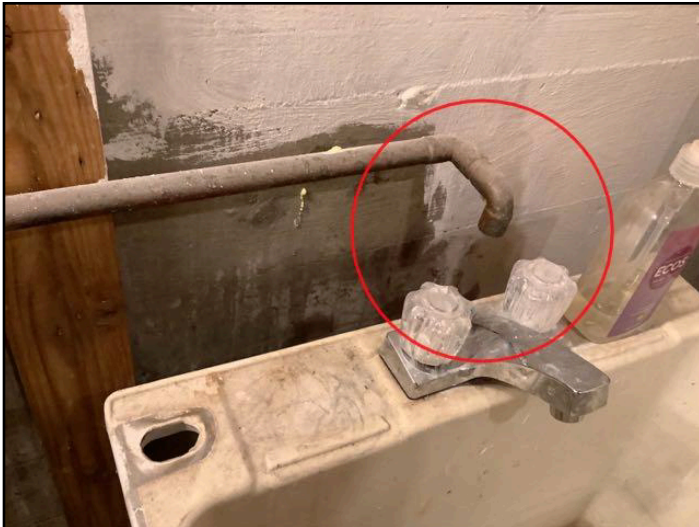
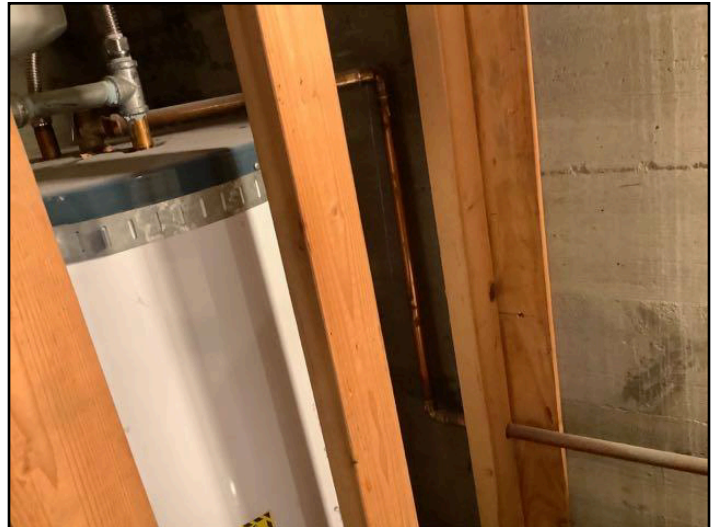
Condition: • Discharge arrangement poor

Implication(s): Fire or explosion

34. Discharge arrangement poor

35. Discharge arrangement poor

Task: Improve

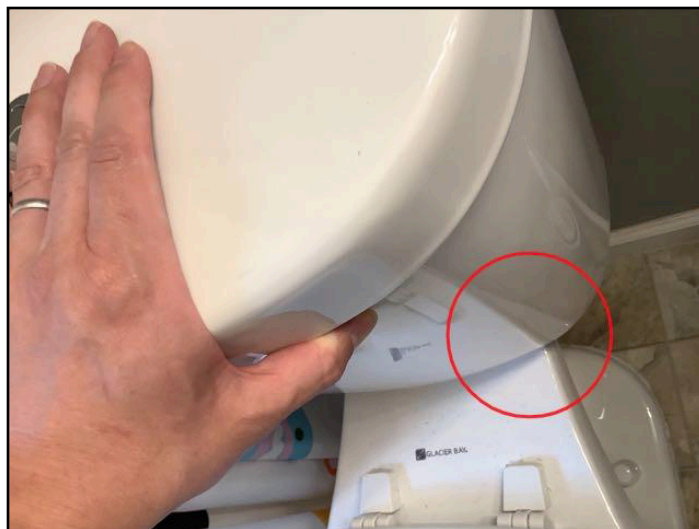
Condition: • [Loose](#)

Implication(s): Chance of water damage to contents, finishes and/or structure | Sewage entering the building | Possible hidden damage

36. Loose

Task: Improve

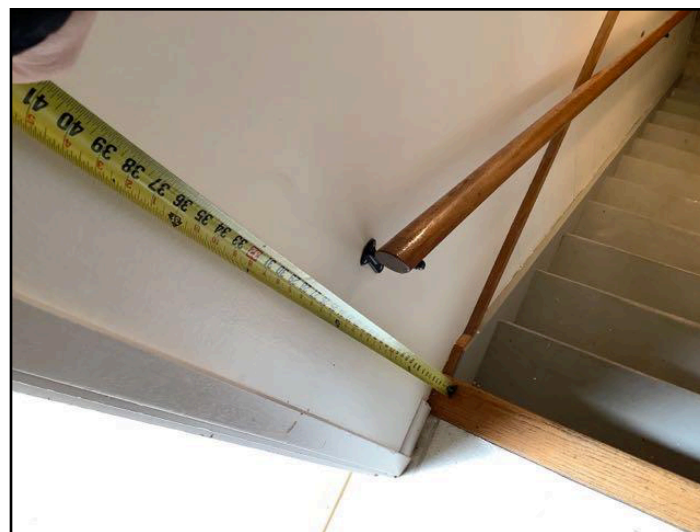
Condition: • [Too low](#)

Implication(s): Fall hazard

37. Too low

Task: Correct
