PROPERTY CONDITION ASSESSMENT REPORT

Sample Report

Minnesota, MN

Friday, November 6, 2015

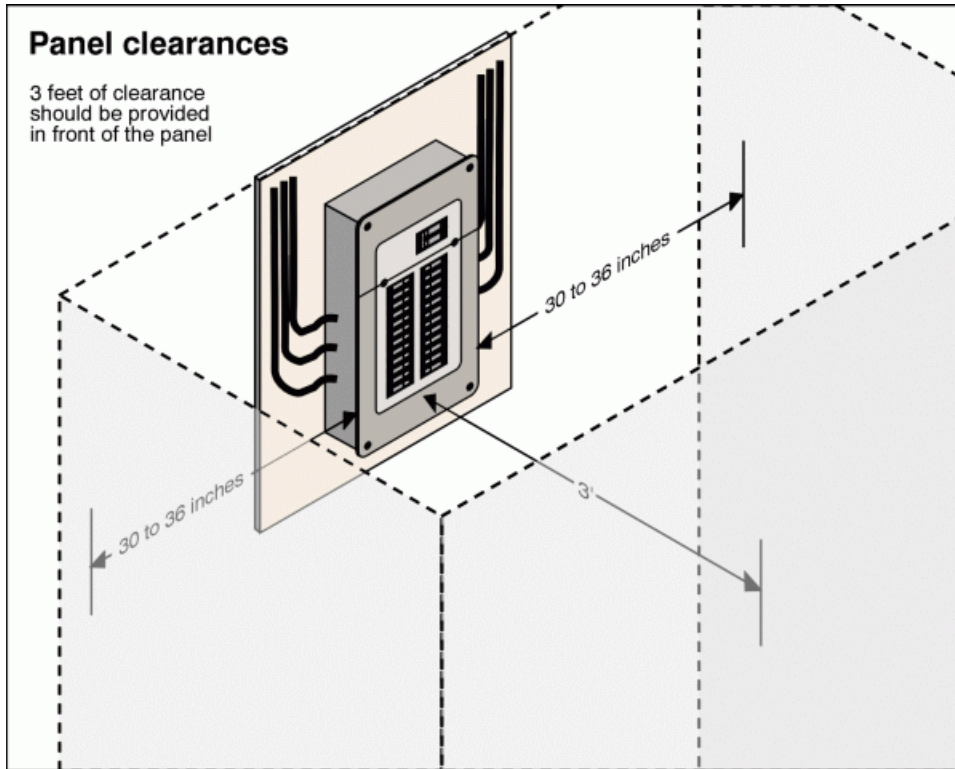
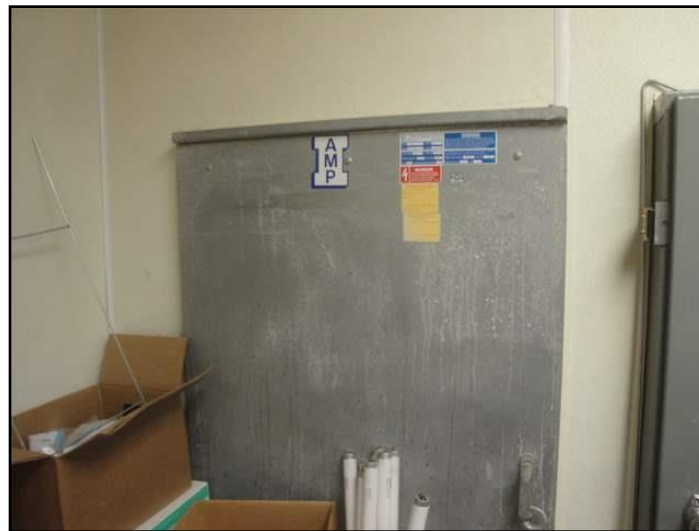
DISTRIBUTION EQUIPMENT \ Main distribution conditions
5. **Condition:** • Storage within one meter of equipment
Location: East Wall
Task: Improve
Time: Immediate

1. Storage within one meter of equipment

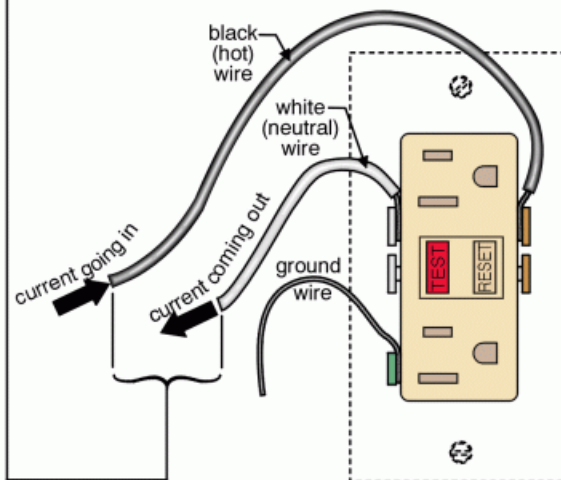
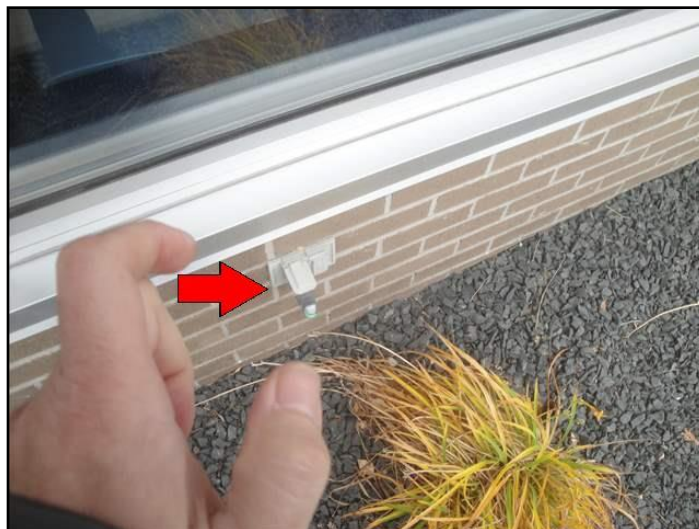
7. **Condition:** • Electrical outlets close to a water source - should be protected by a ground-fault circuit interrupter (GFCI)

2. Electrical outlets close to a water source...

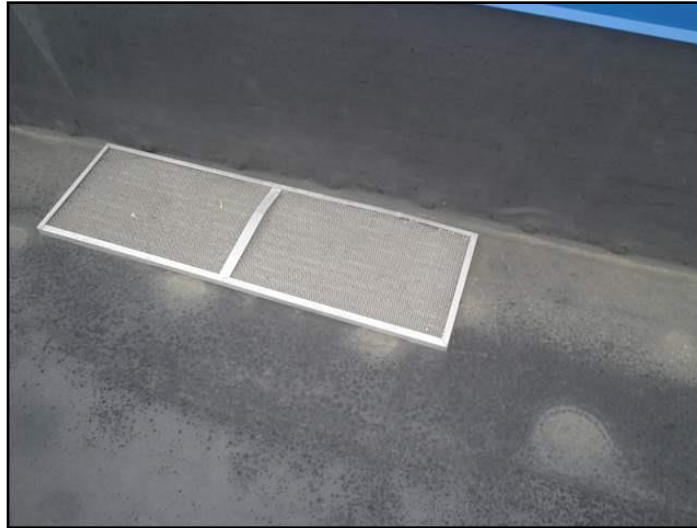
3.

19. Condition: • Economizer filter is loose

Task: Replace

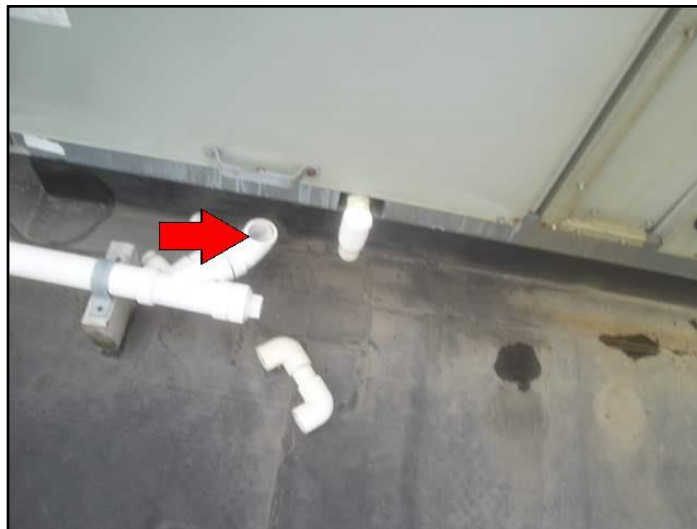
20. Condition: • Missing condensate trap

Damaged or disconnected

4. Missing condensate trap

Task: Repair

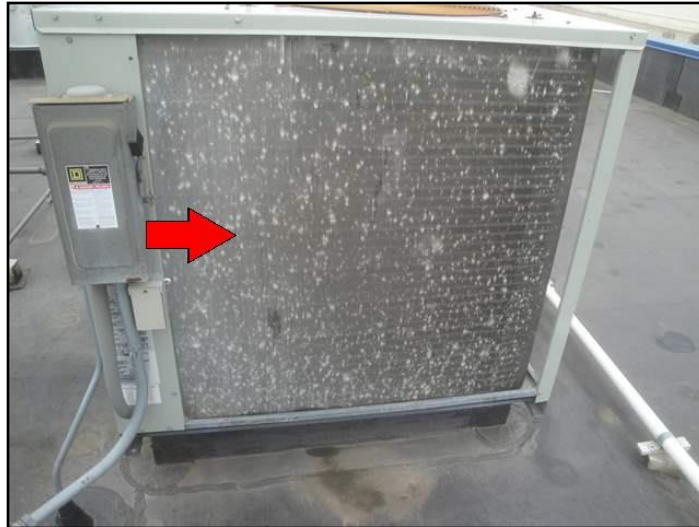
21. Condition: • Condenser coil damaged / obstructed / dirty

5. Condenser coil damaged / obstructed / dirty

Task: Repair or replace

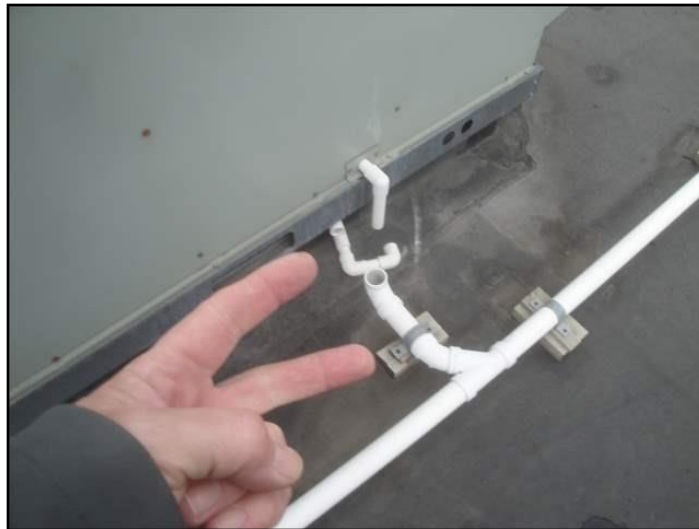
22. Condition: • Missing condensate trap

6. Missing condensate trap

Task: Repair

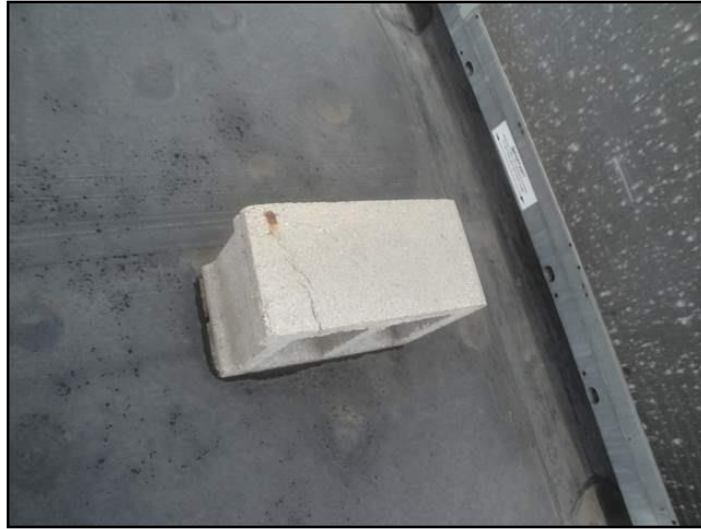
9.

37. Condition: • Provide annual roof tune ups to prolong the life of the roof

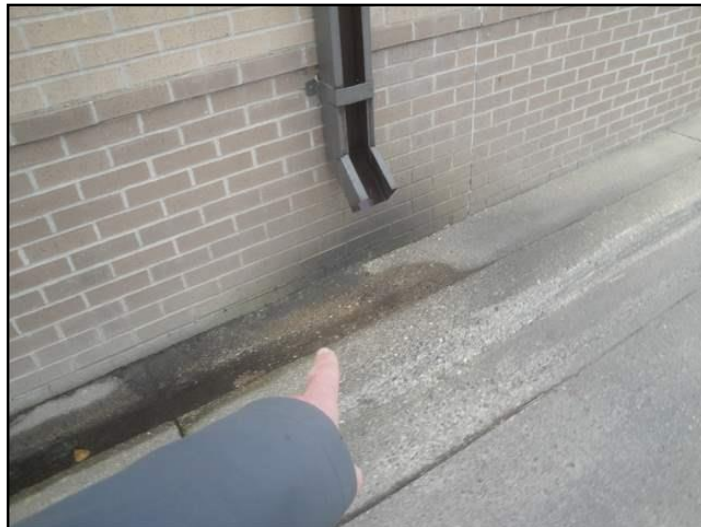
10. *Discharging too close to building structure*

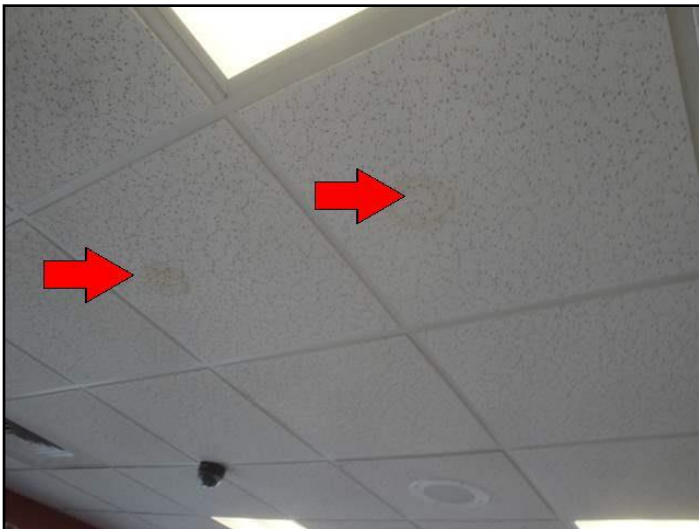
20. Water stain

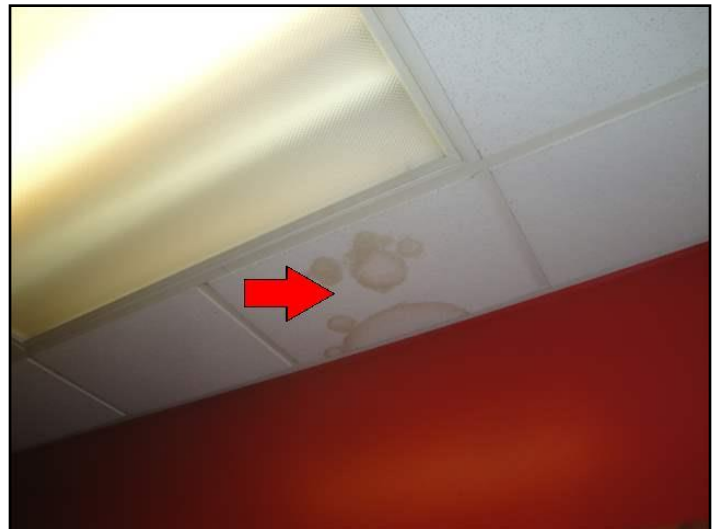
21. Water stain

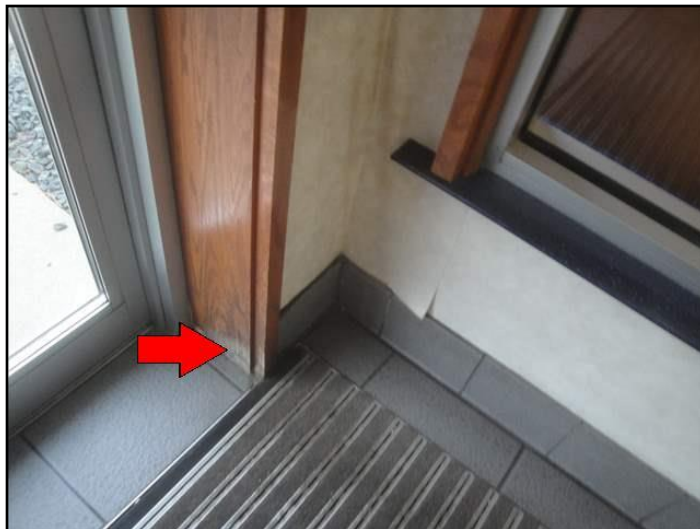
Condition: • A water stain was noted. Refer to the relevant sections of the report for discussions of the related systems.

22. A water stain was noted. Refer to the...

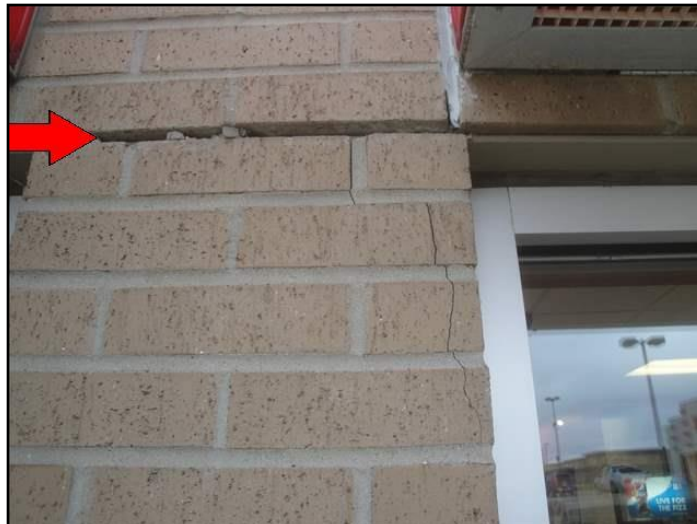
49. Condition: • Mortar deterioration

35. *Mortar deterioration*

Task: Repair

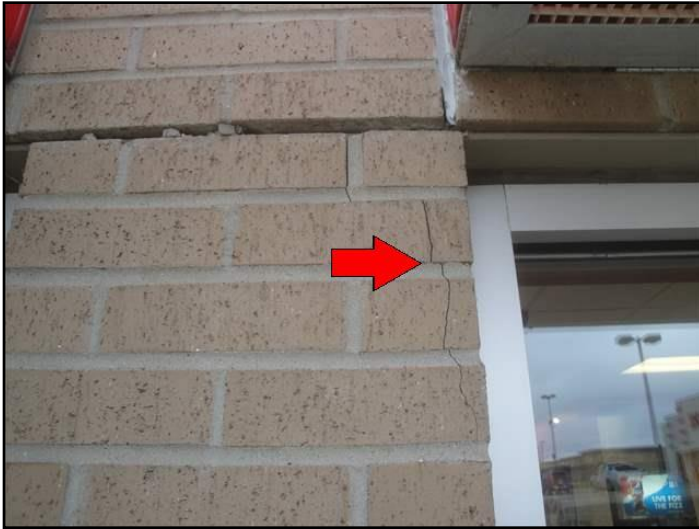
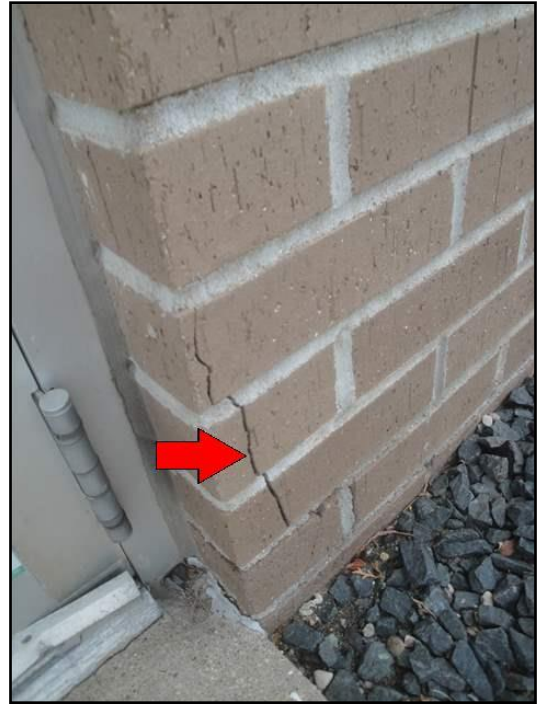
50. Condition: • Cracks
Minor cracks were observed.
Location: South Entry
Task: Repair
Time: Less than 2 years

36. Cracks

37. Cracks

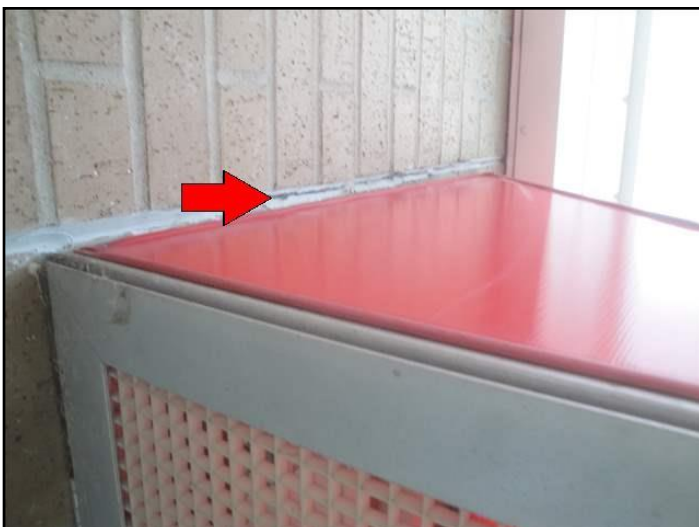
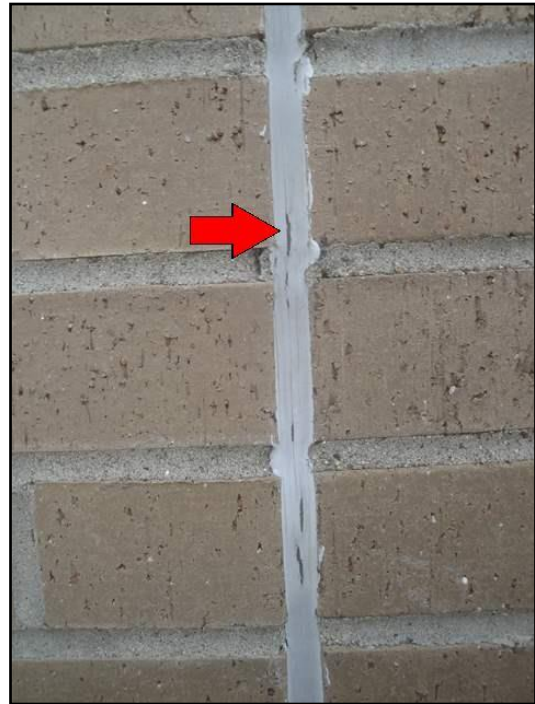
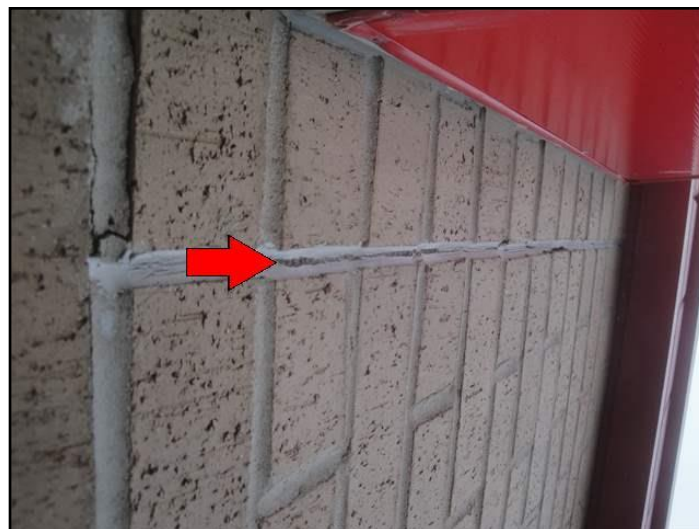
51. Condition: • Deteriorated caulking wall expansion joints
Location: Various
Task: Repair
Time: Less than 2 years

38. Deteriorated caulking wall expansion joints

39. Deteriorated caulking wall expansion joints

40. Deteriorated caulking wall expansion joints

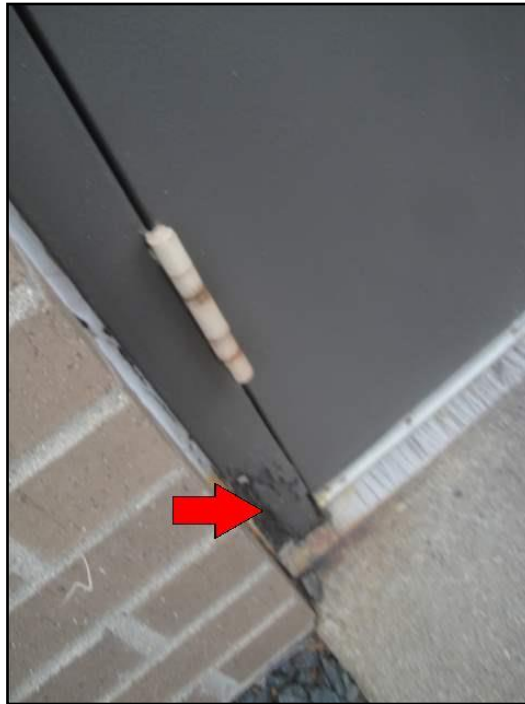
Typical minor to moderate corrosion was observed at rear personnel door frames.

41. Corroded

Task: Repair

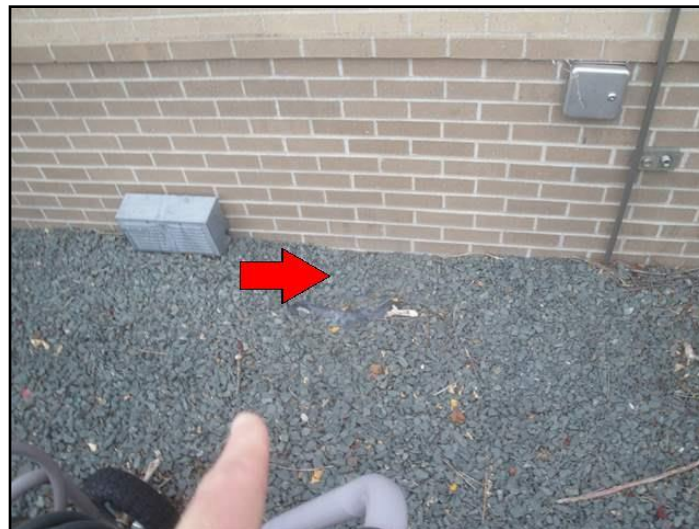
55. **Condition:** • Improper grading

43. Improper grading

Task: Improve
Time: Less than 1 year

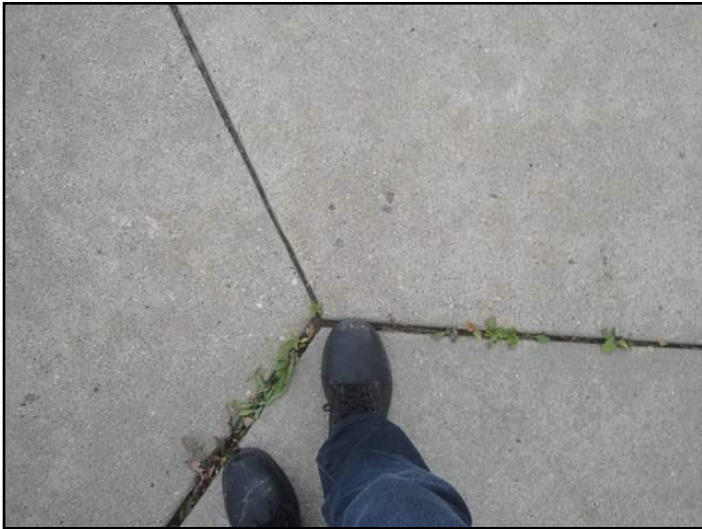
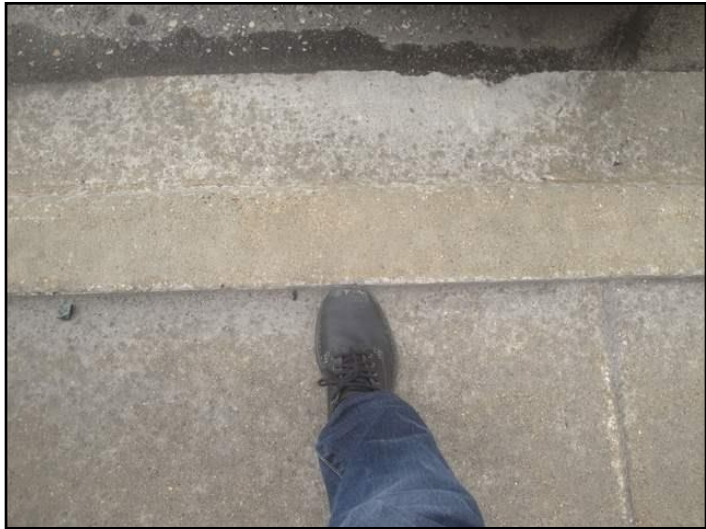
Potential trip hazard. Recommend grinding flush or replacing the affected areas.

44. Settled

45. Settled

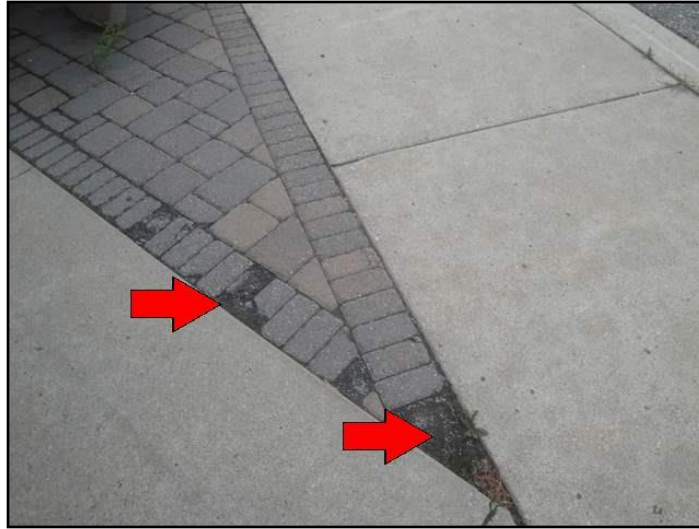
57. Condition: • Deteriorated
Location: West
Task: Replace
Time: Less than 2 years

46. Deteriorated

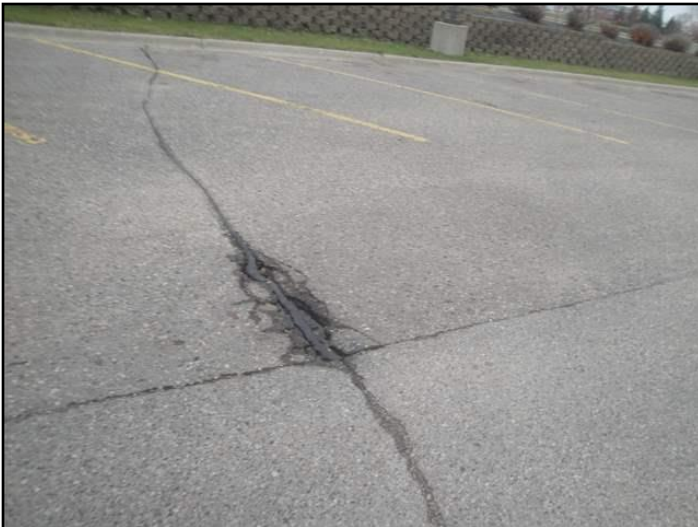
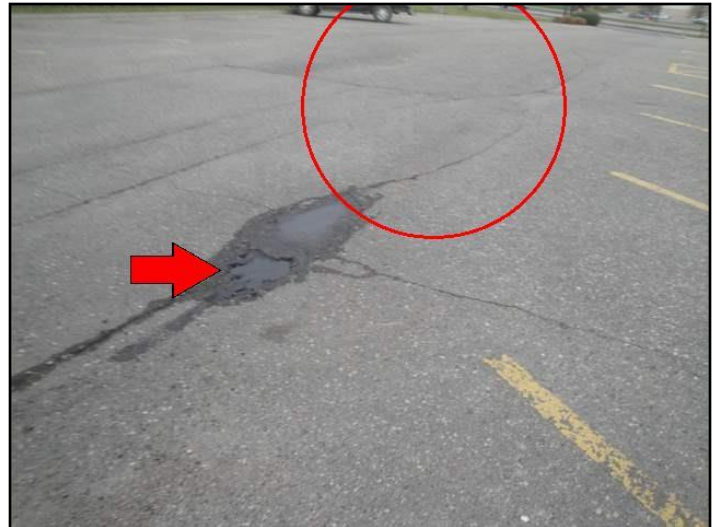
Condition: • Parking surface in need of repair, seal coating and striping.

47. Parking surface in need of repair, seal...

48. Parking surface in need of repair, seal...

Task: Repair
