Hill's Property Inspection LLC

Property Inspection Report

123 anywhere street, USA, Oregon 12345
Inspection prepared for: John Doe
Date of Inspection: 10/13/2018 Time: 9:00
Age of Home: 39 Size: 2200
Weather: Sunny

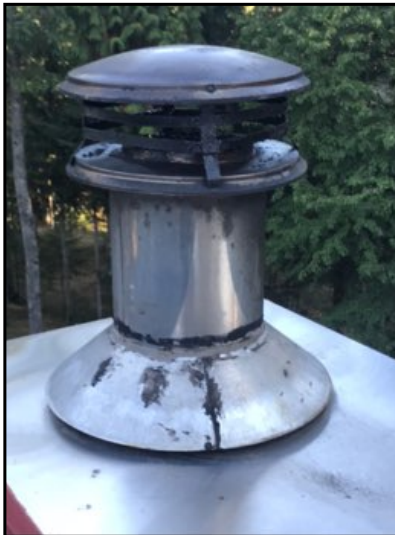
- Chimney rain cap is severely rusted and deteriorated. Suggest painting to preserve its remaining life.

Melted and lot of cresote

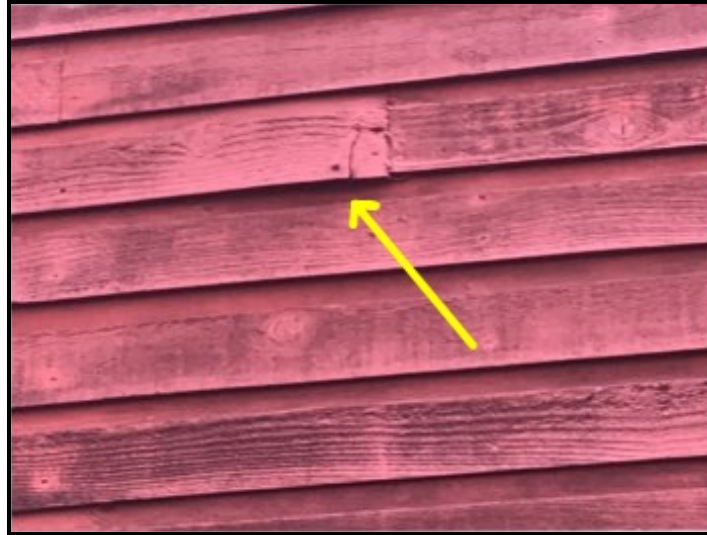
- Some areas need restaining, or priming and repainting.
- Some siding on the west side is buckling. Recommend keeping an eye on it. Possible moisture or water can intrude into interior.

Wood siding is buckling by kitchen window.

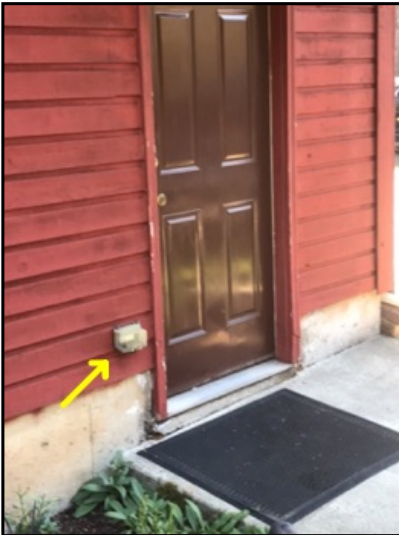
- Outdoor receptacles that are not **GFCI** protected, need to be updated.

Not GFCI protected. Recommend having a licensed electrician installed one.

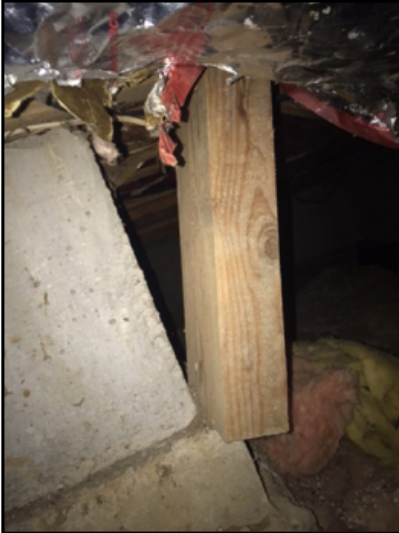
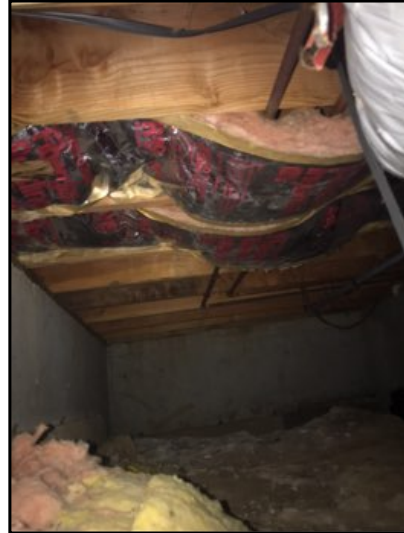
- One or more support post/s lack fasteners to prevent possible kick-out of post at bottom. Review and repair by a Qualified Contractor recommended to prevent potential damage to structure/persons in the event of damage to post.

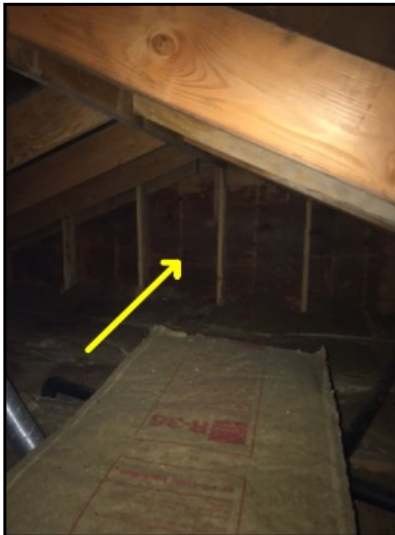
Lot of moisture in new addition. Recommend adding a cable vent to side.

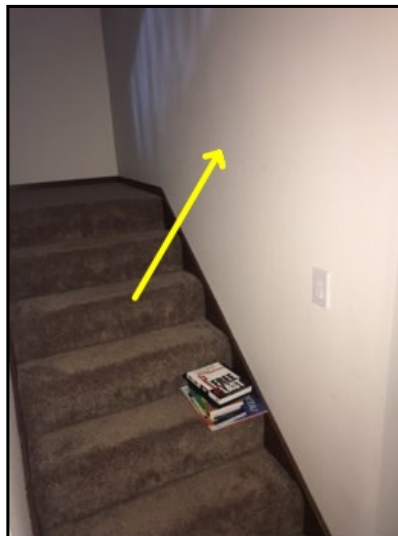
- A handrail is MISSING.

Recommend a handrail going up to landing.

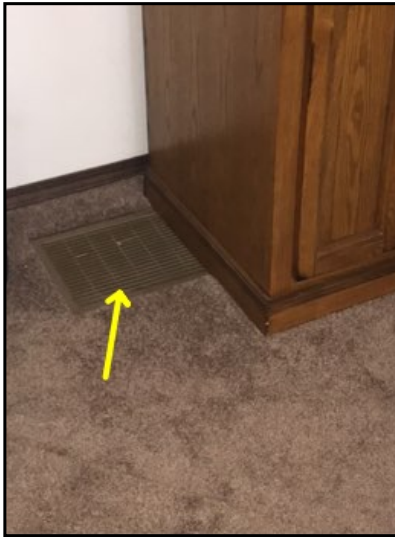
- The register location is in back corner of room.

Recommend raising any furniture over floor returns or register. So you have good airflow.
