PROPERTY CONDITION ASSESSMENT REPORT

Sample Report
Watertown, MN

Monday, November 23, 2015

RE: Report No. 1493, v.3
Sample Report
Watertown, MN

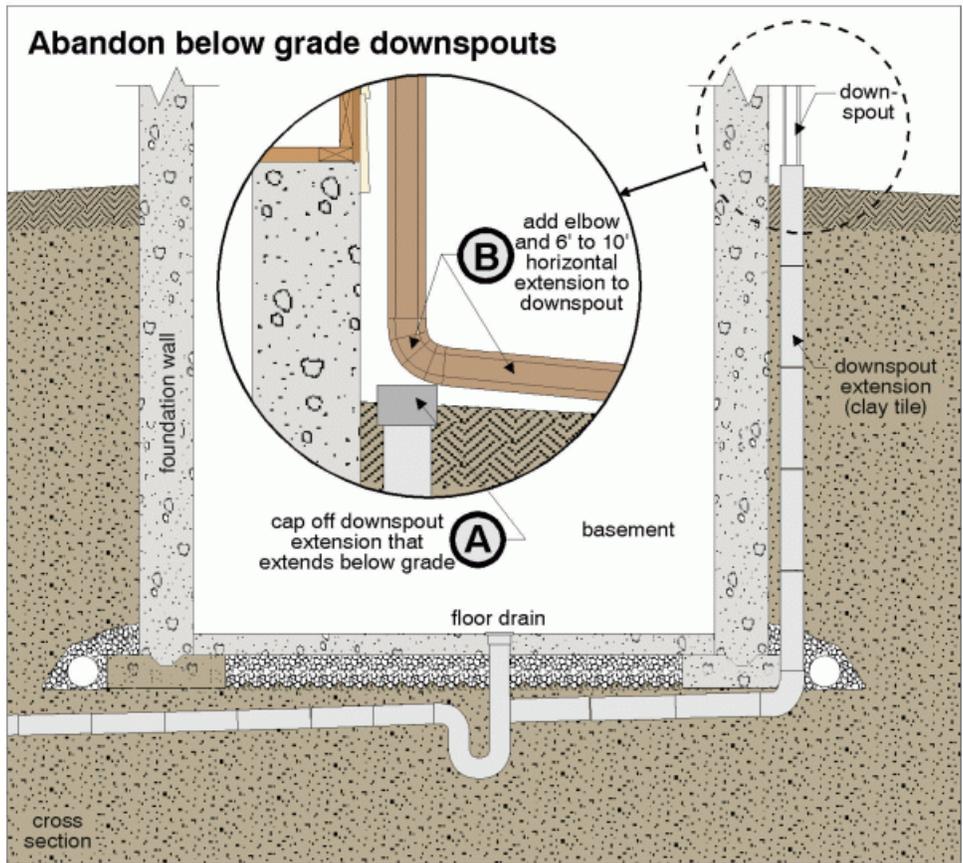
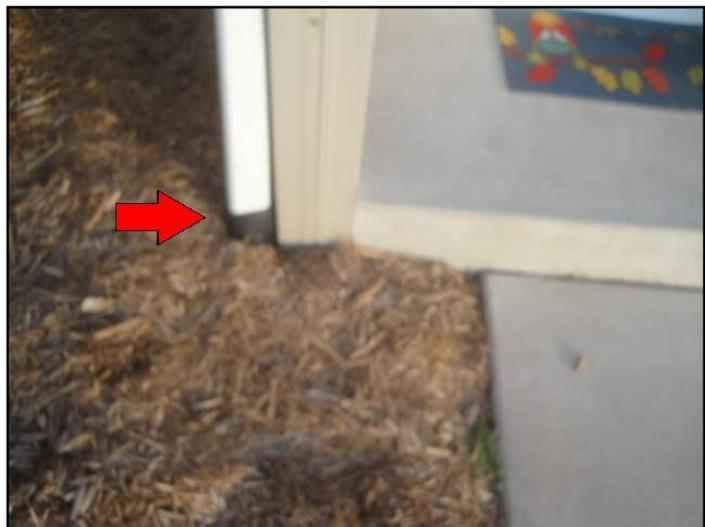
3. Downspouts discharging below grade

Condition: • [Downspouts discharging below grade](#)

Request location of termination point of below grade drain. If not properly terminated at "daylight" or a pop up drain there is a potential the drains may discharge and hold water against the foundation.

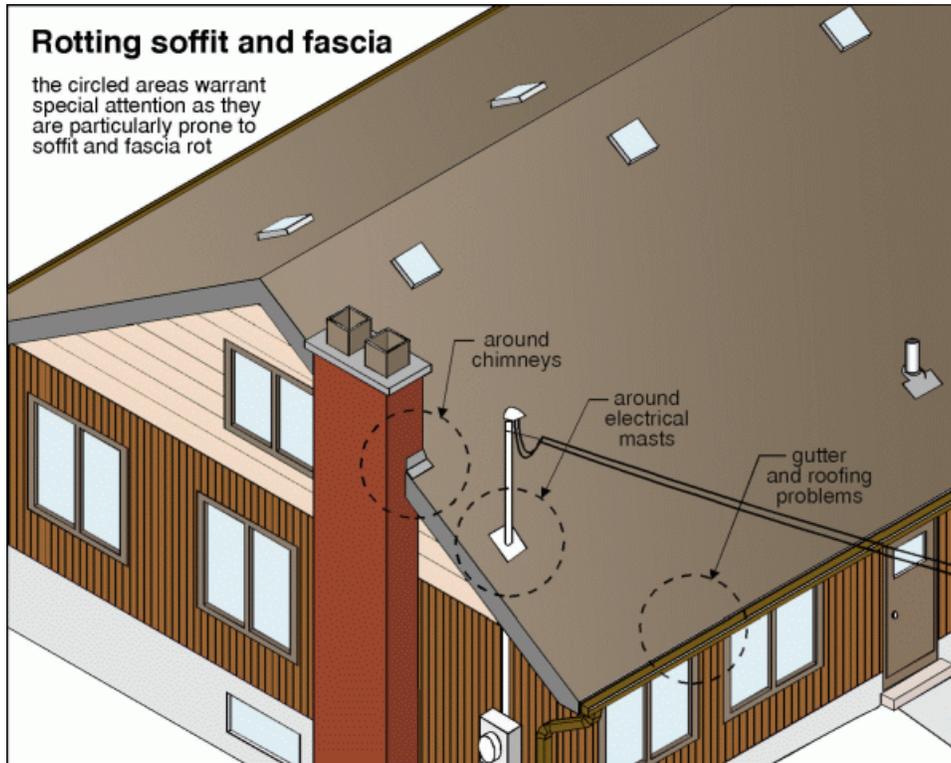
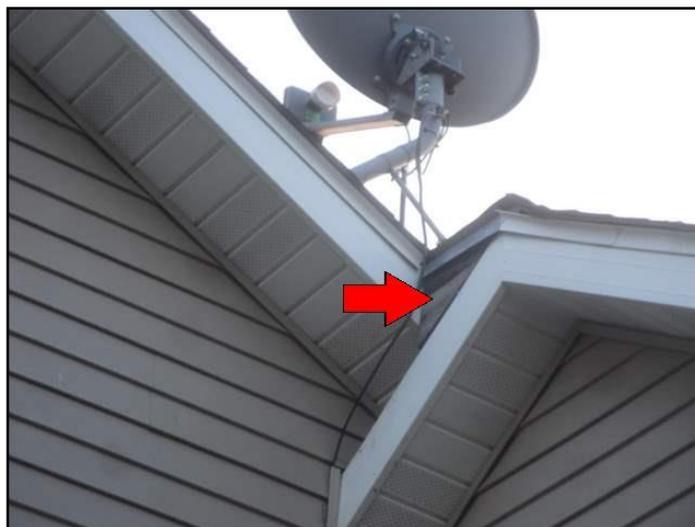
6. Loose or missing pieces

Condition: • [Loose or missing pieces](#)

Missing.

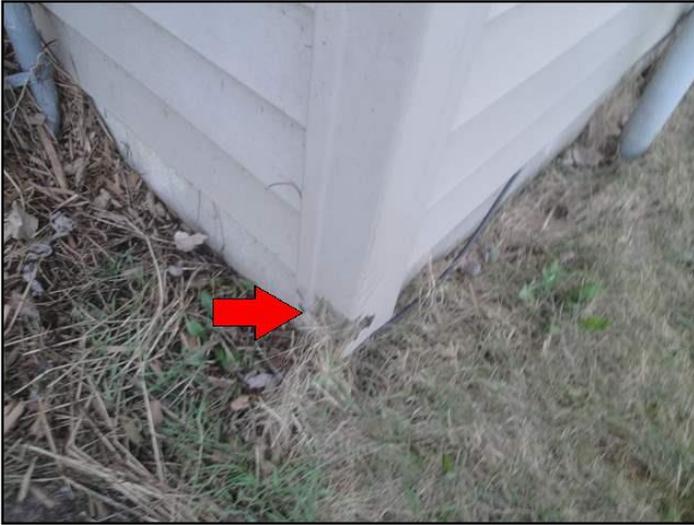
8. Mechanical damage

Condition: • [Mechanical damage](#)

Typical minimal damage. Voids may be sealed with clear or colored caulk.

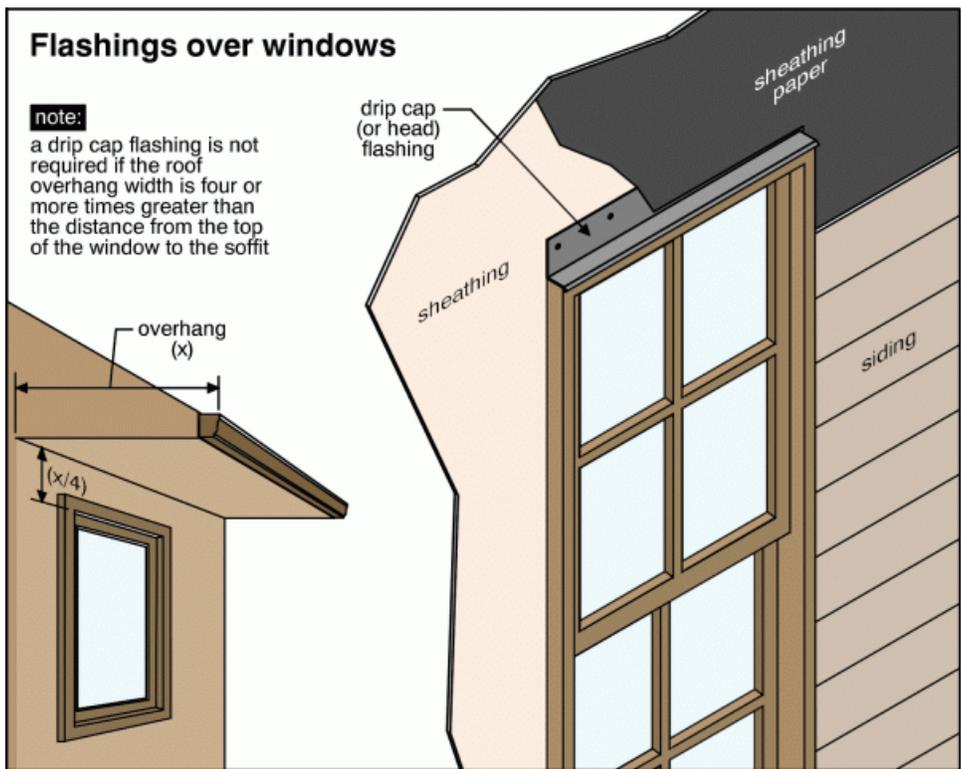
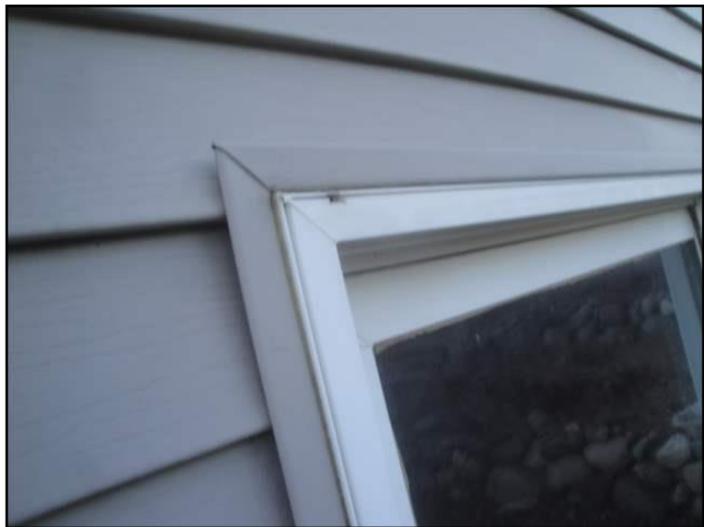
13. Missing

Condition: • [Missing](#)

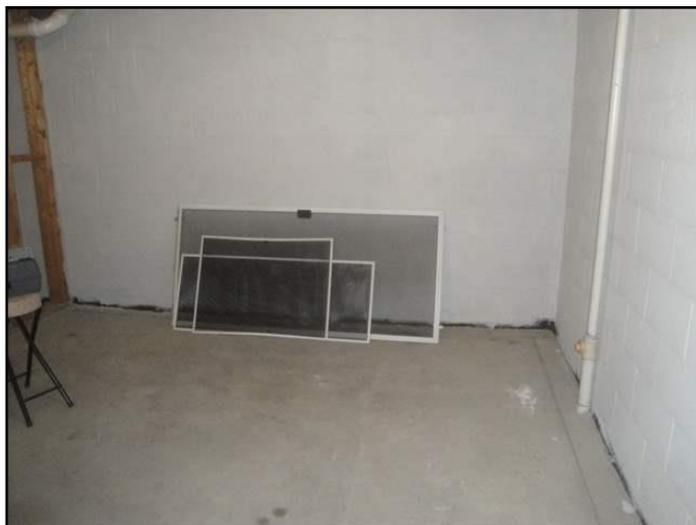
14. Missing

Condition: • [Missing](#)

Request seller confirm quantity and install missing storms or screens. Some missing screens were located in the basement.

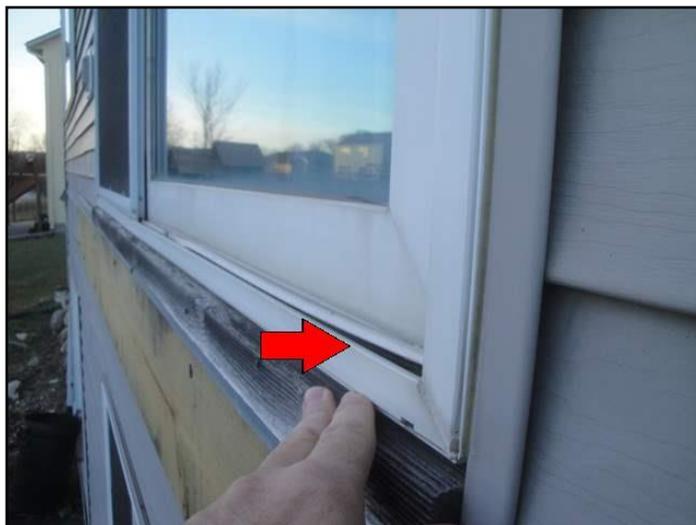
15. Damage

Condition: • [Damage](#)

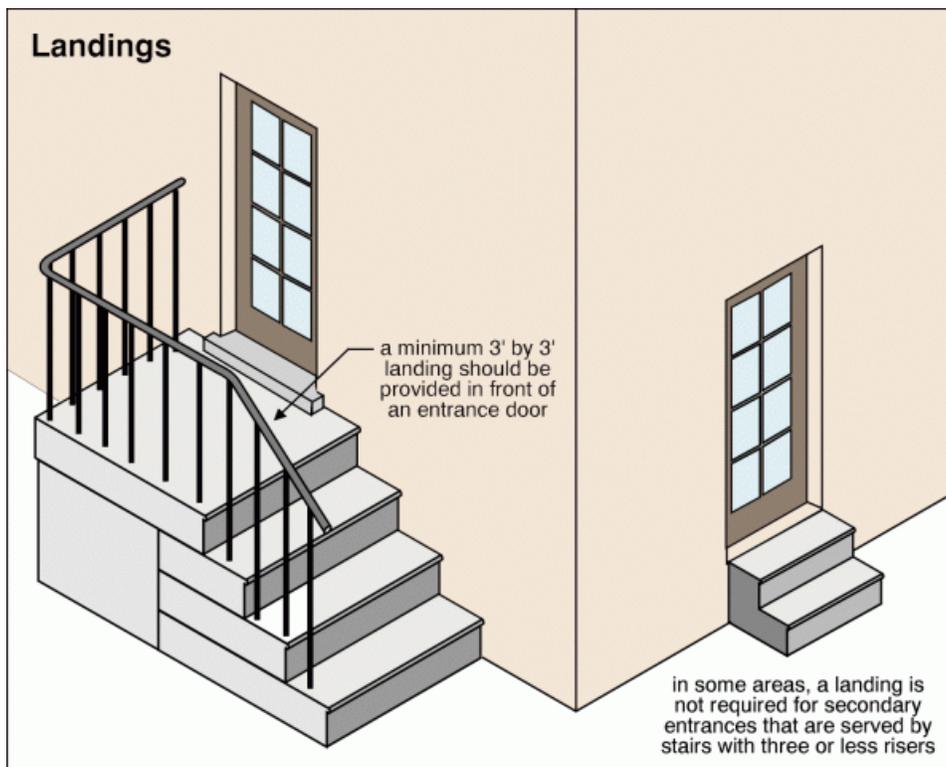
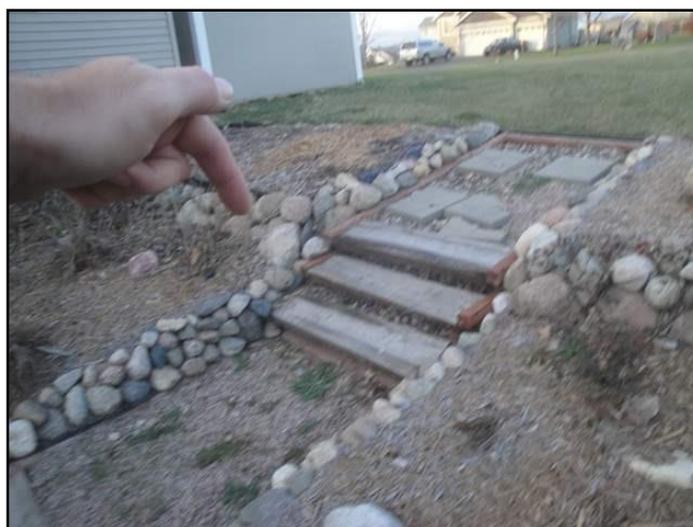
16. Steps slope

Condition: • [Steps slope](#)

Implication(s): Trip or fall hazard

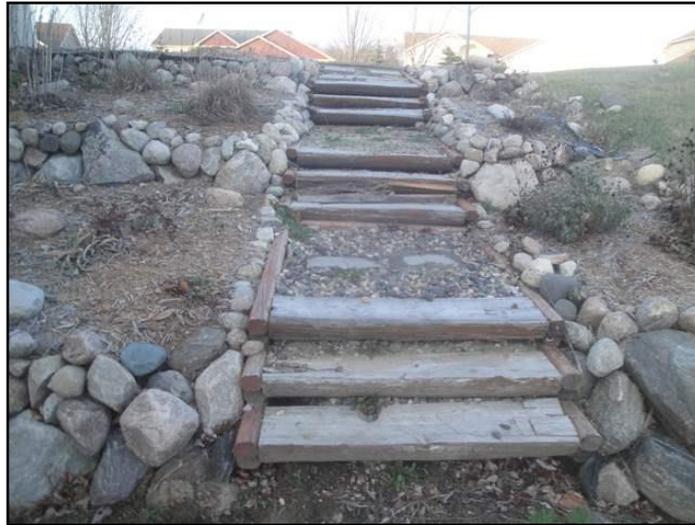
17. Stair rise too big or not uniform

Condition: • [Stair rise too big or not uniform](#)

Implication(s): Trip or fall hazard

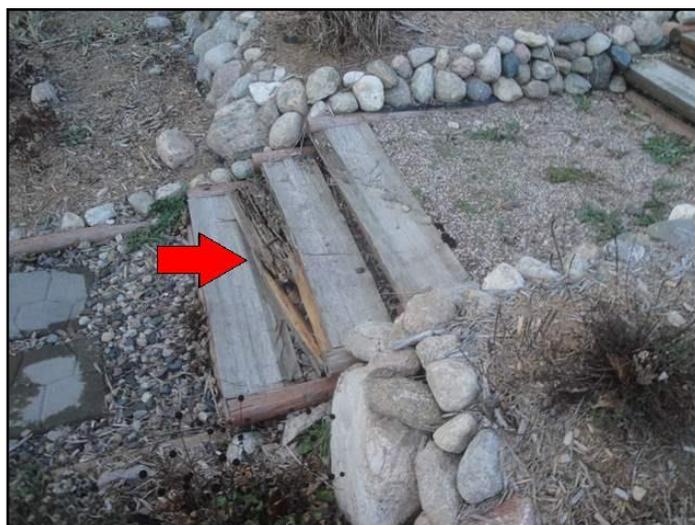
18. Rot

Condition: • [Rot](#)

Implication(s): Weakened structure | Material deterioration

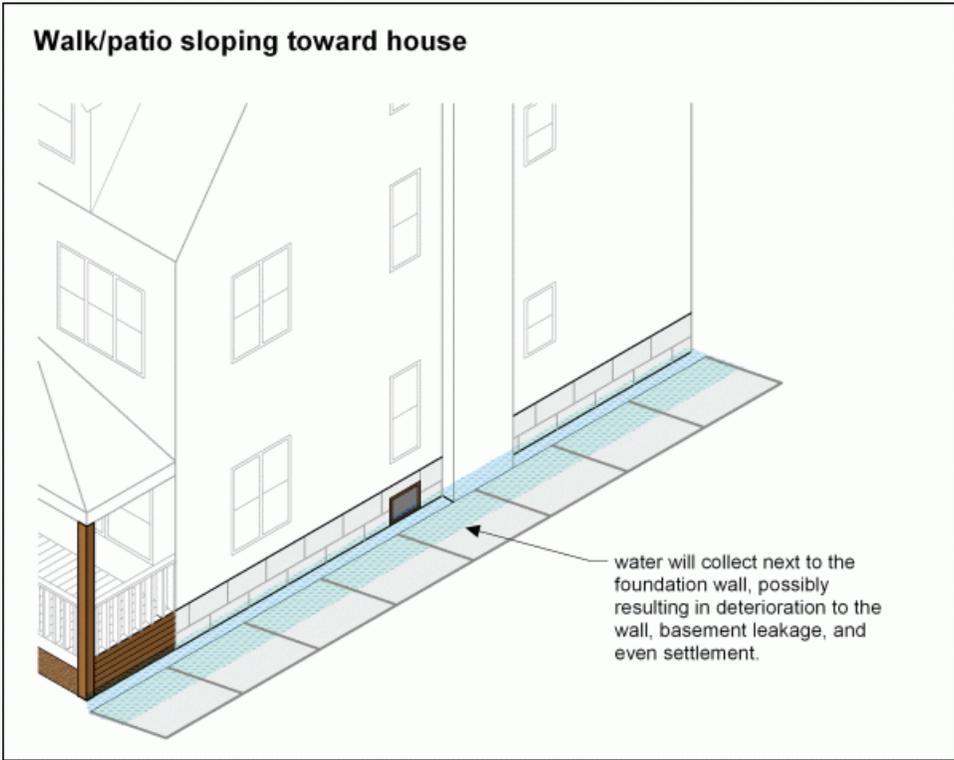
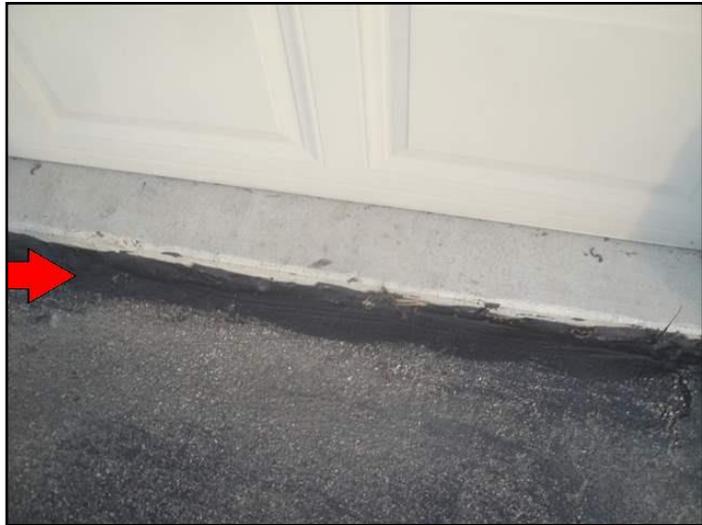
20. *Improper slope or drainage*

Condition: • [Improper slope or drainage](#)

Implication(s): Chance of water damage to contents, finishes and/or structure

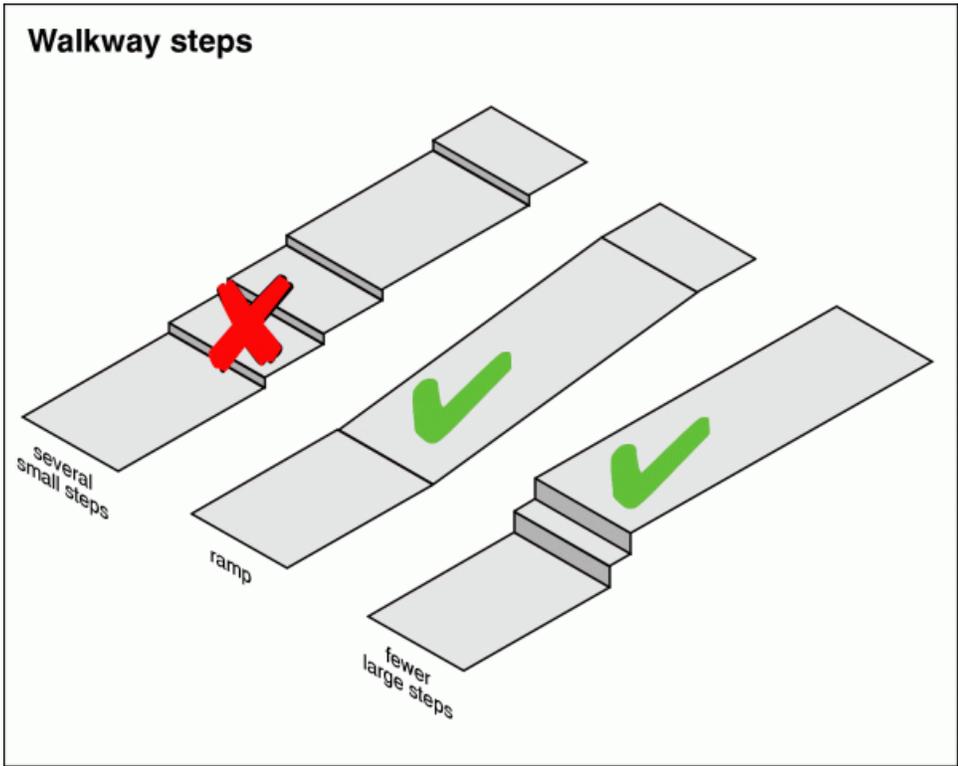
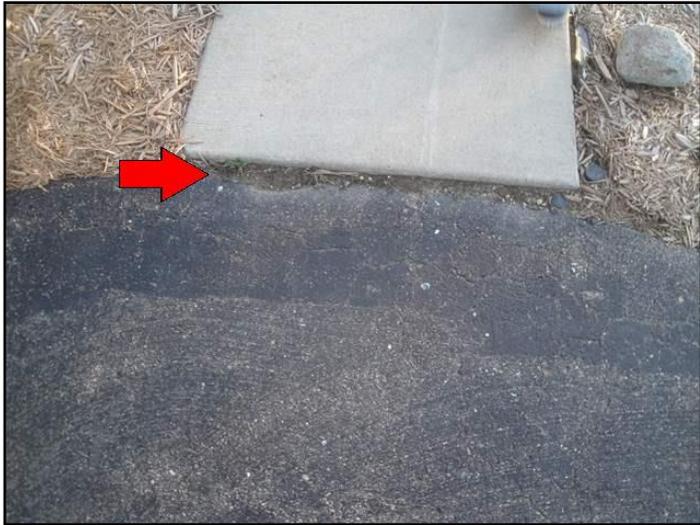
21. Uneven (trip hazard)

Condition: • [Uneven \(trip hazard\)](#)

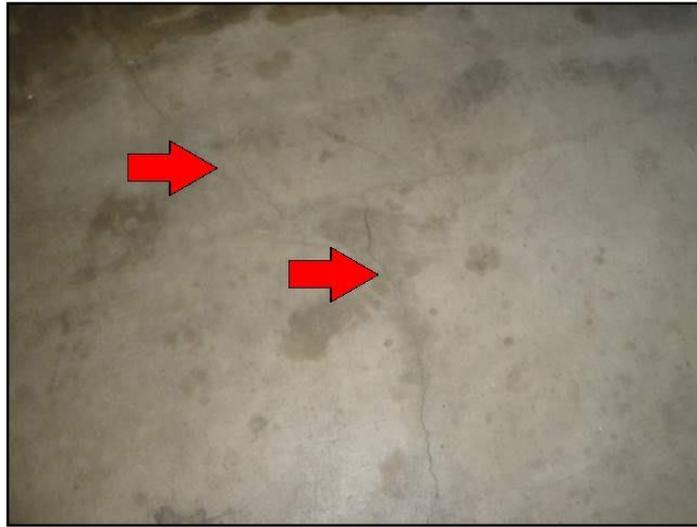
22. Cracked

Condition: • [Cracked](#)

Typical minor surface defects and/or chips in surface. The floor is in good overall condition.

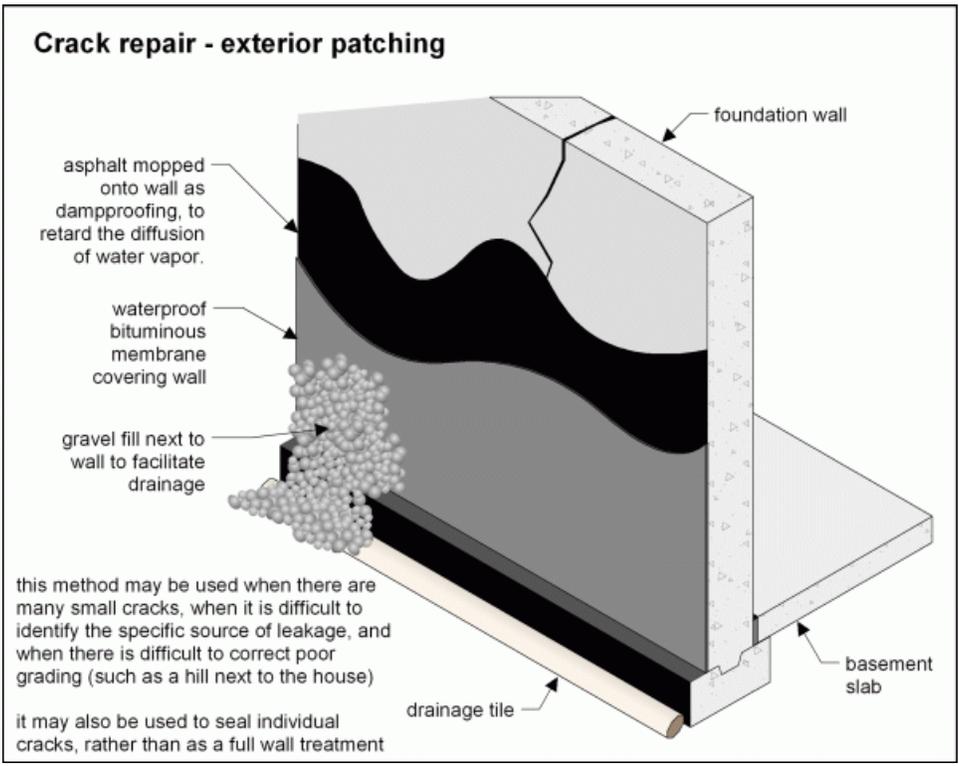
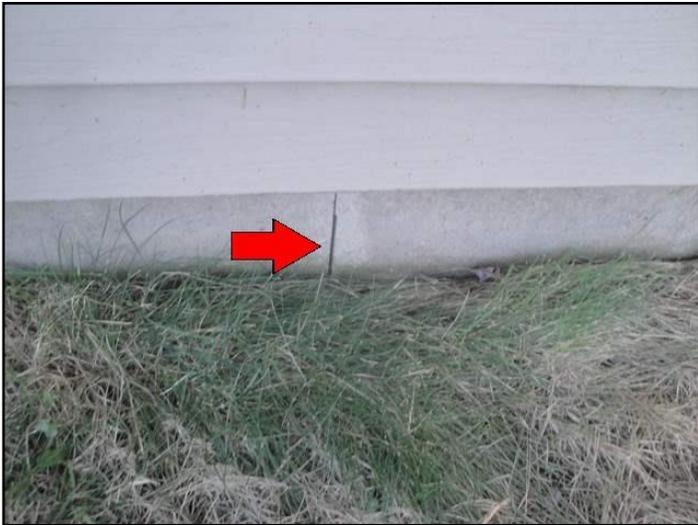
29. Typical minor cracks

Condition: • Typical minor cracks
Typical minor cracks. Not a structural concern. Seal cracks to prevent moisture intrusion.
Implication(s): Chance of water entering building
Location: Basement and Garage
Task: Repair
Time: Less than 1 year

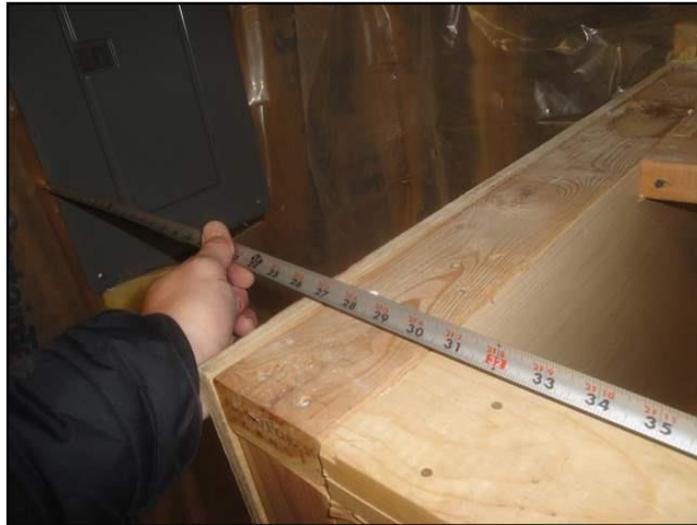
32. Poor access

Condition: • [Poor access](#)
Implication(s): Difficult to service
Location: Garage
Task: Improve
Time: Less than 1 year

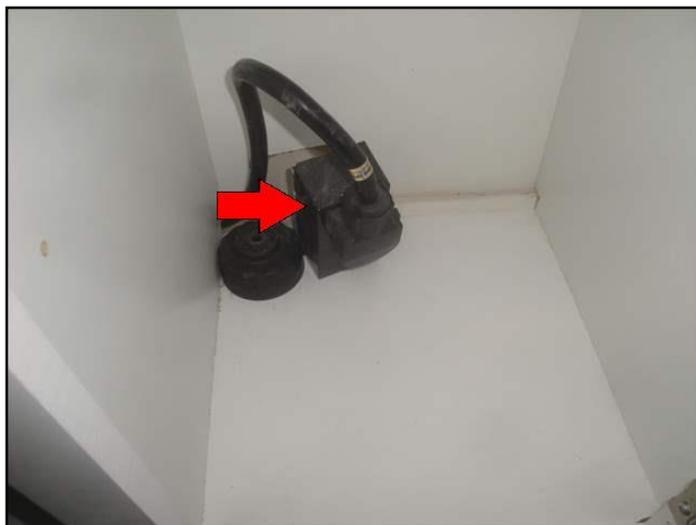
36. Loose

Condition: • [Loose](#)

Implication(s): Electric shock | Fire hazard

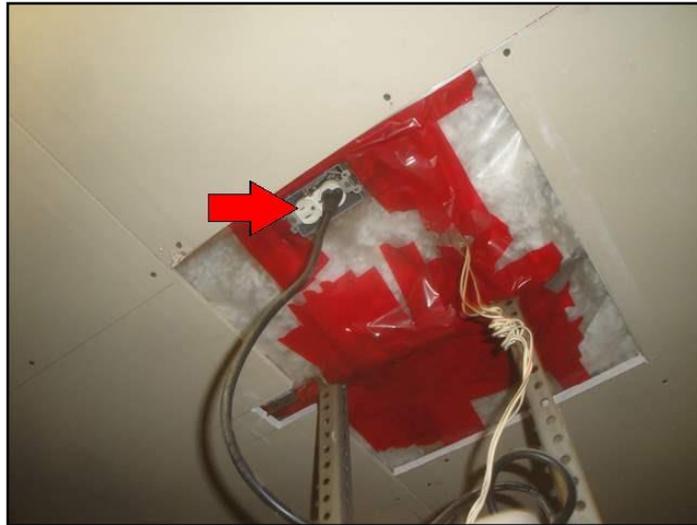
37. Missing

Condition: • [Missing](#)

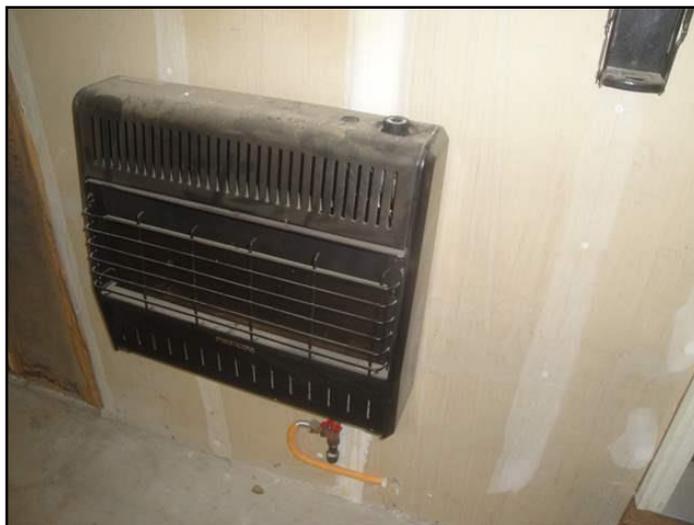
38. *Unvented*

Condition: • [Unvented](#)

Implication(s): Hazardous combustion products entering home

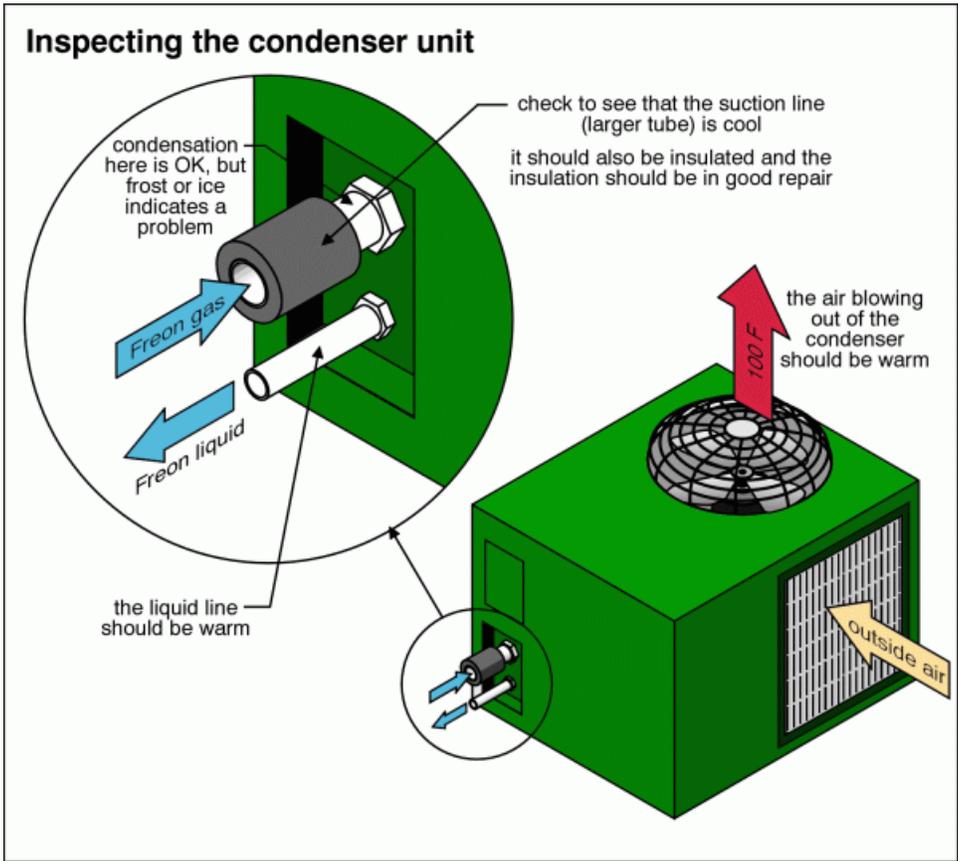
40. Dirty

Condition: • [Dirty](#)

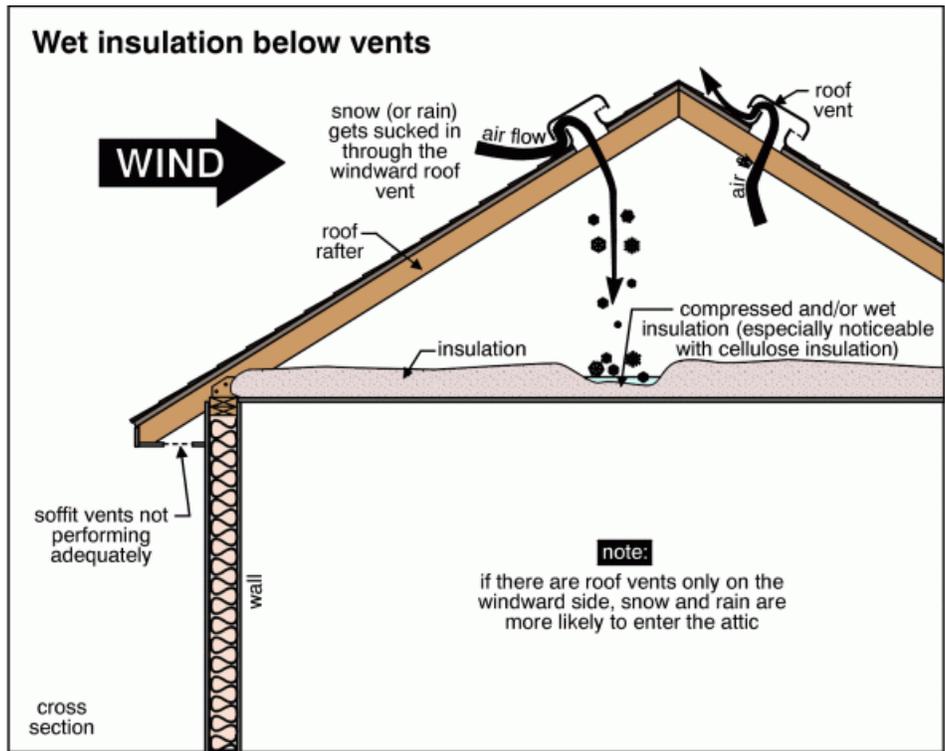
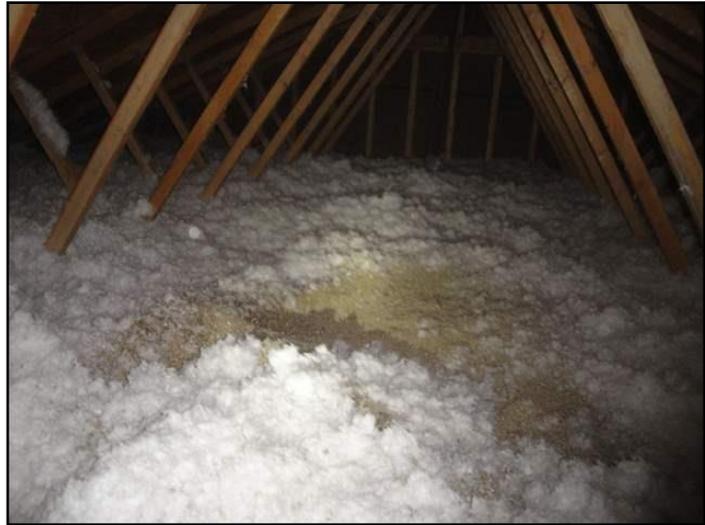
41. Compressed

Condition: • [Compressed](#)

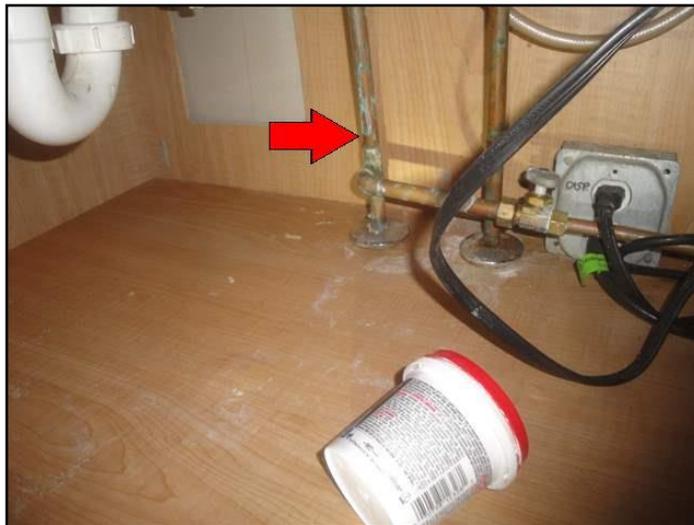
51. Leak

Condition: • [Leak](#)

Evidence of past leaks, no active leak were observed. Evaluate and tighten or repair fittings, unions and valves if needed.

Implication(s): Chance of water damage to contents, finishes and/or structure | System inoperative

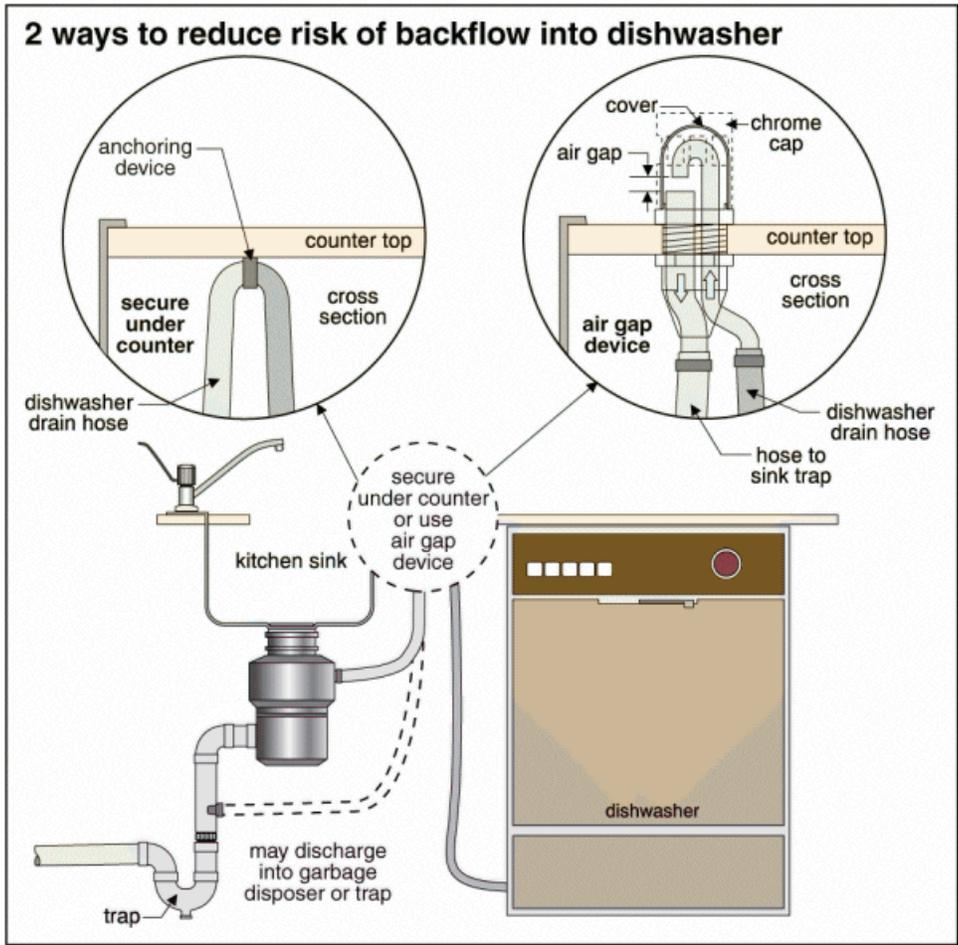
53. Dishwasher drain connections

Condition: • [Dishwasher drain connections](#)

Implication(s): Chance of water damage to contents, finishes and/or structure

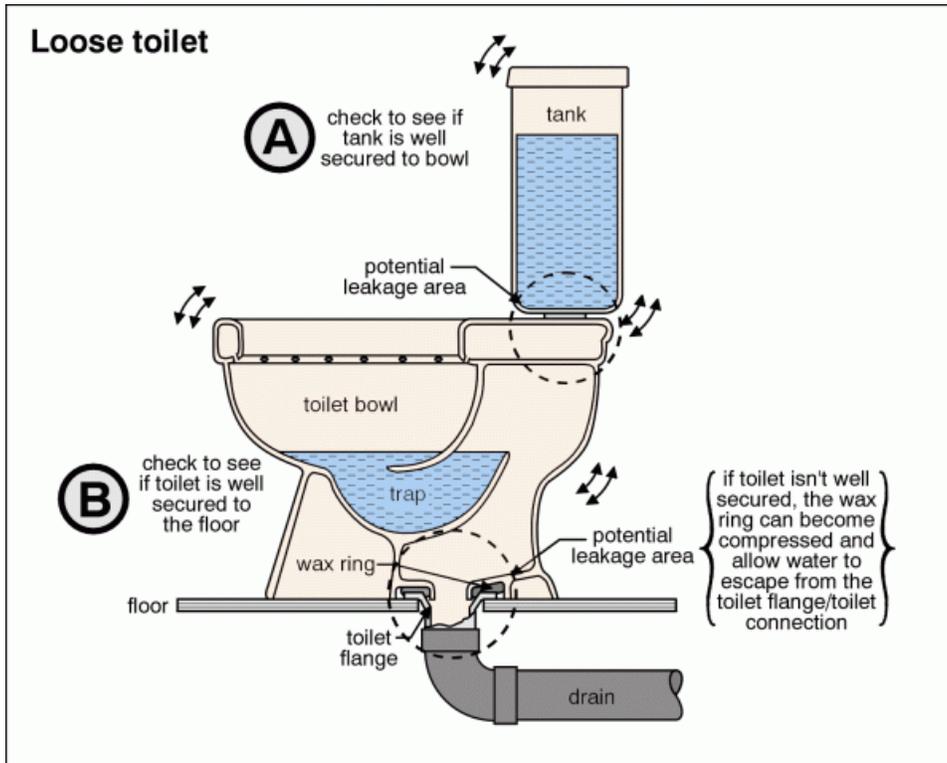
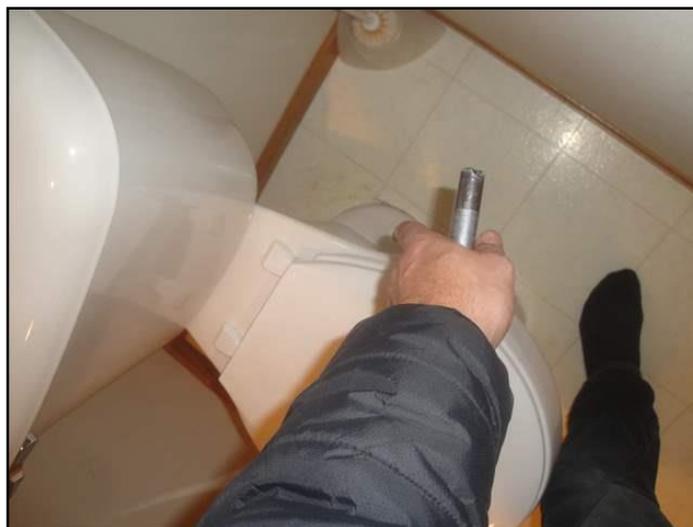
56. Loose

Condition: • [Loose](#)

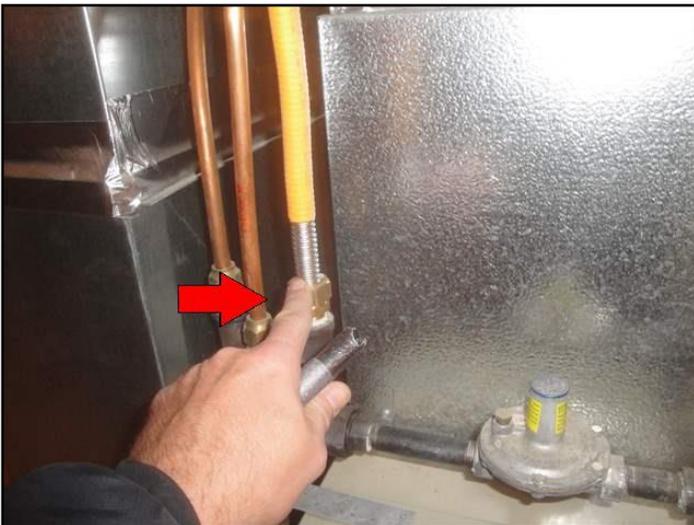
58. Piping not properly bonded

63. Condition: • Piping not properly bonded

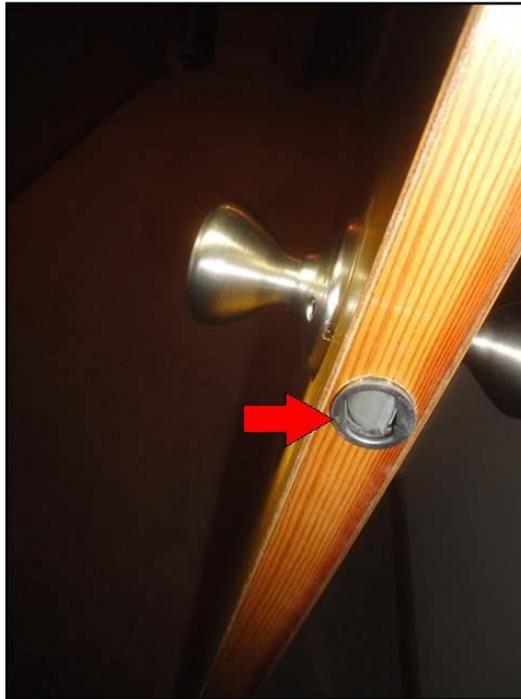
69. Loose

72. Condition: • [Loose](#)

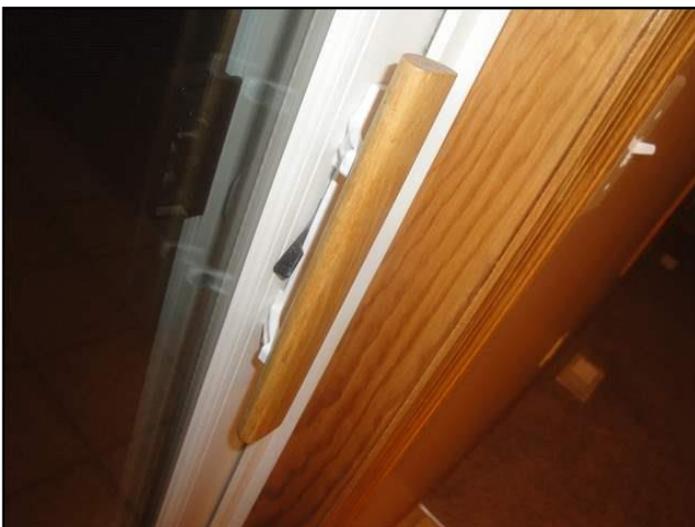
70. Lock not effective on exterior door

73. Condition: • Lock not effective on exterior door
