Property Condition Assessment Report

C Industries
9999
Anytown, MN 55060

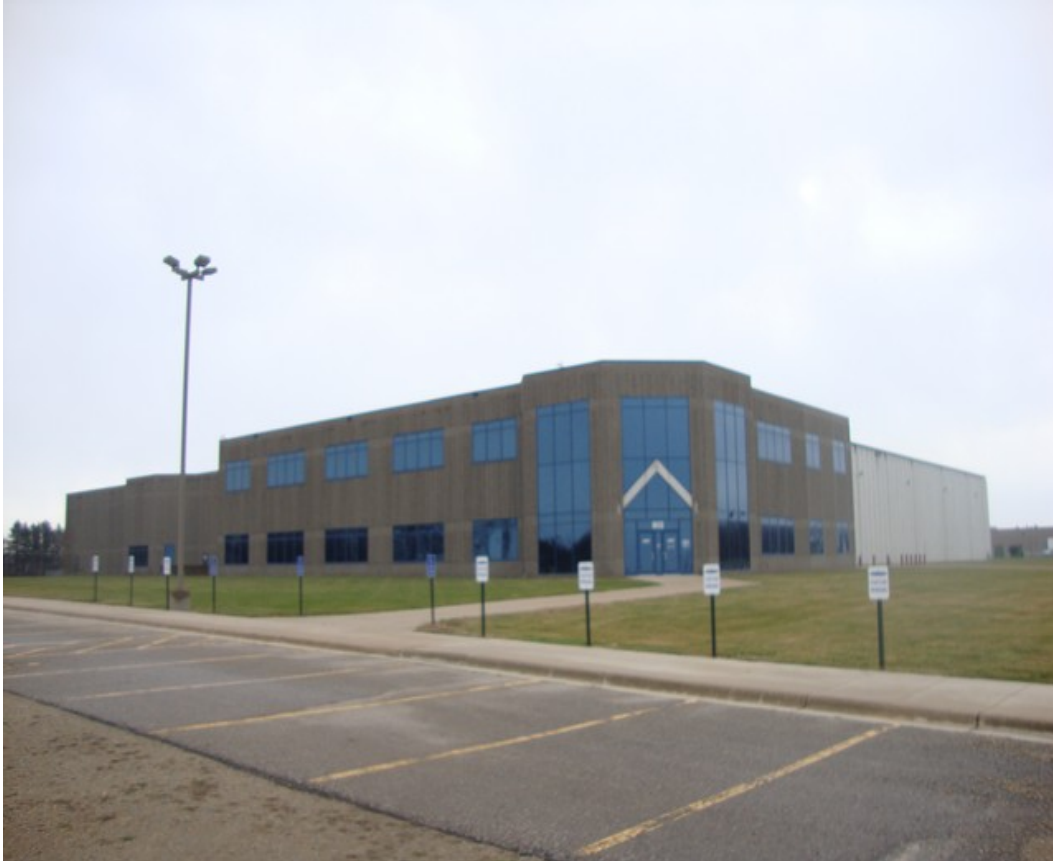
Prepared by
Minnesota Inspections
7620 Pioneer Creek Road
Independence, MN 55359

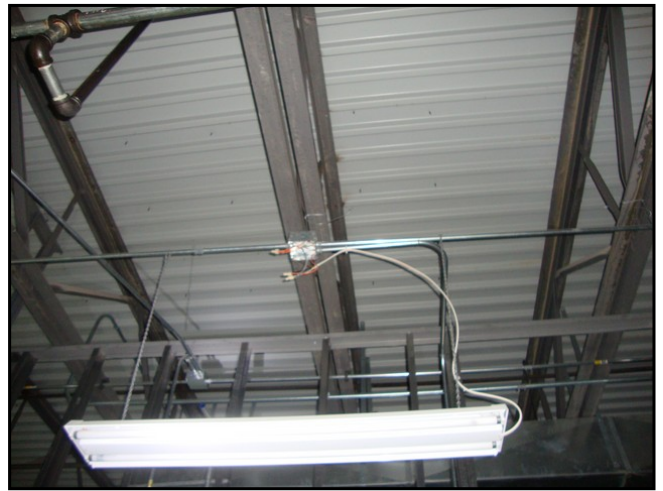
10 : Electrical - Missing Cover Plate 2

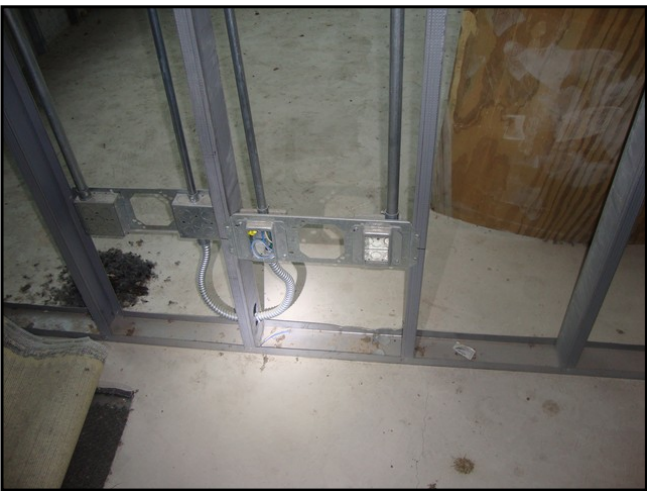
11 : Electrical - Missing Cover Plate 3

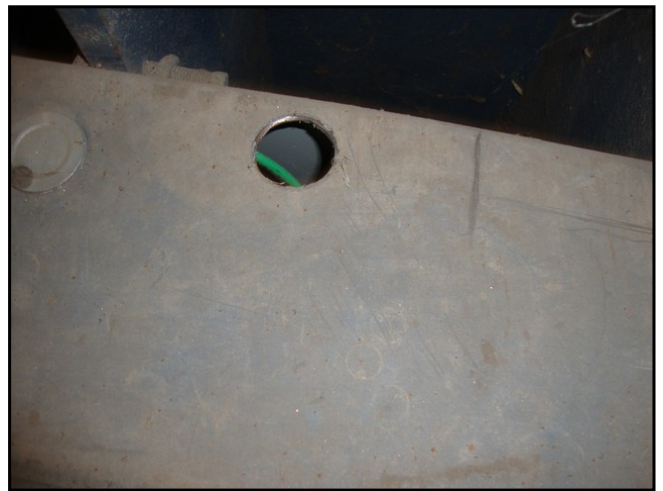
12 : Electrical - Missing Knock Out 1

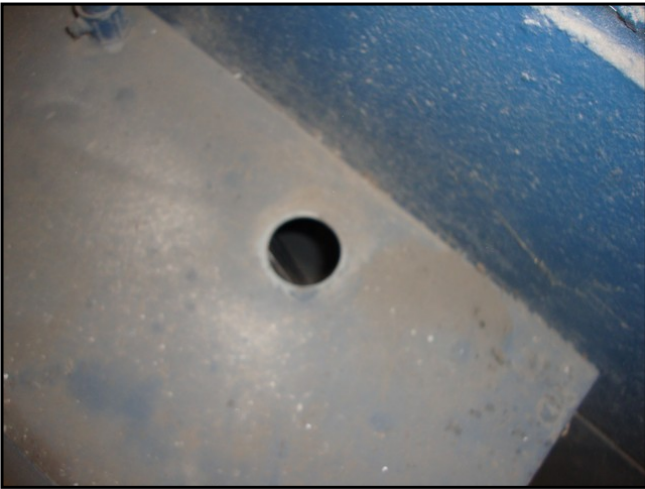
13 : Electrical - Missing Knock Out 2

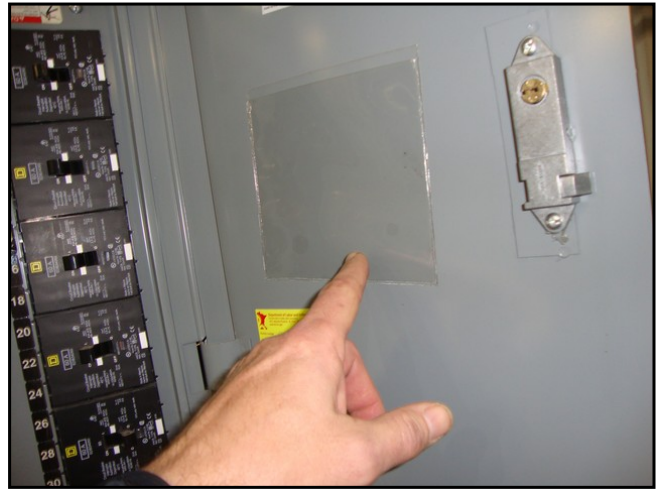
14 : Electrical - Missing Panel Index

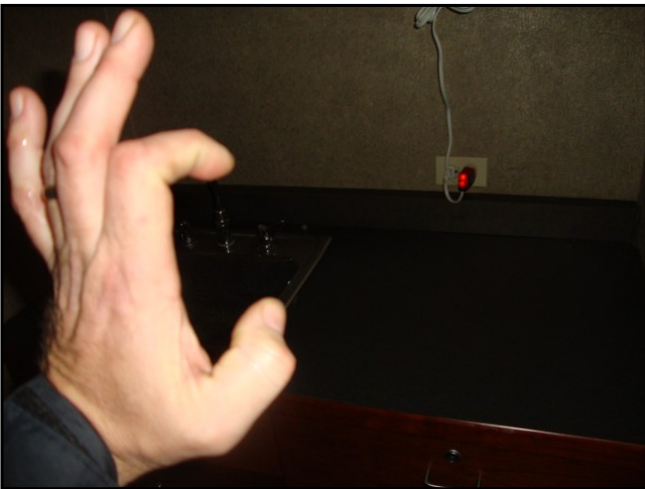
15 : Electrical - No GFCI Near Sink 1

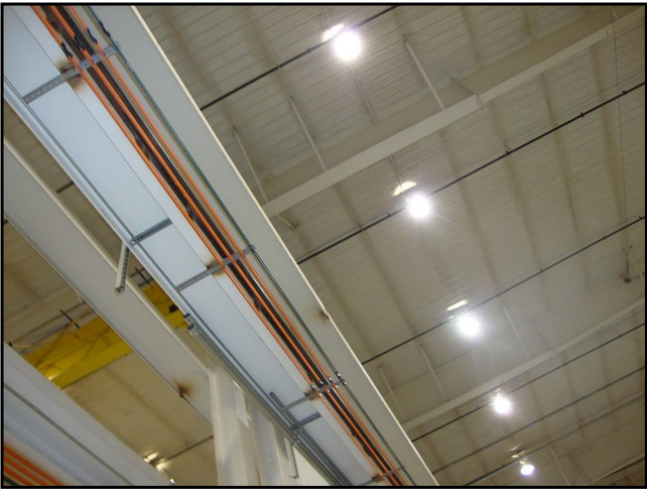
19 : Electrical - Recommend Warning Signs At Exposed Crane Feeders

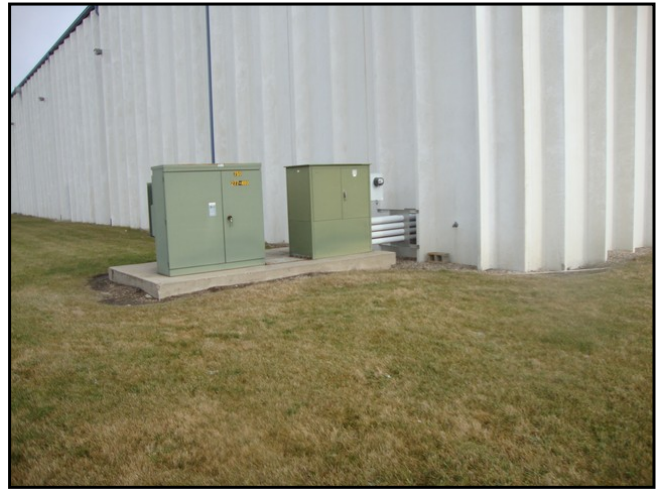
20 : Electrical - Transformer

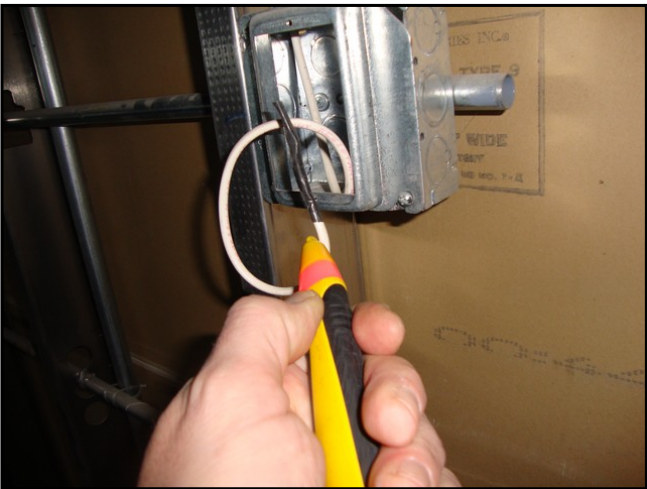
27 : Electrical - Missing Cover Plate 1

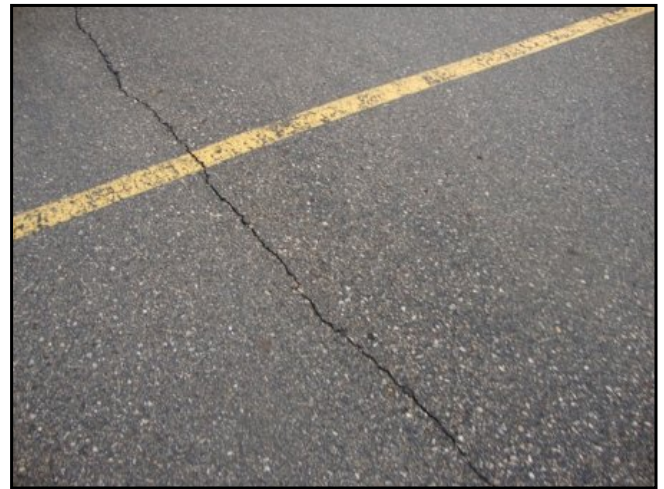
28 : Parking - Crack 3

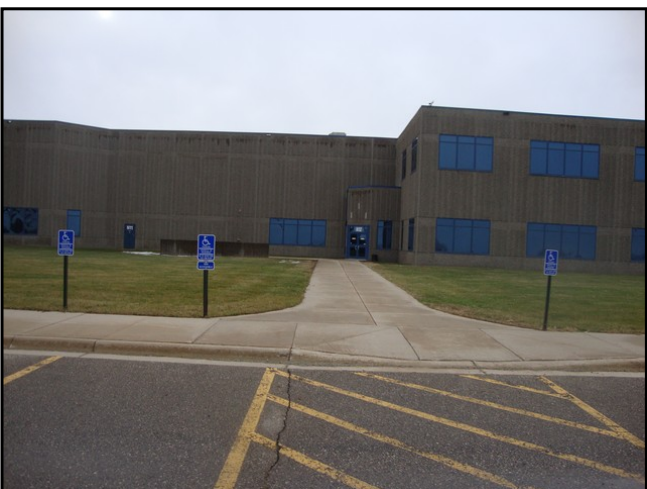
29 : Parking - Curb Cut

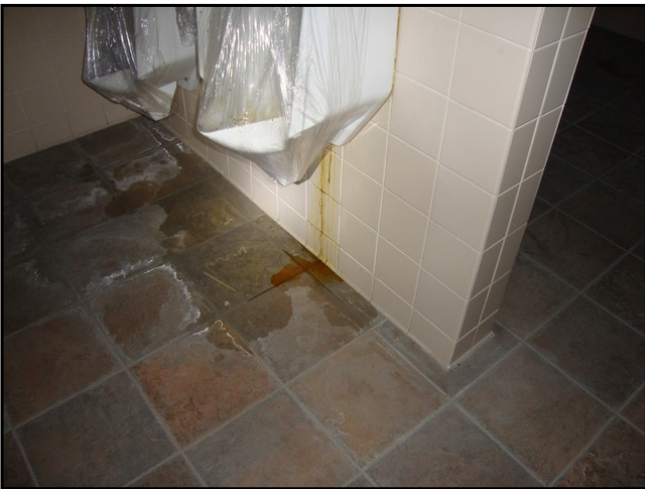
33 : Plumbing - Leak @ 2nd Floor Office 1

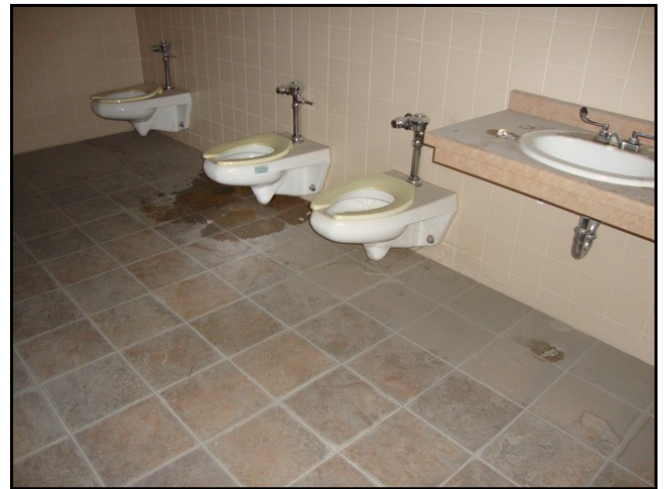
34 : Plumbing - Leak @ 2nd Floor Office 2

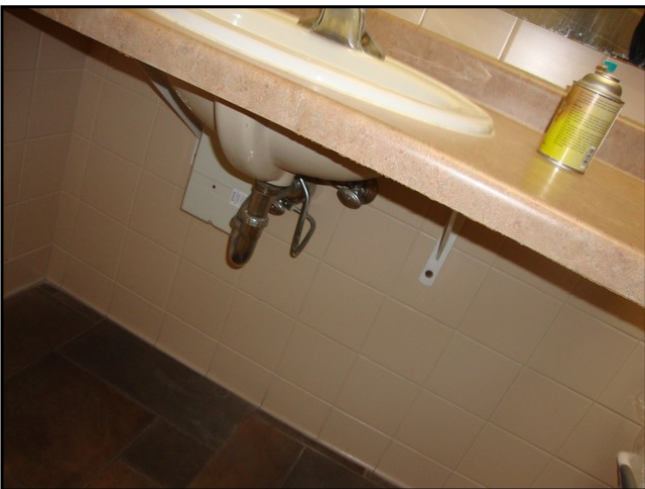
35 : Plumbing - Missing Insulation @ Sinks

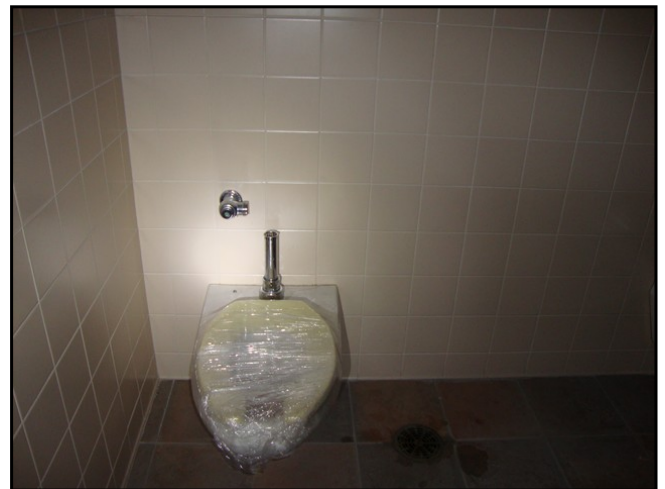
36 : Plumbing - Missing Valve @ 2nd Floor Office

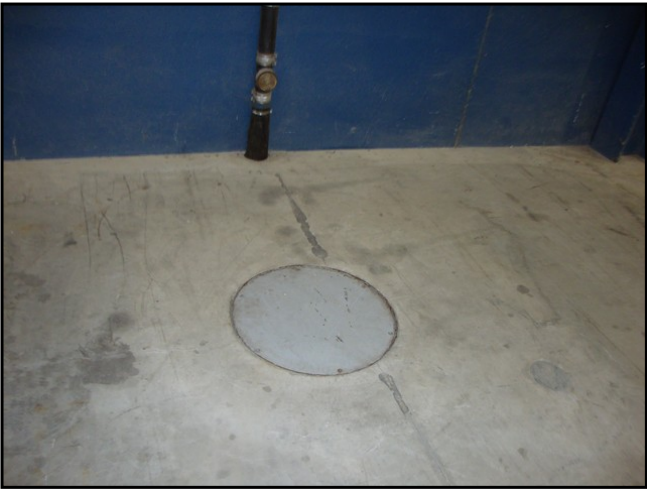
37 : Plumbing - Sump 1

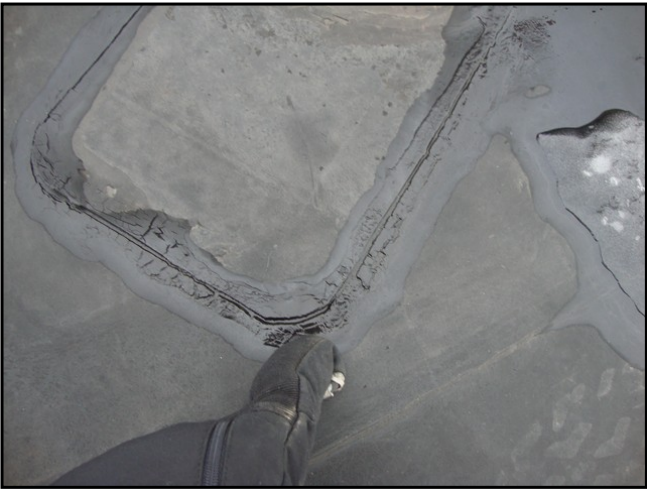
43 : Roof - Failing Seams 1

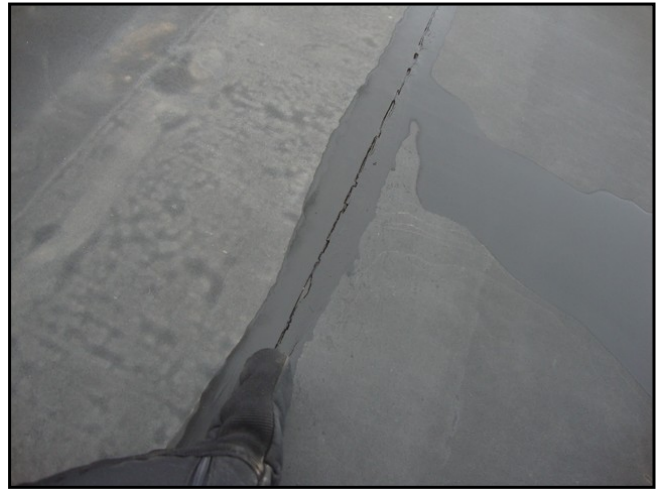
44 : Roof - Failing Seams 2

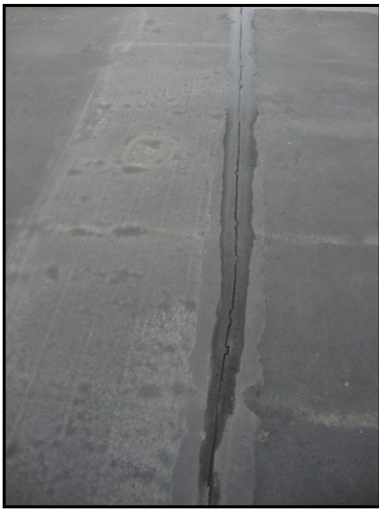
45 : Roof - Failing Seams 3

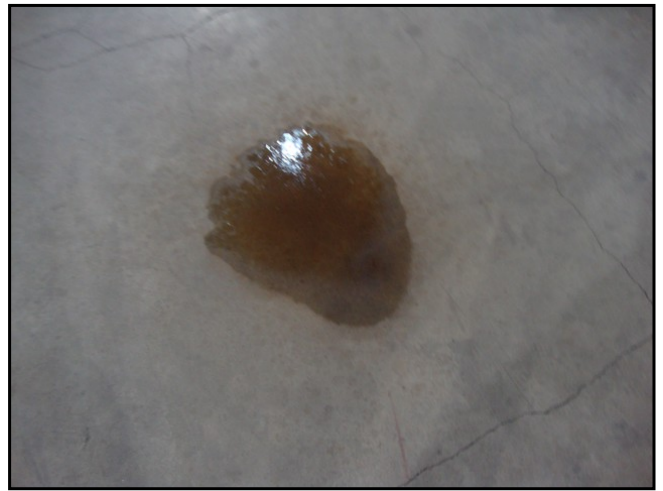
46 : Roof - Leak @ Mezzanine Manufacturing

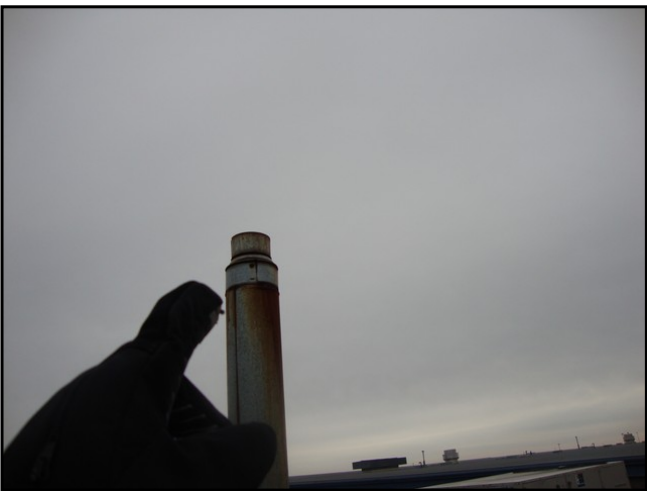
47 : Roof - Missing Rain Cap Suspect Source of Leak

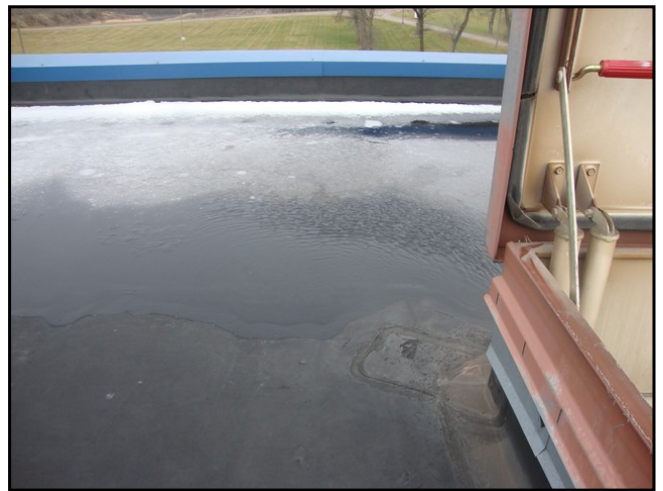
48 : Roof - Ponding Water Near Hatch

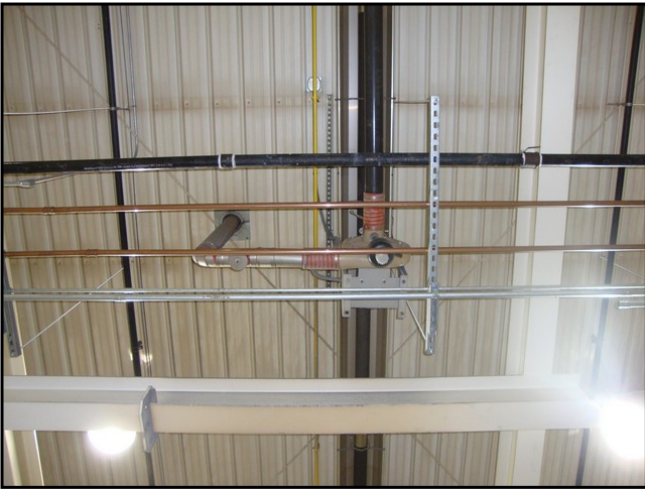
49 : Roof - Suspect Source of Leak @ Vent

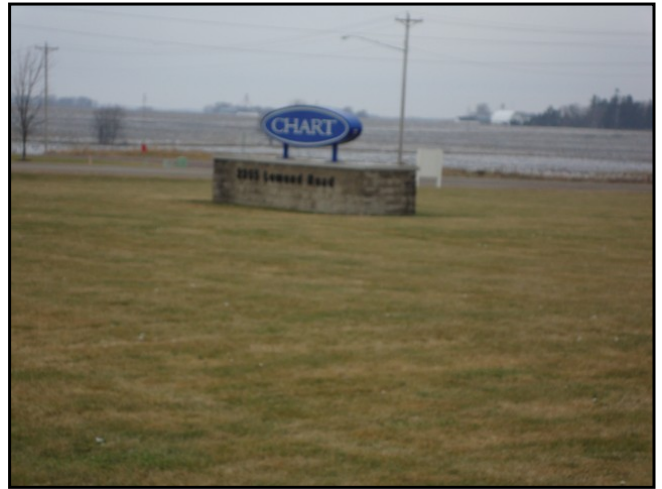
50 : Signs - Entrance Sign

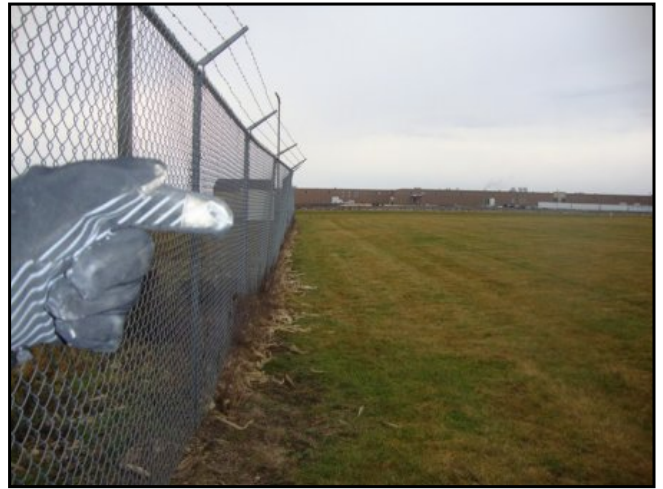
56 : Site - Minor Fence Damage

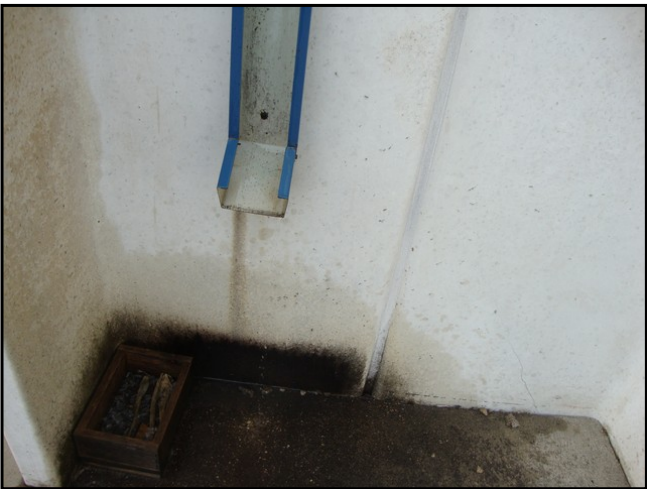
57 : Site - Missing Downspout Extension or Splash Guard

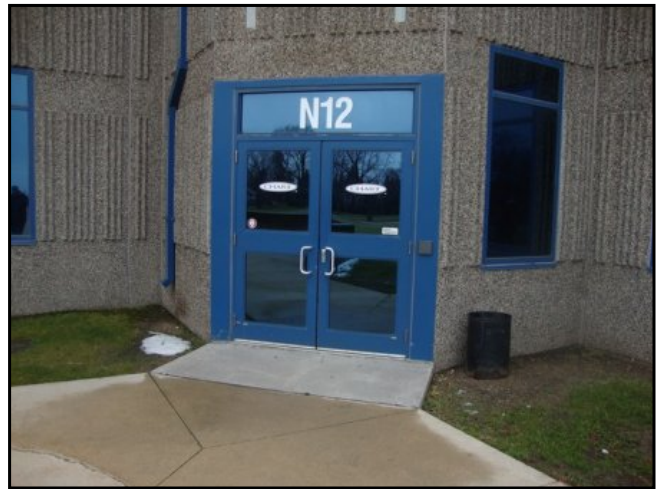
58 : Site - Missing downspout Extension

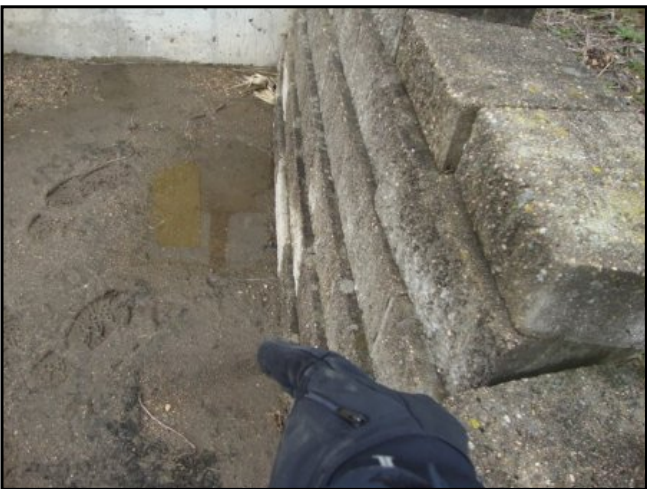
59 : Site - No Provision for Drainage at Retaining Wall

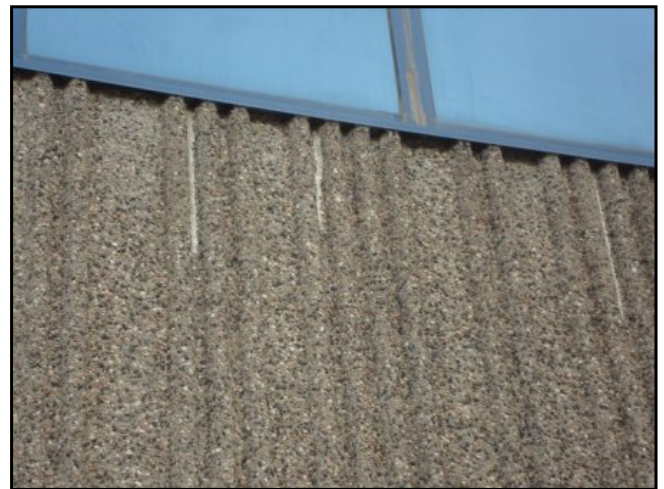
72 : Structure - Cracks Repaired With Sealant @ Office
1

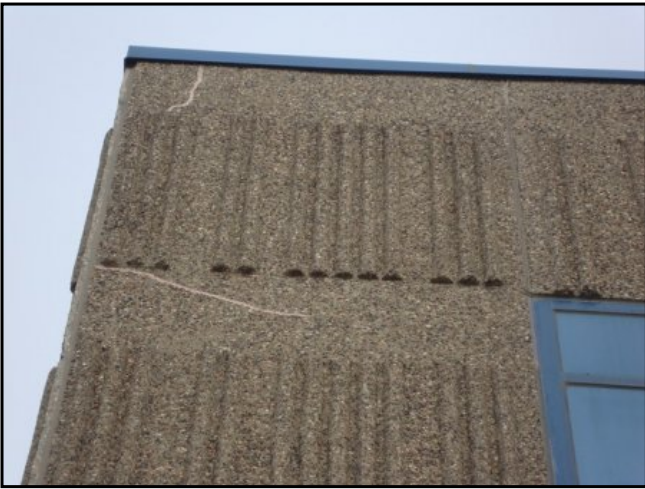
73 : Structure - Cracks Repaired With Sealant @ Office
2

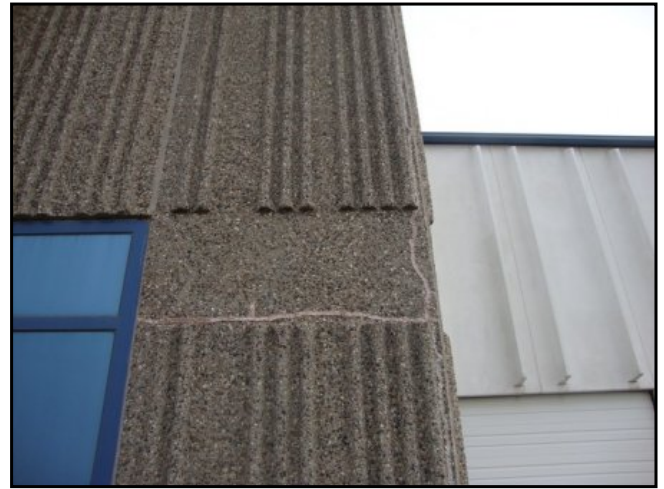
74 : Structure - Cracks Repaired With Sealant @ Office
3

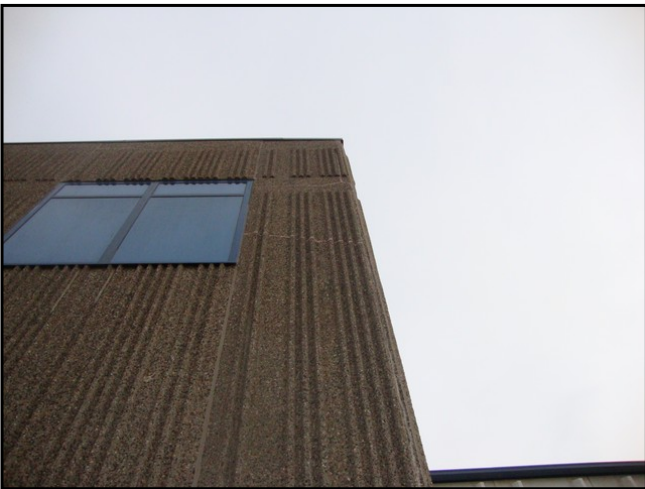
75 : Structure - Cracks Repaired With Sealant @ Office
4

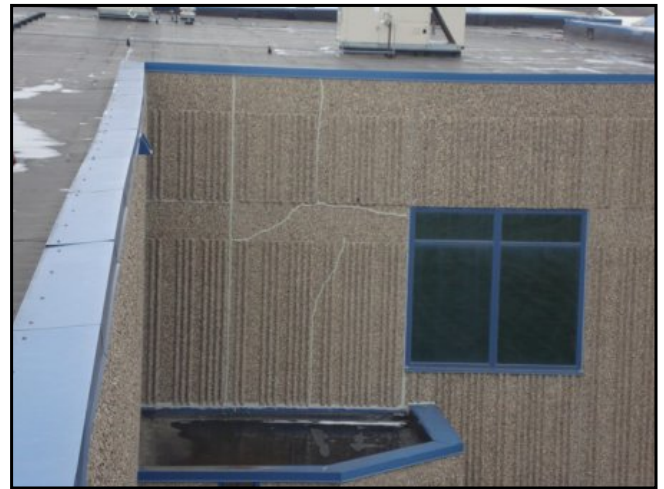
76 : Structure - Cracks Repaired With Sealant @ Office
5

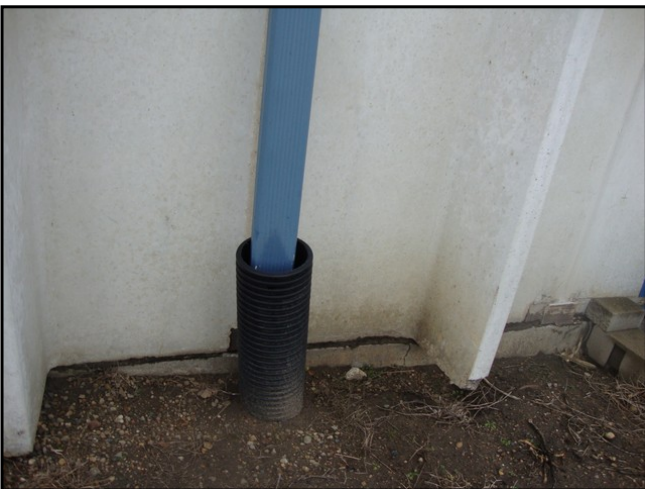
77 : Structure - Foundation Crack

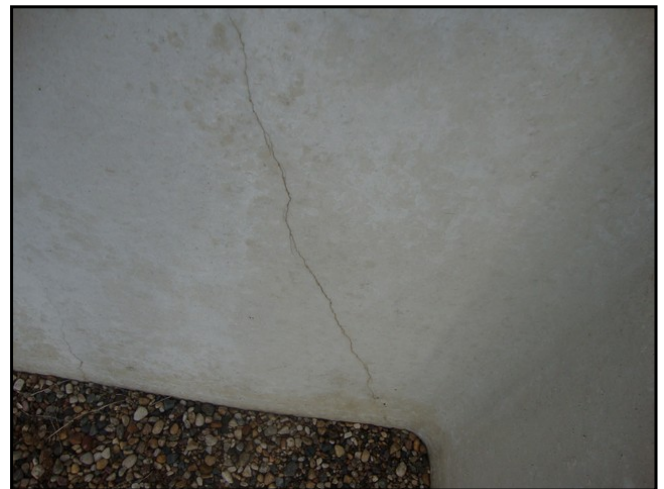
78 : Structure - Minor Cracks @ Warehouse 1

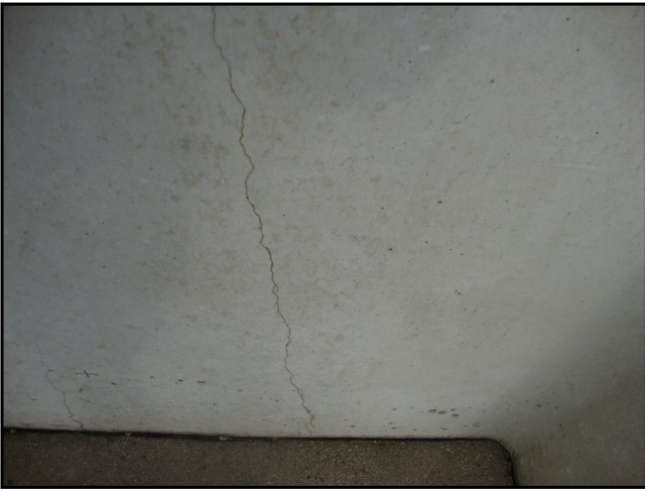
79 : Structure - Minor Cracks @ Warehouse 2

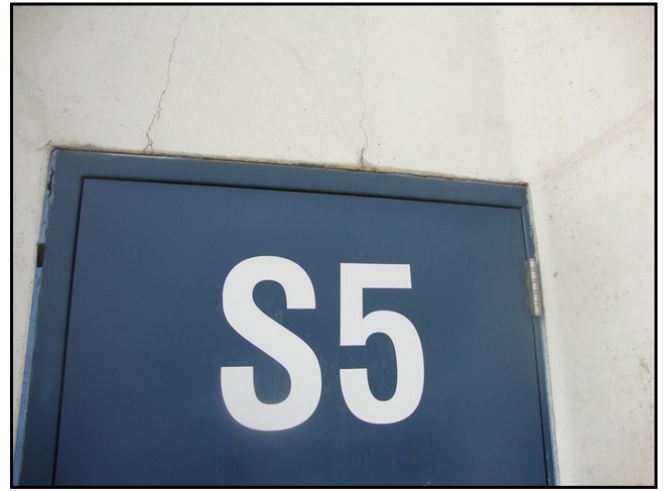
80 : Structure - Minor Cracks @ Warehouse 3

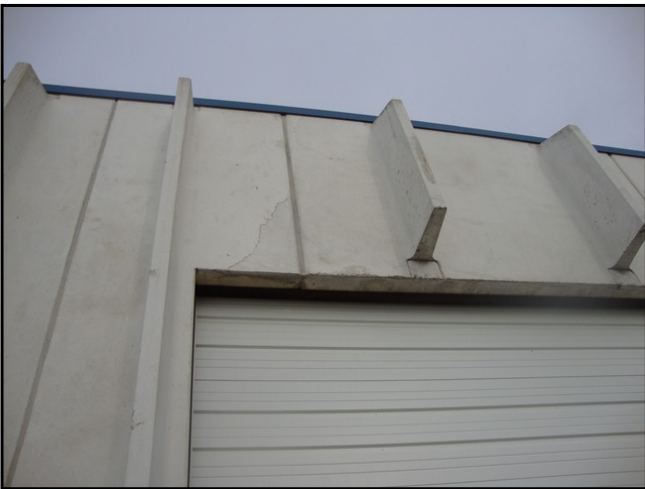
81 : Structure - Minor Cracks @ Warehouse 4

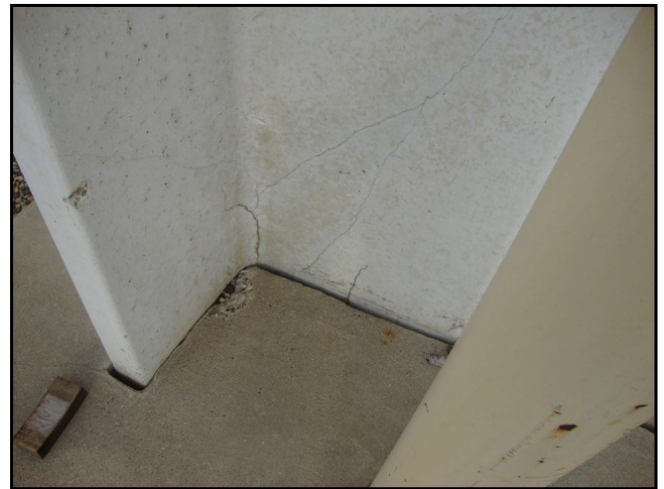
82 : Structure - Minor Cracks @ Warehouse 5

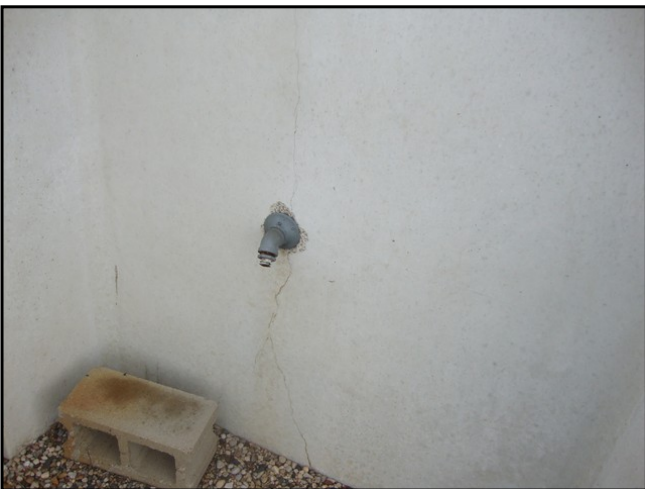
83 : Structure - Minor Cracks @ Warehouse 6

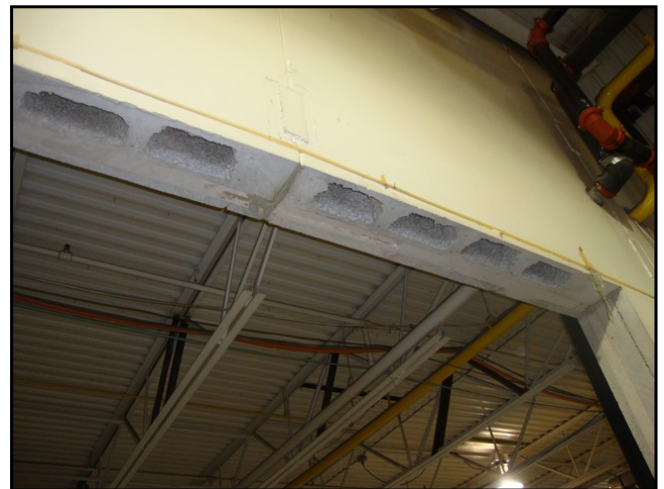
84 : Structure - Modified Opening at Addition

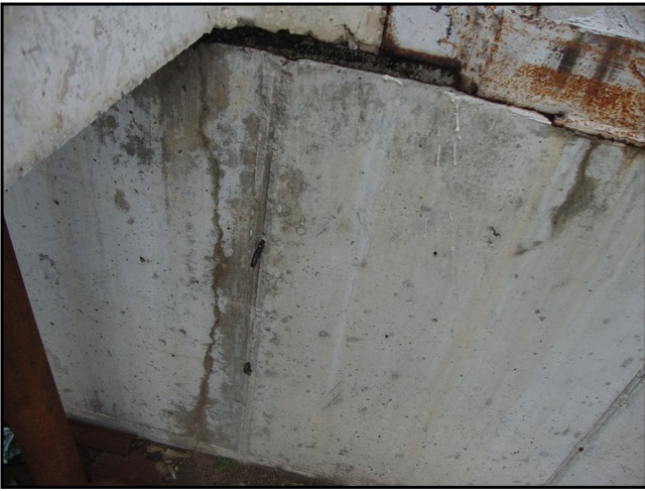
85 : Structure - Typical Cracks or Minor Damage at Dock Bays

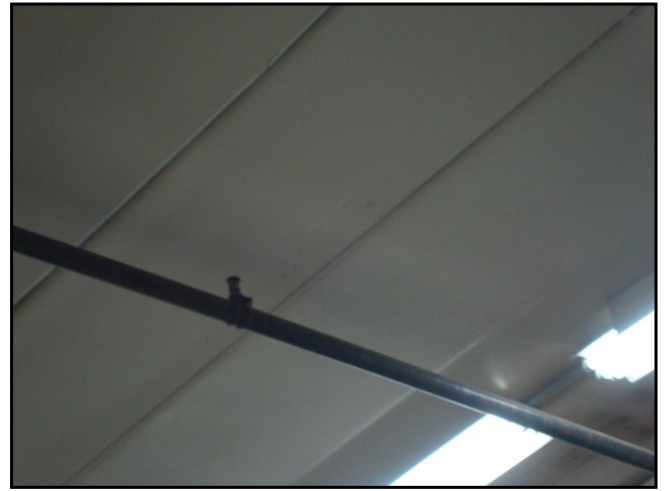
86 : Structure - Typical Floor Framing

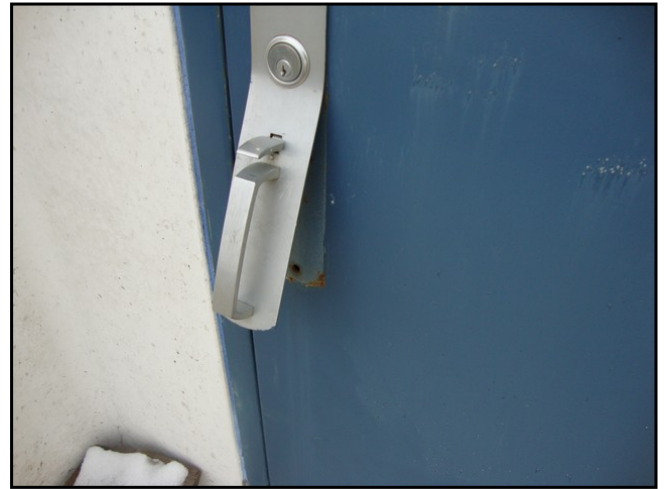
98 : Exterior - Damaged Door Hardware S5

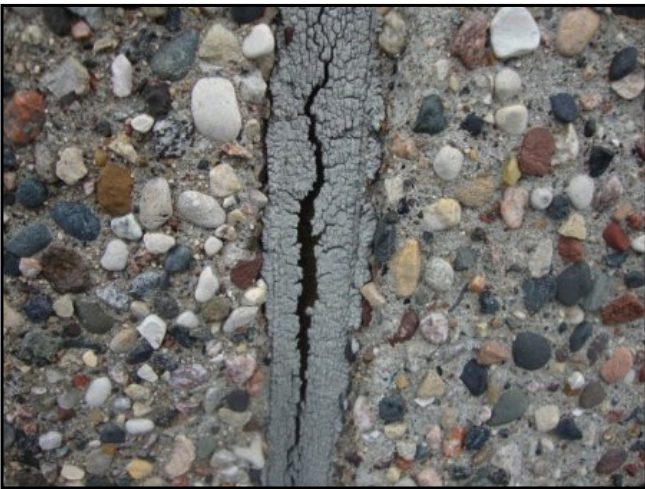
99 : Exterior - Deteriorated Expansion Joint 1

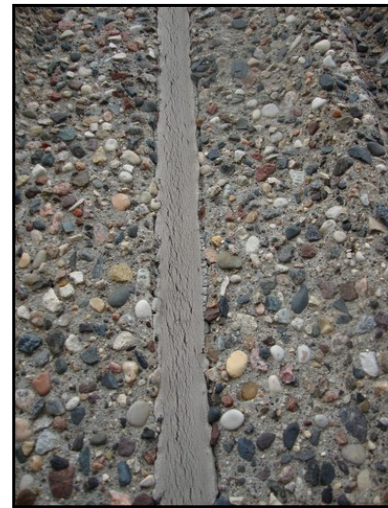
100 : Exterior - Deteriorated Expansion Joint 2

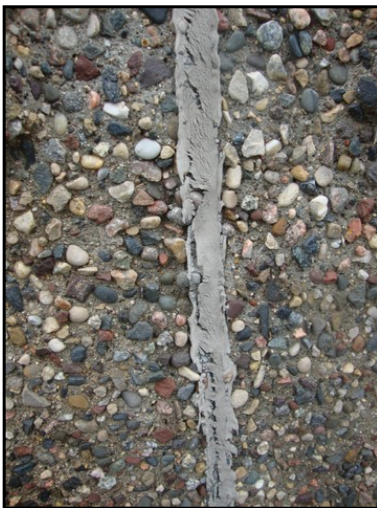
101 : Exterior - Deteriorated Expansion Joint 3

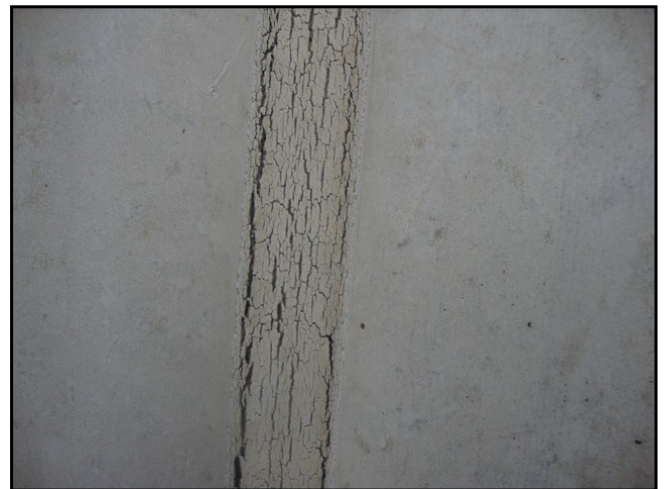
102 : Exterior - Deteriorated Expansion Joint 4

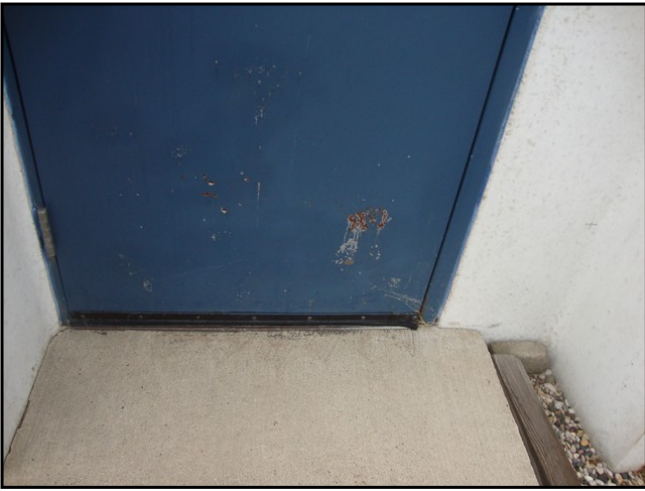
103 : Exterior - Door Rust 1

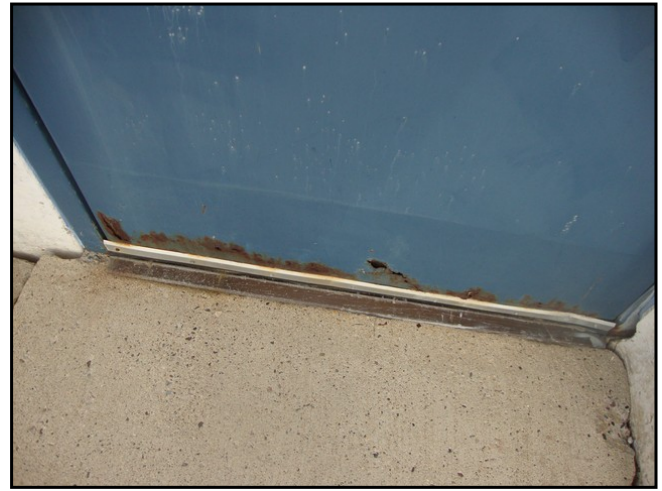
104 : Exterior - Door Rust 2

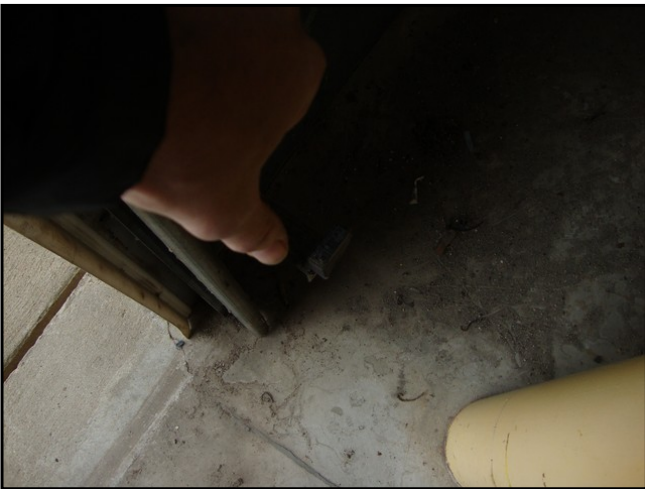
105 : Exterior - Inoperable Auto Reverse @ Door 104

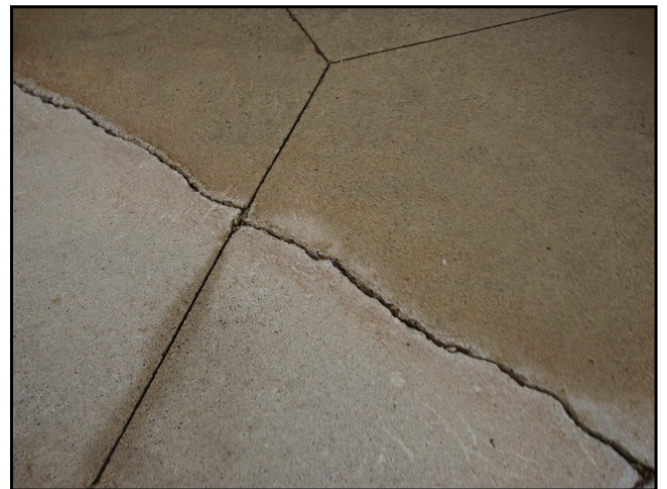
120 : Flatwork - Crack 1

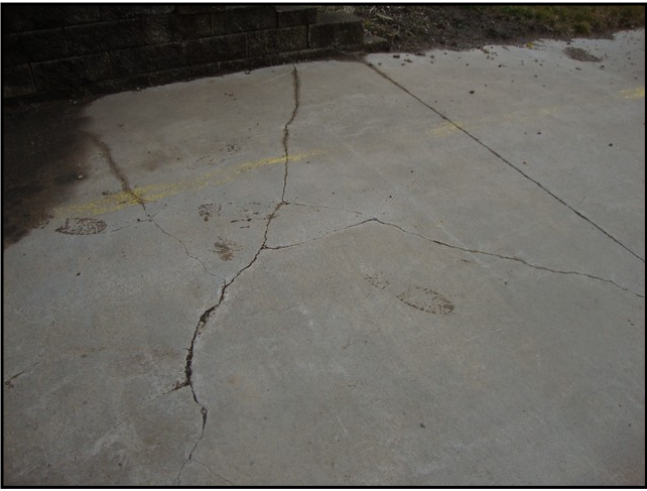
121 : Flatwork - Crack 2

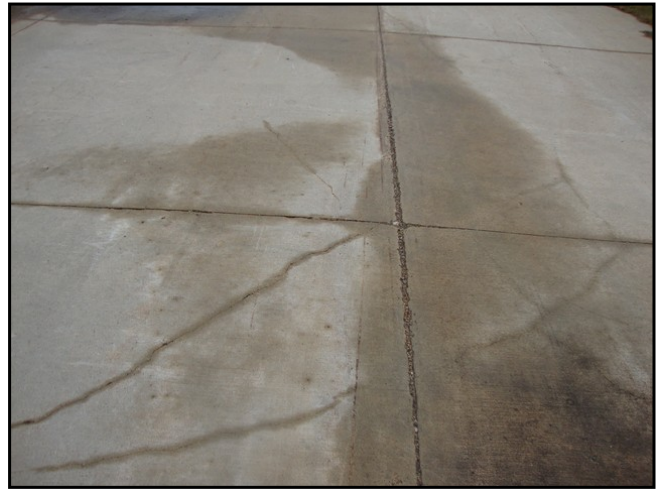
122 : Flatwork - Crack 3

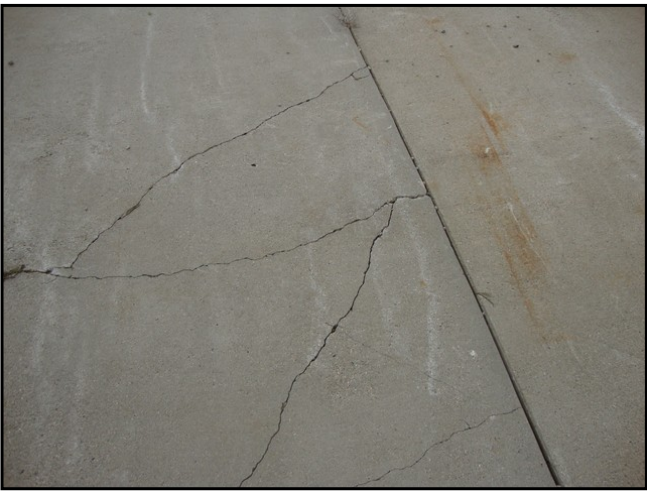
123 : Flatwork - Crack 4

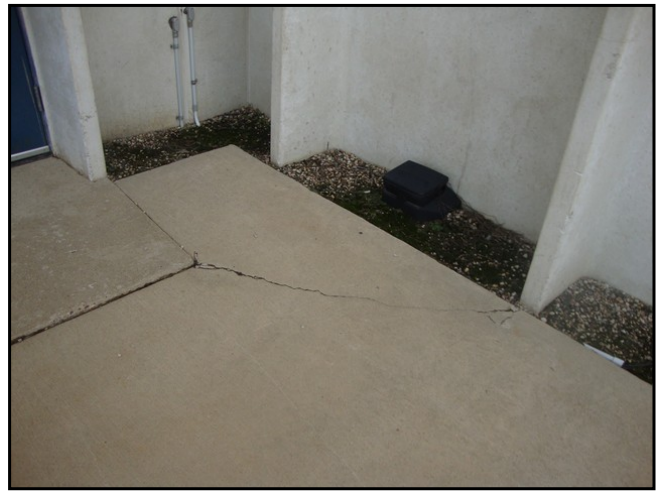
124 : Flatwork - Crack 5

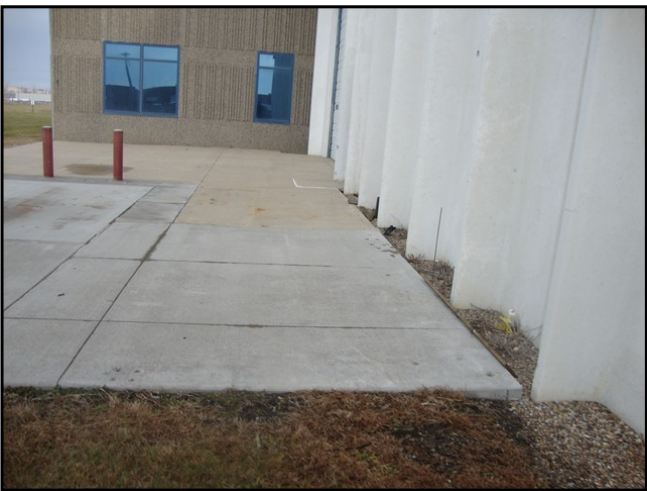
125 : Flatwork - New Sections

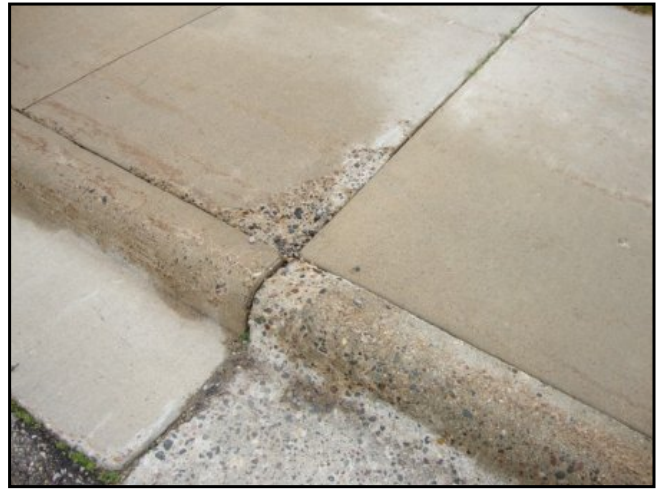
128 : Flatwork - Spalling or Mechanical Damage

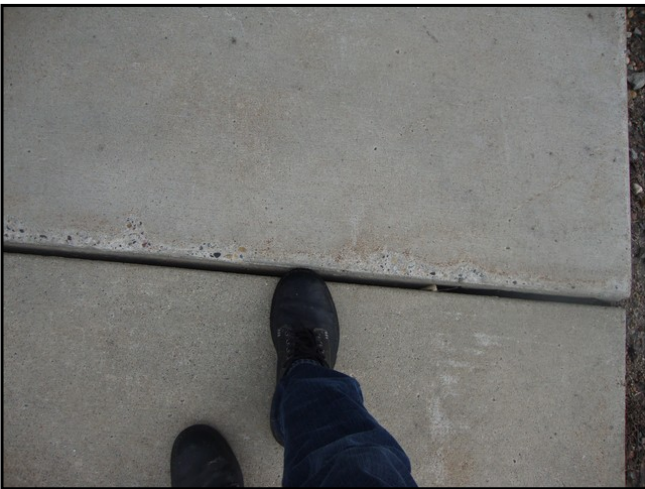
129 : Flatwork - Trip Hazard Near N13

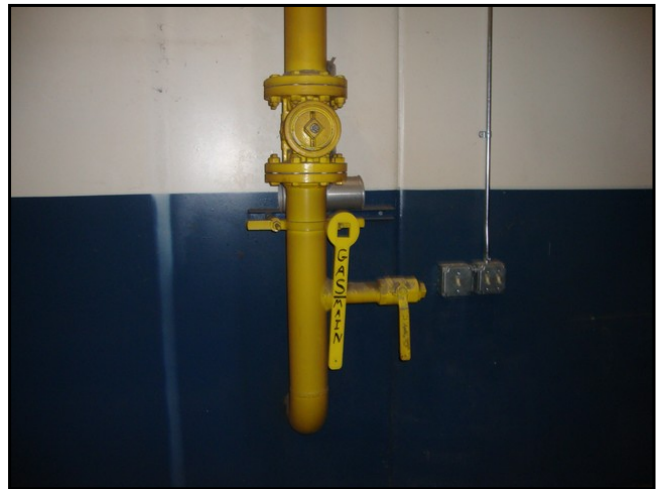
130 : Gas - Main Shut Off

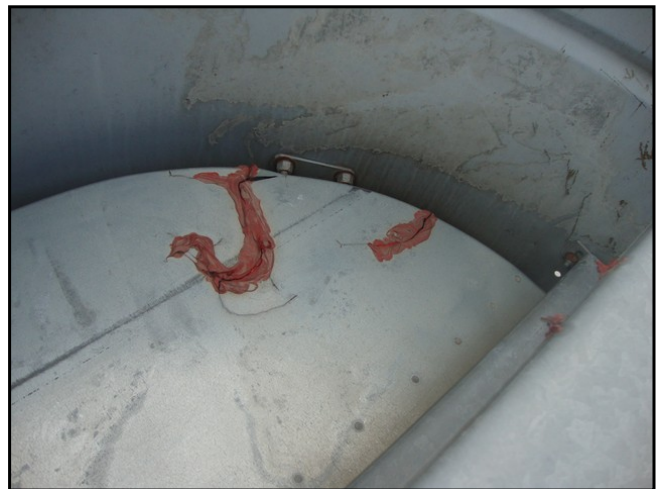
132 : HVAC - Cracked PRV Hood

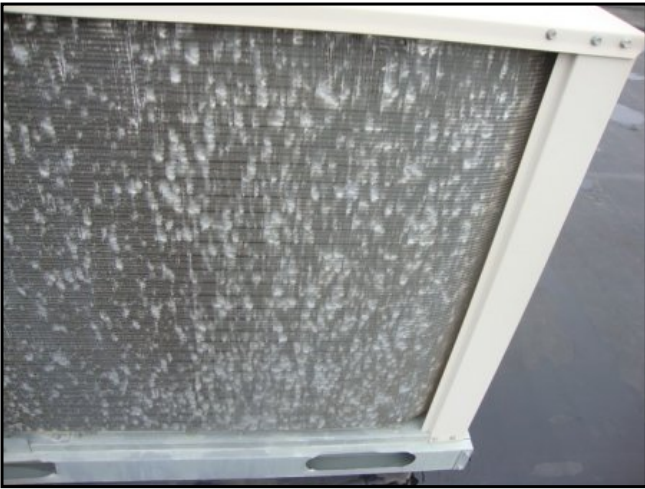
133 : HVAC - Damaged Coil

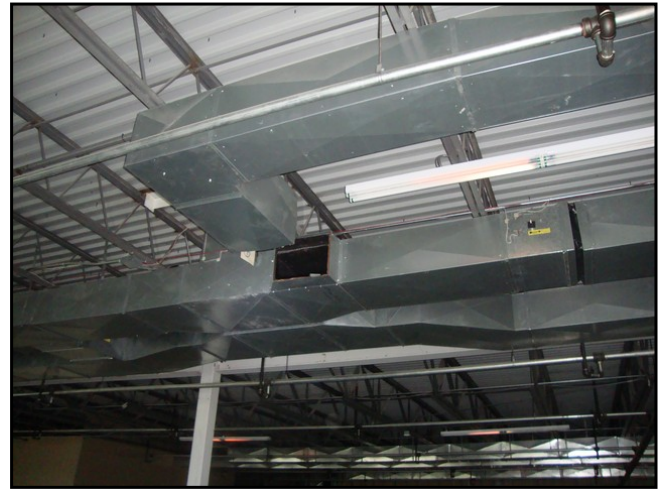
134 : HVAC - Disconnected 2nd Floor Office Duct

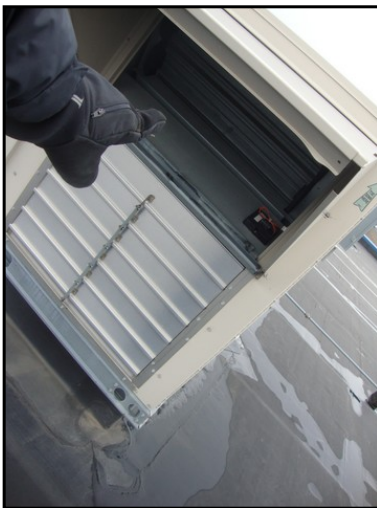
137 : HVAC - Missing Economizer Filter

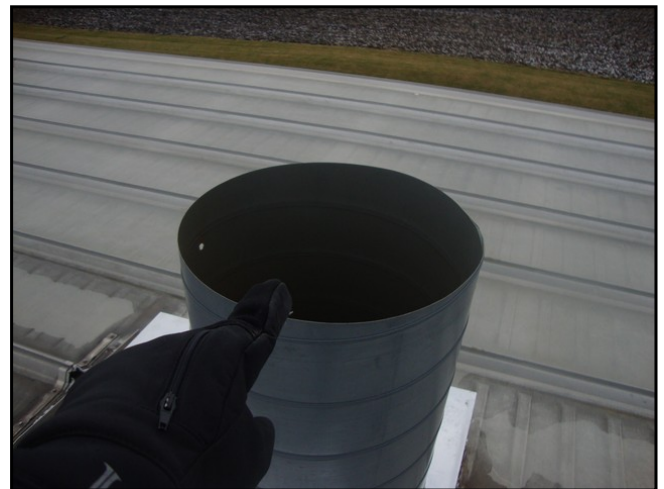
138 : HVAC - Recommend Capping or Removing Abandoned Exhaust Duct 1

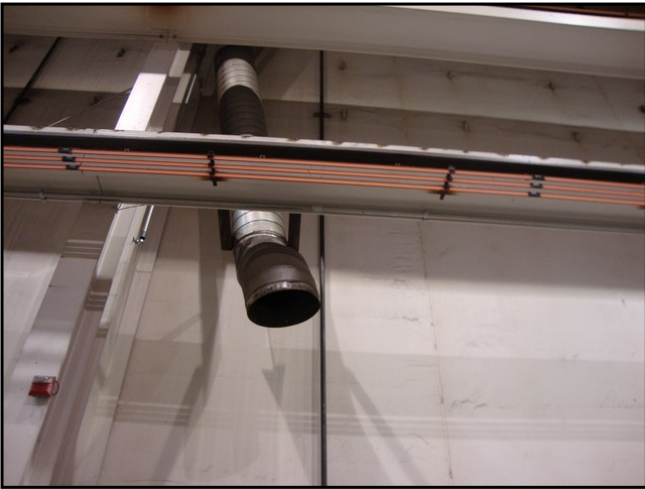
139 : HVAC - Recommend Capping or Removing Abandoned Exhaust Duct 2

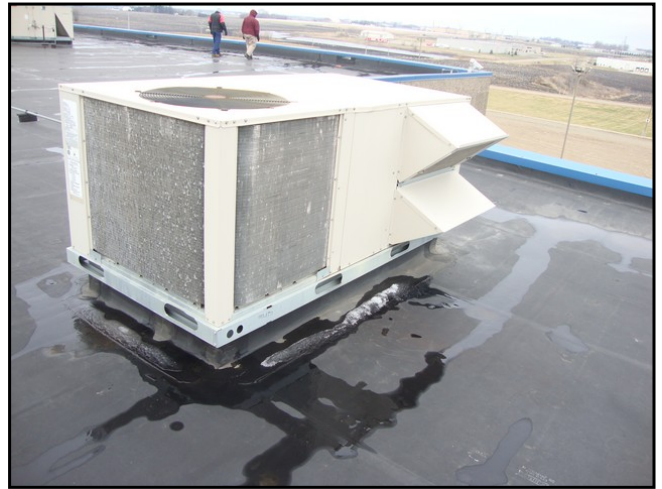
140 : HVAC - Typical RTU

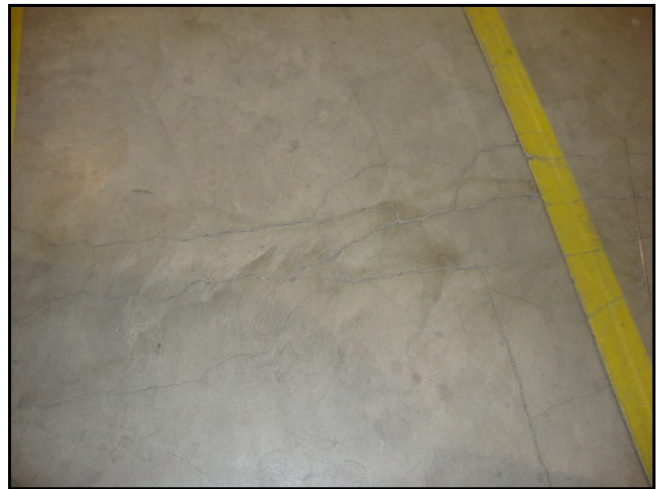
142 : Interior Defects - Floor Cracks

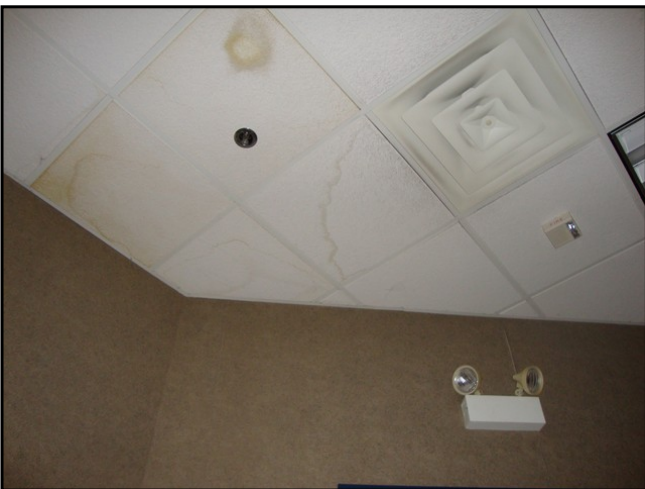
143 : Interior Defects - Hall Water Stains
