Property Condition Assessment Report

C Industries
9999
Anytown, MN 55060

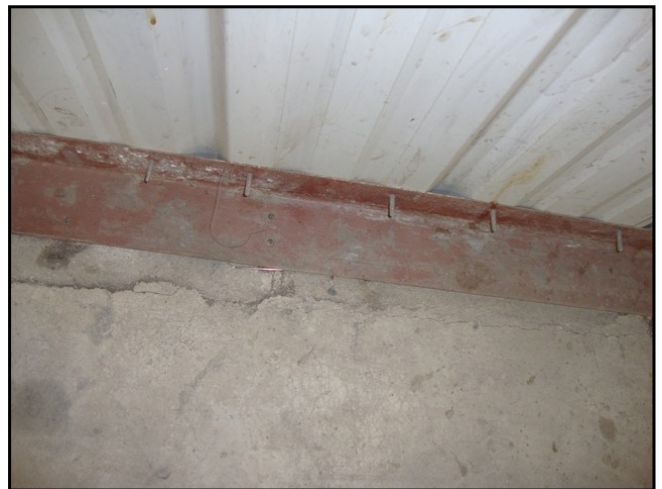
144 : Interior Defects - Loose Fasteners at Mezzanine Wall

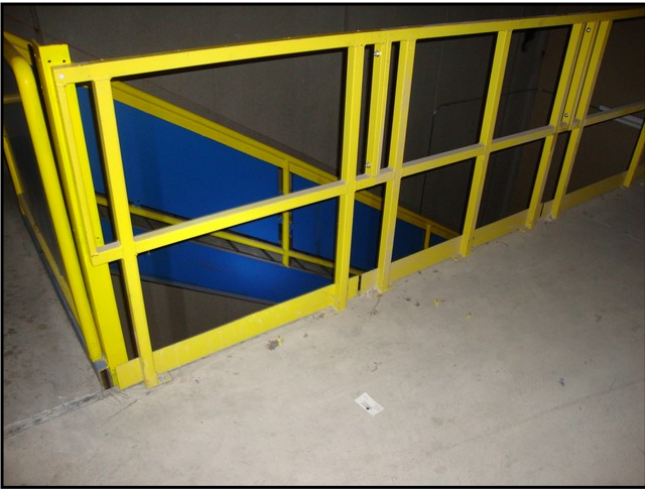
145 : Interior Defects - Missing Filler At Guard Rail 1

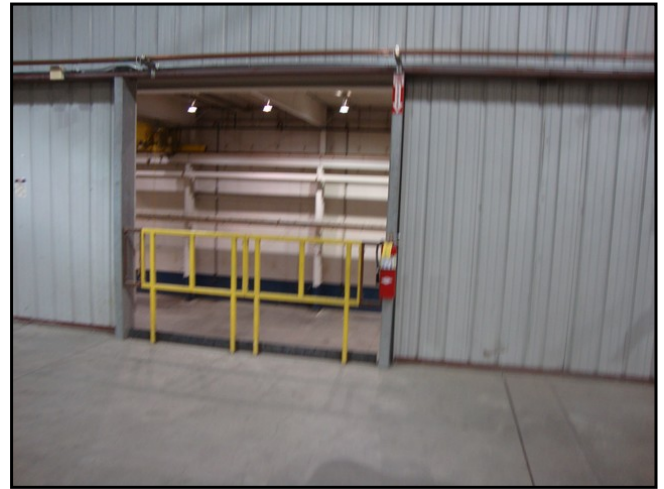
146 : Interior Defects - Missing Filler At Guard Rail 2

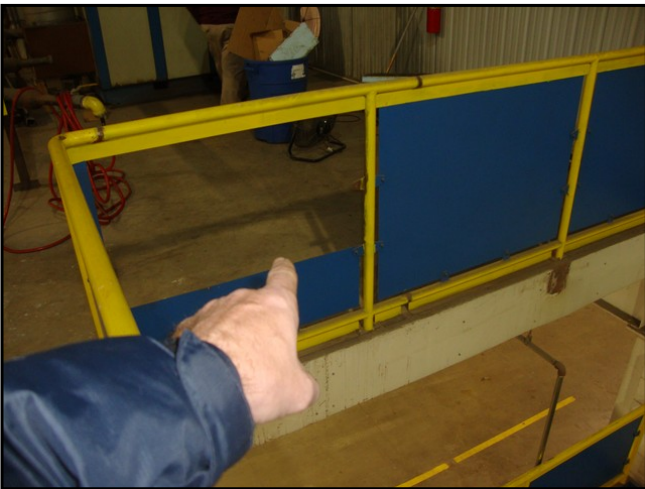
147 : Interior Defects - Missing Filler At Guard Rail 3

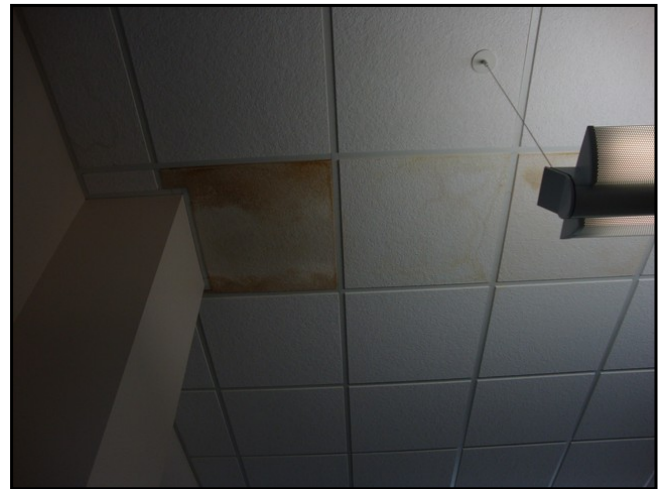
148 : Interior Defects - Office Water Damage 1

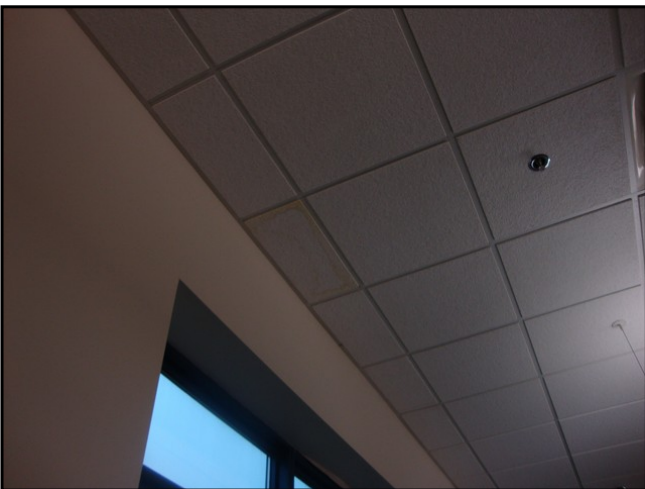
149 : Interior Defects - Office Water Damage 2

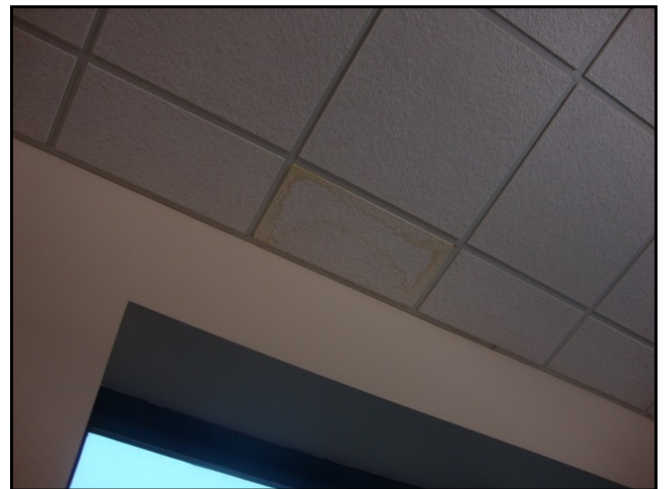
150 : Interior Defects - Office Water Damage 3

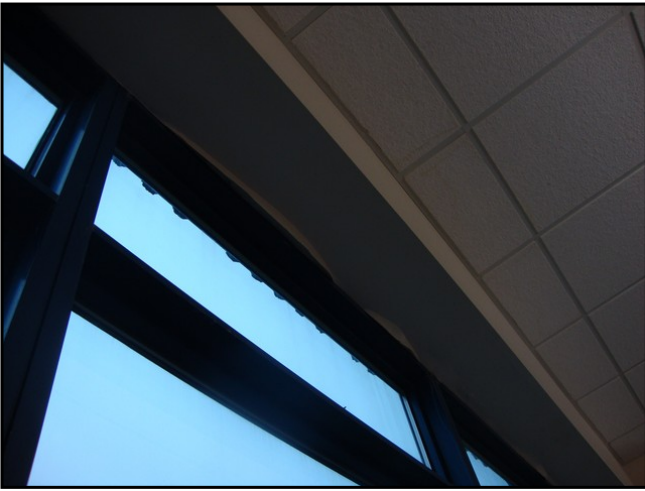
151 : Interior Defects - Office Water Damage 4

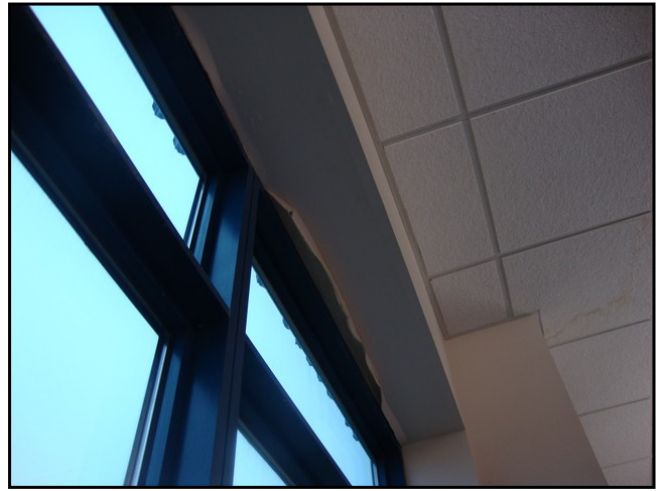
152 : Interior Defects - Office Water Damage 5

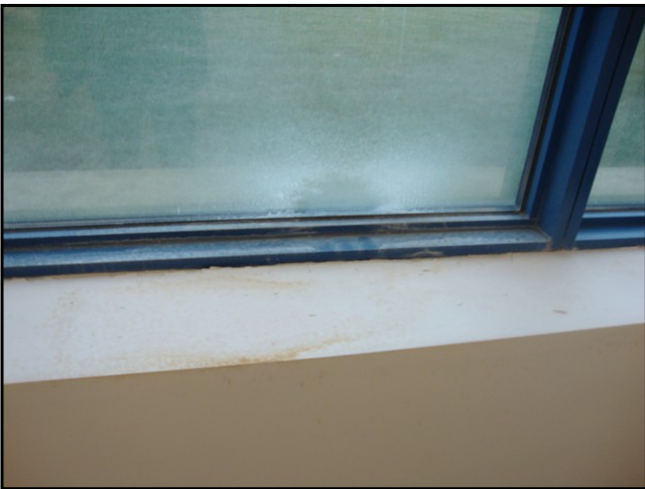
153 : Interior Defects - Office Water Damage 6

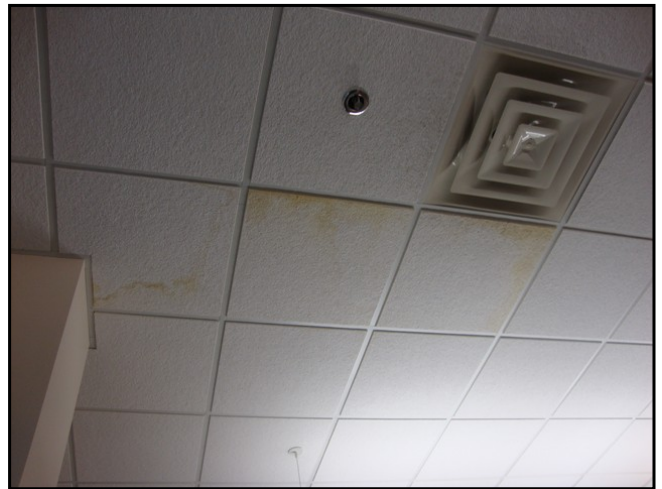
154 : Interior Defects - Office Water Damage 7

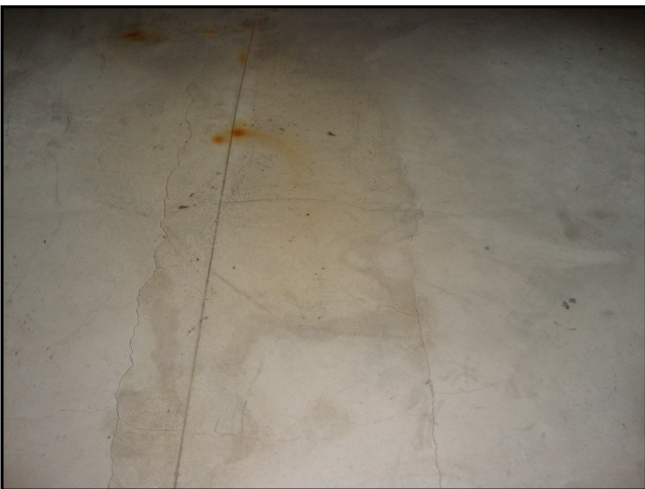
155 : Interior Defects - Patched Floor

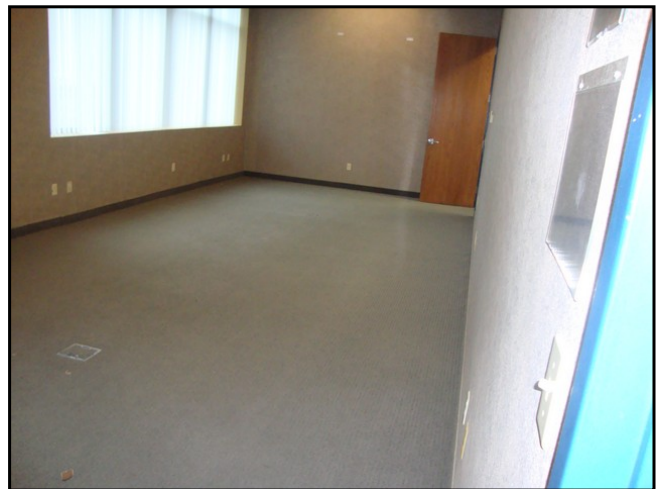
156 : Interior Photos - Conference Room

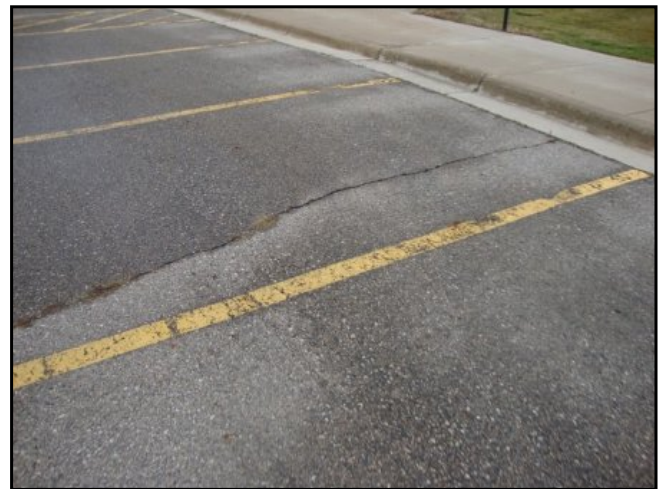
180 : Parking - Crack 1

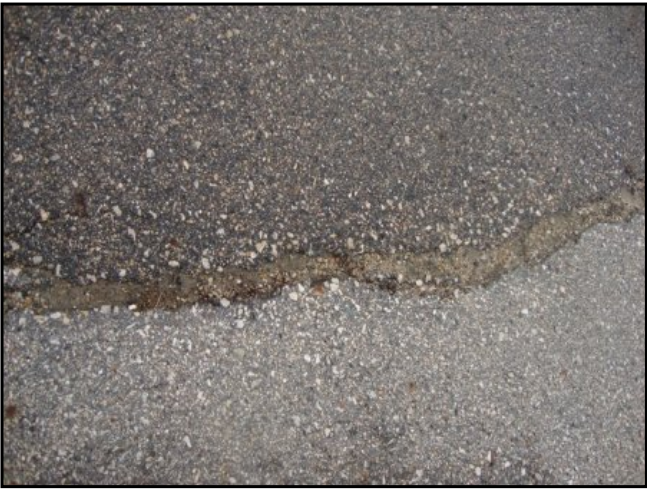
181 : Parking - Crack 2
