<b>Client</b> John & Kathleen Driscoll 12 Tommy Luther Dr Saratoga , 12866 HIN™: 128665433 Email: <a href="mailto:dosborn@catsofalbany.com">dosborn@catsofalbany.com</a> Inspection Date: 02-21-2015	 
<b>Inspector</b>  Phone: _____ E-Mail: _____

Thank you for choosing Zielinski Home Inspection. With 30 plus years of experience in the building trades, I will bring you, my experience and the integrity that I have to every client in the past.

# Report Summary

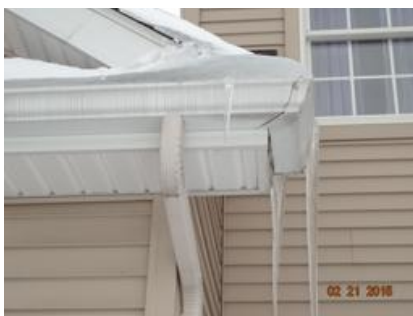
02/26/2015 There where ice covered side walks,as well as in front of the garage door at the time of the inspection. This may lead to personal injury. There are short gutter extensions. Adding gutters extensions would help prevent the amount of ice build up. Recommend contacting a qualified contractor to evaluate and or replace as necessary.

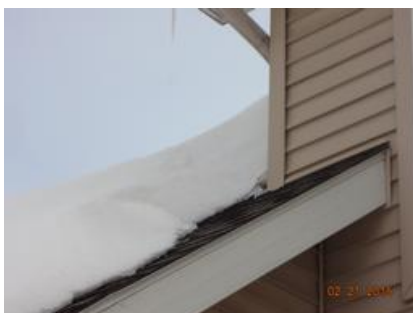
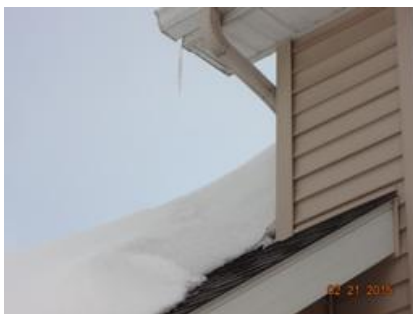
02/22/2015 The gutter is releasing the rain water from the upper roof unto the lower roof which may erode the stones on the lower roof shingle.This may reduce the life of the shingle and may start to penetrate the roof decking. Monitor this area in the future. Recommend contacting a qualified contractor to evaluate and or replace as necessary.

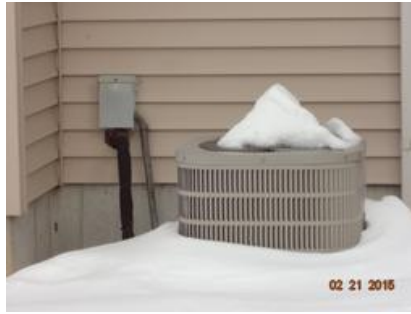
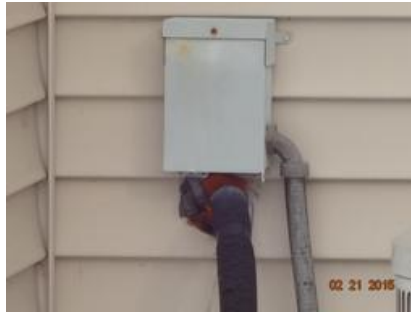
02/23/2015 No duct seal around entry point for service disconnect and coil line. This may allow water to travel to main disconnect breaker potentially lead to a fire hazard. Recommend repair as necessary to prevent moisture penetration.

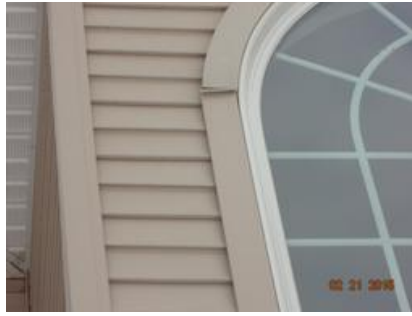
Vinyl trim is damaged in one or more areas and may lead to water infestation and may also allow a direct path for pest and insect intrusion therefore allow dampness to set in. Contact a qualified contractor to evaluate and make repairs and/or replace siding as necessary.

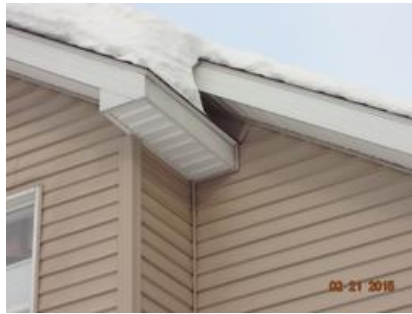
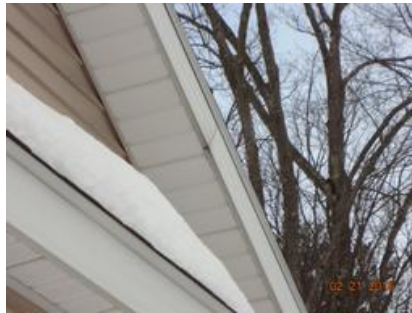
The lower piece of fascia on the upper gable is over lapping the upper piece of fascia. This may lead to water running down the upper fascia and behind the lower piece fascia and may also allow a direct path for pest and insect intrusion. Recommend contacting a qualified contractor to evaluate and or replace as necessary.

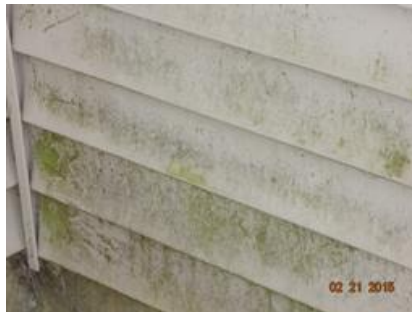
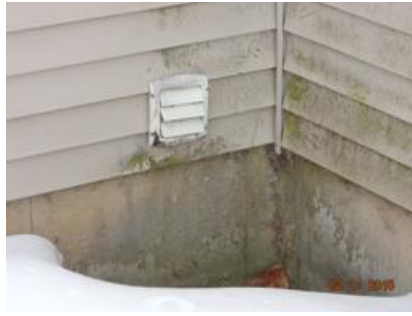
Noted Mildew & Algae forming on the siding on the rear of the garage wall where the dryer vent is venting. This may be caused by the release of water droplets from the dryer, with the mixture of pollen, dirty in the air and the lack of direct sunlight being on the North side. Maintenance in this area is need more often than the south side of the house. Contact a qualified contractor to evaluate and service as necessary.

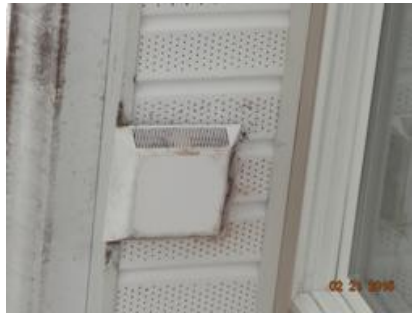
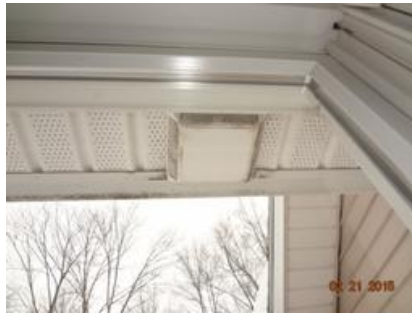
Mildew like substance is around the main bathroom vent on the second floor that is coming out the soffit area. Cleaning this area annually may help maintain the mildew like in this area. Contact a qualified contractor to evaluate and service as necessary.

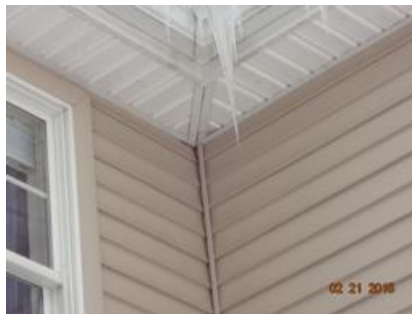
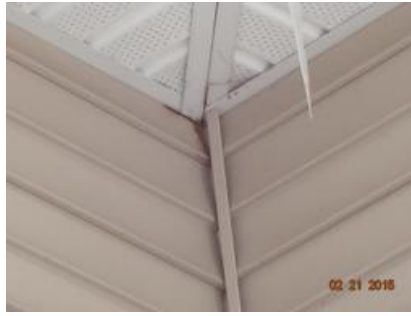
At the time of the home inspection it was noted there was what looked like to be an old water stain in the soffit at one time. This area was not accessible in the attic. Water leaks can cause extensive damage to your property and will result in expensive repair and replacement costs. Recommend monitoring this area in the future.

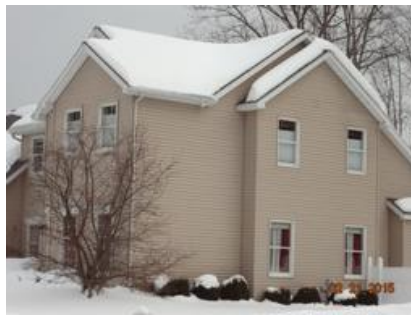
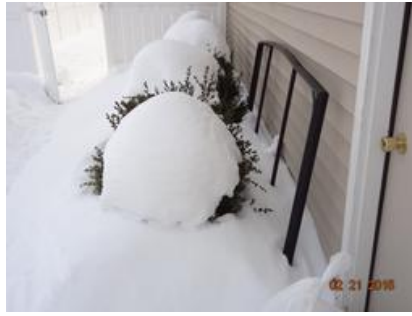
02/23/2015 Shrubs are in contact with siding. Recommend pruning or moving shrubs so there's at least a one foot gap between shrubs and siding. Recommend contacting a qualified contractor to evaluate and or trim back as necessary.

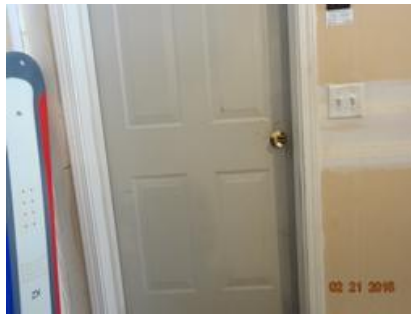
Garage-house door is an auto-closing door but does not close by it self. Recommend adjusting the hinges on the automatic door closing device so door closes automatically to prevent vehicle fumes from entering building. Recommend contacting a qualified contractor to evaluate and or replace as necessary.

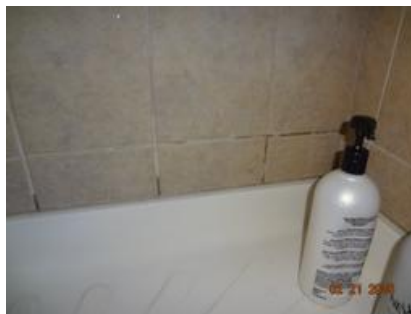
Missing, Cracked, and brittle grout joints are an open invitation for mold, mildew and stains to set in. The intrusion of water through the open grout joints may start the decaying under the tile. Recommend contacting a qualified contractor to evaluate and or replace as necessary.

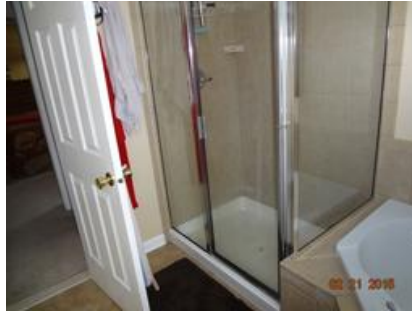
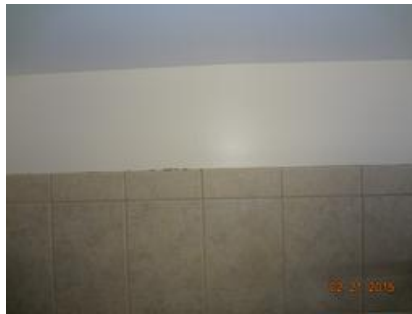
Noted missing caulk around shower. This will allow water penetration to effect the rough lumber behind the walls and sub flooring wood. Sealing these areas with new caulk may help. Recommend a qualified contractor repair or replace as necessary.

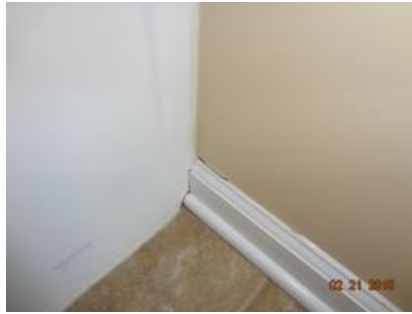
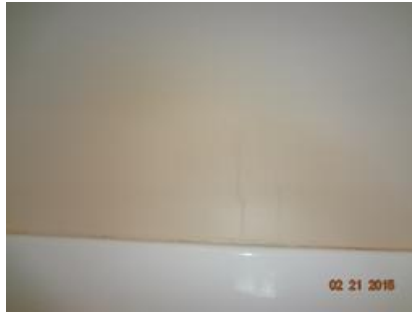
02/23/2015 Noted missing caulk in bathtub area. This may allow water penetration to effect sub flooring and may damage wood. Caulking these areas may help protect these areas from water penetration. Recommend a qualified contractor repair or replace as necessary.

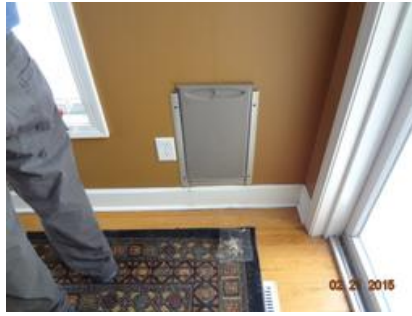
02/23/2015 There is a doggie door on the back side of the kitchen were there is no lock present. This may be an access for an unwanted intruder (persons)that would like to gain access to your home. Recommend adding some type of a lock for you safety. Recommend contacting a qualified contractor to evaluate and or replace as necessary.

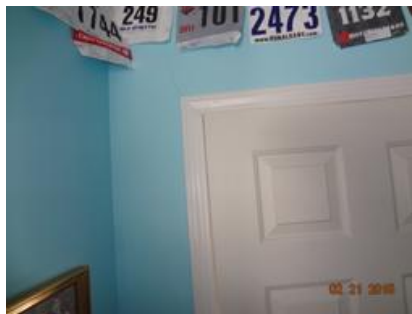
02/23/2015 At the time of the inspections there were multiple doors that were rubbing when trying to close. Recommend contacting a qualified contractor to evaluate and repair as necessary.

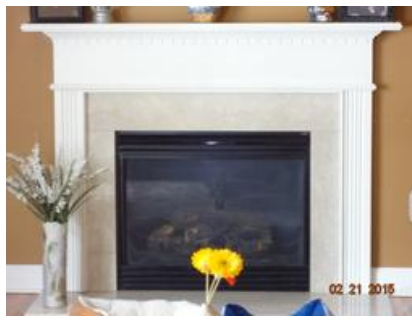
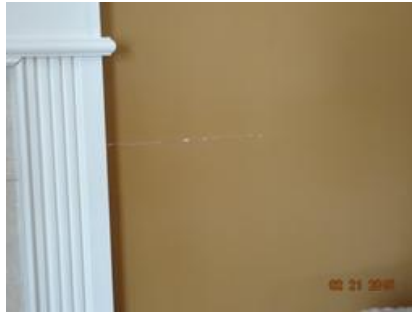
02/23/2015 There was a crack in the wall on the right side of the fireplace. Recommend monitoring this area on large snow loads, and recommend contacting a qualified contractor to evaluate if necessary.

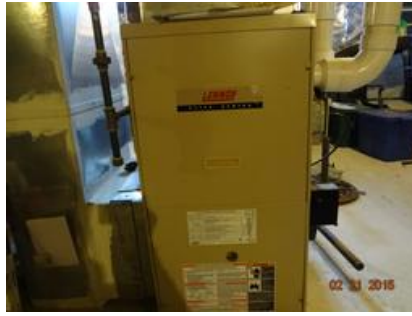
At the time of the inspection there was rust stains on the rear of the furnace. This could of been caused by the indoor evaporator coil and the suction line (the large copper refrigerant line in black insulation) sweats. This looked to be taken care of according to the log records that are posted on of the heating unit. Recommend monitoring this in the future. If there are any changes please contacting a qualified heating contractor to evaluate and or replace as necessary.

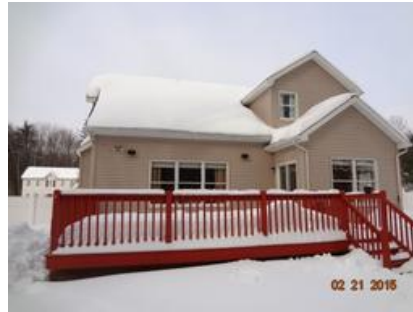
Vents admit oxygen into to the waste system to allow aerobic sewage digestion. Vents provide a way to equalize the pressure on both sides of a trap, thereby allowing the trap to hold water, which is needed to maintain effectiveness of the trap. Vents provide a means to release sewer gases outside instead of inside the house. Recommend monitoring large amount of snow covering that may cover vent pipe.

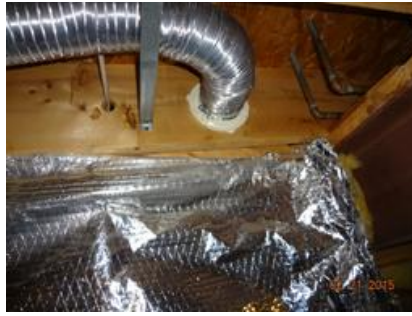
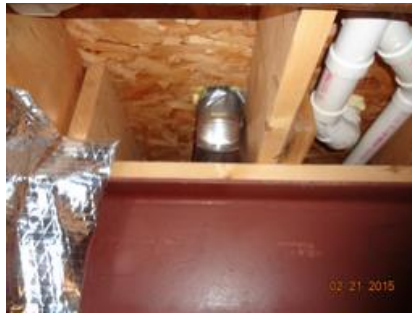
In all cases the longest possible working vent should be made of rigid metal vent material with a large mouth or louvered outdoor hood. Flexible metal ducting although a bit easier to work with causes but reduces air flow due to its corrugated design and will contribute to a lint buildup in the ducting over time. This type of dryer duct materials are more likely to sag and let lint, or even water to build up at low points. A dryer on average will remove 1 gallon of water per load of laundry dried. Recommend contacting a qualified contractor to evaluate and or replace as necessary.

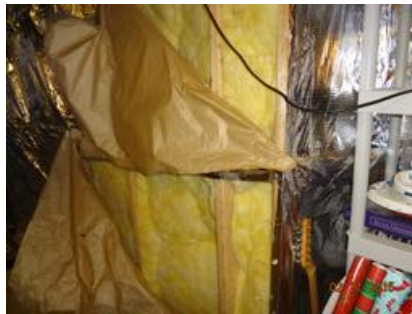
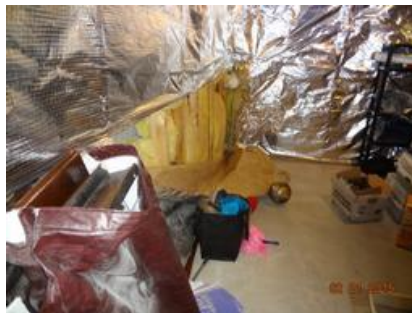
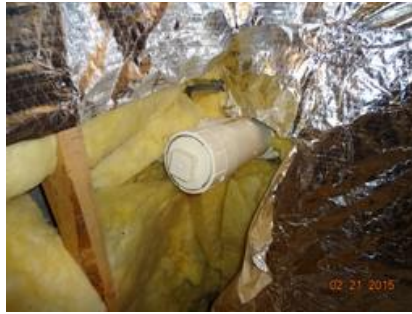
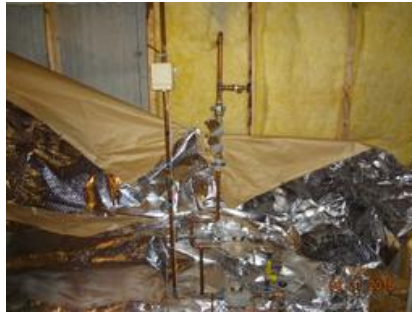
The foil vapor barrier is pulled off the studs in multiple areas within the basement. The vapor barrier keeps the warm air from escaping through cracks into the walls or ceiling. This is done by a vapor barrier, a large sheet of foil paper, or plastic that will not allow air to escape from the room into the walls. Recommend stapling the foil back on the studs, or contact a qualified contract to do so.

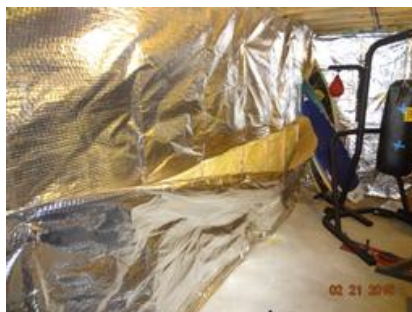
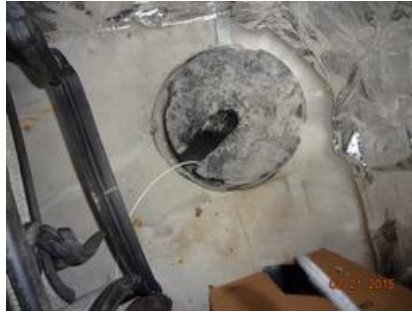
There is a sump pump pit that is not being used in the rear corner of the basement. Noted the basement was dry at that time of the home inspection, but noted there was water in the sump pit.
