Home Inspection Report

1234 Main Street
Our Town, Kansas 67890

Prepared for: John Smith

TM Property Inspections LLC
Wichita, Kansas 67226
316-651-0486 or 316-573-2235

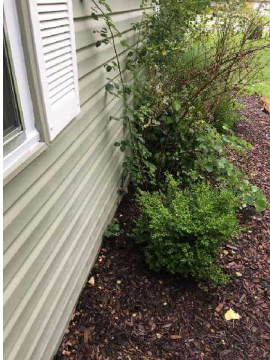
6. ☐ ☒ ☐ ☐ ☐ Deck:
7. ☐ ☒ ☐ ☐ ☐ Balcony:
8. ☐ ☐ ☐ ☒ ☐ Grading: Flat - Improper soil slope towards foundation, recommend the addition of fill dirt to improve grade so water will runoff away from house and garages.
9. ☐ ☐ ☐ ☒ ☐ Vegetation: Shrubs - Tree limbs over hang the roof and should be cut back from home and garages.

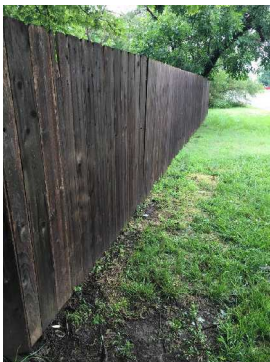
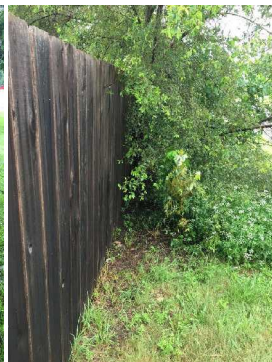
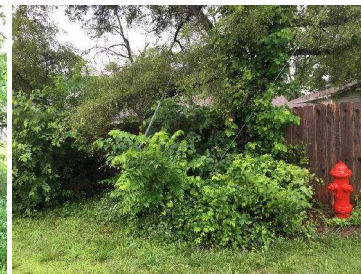
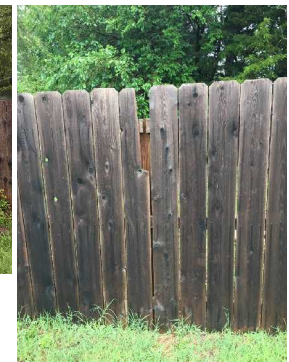
10. ☐ ☐ ☐ ☒ ☐ Fences: Wood - Recommend to trim all trees and shrubs away from the the wooden fence to assist in a longer fence life. Furthermore, recommend to seal and treat fence annually to assist in longer fence life.

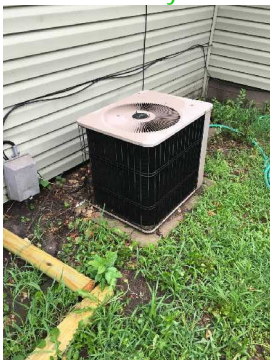
1. ☒ ☐ ☐ ☐ ☐ A/C System Operation: Appears serviceable
2. ☐ ☐ ☒ ☐ ☐ Condensate Removal: The AC/furnace located under the house was difficult to get to. Recommend to have a HVAC technician look at unit for functionality.
3. ☐ ☐ ☐ ☒ ☐ Exterior Unit: Pad mounted - Unit is near the end of it's life. Recommend to budget for new unit in the next few years.

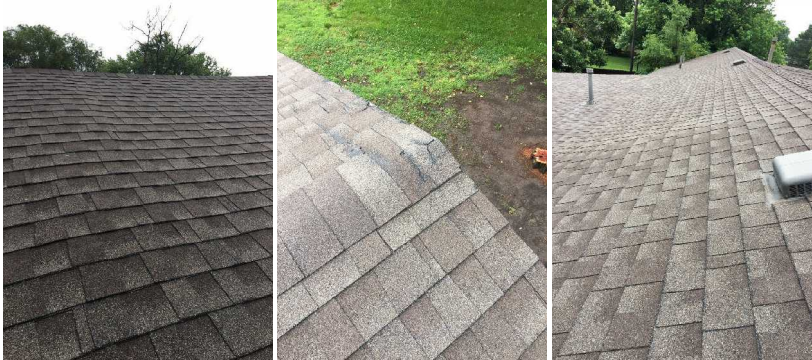
1. Method of Inspection: On roof
2. ☒ ☐ ☐ ☐ ☐ Material: Asphalt shingle - Recommend to monitor bulging areas on the roof and where they are located in relation to rooms so leaks can be detected early in the attic.

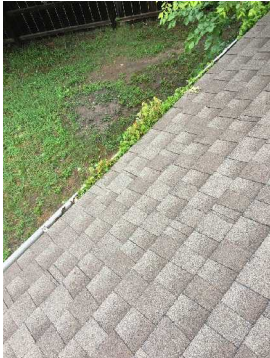
9. ☒ ☐ ☐ ☐ ☐ Electrical Mast: Underground utilities
10. ☒ ☐ ☐ ☐ ☐ Gutters: Aluminum - Recommend to clean dirt and debris from gutters to prevent vegetation growth.

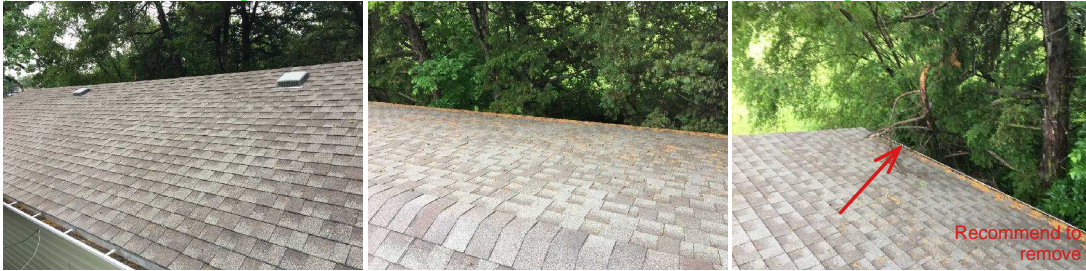
1. ☒ ☐ ☐ ☐ ☐ Exterior Surface: Vinyl siding
2. ☒ ☐ ☐ ☐ ☐ Roof: Asphalt shingle - Recommend to trim all trees away from the roof is much is possible to prevent roof damage and to assist in less leaves and debris in the gutters.

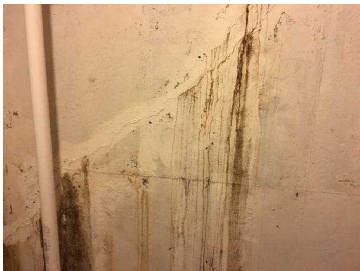
4. ☒ ☐ ☐ ☐ ☐ Ceiling: Exposed framing
5. ☒ ☐ ☐ ☐ ☐ Walls: Exposed framing
6. ☒ ☐ ☐ ☐ ☐ Floor: Poured
7. ☒ ☐ ☐ ☒ ☐ Foundation: Poured - The foundation in the storm shelter has leaks near the sump and in the south east corner. Recommend further evaluation by a foundation technician.

6. Northwest corner of home Outbuilding Foundation: Poured - The foundation in the storm shelter has leaks near the sump and in the south east corner. Recommend further evaluation by a foundation technician.

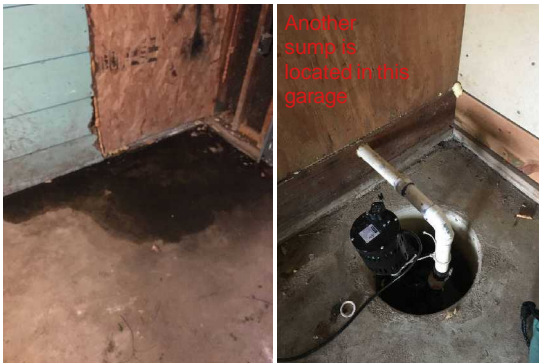
1. Type of Structure: Attached Car Spaces: 1
2. ☒ ☐ ☐ ☐ ☐ Garage Doors: Metal
3. ☒ ☐ ☐ ☐ ☐ Door Operation: Manual
4. ☐ ☒ ☐ ☐ ☐ Door Opener:
5. ☒ ☐ ☐ ☐ ☐ Exterior Surface: Vinyl siding
6. ☒ ☐ ☐ ☐ ☐ Roof: Asphalt shingle
7. ☒ ☐ ☐ ☐ ☐ Roof Structure: 2x6 Rafter
8. ☐ ☒ ☐ ☐ ☐ Service Doors:
9. ☒ ☐ ☐ ☐ ☐ Ceiling: Exposed framing
10. ☒ ☐ ☐ ☐ ☐ Walls: Exposed framing
11. ☐ ☐ ☐ ☒ ☐ Floor/Foundation: Poured slab - At the time of the inspection, there were signs of moisture penetration in the garage toward the garage door. Recommend a qualified foundation technician to evaluate the situation.

8. Attached Garage Floor/Foundation: Poured slab - At the time of the inspection, there were signs of moisture penetration in the garage toward the garage door. Recommend a qualified foundation technician to evaluate the situation.

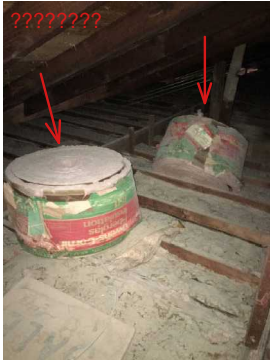
5. ☒ ☐ ☐ ☐ ☐ Insulation: Batts - Recommend additional insulation to be installed.

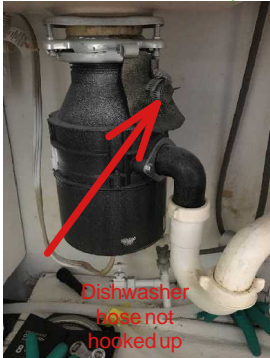
1. ☒ ☐ ☐ ☐ ☐ Cooking Appliances: Frigidaire
2. ☒ ☐ ☐ ☐ ☐ Ventilator: Control button is on microwave
3. ☐ ☐ ☐ ☐ ☒ Disposal: In-Sinkerator - At the time of the inspection, the disposal unit was not operative. Recommend to replace or repair or ask owners about the unit.

1. 1st Floor Kitchen Disposal: In-Sinkerator - At the time of the inspection, the disposal unit was not operative. Recommend to replace or repair or ask owners about the unit.

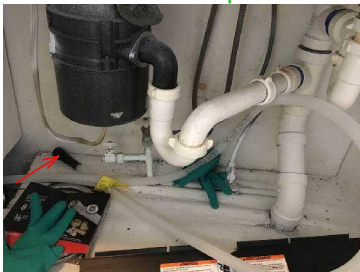
4. ☒ ☐ ☐ ☐ ☐ Dishwasher: Frigidaire - Unit was not tested for functionality for the hose to the garbage disposal was not hooked up.

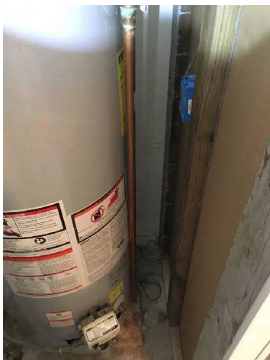
13. ☒ ☐ ☐ ☐ ☐ TPRV and Drain Tube: Copper - Recommend to install a drip pan to assist in catching water when the unit rusts out or needs to be flushed out.

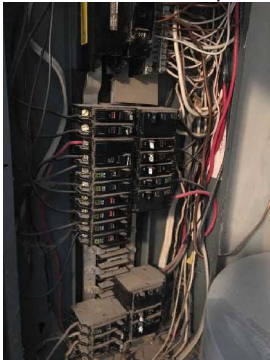
15. ☒ ☐ ☐ ☐ ☐ Manufacturer: Square D - Recommend cleaning by qualified electrician.

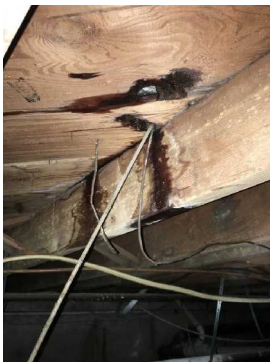
2. ☒ ☐ ☐ ☐ ☐ Access: Large - **Located in the master bedroom closet.**
 3. ☐ ☐ ☐ ☒ ☐ Moisture Penetration: Small leak from water line to reffridgerator

19. Main Crawl Space Moisture Penetration: Small leak from water line to refridgerator

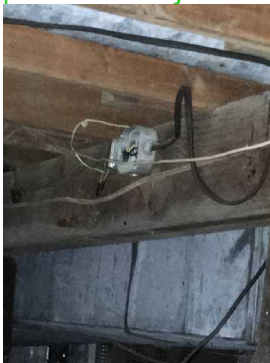
10. ☐ ☐ ☐ ☒ ☐ Electrical: 110 VAC - Open junction box located in the crawlspace. Recommend to install cover plates on the junction boxes by a qualified electrician.

20. Main Crawl Space Electrical: 110 VAC - Open junction box located in the crawlspace. Recommend to install cover plates on the junction boxes by a qualified electrician.

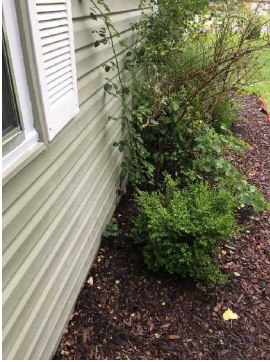
1. Grading: Flat - Improper soil slope towards foundation, recommend the addition of fill dirt to improve grade so water will runoff away from house and garages.
2. Vegetation: Shrubs - Tree limbs over hang the roof and should be cut back from home and garages.

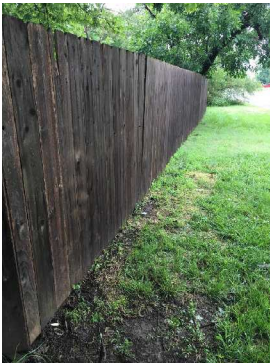
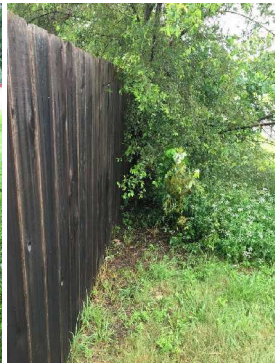
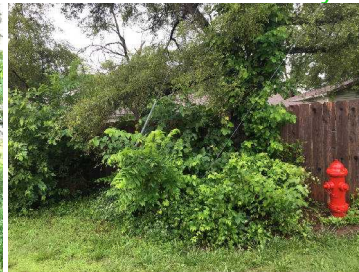
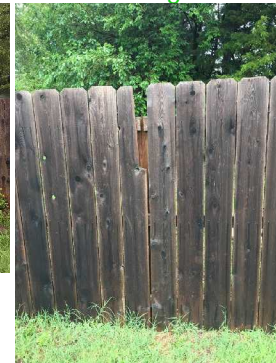
3. Fences: Wood - Recommend to trim all trees and shrubs away from the the wooden fence to assist in a longer fence life. Furthermore, recommend to seal and treat fence annually to assist in longer fence life.

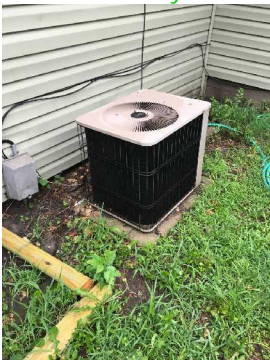
4. Main AC System Exterior Unit: Pad mounted - Unit is near the end of it's life. Recommend to budget for new unit in the next few years.
