Duke's Home Inspections

Property Inspection Report

191 Easy Street, Houston, TX 77777 Inspection prepared for: Best Client Real Estate Agent: Kelli Semar - JLA Realty

Date of Inspection: 10/28/2016 Time: 4:00 PM

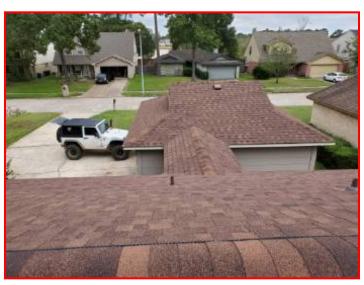
Trees need cutting back

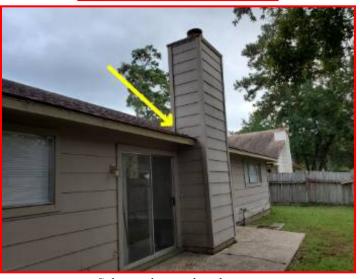
Siding is damaged at chimney.

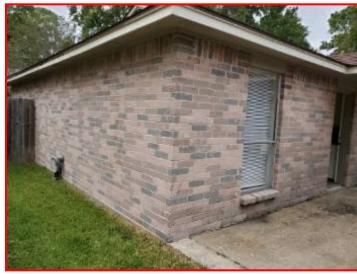
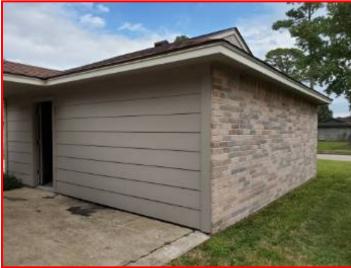
Exterior areas around the home should be painted to protect from the weather.

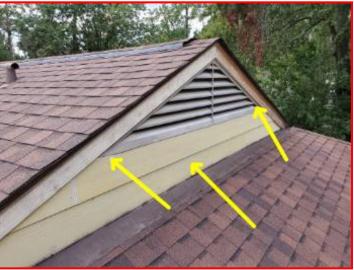
The wood siding on the garage is in poor shape.

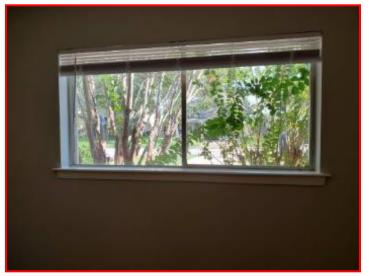
Front guest bedroom window would not open.

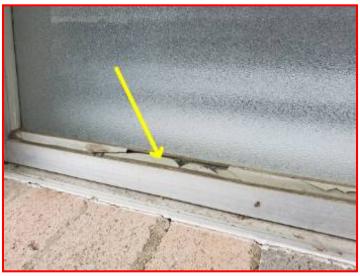
Some exterior window sills appeared to be damaged in one or more locations

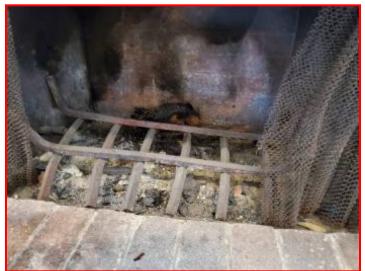
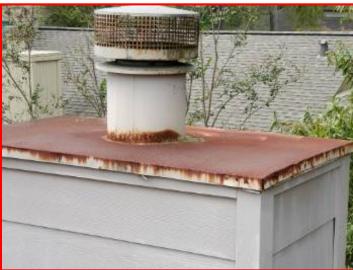
Chimney cap and or rain cap is rusty

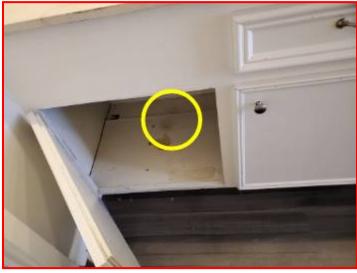
Drain leaking under master bathroom sink.
