# Dependable Home Inspections

## \*\*\* Residential Inspection Report \*\*\*

March 13, 2019

Gridley, Ca 95948

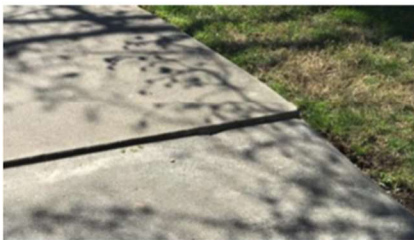
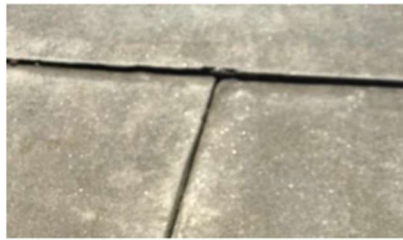
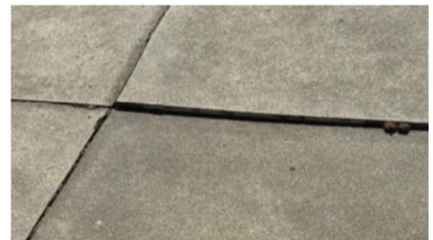
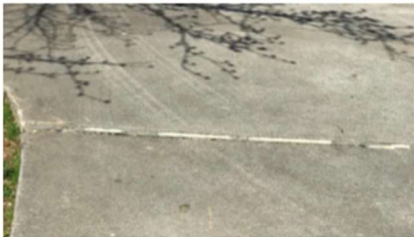
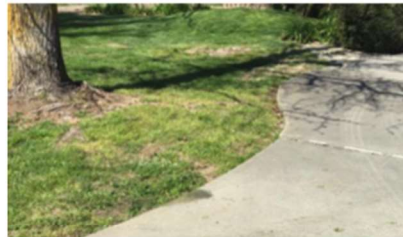
Further Comments: Lifting spots in driveway, appears to be caused by tree roots

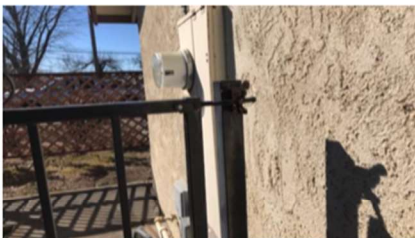
Further Comments: Garage side gate latch is rusted closed; Gate to pool drags on cement and does not close properly

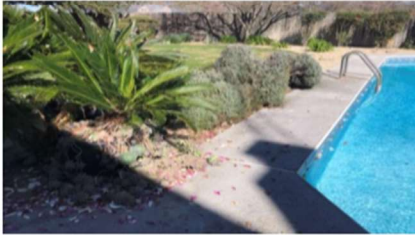
**Further Comments:** Some shrubbery blocking pool deck

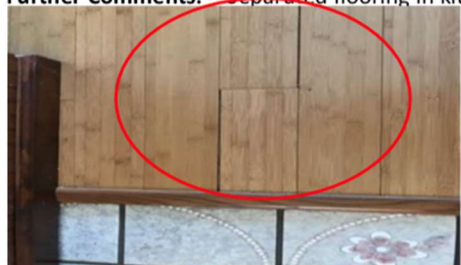
Further Comments: Separated flooring in kitchen

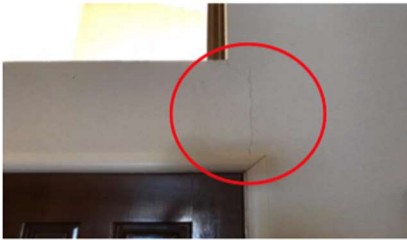
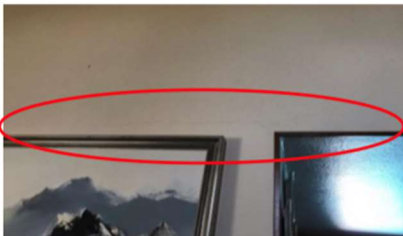
**Further Comments:** Crack over entry door, right hand side; crack at wall leading to kitchen area, left hand side

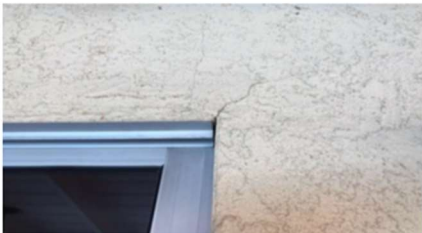
**Further Comments:** Crack in stucco near slider from kitchen

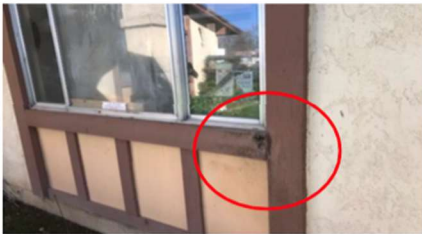
**Further Comments:** Window trim damaged at exterior garage window, lower right side

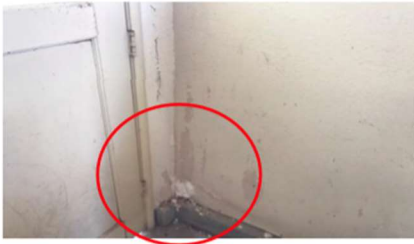
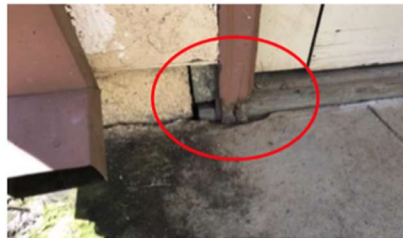
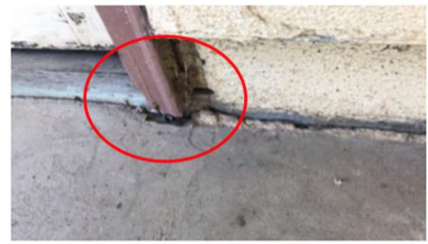
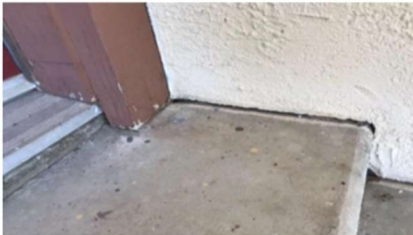
**Further Comments:** Exterior man door of garage is showing framing material at bottom; Front entry step should be as wide as the door and 3 ft. in length.

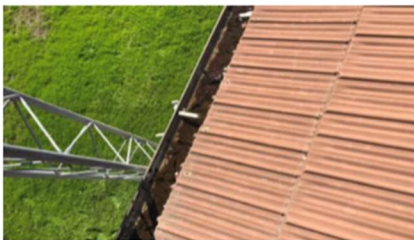
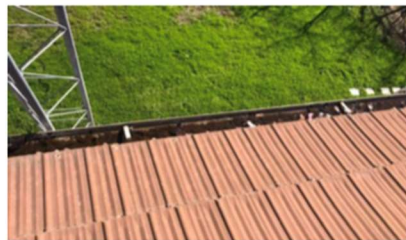
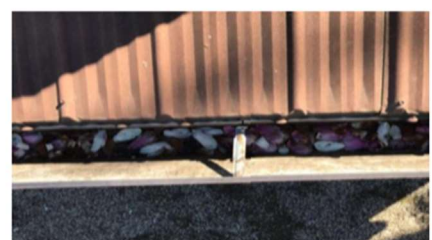
Further Comments: Gutters are pulling away from home, full of water

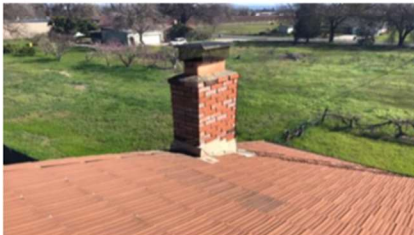
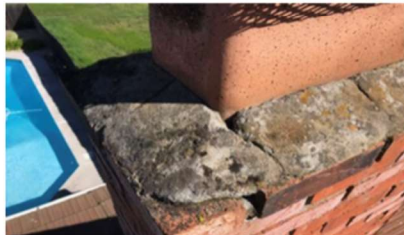
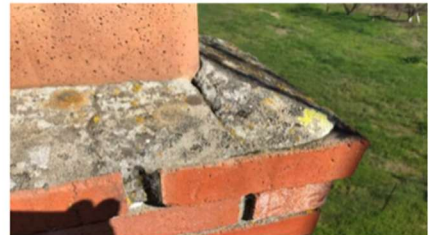
**Further Comments:** Missing and cracked parts of crown

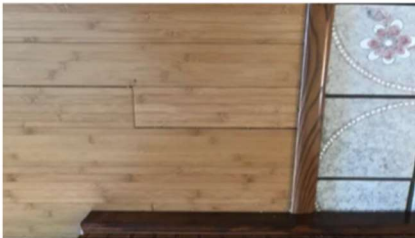
Further Comments: Separated flooring in kitchen

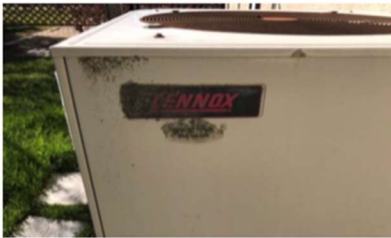
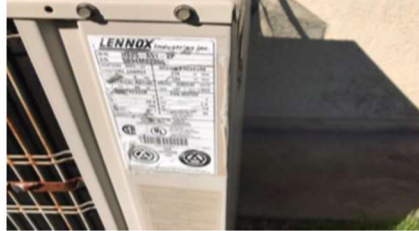
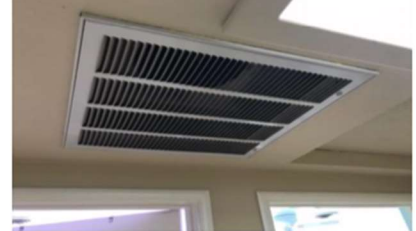
No concerns observed; Return air grill missing filter.

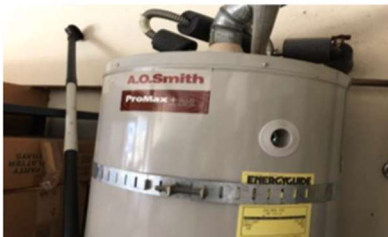
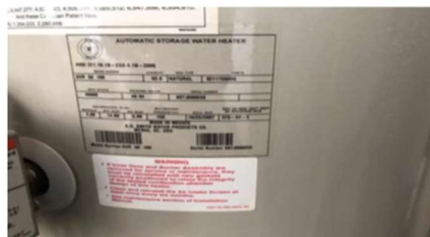
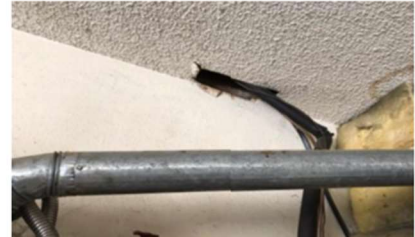
No concerns observed with water heater. Penetrations through roof need to be sealed above water heater and furnace.

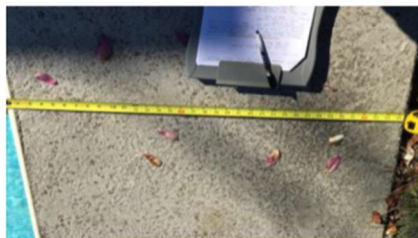
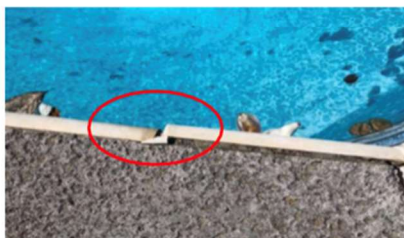
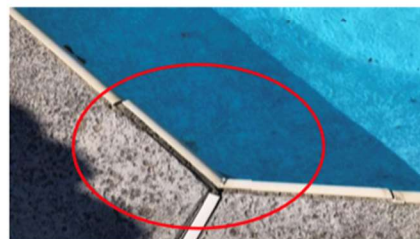
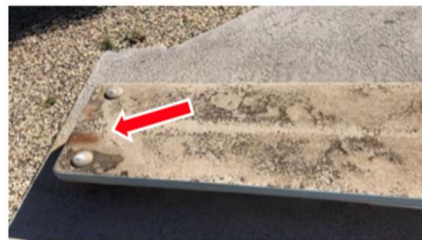
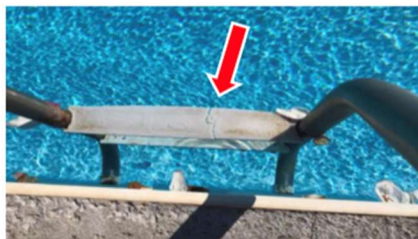
Further Comments: Width of pool deck appears to be narrow. Coping in some areas need repair. Rust and crack on diving board. Crack on ladder to pool.

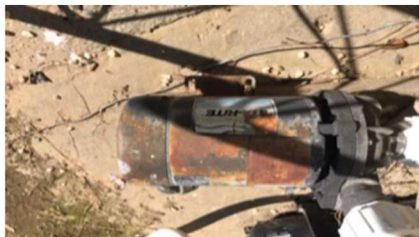
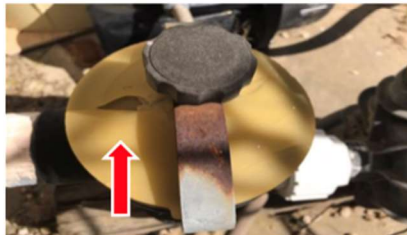
Further Comments: Pool pumps not on at time of inspection, crack in equipment

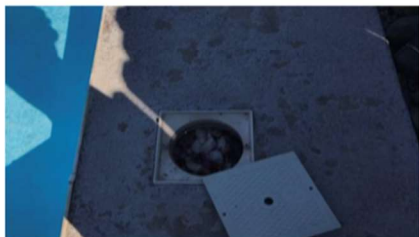
Further Comments: Skimmer and basket need cleaning

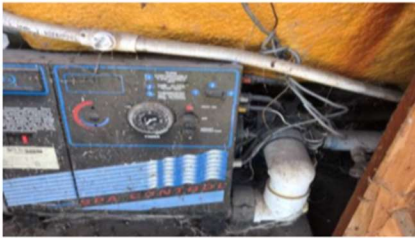
Further Comments: Spa was drained; No evidence of leaks; No emergency shutoff noted.
