PROPERTY CONDITION ASSESSMENT REPORT

Sample Report

St. Paul, MN

Wednesday, December 30, 2015

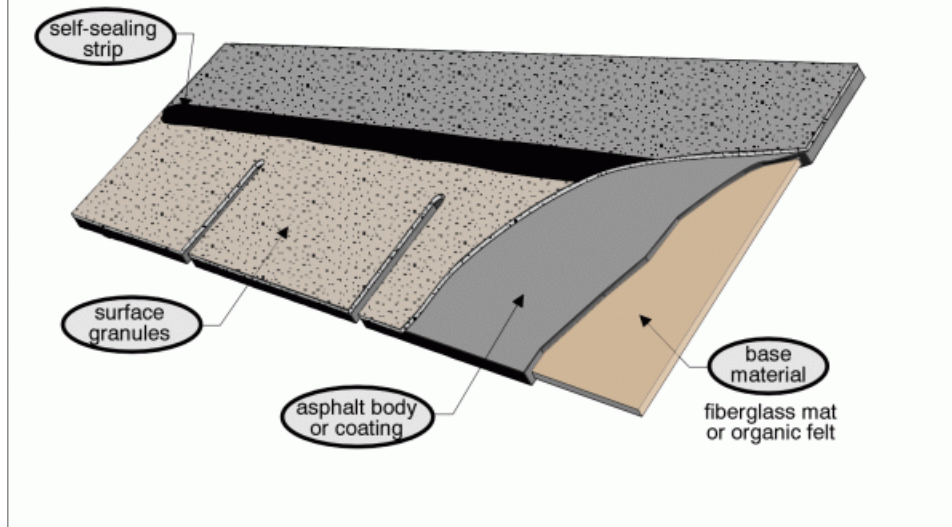
Condition: • [Granule loss](#)

Typical minor granule loss consistent with roof age. The shingles were in good condition, where visible.

2. Granule loss

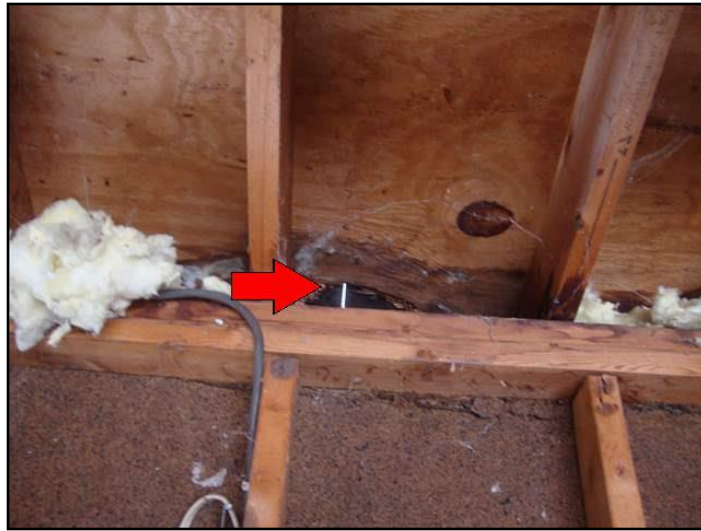
Condition: • [Overhangs too big or too small](#)

Poor exposure (overhang too small at eaves) and installation defects have resulted in rotted sheathing at the eaves.

5. Overhangs too big or too small

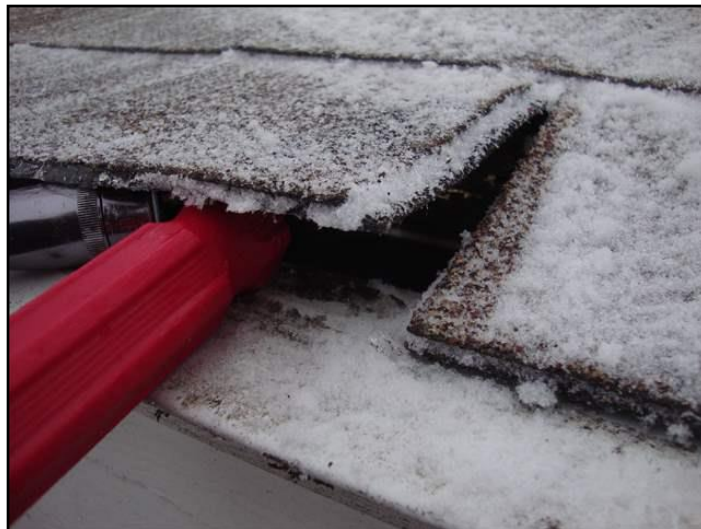
Condition: • [Multiple layers](#)

Two layers on garage or improper installation of starter course with keyways aligned with shingles.

6. Multiple layers

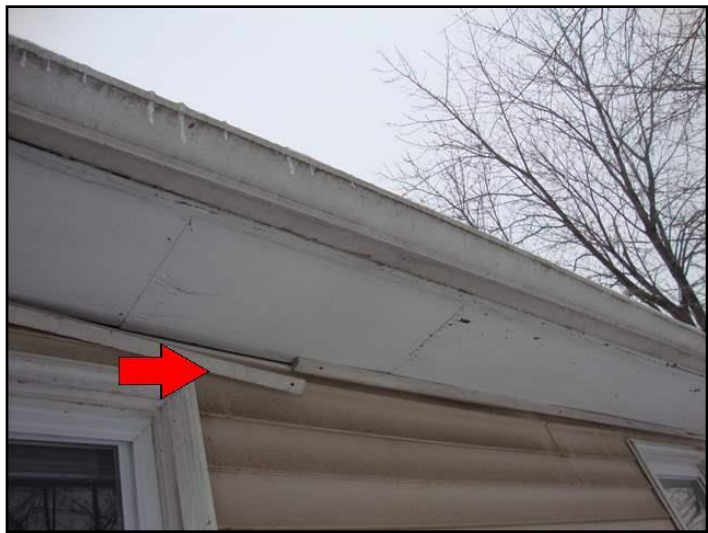
12. Loose or missing pieces

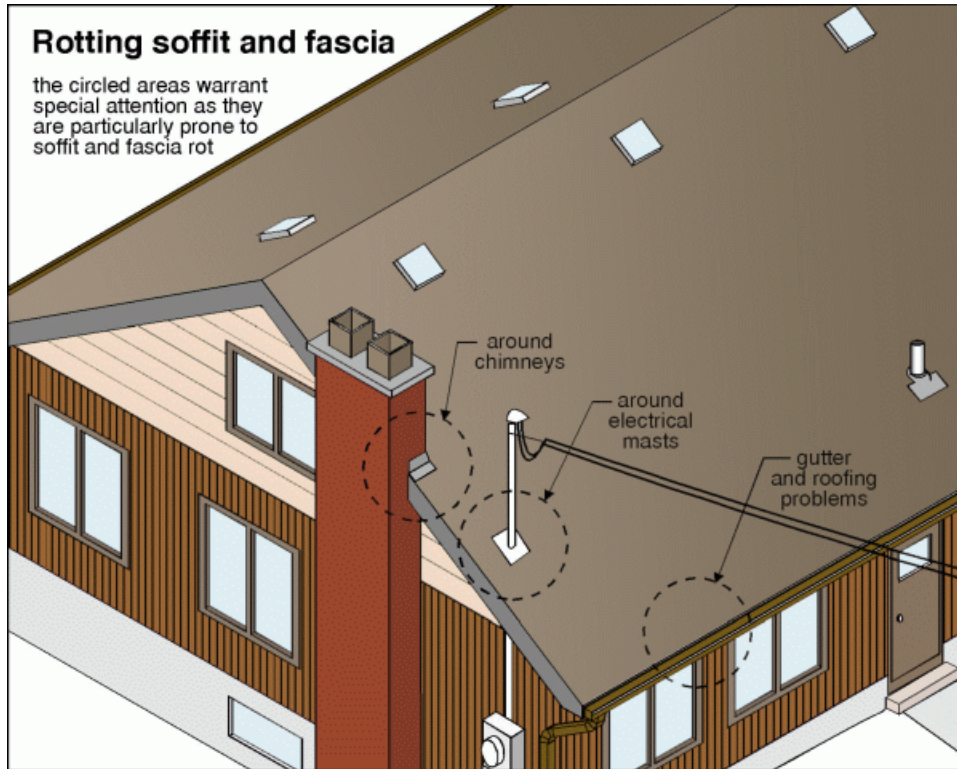
13. Paint or stain needed

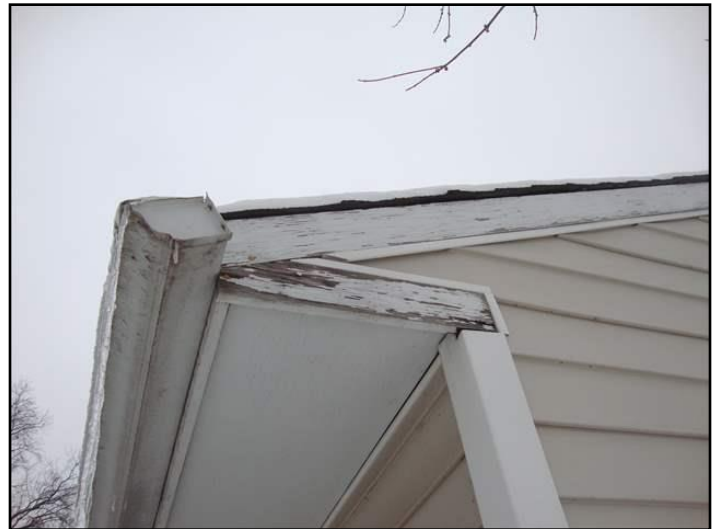
14. Paint or stain needed

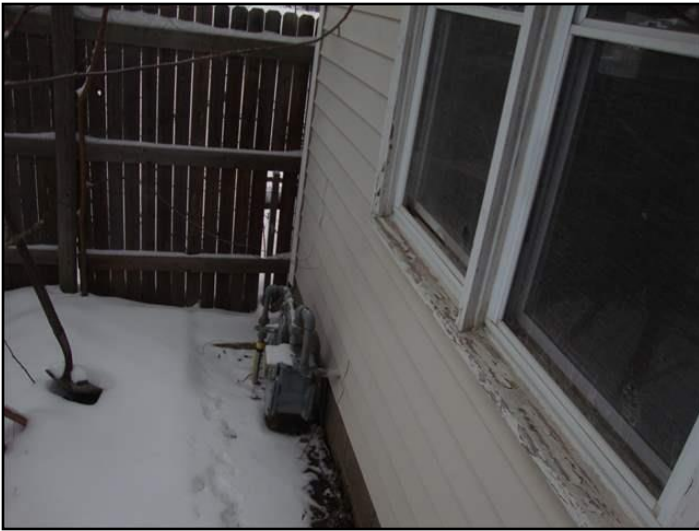
15. *Paint or stain needed*

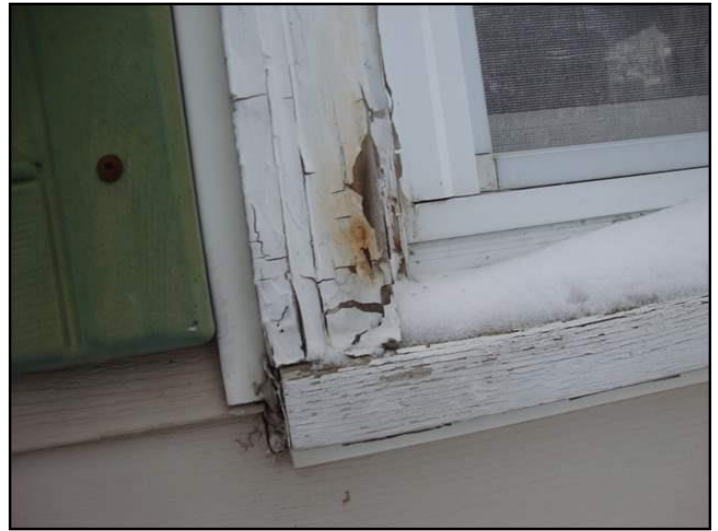
16. *Paint or stain needed*

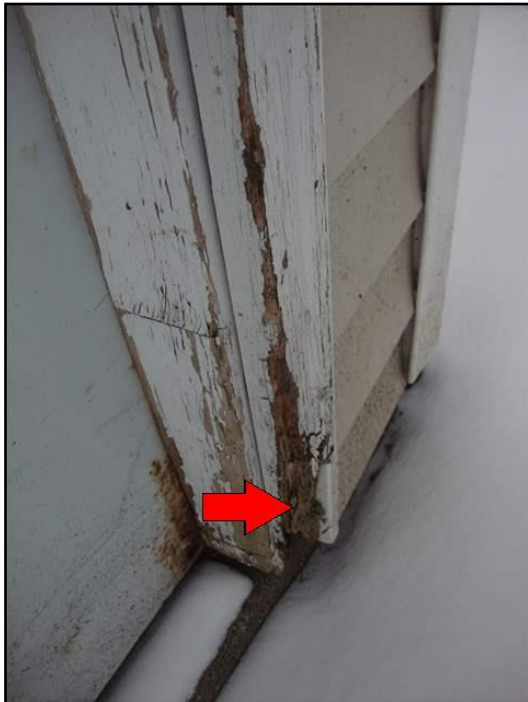
17. *Rot*

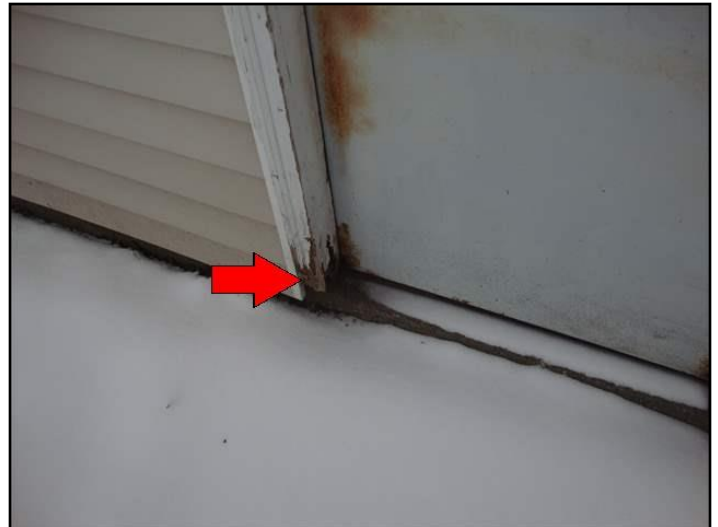
18. *Rot*

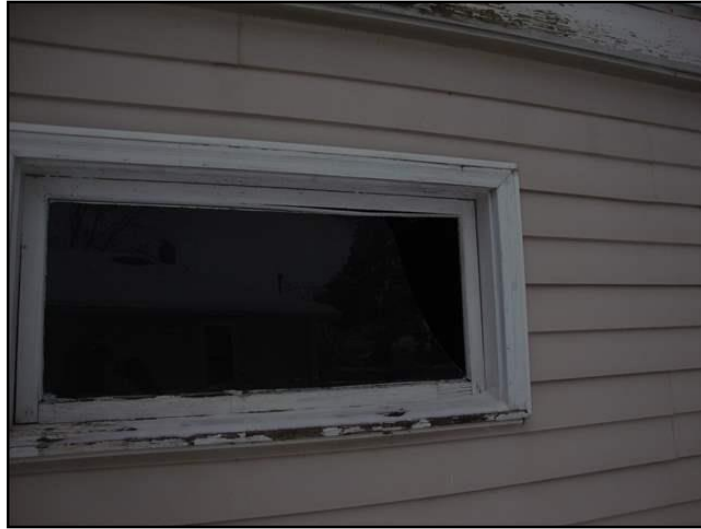
22. Broken

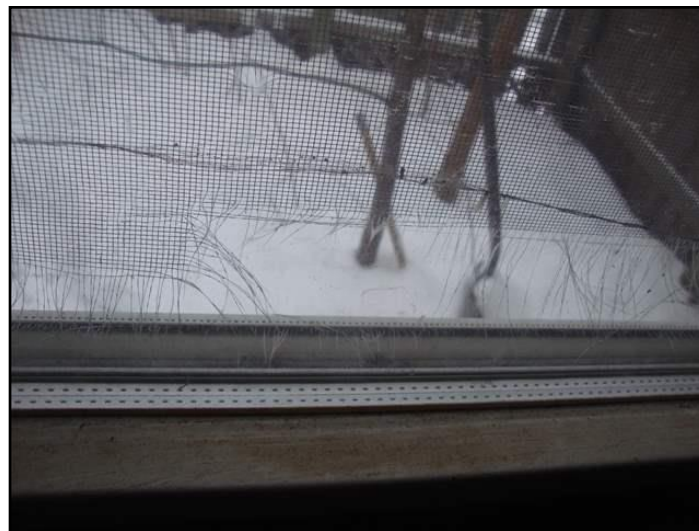
25. Torn or holes

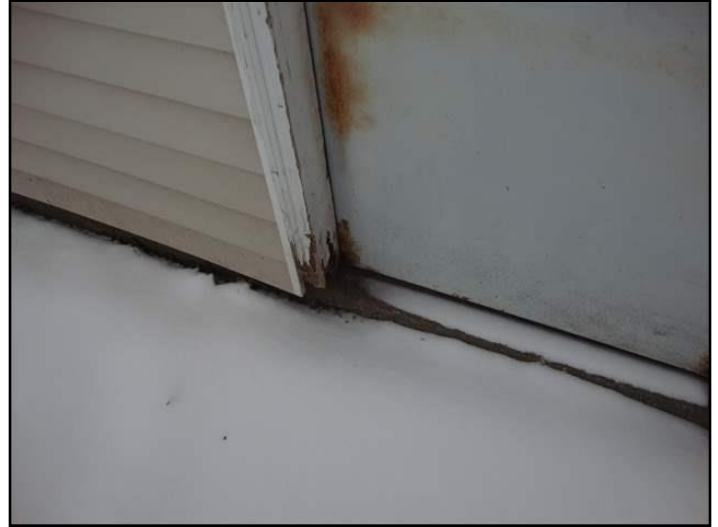
27. Rust

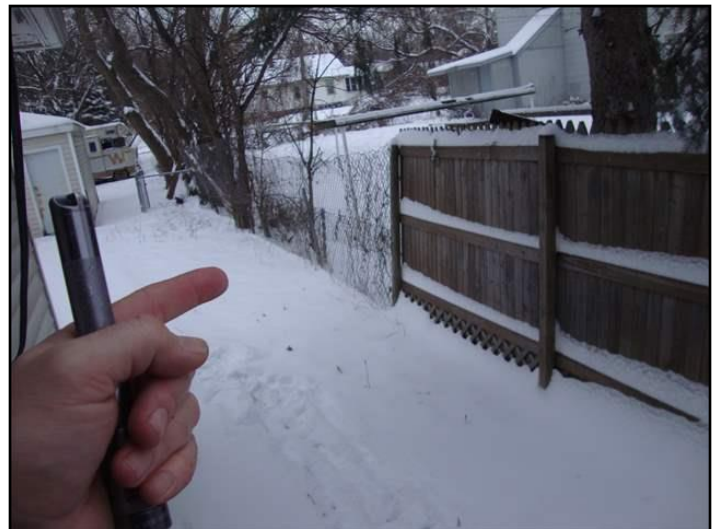
31. Damage

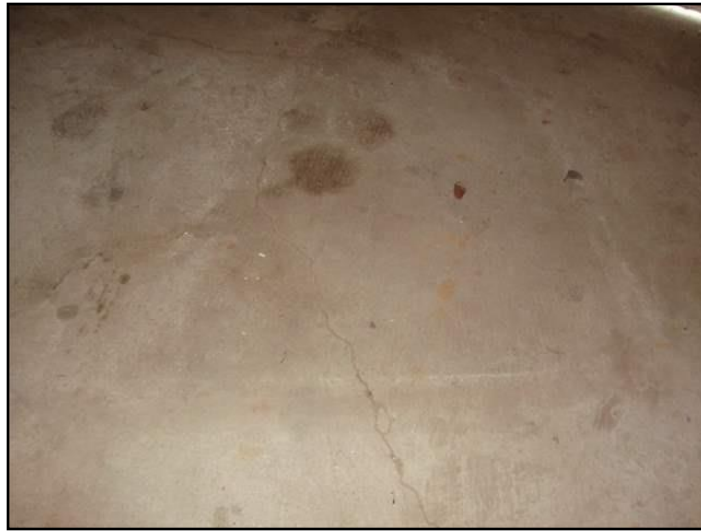
Condition: • [Cracked](#)

Typical cracks and/or chips in the surface. The concrete floor is serviceable.

32. Cracked

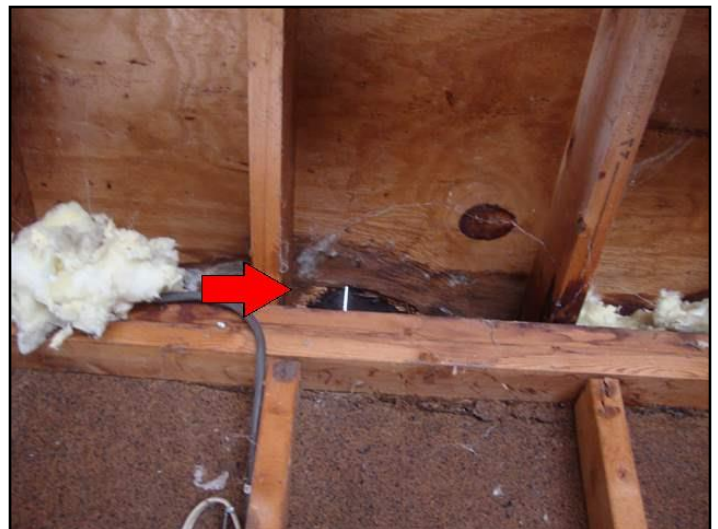
41. Rot

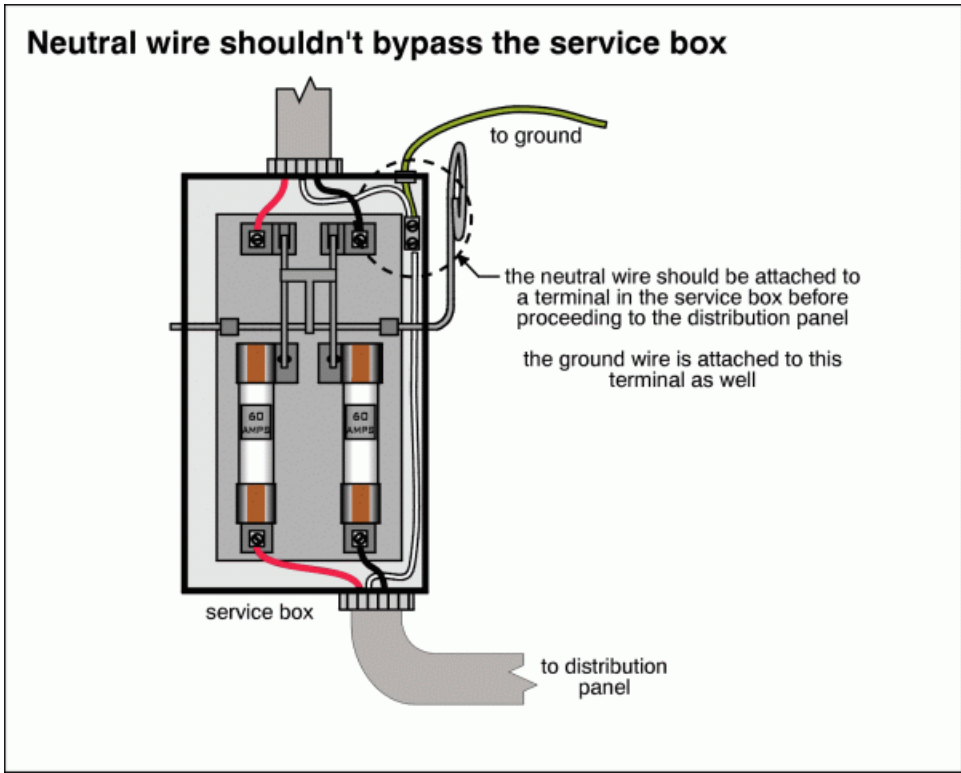
Condition: • [Neutral bonded to ground downstream of box](#)

43. Neutral bonded to ground downstream of box

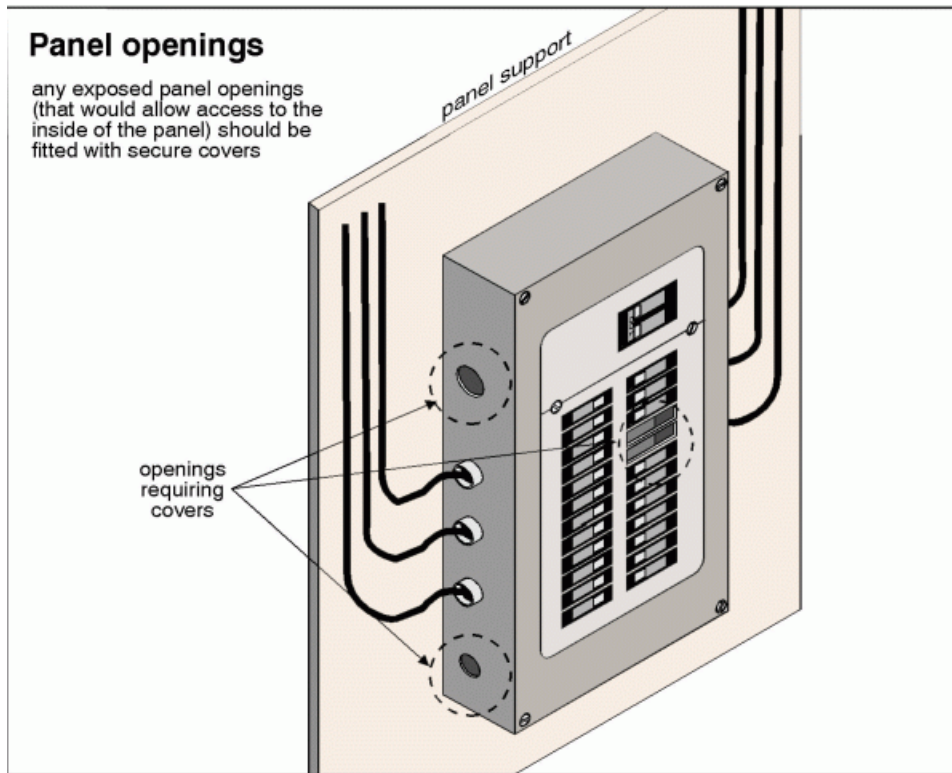
Condition: • [Openings in panel](#)

44. Openings in panel

Provide blanks for missing breakers. Simple inexpensive repair. Available at most home improvement stores.

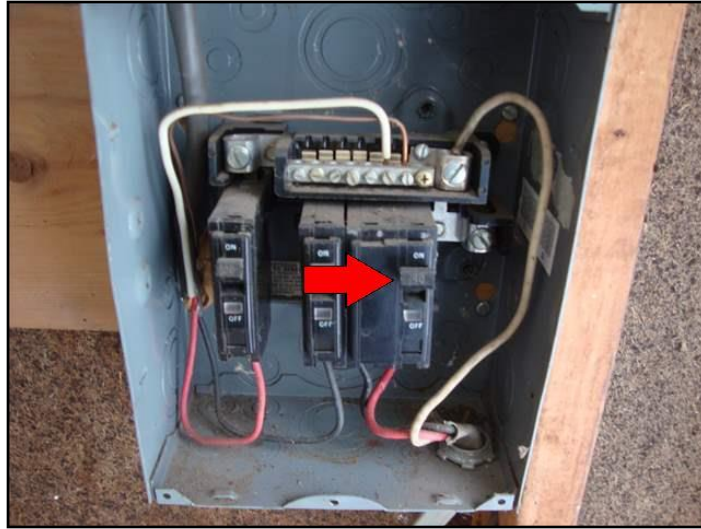
Condition: • [Fuses or breakers too big](#)

46. Fuses or breakers too big

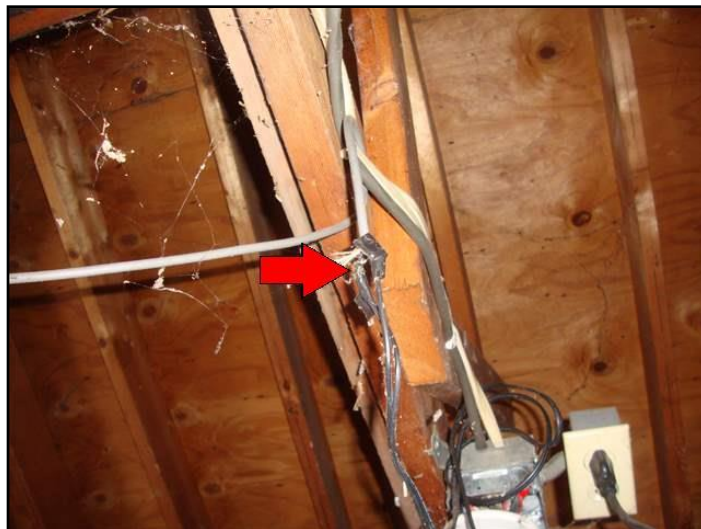
Condition: • [Open splices](#)

Spliced lamp cord wiring is a potential fire hazard

48. Open splices

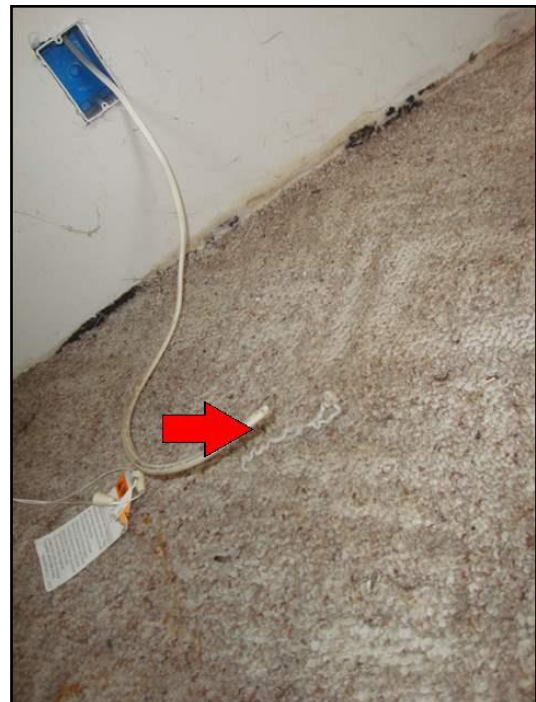
Condition: • [Abandoned wire](#)

51. *Abandoned wire*

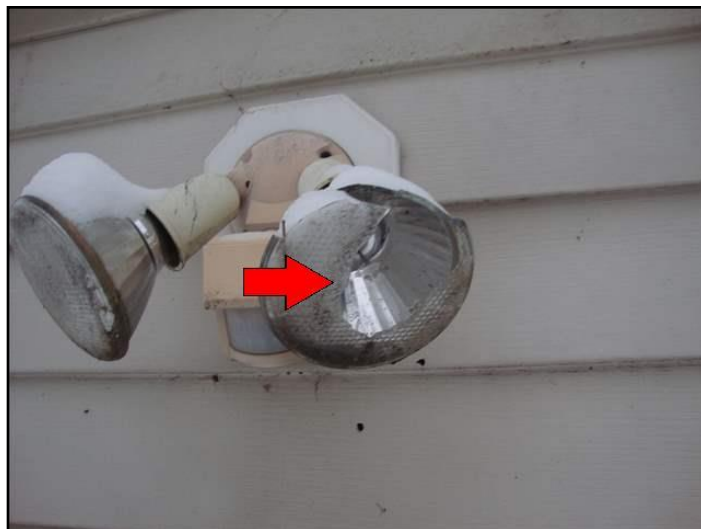
Condition: • [Inoperative](#)

55. *Inoperative*

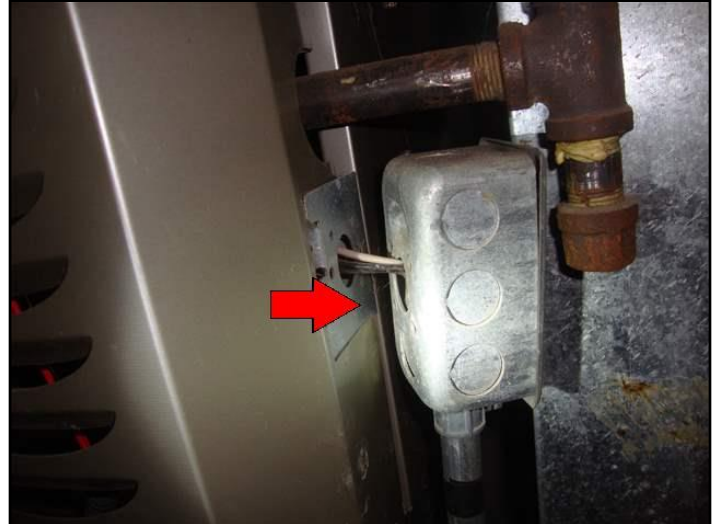
59. Loose

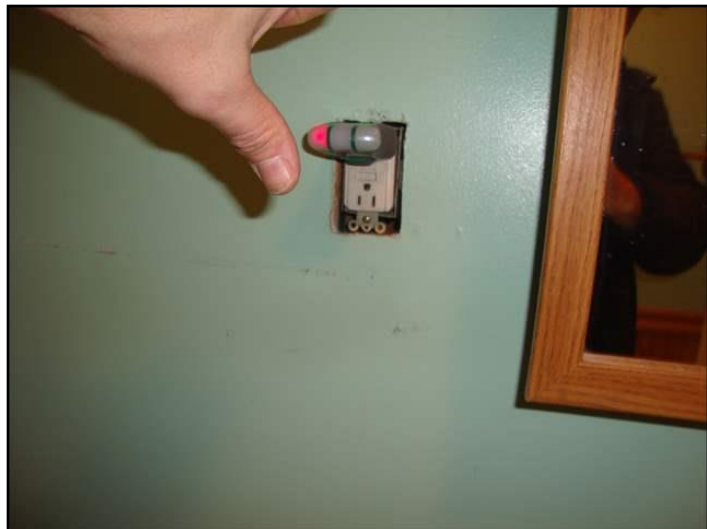
60. *Ground Fault Circuit Interrupter (GFCI)...*

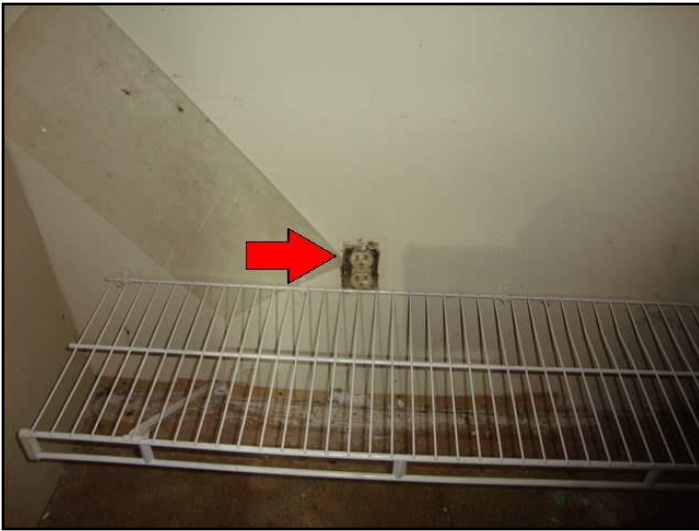
61. Missing

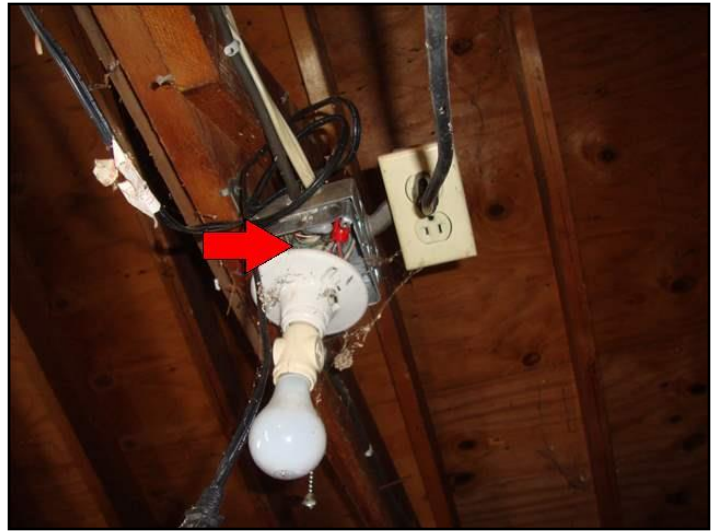
62. Missing

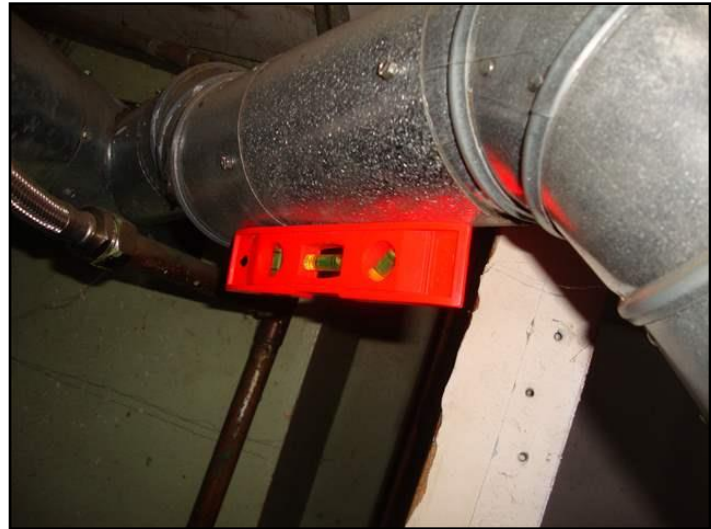
65. Poor slope

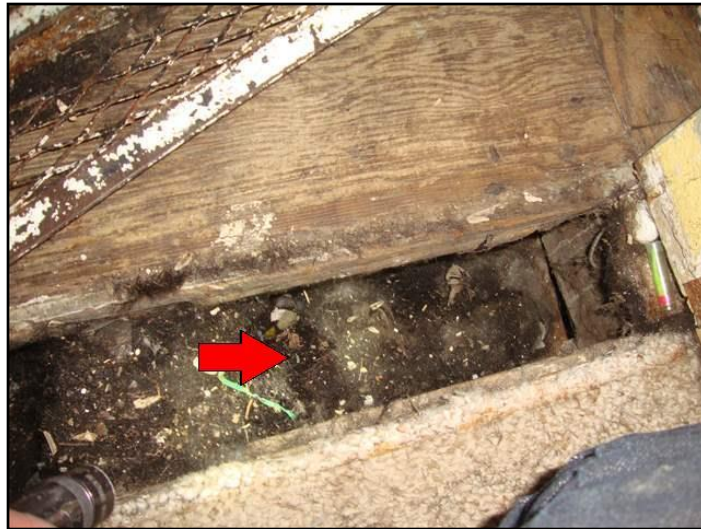
67. Dirty, obstructed or collapsed

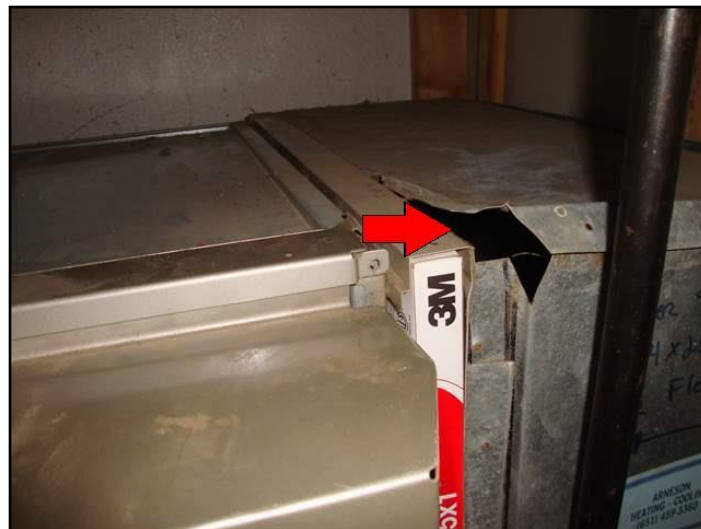
69. *Leaky joints*

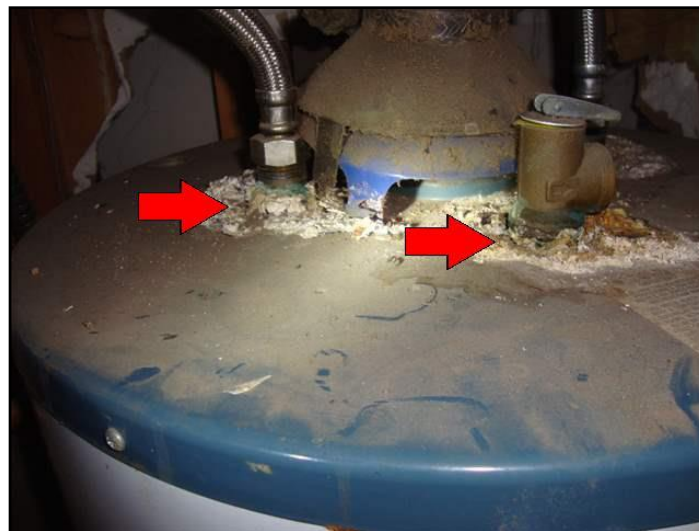
78. Rust

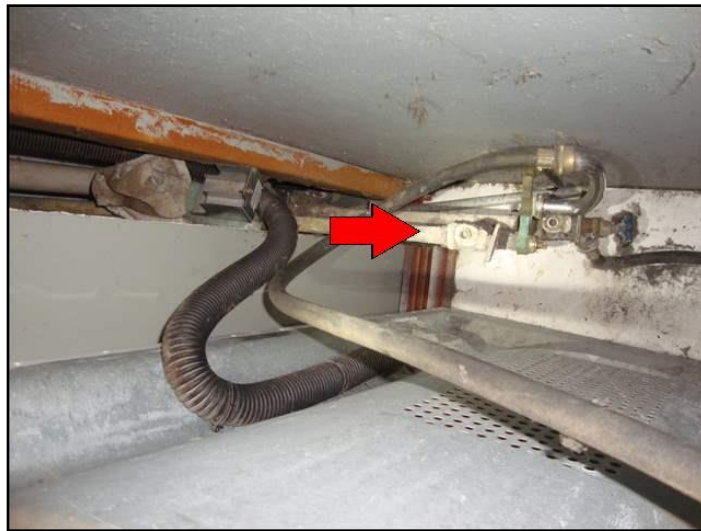
79. Galvanized steel

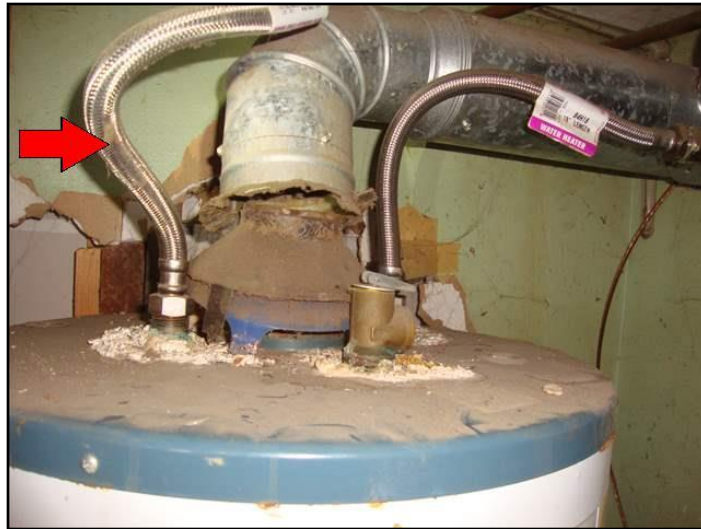
80. *Non-standard material*

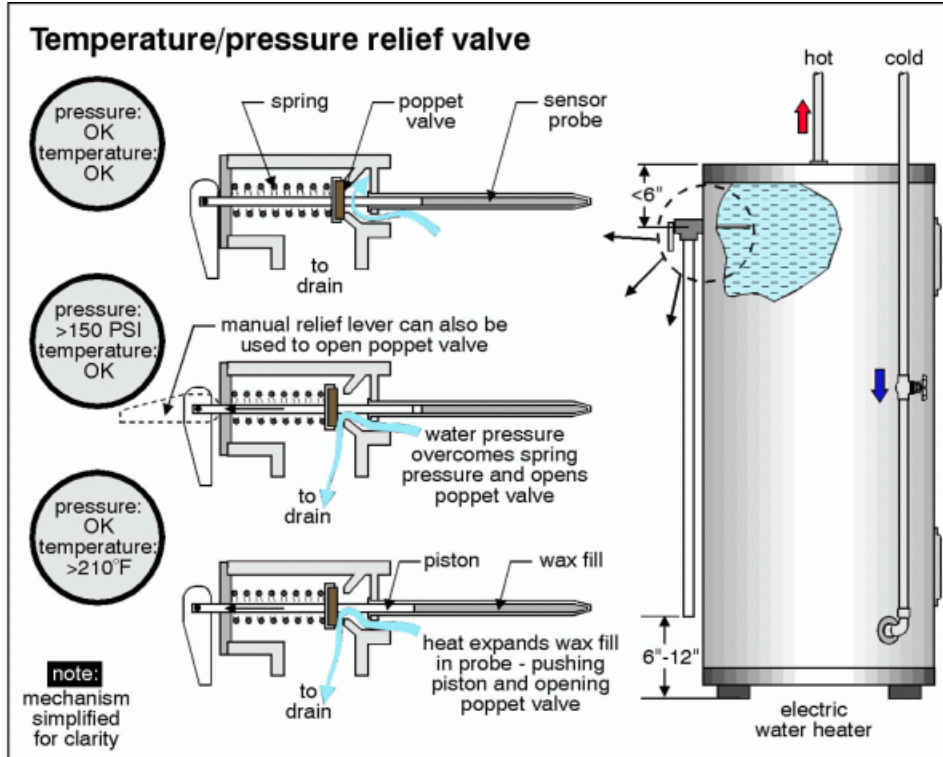
82. Discharge tube missing

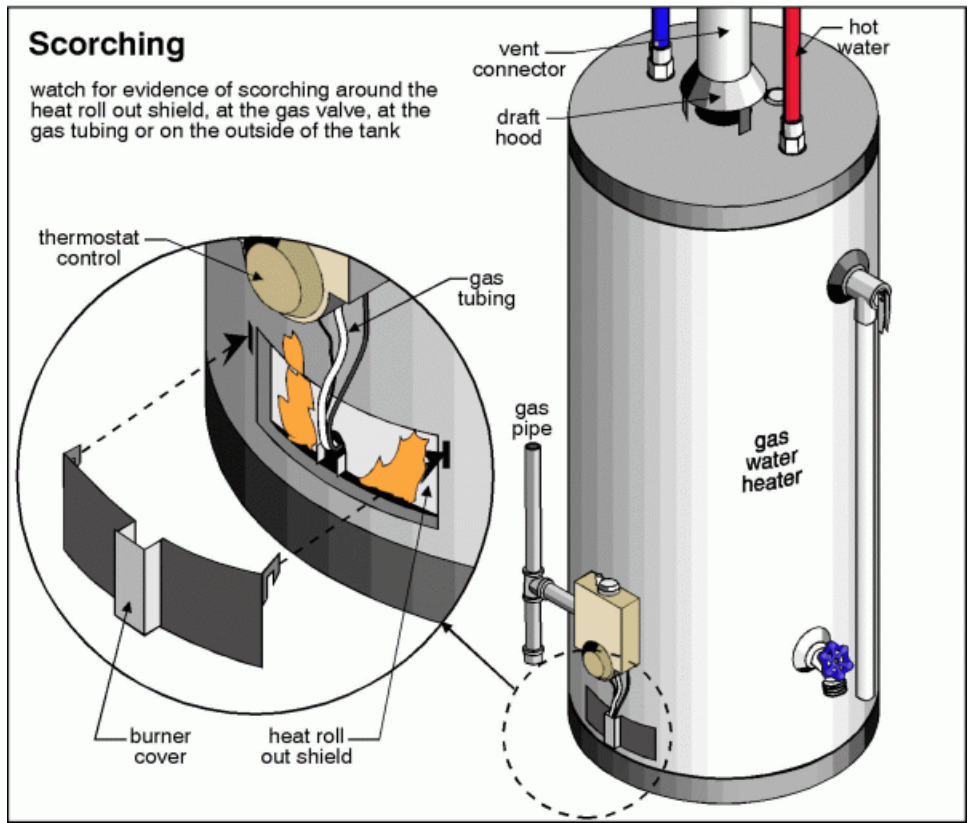
84. Scorching

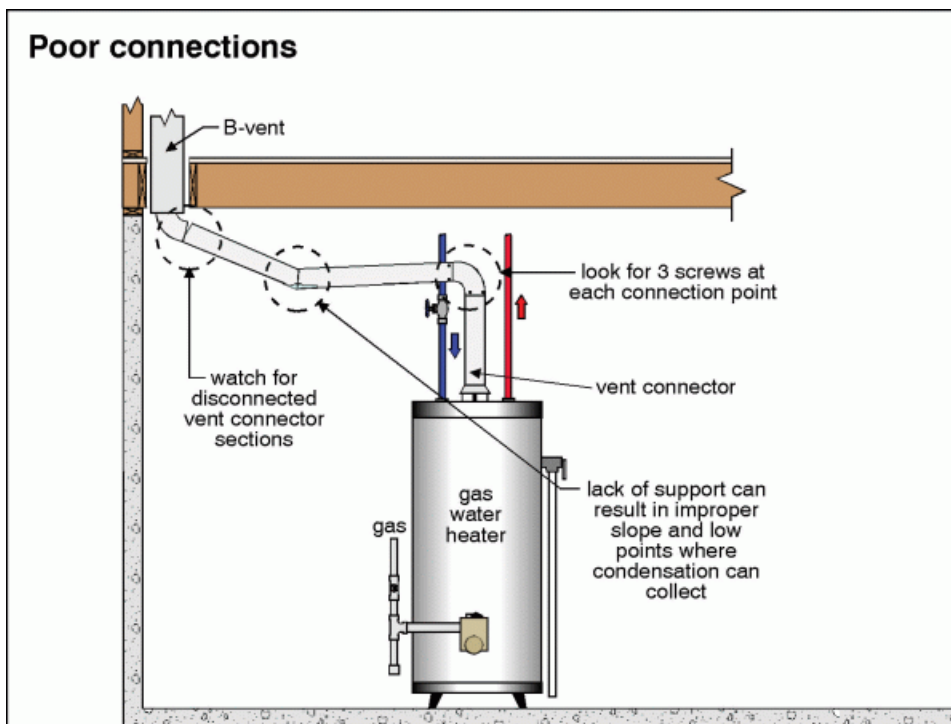
85. Poor connections

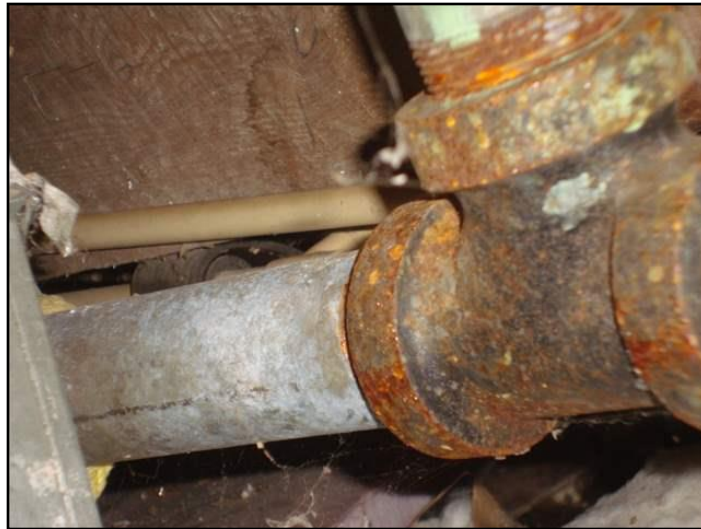
87. *Rust*

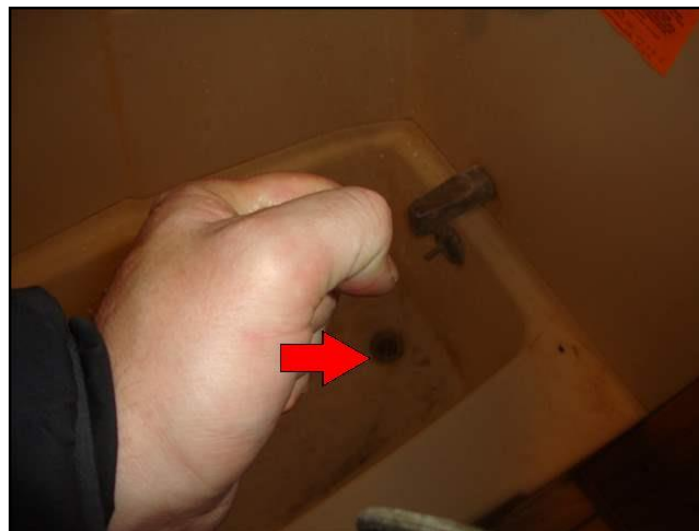
93. Slow drain

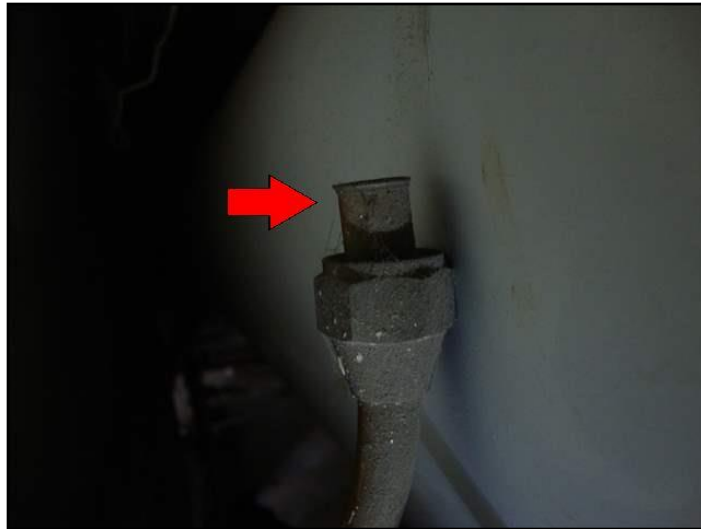
94. *Improper connections*

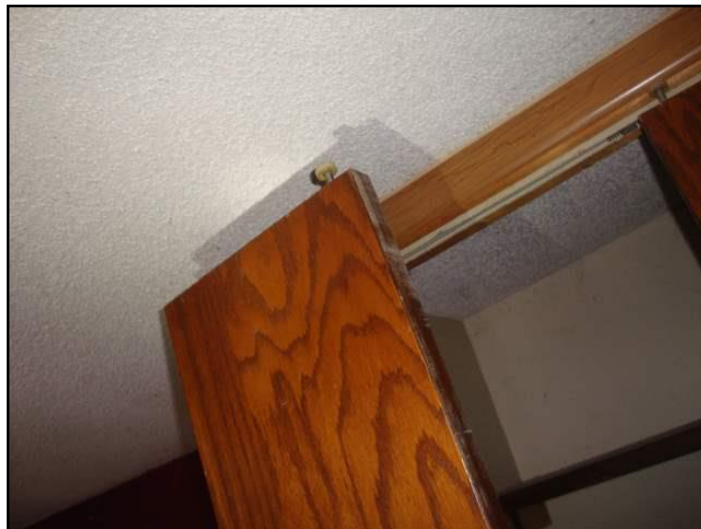
104. Damage

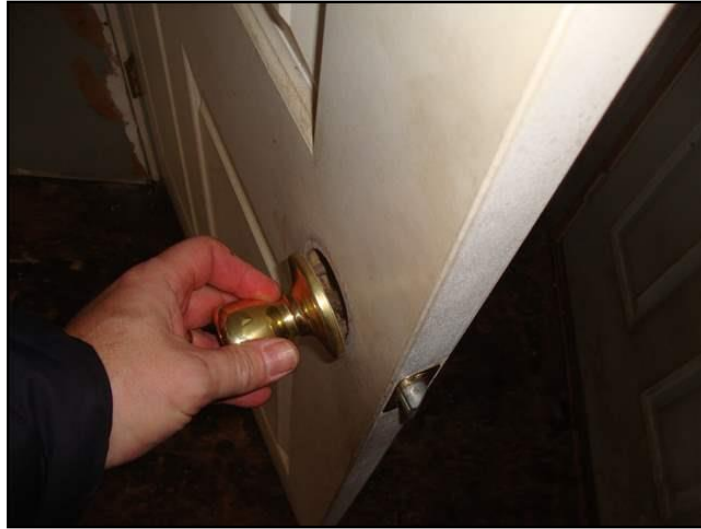
108. Loose

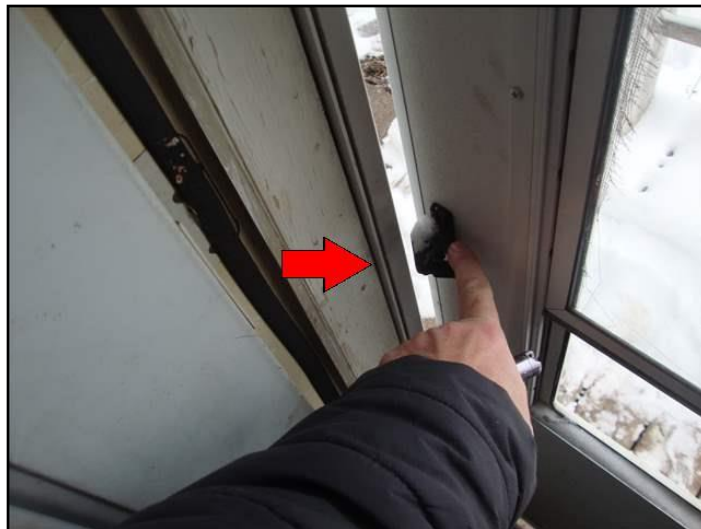
109. Latch not effective on exterior door
