Home Inspection Report

123 Main Street, Pensacola, AL 32506

Tuesday, May 14, 2019

2800

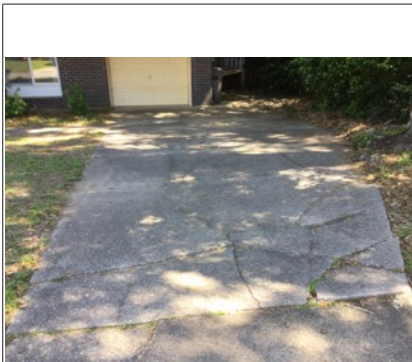
DRIVEWAY
Driveway has large settling cracks and upheaval from tree roots. Recommend repair as needed

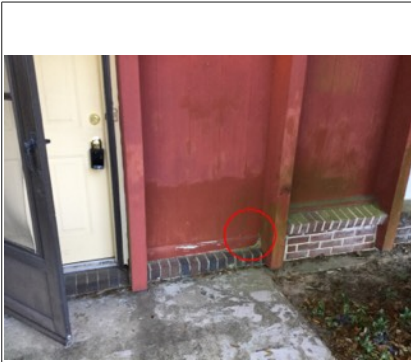
Wood rot on base of wood siding adjacent to front porch

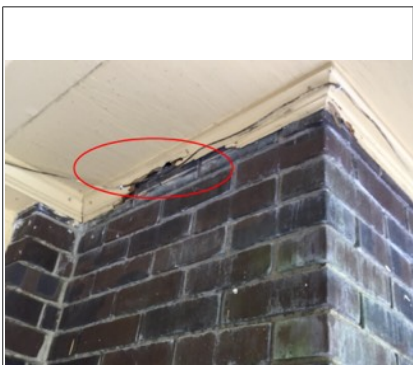
CHIMNEY
Wood rot on wood trim adjacent to chimney. Recommend consulting a Roofer for evaluation / repair. see photo

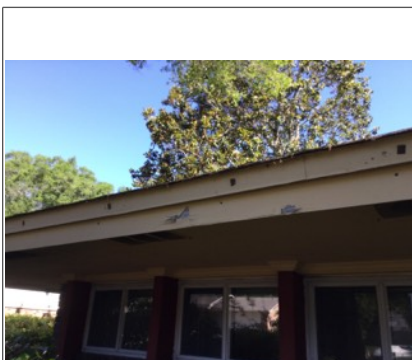
5. Fascia on North West corner is rotted. Recommend repair

Fascia has wood rot on North West corner of roof

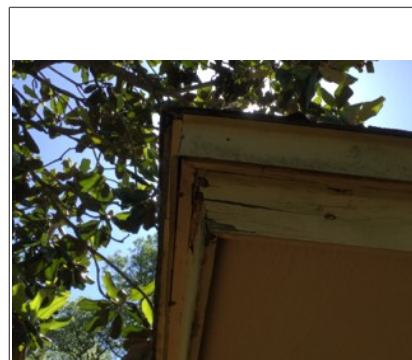
6. Fascia on South West corner is rotted. Recommend repair

Wood rot on Fascia on South West corner

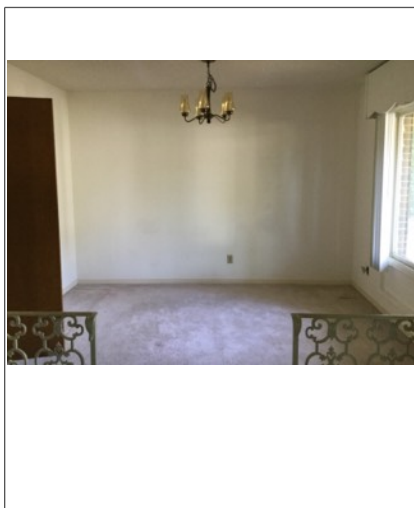
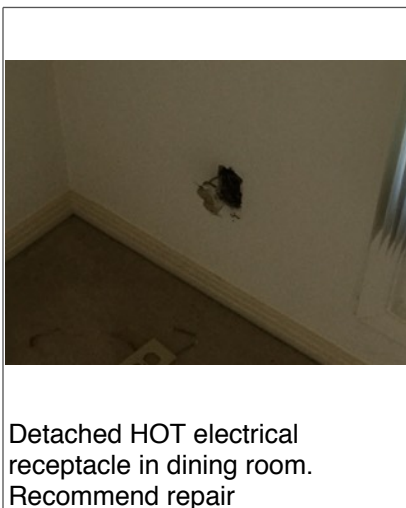
1. Electrical receptacle on south wall of Dining room is detached from wall and HOT. Recommend consulting a licensed electrician for evaluation / repair. see photo

Electrical receptacle on south wall of Dining room is detached from wall and HOT. Recommend consulting a licensed electrician for evaluation / repair. see photo

Detached HOT electrical receptacle in dining room. Recommend repair

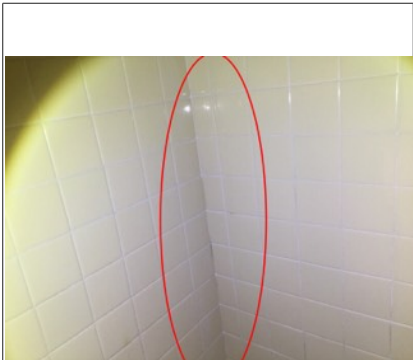
Recommend caulk/ grout as needed

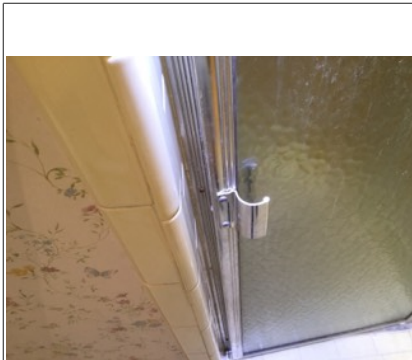
Comments MASTER BATHROOM
 Master shower door does not close properly. Recommend repair see photo

Master shower door needs repair

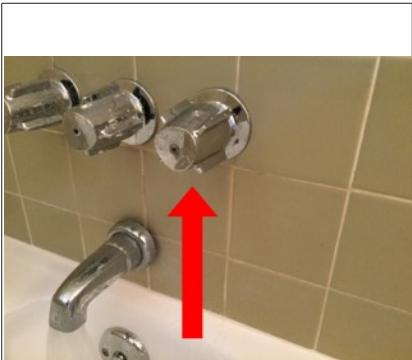
Comments HALL BATHROOM
 Water leaks from Cold water knob in tub. Recommend consulting a licensed plumber for evaluation / repair.
 see photo.

Water leaks from cold water handle during operation. Recommend consulting a licensed plumber for evaluation / repair. see photo.

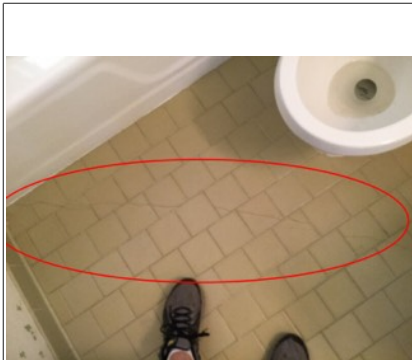
Floor tile cracked in several spots in Hall bathroom. Recommend repair

Cracked floor tile

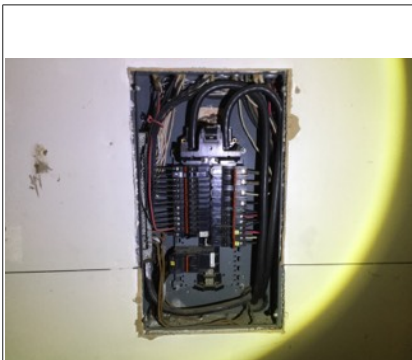
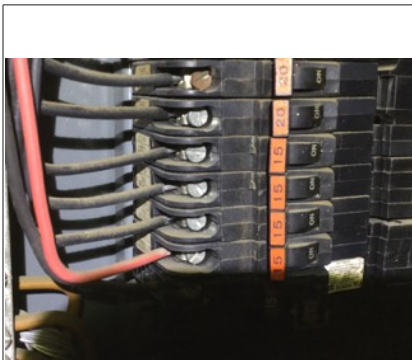
Comments MAIN ELECTRICAL PANEL
 Wiring in main electrical panel is solid Branch wiring. Recommend repair. SAFETY HAZARD

MAIN ELECTRICAL PANEL
 Wiring in main electrical panel is solid Branch wiring. Recommend repair. SAFETY HAZARD

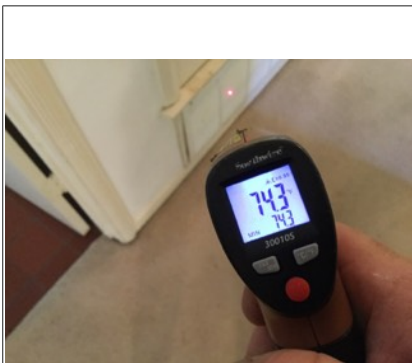
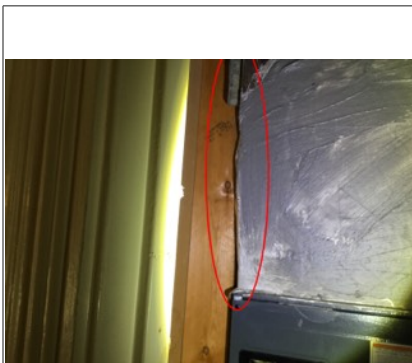
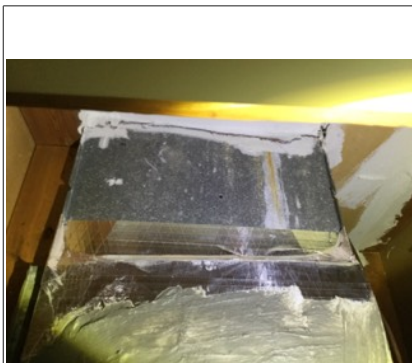
Cold air leaks from detaching duct tape on plenum. Recommend consulting a licensed HVAC technician for evaluation / repair. see photo
