Home Inspection Report

46578 Anywhere St., Hagerstown, MD 21740

Saturday January 28, 2017

Stine's Home Inspection Services LLC
12907 Draper Road
Clear Spring , MD 21722
(301) 667-8927
gstine5402@gmail.com

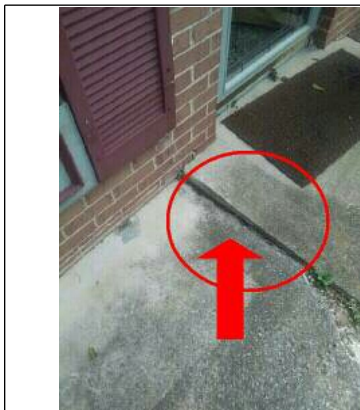
Comments Uneven slabs in walks, could be a tripping hazard, recommend repair and/or replace

Front entrance walkway trip hazard

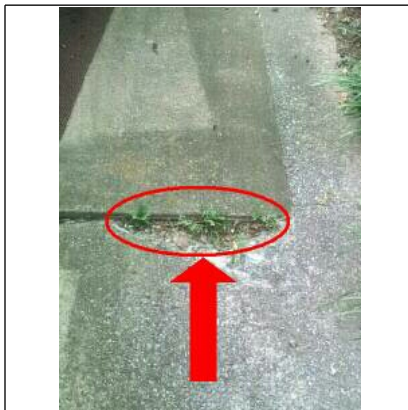
Front entrance walkway trip hazard

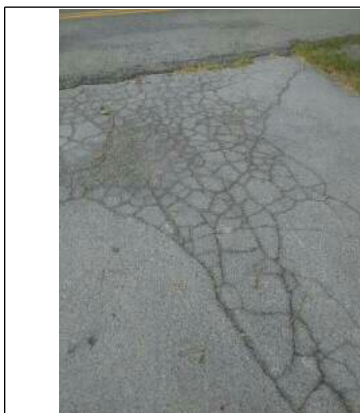
Comments Driveway had some settlement, but usable, recommend removing vegetation and sealing cracks.

Driveway cracks.

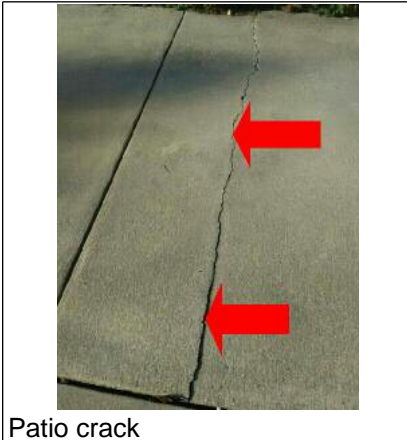
Comments Patio had some cracking and settlement, but was in usable condition. Recommend sealing cracks with a compatible sealant/caulking.

Patio crack

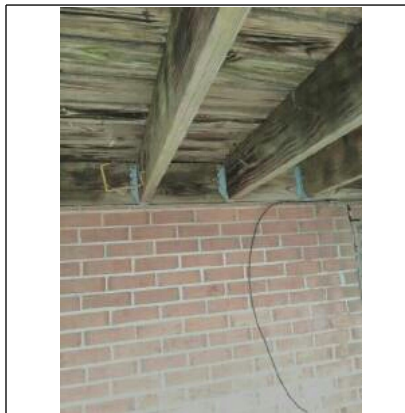
Proper construction and attachment to house

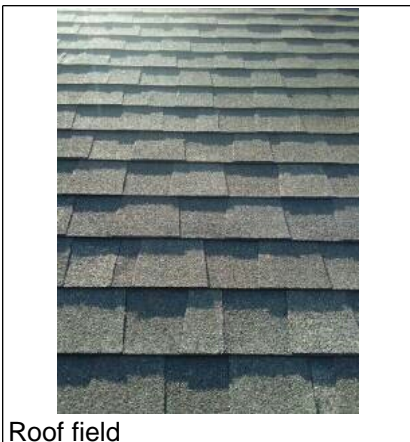
Roof field

Comments Roof appeared to be nearing end of its useful life, budget to replace soon.
Minor maintenance recommend, repair nail pops (2)

- Roof appeared to be nearing end of its useful life, budget to replace soon.
- Roof is in need of repair (loose flashing and nail pops) if imediate replacement is not done.

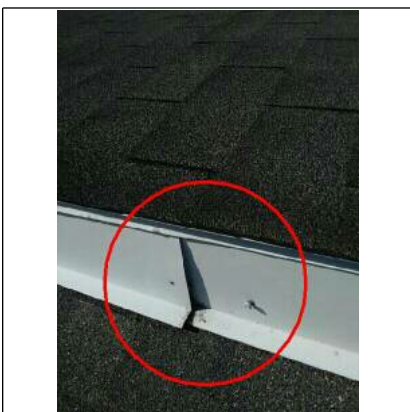
Comments flashing loose on west side of roof

Loose Flashing

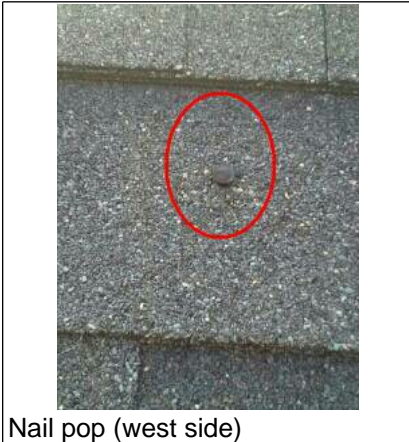
Nail pop (west side)

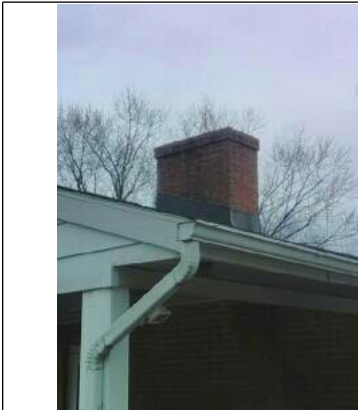
Comments Flue covered with creosote, recommend cleaning and re-evaluate by a licensed professional. Inspection was limited to the upper and lower third of the chimney.

Spark arrestor/cap recommend on chimney

Recommend installing rain cap/spark arrestor

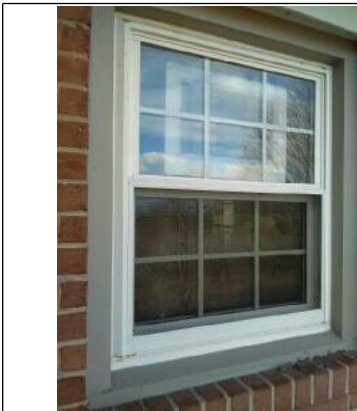
Comments newer good quality replacement windows have been installed.

Replacement windows

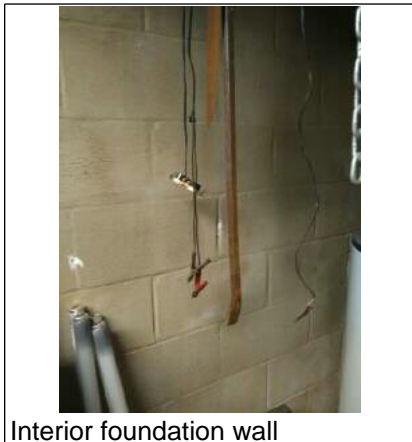
Comments Typical hairline cracks in slab.

Interior foundation wall

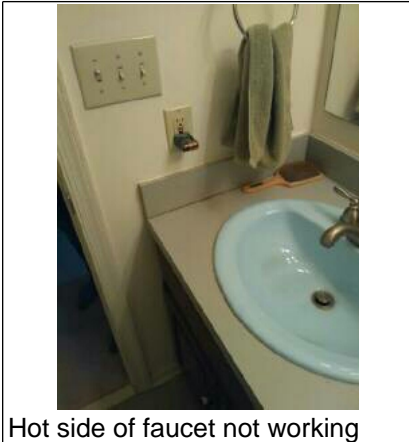
Comments hot side of basement bathroom sink was not operational. The service valve was in the off position.

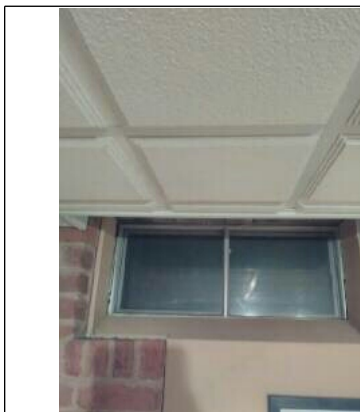
Comments The two small windows in the basement were not operational at the time of the inspection. Recommend repairs.

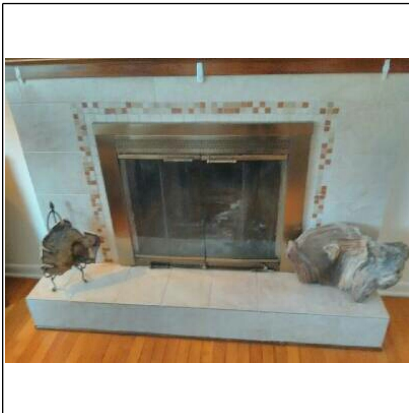
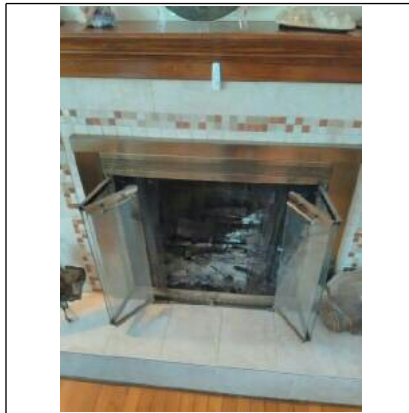
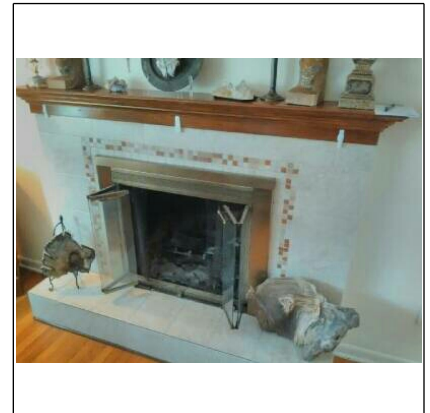
Physical condition ☒ Satisfactory ☒ Recommend having flue cleaned and re-examined

Comments lots of ashes in fireplace at time of the inspection

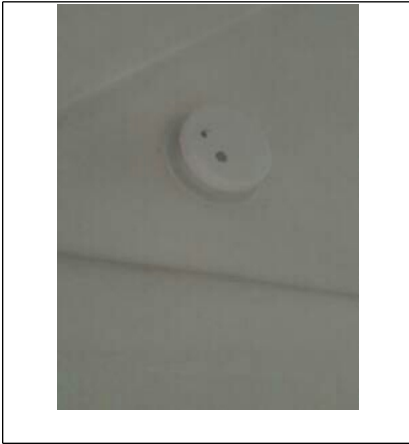
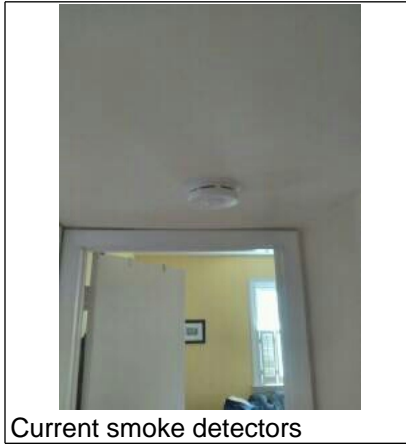
CO Detector ☒ Not Present ☒ Safety Hazard

Current smoke detectors

Comments Recommend the replacement of all smoke detectors with hard wired 10 year sealed lithium battery carbon monoxide and smoke combo's. They should be installed on every level of the home and outside each bedroom.

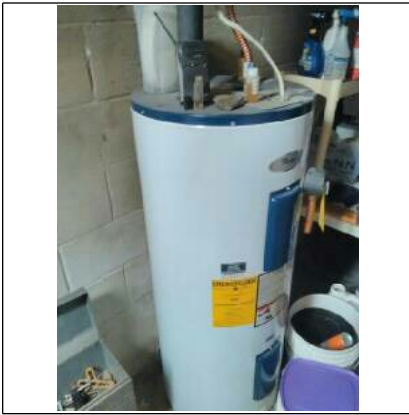
Comments -There is no expansion tank installed on water heater. Recommend the installation of a expansion tank by a licensed plumber, this will aid in the expansion of water and help protect the plumbing system from excessive water pressure.

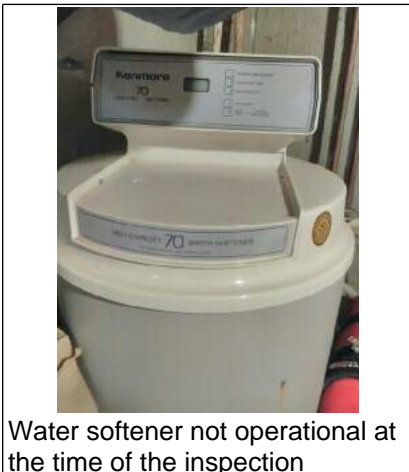
Comments Brine tank empty of water/salt. Does not appear to be in use.

Water softener not operational at the time of the inspection
