Your Inspection Report

Commercial Building Twin Cities Area, MN

INSPECTION DATE:
Monday, October 14, 2013

RE: Report No. 1124
Commercial Building
Twin Cities Area, MN

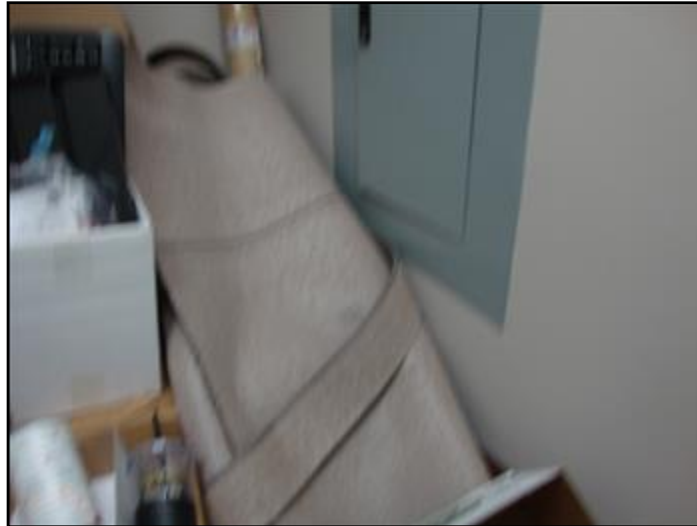
3. Condition: • Storage within one meter of electrical equipment

Storage within one meter of electrical...

Task: Improve

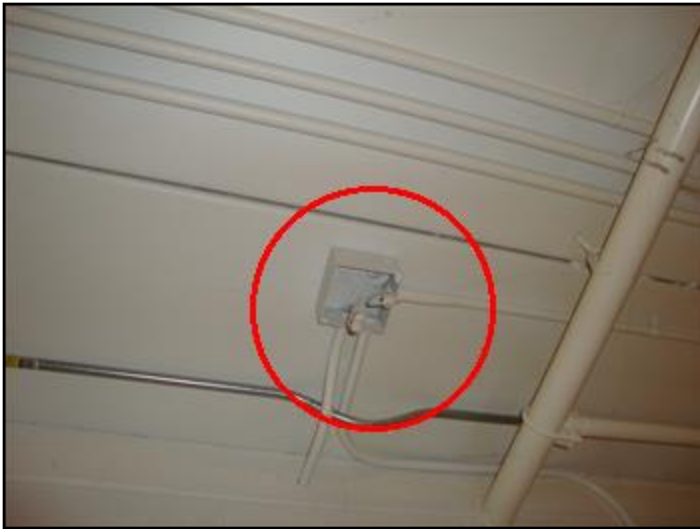
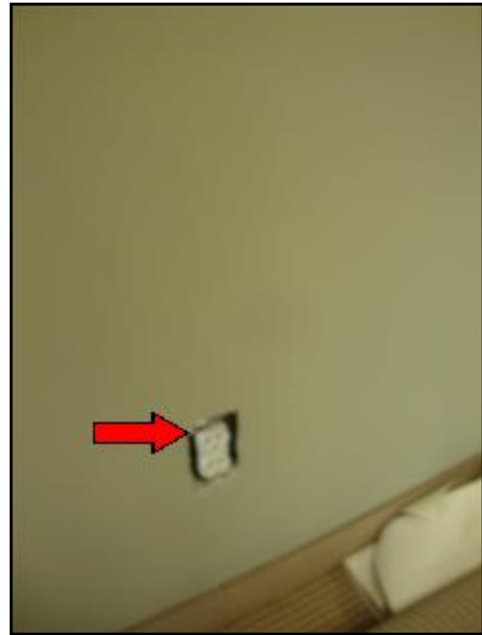
6. Condition: • Missing on switches, outlets and junction boxes

Missing on switches, outlets and junction...

Task: Repair or replace

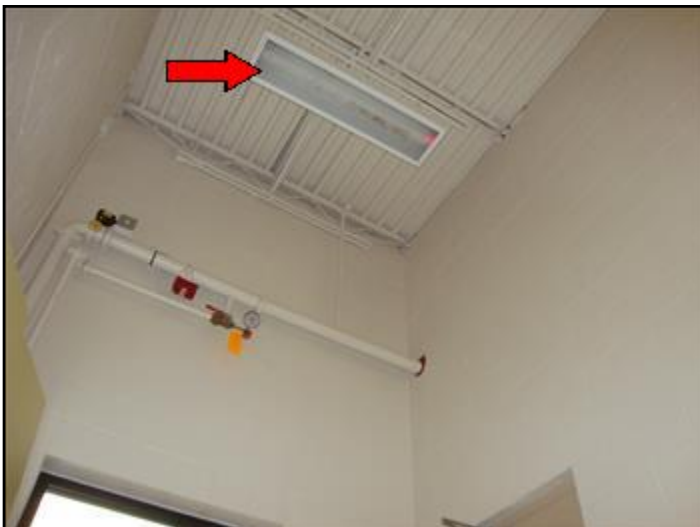
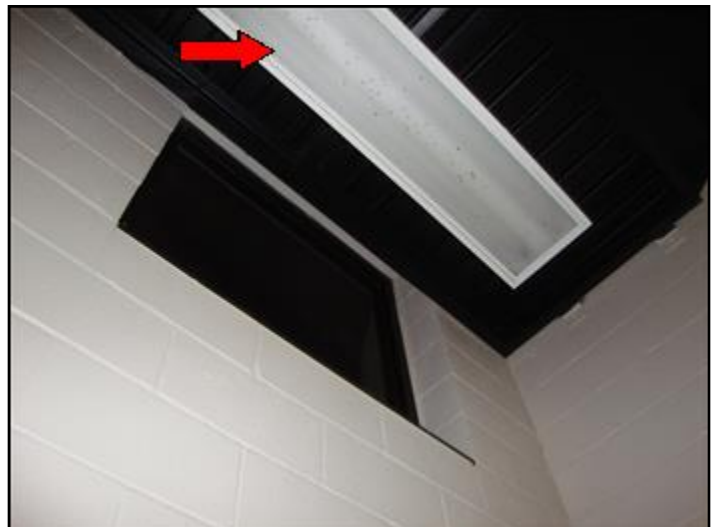
7. Condition: • Inoperative

Inoperative

Task: Repair

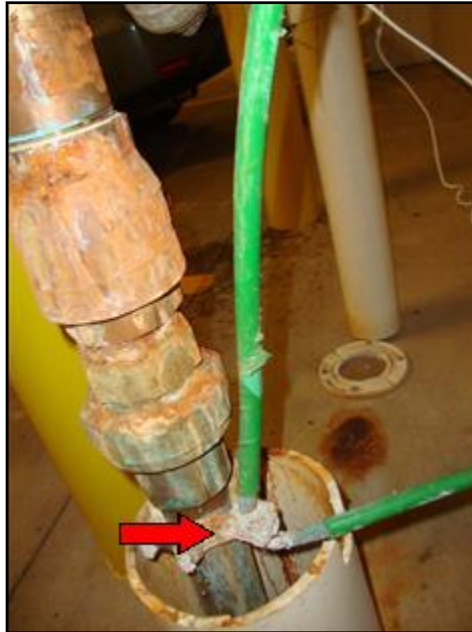
8. Condition: • Corrosion on ground wire may reduce effectiveness of ground.

Corrosion

Task: Evaluation by licensed electrician Improve

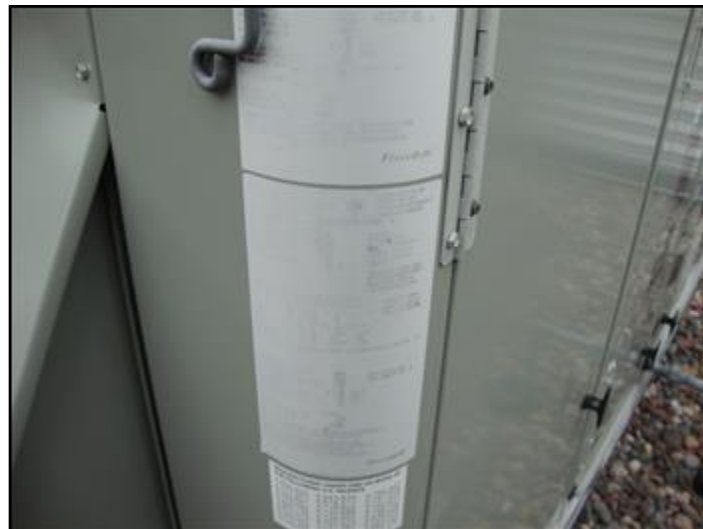
• Illegible - heating capacity and age could not be determined

Middle rooftop unit near front of building.

Illegible - heating capacity and age could...

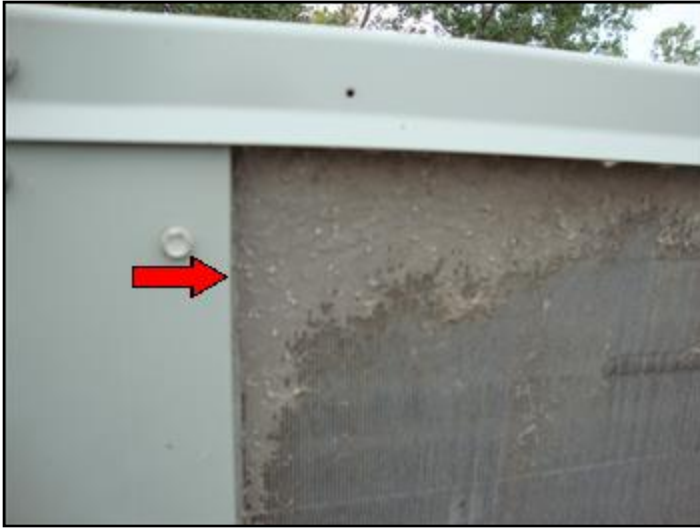
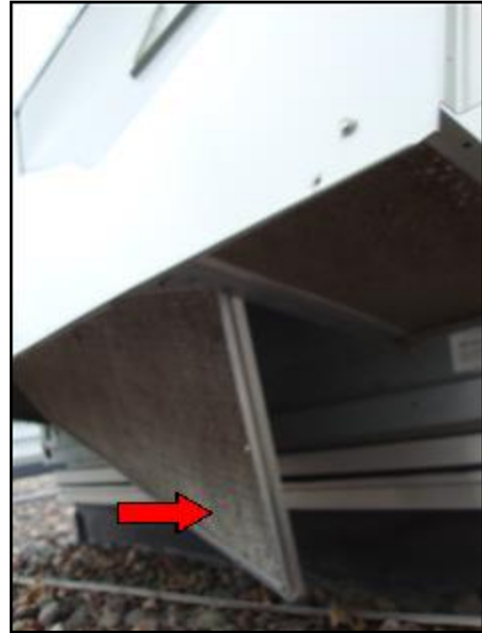
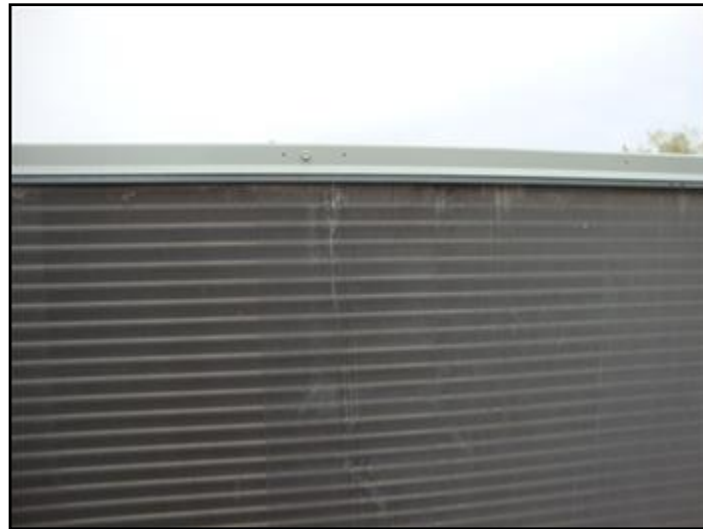
Condition: • Less than ideal

Debris in cooling fins. Loose filter screens on economizer. Minor mechanical damage noted on cooling fins.

AC Less than ideal

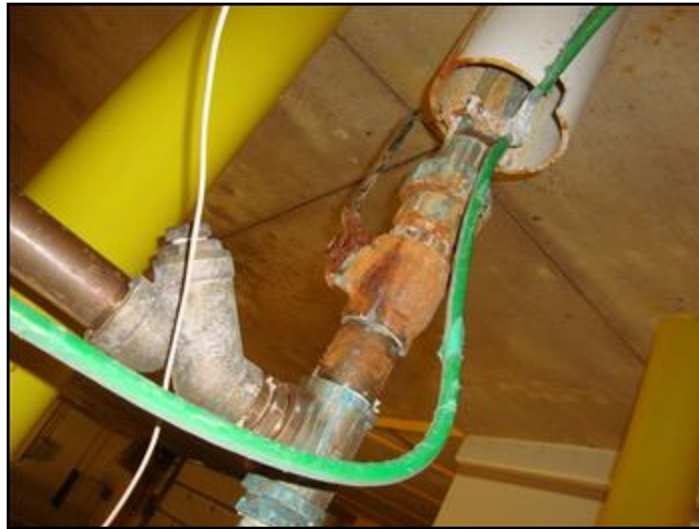
Condition: • Corrosion observed on service line and main service line valve.

Corrosion

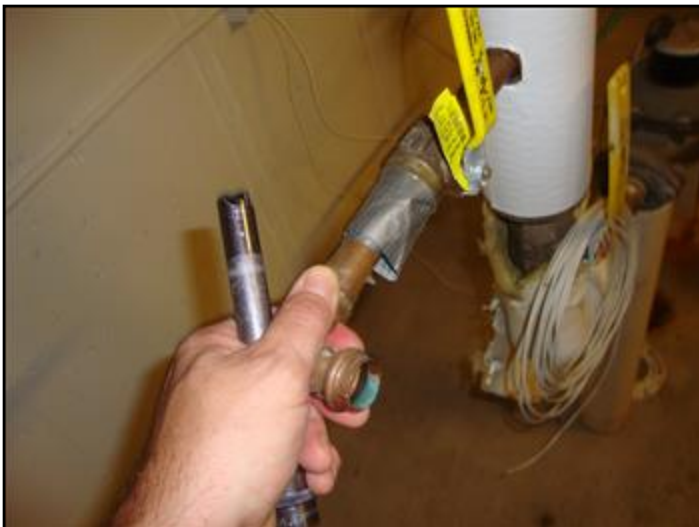
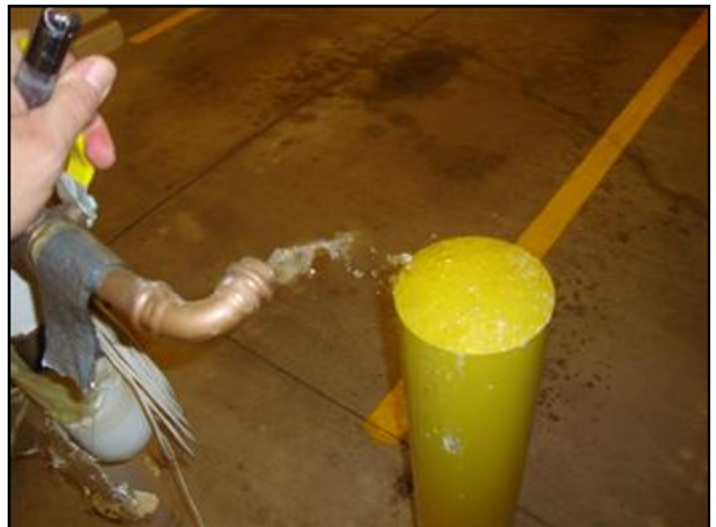
25. Condition: • Loose pipe.

Loose pipe

Task: Repair or replace

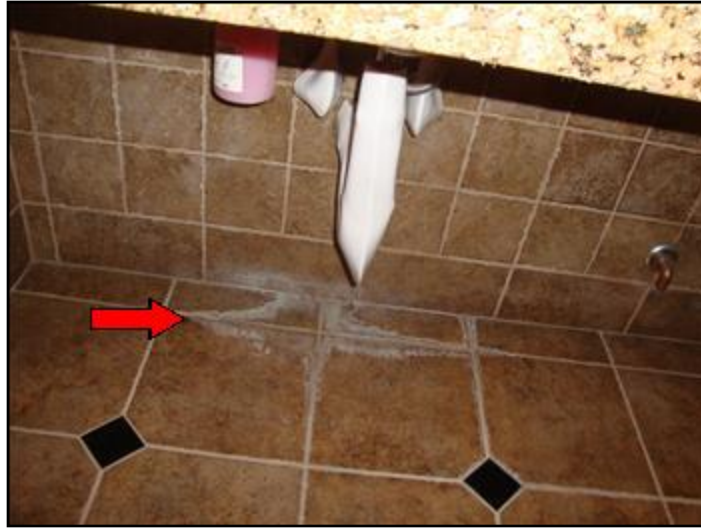
Leak or soap spill.

26. Condition: • Evidence of past leakage noted

Evidence of past leakage noted

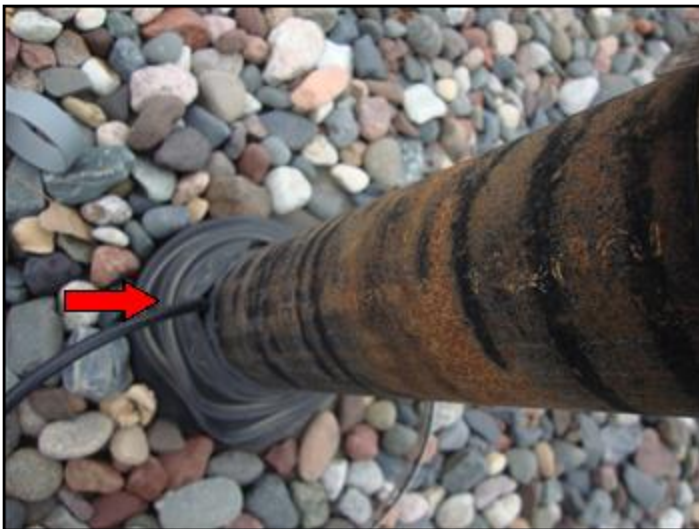
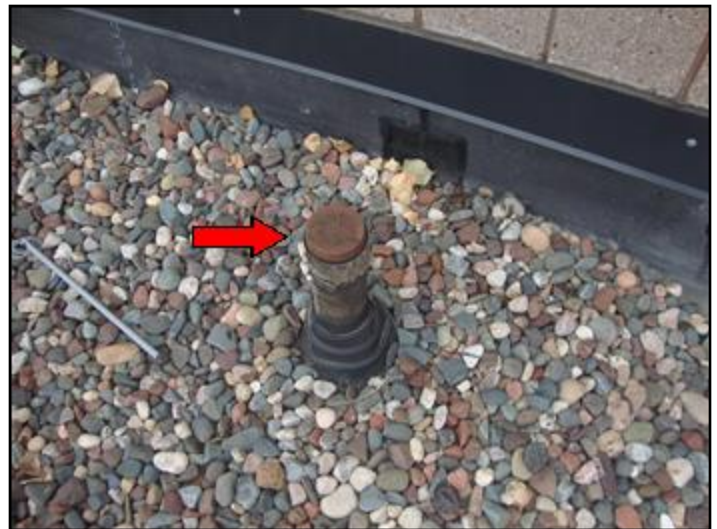
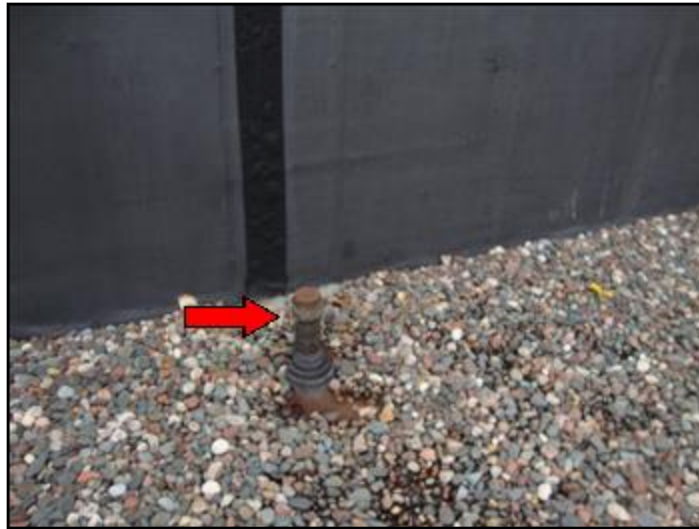
Condition: • Several apparent vents on the roof were capped. Confirm vent arrangement with building plans and consult plumber if slow or noisy drains become a problem. Two vents had coaxial cable from satellite units penetration boot seal. Void in boot has the potential for water infiltration.

Wire in boot flashing

Capped Vent?

Task: Further evaluation - Repair

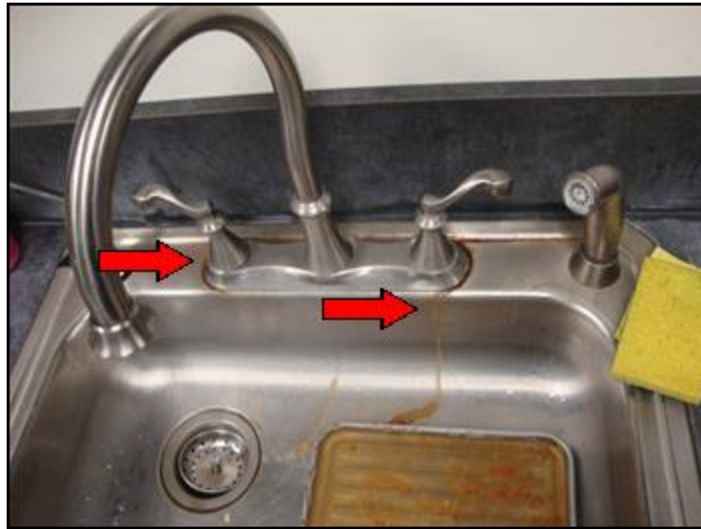
Condition: • Rust stains indicate a potential leak.

Rust stains

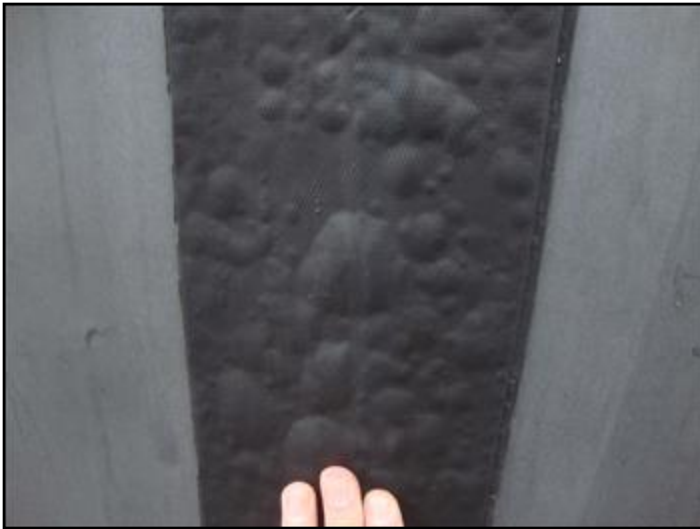
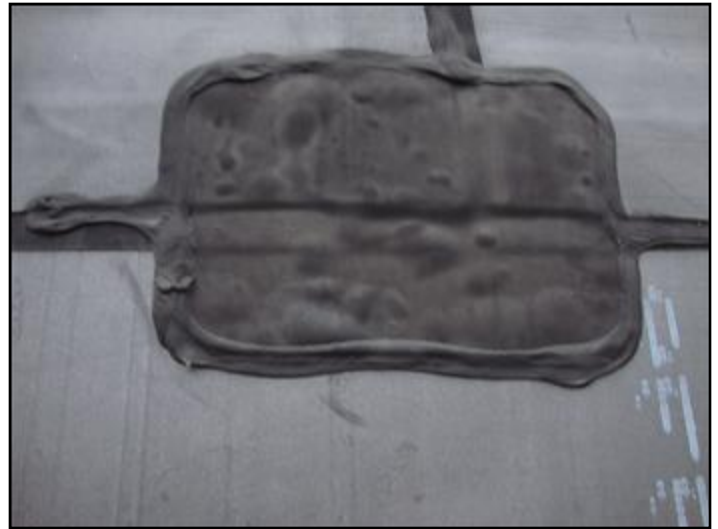
Condition: • Blistering, which occurs when air or moisture gets trapped within or below the roof assembly, and may be a function of age, building conditions, or installation quality, was noted - This increases the risk of damage and leakage

Blistering,

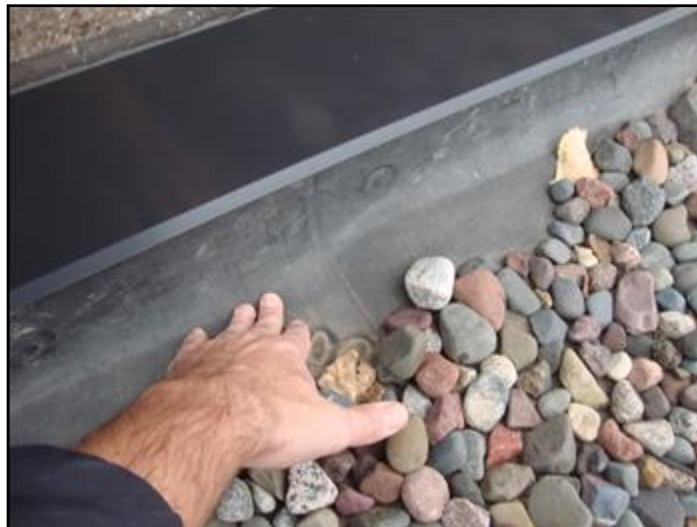
37. Condition: • Tenting noted - A symptom of age and influenced by the installation quality
Minor tenting observed at perimeter.

Tenting noted

Task: Inspect annually

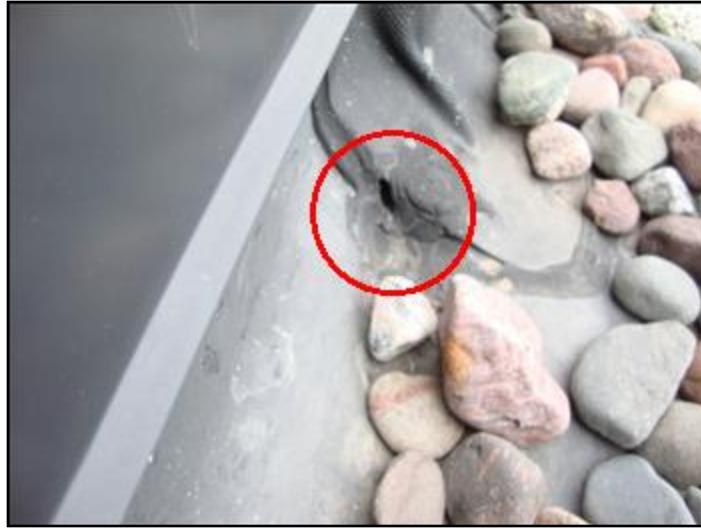
38. Condition: • Open seams at lap joints
Located directly above unit 320 and area where water stains were observed.

Open seam

Task: Repair or replace

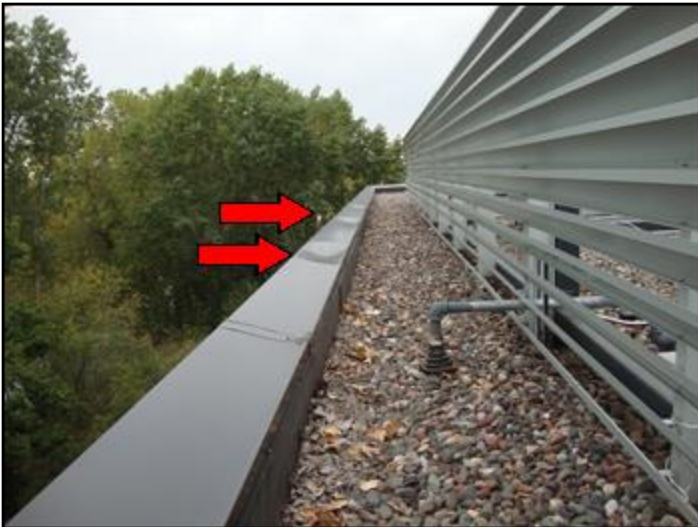
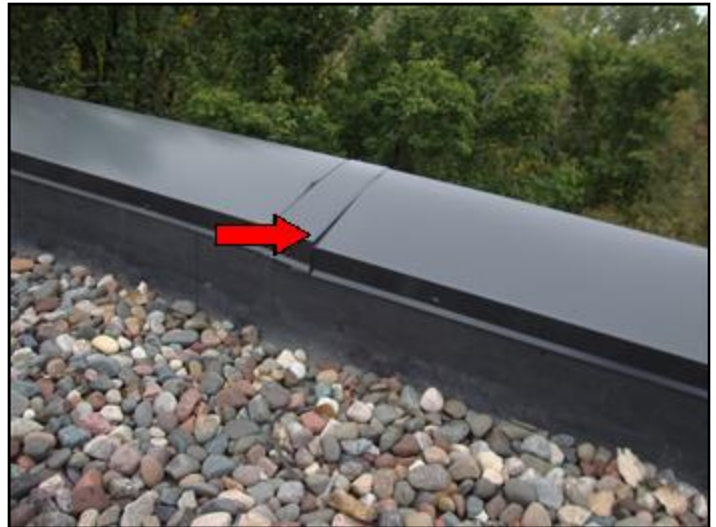
Condition: • Damage (dented) and loose seam flashing and sealant.

Damage

Loose

Task: Further evaluation

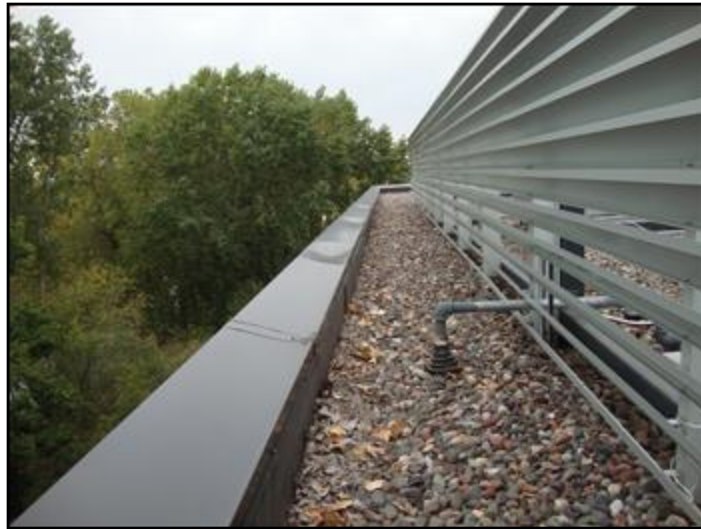
Condition: • Large trees adjacent to building have the potential to clog roof drains. Inspect in the spring and fall of the year, at a minimum.

Trees

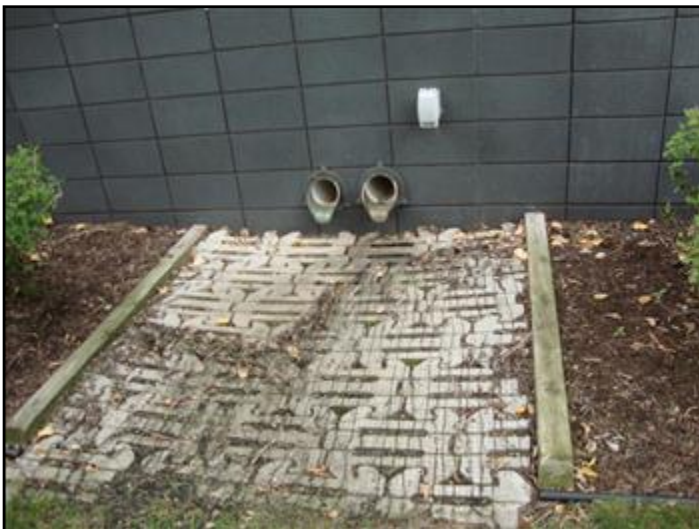
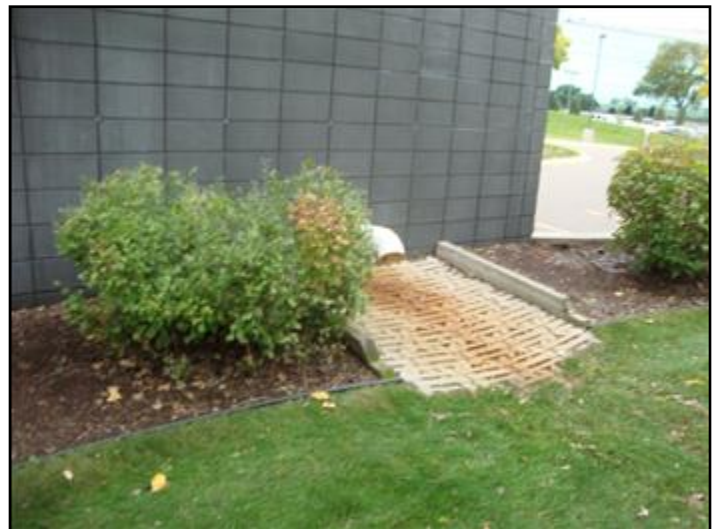
Condition: • Discharging too close to building structure - Downspouts should discharge water at least six feet from the building, where practical

Discharging too close to building structure...

Task: Improve

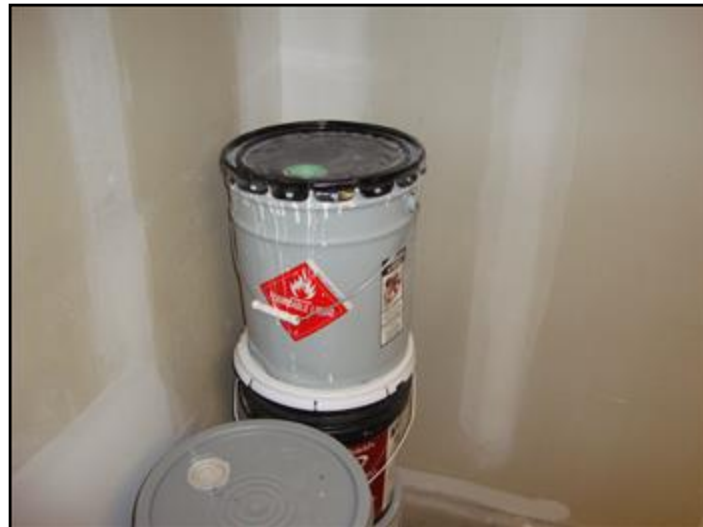
Flammable

Task: Remove

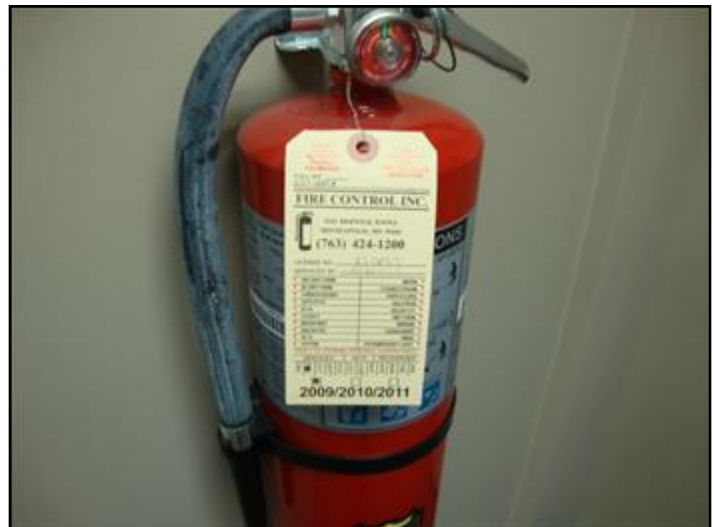
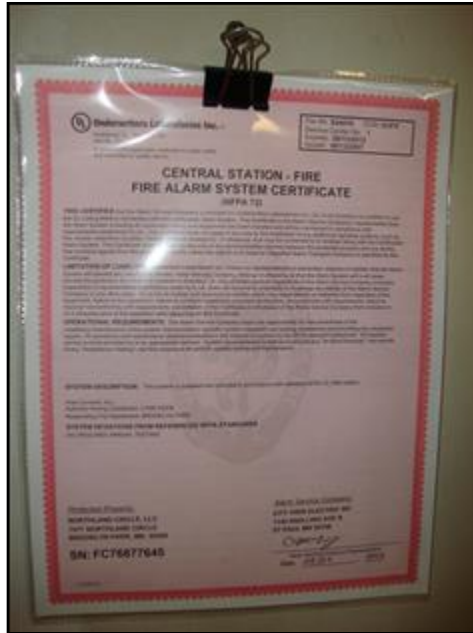
Expired

Task: Service

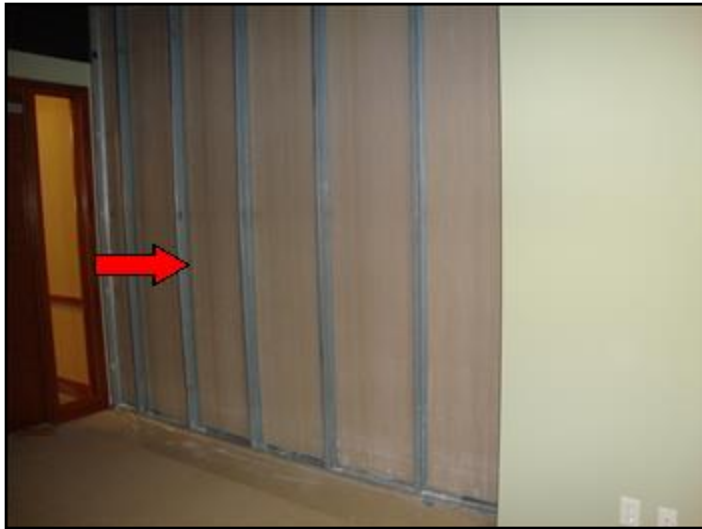
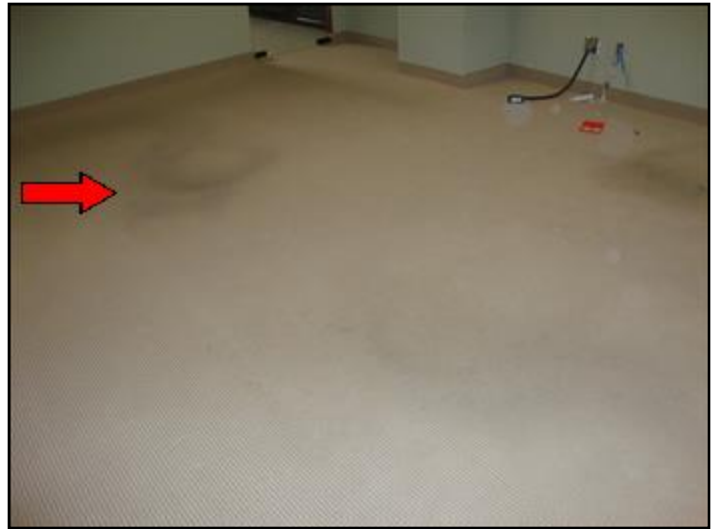
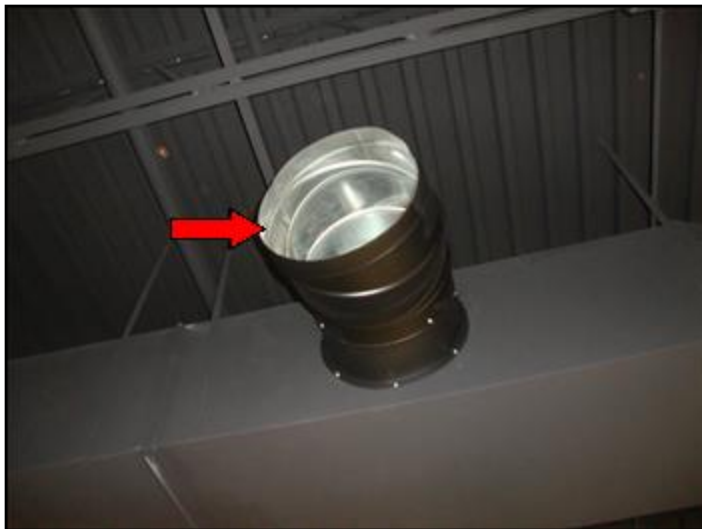
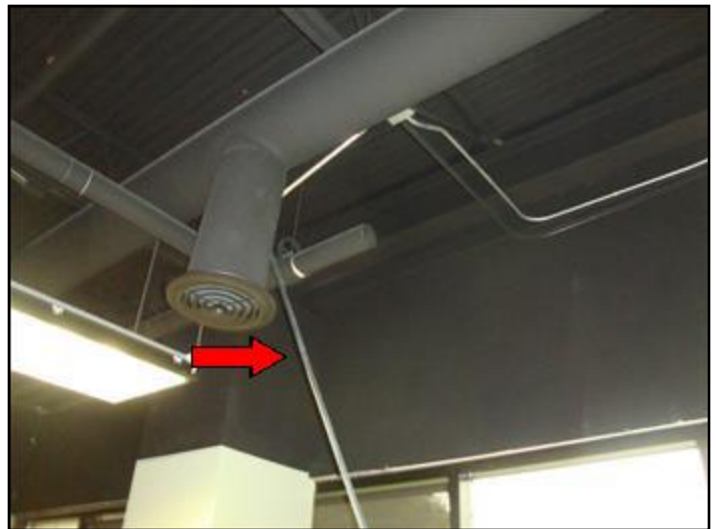
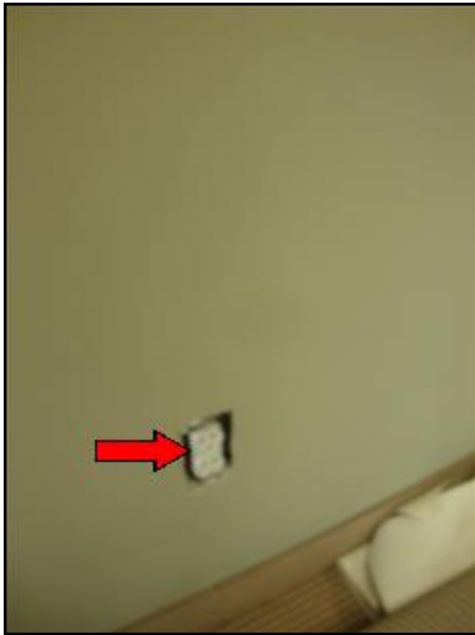
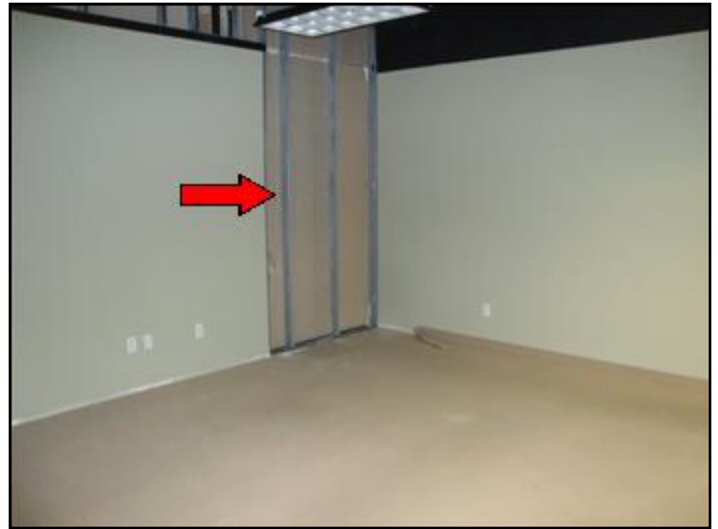
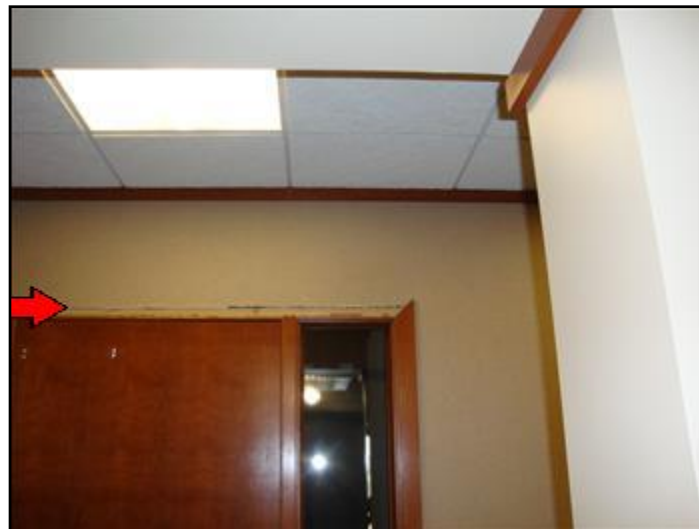
Condition: • Unit 320 had the following conditions: Stained and buckled carpet, missing drywall, water stains on walls, missing trim above door, loose electrical conduit, missing ducts and missing electrical cover plates.

Task: Repair

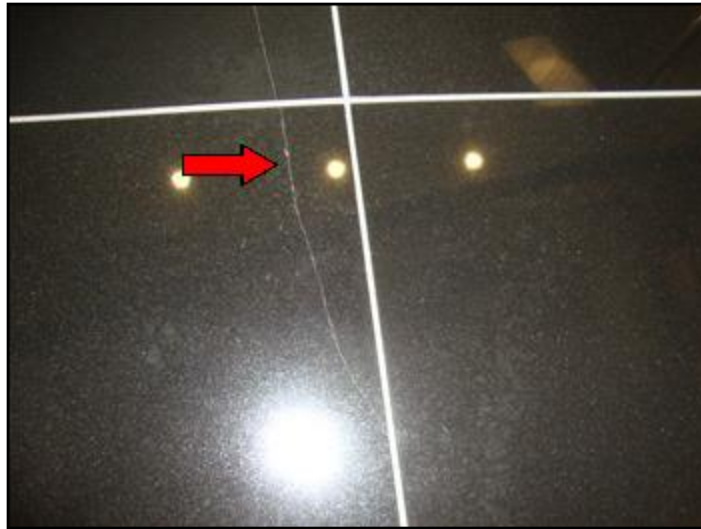
Condition: • Minor cracks observed in tile on main staircase.

Minor cracks

Task: Monitor - Repair

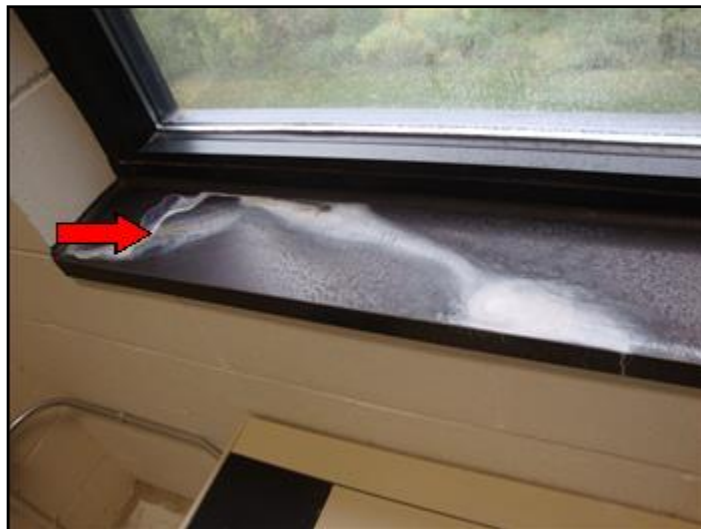
54. Condition: • Water stains observed on wall and windows sill in fire escape outside of unit 330.

Water stains

Task: Monitor

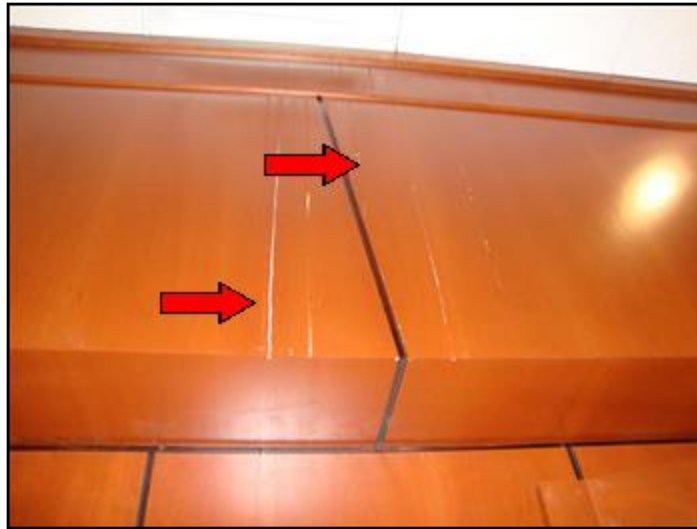
55. Condition: • Water stains located on third level near the elevator.

Water stains

Task: Monitor Repair

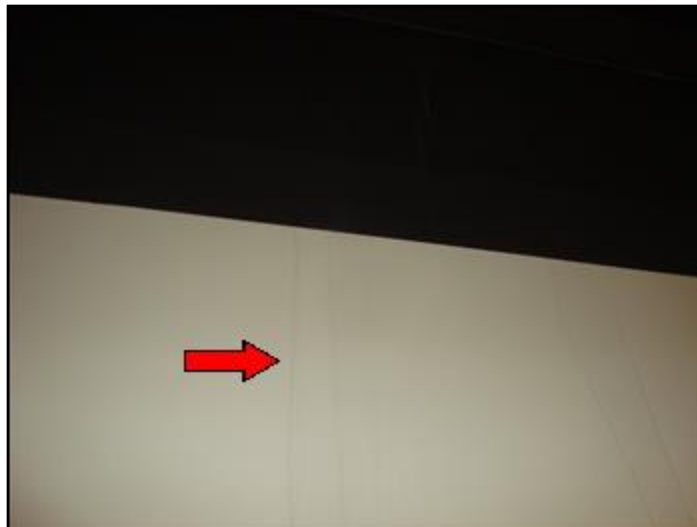
56. Condition: • A water stain was noted

A water stain was noted

Task: Further evaluation

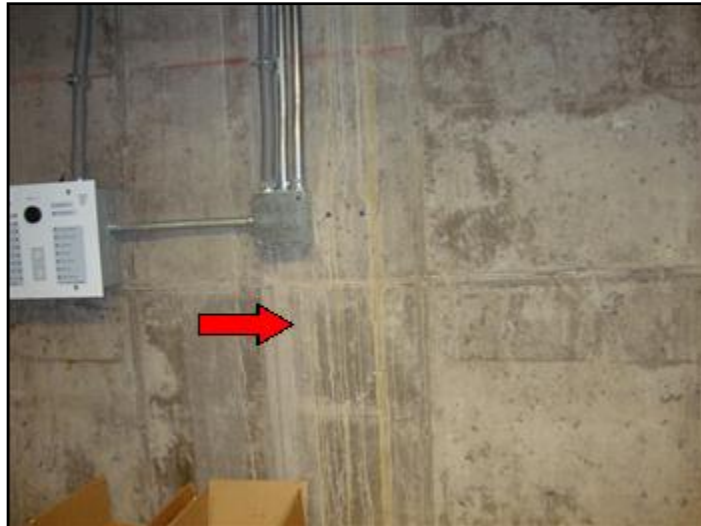
Condition: • Staining

Staining

Task: Monitor

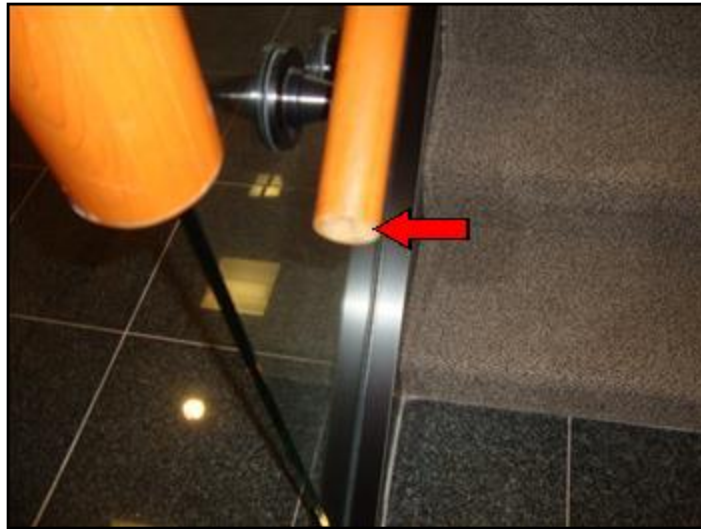
Condition: • Hand rail does not return to glass.

Hand rail

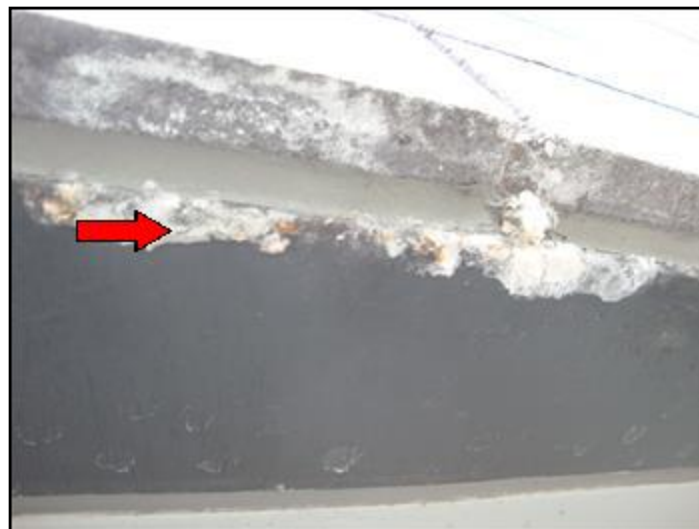
Condition: • Corrosion observed in lintel above overhead garage door.

corrosion

Condition: • Replacement of the steel is not considered warranted at this time; however, the steel should be scraped clean and repainted to minimize future corrosion

Task: Repair

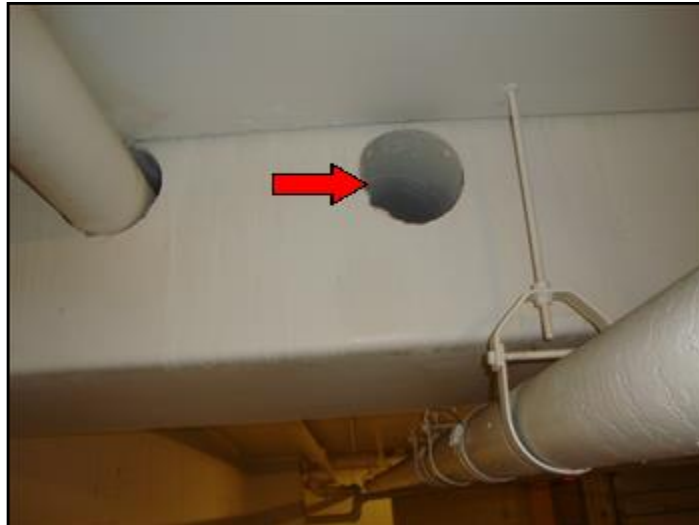
Condition: • A supporting beam has been notched

Several pre-cast holes observed in beams. Confirm engineering specifications for location and hole diameter with original building documents. No cracks or other defects observed.

Holes in beam

Task: Further evaluation

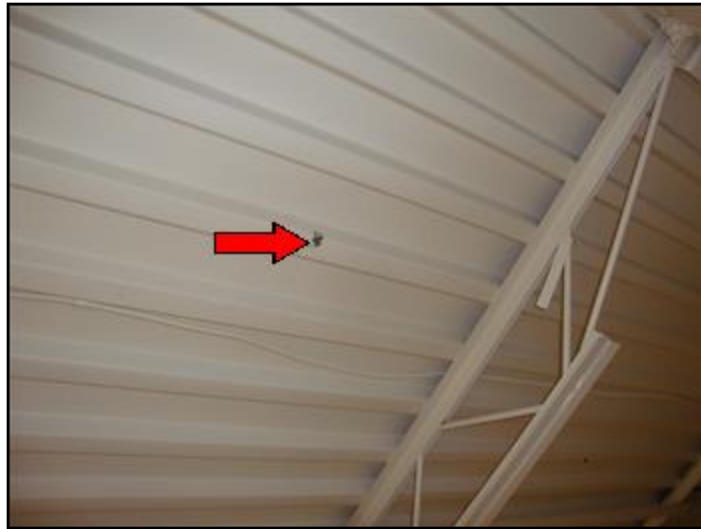
Condition: • Small holes observed in bottom of decking in north fire escape stairs.

Small holes

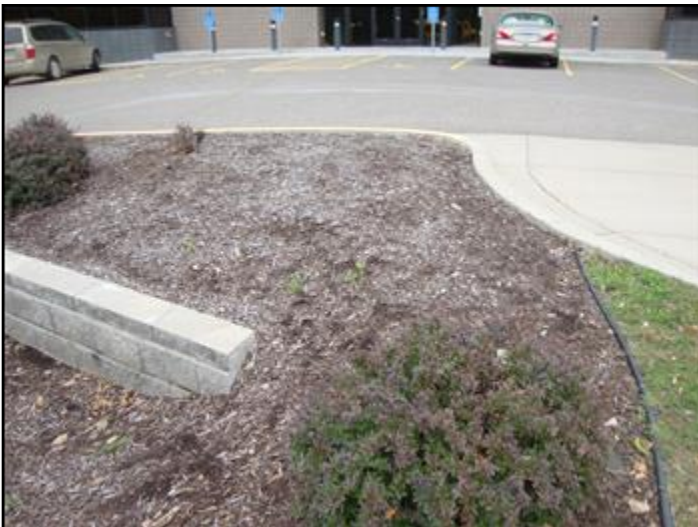
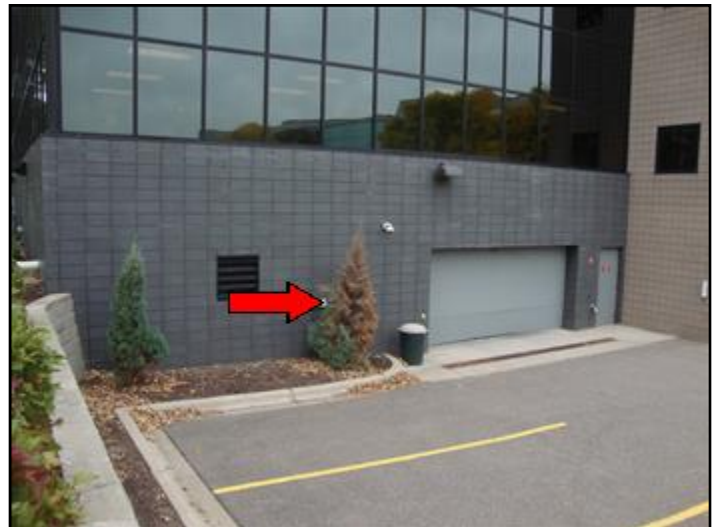
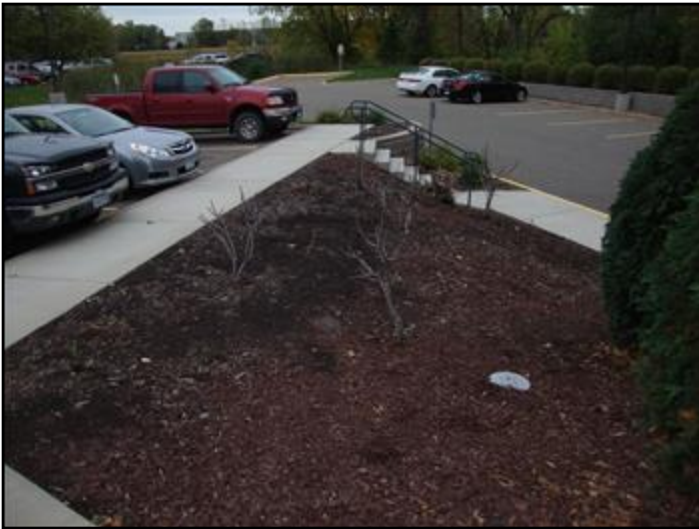
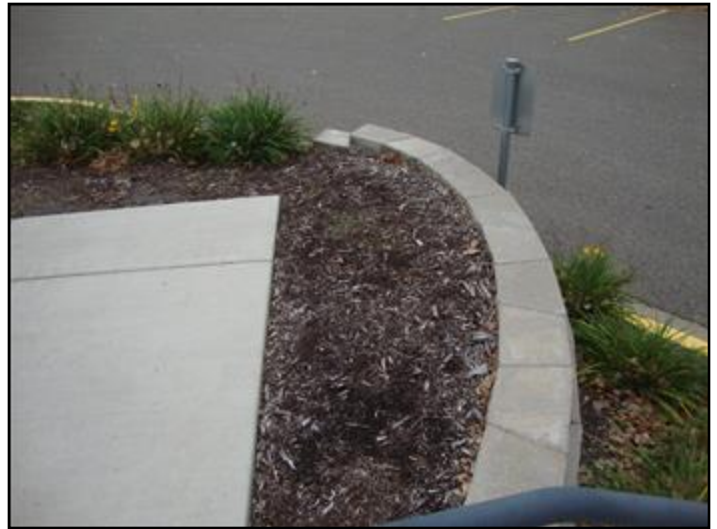
- 73.** • Estimated cost to repair exterior items.
Cost: \$5,000 - \$7,000
- 74.** • Dead and missing trees, shrubs, mulch and plant materials.
Task: Repair or replace
Time: Discretionary

Dead and missing

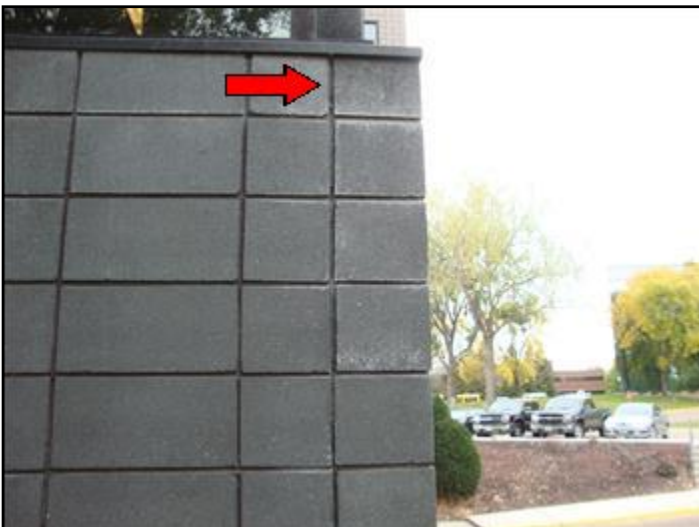
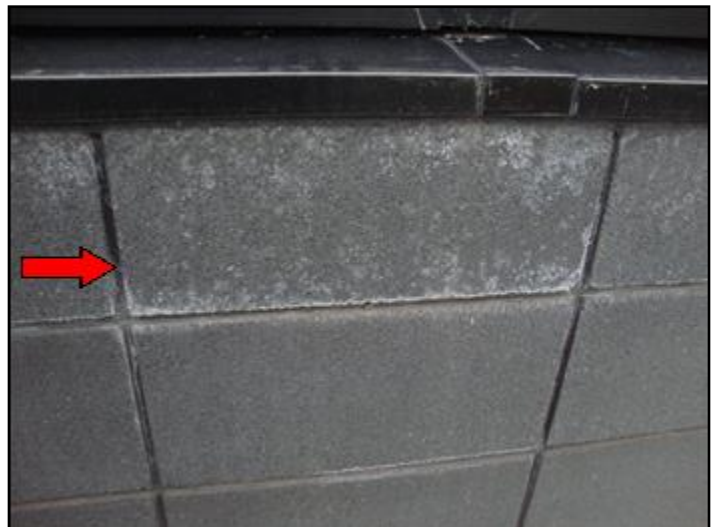
Condition: • Efflorescence observed on finish block.

Efflorescence

Task: Monitor

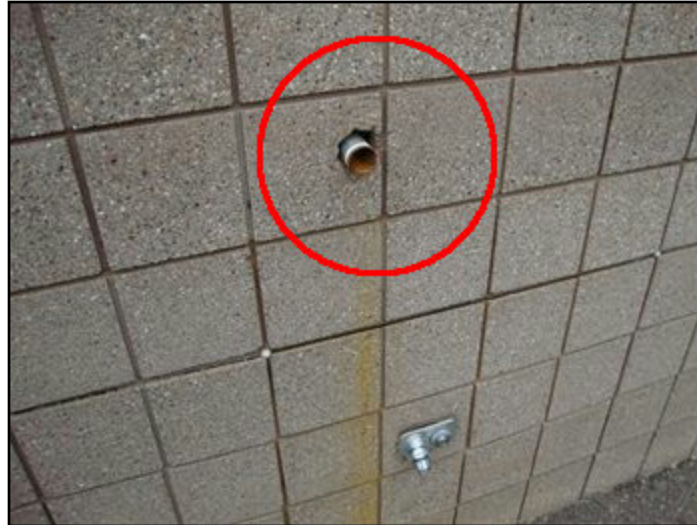
Condition: • Unknown drain pipe?

Unknown drain pipe?

Task: Further evaluation

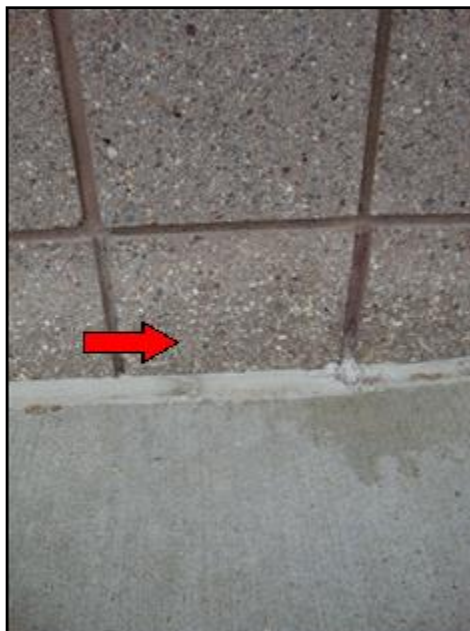
Minor spalling near the front entrance. Damage to first course of block adjacent to sidewalk likely due to chlorides in ice melt products. Included language in snow removal contracts to remove accumulated ice melt from masonry surfaces and use care when spreading to avoid contact with masonry wall surfaces.

79. Condition: • Water penetration has caused spalling of the brickwork

Spalling

Task: Repair or replace

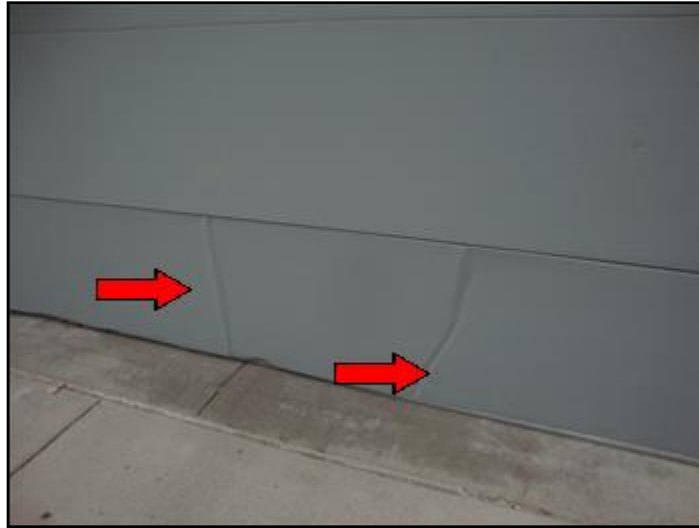
Condition: • Impact damaged

Impact damaged

Task: Repair or replace

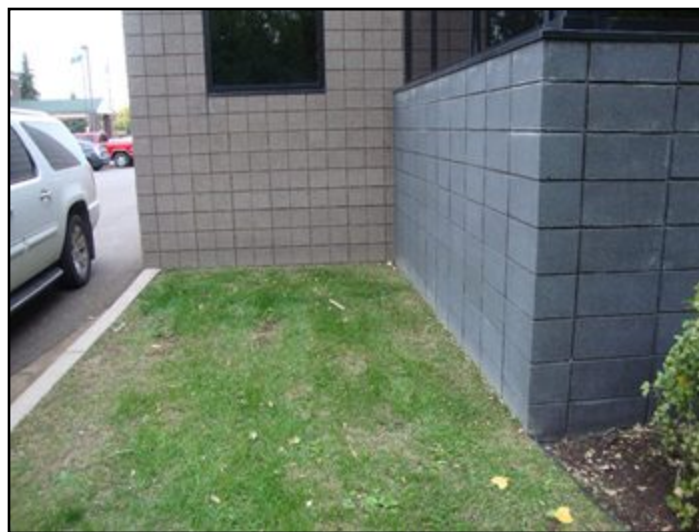
Condition: • Flat grade in south corner in the rear of the building near the fire escape. Improve grade and slope away from building.

Flat grade

Task: Improve

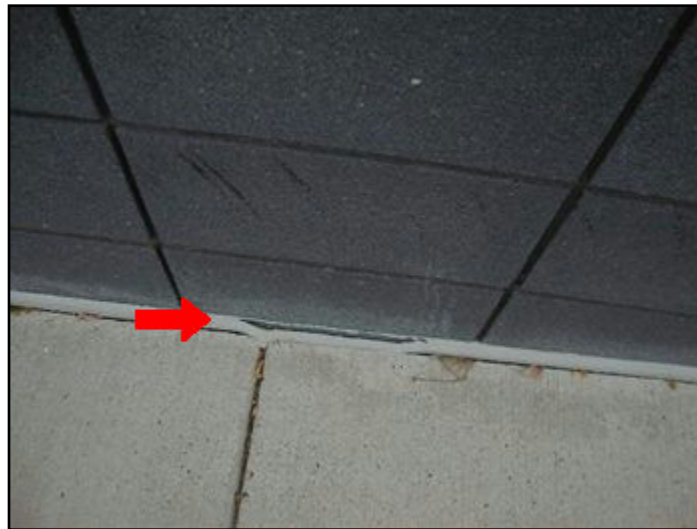
Condition: • Unsealed gap at building. Caulk needs replacement.

Unsealed gap

Task: Repair

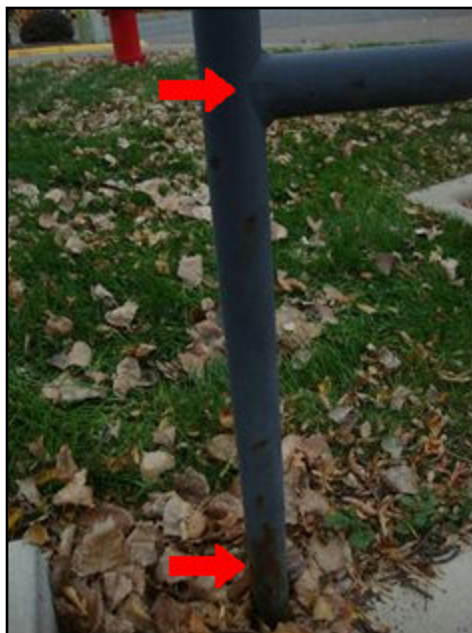
84. Condition: • Metal hand rails beginning to rust.

Task: Repair

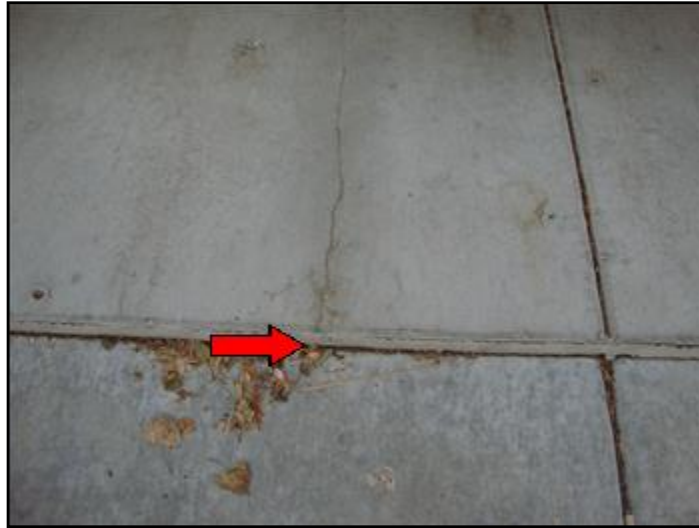
Condition: • The sidewalk has settled relative to the curb, creating a trip hazard

The sidewalk has settled

Task: Repair or replace
