Your Inspection Report

Commercial Building Twin Cities Area, MN

INSPECTION DATE:
Monday, October 14, 2013

RE: Report No. 1124
Commercial Building
Twin Cities Area, MN

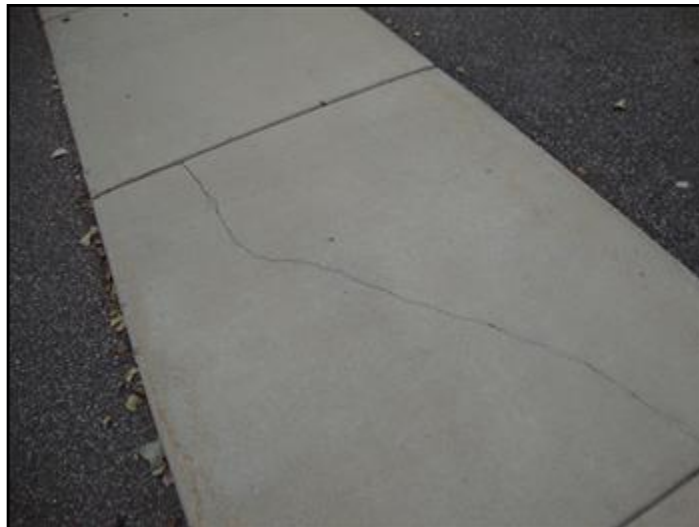
87. Condition: • Cracked

Typical cracks.

Cracked

Task: Monitor

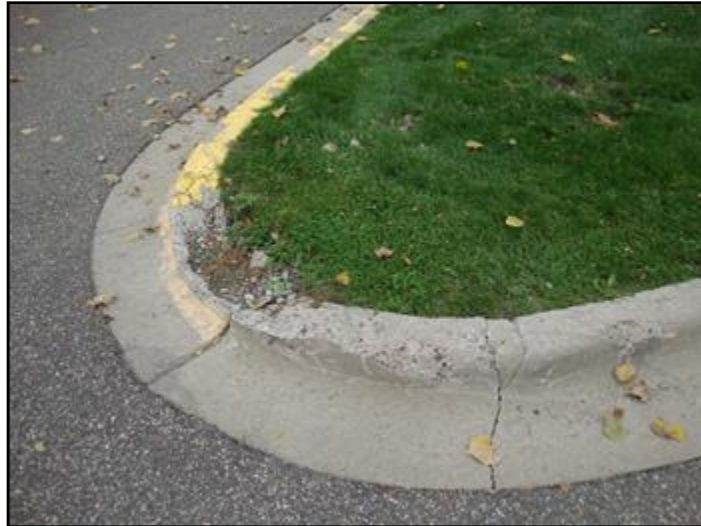
Condition: • Curbing damaged.

Curbing damaged

Task: Repair or replace

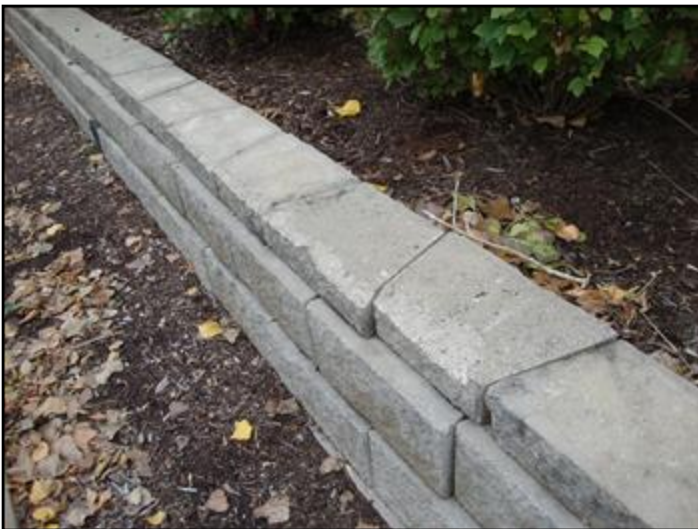
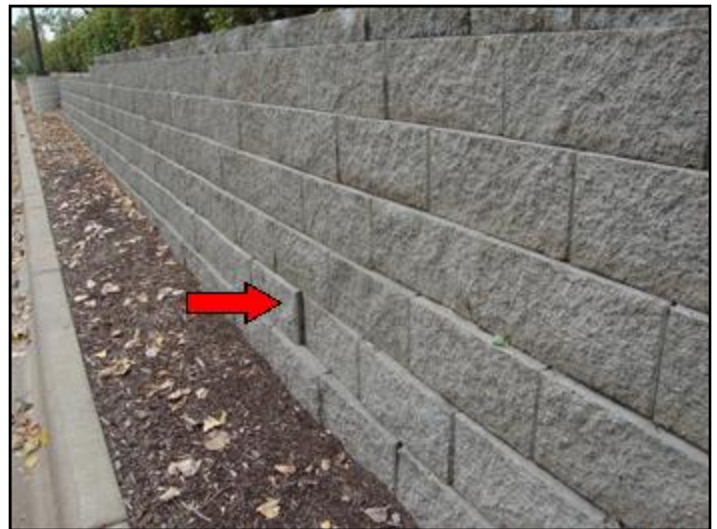
Some minor impact damage was observed.

Minor impact damage

Task: Repair

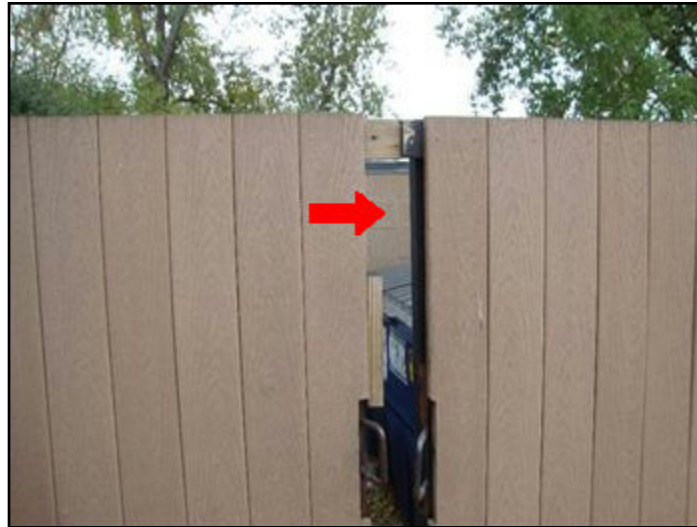
Missing board

Task: Repair or replace
