RREQUEST FOR PROPOSAL 70Z08319RPBA00300; CPOP REPAIR WEST WHARF, U.S. COAST GUARD YARD BALTIMORE, BALTIMORE, MARYLAND., Request For Information Responses A00003 5/13/19

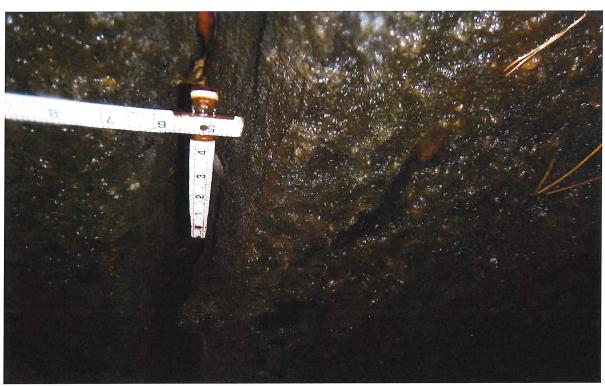
**Photo A-9:** Deck Plank – Typical Condition (underside view looking up from waterline)

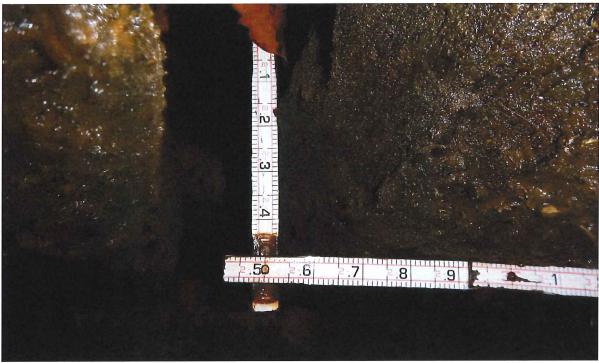
Photo A-10: Deck Plank – Deterioration with Active Fill Loss (underside view looking up from waterline)

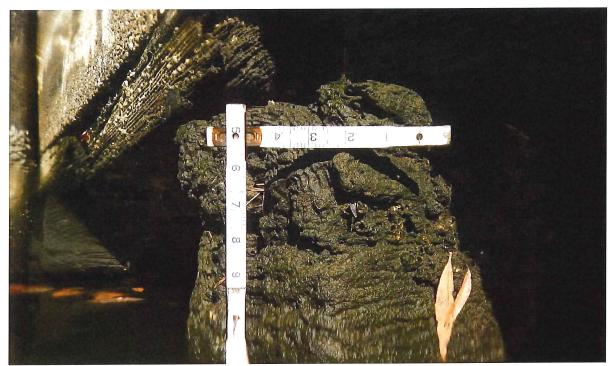
Photo A-11: Pile Cap – Typical Condition

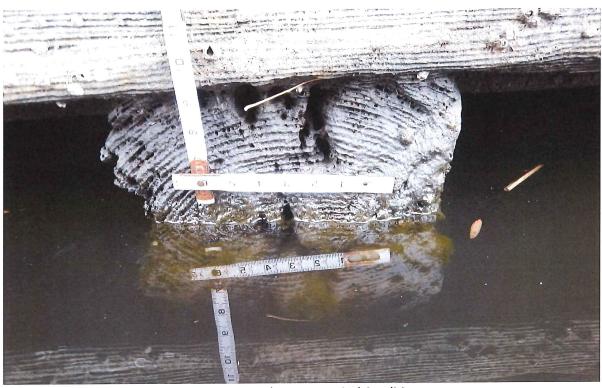
Photo A-12: Pile Cap — Typical Condition

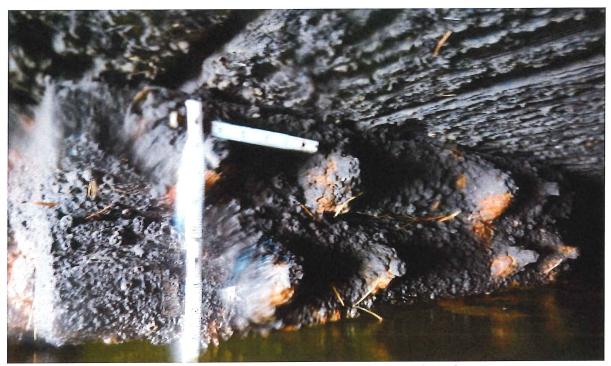
Photo A-13: Pile Cap Splice and Hardware — Typical Condition

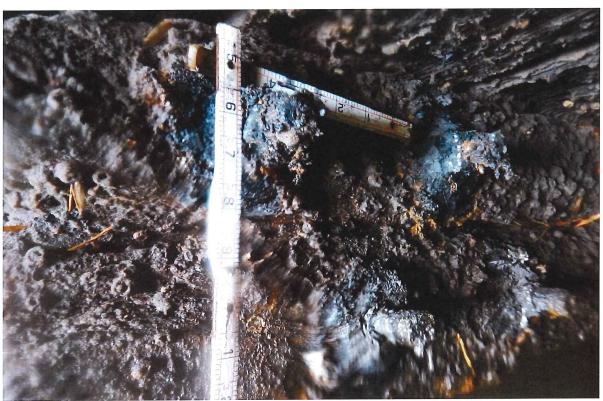
Photo A-14: Pile Cap Splice Hardware – up to 75% section loss.

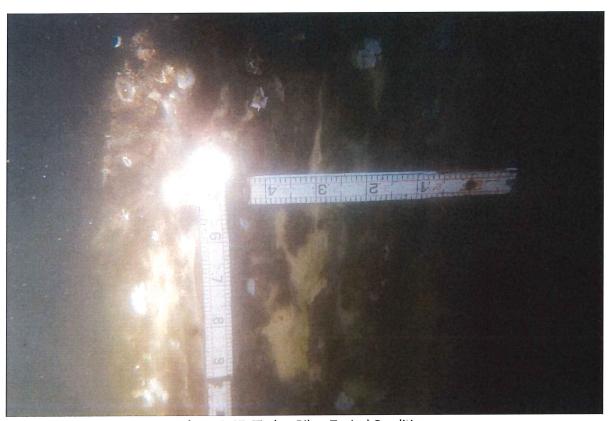
Photo A-15: Timber Pile – Typical Condition

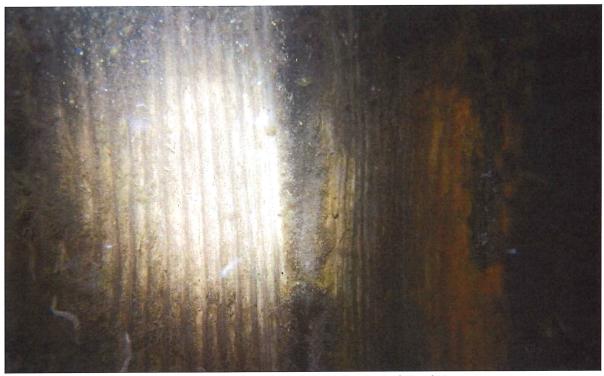
**Photo A-16:** Timber Sheet Pile Wall – Typical Condition

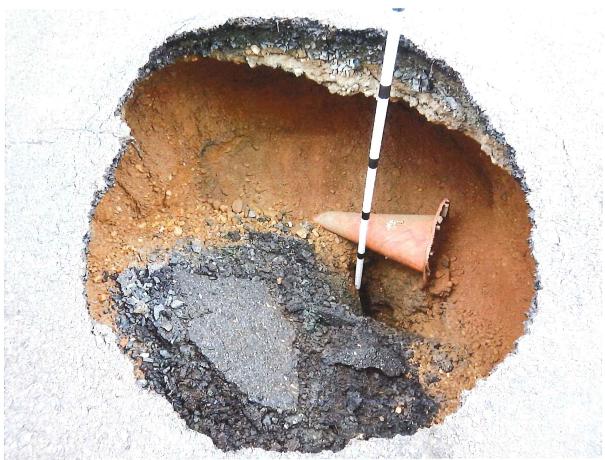
Photo A-17: Sinkhole at Sta. 2+00 (sinkhole extends to Deck Planks)

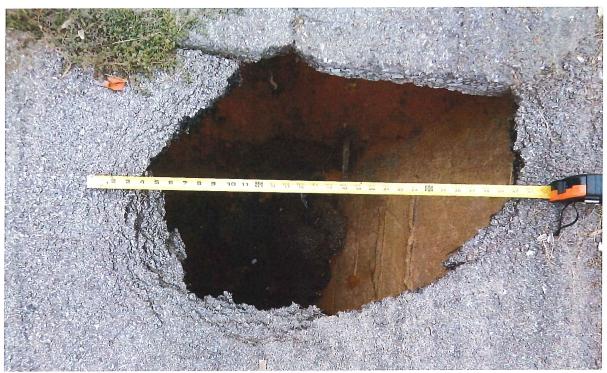
Photo A-19: Sinkhole at Sta. 2+62

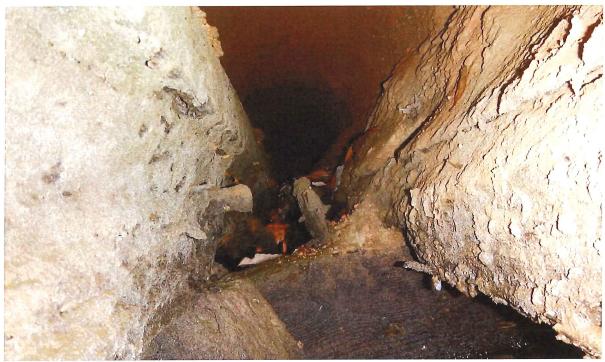
Photo A-21: Void at Sta. 5+55 (Pile Cap at bottom of photo, deteriorated Deck Planks to right and left)

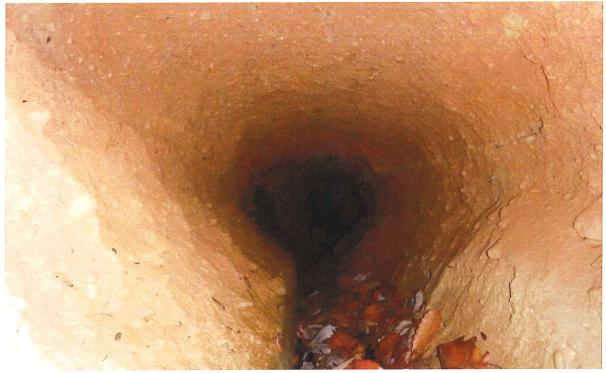
Photo A-22: Void at Sta. 5+55

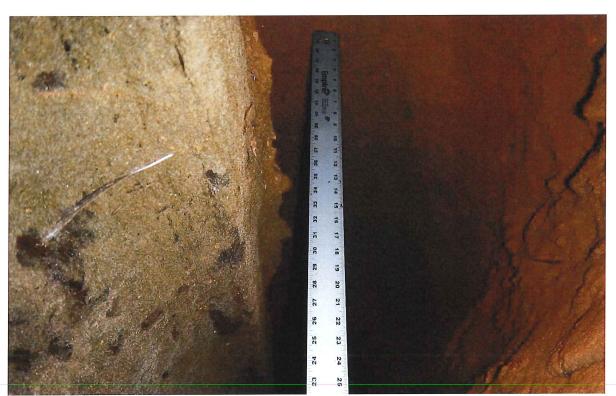
Photo A-23: Void with scale measurement at Sta. 5+55
