Three Rivers Team Home Inspections

123 Sky Ridge View
Vancouver, WA. 98685

11:08 October 03, 2018

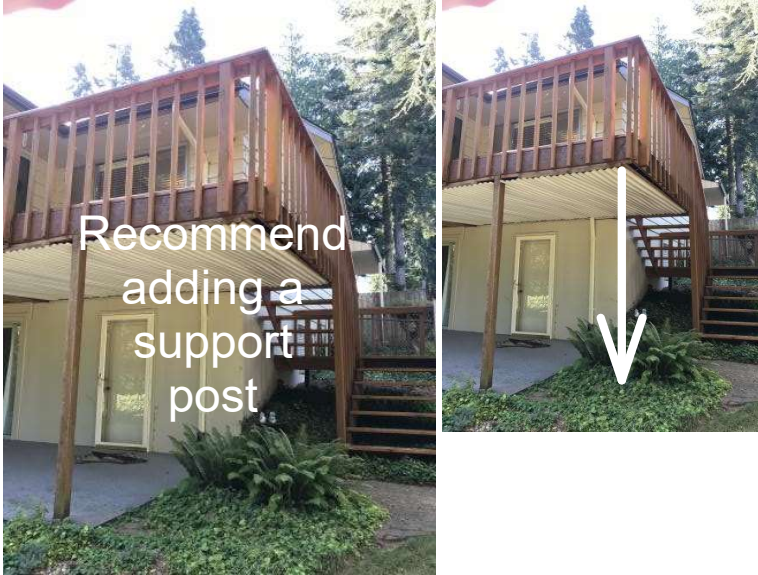
9. Defective Deck: Wood - **Rot is noted to various areas of the deck including structural components.**
Weathered/damaged: Repair/seal all exposed/damaged decking to reduce deterioration and rot.
Replace areas of damage that are beyond being responsive to normal repairs.

NW corner of deck appears to be sagging. Recommend adding a support post below corner of deck to promote added structural durability.

Avoid earth to wood contact to prevent moisture damage and invitation of wood destroying organisms.

Recommend bolting the deck and balcony to the house for added safety.

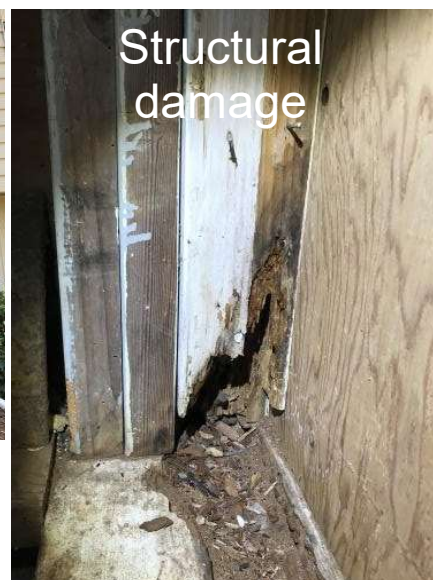
Balcony: Wood - *Rot is noted to secondary storage structure below the balcony including its leaking ceiling and structural components.

*Damaged structure below the balcony also appears to serve as the balconies support system.

*Rot noted to ceiling of structure below balcony / ceiling is leaking.

Recommend consulting a structural contractor to further assess and advise repairs to ensure structural durability and to prevent further subsequent damages.

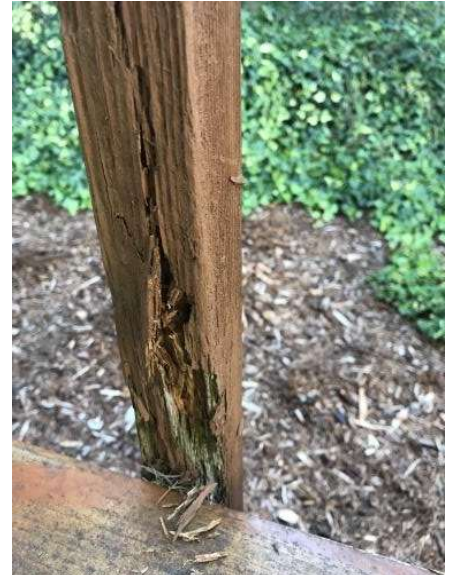
Railing: Wood - Rot is noted to various areas of wood railing. Weathered/damaged: Repair/seal all exposed/damaged railing to reduce deterioration and rot. Replace areas of damage that are beyond being responsive to normal repairs.

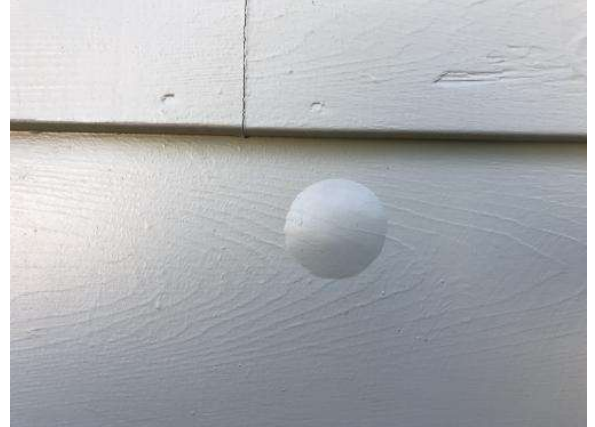
2. Marginal Wall surface/Trim: Wood siding, Wood trim -
Weathering noted to various areas of siding.
Paint is blistering in various areas.
Weathered/damaged: Recommend further
assessment to Repair/caulk/paint all
exposed/damaged wood siding/trim to reduce
deterioration and rot.

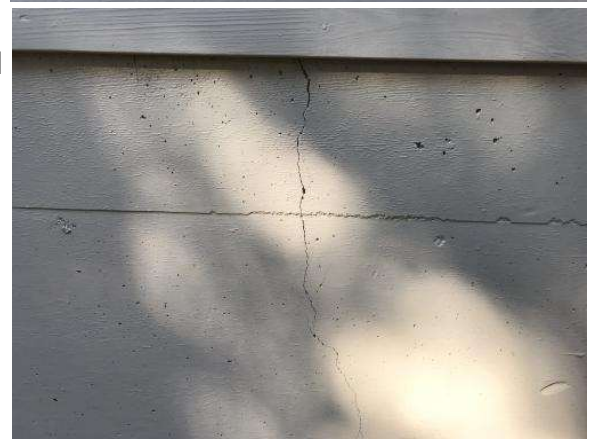
3. Foundation wall: Poured Concrete Vertical Cracks/gaps noted.
Fill and seal cracks/gaps to reduce further separation and potential
water entry.

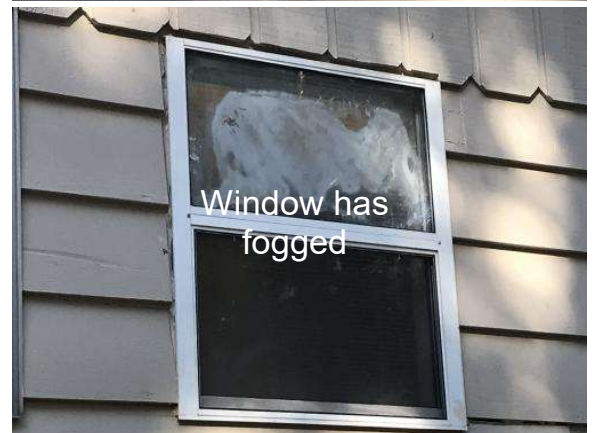
4. Marginal Windows: Metal/aluminum - Failed seals between
double panes of glass. Windows have fogged.

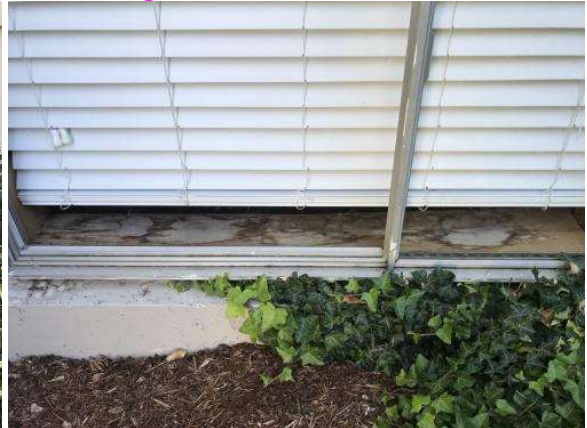
Basement Windows: Aluminum - Foundation is Mostly concealed below grade causing earth is making contact with window trim. Moisture damage noted to interior window sill. Regrade earth away from the house and add window wells to prevent entry of water into the house and to prevent subsequent damages to the siding/trim.

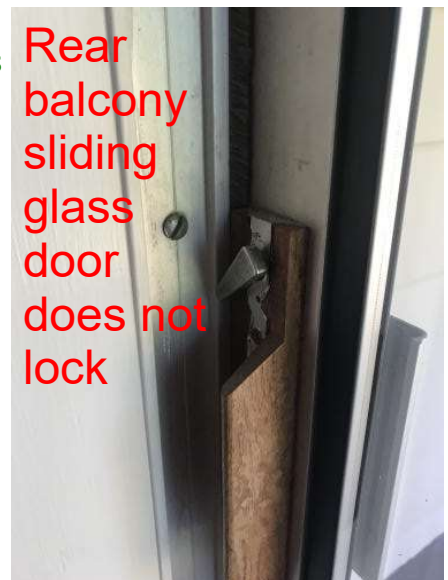
Doors/Jams: Hinged wood doors, Hinged Metal door, Metal sliders, Wood trim/jams - Rear balcony sliding glass door does not lock. Advise repairs to ensure intended use

Re-caulk, Re-paint weathered and exposed wood trim/jams for intended weather protection

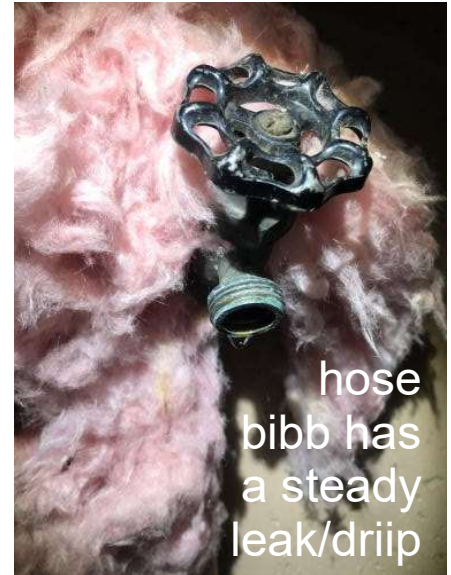
9. Defective Hose Bibbs: Operational - **Rear hose bibb has a steady leak/driip.**
A licensed plumber is recommended to evaluate and advise repairs.

Not all hose bibbs are anti siphon.
Recommend installing anti siphon hose bibbs to prevent outside water from siphoning through an outside faucet and contaminating the drinking water used in your home.

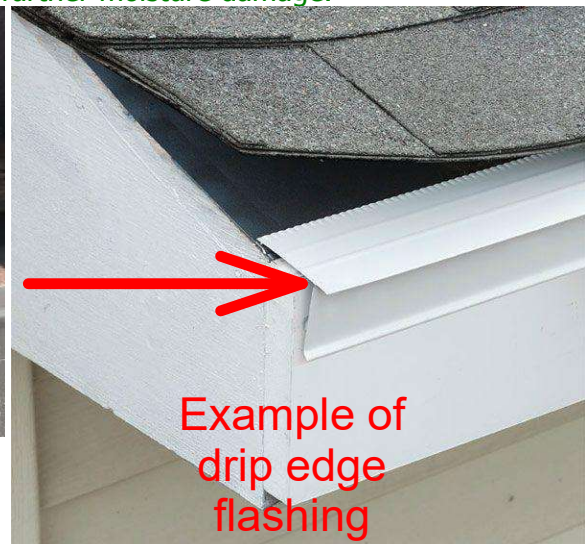
9. Acceptable Flashing: Roof to wall, Chimney, Vent/vent stack - Drip edge Flashing: Recommend drip edge flashing to protect the sheathing ends from further moisture damage.

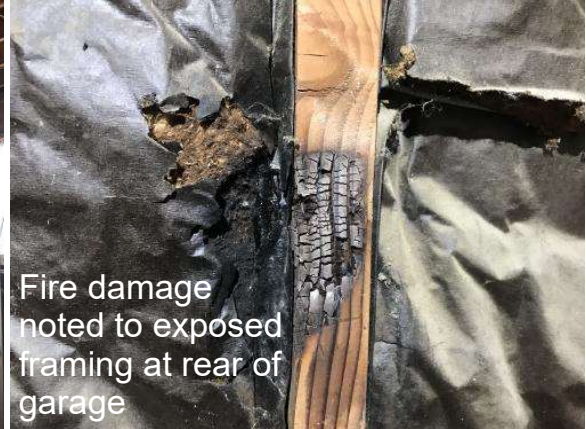
- Walls: Exposed framing - Addition noted to rear of garage. Addition accommodates master bedroom/bathroom.
 - Recommend obtaining structural/electrical/plumbing permits to ensure proper construction/installations.

- Fire damage noted to exposed framing at rear of garage.
 - Consult a structural contractor to further assess damages and advise repairs to ensure structural durability.

- Recommend determining cause of damage to ensure that under lying conditions do not exist.
 - Extreme Clutter/stored items limited visibility to walls and stem walls

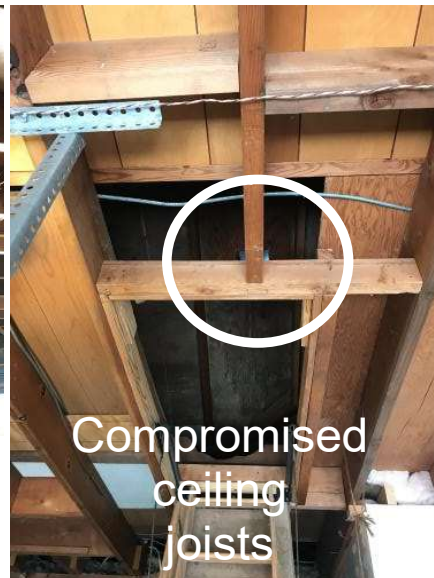
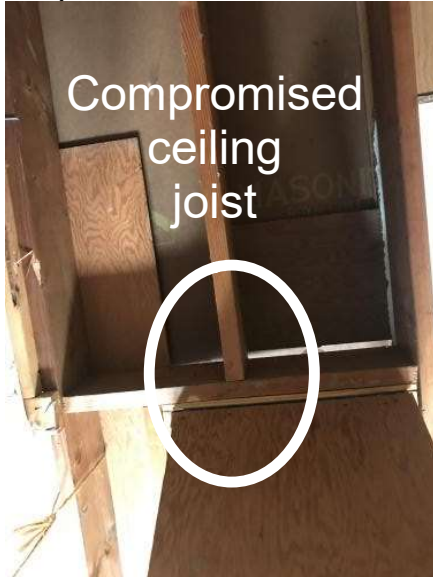
Ceiling: Exposed framing - **Garage ceiling joist appears to have been compromised to accommodate a pull down attic access. Ceiling appears to be sagging as a result. Consult a qualified structural contractor to further assess and advise repairs to ensure structural durability and to prevent further subsequent damages.**

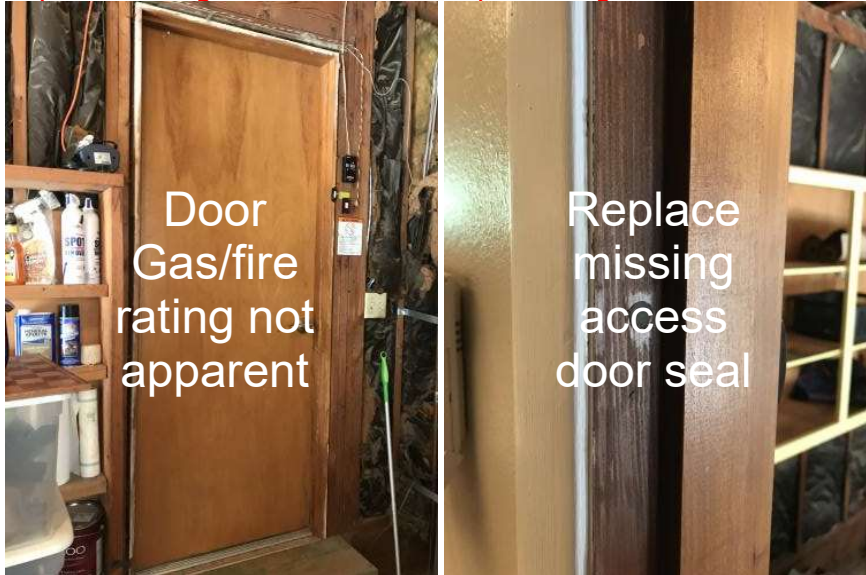
11. Defective Service Doors: Wood, hinged, not self closing, to kitchen - **Door Gas/fire rating not apparent. Replace door with an approved fire rated unit combined with associated hardware for self closing to promote gas/fire barrier.**

Replace missing access door seal to promote gas barrier

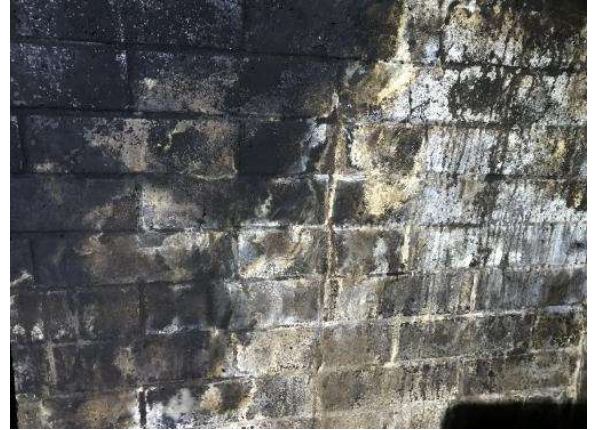
Fire box: Brick, Metal - Cracks and deterioration noted to Built in fireplace fire box.
Repair firebox to promote structural safety/stability and safe exhaust

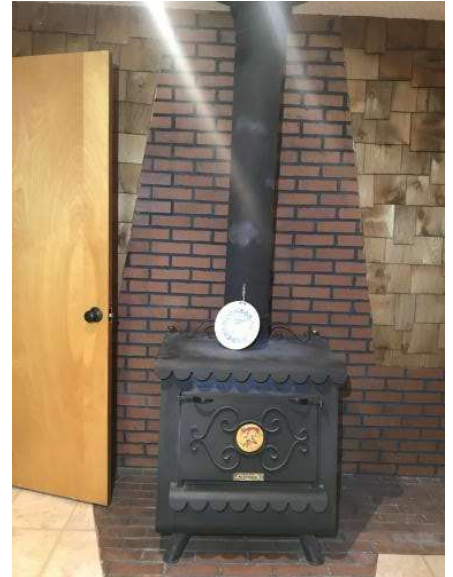
Freestanding Stove: Wood burning - Installation Certification not apparent, One might consider Consulting a certified technician to review installation in accordance with manufacturers specification to ensure proper installation and safe operation.

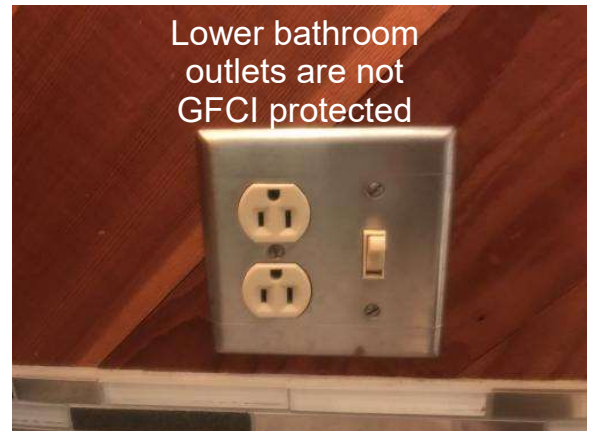
8. Marginal Outlets: GFCI protected, Not operational - Lower bathroom outlets are not GFCI protected. Install GFCI units to promote intended shock protection

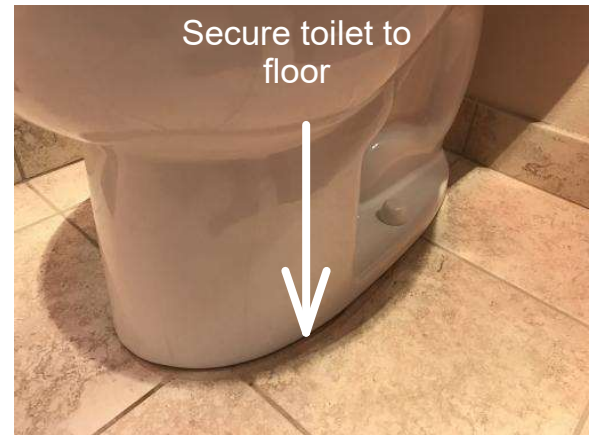
13. Defective Toilets: Operational - Toilet/s loose at bases.
Secure toilets to floor to prevent leaks, subsequent damages, and to promote personal safety.

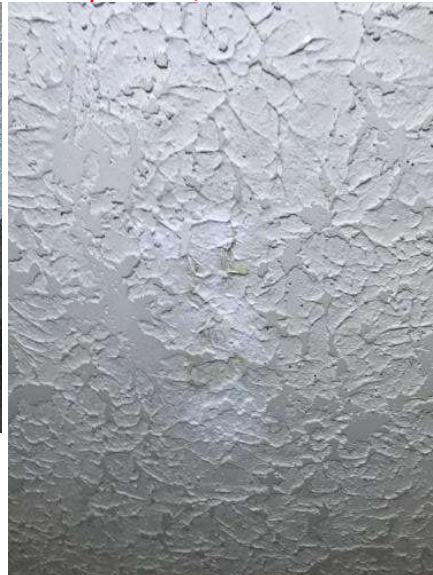
- 1. Acceptable Floor: Carpet, Laminate
- 2. Acceptable Walls: Dry wall / Plaster / Painted
- 3. Defective Ceiling: Dry wall, Dry wall / Plaster / Painted - Moisture stains around the chimney. Recommend determining of origin of stains to ensure that under lying conditions do not exist.
*No moisture reading at time of inspection.

Crack/s present: Repair cracks to reduce further separation/deterioration.

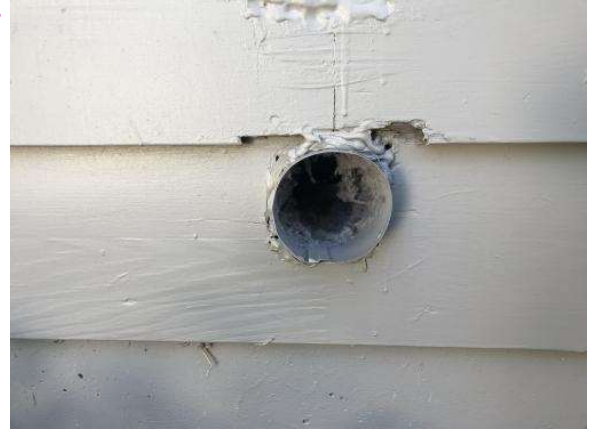
7. Marginal Dryer Vent: Metal flex, To exterior - **Repair exterior vent to prevent entry of vermin**

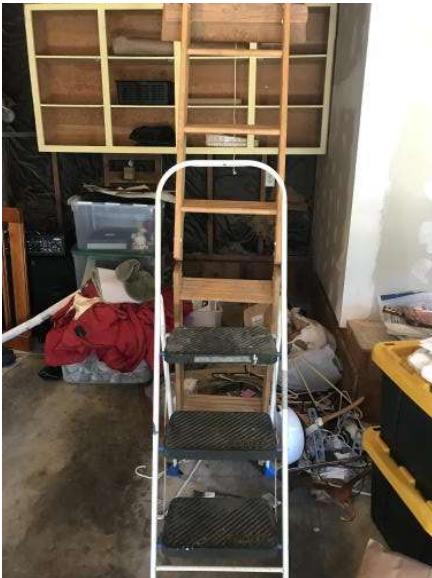
1. Note: Pull down ladder for attic access in garage does not make contact with floor.
Alternative step ladder is being to used to accommodate inefficiency.
Advise repairs to ensure intended safe operation.

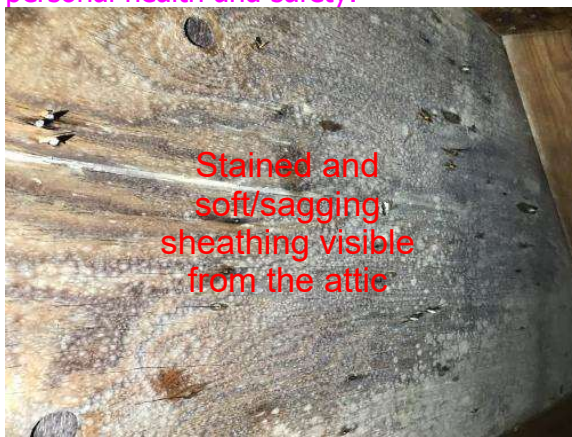
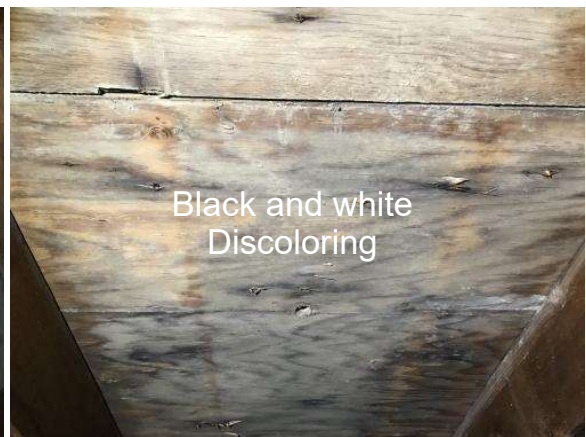
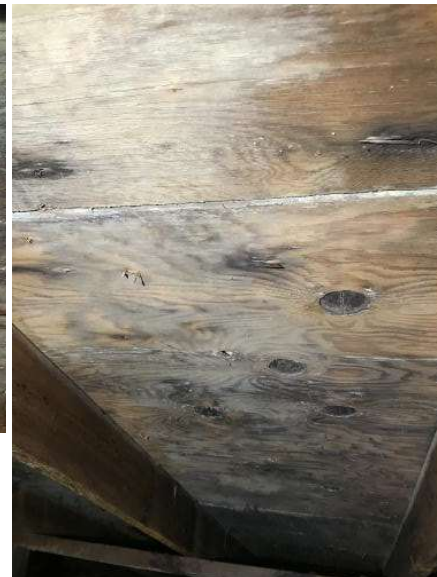
Sheathing: Plywood, Stained - Stained and soft/sagging sheathing visible from the attic. most likely due to moisture from poor ventilation.
See attic ventalaion section for related notes.

Black and white Discoloring most likely due to moisture from poor ventilation.
Black/white substance noted that shares the same characteristic of mold/mildew.
Stained sheathing: Recommend consulting a qualified contractor to further assess stained sheathing and advise cleaning solutions to prevent further subsequent damages and to ensure personal health and safety.

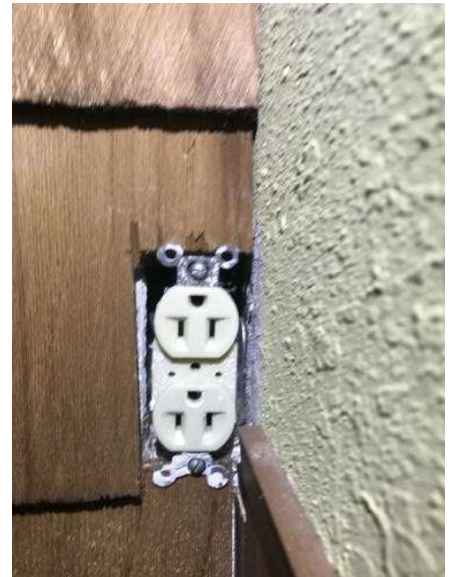
1. Acceptable Limitations: Dry Weather, Finished
2. Acceptable Floor: Vinyl
3. Acceptable Walls: Panel board, Dry wall / Painted
4. Acceptable Ceiling: Dry wall / Painted / textured
5. Acceptable Windows: Metal, sliding
6. Acceptable Doors: Hinged, Wood product, Operational
7. Acceptable Lighting: Operational
8. Marginal Outlets: Operational - Replace missing outlet covers for intended shock protection

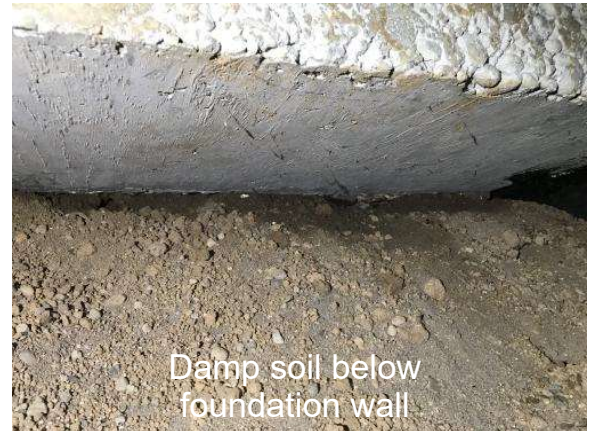
1. Method of Inspection: In the crawl space
2. Acceptable Limitations: Dry Weather
3. Acceptable Access: Basement/lower level
4. Defective Moisture Penetration: Damp - **Damp soil noted below foundation wall at SW corner of crawl space. Earth erosion below wall is also evident. Recommend consulting a qualified contractor to further assess, determine point of water entry, and advise exterior drainage solutions to prevent water from entering the crawl space and causing subsequent foundation problems.**

Also See Property and site/landscape section for related notes

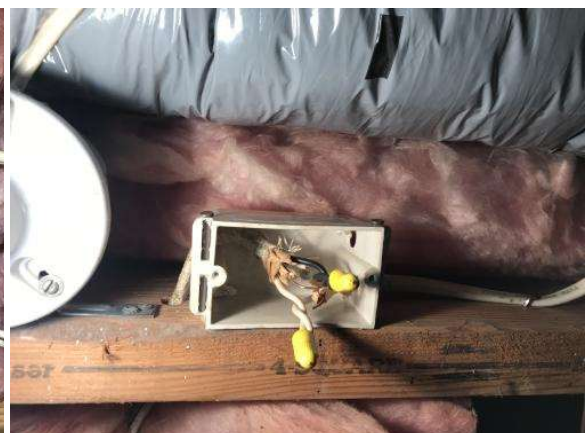
5. Acceptable Insulation: Present
6. Acceptable Vapor Barrier: Present
7. Marginal Electrical: Mostly concealed - **Open splices: Consult an electrician to conceal open splice wires into a junction box for intended fire and shock protection.**

Low hanging/grounded wires noted. Recommend securing wires up to promote intended shock protection

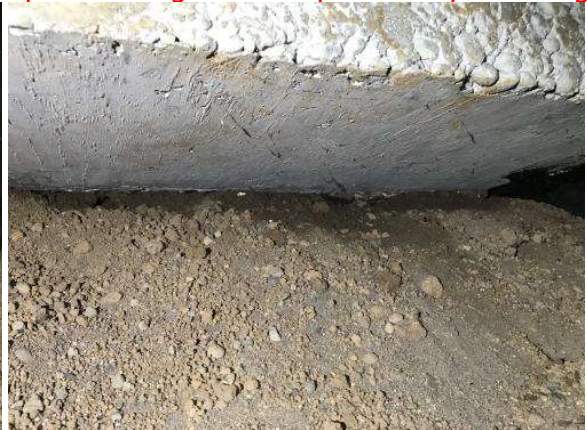
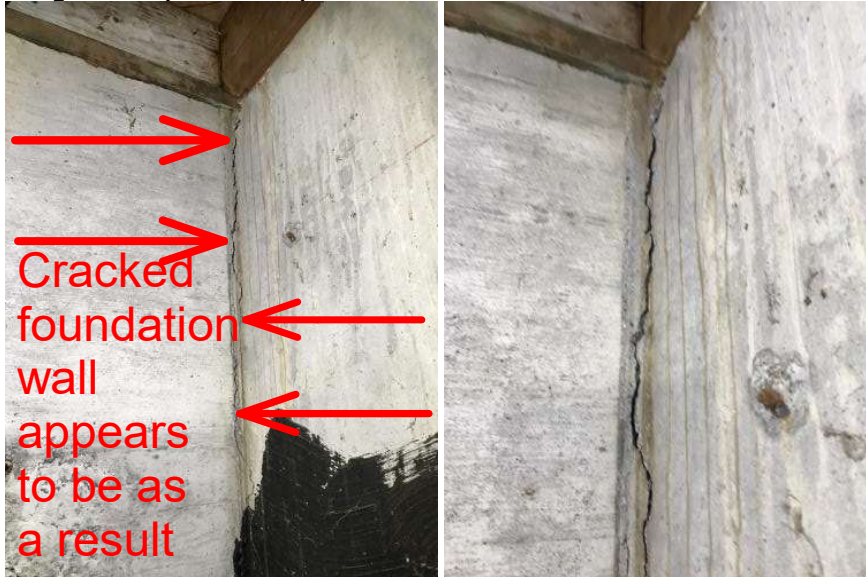
| 6. Defective | Foundation/Bearing walls: Poured Concrete, Concealed poured concrete slab & walls - Earth erosion noted below SW corner foundation wall visible from crawl space

Crack with separation noted to foundation wall at SW corner most likely as a result.
Recommend consulting a foundation contractor to further assess and advise repairs/maintenance to prevent further subsequent damages and to promote system longevity. |

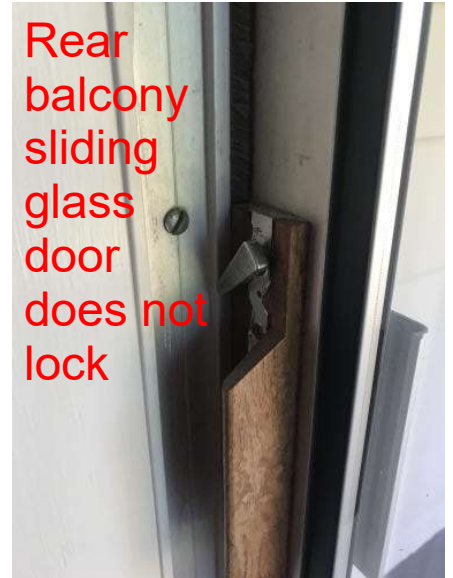
Rear
balcony
sliding
glass
door
does not
lock

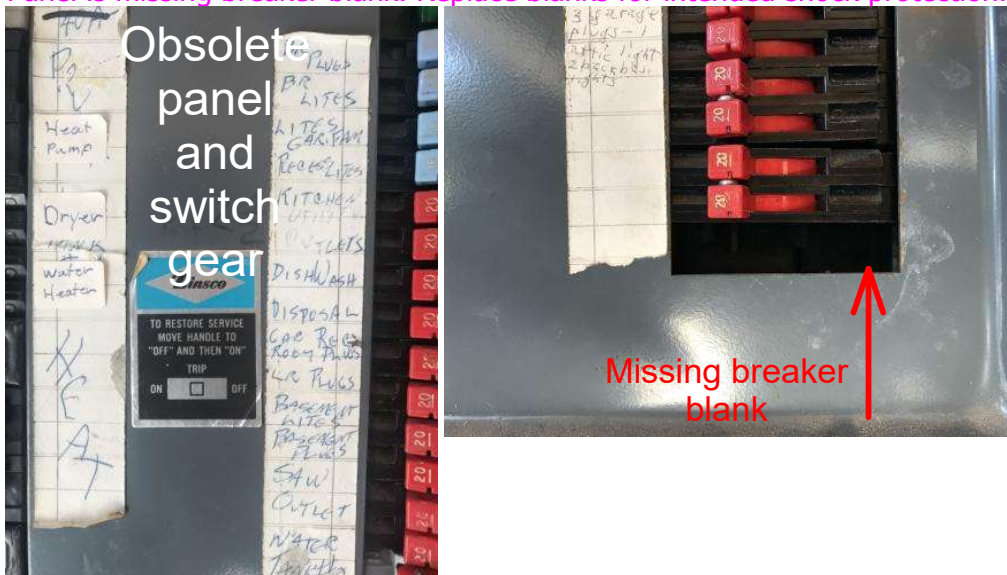
Panel is missing breaker blank. Replace blanks for intended shock protection.
