# PROPERTY CONDITION ASSESSMENT REPORT

X  
x, MN

Wednesday, March 18, 2015

RE: Report No. 1345, v.2

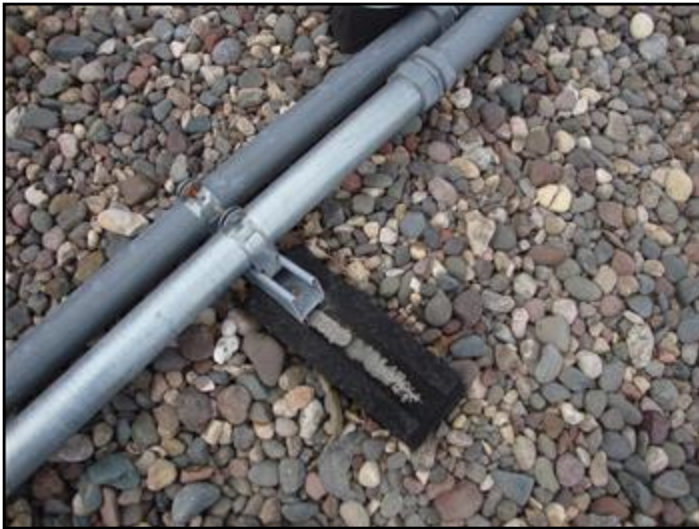
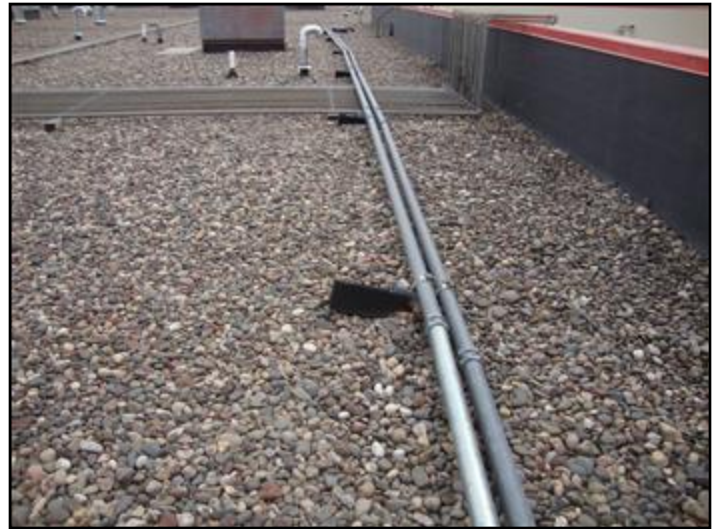
1. • Illuminated exit sign is inoperable or has defective lamps

2. **Condition:** • Conduit is poorly supported with several broken supports observed.

**Task:** Repair

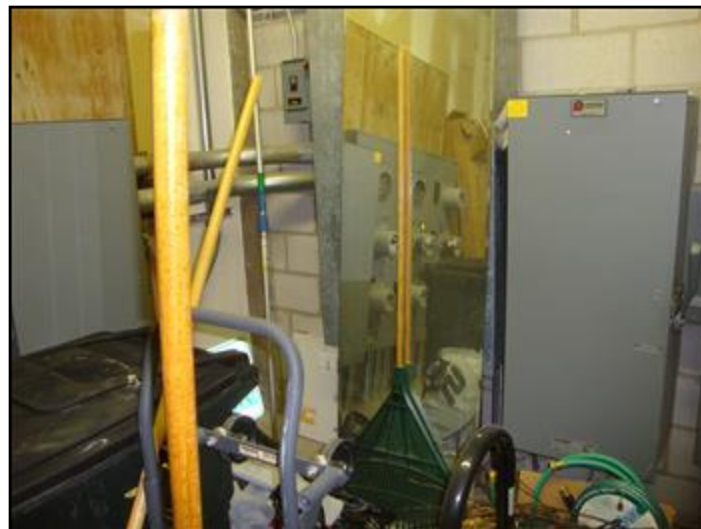
**5. Condition:** • Storage within one meter of equipment

3. Storage within one meter of equipment

**Time:** Immediate

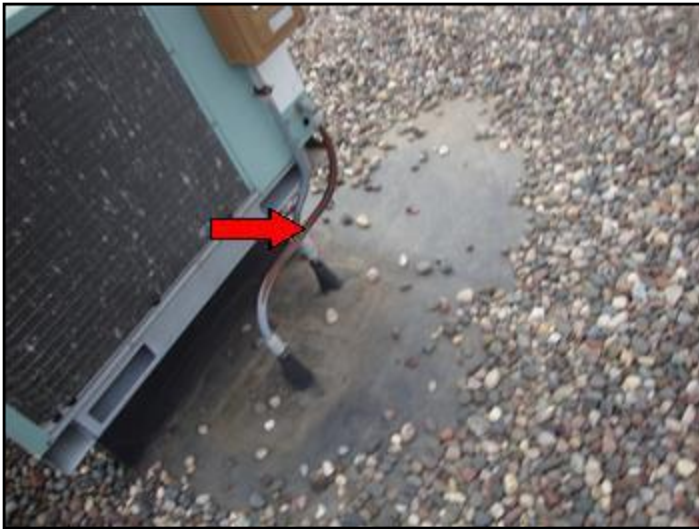
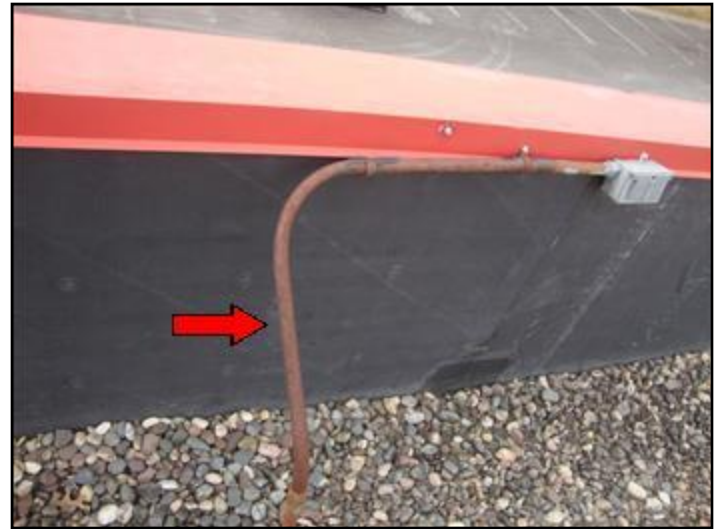
**6. Condition:** • Rusting conduit

**Task:** Monitor - Replace

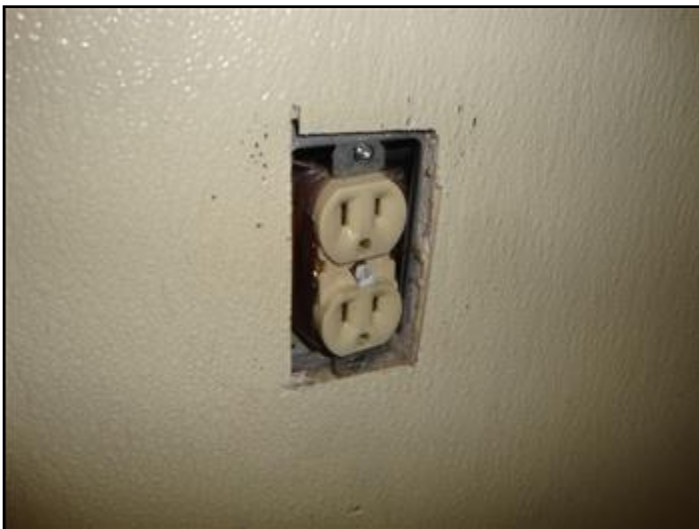
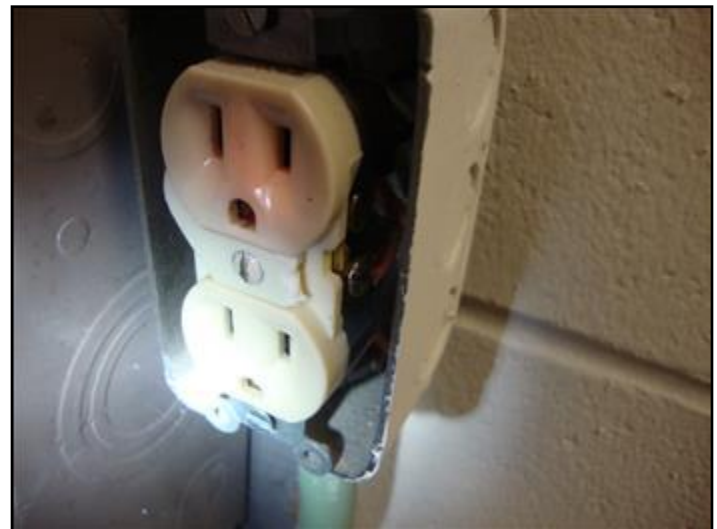
7. Condition: • Missing on switches, outlets and junction boxes

6. Missing on switches, outlets and junction...

7. Missing on switches, outlets and junction...

Task: Repair

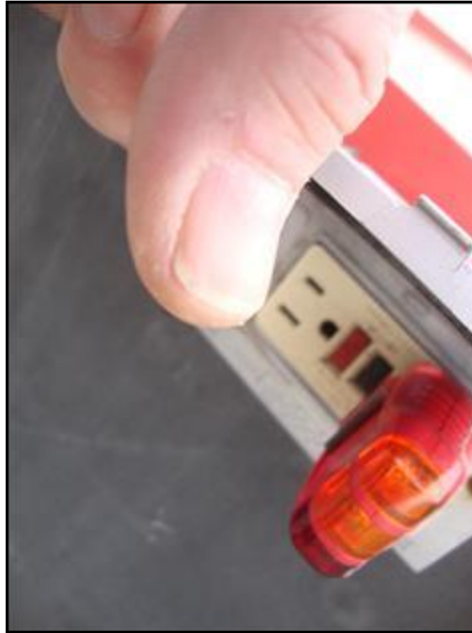
8. Condition: • Roof top GFCI at the parapet were inoperable.

Task: Repair

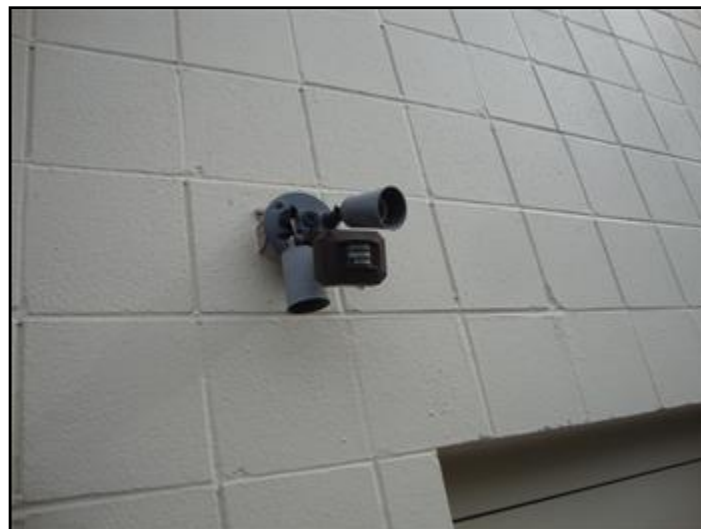
**9. Condition:** • Inoperative

Missing Lamps.

9. Inoperative

**Task:** Repair

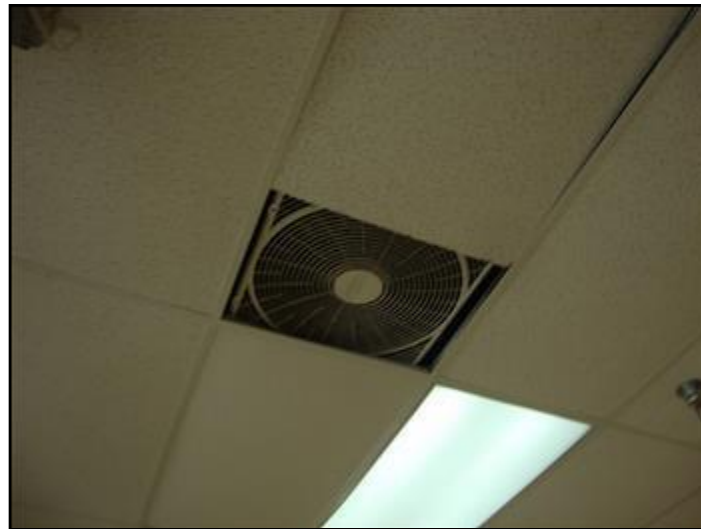
10.

12. • The tenant in suite 2544 had a fan mounted in the ceiling and indicated the ceiling space was warm. This condition should be evaluated by an HVAC contractor to determine if any problems with the duct work exist.

**Task:** Further evaluation

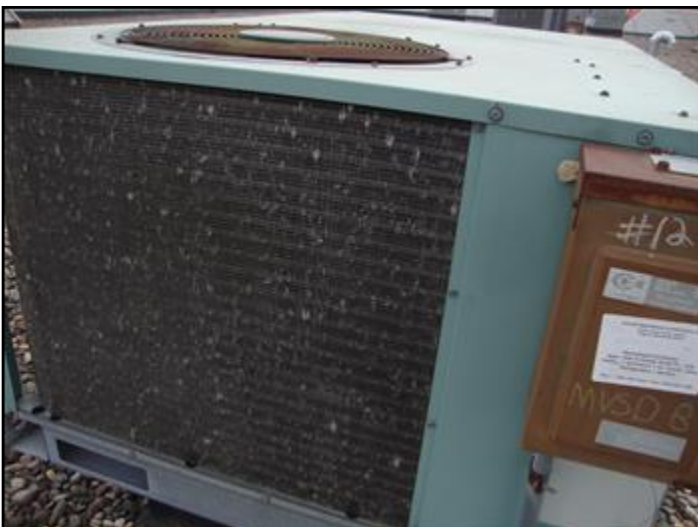
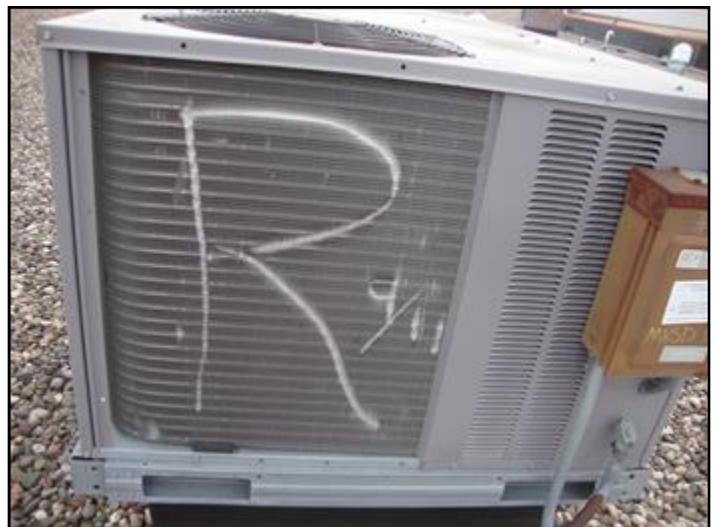
- 17. Condition:** • Damaged and vandalized coils observed on five units. Comb fins or replace coils.

**Task:** Repair

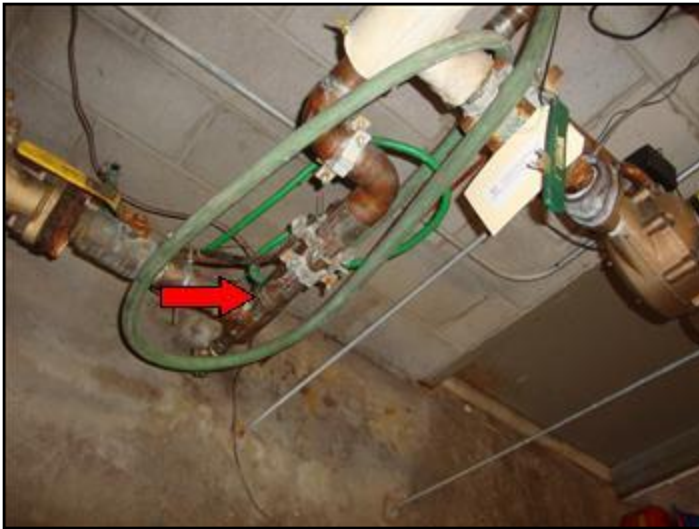
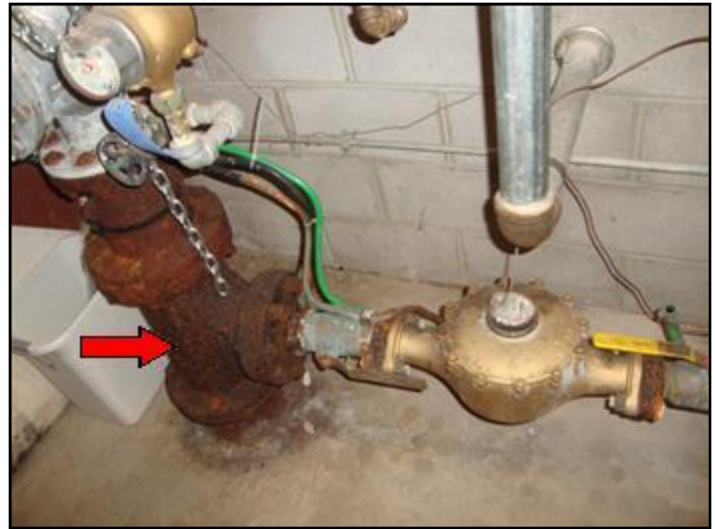
21. • Rust and evidence of past leak at service/sprinkler pipe.

**Task:** Monitor

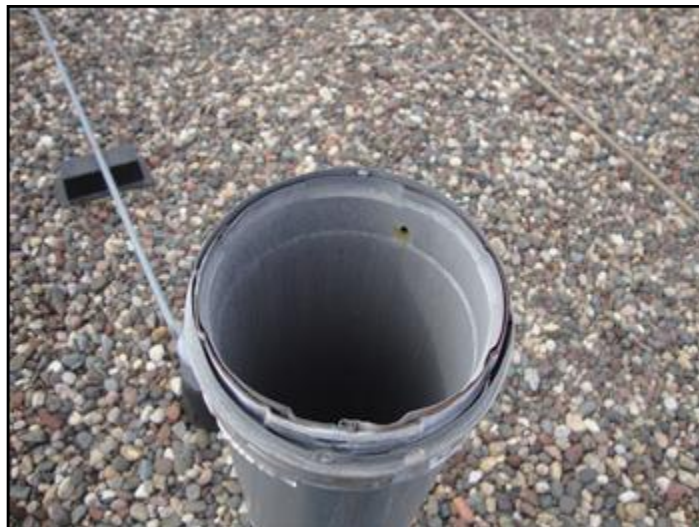
**Condition:** • Missing rain cap(s)

24. *Missing rain cap(s)*

**Task:** Provide

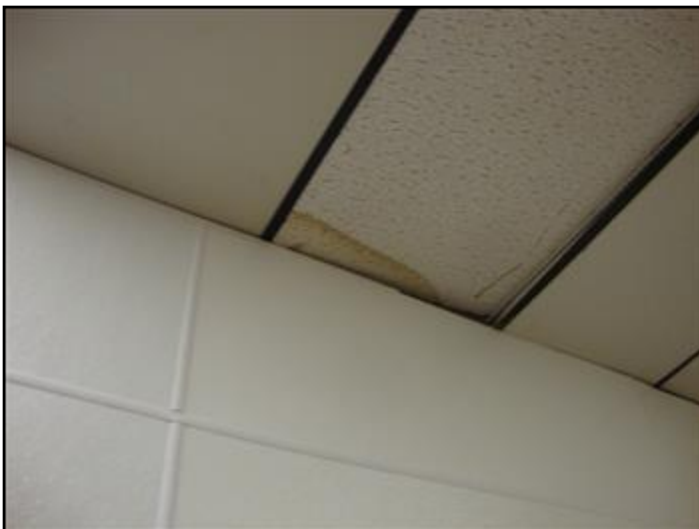
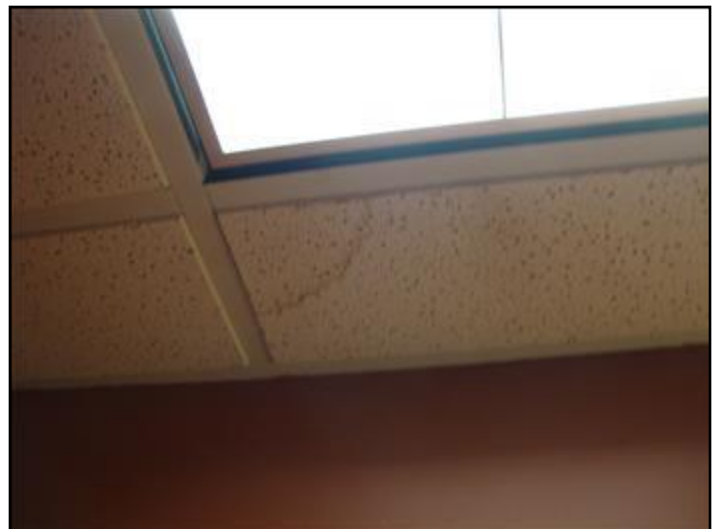
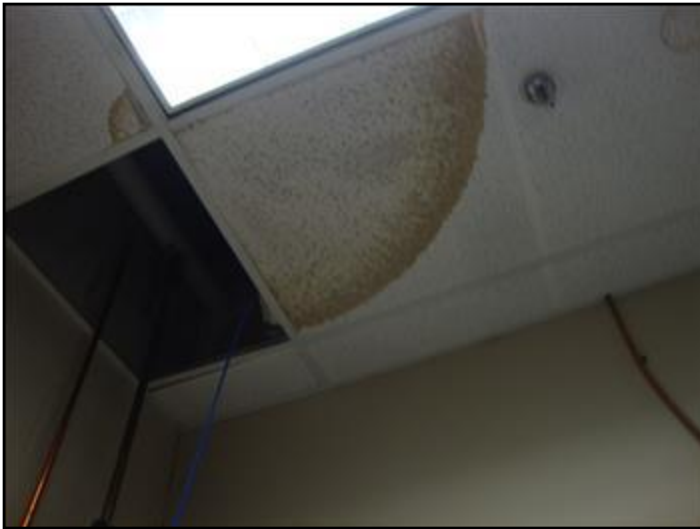
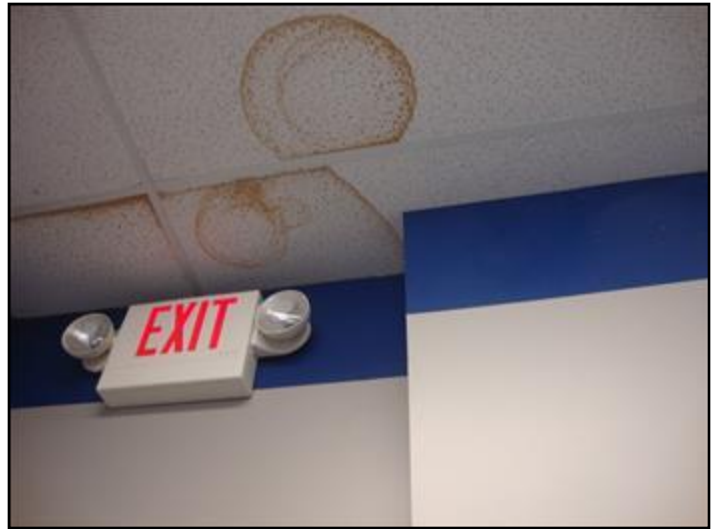
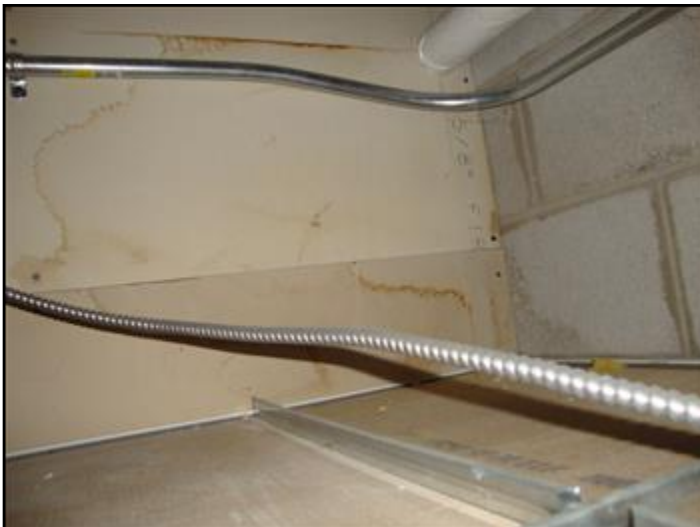
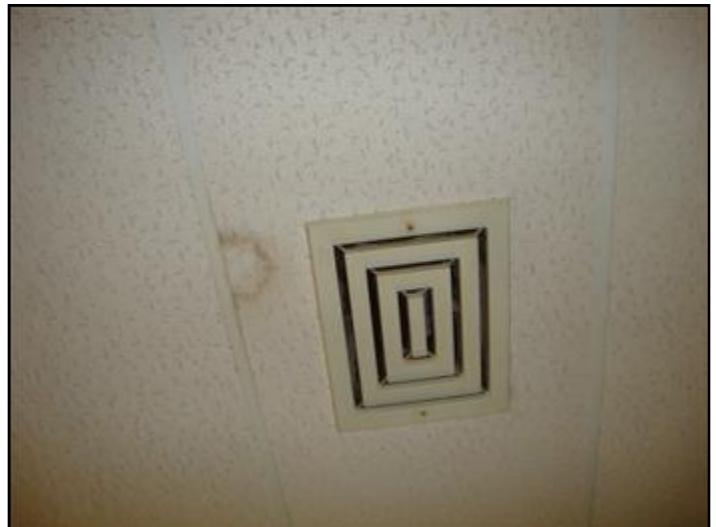
Minor water stains were observed on the suspended ceiling tiles at various locations. The stains were minor in scope and may be the result of condensation on wet sprinkler pipes or minor roof or plumbing leaks. No active leaks were observed.

25. Water stain

26. Water stain

27. Water stain

28. Water stain

29. Water stain

30. Water stain

**Task:** Monitor

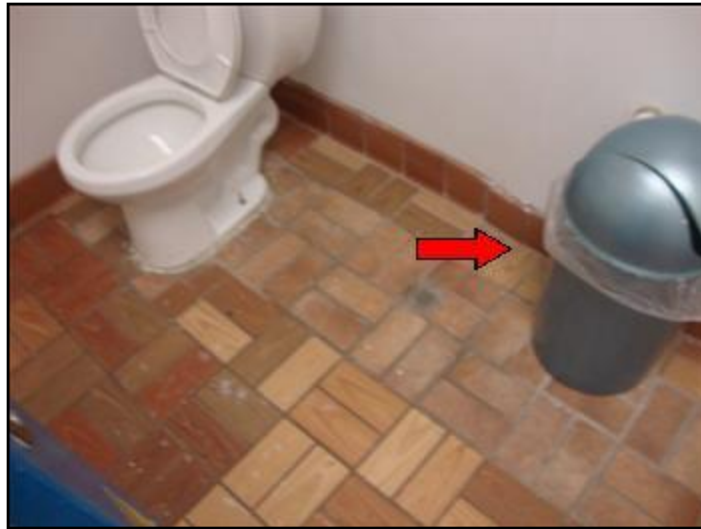
**Condition:** • Cracked tiles

31. Cracked tiles

**Task:** Repair

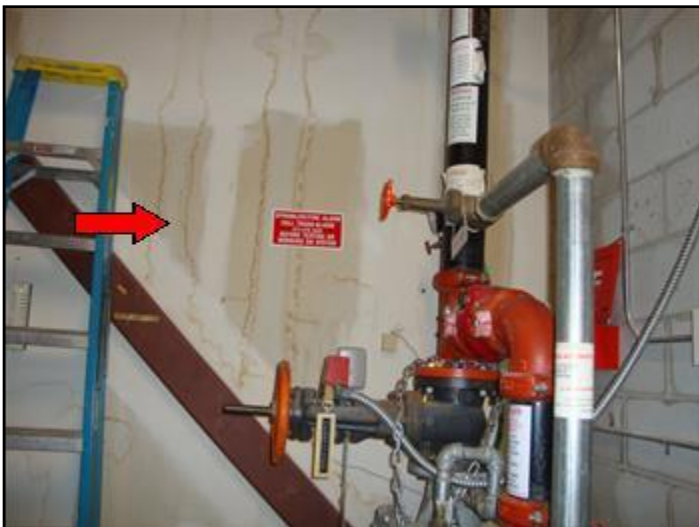
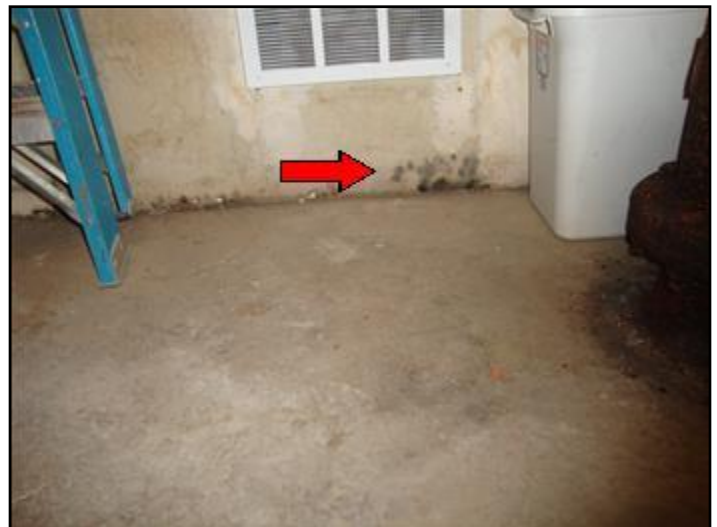
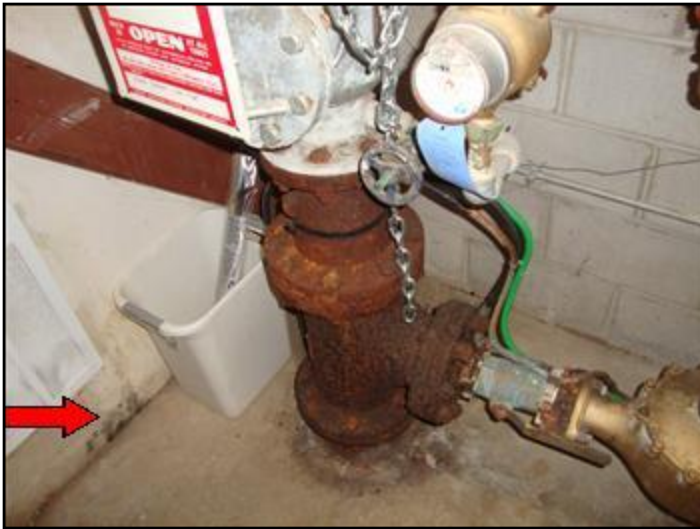
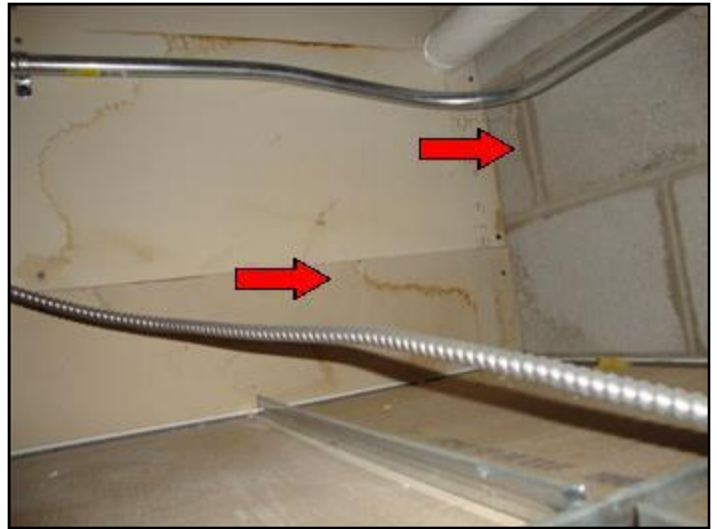
**Condition:** • A water stain was noted. Refer to the relevant sections of the report for discussions of the related systems. Likely from past plumbing leak.

32. A water stain was noted. Refer to the...

33. A water stain was noted. Refer to the...

34. A water stain was noted. Refer to the...

35. A water stain was noted. Refer to the...

**Task:** Repair

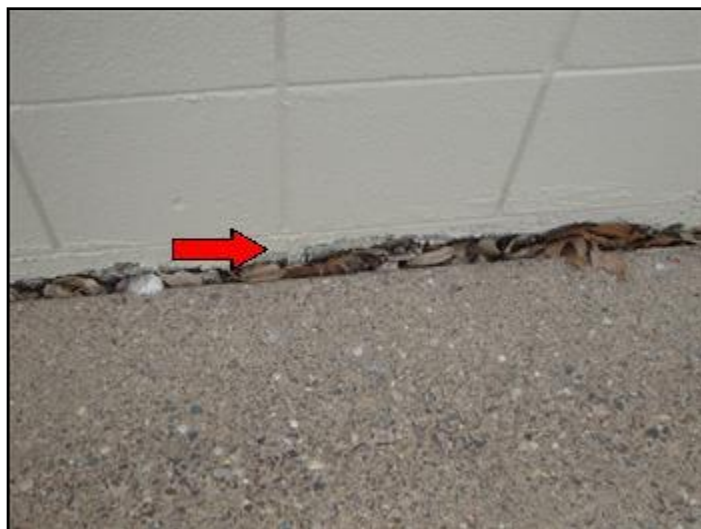
**Condition:** • Spalled

48. *Spalled*

**Task:** Repair

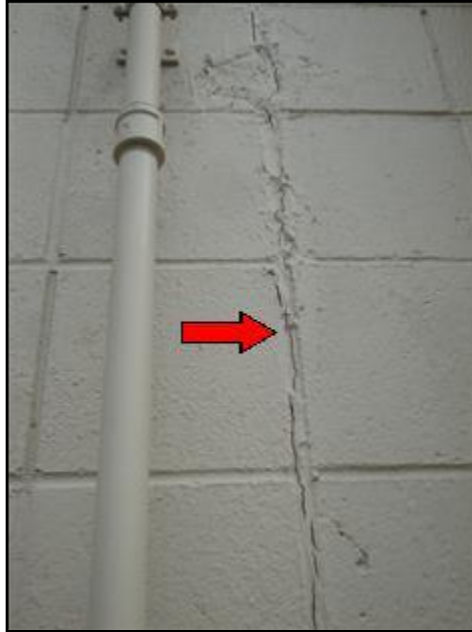
**Condition:** • Deteriorated caulking wall expansion joints

Sealants installed at expansion and control joints should typically be replaced every ten to twelve years. Prolonged exposure to sunlight and moisture can cause the sealants to shrink and crack, decreasing the protective properties of the sealants. Currently the sealants are in fair condition.

49. Deteriorated caulking wall expansion joints

**Task:** Repair or replace

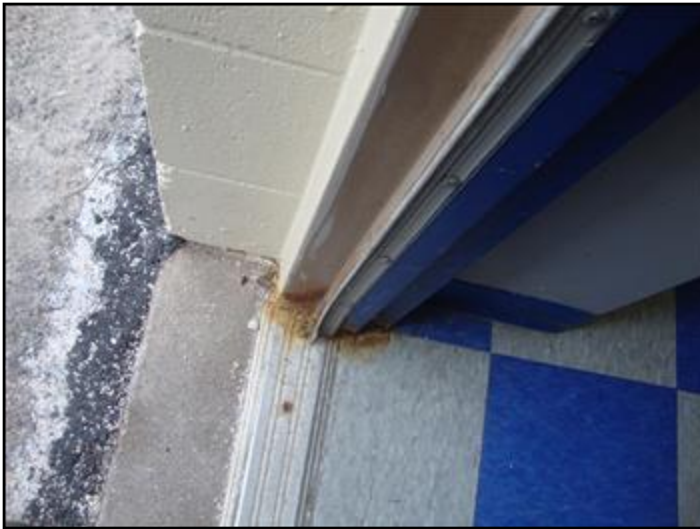
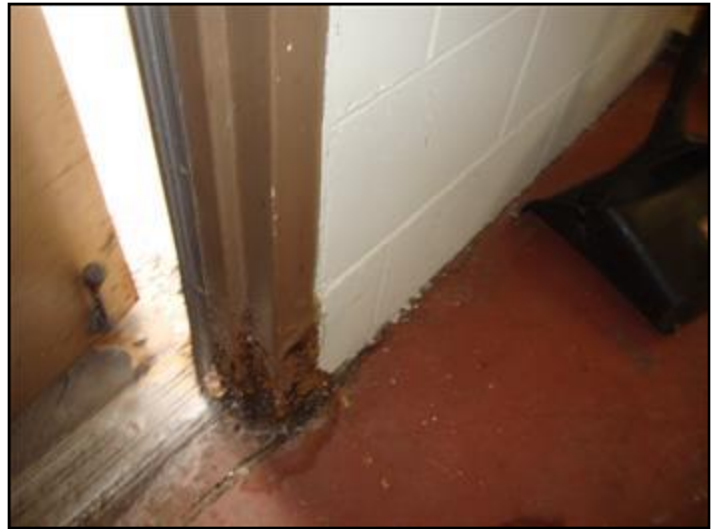
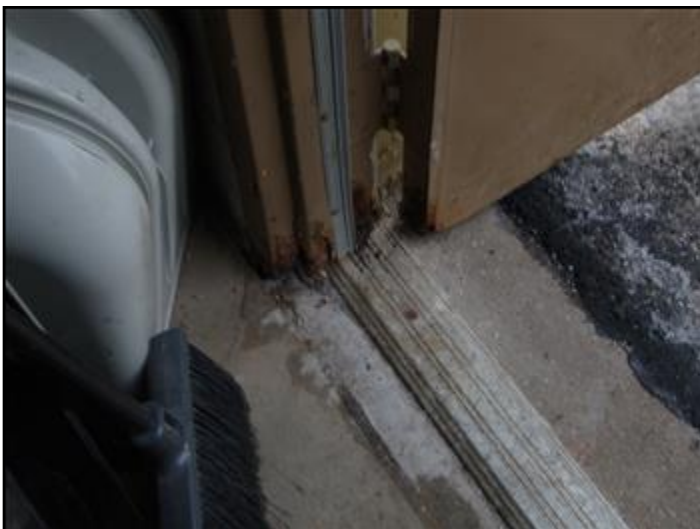
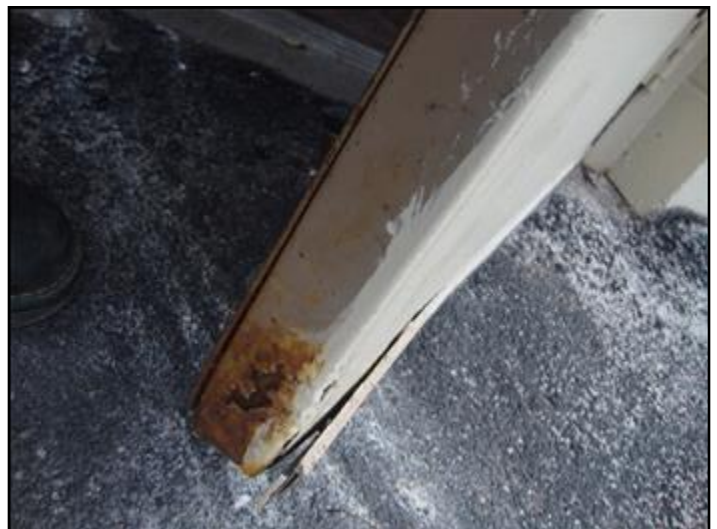
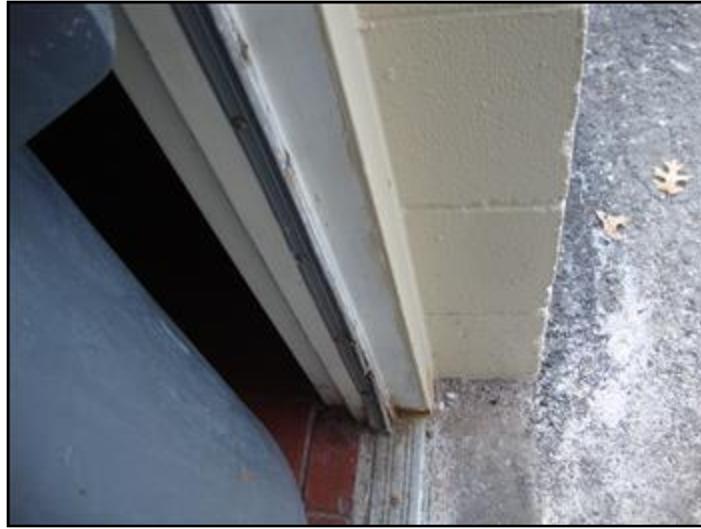
Typical minor to moderate corrosion was observed at rear personnel doors and frames. Recommend cleaning and painting affected surfaces as part of regular maintenance. Some of the frames were beginning to rust through. The worst damage was observed at 2554,2550,2548 and the electrical room.

50. Corroded

51. Corroded

52. Corroded

53. Corroded

54. Corroded

**Task:** Repair or replace

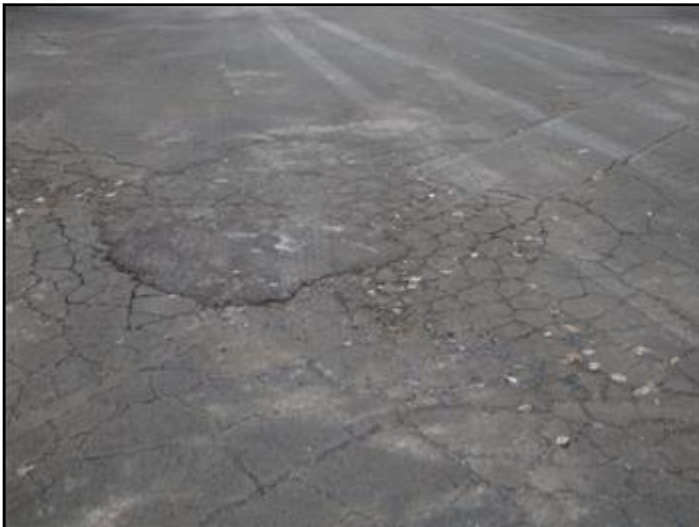
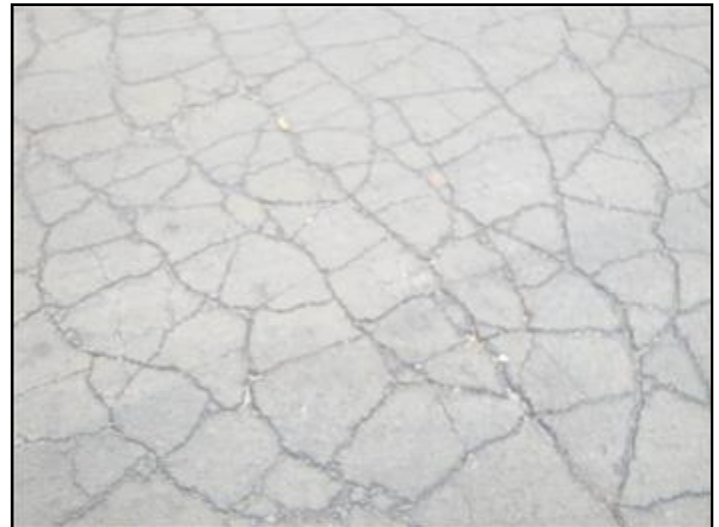
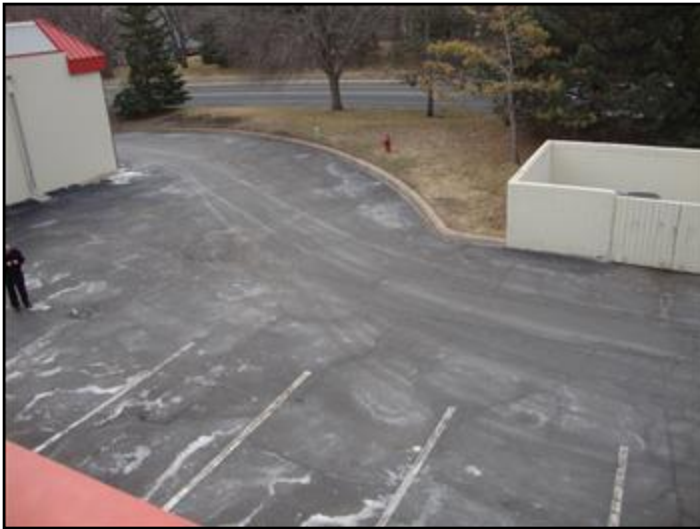
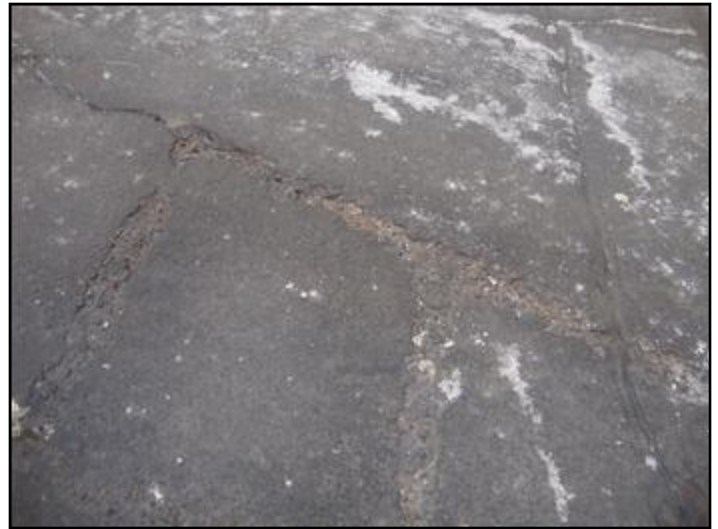
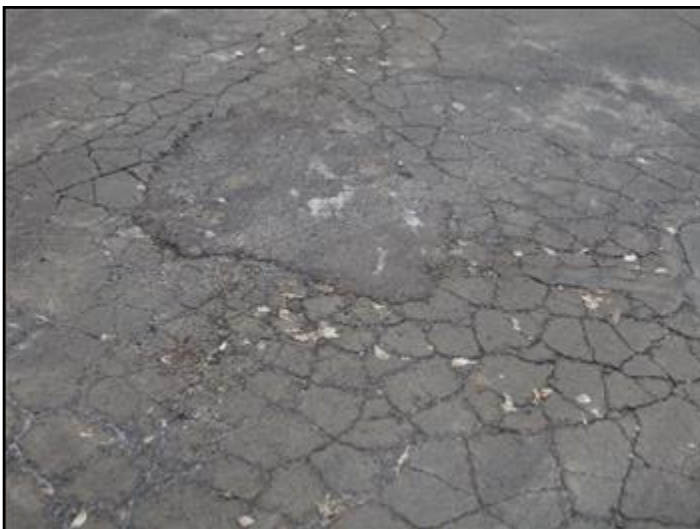
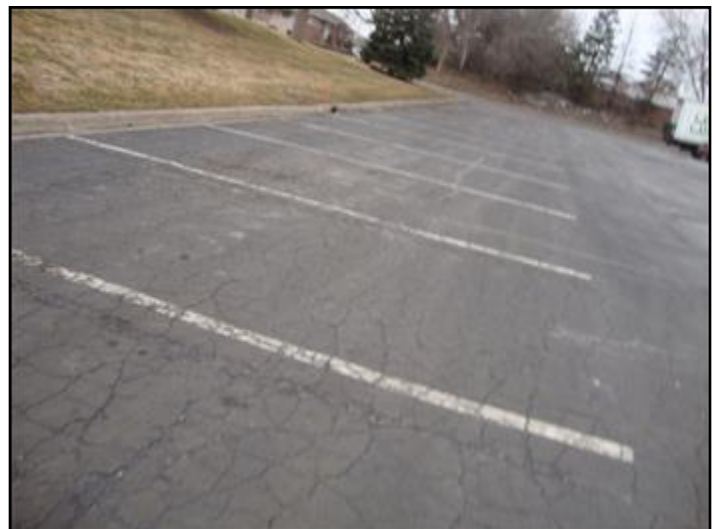
Several large cracks a surface are defects present. The parking surface will require major repair or replacement.

58. *Poor overall condition*

59. *Poor overall condition*

60. Poor overall condition

61. Poor overall condition

62. Poor overall condition

63. Poor overall condition

**Task:** Repair

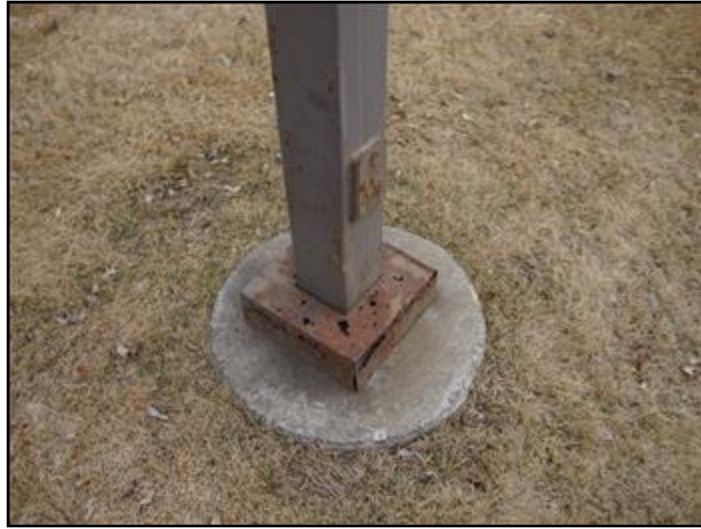
**Condition:** • Corroded lighting

Base coverers require replacement and poles are in need of paint.

**64.** *Corroded lighting*

**Task:** Repair
