UNIVERSAL ENGINEERING SCIENCES

April 17, 2015

Reference: **PAVEMENT EVALUATION**
LAKESIDE CONDOMINIUMS
25275 RAMPART BOULEVARD
Punta Gorda, Florida

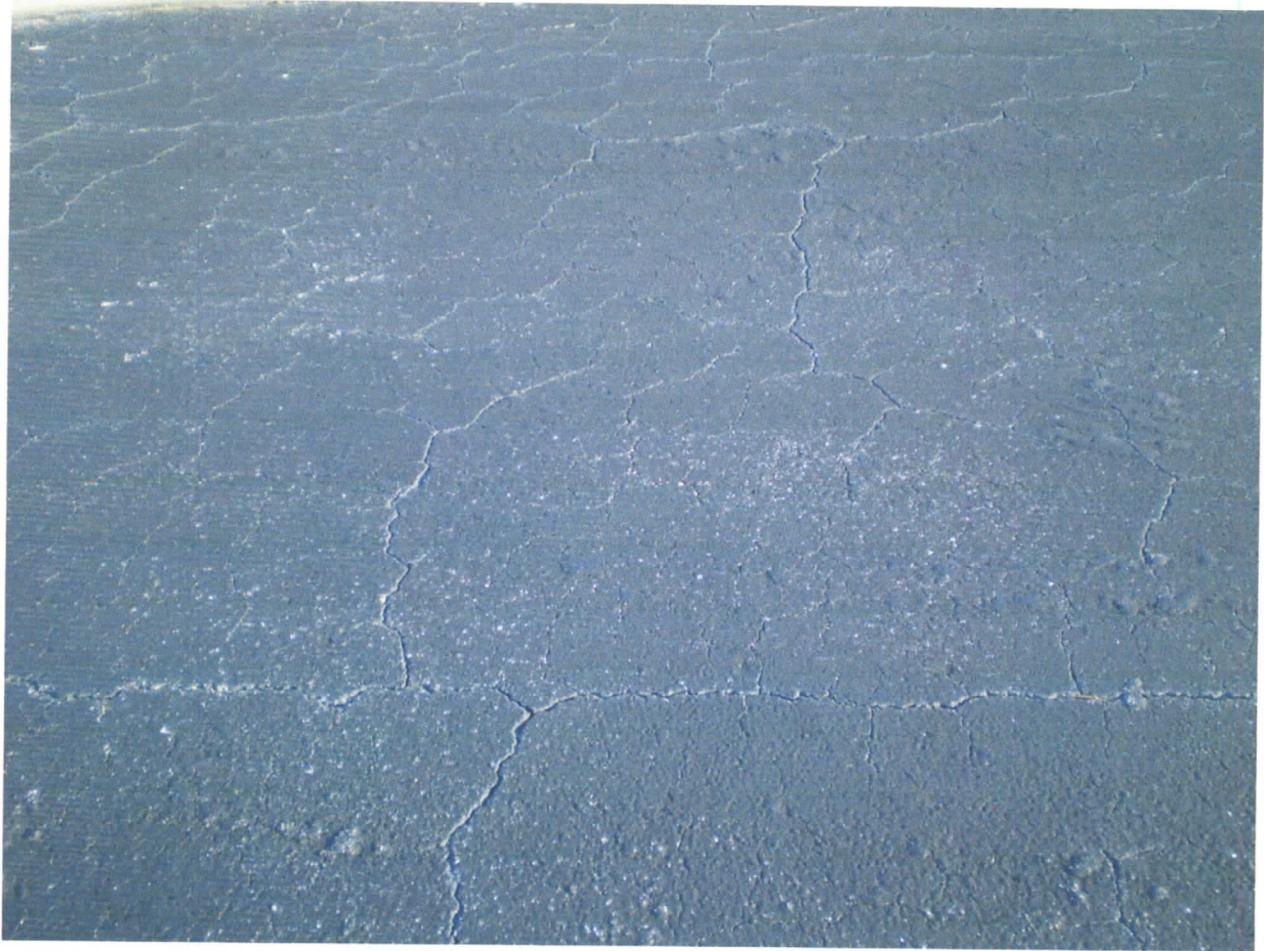
- There are widespread random block type cracks present throughout the drive and parking areas. We attribute most of this type of cracking to the age of the asphaltic concrete layers. As asphalt cement ages, it releases volatiles which cause the asphaltic concrete pavement to become more brittle inhibiting the ability to expand and contract with temperature cycles.

Photo#1- Typical Random Block Type Cracking

We believe the life of the existing pavement can be extended several years, until such time that complete reconstruction is undertaken by implementing an interim rehabilitation program. Although severely cracked, the existing pavement appears to be in a serviceable condition and does not appear to negatively impact vehicle or pedestrian traffic for the residences. The purposes of the rehabilitation program will be to slow the deterioration of asphaltic surface layer and to slow the degradation of the underlying base due to surface water intrusion. For the pavement at this site, we recommend the placement of a sand slurry surface treatment/seal coat to extend the current pavement life. The slurry seal should consist of a quick setting asphalt emulsion, fine aggregate, mineral filter, additives and water. The slurry should be spread with a squeegee in a manner that fills the existing cracks to the extent possible.

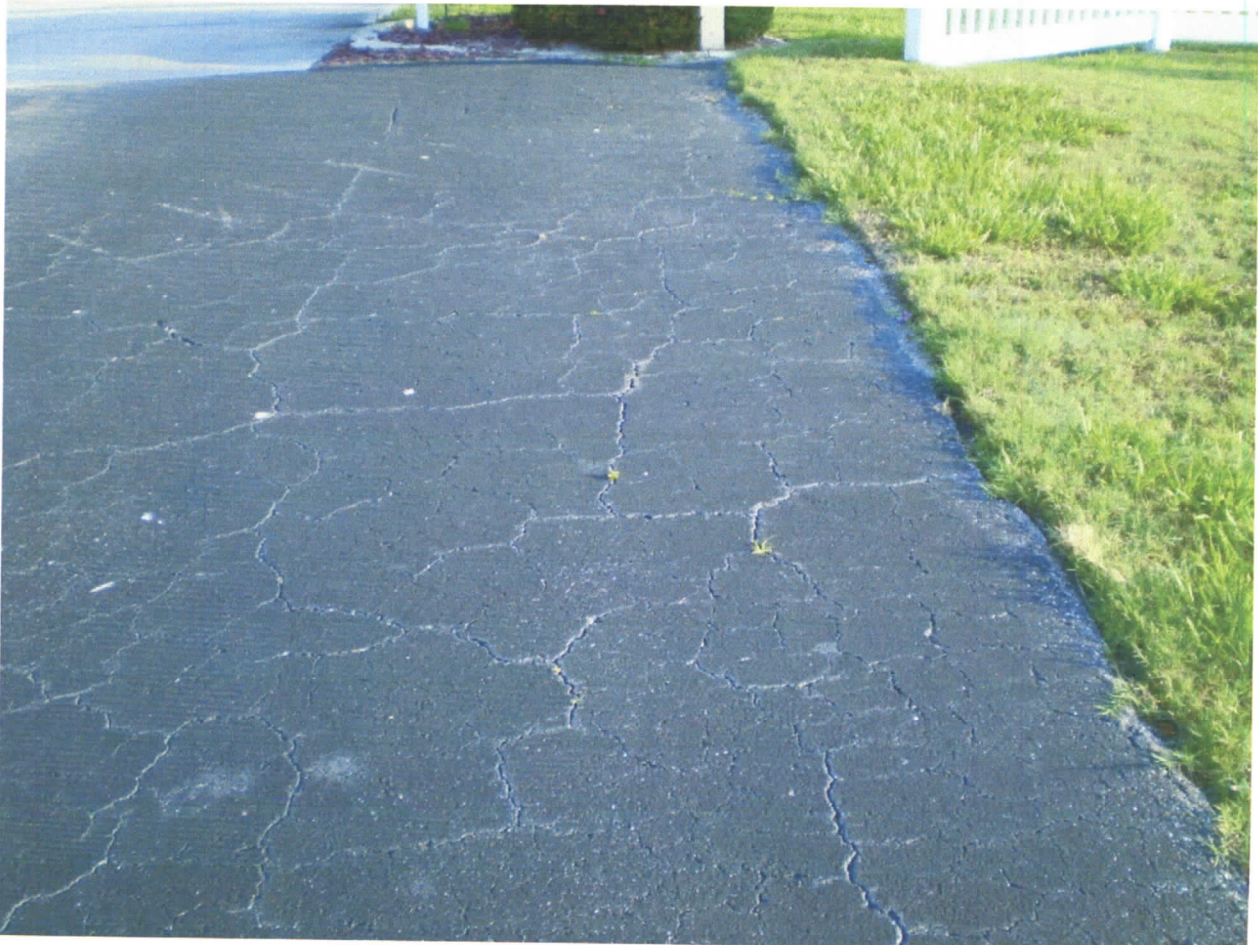
Photo#2- Typical Random Block Type Cracking

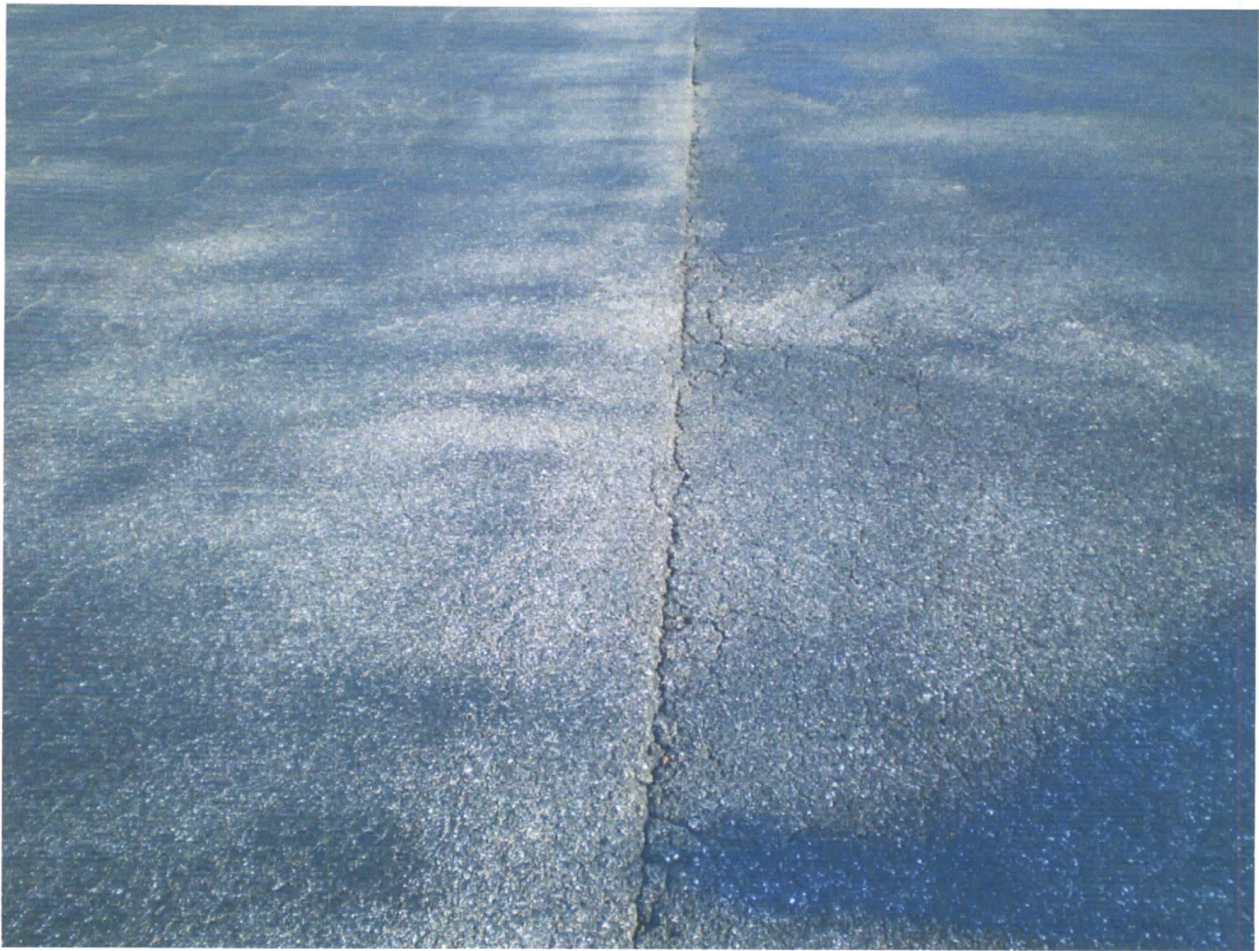
- Deterioration was present along some of the pavement joints. Generally, the compaction of the asphalt layer is lower at the interface of two paving lanes which over time fail prematurely (in relation to the main pavement) from raveling or cracking.
- No significant areas of alligator cracking, rutting or displacement indicative of a subgrade or base failure were evident. There was some minor alligator cracking in previous patch areas present immediately adjacent to the grate inlet in the low point of the pavement. The cracking is likely the result of saturated base due to accumulation of surface run off in these low areas.

Photo#3- Typical Open Pavement Joint

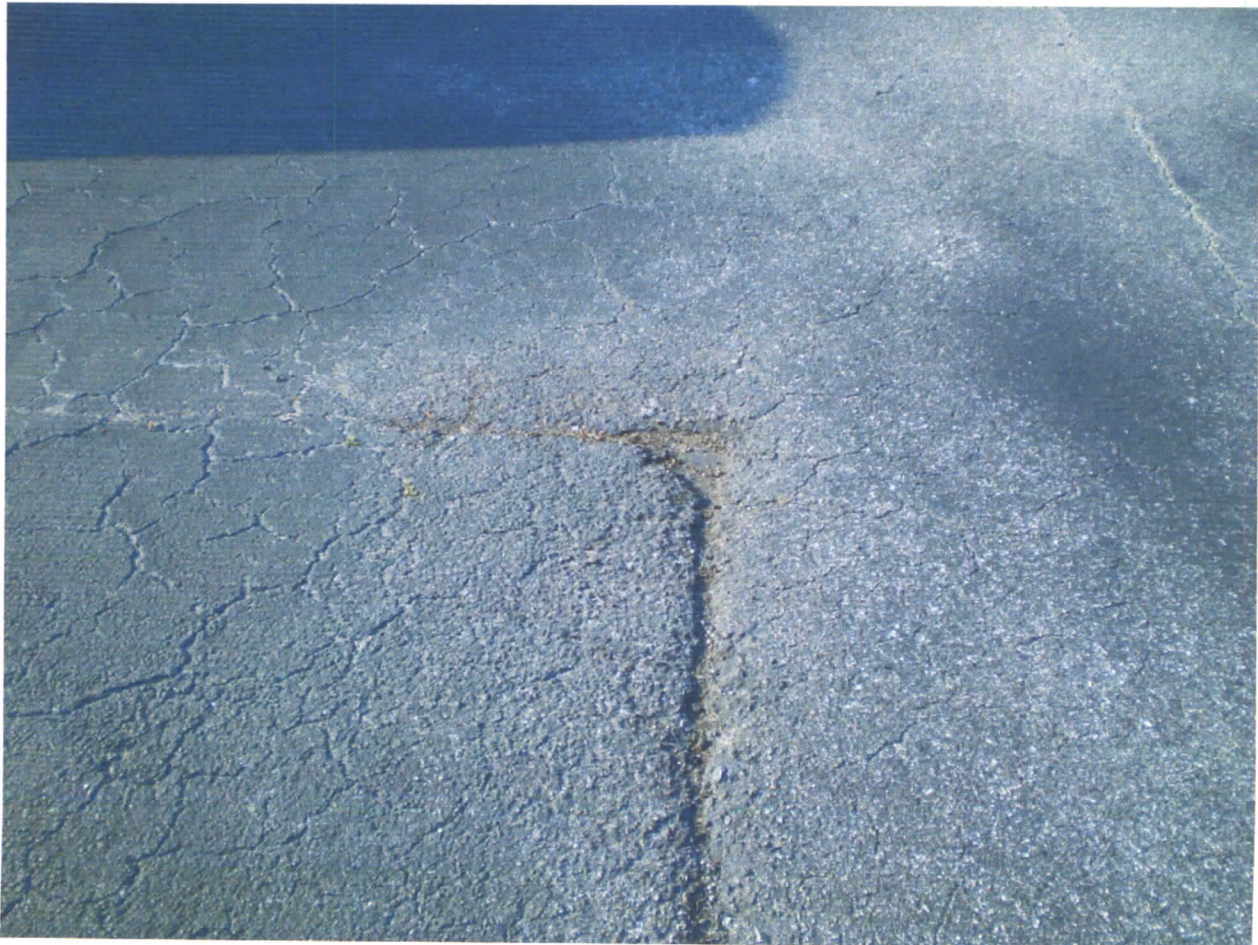
Photo#4- Typical Open Pavement Joint

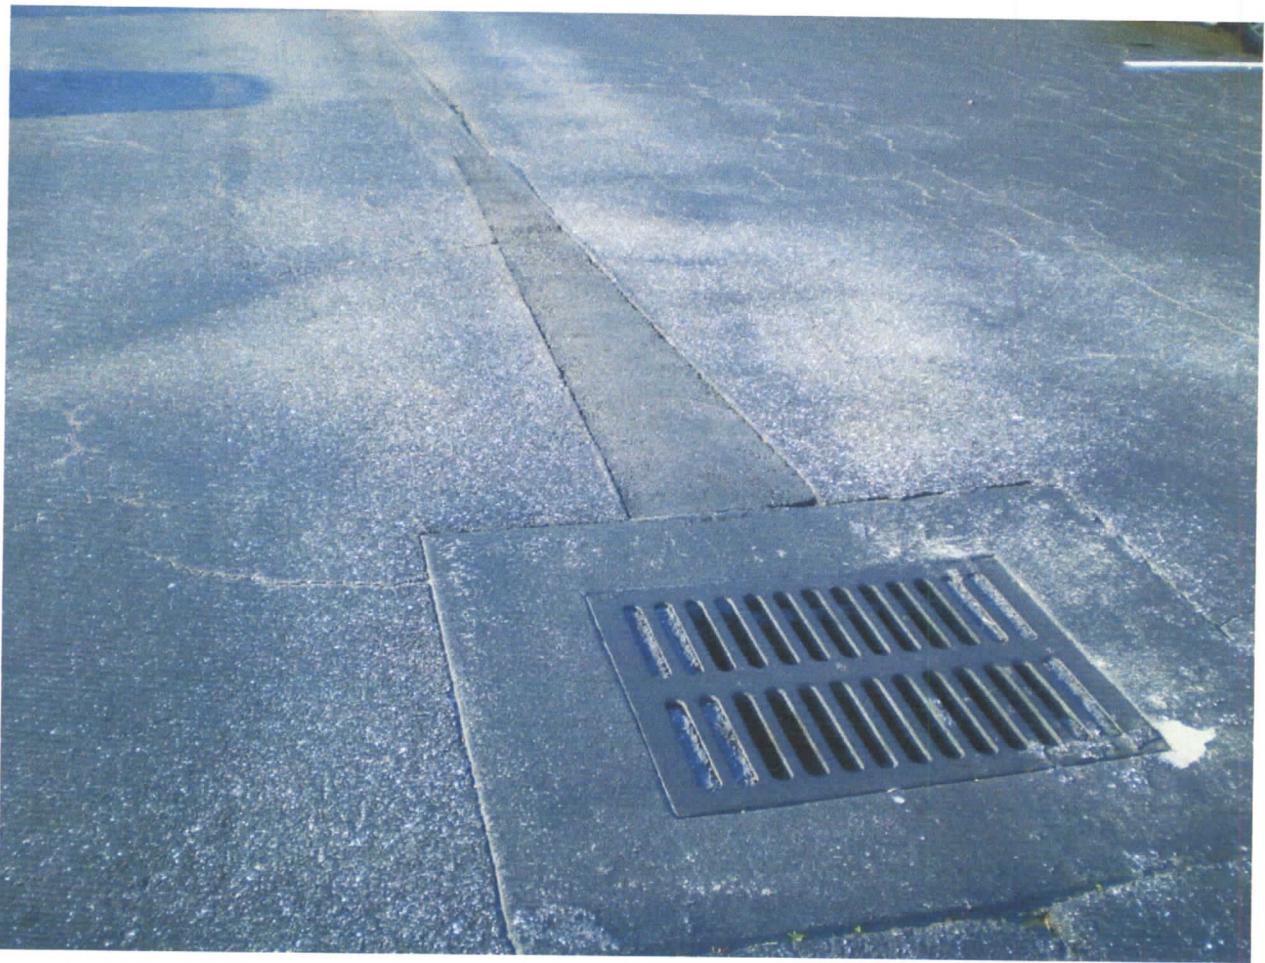
Photo#5- Patch in Low Point in Pavement Adjacent to Grate Inlet

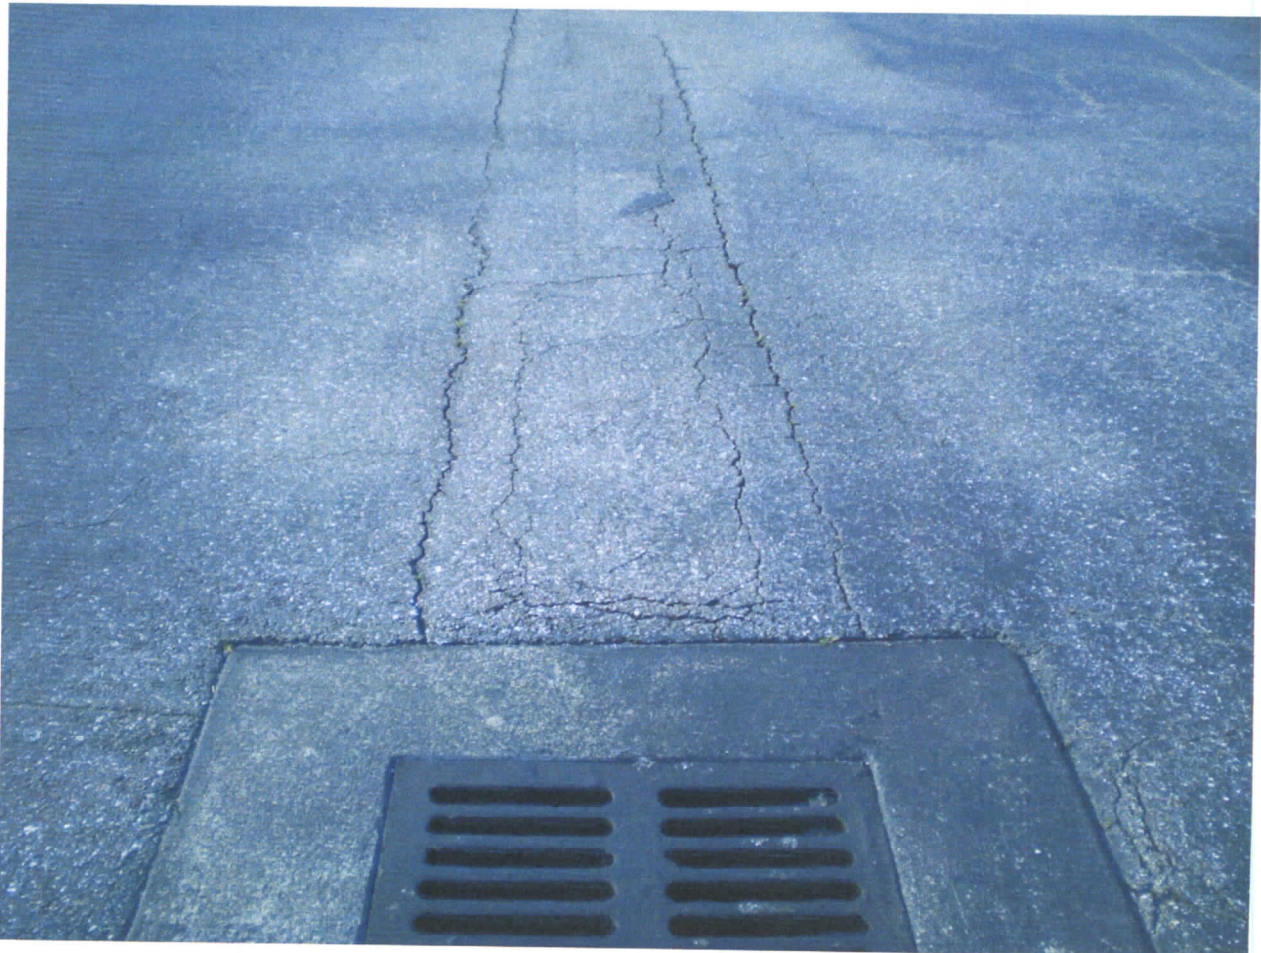
Photo#6- Cracking Near Low Point in Pavement Next to Grate Inlet

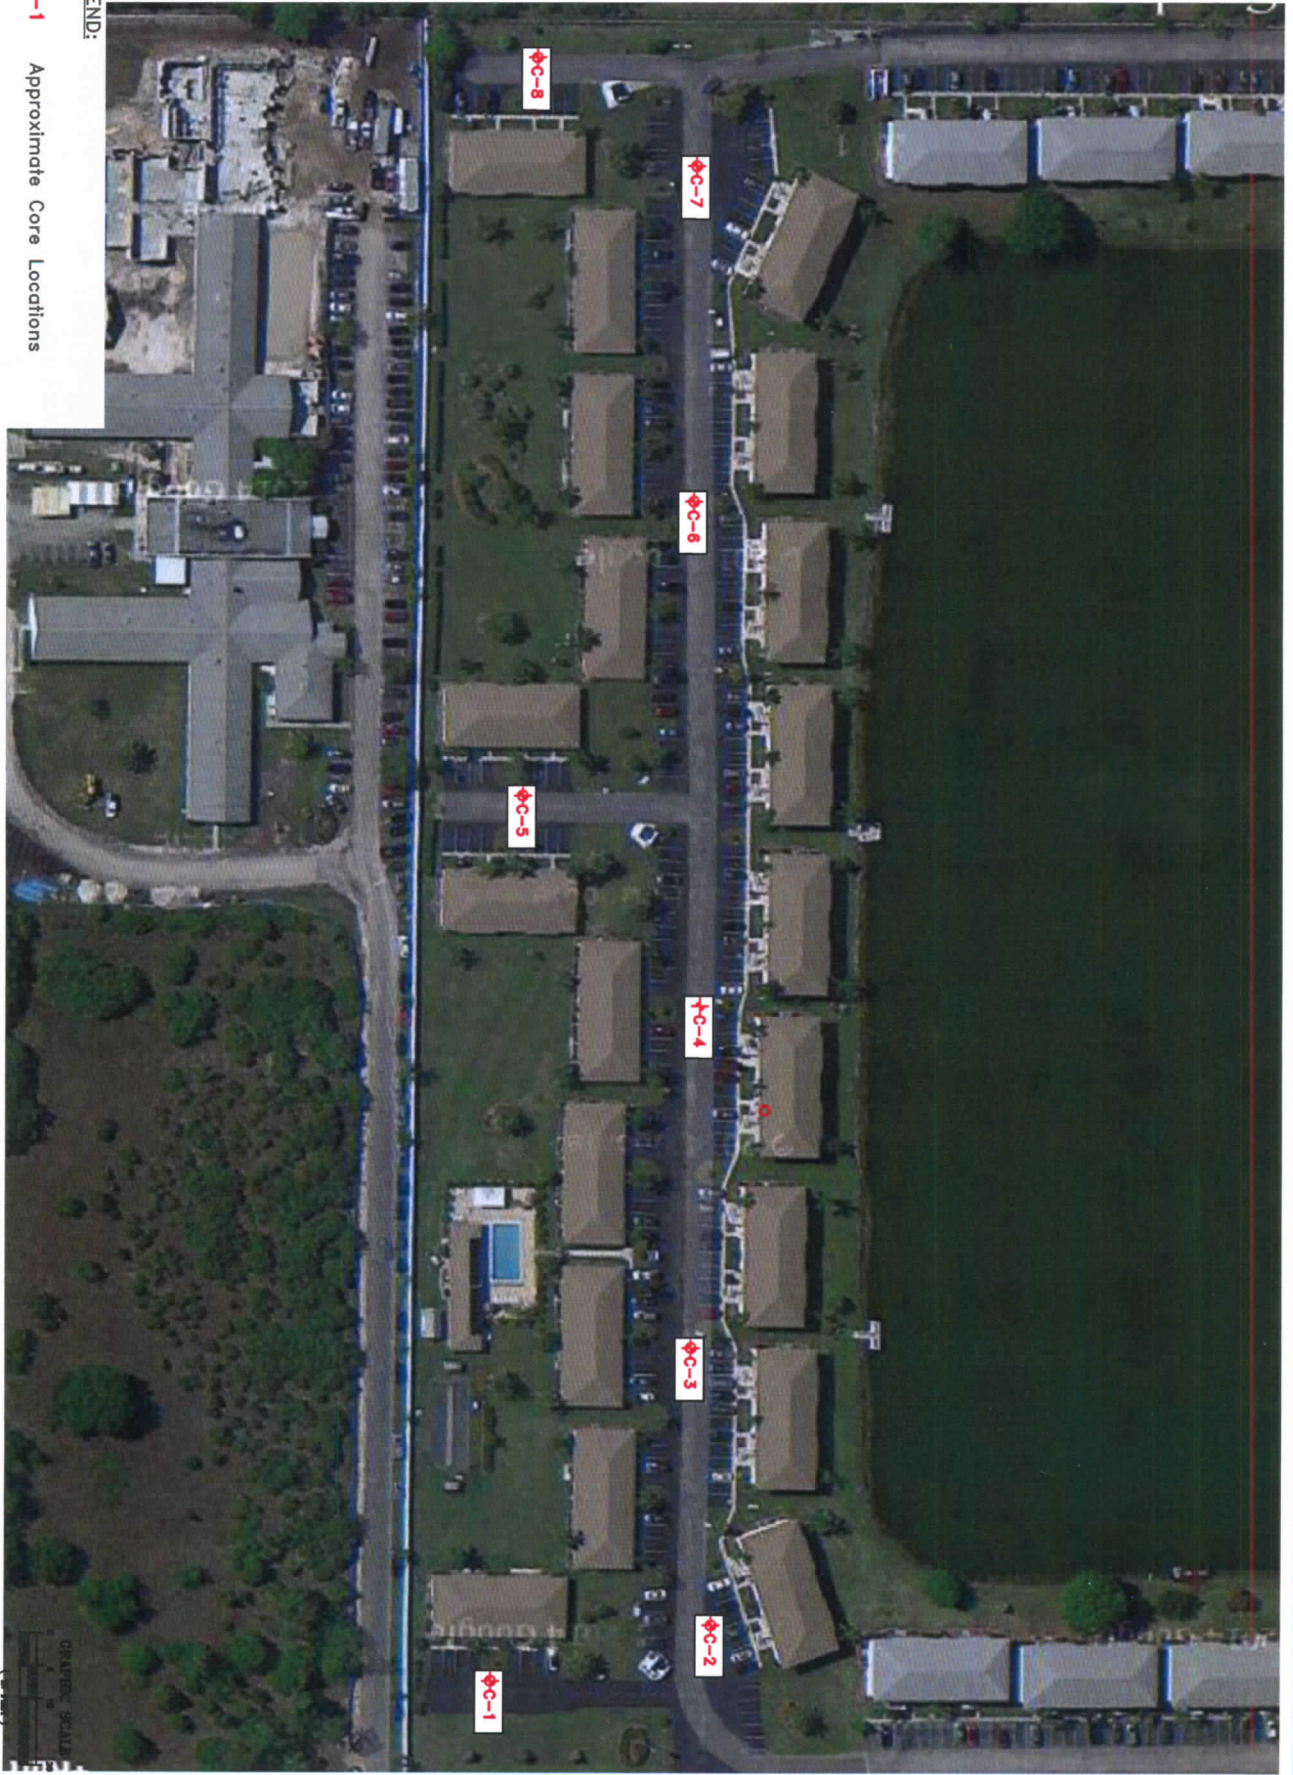
CORE LOCATION PLAN

TEST #	LOCATION	ASPHALT THICKNESS (Inches)			BASE THICKNESS (Inches)
		Top Layer	Bottom Layer	Total	
1	See Core Location Plan	1.1"	0.8"	1.9"	6.5"
2	See Core Location Plan	0.8"	1.1"	1.9"	8.0"
3	See Core Location Plan	1.1"	0.7"	1.8"	7.5"
4	See Core Location Plan	0.9"	1.1"	2.0"	8.0"
5	See Core Location Plan	1.5"	0.6"	2.1"	8.0"
6	See Core Location Plan	0.8"	1.4"	2.2"	7.5"
7	See Core Location Plan	0.5"	1.0"	1.5"	7.0"
8	See Core Location Plan	1.2"	1.1"	2.3"	6.0"
Average		1.0"	1.0"	2.0"	7.3"

1. Bottom layer of asphalt appeared to be an old FDOT Type II or III.
2. Top layer of asphalt appears to be a fine S-3 Mix.
3. The base appeared to be Bank Run Shell.
4. A well defined stabilized subgrade layer was not evident below the base.
