For the Property at:
1SOMEPLACE
SOMEWHERE, NS

Prepared for: CAHPI ATLANTIC
Inspection Date: Friday, January 22, 2010
Prepared by: Armand Dufresne

Total Check Home Inspection
216 New Harbour Road, Suite RR1 Hubbards
Blandford, NS B0J1T0
1 866 704 4888
Fax: 1 866 704 4888

Report No. 1116, v.0

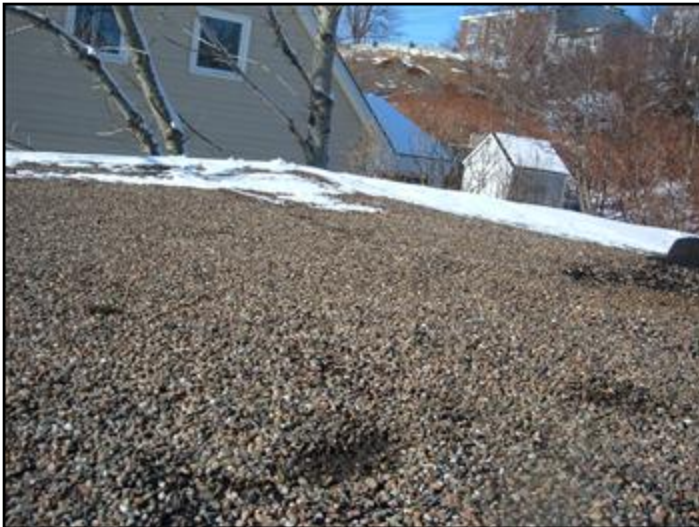
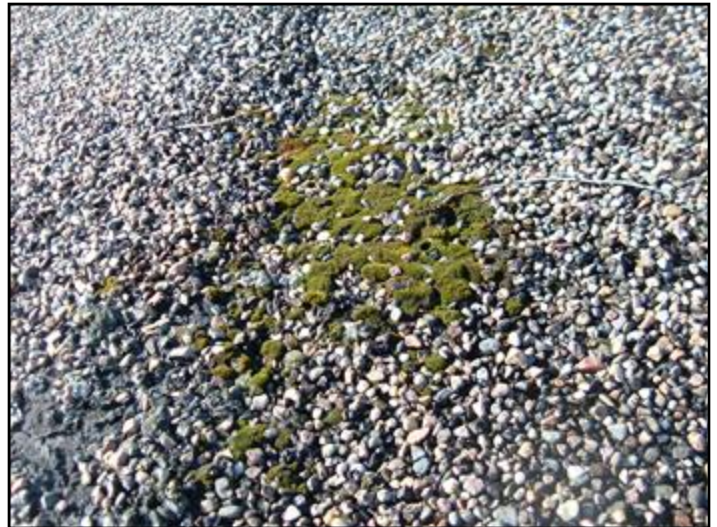
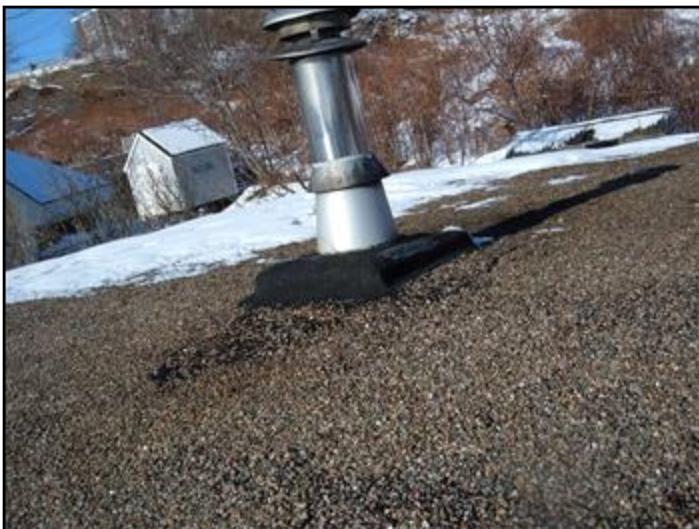
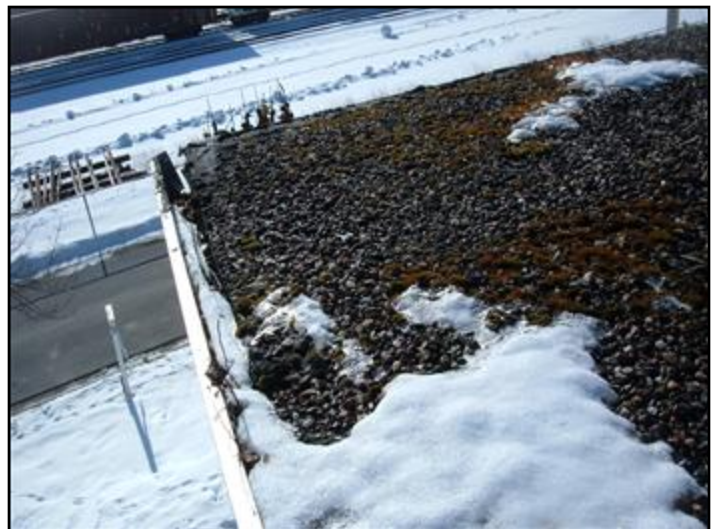
• Roof and roof flashing in very poor condition.

Implication(s): Risk of leaks, damage to contents. Cost of repair. Insurance concerns

Task: Replace

Time: Immediate

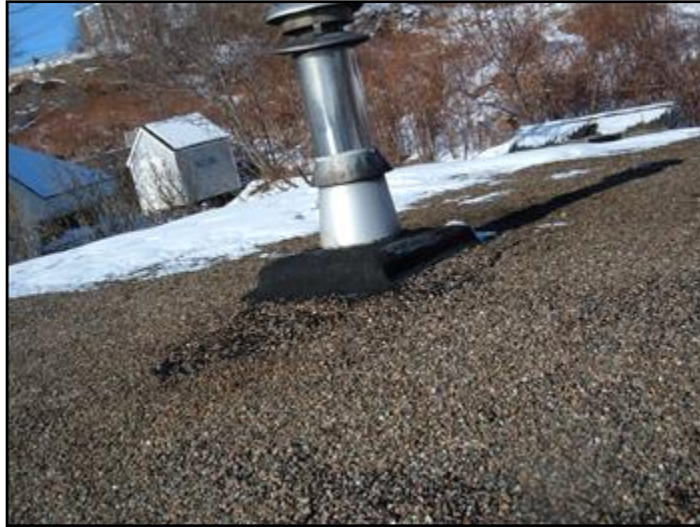
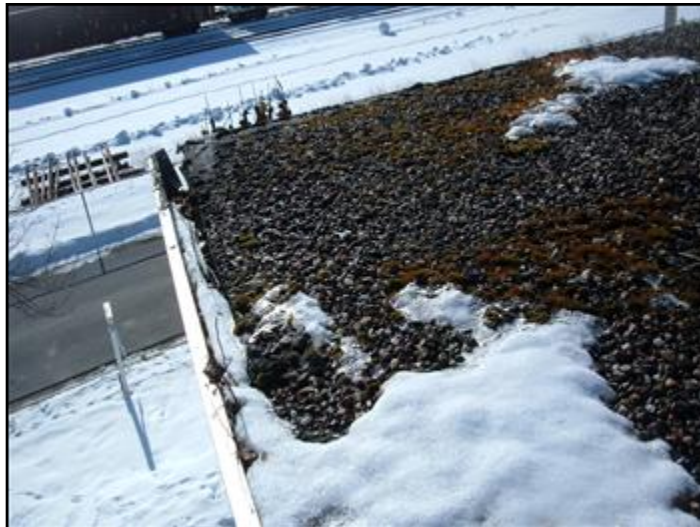
SLOPED ROOF FLASHINGS \ Roof/wall flashings

Condition: • Damage, loose, open seams, patched

Location: Left Side Yard Roof

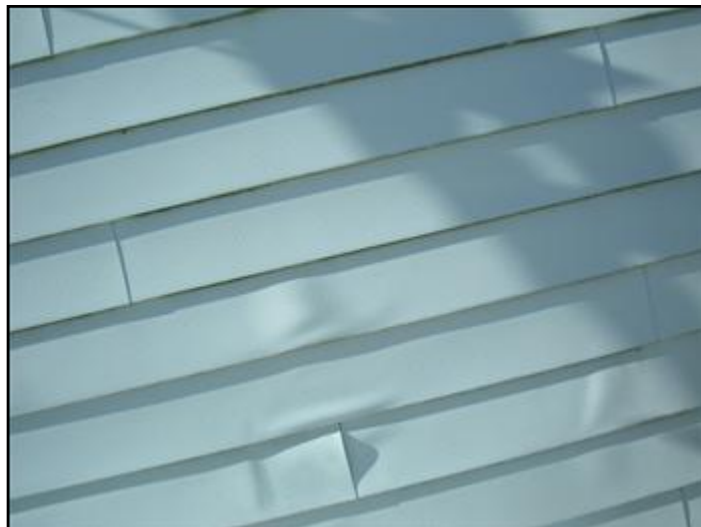
9.

WALLS \ Vinyl siding

Condition: • Buckled or wavy

Location: Right Side Exterior

Task: Repair or replace

Time: Discretionary

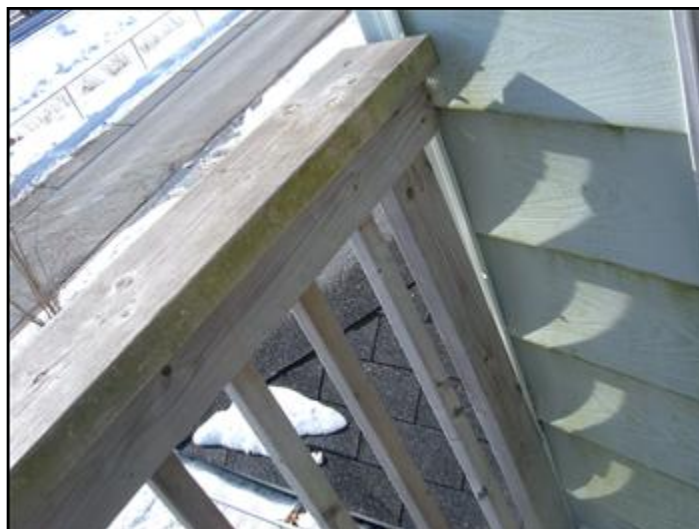
10.

PORCHES, DECKS, STEPS, PATIOS AND BALCONIES \ Handrails and guards

Condition: • Weak

Post is loose and too small

Location: Deck

Task: Improve

Time: Immediate

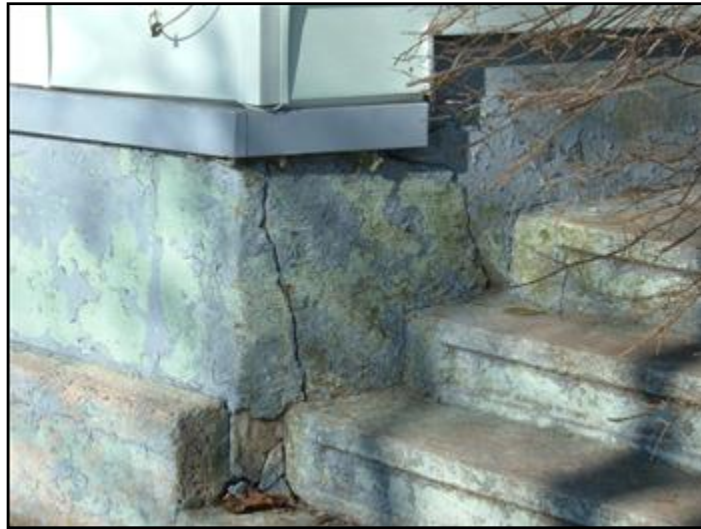
11.

Condition: • Cracked

Location: Left Side Exterior Wall

Task: Repair or replace

Time: Discretionary

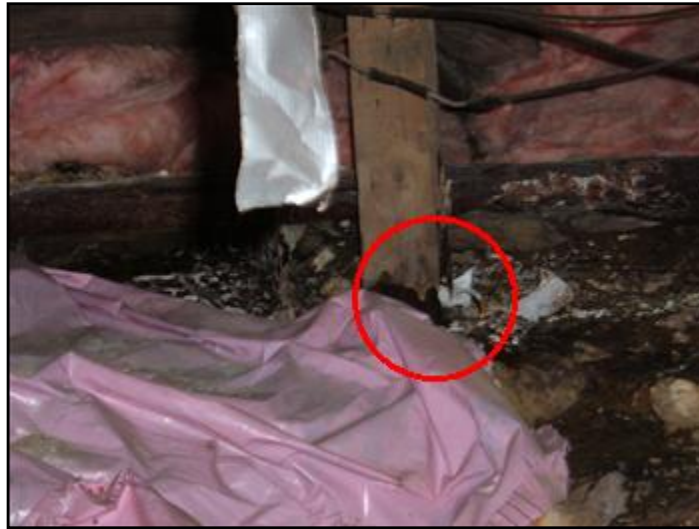
12.

Condition: • Poorly secured at top or bottom

Location: Crawl Space

Task: Repair

Time: Immediate

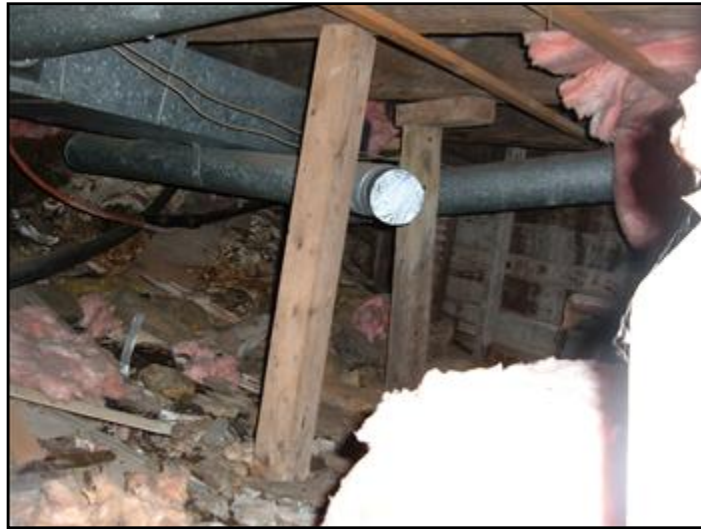
13.

Condition: • No footing

Location: Various Crawl Space

Task: Provide

Time: Immediate

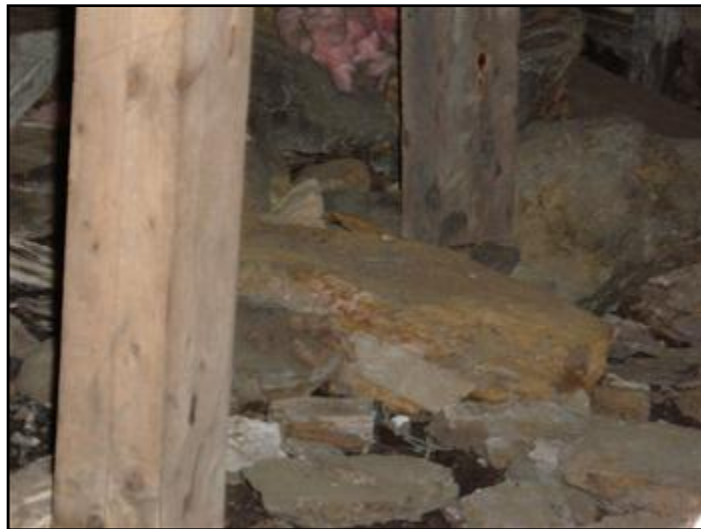
14.

FLOORS \ Beams

Condition: • Sag

Location: Crawl Space

Task: Repair or replace

Time: Discretionary

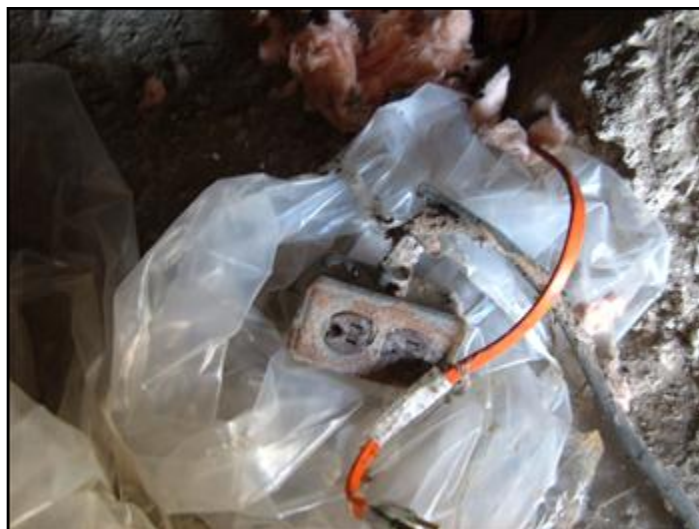
17.

DISTRIBUTION SYSTEM \ Wiring - damaged or exposed

Condition: • Damaged and exposed wire and box in crawl space entry

Implication(s): POSSIBLE SHOCK HAZARD, INJURY

Location: Crawl Space

Task: Repair or replace

Time: Immediate

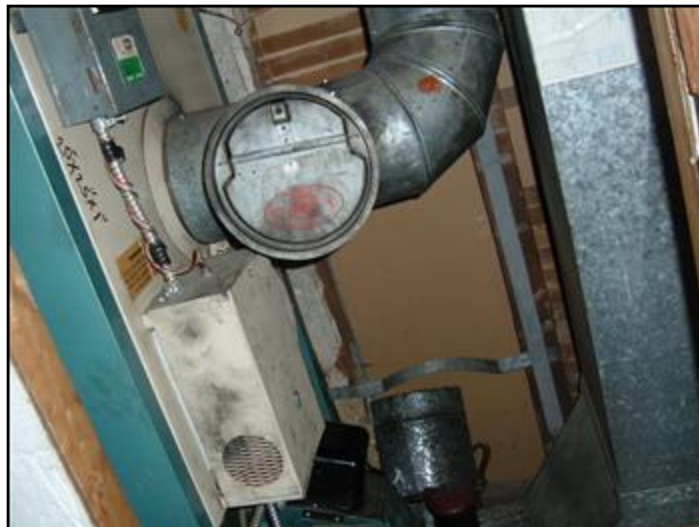
20.

OIL FURNACE \ Life expectancy

Condition: • Near end of life expectancy

Location: First Floor Kitchen

Task: Replace

Time: Discretionary

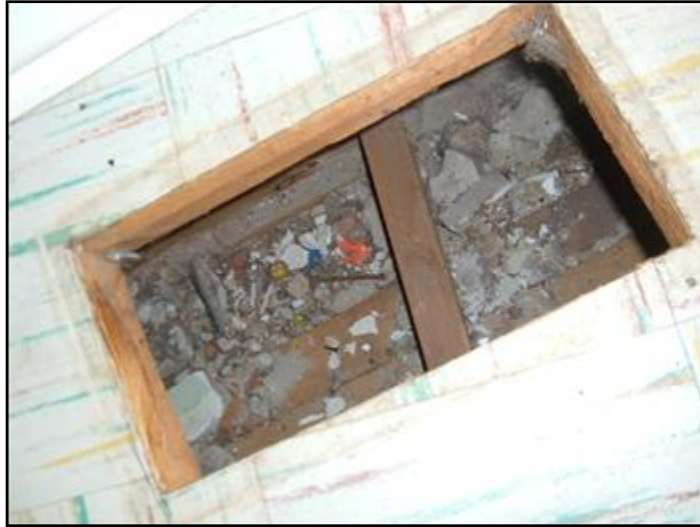
21.

OIL FURNACE \ Ducts, registers and grilles

Condition: • Dirty, obstructed or collapsed

Condition: • Missing

The is no duct work for return aria. Ceiling being used as a duct.

Task: Provide

Time: Immediate

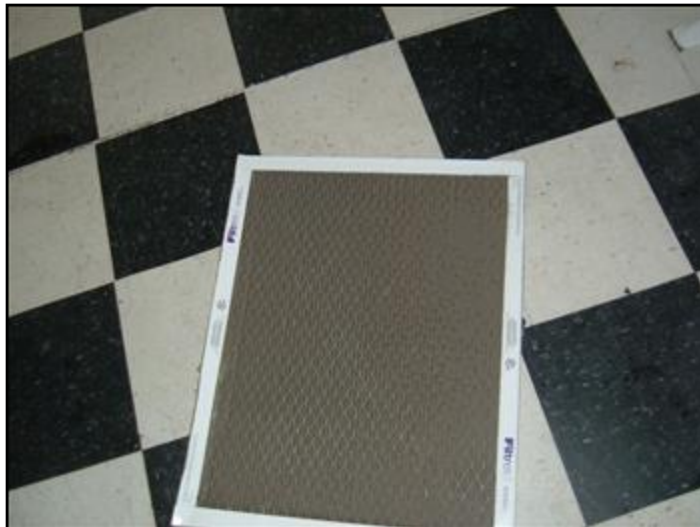
22.

OIL FURNACE \ Mechanical air filter

Condition: • Dirty

Location: First Floor Kitchen

Task: Replace

Time: Immediate

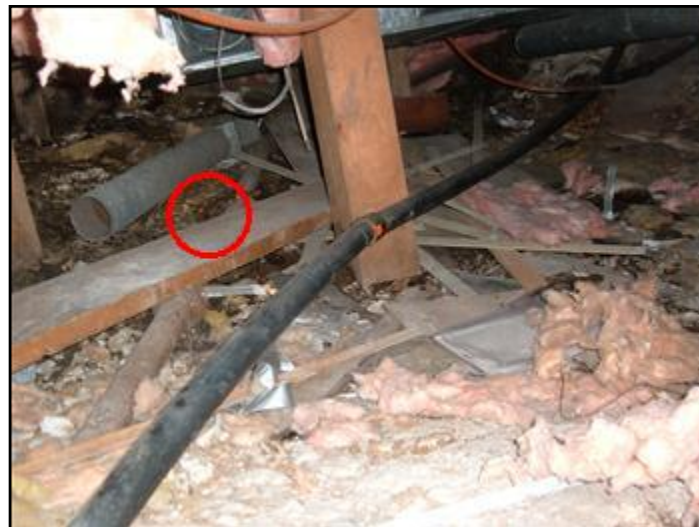
24.

WASTE PLUMBING \ Drain piping - performance

Condition: • Cast iron pipe broken in crawl space. Risk of sewer gases entering house. Health hazard.

Implication(s): Health hazard.

Location: Crawl Space

Task: Replace

Time: Immediate

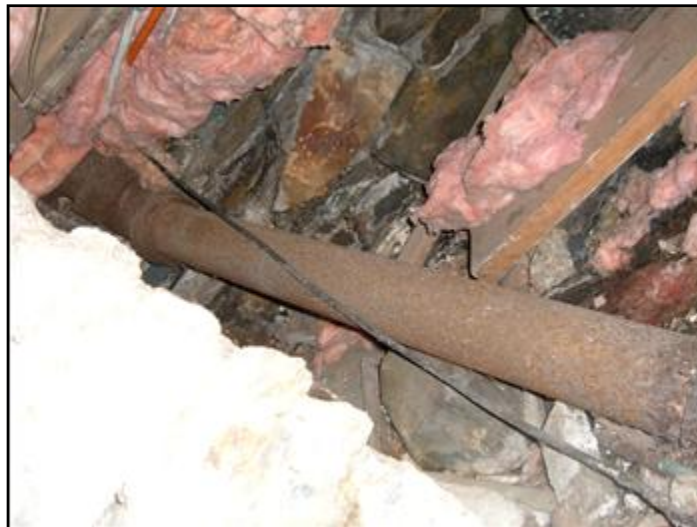
25.

Condition: • Poor slope

Location: Crawl Space

Task: Improve

Time: Discretionary

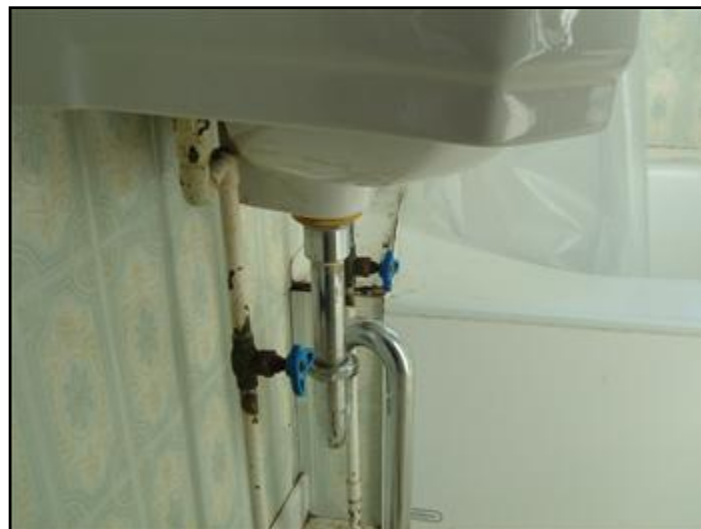
26.

FIXTURES AND FAUCETS \ Faucet

Condition: • Drip, leak

Location: Second Floor Bathroom

Task: Repair

Time: Immediate

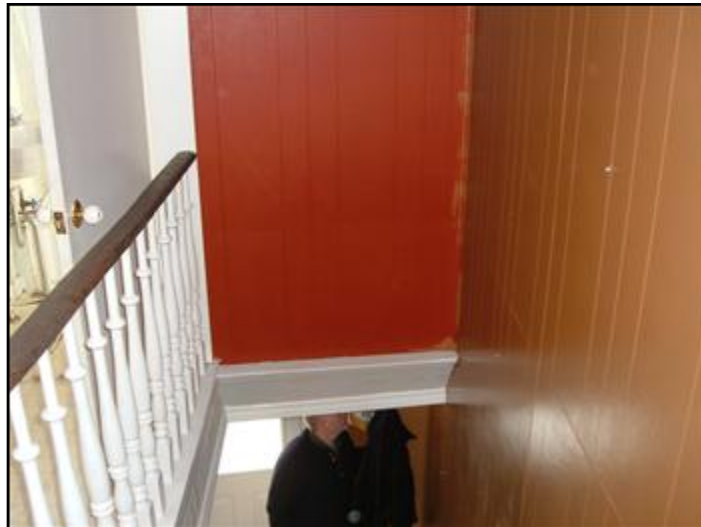
33.

STAIRS \ Handrails

Condition: • Damage

Task: Repair

Time: Immediate
