Insight Home Inspections

Home Inspection Report

850 E 95th St

Inspected on Fri, Nov 2 2018 at 9:04 AM

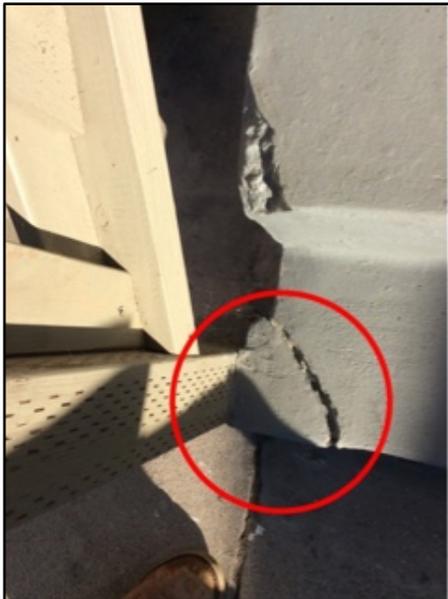
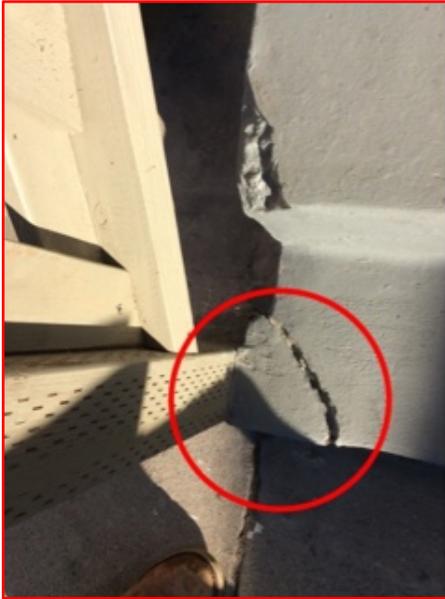
Figure 1-1

Comment 1:
Concrete step is cracked and separated at banister post. Repair is needed.

- 1) Concrete step is cracked and separated at banister post. Repair is needed.

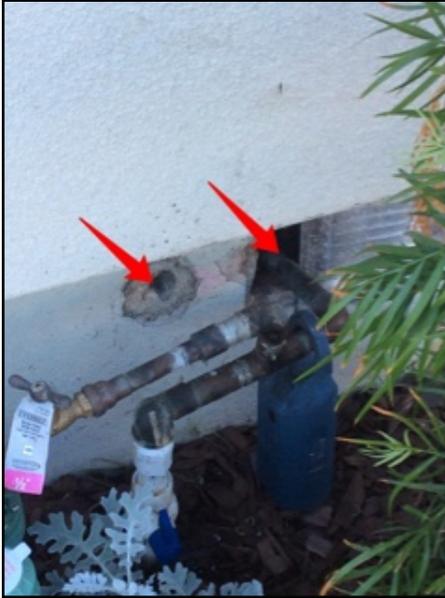
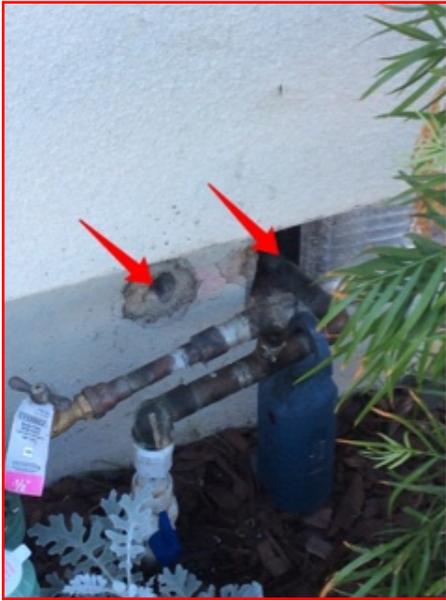
Figure 2-1

Recommend patching hole and covering crawlspace vent to prevent intrusion of animals.

- 2) Recommend patching hole and covering crawlspace vent to prevent intrusion of animals.

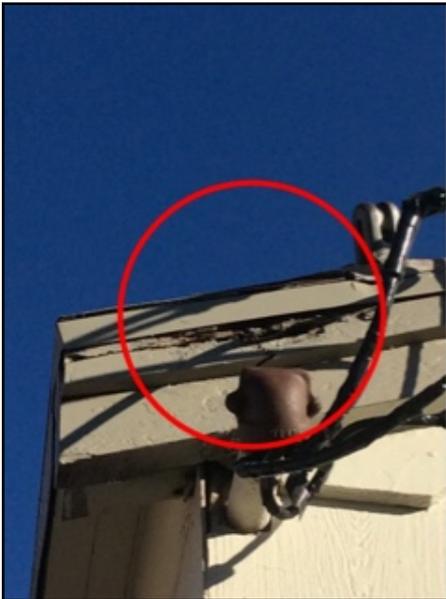
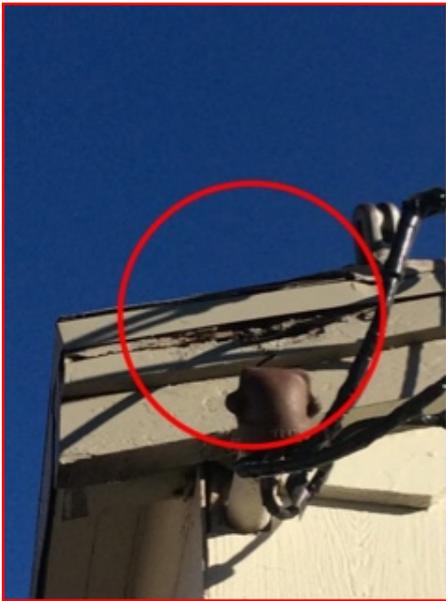
Figure 4-1

Areas of dry rot and/or termite damage along eaves and fascia. Recommend repair.

3) Areas of dry rot and/or termite damage along eaves and fascia. Recommend repair.

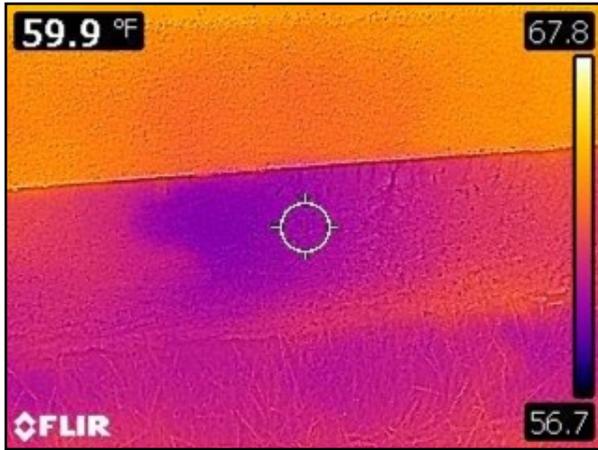
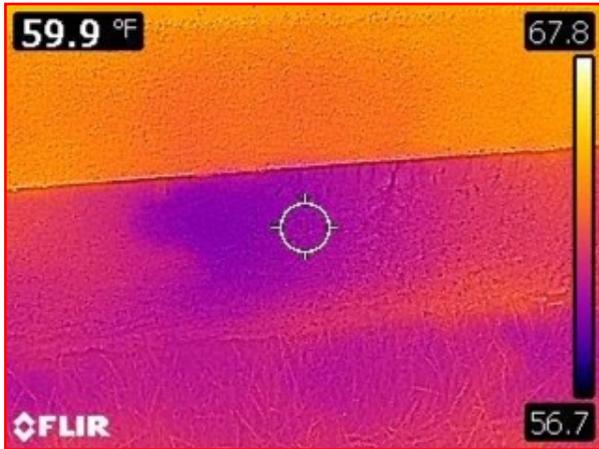
Figure 5-1

Comment 5:
Moisture is present along foundation wall due to supply pipe leak in crawlspace.

4) Moisture is present along foundation wall due to supply pipe leak in crawlspace.

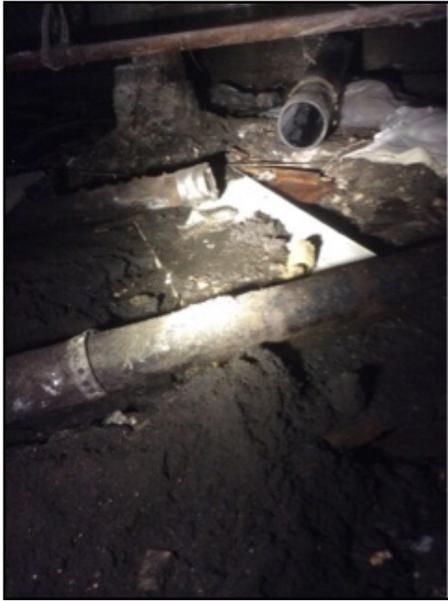
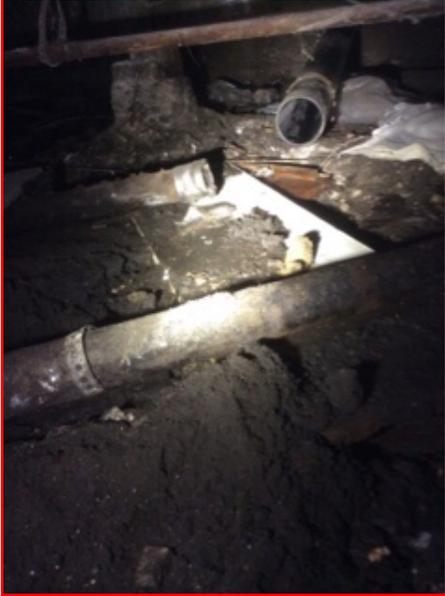
Figure 7-1

Heavy moisture and water pooling is present from supply pipe leak and unfinished and broken drain pipe.

6) Heavy moisture and water pooling is present from supply pipe leak and unfinished and broken drain pipe.

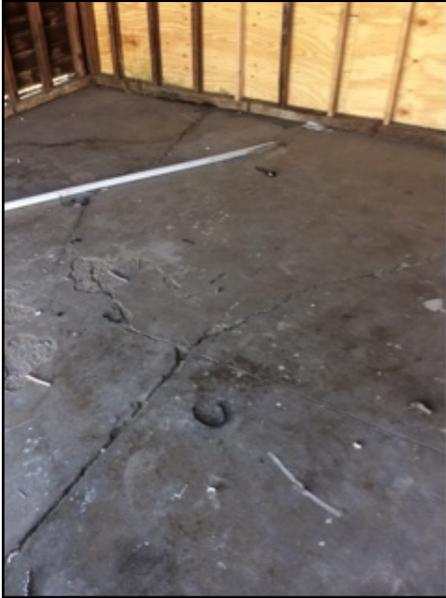
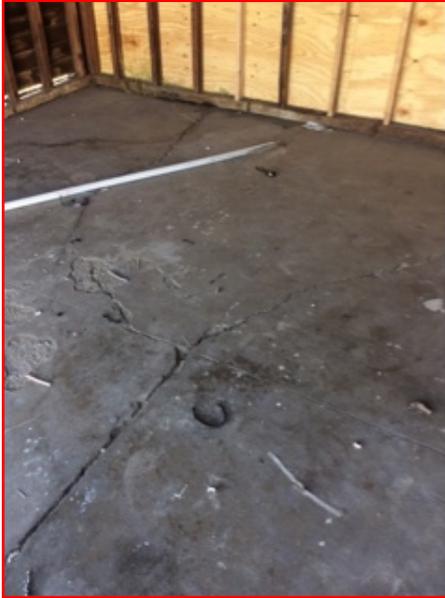
Figure 8-1

Settlement cracks are present along garage flooring.

7) Settlement cracks are present along garage flooring.

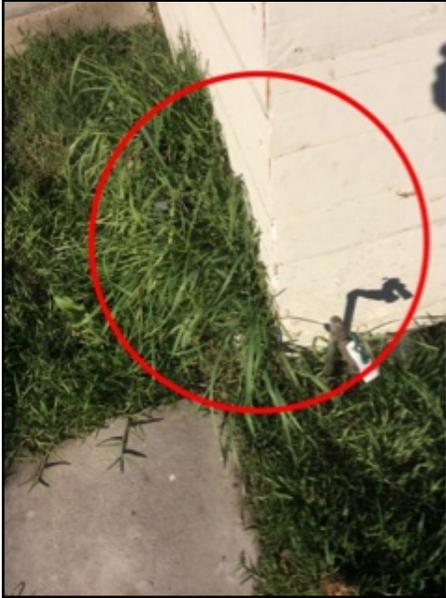
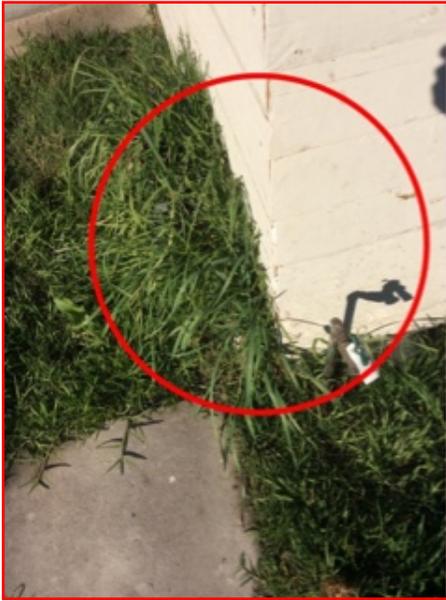
Figure 10-1

Wood siding is exposed to sprinklers and rain run off. This will deteriorate material over time of exposure.

9) Wood siding is exposed to sprinklers and rain run off. This will deteriorate material over time of exposure.

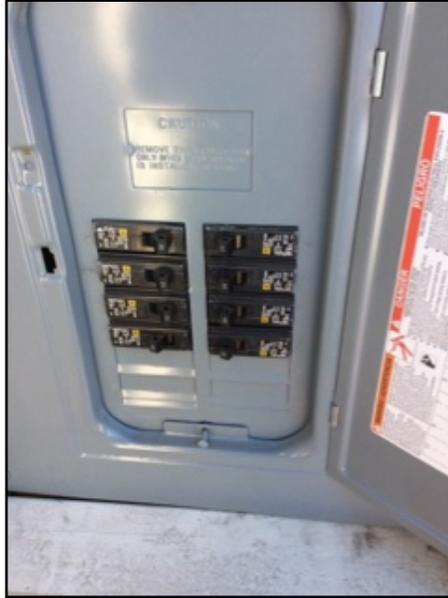
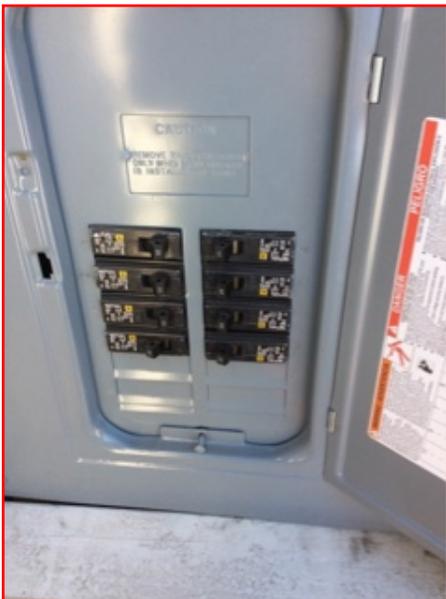
Figure 11-1

Main disconnect is not present. Recommend further evaluation by a certified electrician.

10) Main disconnect is not present. Recommend further evaluation by a certified electrician.

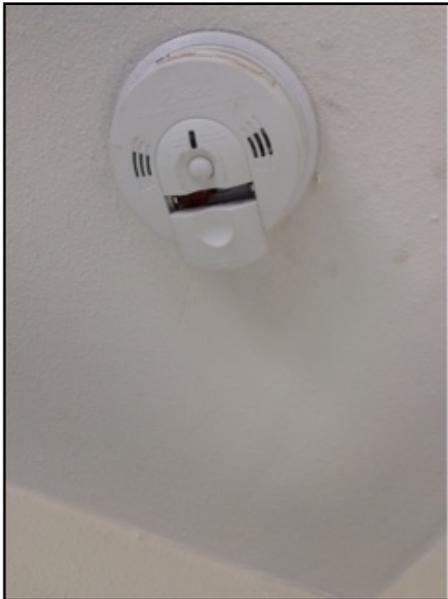
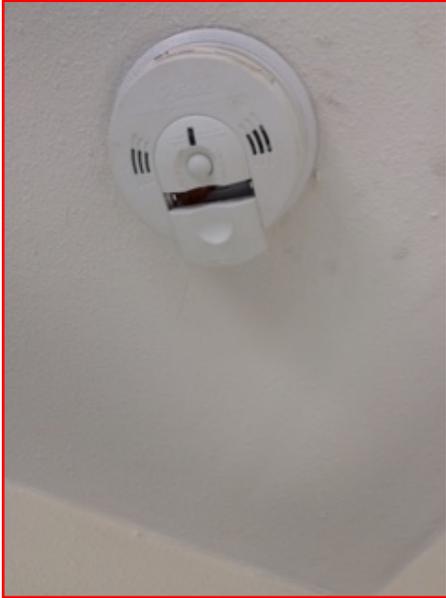
Figure 12-1

All smoke detectors are missing 9volt batteries. This is a safety hazard.

11) All smoke detectors are missing 9volt batteries. This is a safety hazard.

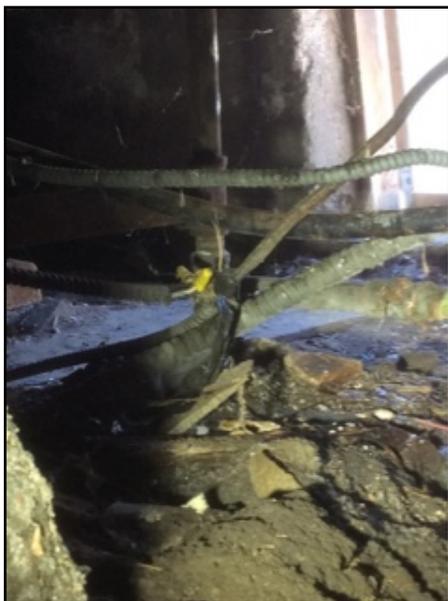
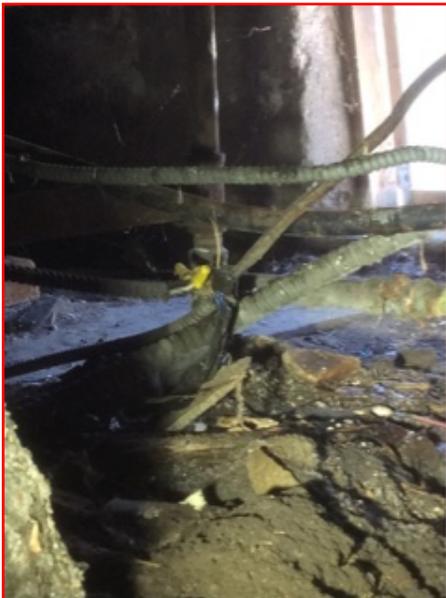
Figure 13-1

Junction box is needed at electrical splice. Splice is within 6" of a leak from the laundry hook up supply pipe. This is a safety issue, recommend repair.

12) Junction box is needed at electrical splice. Splice is within 6" of a leak from the laundry hook up supply pipe. This is a safety issue, recommend repair.

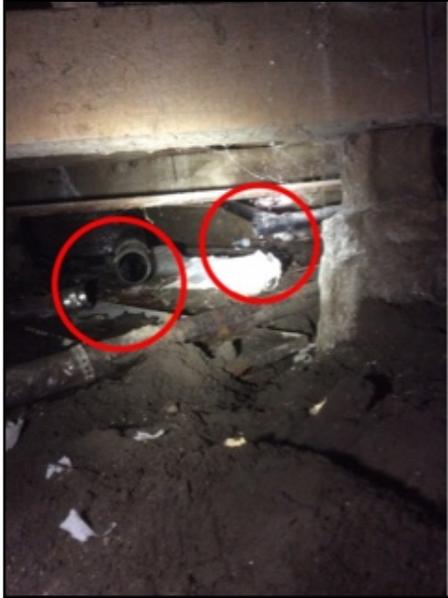
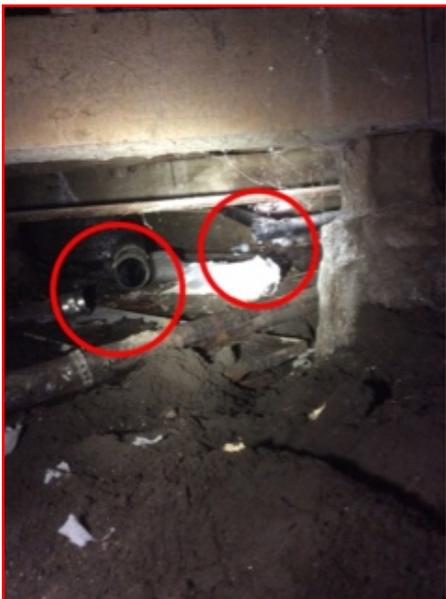
Figure 15-1

Waste pipes are not connected to sewer main. All waste is running to floor of crawlspace. Recommend repair by certified plumber.

14) Waste pipes are not connected to sewer main. All waste is running to floor of crawlspace. Recommend repair by certified plumber.

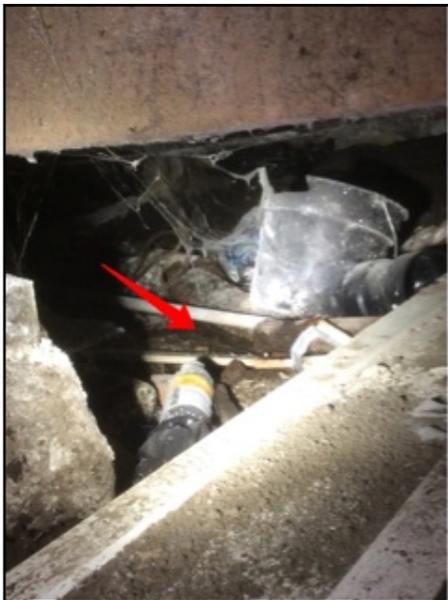
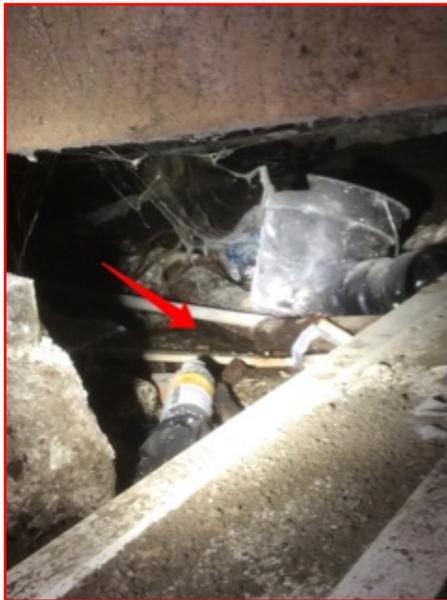
Figure 16-1

Water pooling is present from disconnected and broken drain lines.

15) Water pooling is present from disconnected and broken drain lines.

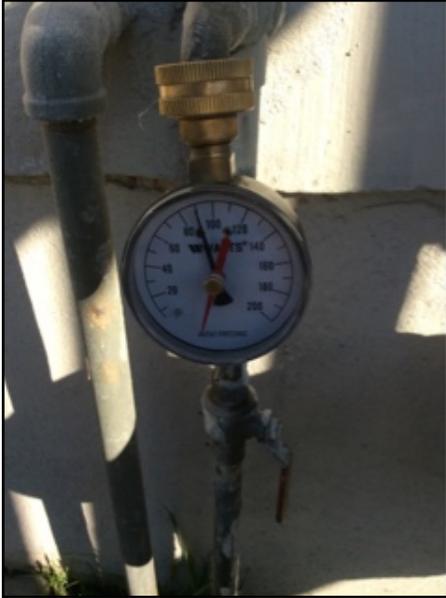
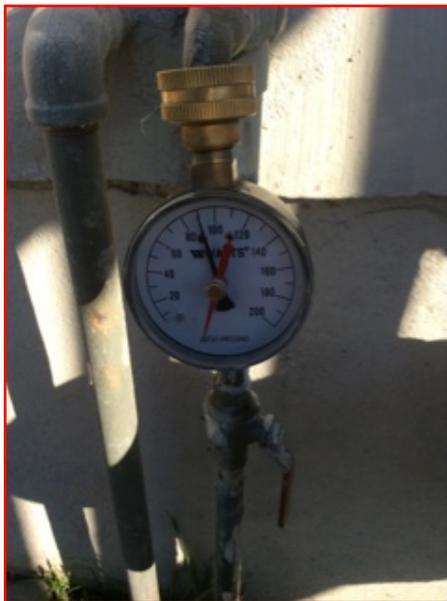
Figure 17-1

Water pressure is elevated at 90 psi. Recommend installing pressure regulator.

16) Water pressure is elevated at 90 psi. Recommend installing pressure regulator.

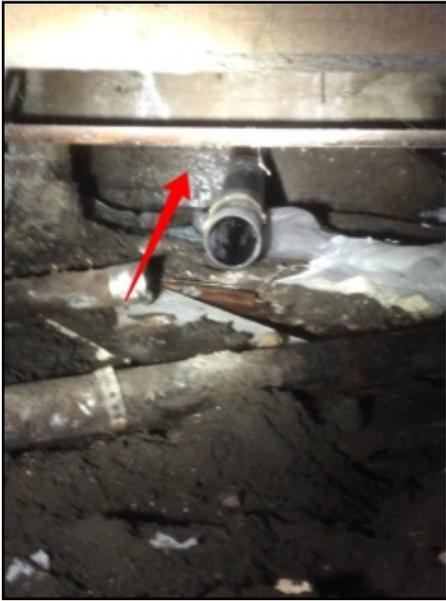
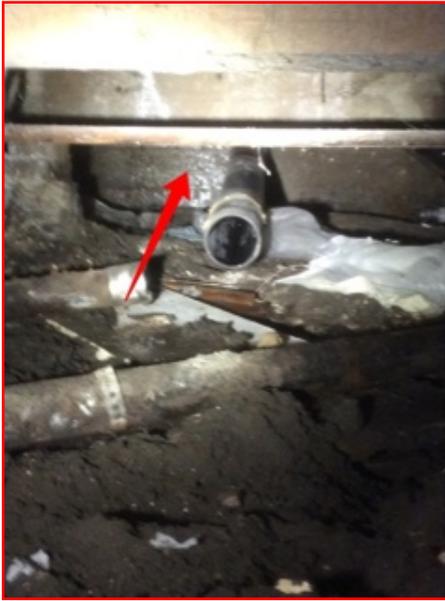
Figure 18-1

Severe water leak from bathroom sink supply line. Water was pooling and I was unable to further investigate. Recommend further evaluation and repair by certified plumber.

17) Severe water leak from bathroom sink supply line. Water was pooling and I was unable to further investigate. Recommend further evaluation and repair by certified plumber.

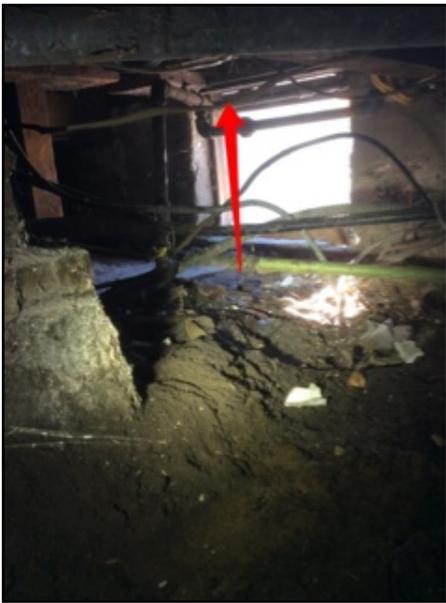
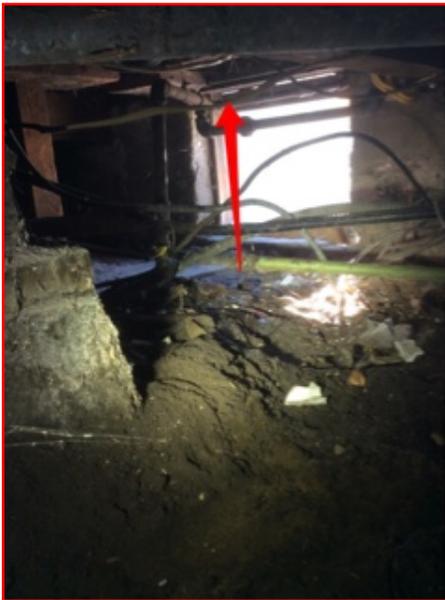
Figure 19-1

Leak at laundry supply pipe. Recommend repair by certified plumber.

18) Leak at laundry supply pipe. Recommend repair by certified plumber.

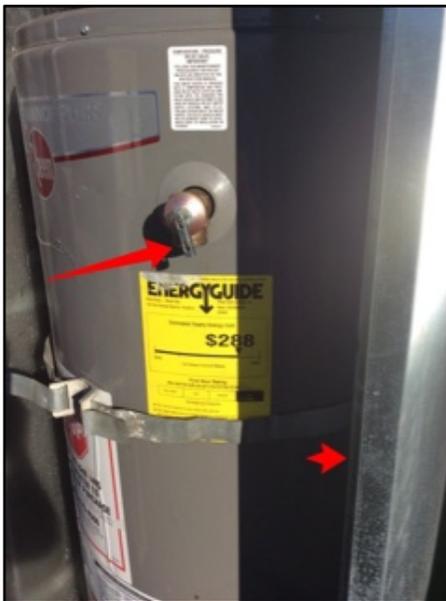
Figure 20-1

Blow off leg is not present from T&P valve. Copper leg needs to be installed.

19) Blow off leg is not present from T&P valve. Copper leg needs to be installed.

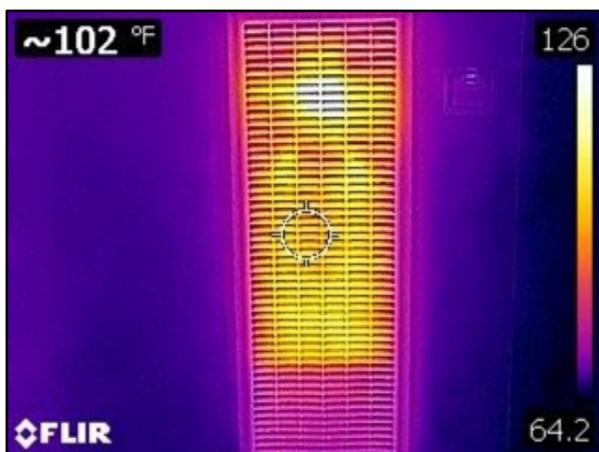
Figure 21-1

This Thermal Image indicates the out put temperature and functional air supply from the furnace.

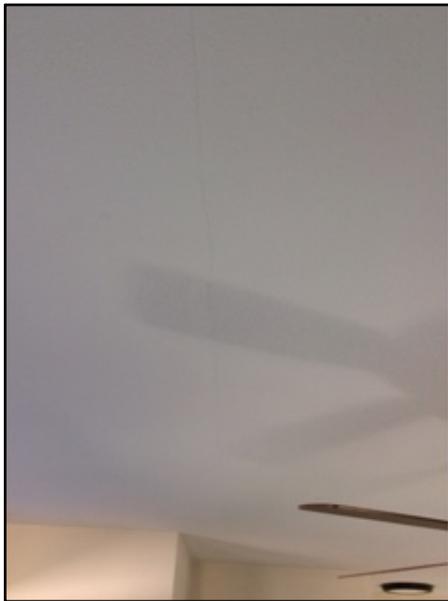
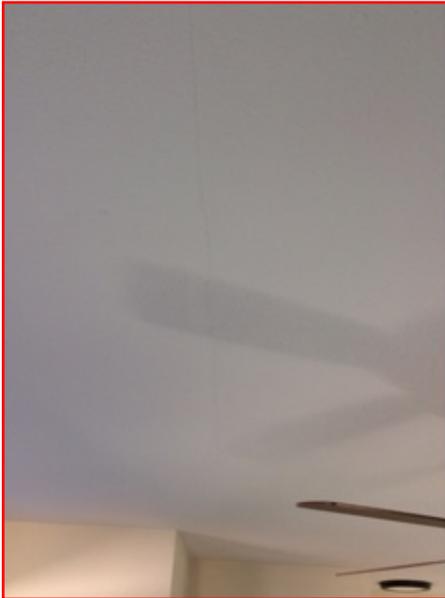
Figure 22-1

Comment 22:
Slight cracks at drywall seams on ceiling.

20) Slight cracks at drywall seams on ceiling.

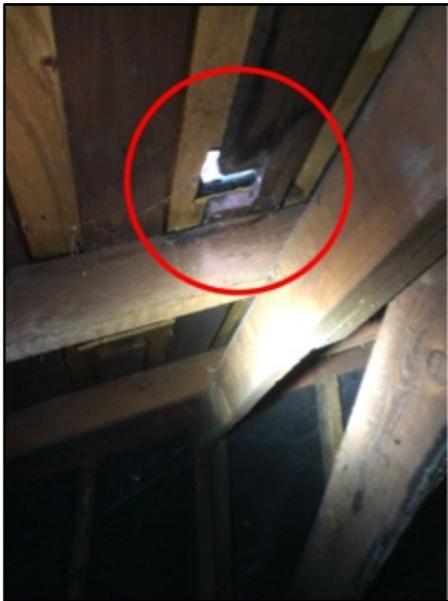
Figure 23-1

Open vent from previous drain line vent from bathroom. This is allowing water intrusion.

21) Open vent from previous drain line vent from bathroom. This is allowing water intrusion.

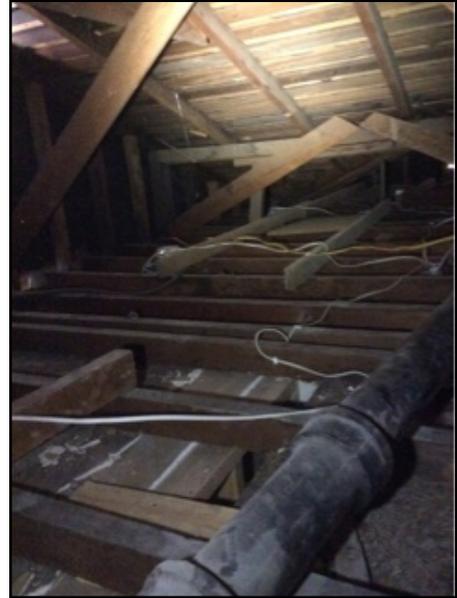
Figure 24-2

Comment 24:
Insulation needs to be installed in attic.

22) Insulation needs to be installed in attic.

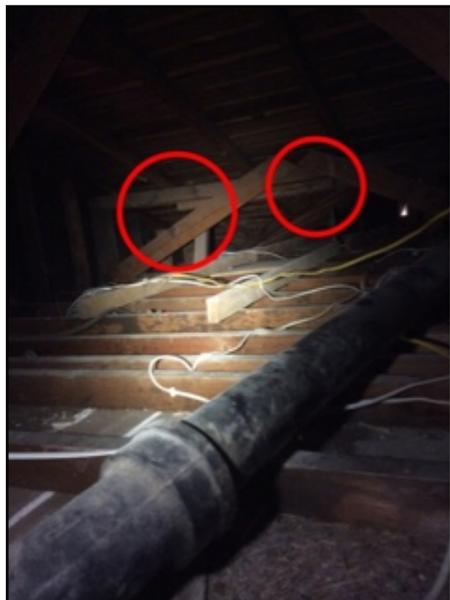
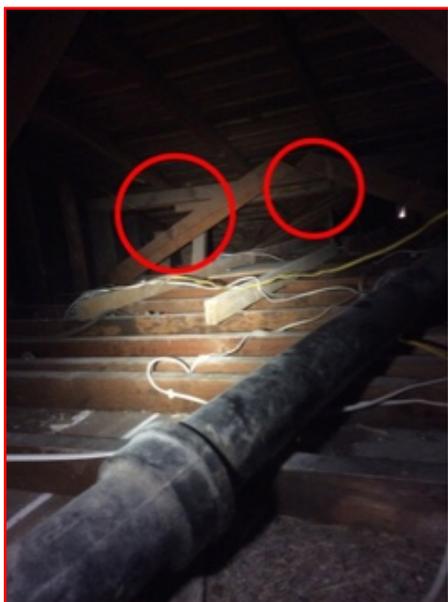
Figure 26-1

Water stains are present from previous roof leaks. Moisture not present at time of inspection.

24) Water stains are present from previous roof leaks. Moisture not present at time of inspection.

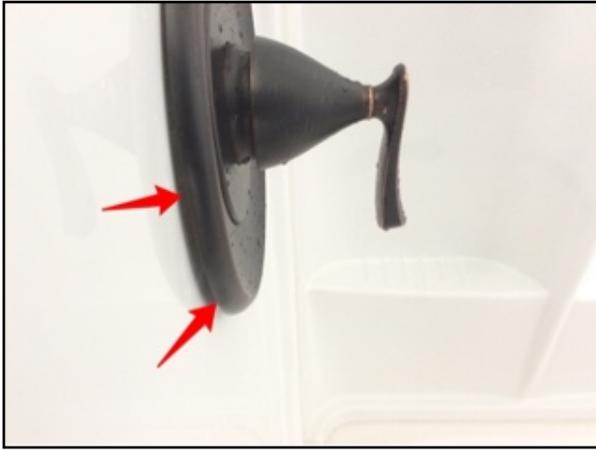
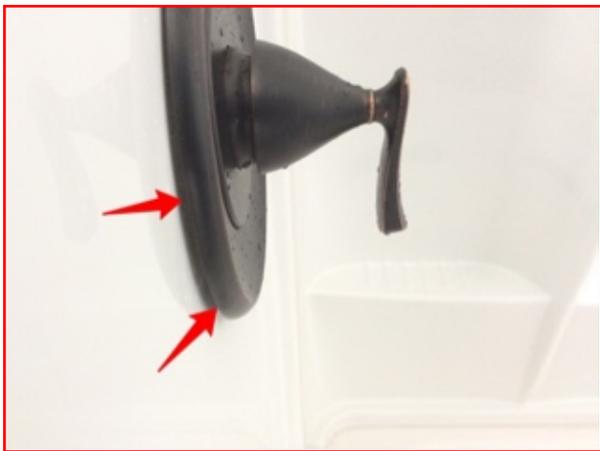
Figure 27-1

Comment 27:
Recommend sealing shower valve plate to prevent water intrusion.

25) Recommend sealing shower valve plate to prevent water intrusion.

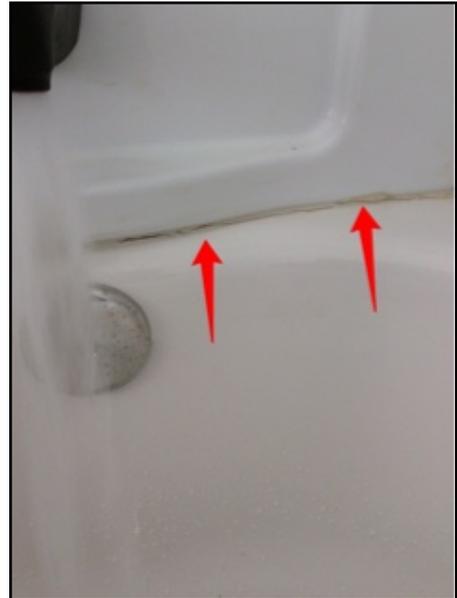
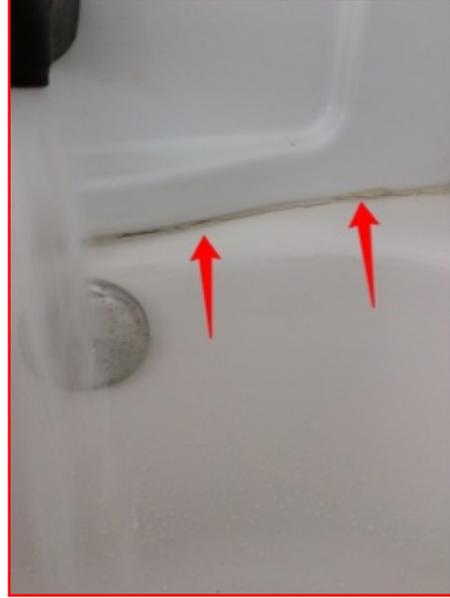
Figure 28-2

Comment 28:
Water seal is needed around tub edge.

26) Water seal is needed around tub edge.

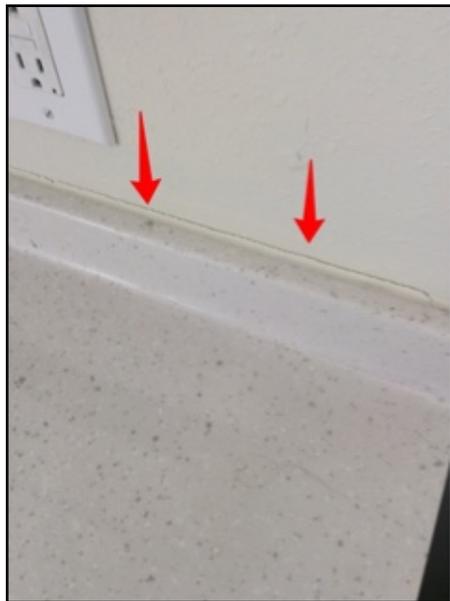
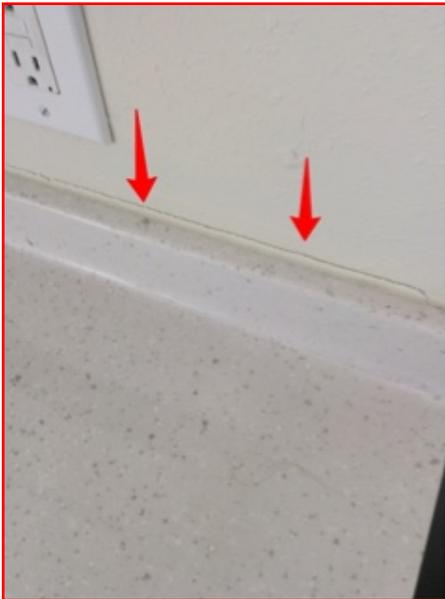
Figure 29-1

**Comment 29:**
Recommend repairing water seal behind sink to prevent water intrusion.

27) Recommend repairing water seal behind sink to prevent water intrusion.

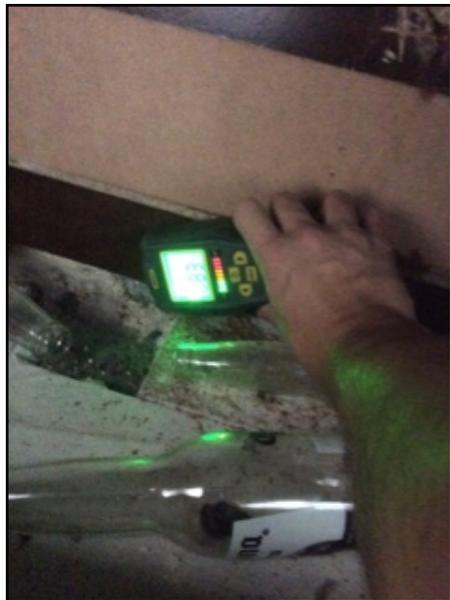
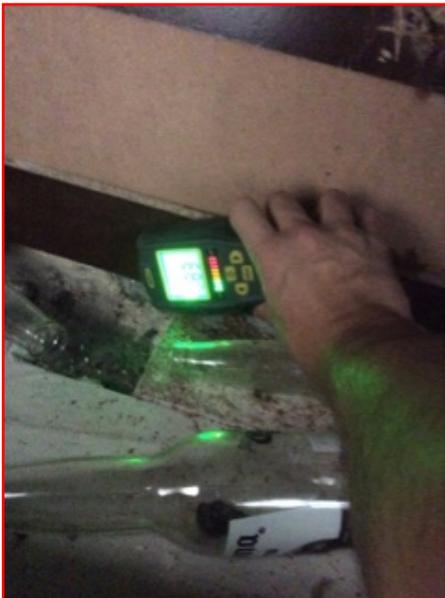
Figure 30-1

**Comment 30:**
Moisture is present under the sink from a supply line leak. Recommend further evaluation by a certified plumber. Recommend properly drying material out.

28) Moisture is present under the sink from a supply line leak. Recommend further evaluation by a certified plumber. Recommend properly drying material out.

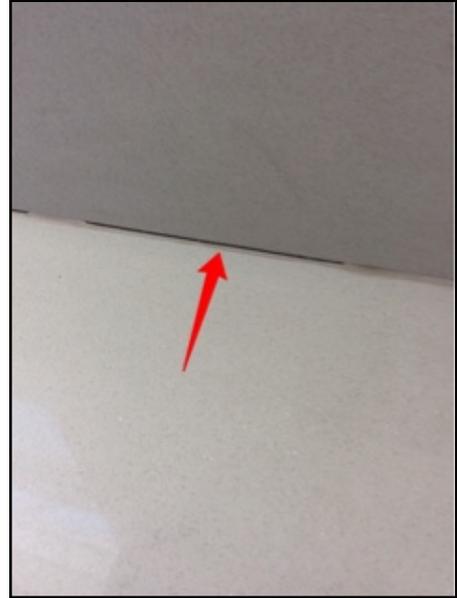
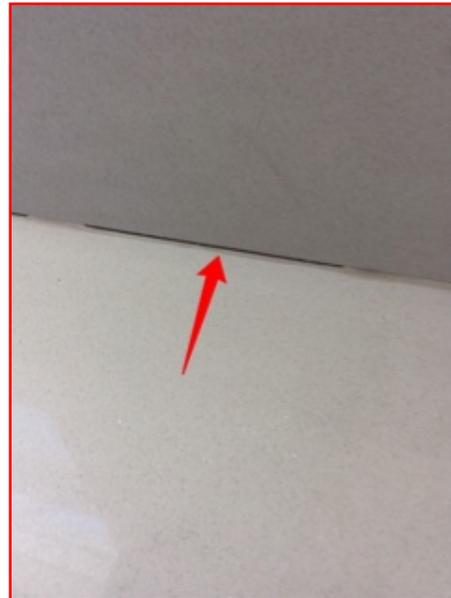
Figure 31-2

Water seal is needed behind sink to prevent water intrusion.

29) Water seal is needed behind sink to prevent water intrusion.

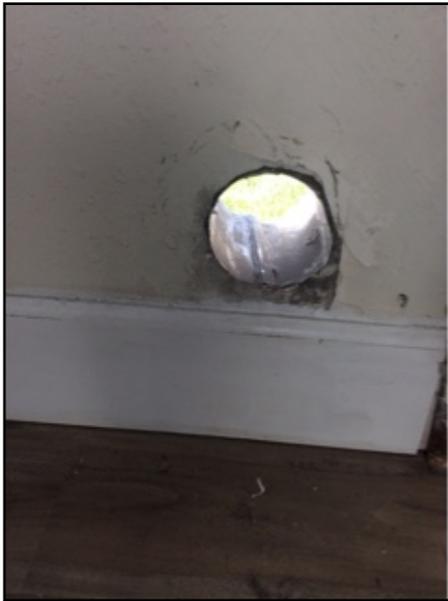
Figure 32-1

Comment 32:
Dry vent needs a screen to prevent animal intrusion.

30) Dry vent needs a screen to prevent animal intrusion.

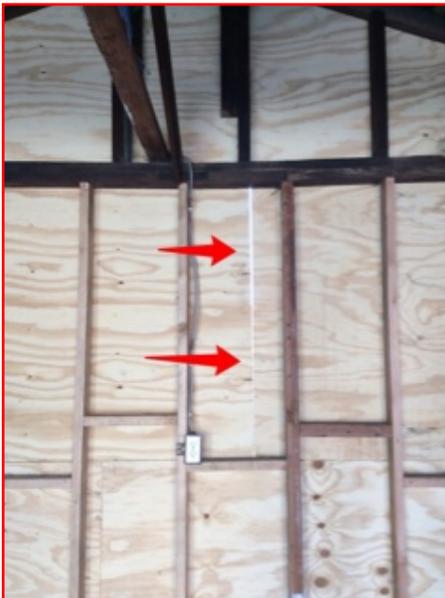
Figure 9-1

Multiple gaps along back wall of garage. Water proof material is not present behind wood siding. This may create breakdown of material over time.

8) Multiple gaps along back wall of garage. Water proof material is not present behind wood siding. This may create breakdown of material over time.

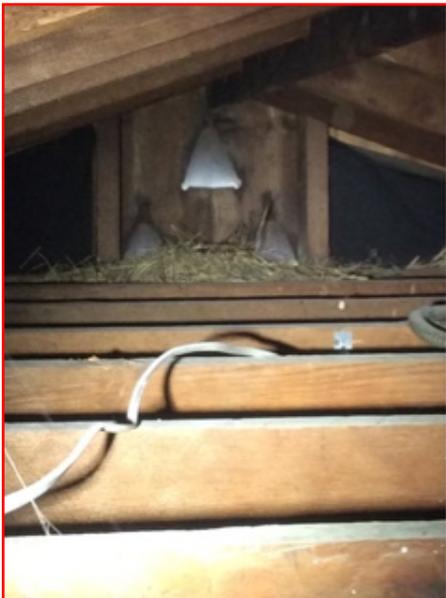
Figure 25-1

Comment 25:
Birds nest are present in attic due to lack of screening from gable end vents.

23) Birds nest are present in attic due to lack of screening from gable end vents.
