# PROPERTY CONDITION ASSESSMENT REPORT

Sample Report  
Minneapolis, MN

Tuesday, December 1, 2015

RE: Report No. 1497  
Sample Report  
Minneapolis, MN

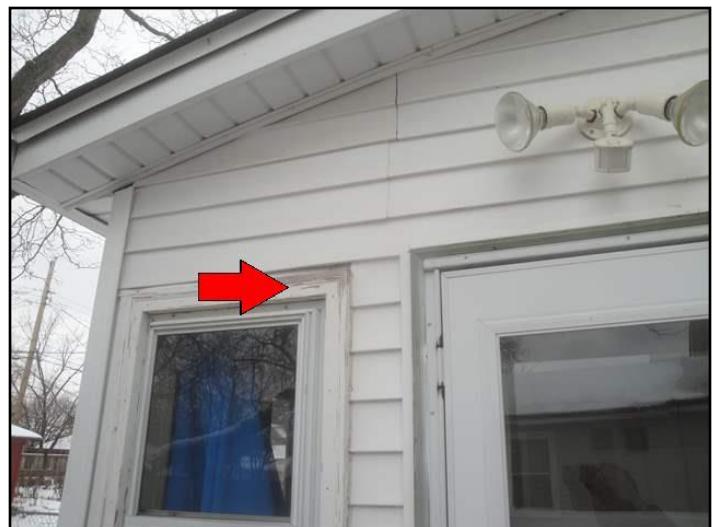
7. *Paint or stain needed*

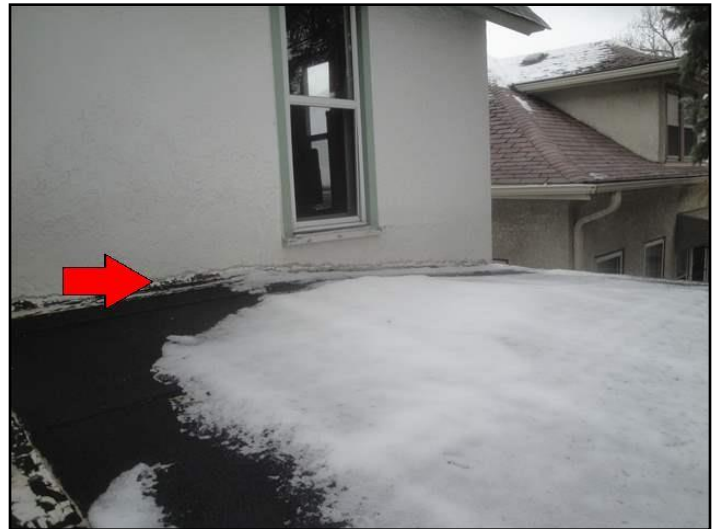
Caulk is beginning to shrink or is missing in areas. Monitor and repair/replace as necessary. It is important to keep vulnerable areas sealed to prevent moisture intrusion.

9. Caulking missing or ineffective

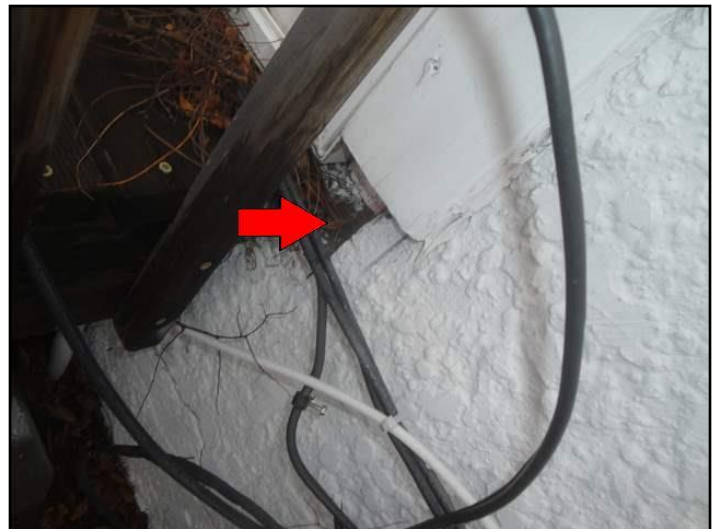
11. Caulking missing or ineffective

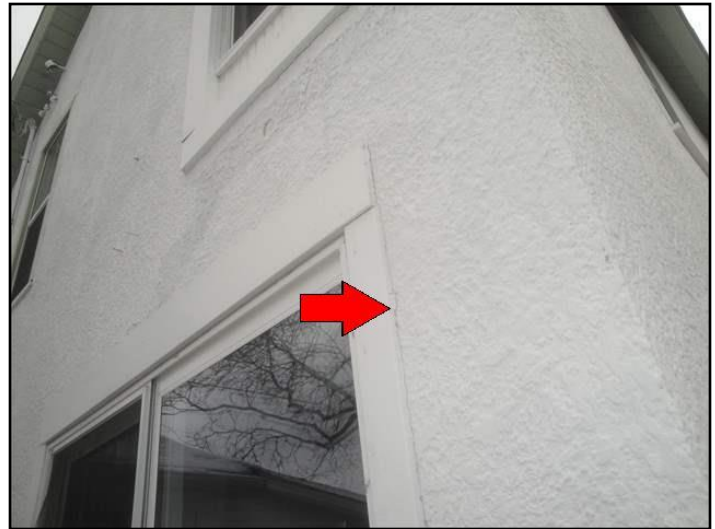
13. Caulking missing or ineffective

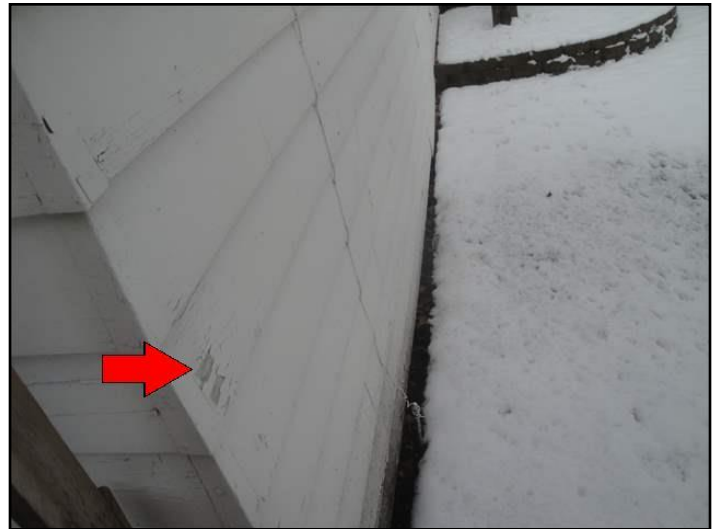
15. Paint or stain - needed

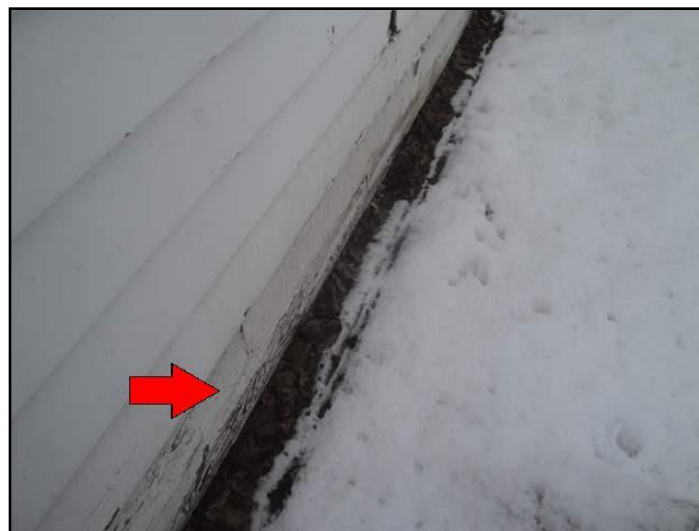
Vulnerable to rot. Siding is generally recommended to be held back a minimum of 6 inches from grade however this may vary based on manufacturer recommendations.

16. Too close to grade

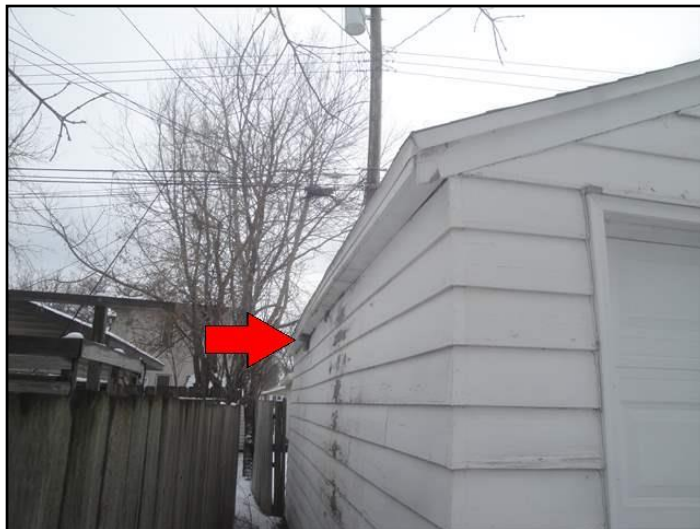
17. Rot

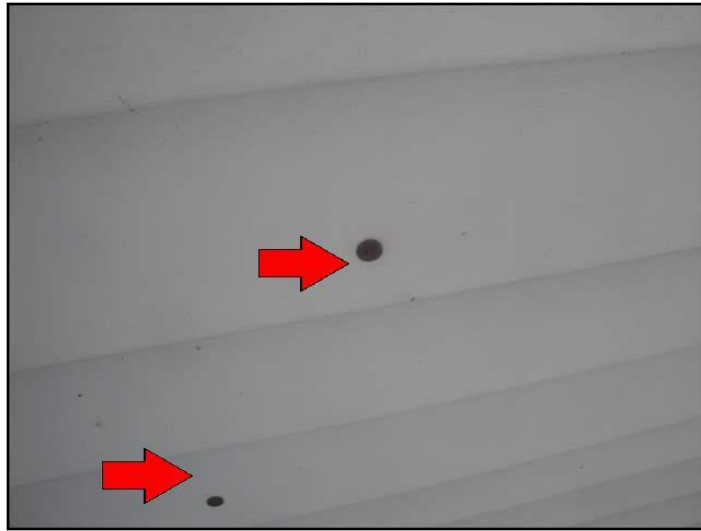
Pieces have been face nailed to secure the siding to the structure. Original installation procedures are suspect. Recommend sealing exposed nail heads.

18. Loose or missing pieces

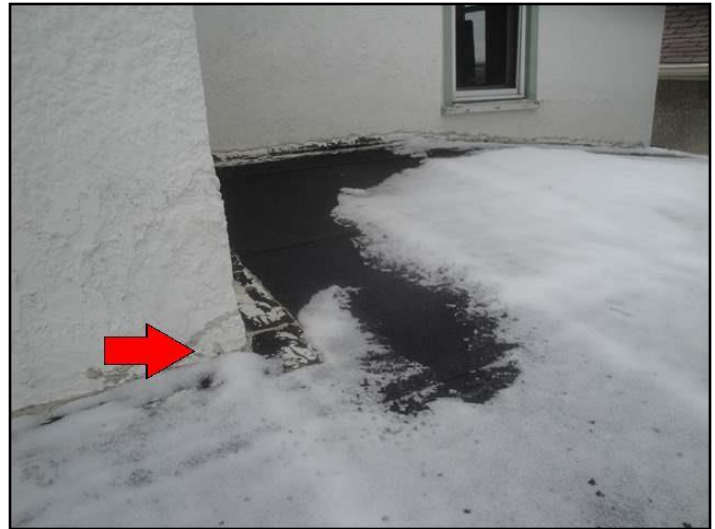
Minor to moderate cracks observed in various areas of the building. There is a potential for moisture penetration and further damage to stucco and hard coat surfaces. Seal cracks and voids with an approved sealant or repair or replace affected areas with a masonry repair.

20. Cracked

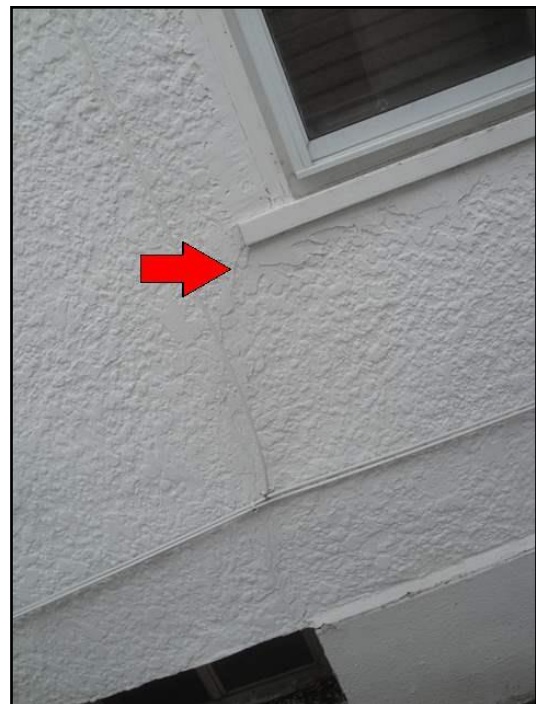
22. Cracked

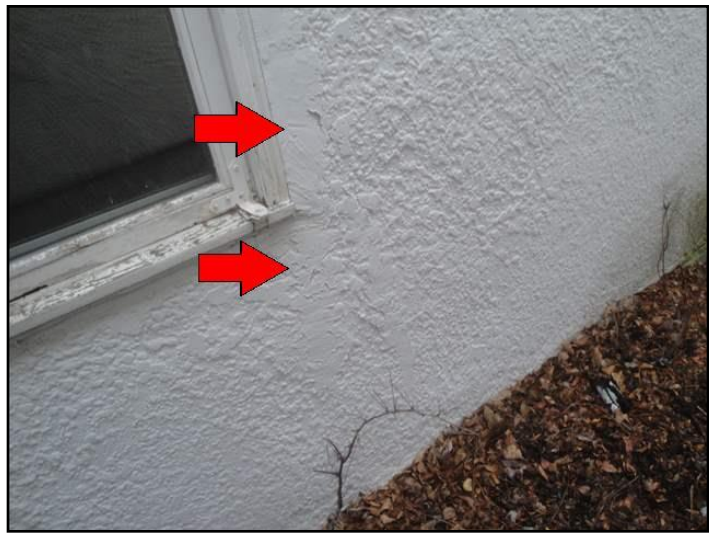
15. Condition: • Patched

23. Patched

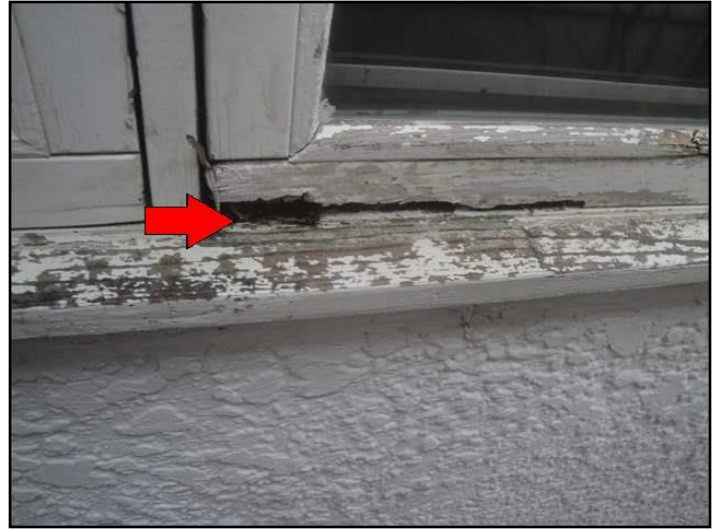
25. Rot

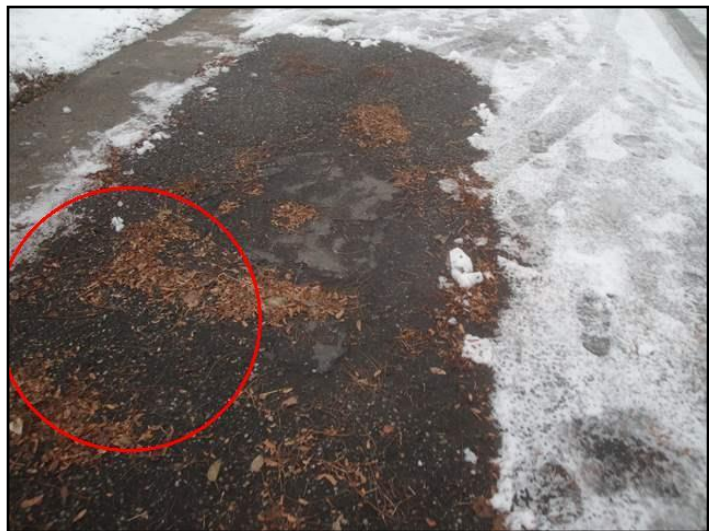
30. Cracked or damaged surfaces

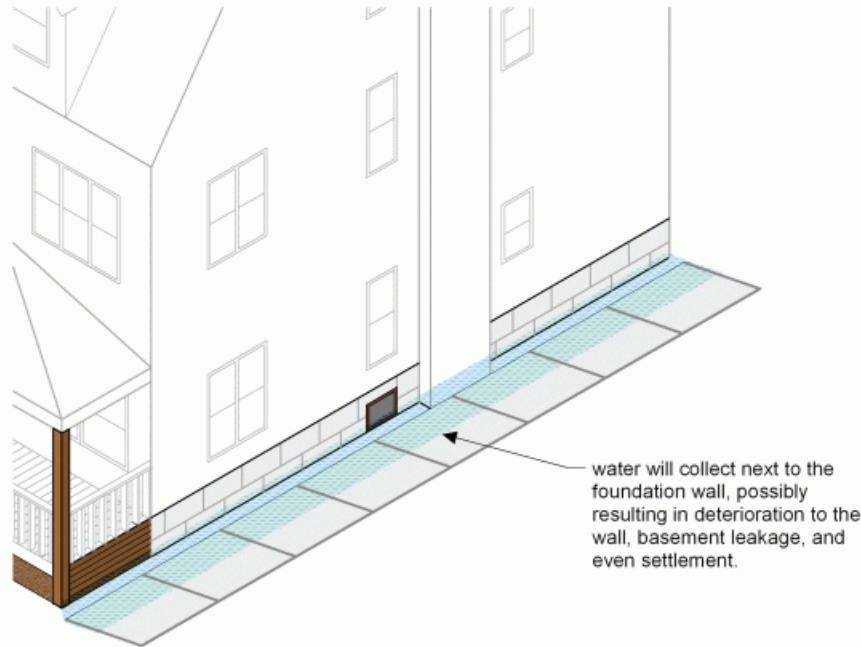
Monitor and improve if leaks are observed.

33. *Improper slope or drainage*

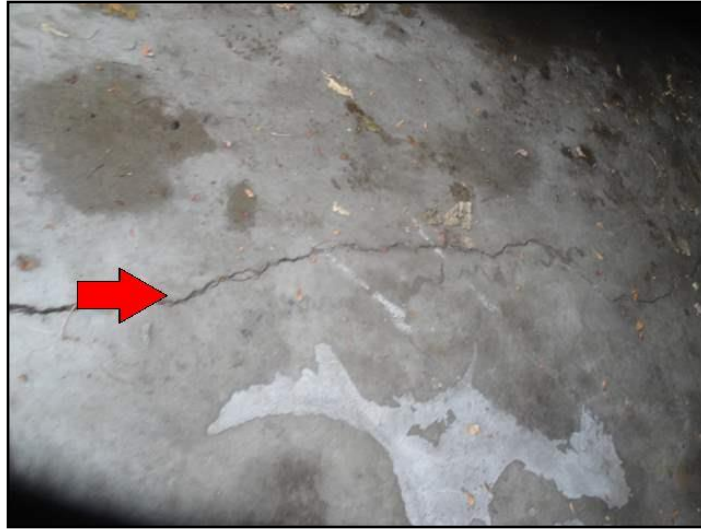
34. Cracked

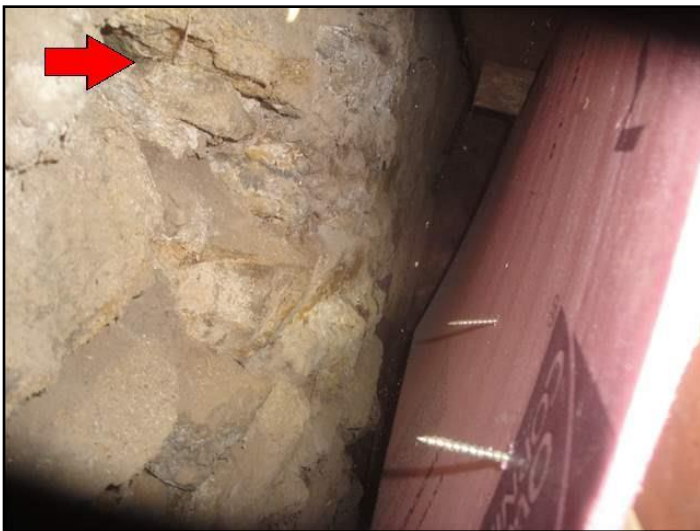
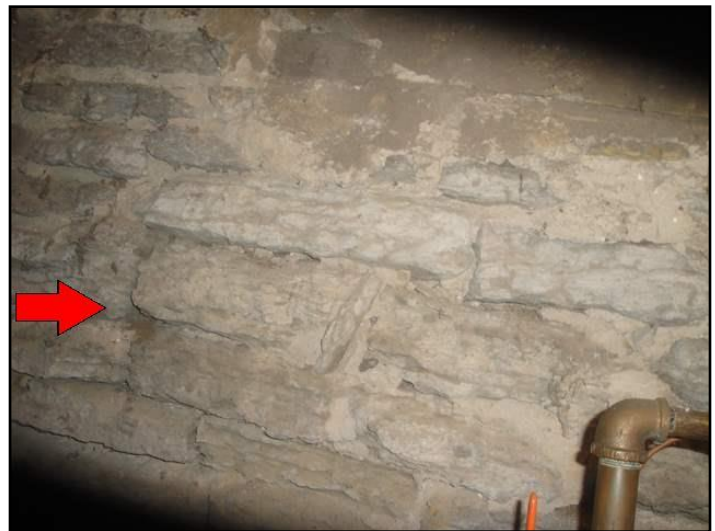
The old stone foundation will likely require regular maintenance repairs to the mortar.

37. Spalling, crumbling or broken material

38. Spalling, crumbling or broken material

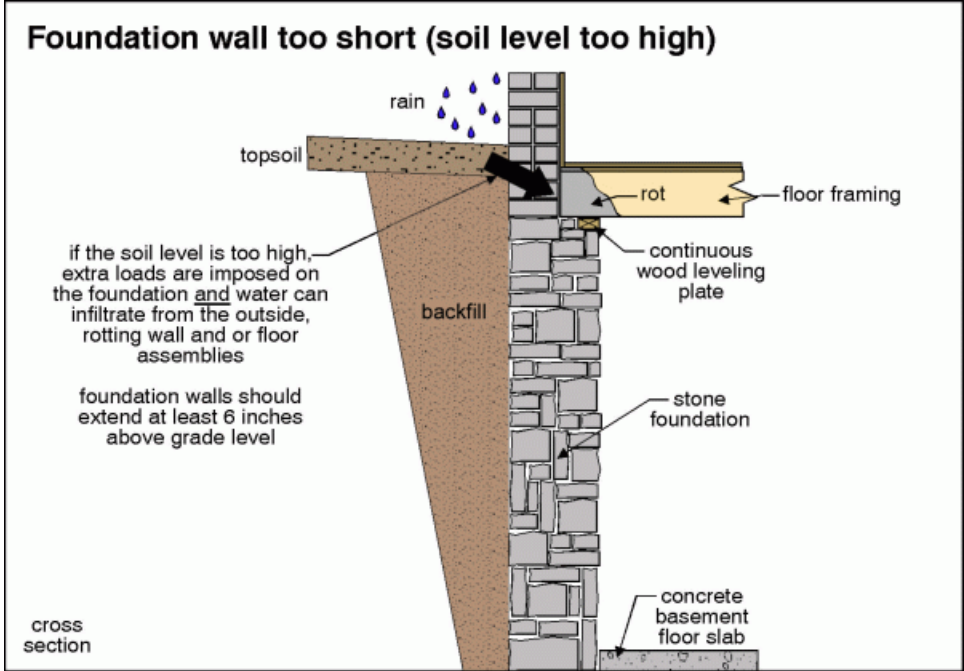
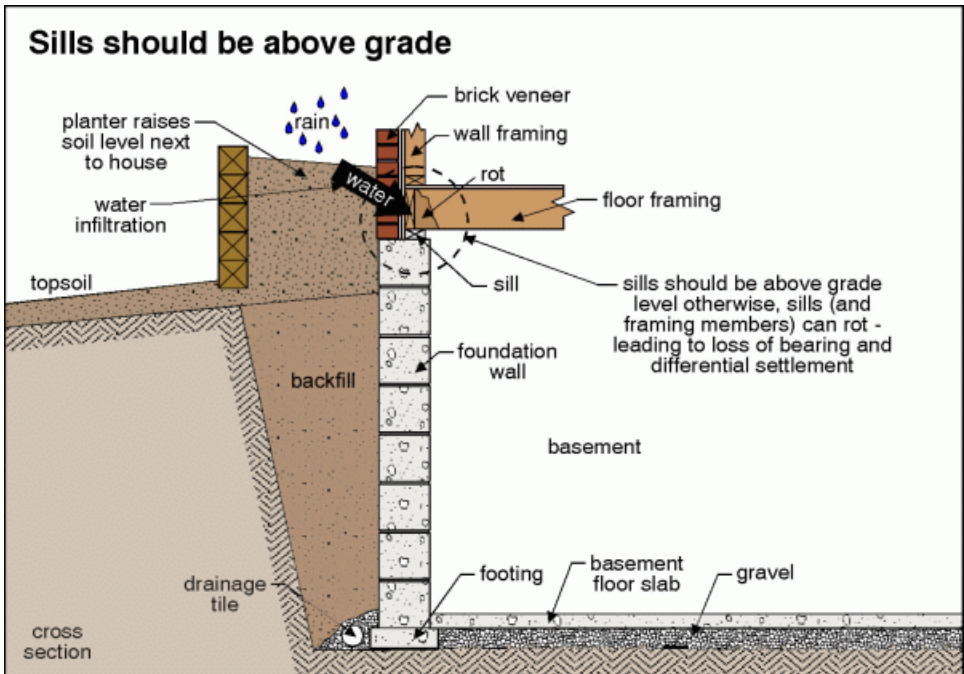
The bottom plate is at grade and water appears to be entering the garage from the exterior. This condition will eventually lead to rot. This defect will be difficult to correct without excavating the soil and installing proper drainage.

43. At or below grade level

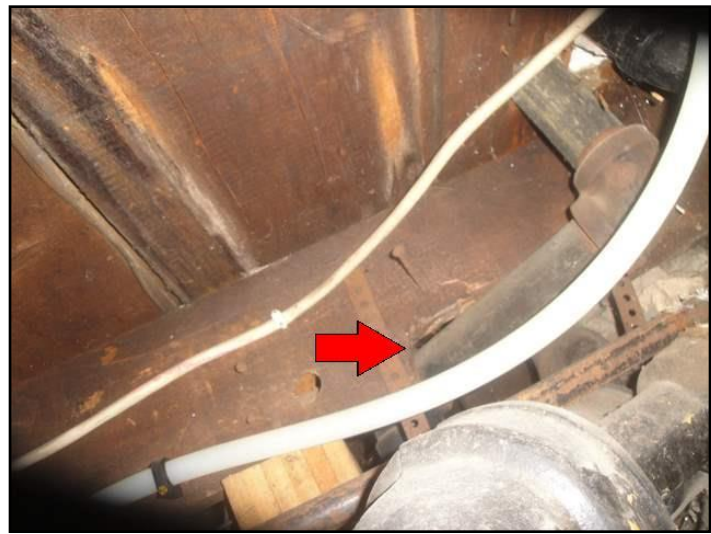
46. Notches or holes

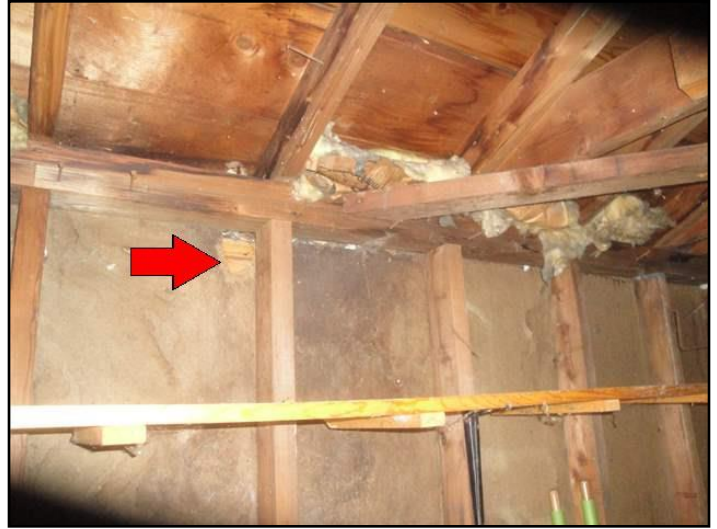
Water damaged sheathing observed.

51. Rot

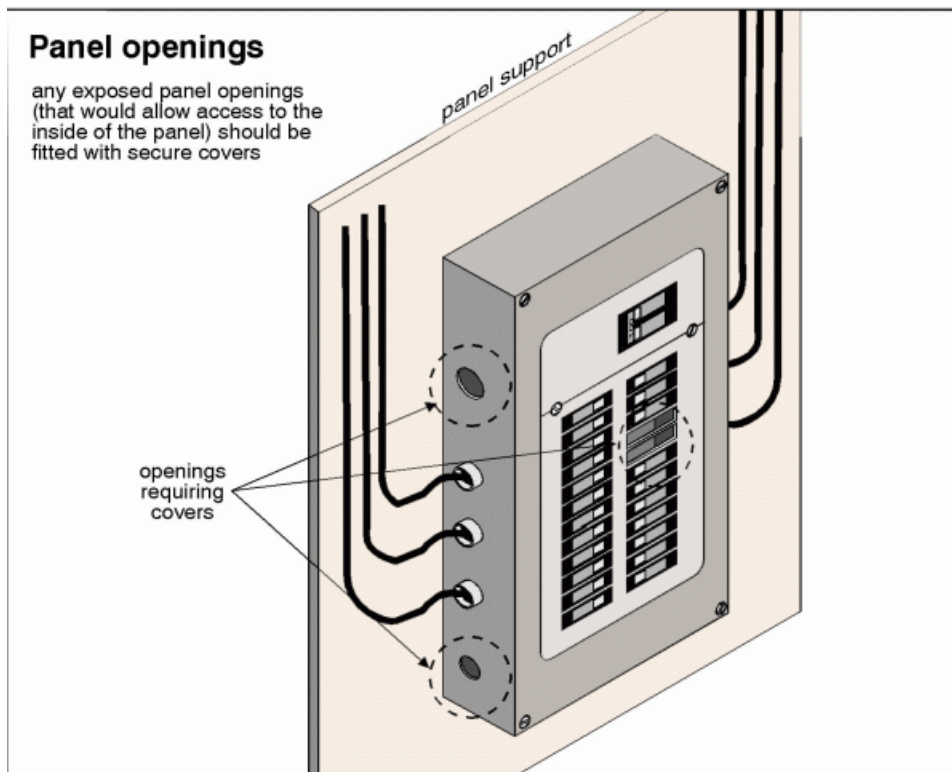
55. Openings in panel

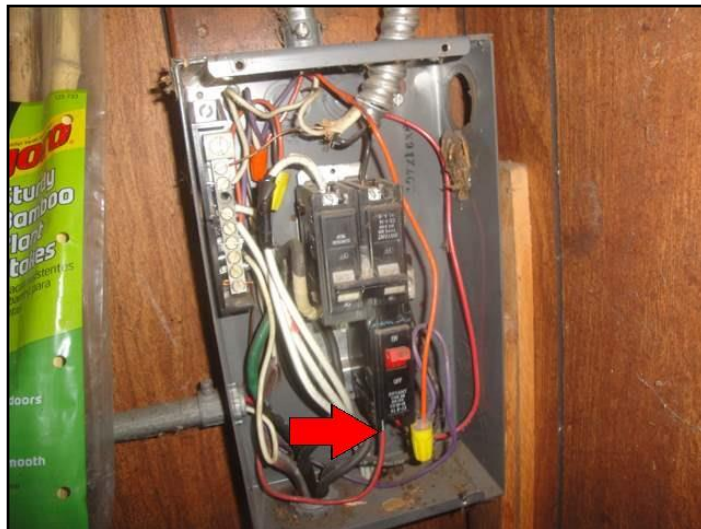
57. Double taps

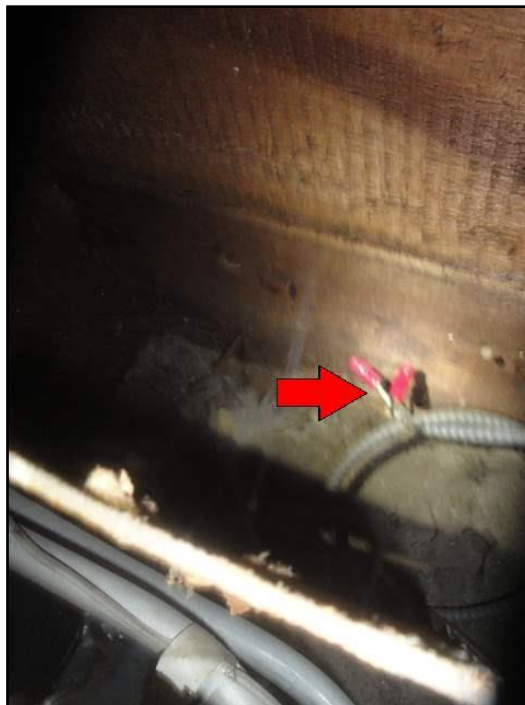
60. Open splices

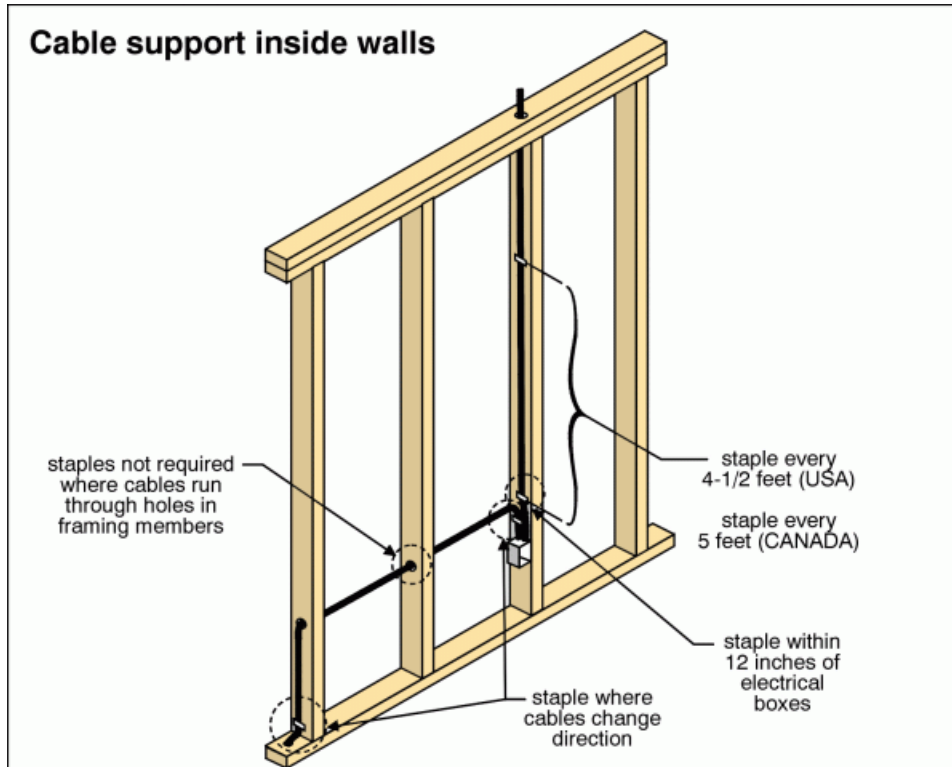
61. *Not well secured*

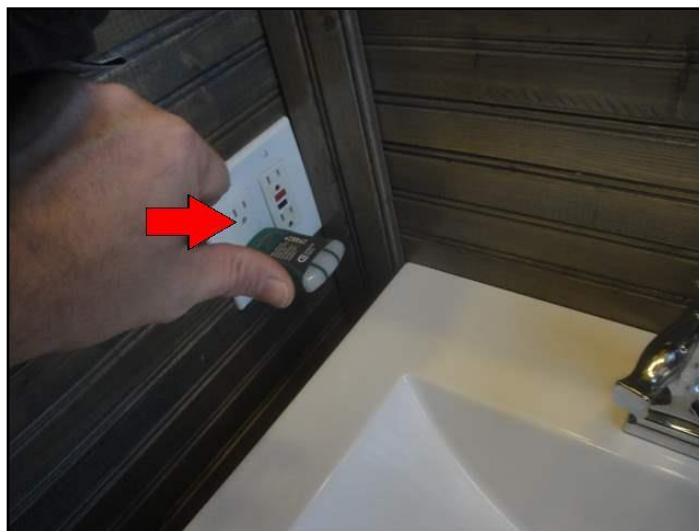
65. Inoperative

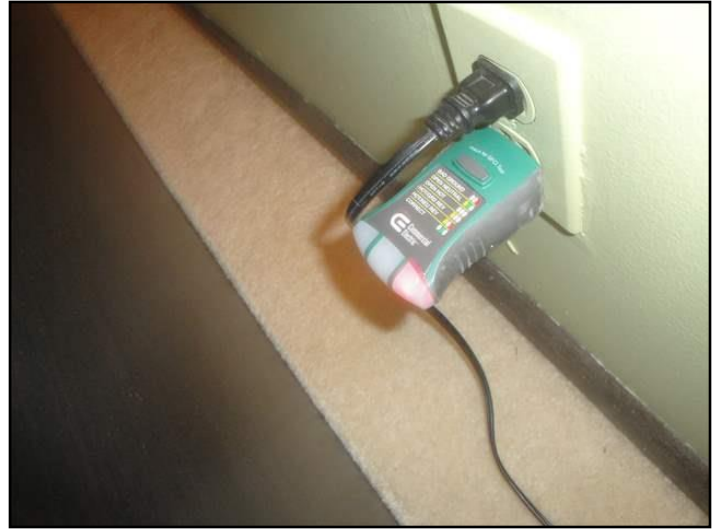
66. Ground needed for 3-slot outlet

67. Ground needed for 3-slot outlet

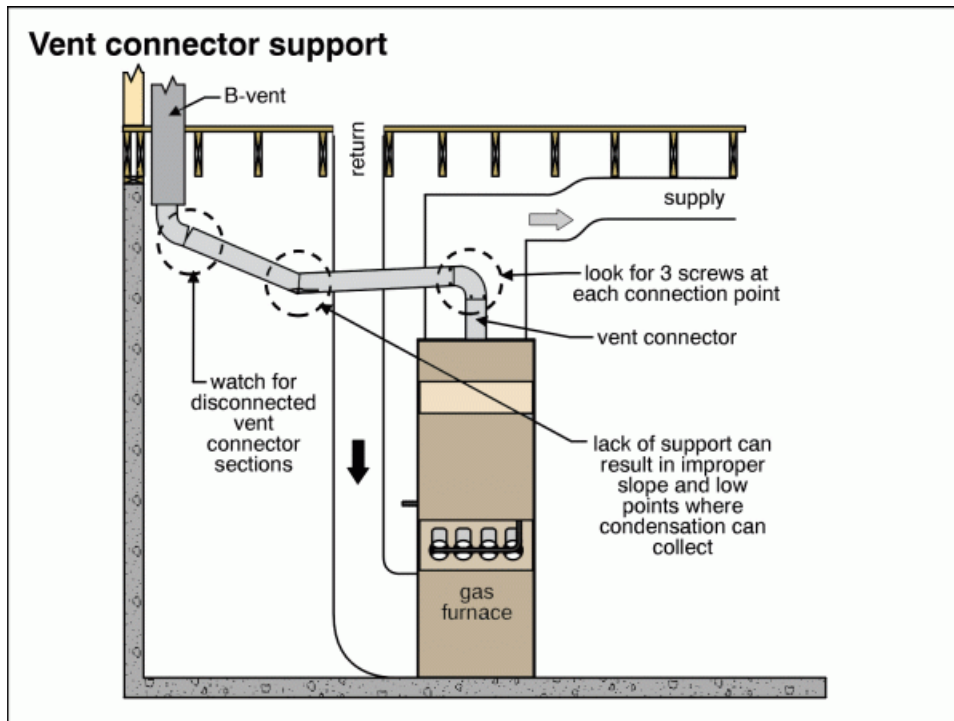
Deteriorated foil tape at CO test hole.

70. Poor connections

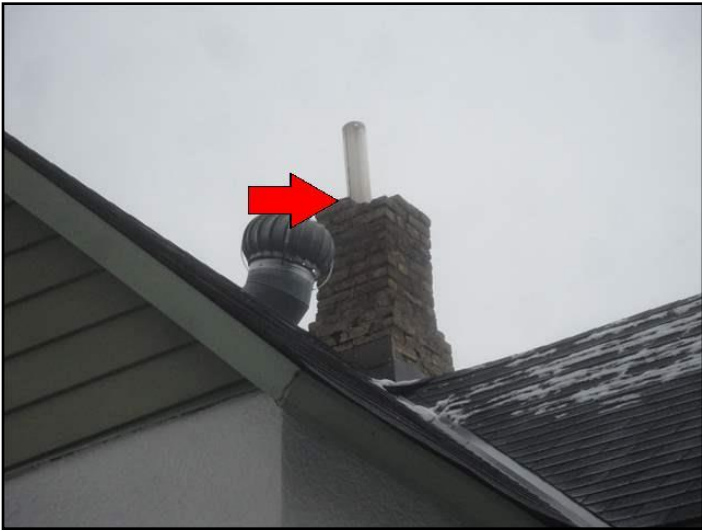
71. Loose, missing or deteriorated mortar

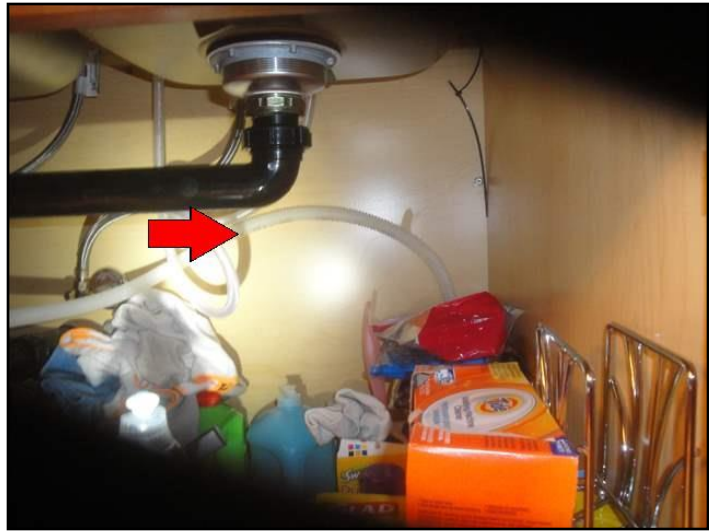
76. Dishwasher drain connections

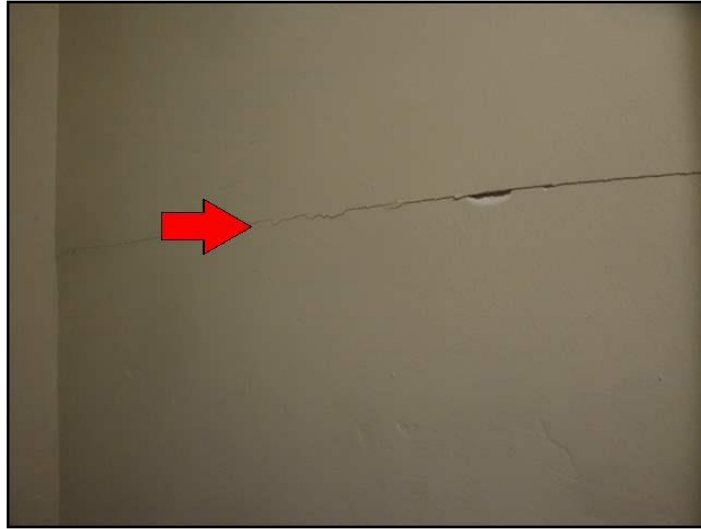
77. Typical flaws

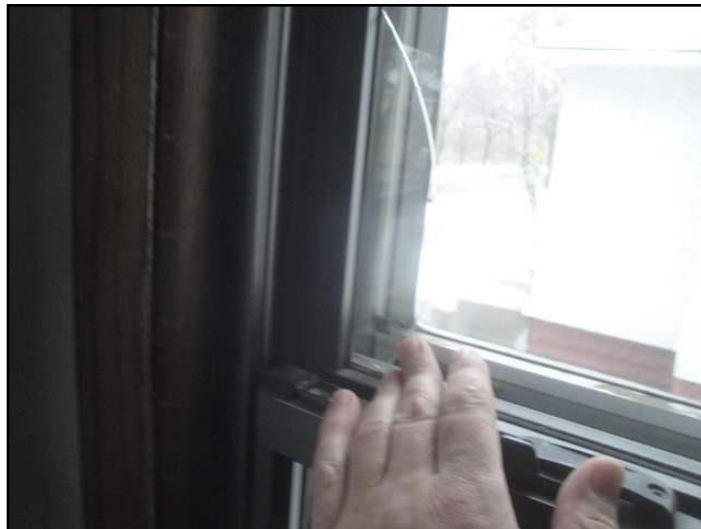
78. Cracked

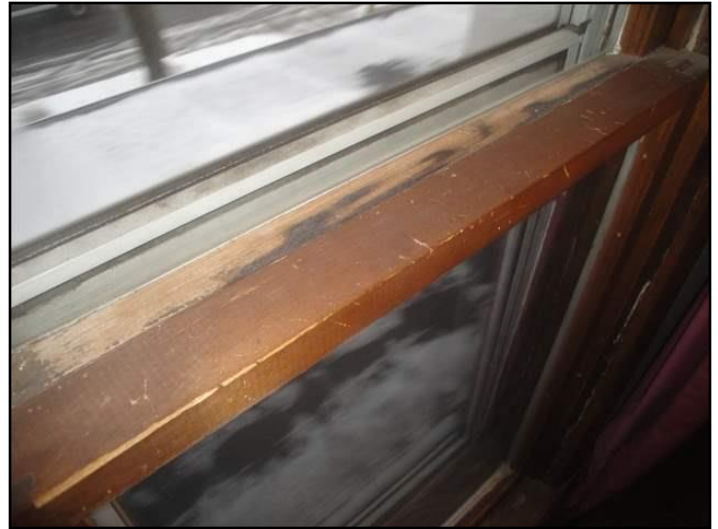
Missing window locks.

81. *Missing*

82. *Missing*

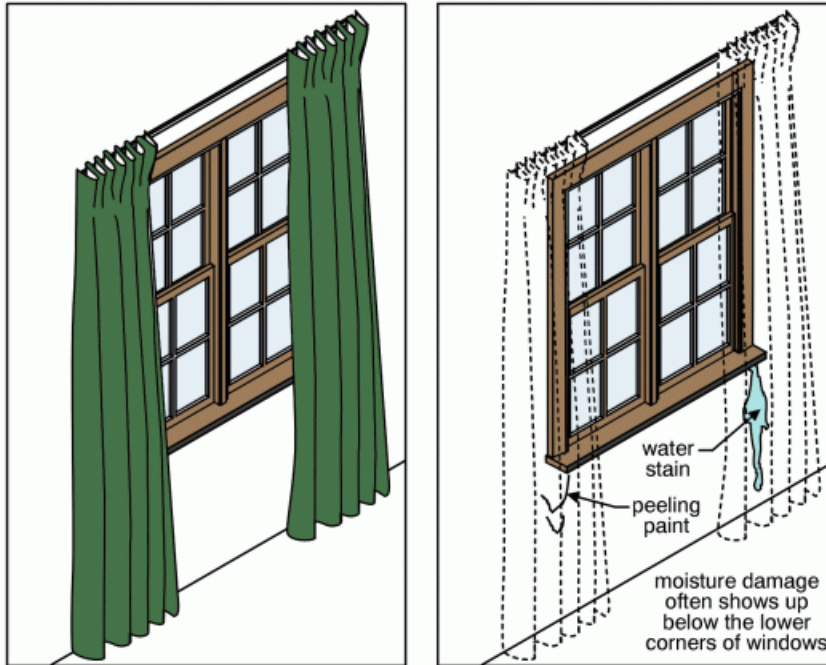
Water stains and faded. Monitor for evidence of moisture when the window is closed.

83. Stained

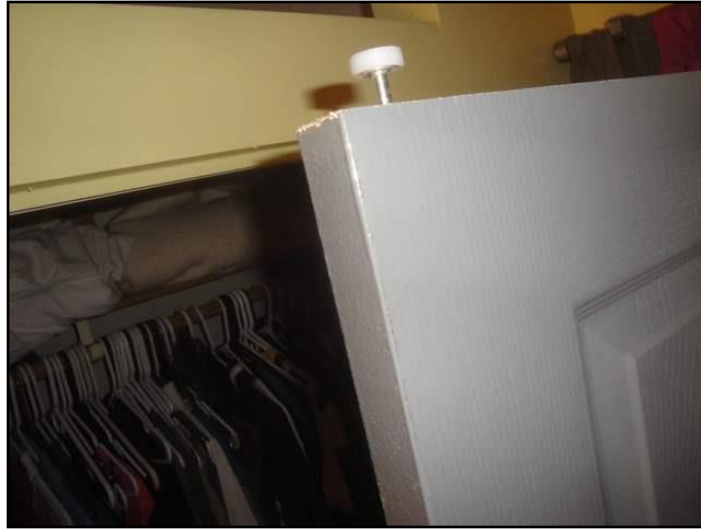
84. Damage

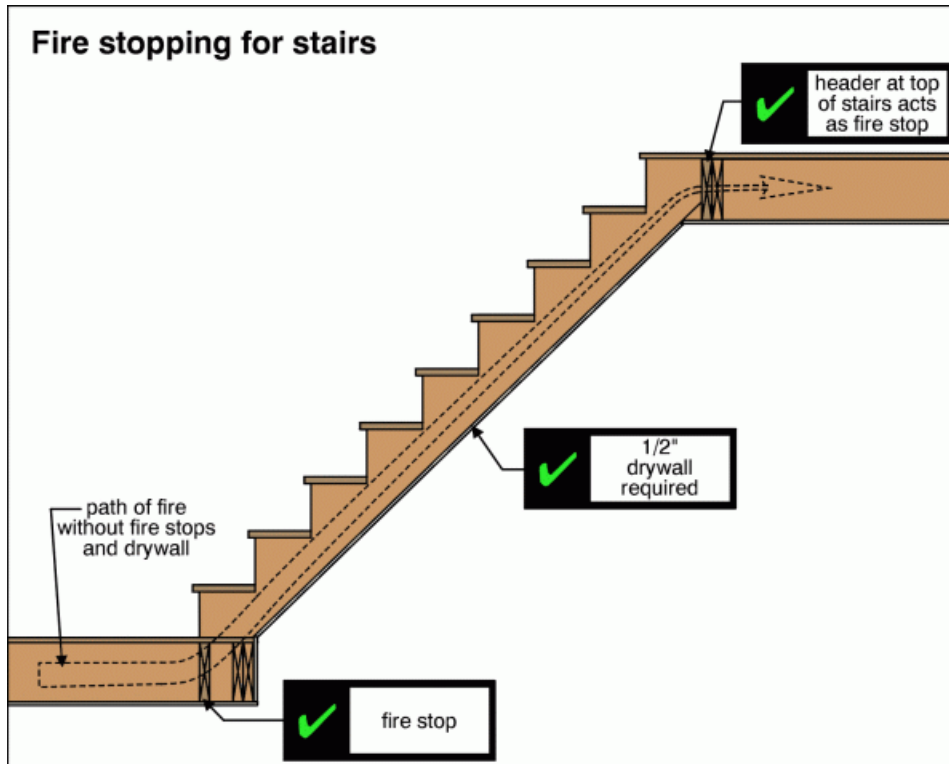
85. Drywall missing or incomplete on underside...
