Sample Home Inspection Report

Client(s): Client Name Property address: 123 ABC Street Anytown, CA Inspection date: Wednesday, January 2, 2019

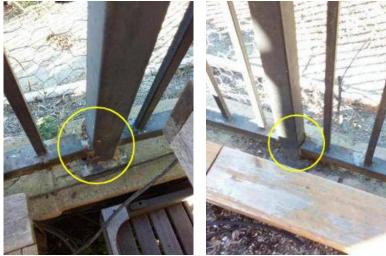
4) Corrosion was noted at the rear wrought iron fencing. Recommend a qualified contractor repair/replace as needed.

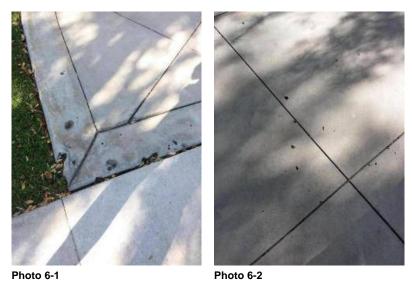
6) OMinor deterioration (e.g. cracks, holes, settlement, heaving) was found in the driveway, but no trip hazards were found. The client may wish to have repairs made for cosmetic reasons.

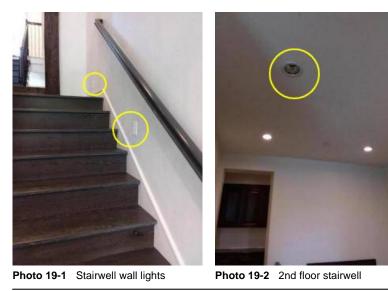
19) One or more light fixtures were inoperable (didn't turn on when nearby switches were operated). Recommend further evaluation by replacing bulbs and/or consulting with the property owner. If replacing bulbs doesn't work and/or no other switch(es) can be found, then recommend that a qualified electrician evaluate and repair or replace light fixtures as necessary.

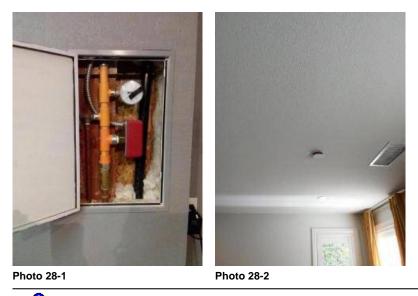
28) A fire suppression system was installed on the premises. These are specialty systems and are excluded from this inspection. Comments in this report related to this system are made as a courtesy only and are not meant to be a substitute for a full evaluation by a qualified specialist. These systems normally require periodic inspection by a specialist to ensure correct operation. For example, checking for possible backflow contamination of the potable water system, or correct operation of valves and gauges. Recommend that a qualified specialist inspect this system in accordance with National Fire Prevention Association (NFPA) 25 standards.

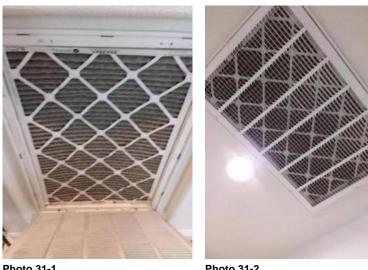
31) The return air filter(s) is/are dirty and should be replaced. When the air filter is clogged, the air handler must work harder to compensate for the blockage of air flow. In addition, dirty/clogged air filters increase energy consumption, cause frozen evaporator coils, cause inadequate heating and cooling, contribute to unhealthy air and can cause the furnace to fail. Recommend replacement of all dirty return air filters with appropriately sized new filters.

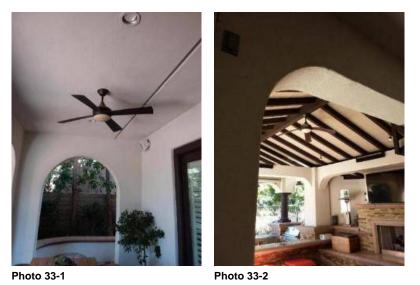
33) One or more ceiling fans appeared to be inoperable, or the inspector was unable to find normal controls with which to operate the fan(s). Recommend asking the property owner about their operation, and if necessary, that a qualified electrician evaluate and repair.

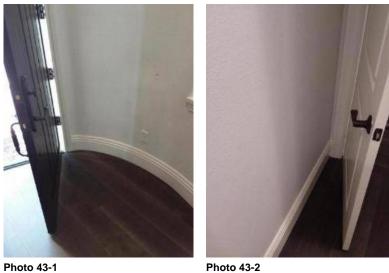
43) Door stops were missing from some interior doors. Drywall damage can occur as a result. Recommend that a qualified person repair or replace as necessary.
