# Your Inspection Report

## Sample Report West St. Paul, MN

**INSPECTION DATE:**  
Monday, June 2, 2014

RE: Report No. 1205, v.8  
Sample Report  
West St. Paul, MN

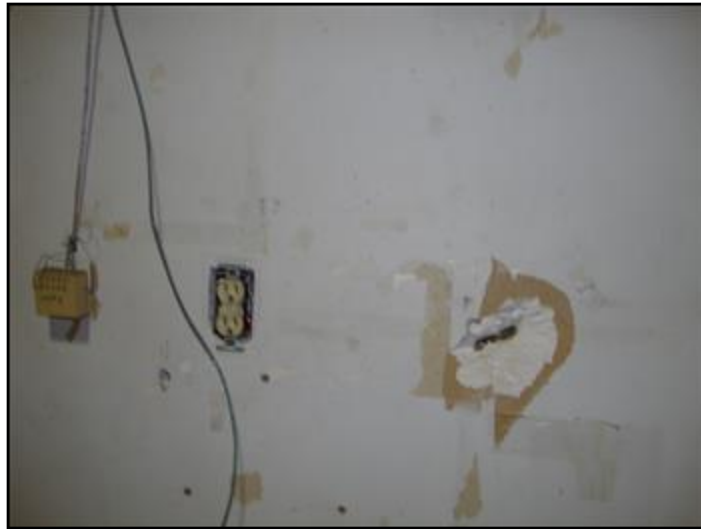
**8. Condition:** • Damaged receptacle.

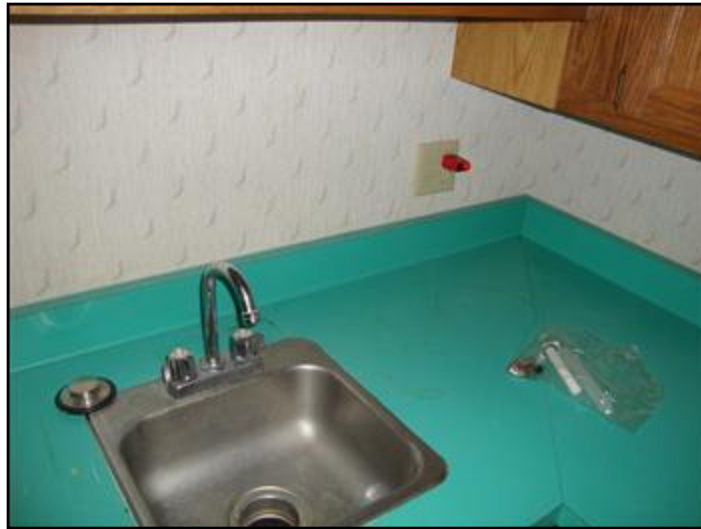
*Electrical outlets in close proximity to a...*

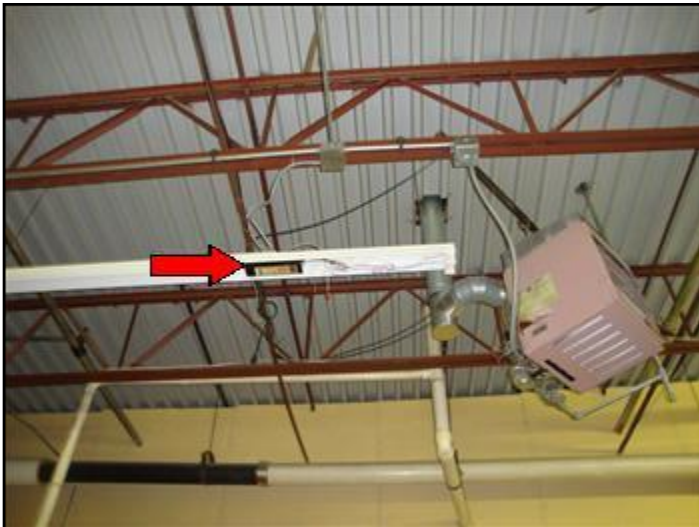
*Inoperative*

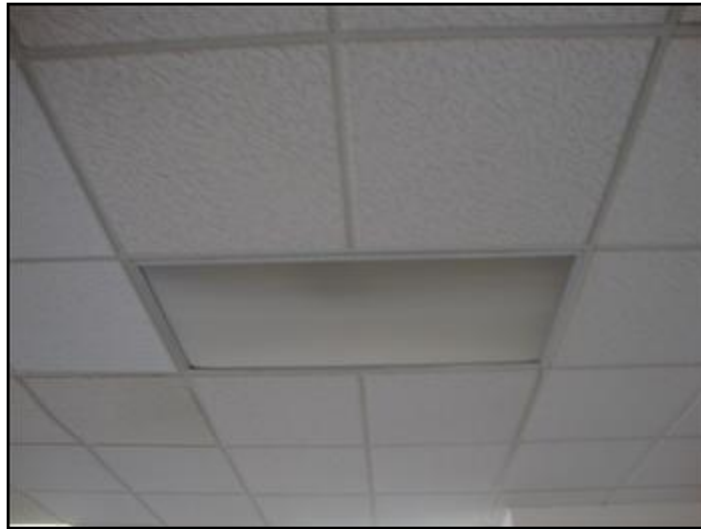
*Inoperative*

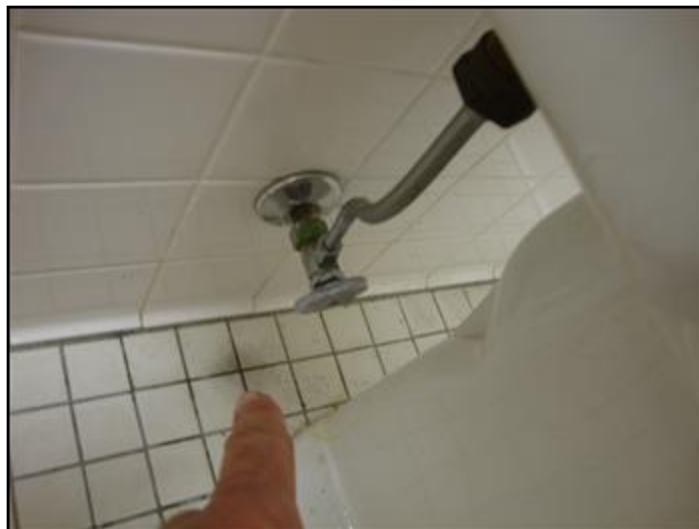
35. **Condition:** • Leaking shut off valve in suite PQ women's room.

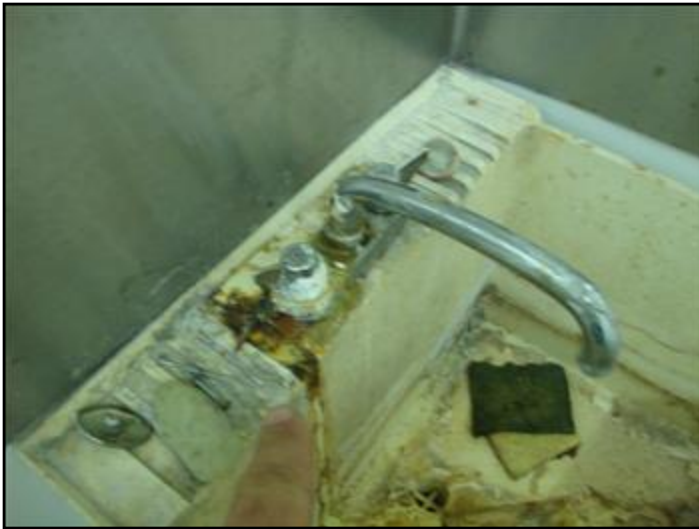
**43. Condition:** • The leaking faucet requires repair

*The leaking faucet requires repair*

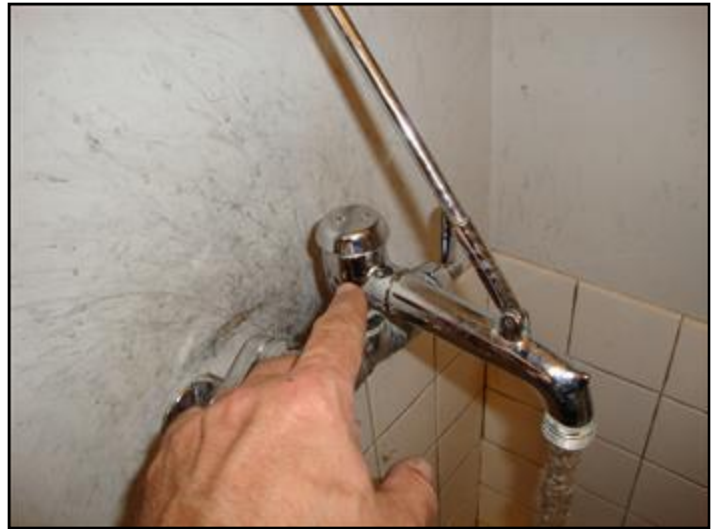
*The leaking faucet requires repair*

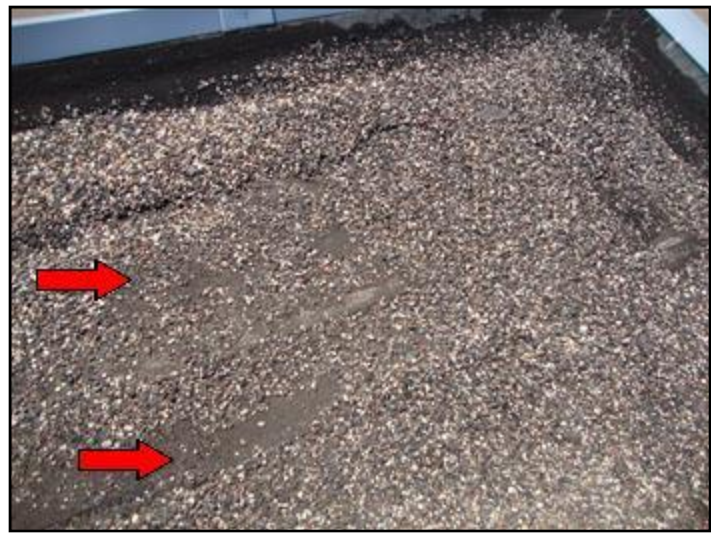
*Missing gravel exposes the membrane to...*

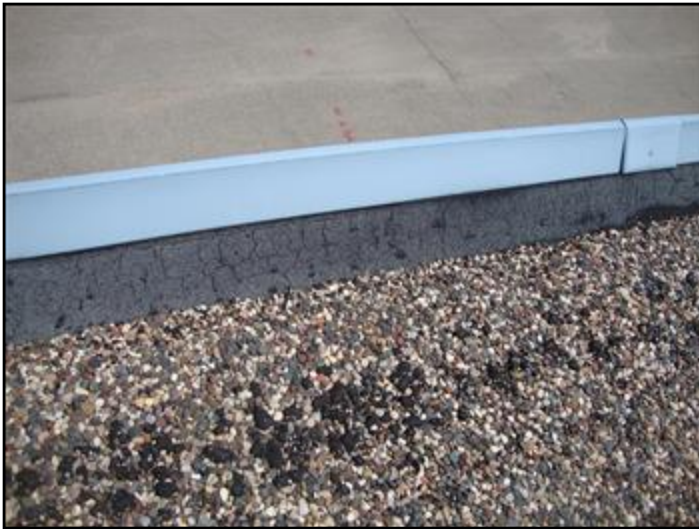
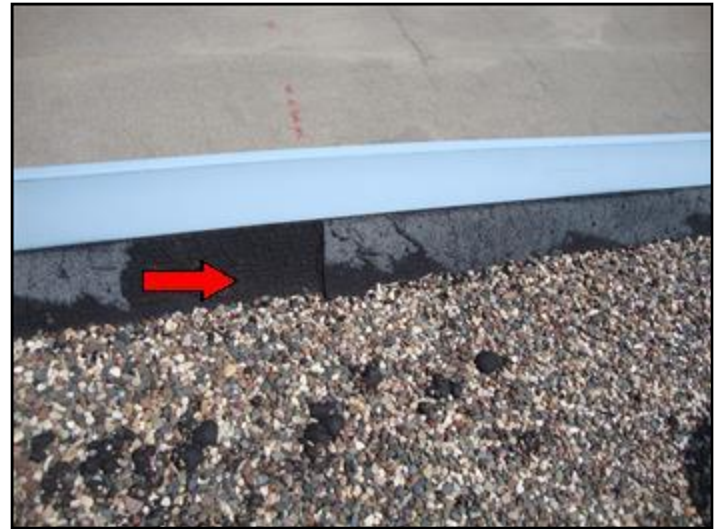
**48. Condition:** • The membrane is exposed to sunlight damage between the gravel and the perimeter metal flashing

The membrane is exposed to sunlight damage...

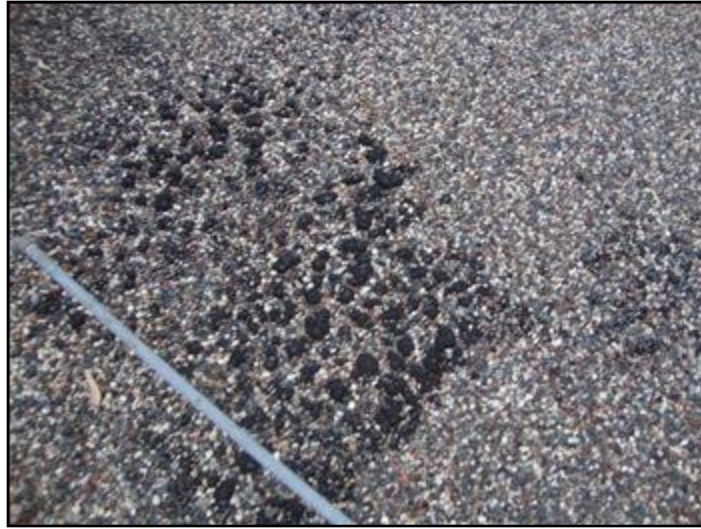
*Blistering, which occurs when air or...*

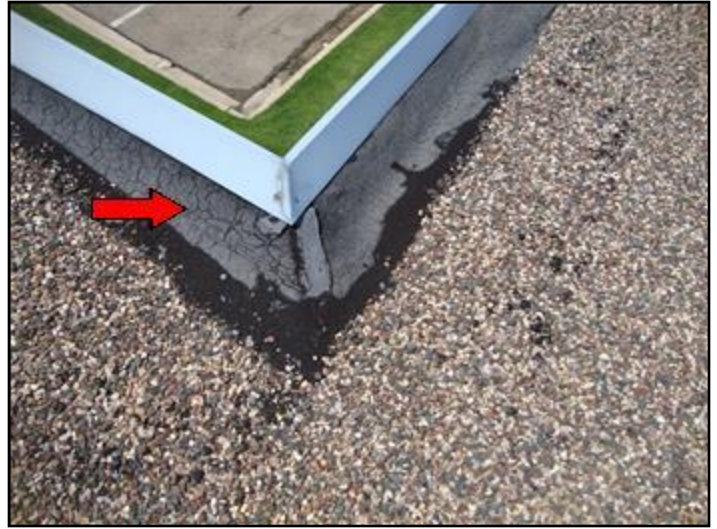
*Damaged membrane on the curb mount*

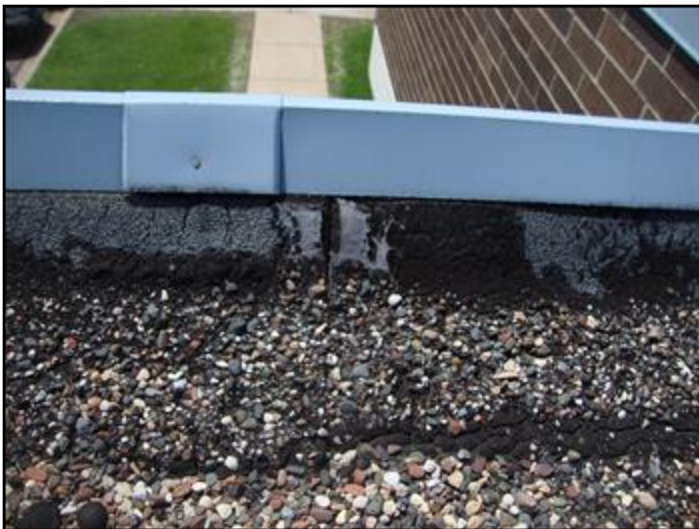
**52. Condition:** • Damaged membrane due to sunlight exposure on the curb mount

*Damaged membrane due to sunlight exposure...*

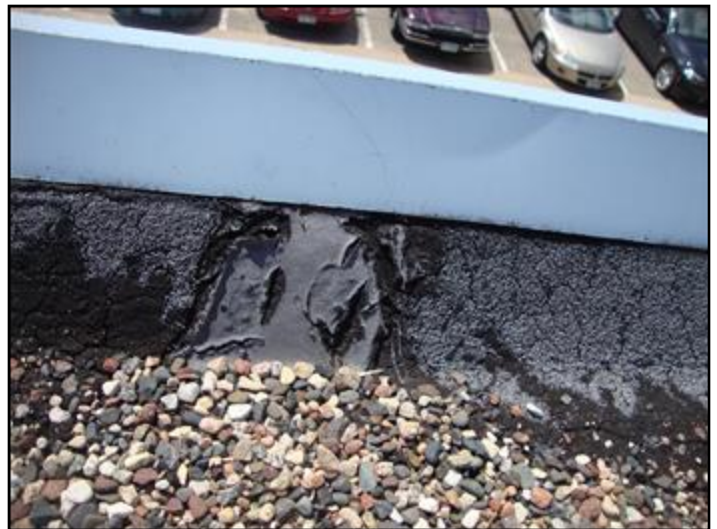
*Damaged membrane due to sunlight exposure...*

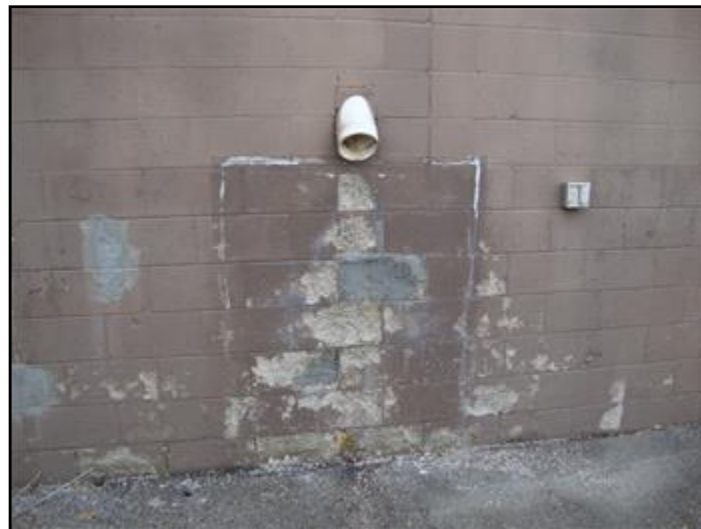
**56. Condition:** • Replace metal guard in area where block has deteriorated. Further deterioration is likely if guard is not replaced.

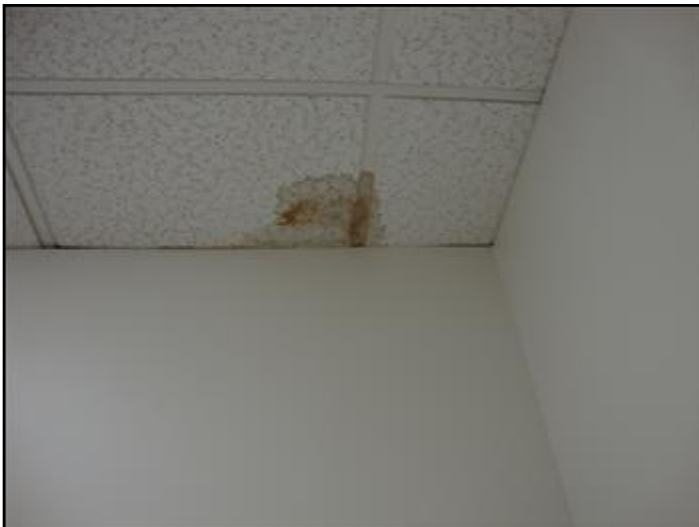
*A water stain was noted*

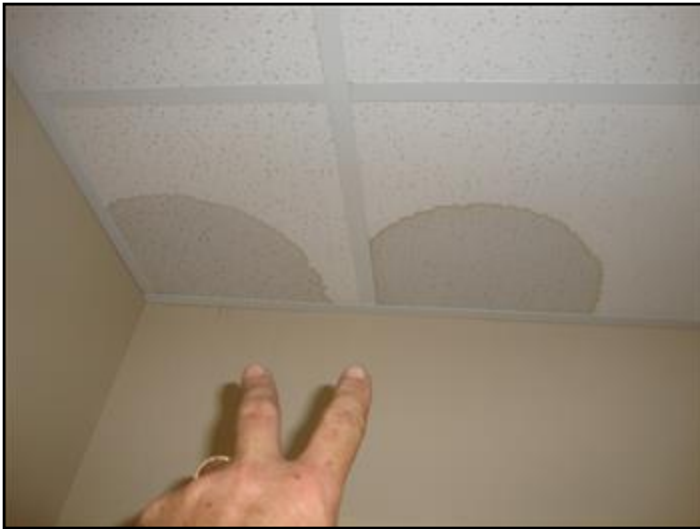
*A water stain was noted*

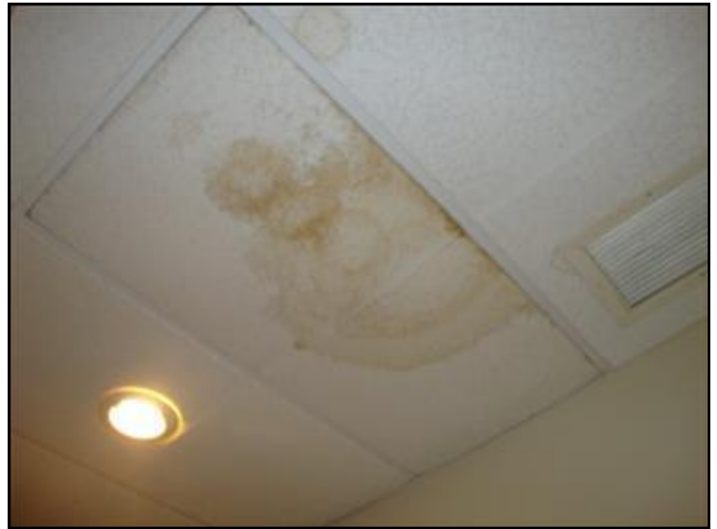
*A water stain was noted*

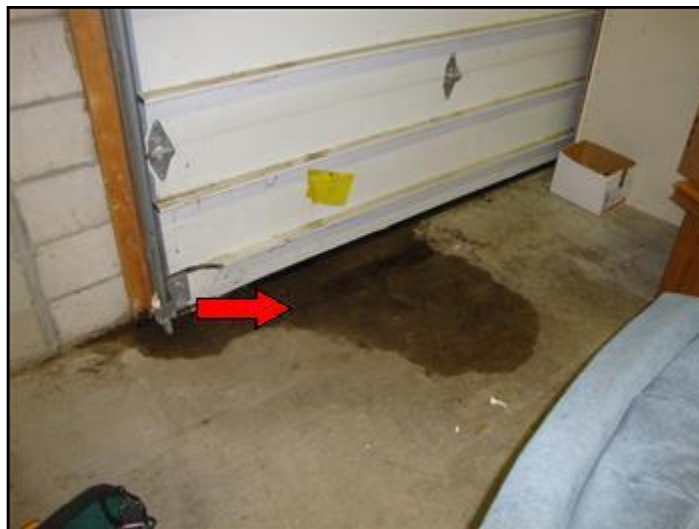
*A water stain was noted*

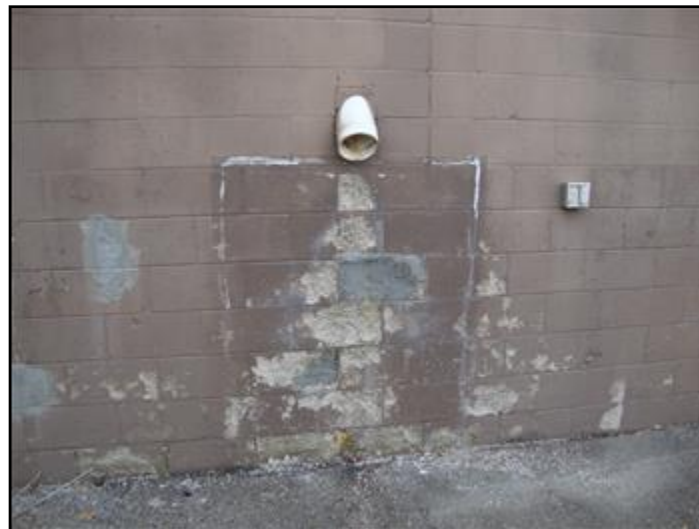
*Water damage was noted*

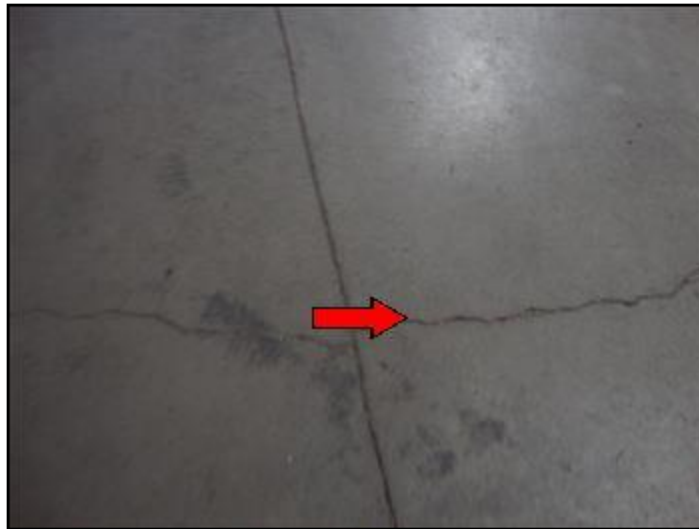
*The cracking noted is consistent with...*

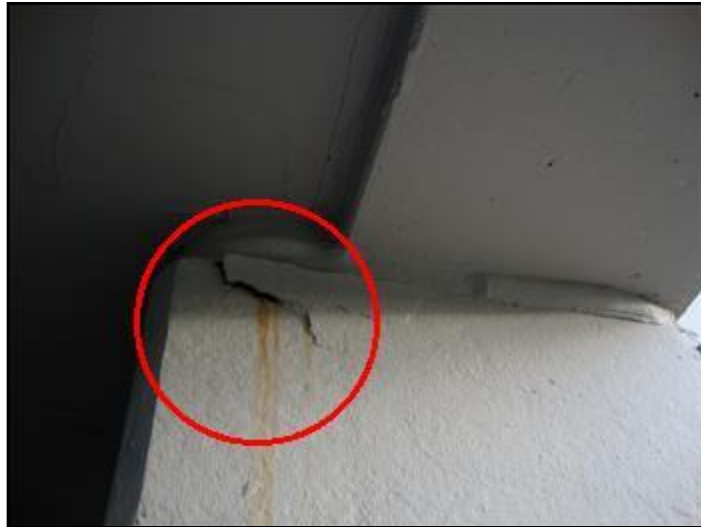
**80. Condition:** • Minor spalling or cracks observed on exterior concrete column.

**81. Condition:** • This damage is not significant, and no remedial action is considered necessary

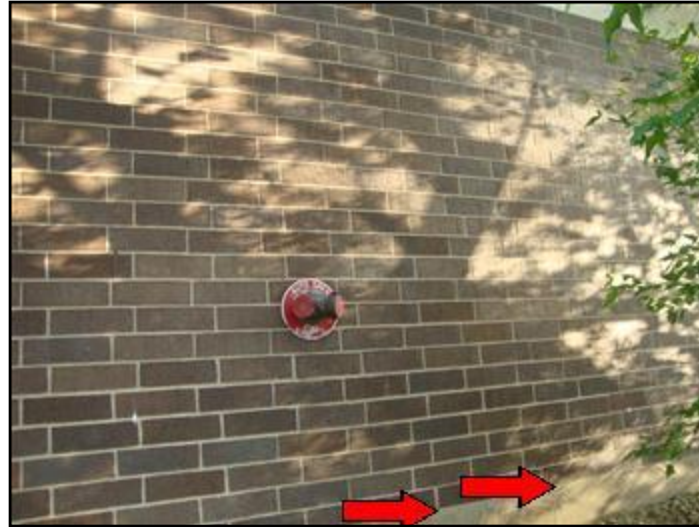
*The brick veneer cladding has not been...*

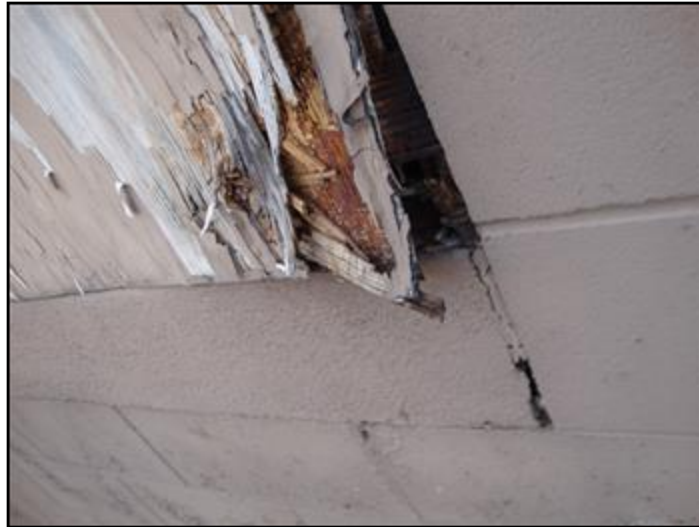
*Rotted plywood*

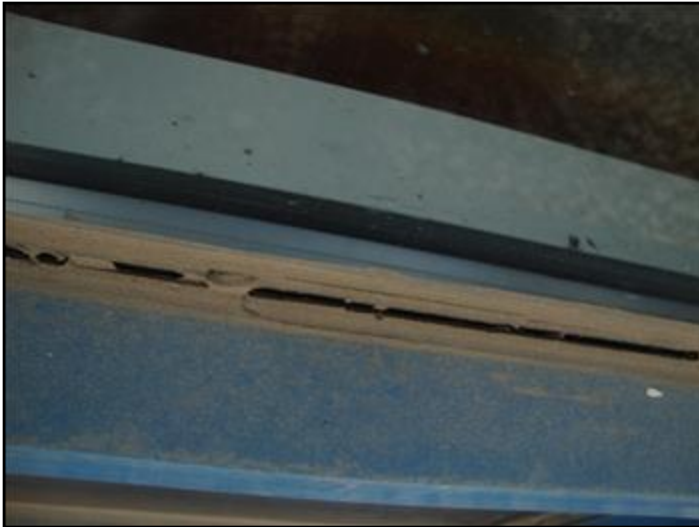
*Deteriorated caulking*

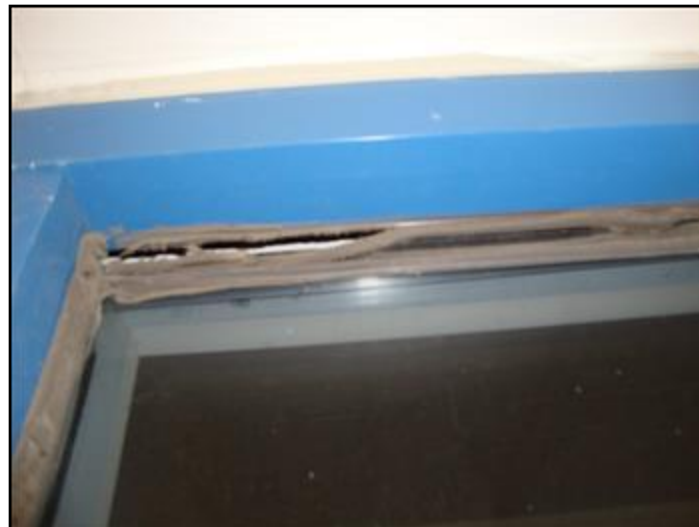
*Deteriorated caulking*

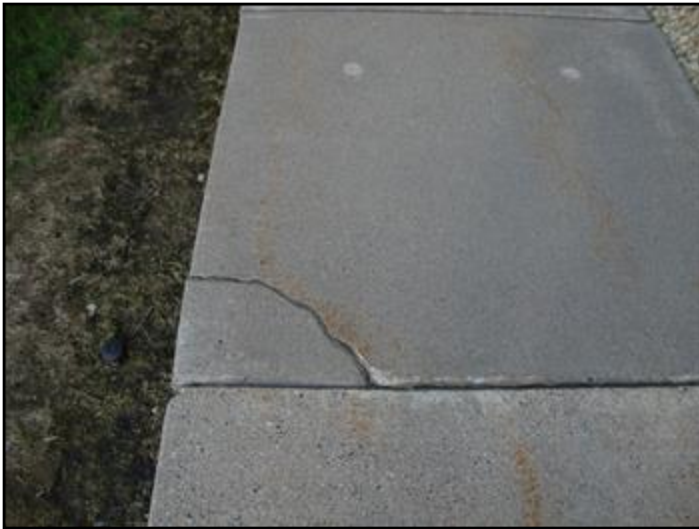
*Cracked*

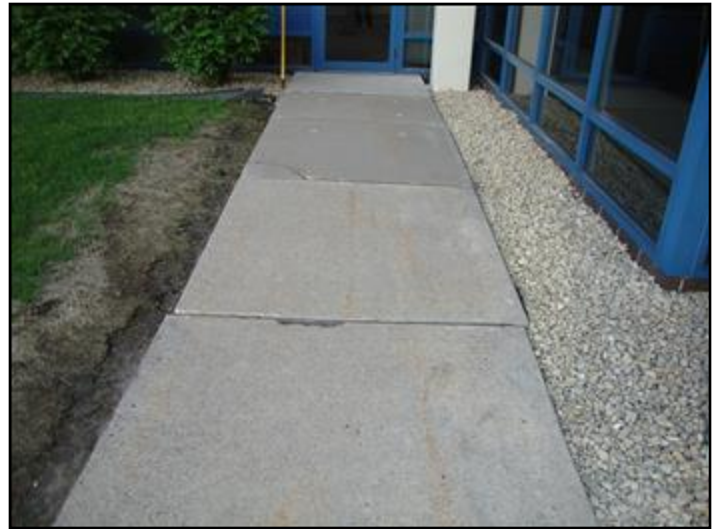
*Cracked*

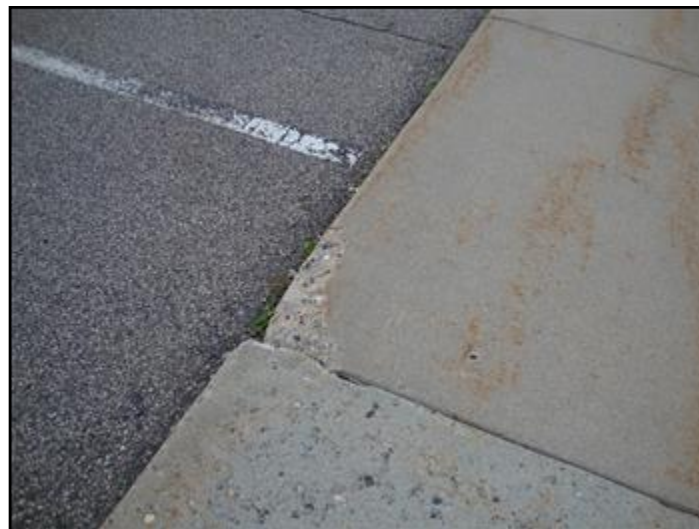
*Cracked*

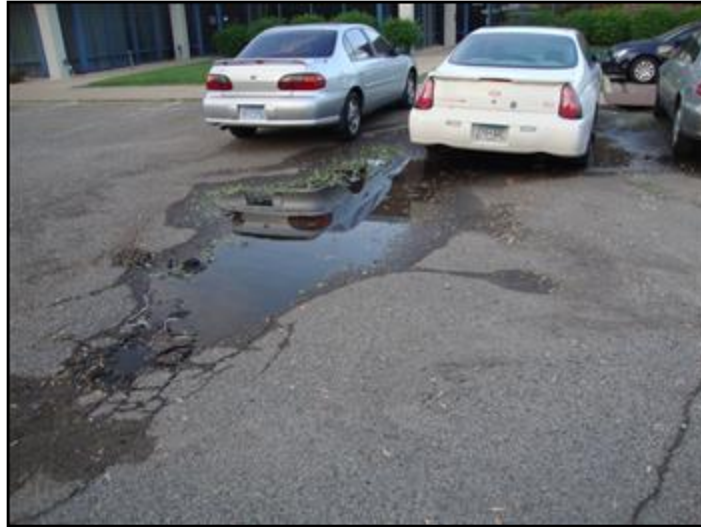
*Potholes are noted*

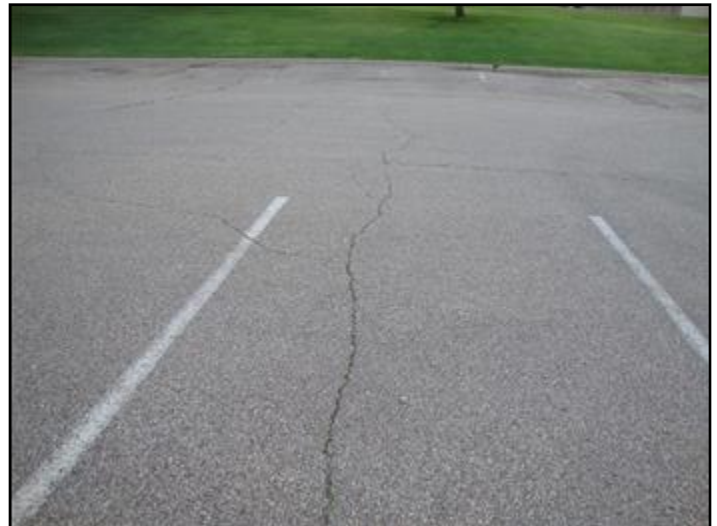
*Major repairs to the asphalt pavement...*
