Inspection Report

Buchanan Home Inspection

PROPERTY INSPECTION REPORT

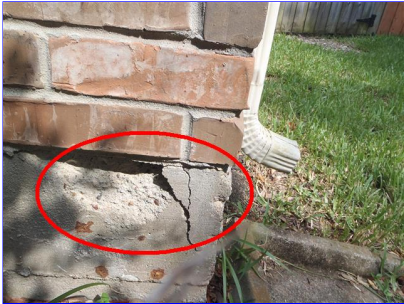
The foundation appeared to be operating as intended, however, there was some cosmetic damage and an exposed post tension end, at the left side of the home, that needs to be sealed/repaired to help prevent damage to home.

A. Item 1(Picture) Cosmetic damage at front of home.

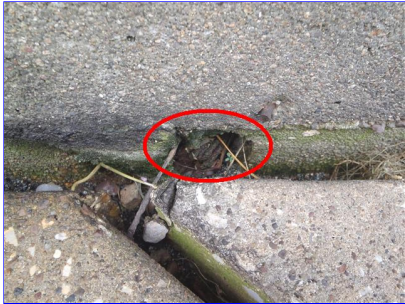
A. Item 2(Picture) Exposed post tension end at the left side of home near the back by the driveway.

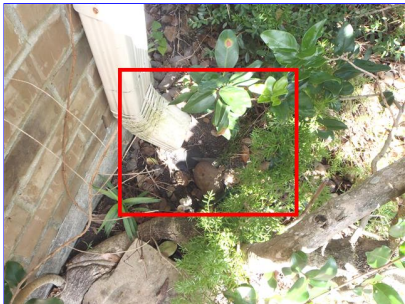
Missing splash block/downspout extension at back right corner of home and back left corner of garage needs replacement/installation.

B. Item 1(Picture) Missing splash block/downspout extension at back right corner of home. Recommend installing to help prevent erosion and damage to property

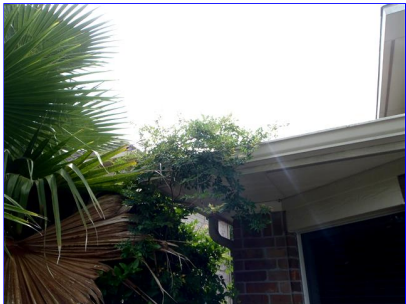
Vegetation growing on gutters at back of home needs to be removed to help prevent damage to property.

B. Item 2(Picture) Vegetation growing on gutters at back of home.

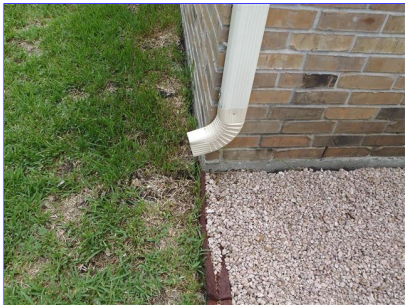
B. Item 3(Picture) Missing splash block/downspout extension at back left corner of garage.

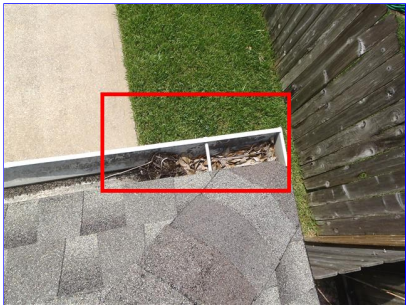
Debris and ponding water in gutters was noted in several areas and needs further evaluation and repair to help prevent damage to property.

B. Item 4(Picture) Debris in gutters at the front of the garage.

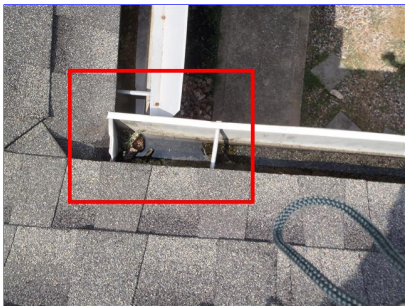
B. Item 5(Picture) Ponding water in gutters at back of home at time of inspection.

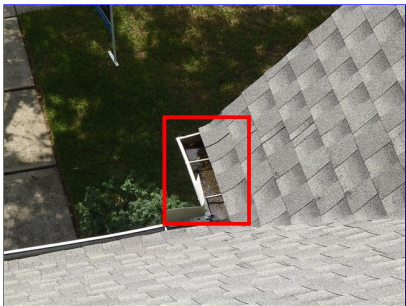
B. Item 6(Picture) Ponding water in gutters at front of home above the front entrance.

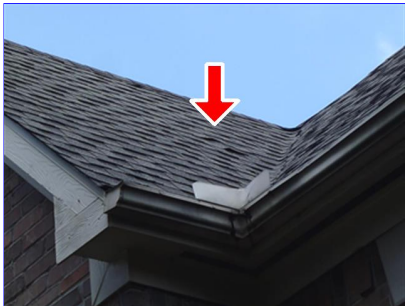
The majority of roof coverings appeared to be operating as intended, however, there were a couple nail pops, at front facet of home above the front entrance, that need repair to help prevent moisture intrusion.

C. Item 1(Picture) Nail pops noted at front facet of home above the front entrance.

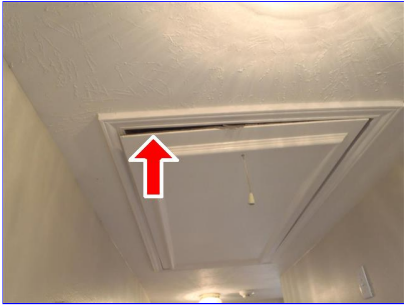
Comments:
Gap in upstairs attic hatch needs repair to help prevent air movement in this area.

D. Item 1(Picture) Gap in upstairs attic hatch.

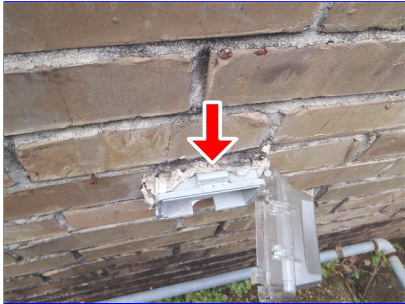
E. Item 1(Picture) Recommend re-sealing around electrical, by the a/c condensers at the right side of home, to help prevent moisture intrusion.

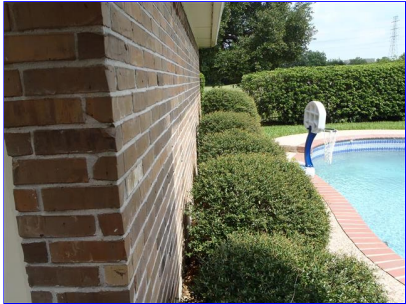
Comments:
Vegetation in contact with exterior garage wall at the right side of home needs to be trimmed to help prevent damage to walls.

E. Item 2(Picture) Vegetation in contact with exterior garage wall at the right side of home.

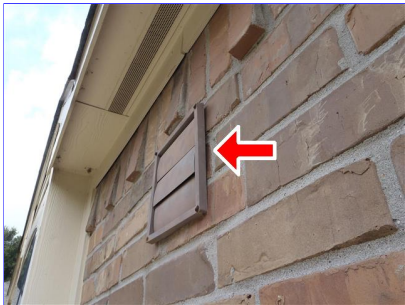
E. Item 3(Picture) Recommend sealing around vent on exterior wall at the left side of home to help prevent moisture intrusion.

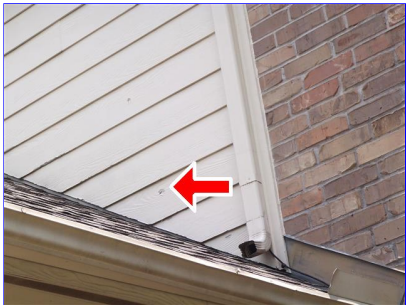
Slightly damaged siding at the front left side of home. Evaluate and repair as needed.

E. Item 4(Picture) Slightly damaged siding at the front left side of home.

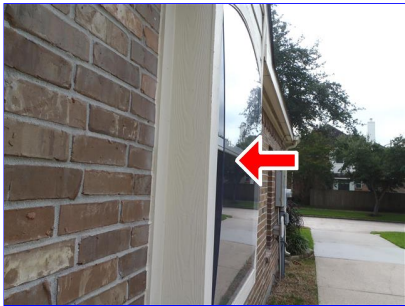
Loose piece of excess glass on exterior of window at the left side of home needs further evaluation and repair as needed.

H. Item 1(Picture) Loose piece of excess glass on exterior of window at the left side of home. Unsure of purpose of this but recommend further evaluation and repair as needed.

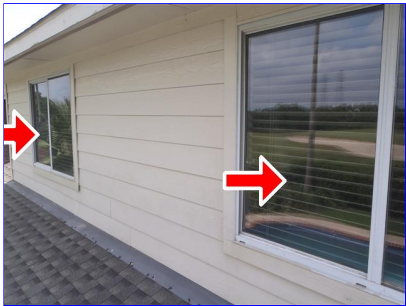
Missing screens, on windows at back of home, need to be replaced to help prevent damage to windows.

H. Item 2(Picture) Missing screens on windows at back of home.

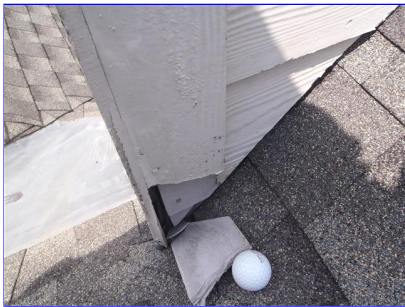
Damaged trim on exterior of chimney needs repair to help prevent moisture intrusion.

J. Item 1(Picture) Damaged trim on exterior of chimney.

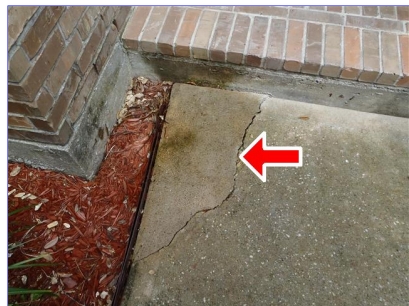
Damaged flatwork at the front of home by the front door should be repaired to help prevent damage to home.

L. Item 1(Picture) Damaged flatwork at the front of home by the front door.

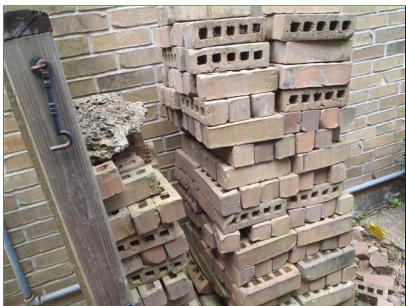
Bricks stacked up on right side of home need to be removed to help prevent damage to property or injury to person, if these were to fall.

L. Item 2(Picture) Bricks stacked up on right side of home.

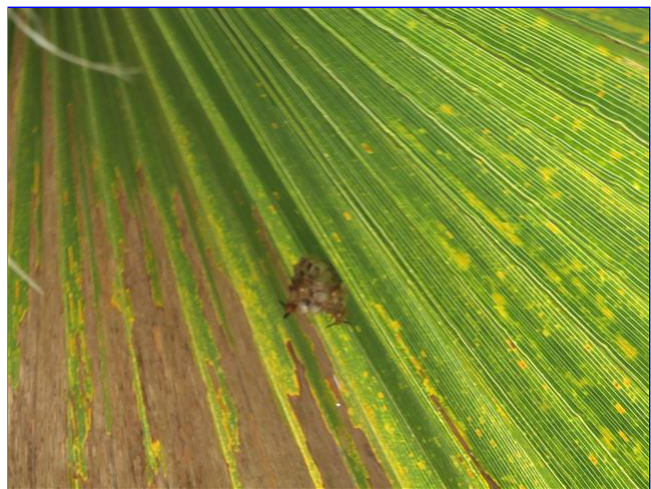
Flying sting insects on tree at the back right corner of home at time of inspection. The inspector was stung by several of these at time of inspection and need to be removed for safety.

L. Item 3(Picture) Flying sting insects on tree at the back right corner of home.

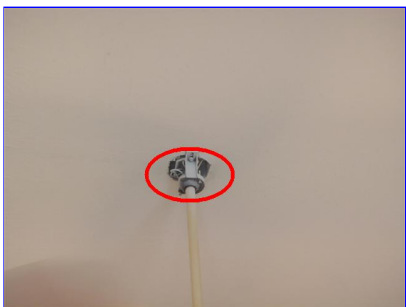
Missing cover at top of ceiling fan in the room at the top of the stairs needs replacement.

L. Item 4(Picture) Missing cover at top of ceiling fan in the room at the top of the stairs.

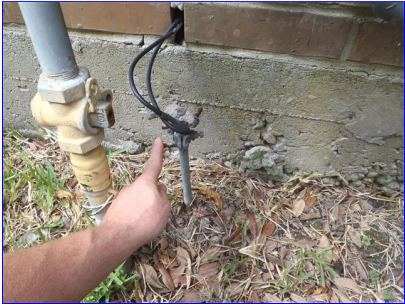
Loose clamp on grounding rod/wire under the gas meter at the right side of home needs to be tightened for safety. This was also noted on the clamp on the ground rod at the meterbase and needs repair.

A. Item 1(Picture) Loose clamp on grounding rod/wire under the gas meter at the right side of home.

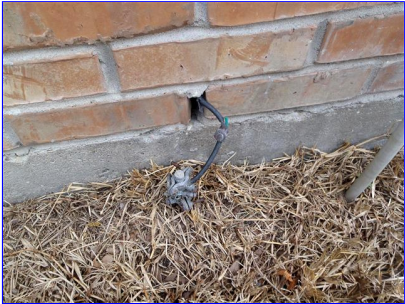
A. Item 2(Picture) Loose clamp on grounding rod at meterbase.

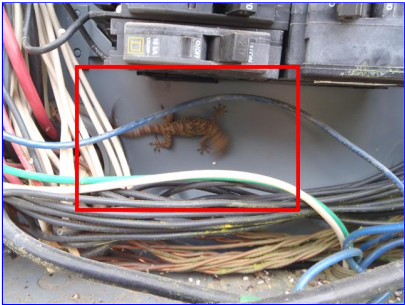
There was a critter in the electrical panel at time of inspection, which is a possible fire hazard, and should be removed. Recommend having a professional remove critter and seal gaps between the pane and wall to help prevent re-entry.

A. Item 4(Picture) Critter in panel at time of inspection.

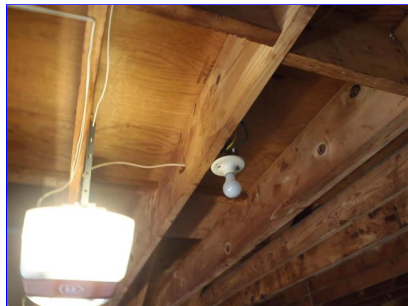
Light in garage not working at time of inspection. Recommend further evaluation and repair .

B. Item 1(Picture) Light in garage not working at time of inspection.

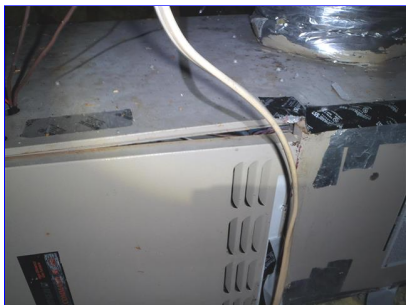
Loose cover on furnace number two, further from attic entrance, needs to be properly secured to help prevent damage to unit.

A. Item 5(Picture) Loose cover on furnace number two at time of inspection.

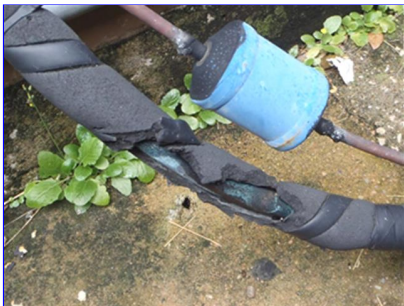
B. Item 4(Picture) Recommend repairing damaged insulation on a/c suction line at the condenser on the right.

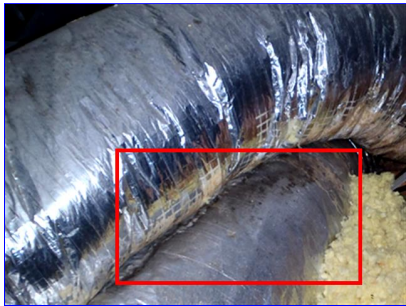
Touching and condensating ducts noted in the attic by furnace number two that needs further evaluation and repair to help prevent damage to property and fungi growth.

C. Item 1(Picture) Touching and condensating ducts noted in the attic at the by furnace number two.

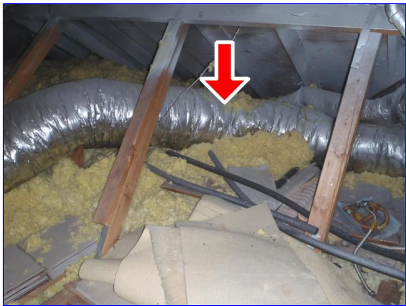
Some ducts laying in insulation at time of inspection. This can cause ducts to condensate and should be evaluated further and repaired.

C. Item 2(Picture) Duct laying in insulation at time of inspection.

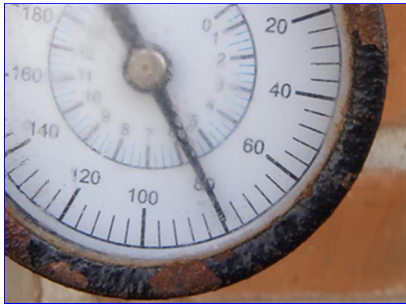
A. Item 1(Picture) Water pressure for the home should be between 40 and 80 psi and was approximately 80 psi at time of inspection.

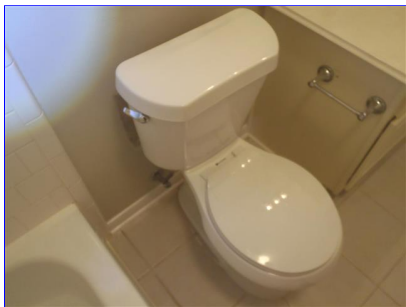
A. Item 3(Picture) Water was off to the toilet, in the upstairs hallway bathroom, and could not be operated. Recommend further evaluation and repair as needed. We do not turn on valves that are off due to not knowing why it is off.

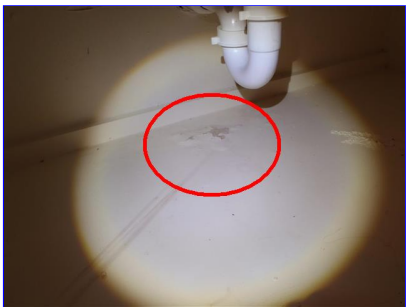
A. Item 4(Picture) Evidence of previous leak under the lavatory in the upstairs hallway bathroom. Recommend monitoring for leaks in this area.

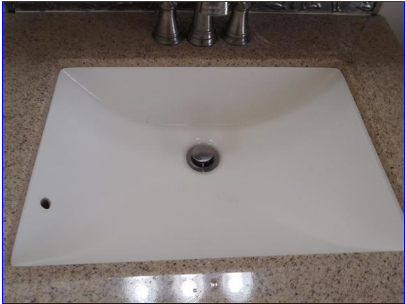
Drain stopper, for the lavatory in the bathroom by the laundry room, does not work properly and needs repair.

B. Item 1(Picture) Drain stopper, in the bathroom by the laundry room, does not work properly.

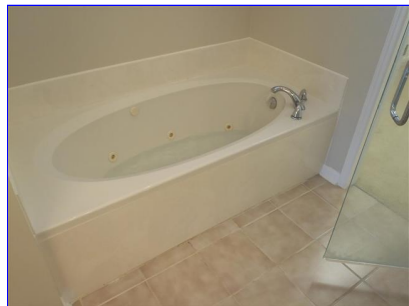
Access should be provided to circulation pumps in accordance with the fixture or pump manufacturers installation instructions. Where instructions do not specify location and size of access openings, an

opening of not less than 12x12 inches should be installed for access to the circulation pump, (unless pump located more than 2 feet from access opening, in which case, opening should be 18x18 inches at minimum) and unobstructed. Due to no access to pump motor, we were not able to inspect the pump motor or circulation piping. Evaluate and repair as needed.

D. Item 1(Picture) Missing access panel for hydro massage tub. This may not have been required when the home was built but should be installed to be able to inspect plumbing.

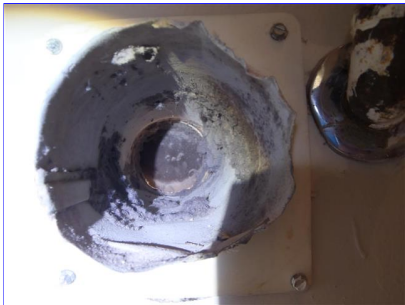
H. Item 1(Picture) Slight bit of debris in the dryer exhaust.
