THERMAL IMAGING

129 Avenue St, Toronto, ON March 18, 2018

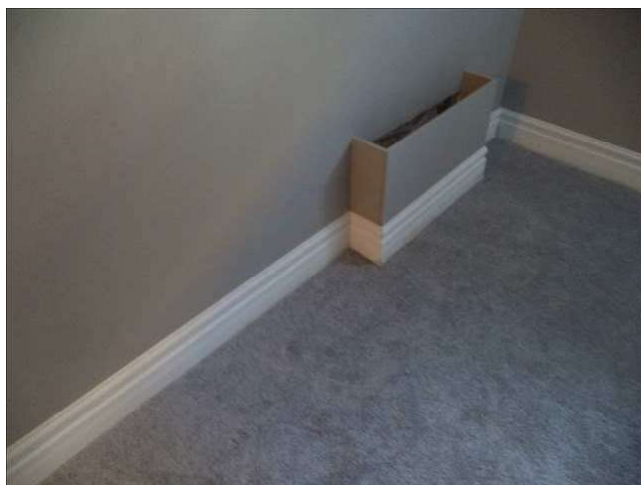
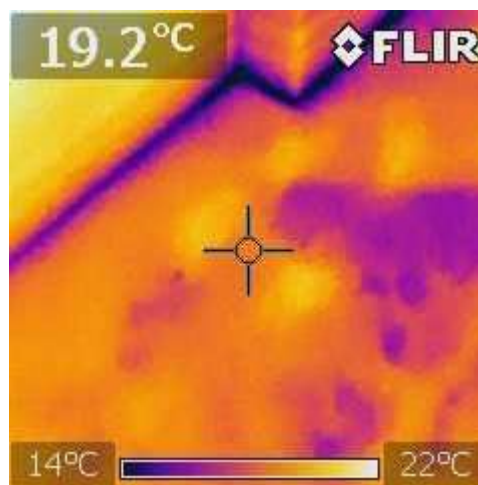
Location: Southeast Basement

Condition: • Moisture detected with moisture meter
Located near the downspout.

Moisture detected with moisture meter

Manage the water from the exterior

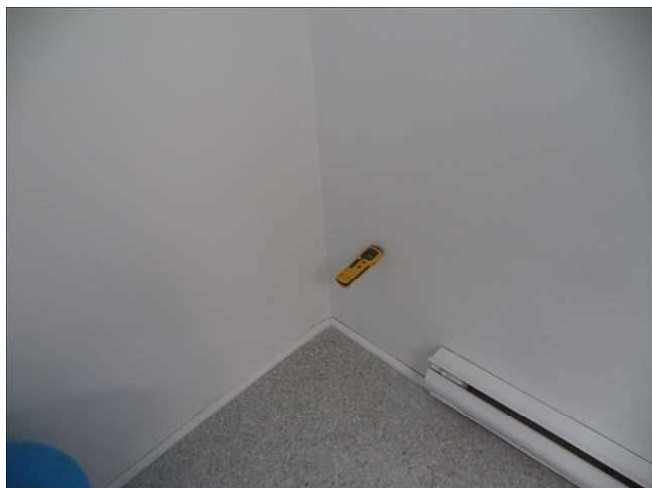
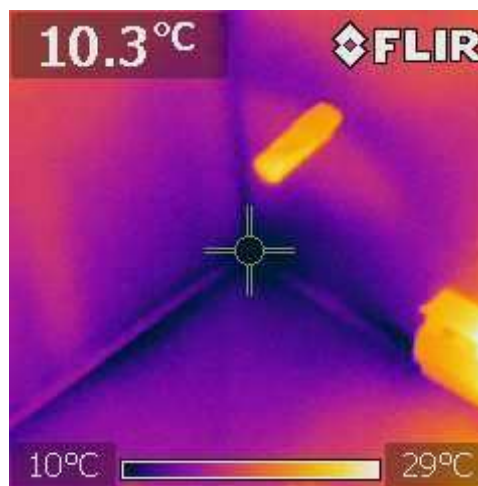
Location: Southeast Basement

Condition: Moisture detected with moisture meter
Located near the downspout.

Moisture detected with moisture meter

Manage the water from the exterior

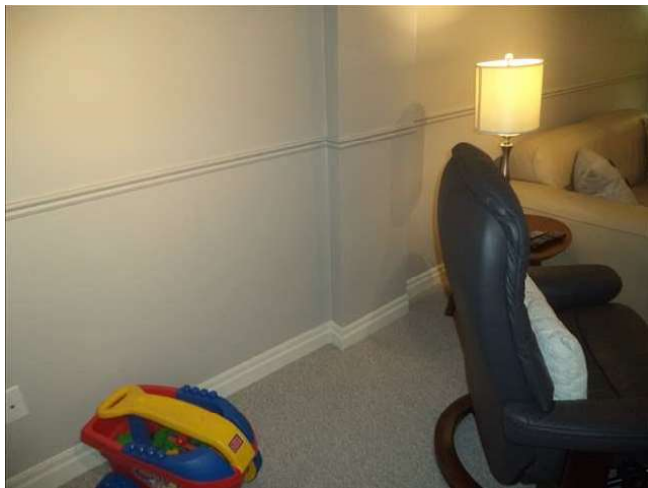
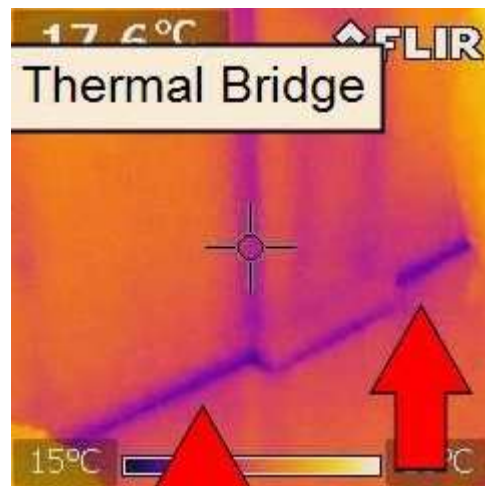
Location: West Basement

Typical thermal bridge (arrow)

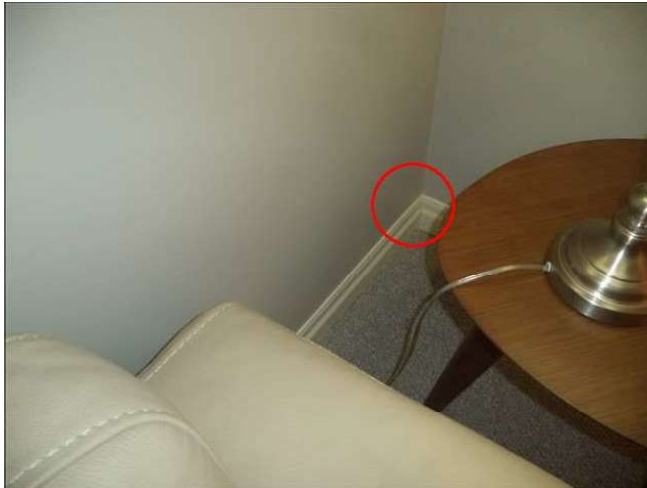
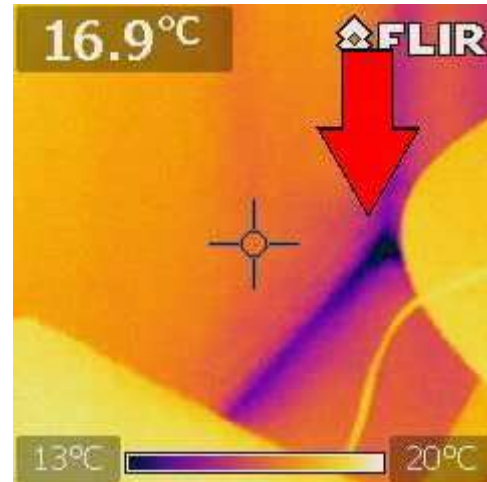
Location: West Basement

Typical thermal bridge (arrow)

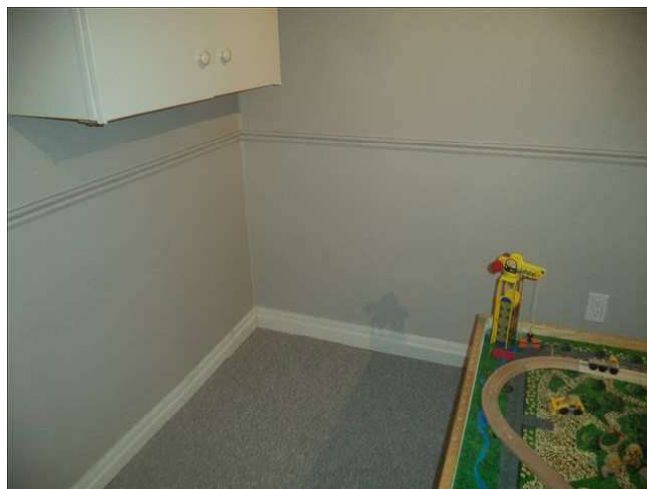
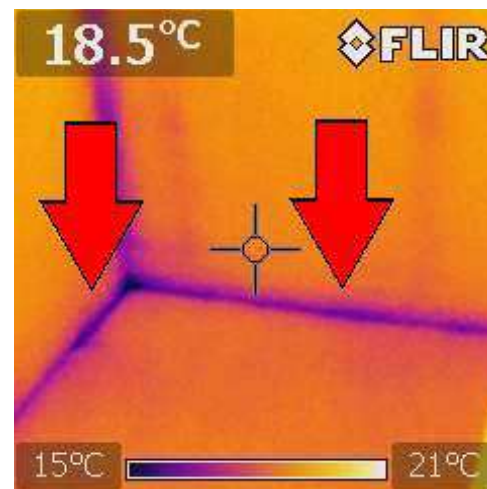
Location: Southwest Basement

Typical thermal bridge (arrow).

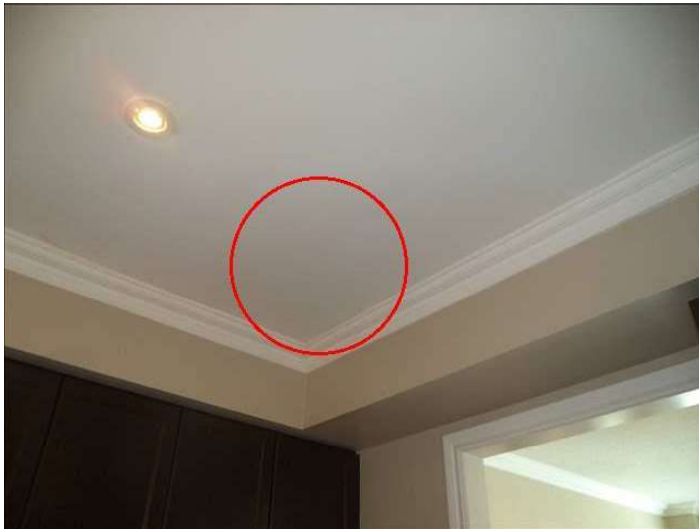
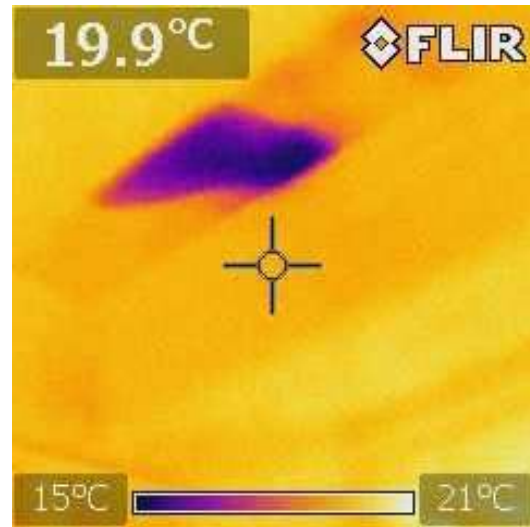
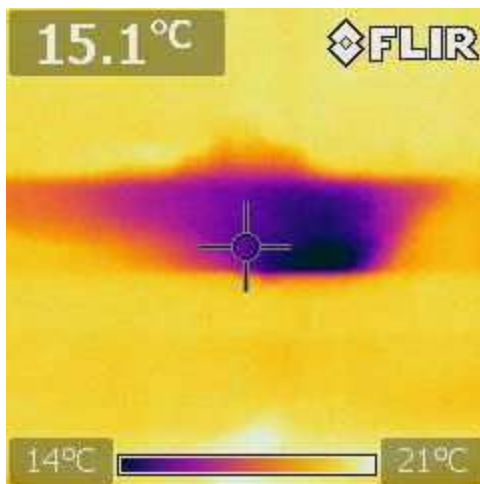
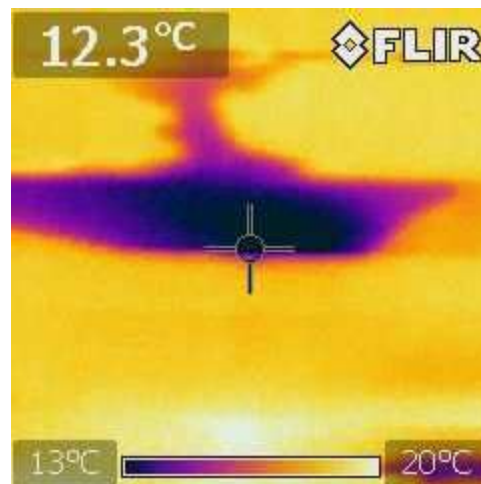
Condition: Moisture detected with moisture meter **Location:**
Under Second Floor Master Bathroom

Moisture detected with moisture meter

5 minutes of running water.

10 minutes of running water.

15 minutes of running water.

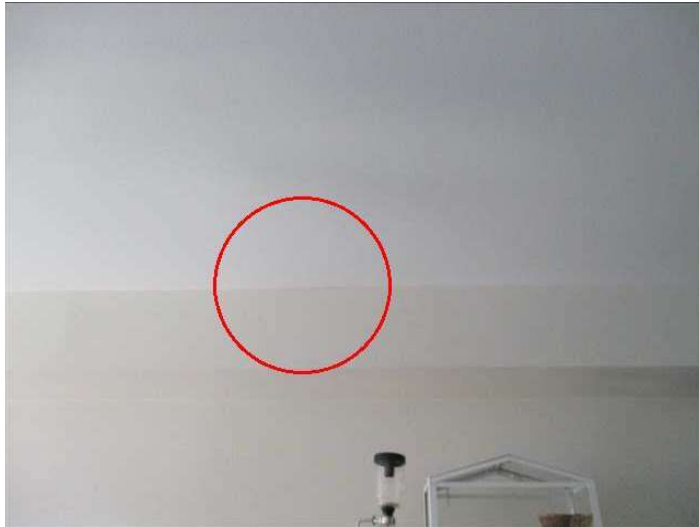
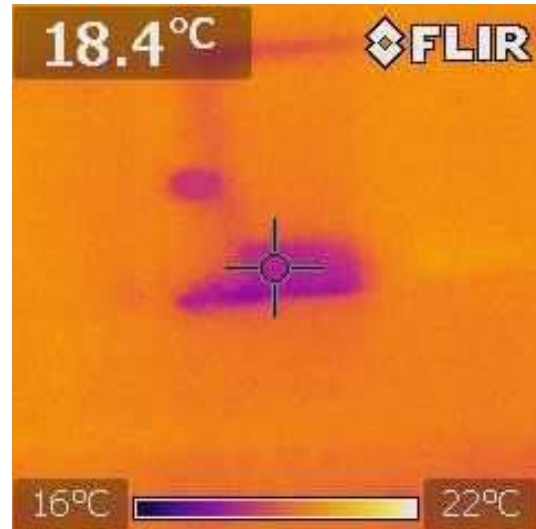
Location: Under Second Floor Bathroom

Condition: • Moisture detected with moisture meter

Moisture detected with moisture meter
