# Home Inspection Report

Property address: 1234 Center Ave.  
Charleston SC 29407

Inspected by: Stephen Houmard  
Solid Ground Home Inspections  
South Carolina License #2046  
*Certified ASHI® Home Inspector*  
*Infrared-Certified® Home Inspector*

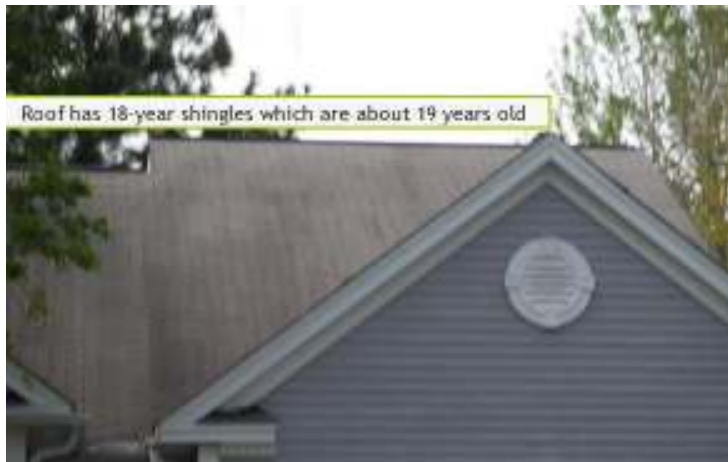
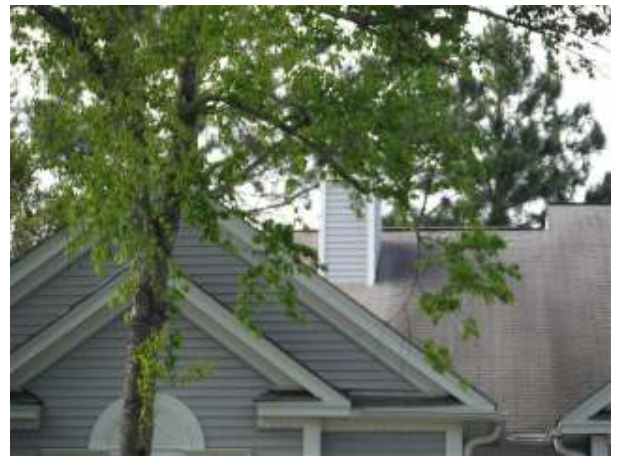
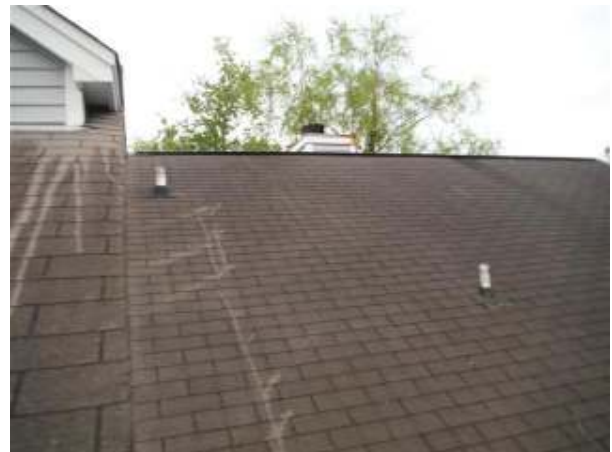
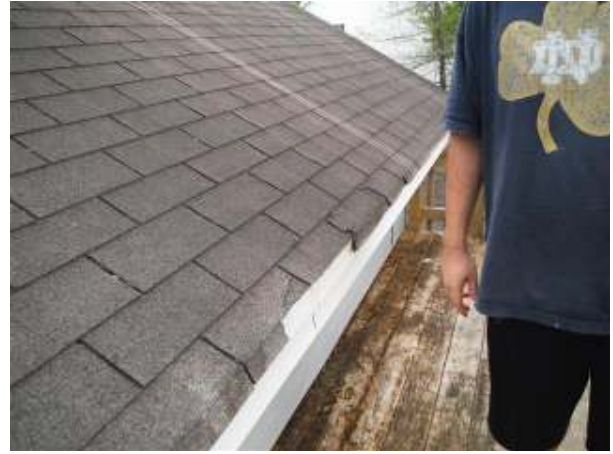
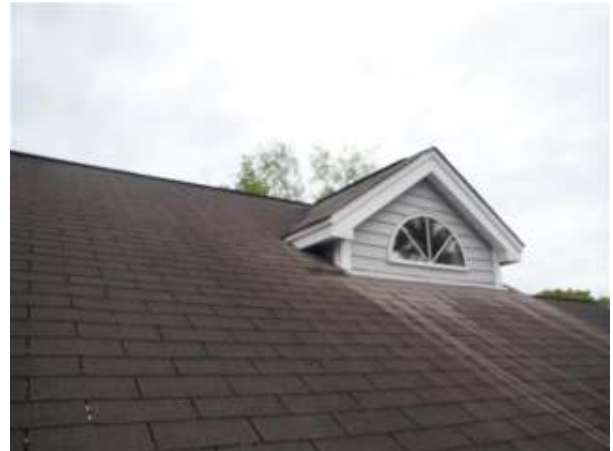
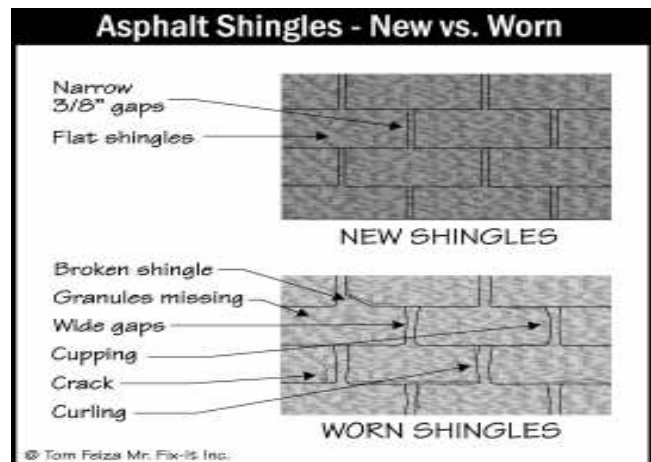
(1) Observed that this home has 3-tab fiberglass shingles which are estimated to be about 19 years old or so. Please note the shingles are showing signs of age and wear -- they are losing their granules (protecting them from the UV rays) which keep them from cracking. For your reference, the average roof with this type of shingles can last up to 18 years and possibly longer depending on the local climate and roof ventilation. Recommend monitoring the roof for possible problems or leaks and plan to replace the shingles in the in the next few years or so when you have a chance.. You may also want to check out the SC Safe Home Program on the web at [www.scsafehome.sc.gov](http://www.scsafehome.sc.gov) -- this organization provides grant dollars to those who qualify for the purpose of making homes more wind and hurricane resistant to include roof covering replacement.

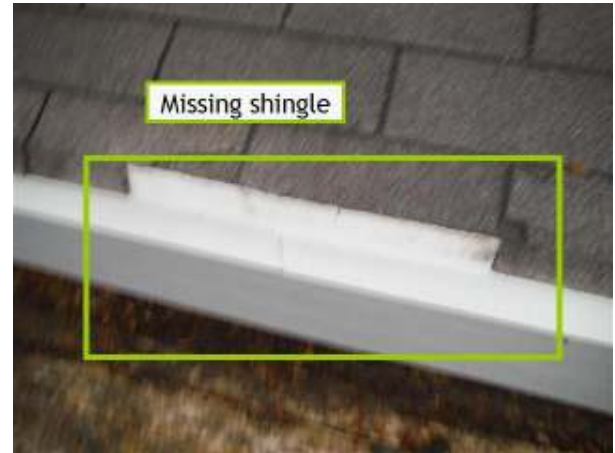
(3) Observed that there are one or more missing shingles on the back of the roof. Recommend having a roofing contractor make the needed repairs to ensure the roof remains water tight.

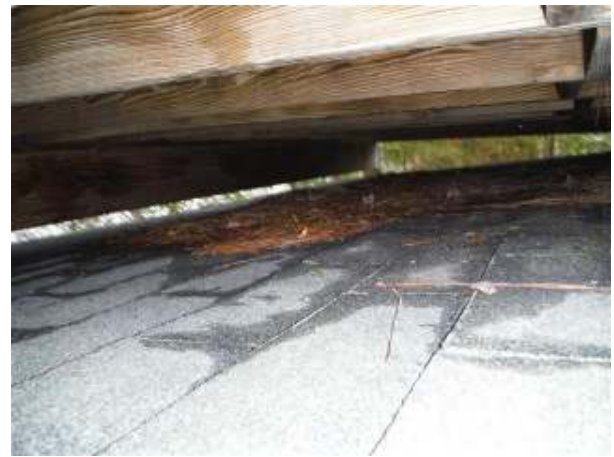
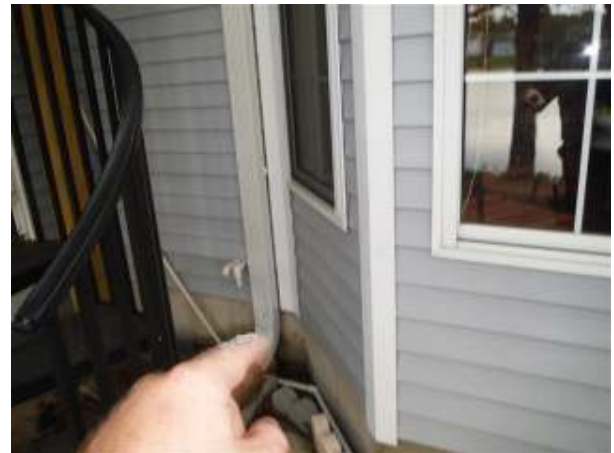
(4) Please note the roof over the sunroom and the area under the deck cannot be repaired without removing the deck. Debris on the shingles on this low slope roof may cause moisture to back up under the shingles. This is an FYI.

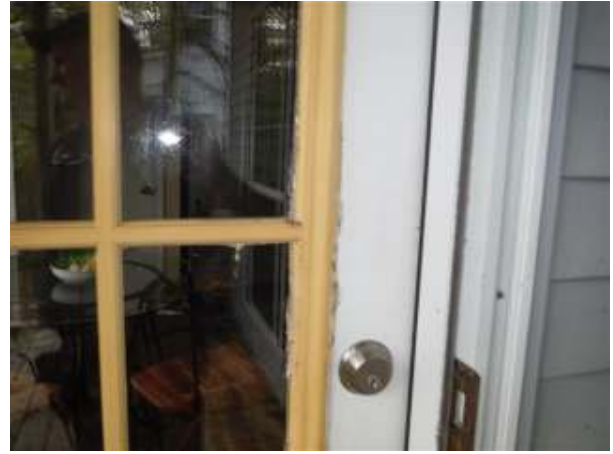
(1) Observed that the back exterior door has been caulked with glue. The bugs are now stuck in this glue and it is running down the door. Recommend having a contractor replace this door which has never been painted.

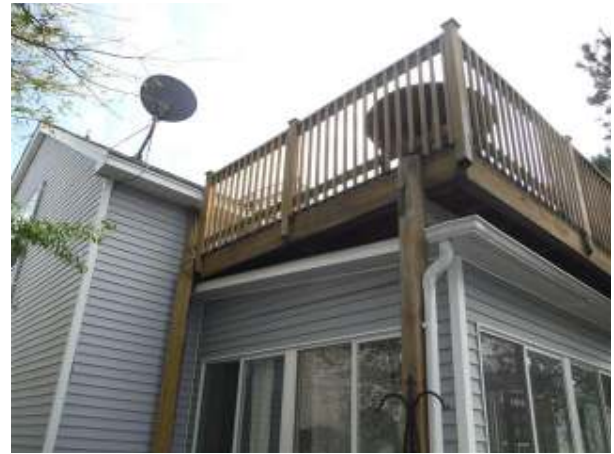
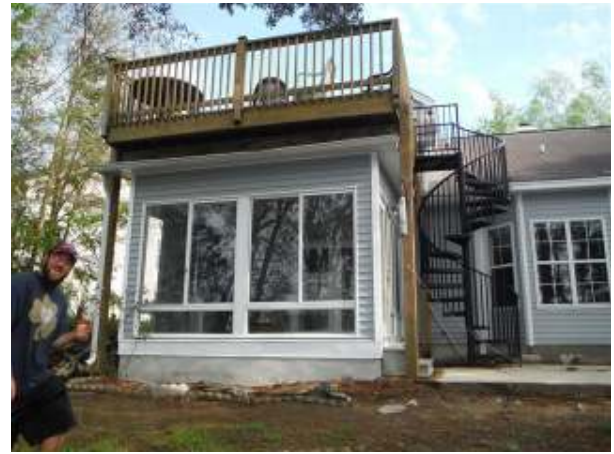
(1) Observed that the deck band is not attached securely to the home. Instead, the deck should be attached with 5/8" galvanized lag screws or carriage bolts about every 36". Recommend having a contractor properly secure the deck to the home, for safety. Please note this deck sits on four posts and there are no signs of bracing or anchoring into the home. Recommend having a contractor evaluate the deck further and make any repairs needed to ensure its structurally sound and properly attached to the home, for safety.

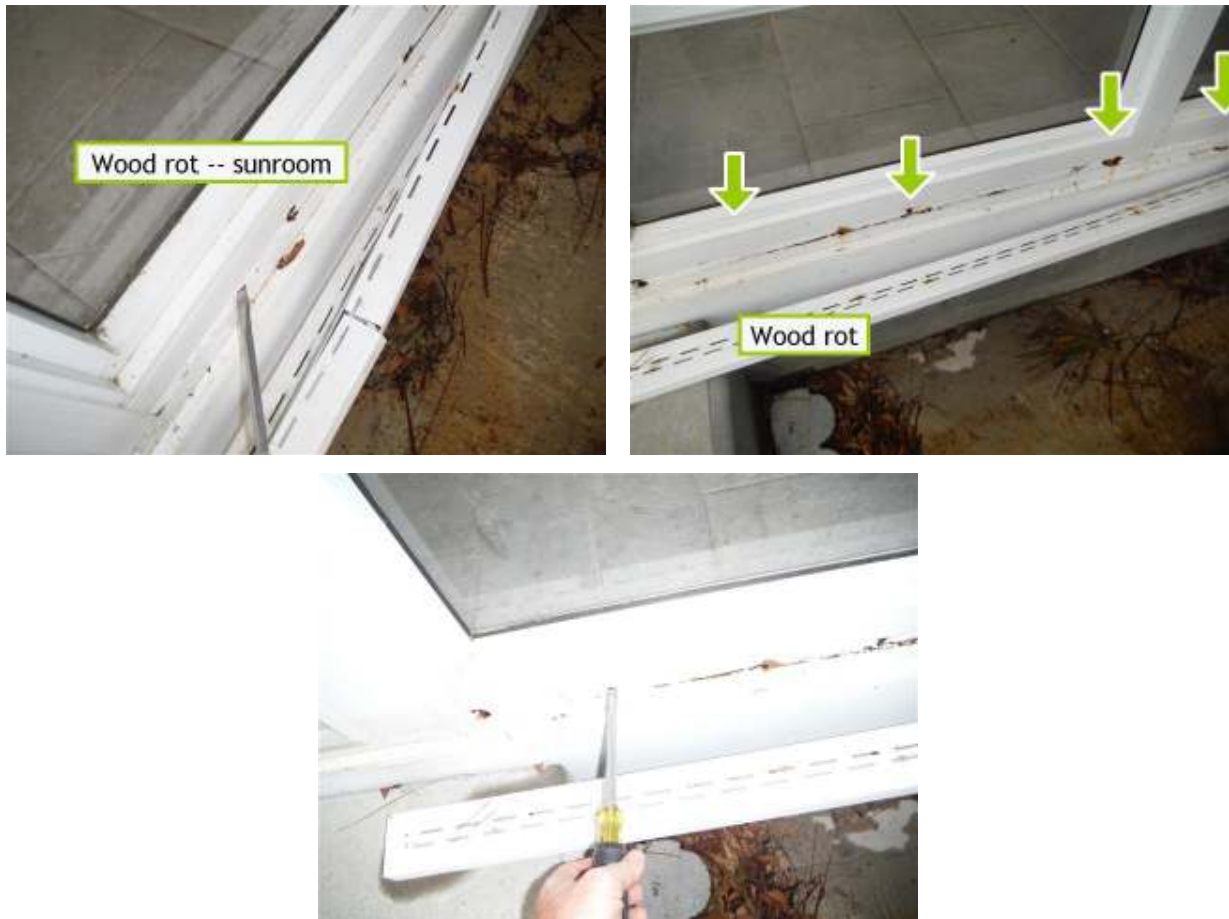
(2) Observed that the exterior siding along the bottom of the sunroom is rotted. Recommend having a contractor specializing in additions make the needed repairs.

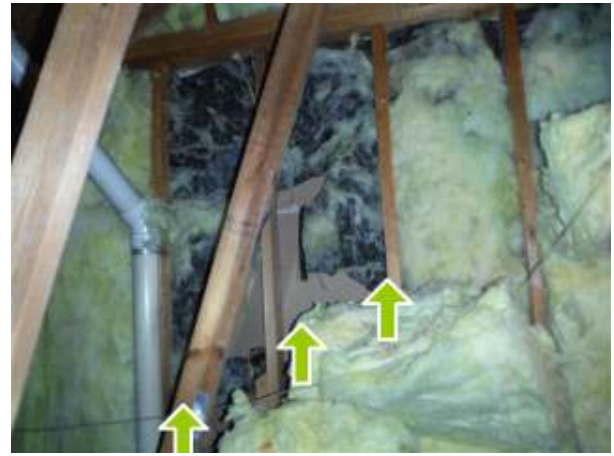
(2) Observed that one or more areas of the attic are missing insulation. Recommend having a contractor replace the missing insulation, where needed, for energy savings.

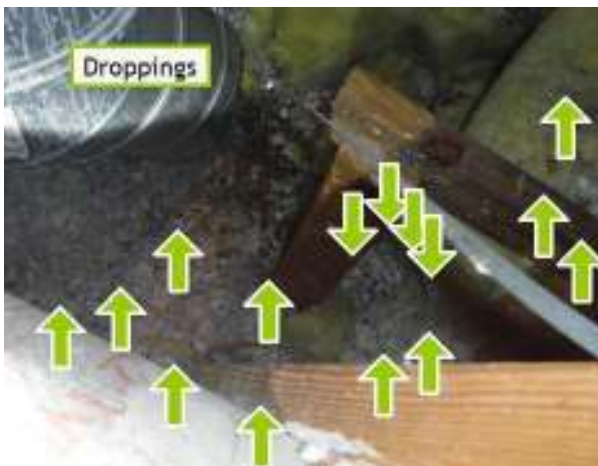
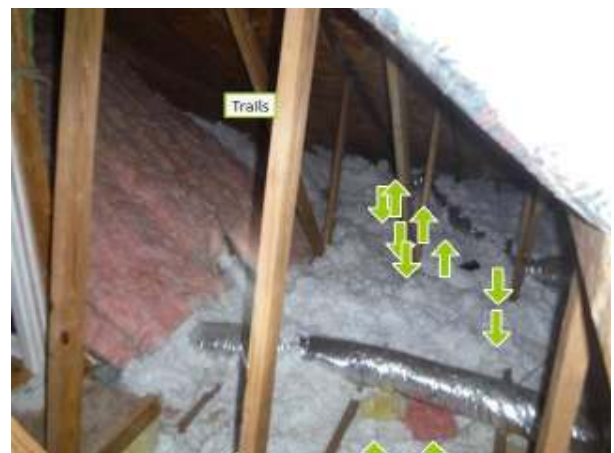
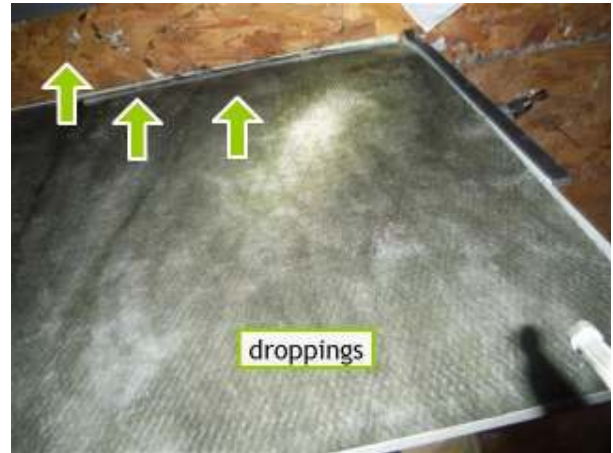
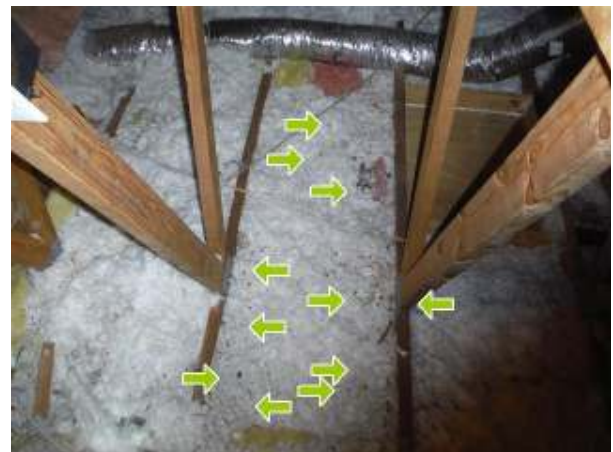
(3) Please note there are squirrel trails through the insulation in the attic and droppings around this space. It appears they're entering the attic through the various roof openings. Since pests can sometimes cause damage to the roof or the components inside the attic, recommend having a pest control company evaluate the attic and treat as needed to eliminate the pests and/or prevent their return.

(4) Observed that the attic has a strong smell of urine and animal droppings. Also, the insulation has rodent trails and rodent hole/nests throughout. The droppings are seen on top of the air handle, the air ducts and throughout the insulation. A small dead rodent was found in the insulation near the HVAC platform. There are signs of past attempts to keep rodents out of the attic with screens and mesh. Due to the amount of droppings and the smell of urine, recommend having an exterminator or contractor remove the insulation, clean the droppings and urine off the air ducts and HVAC unit, then seal the attic to prevent pests from re-entering and install new insulation where needed.

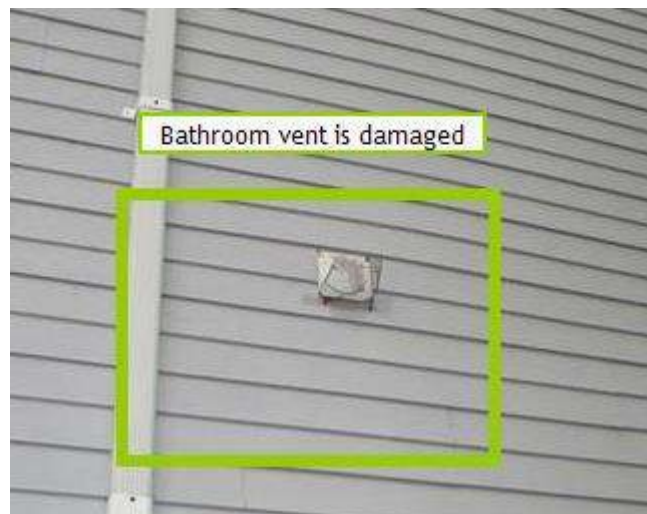
(3) Observed that one or more of the bathroom vents are damaged. Recommend having a contractor replace the vents, where needed, so they are again in good condition.

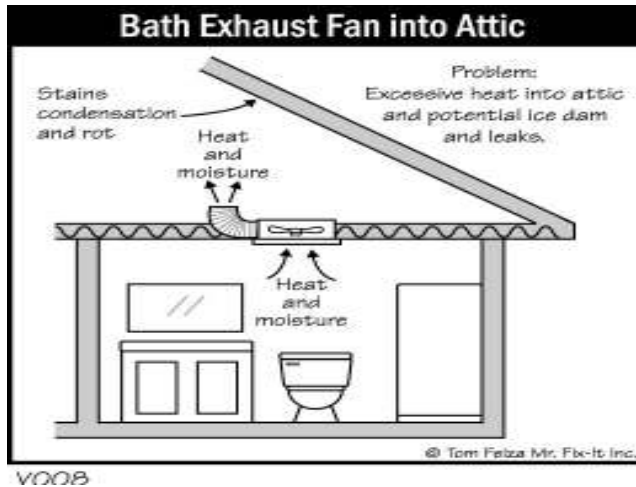
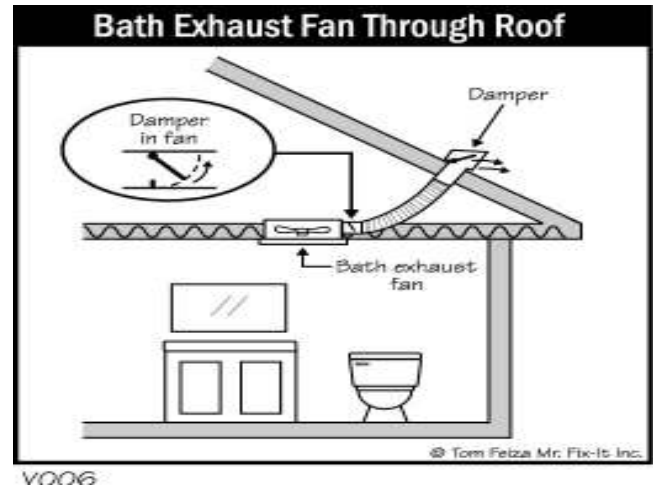
(4) Observed that the bathroom vents terminate in the attic -- this is common for a home of this age. Please note that moist hot air in the attic will hinder the insulation's effectiveness over time. As a result, these vents should terminate to the outside. Recommend having a handyman re-vent to the exterior of the home when or before insulation is added.

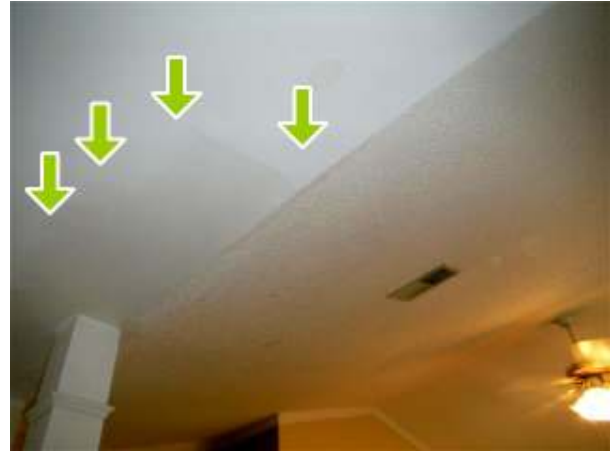
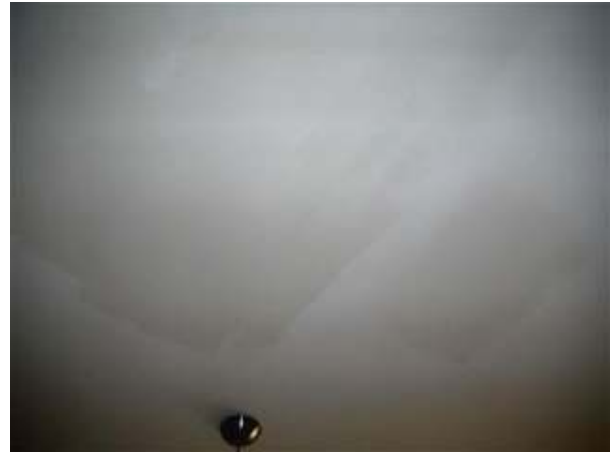
Observed that there are moisture stains on the ceiling in the living room, kitchen and master bedroom. Please note these areas are dry when tested with an infrared camera and moisture meter. Recommend painting the ceilings. You may want to consider KILZ® UPSHOT® ceiling paint for this job -- its an aerosol interior oil-based stain sealer with a unique vertical spray tip for overhead application. It's great for blocking most ceiling stains like water, smoke and grease.

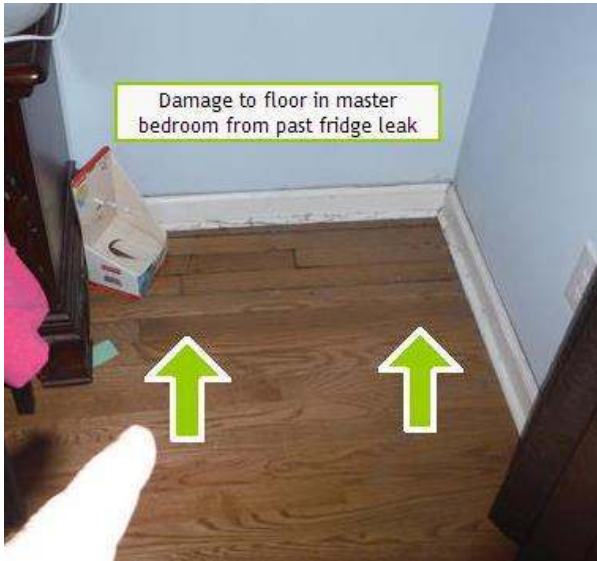
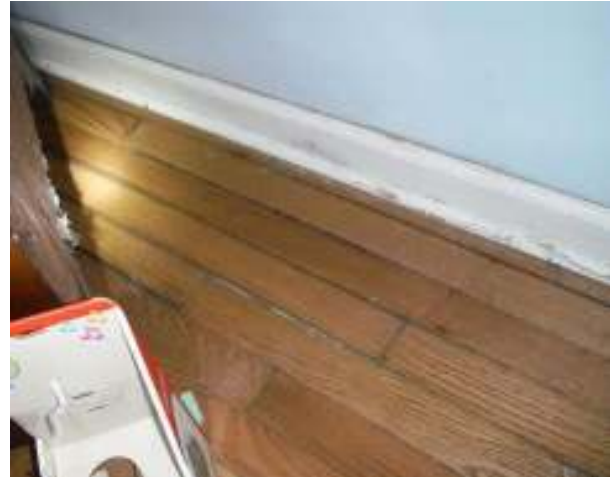
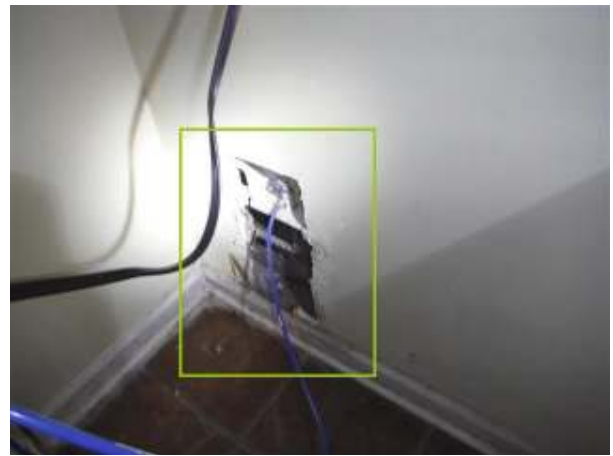
Observed that the part of the wood flooring in the master bedroom is damaged from a past water leak in the kitchen at the refrigerator connection. The floor is damaged and the wall has a large hole. Recommend having a contractor replace the damaged flooring and repair the wall.

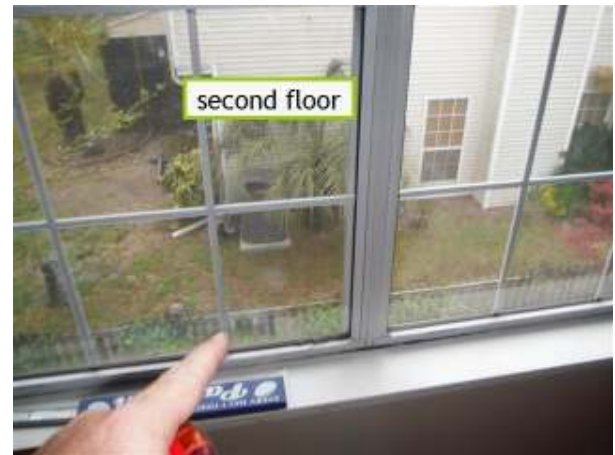
(1) Observed that there three windows which have broken seals causing them to have a cloudy appearance -- one in the master bath and two in upstairs bedroom(s) (see photos for location). When the seal is broken, moisture seeps in between the panes of glass and causes condensation. Additionally, the insulating properties of the window are significantly reduced so that it acts just like a regular piece of glass. Recommend having a window contractor repair or replace these windows, as needed, so that they again have a clear view to the outside and are insulated to help conserve energy. You want want to consult with [www.theglassguru.com](http://www.theglassguru.com) -- they have a moisture removal process which may repair the windows without having to replace them.

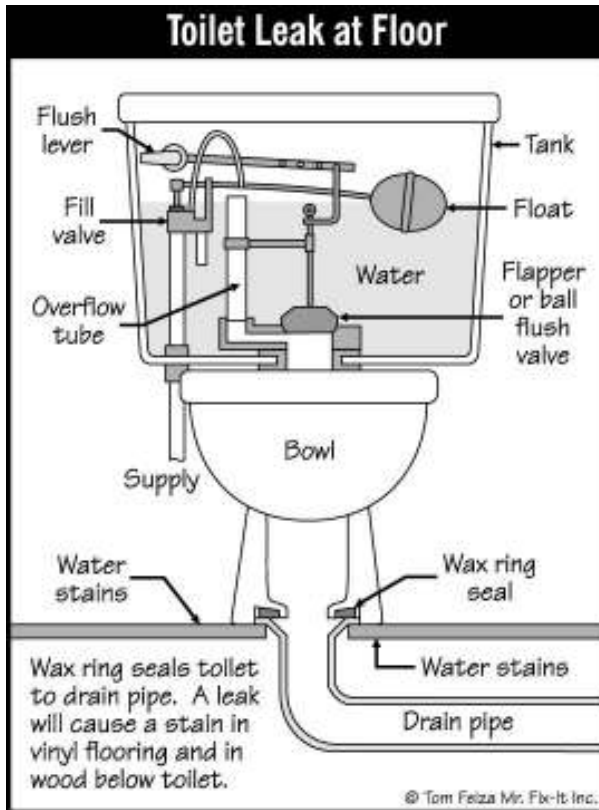
(2) Observed that the toilet in the master bath is loose where it connects to the floor -- this is very common. For your reference, a loose toilet bowl may result in a leak at the wax ring and/or at the supply piping connection which can damage the floor and sub-floor below. Recommend having a handyman tighten the floor bolts so the toilet is properly secure.

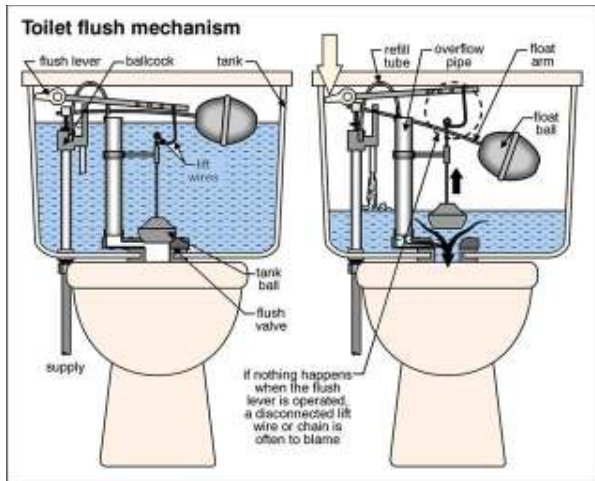
(1) Observed that the fill valve for the toilet in the hall bath leaks from the top instead of draining from the bottom. Recommend having a plumber repair or replace the fill valve, as needed, so the toilet works as it should.

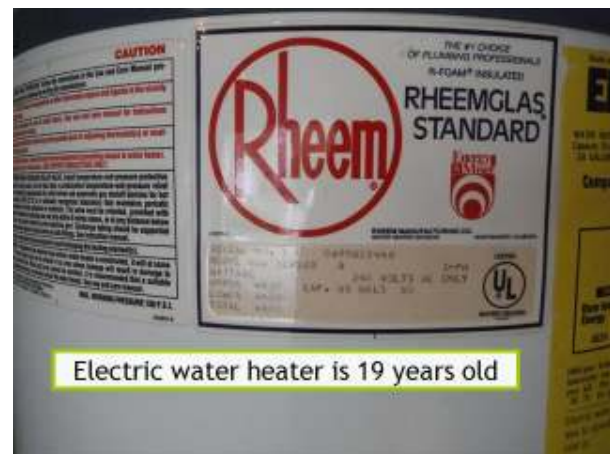
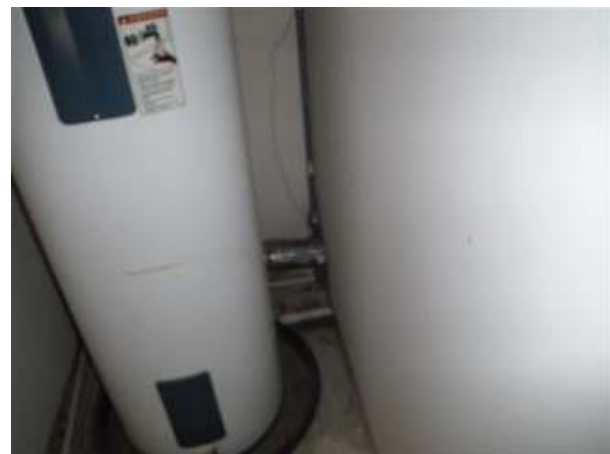
(1) Observed that the electric water heater is 19 years old. Please note the hot water works when tested. For your reference, the average hot water heater lasts about 12 years and sometimes longer. Due to age, recommend monitoring the hot water heater for possible problems or leaks and plan to replace this unit, when needed. *Since this is an older appliance, recommend purchasing a 1-year home warranty at closing -- the 90-day limited warranty provided with this inspection will not cover appliances over 10 years old.*

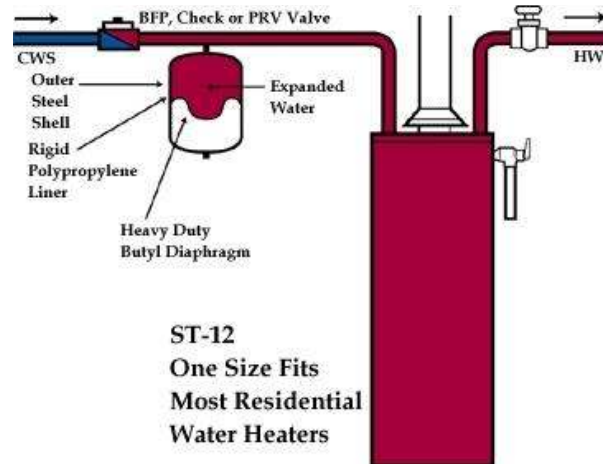
(2) Please note the water heater does not have a thermal expansion tank or earthquake straps. For your reference, an expansion tank is a component which helps to prevent leaks at the TRP (temperature pressure relief) valve. When this unit is replaced, the new heater will have an expansion tank and straps. This is an fyi.

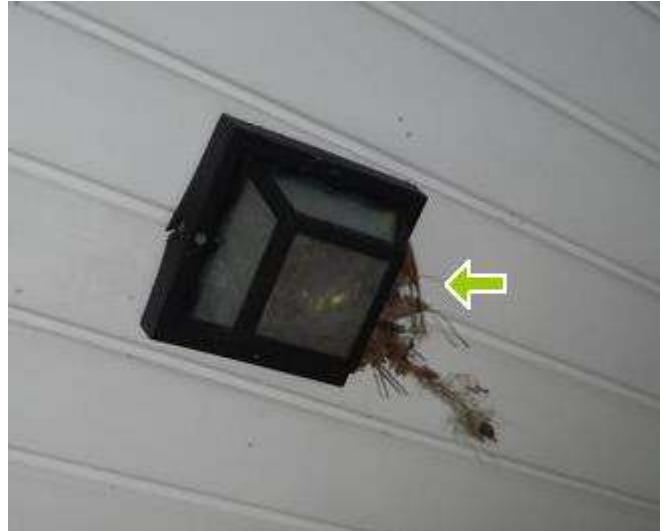
(1) Observed that one or more of the exterior lights have bird nests in them -- this is a fire hazard. Recommend removing the bird nests, for safety.

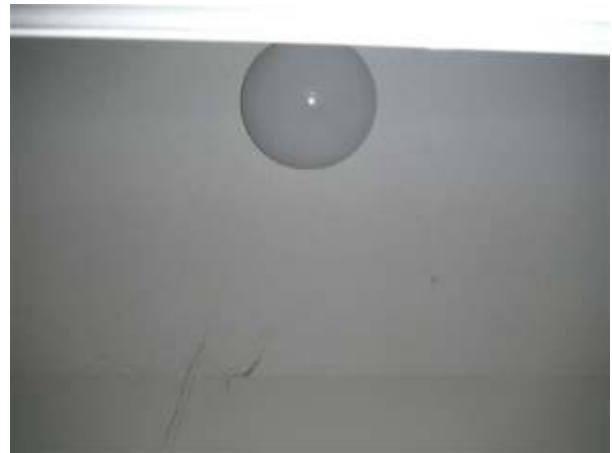
(2) Observed that one or more of the lights did not work likely due to burned out light bulbs. Recommend changing the light bulbs to see if the lights work then. If not, recommend having an electrician make the repairs needed so the lights work as they should.

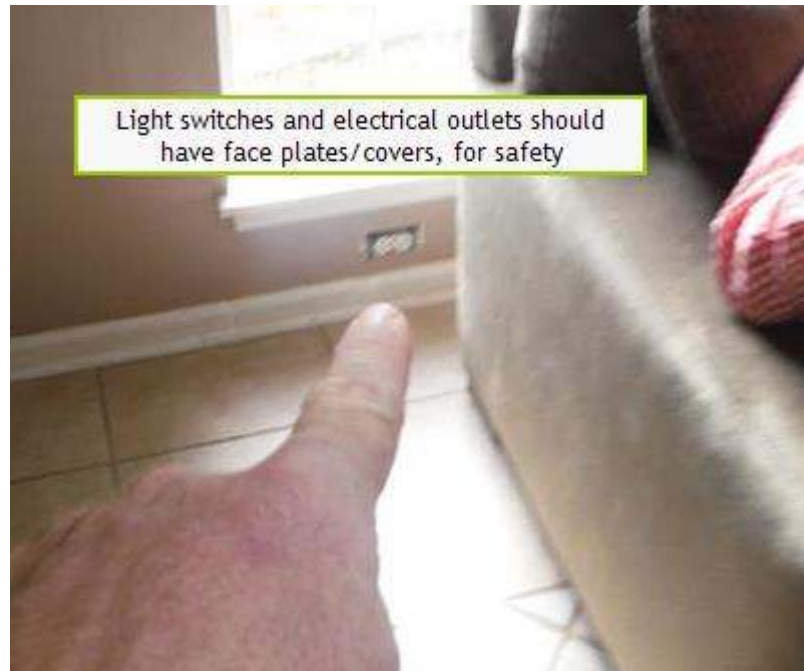
(3) Observed that there is one or more light switches and/or electrical outlets which do not have a face/cover plate. Recommend having an electrician or handyman install a face/cover plates for outlets and light switches, where needed, for safety.

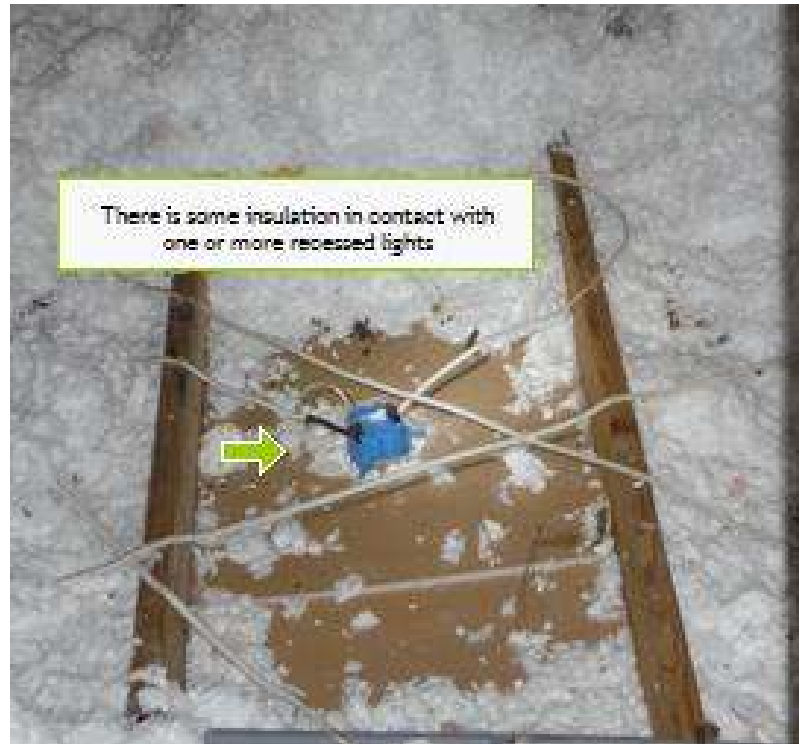
Recommend having a handyman move the insulation away from the lights so there is sufficient clearance all the way around and on top of these fixtures, where needed, for safety.

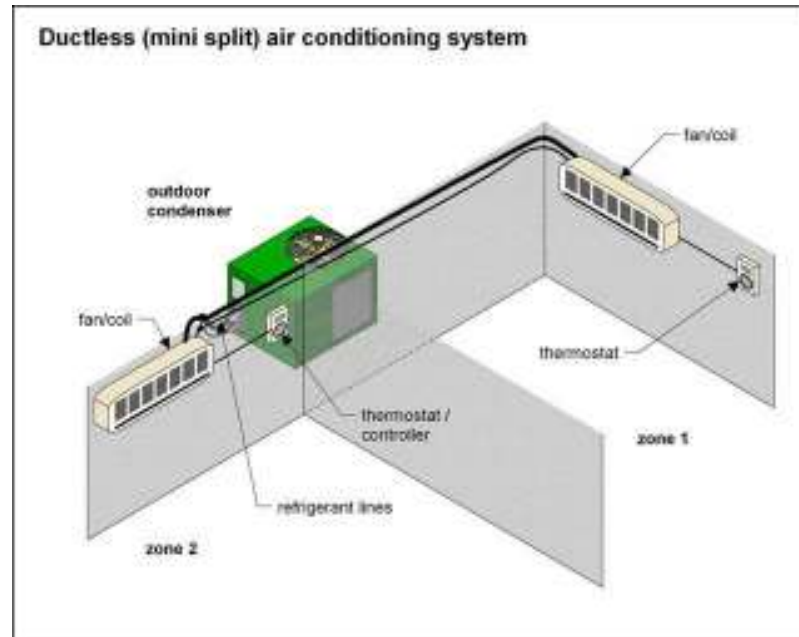
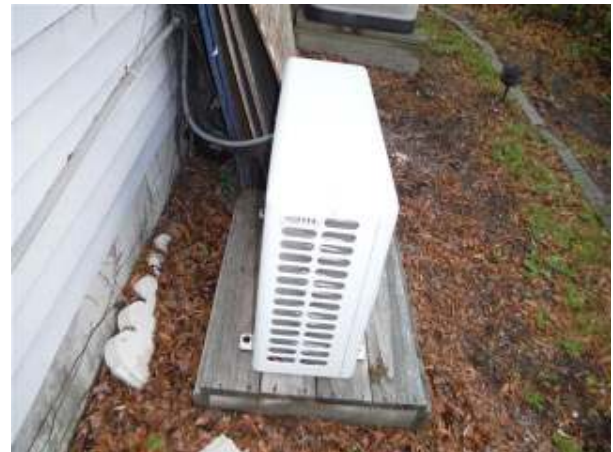
(3) Observed that there is a ductless system (an outdoor 'briefcase a/c unit and a wall-mount indoor air handler) to heat and cool the second floor. Please note this unit did not cool at all. The outdoor unit may not be charged and/or not working due to the damaged electrical connection. Recommend having a HVAC repairman evaluate further and make the needed repairs so the upstairs has good cooling capability.

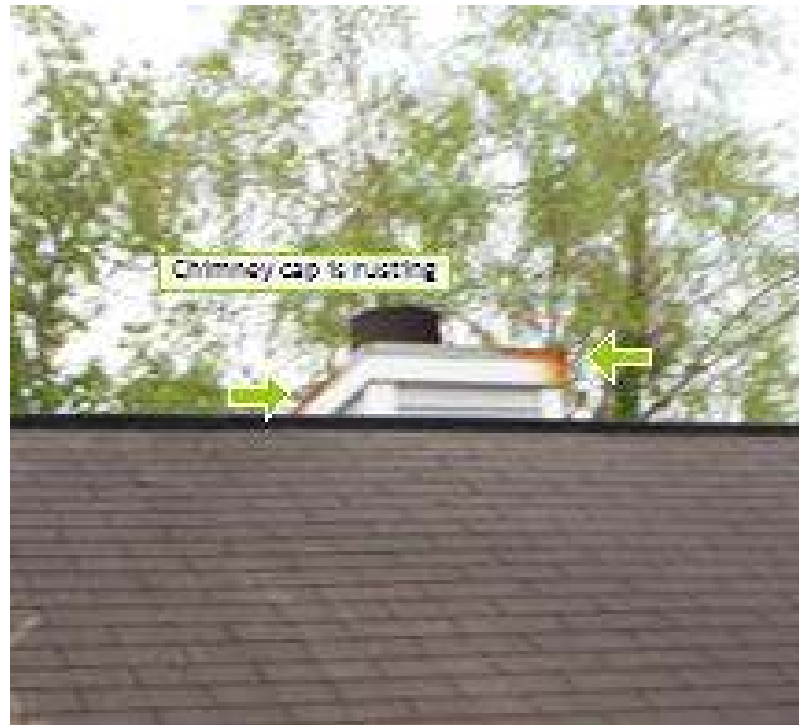
(3) Observed that the chimney cap is rusting. Recommend having a handyman paint the cap with rust-proof paint to help keep it in good condition.
