INSPECTION REPORT

For the Property at:
123 RUE ABCD
QC A0B 0C0

Prepared for: Jim Smith
Inspection Date: Wednesday, December 1, 2021
Prepared by: Hamed Khani, NACHI20082410

Report No. 1001, v.3

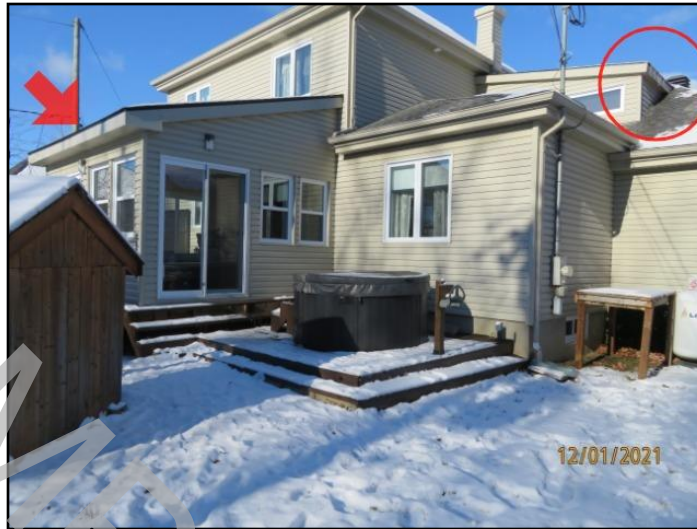
14. Condition: • [Missing](#)

Missing gutter and downspout extension to the lower roof.

3. Missing

Task: Provide

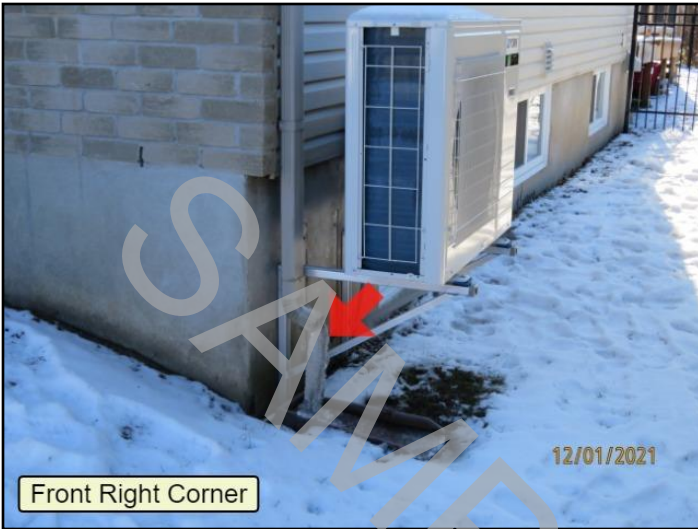
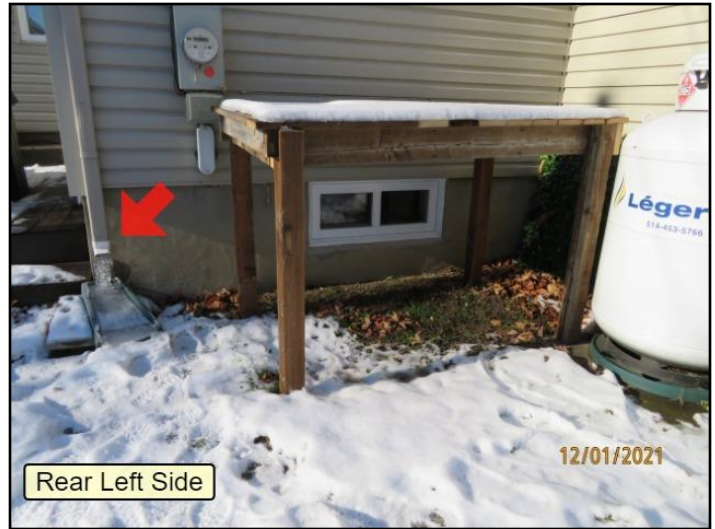
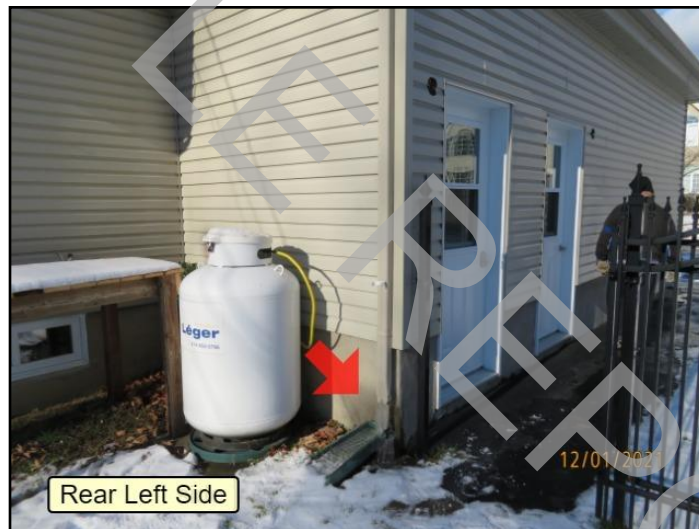
15. Condition: • [Discharge too close to building](#)

4. Discharge too close to building

5. Discharge too close to building

6. Discharge too close to building

Task: Improve

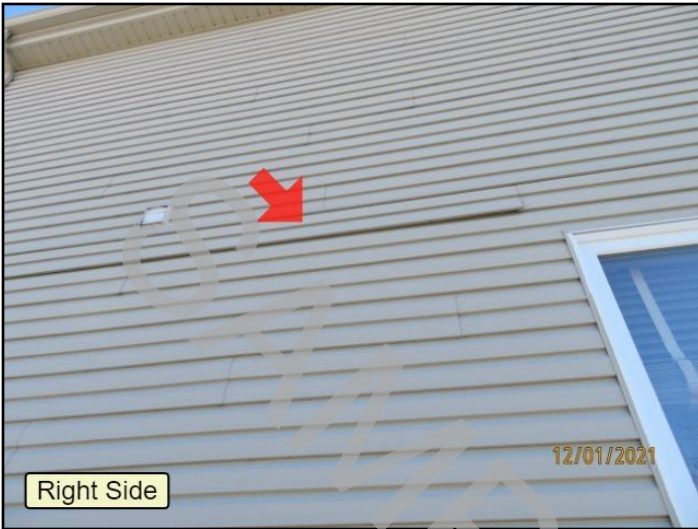
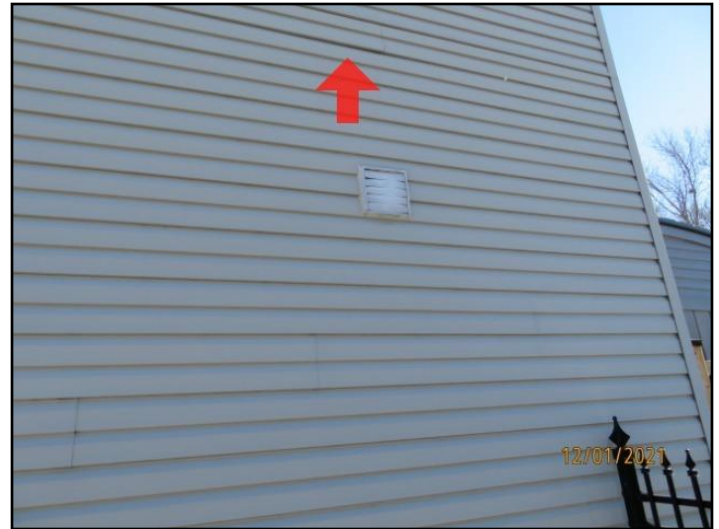
16. Condition: • [Loose or missing pieces](#)

7. Loose or missing pieces

8. Loose or missing pieces

Task: Correct

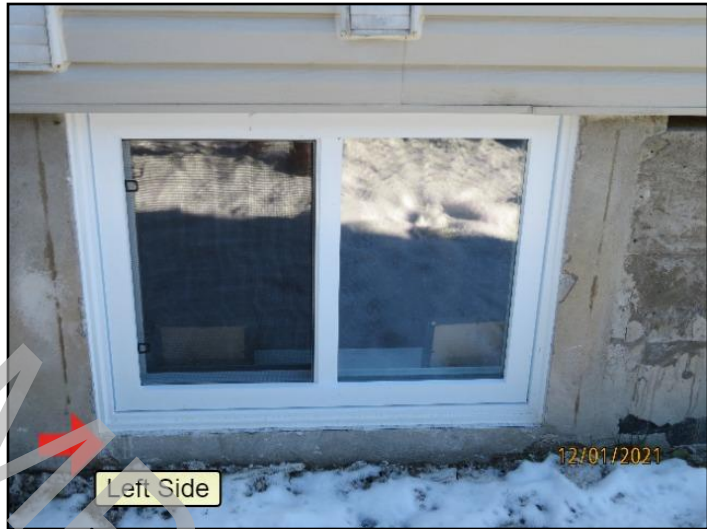
17. Condition: • [Less than 6 inches below window](#)

9. Less than 6 inches below window

Window well recommended.

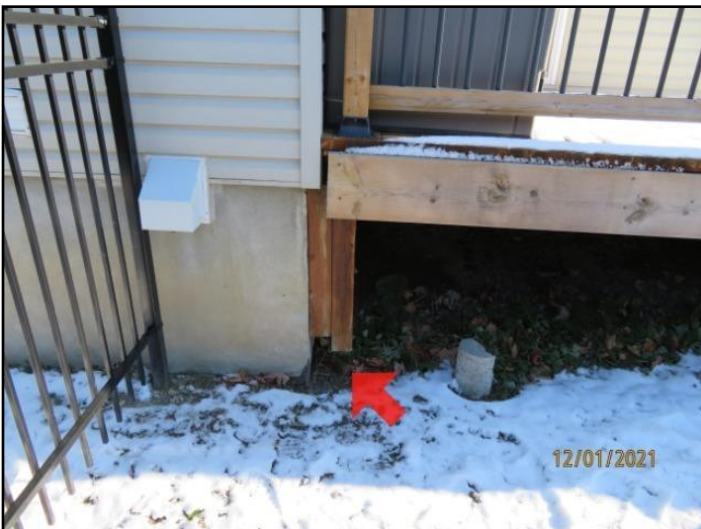
18. Condition: • Poorly built

At the point where a beam meets a post, it must be properly connected to the post in order to resist gravity, lateral and uplift loads. This pertains to solid sawn beams or those composed of multiple members. In addition, the post base must be correctly attached to a footing in order to also resist lateral and uplift loads. Posts can lift out of pre-cast concrete piers, and piers simply resting above ground can slide, shift and settle over time. Proper footings/piers should be installed below ground, past the frost line to resist settlement and frost heave.

10. not secured at bottom

Task: Further evaluation

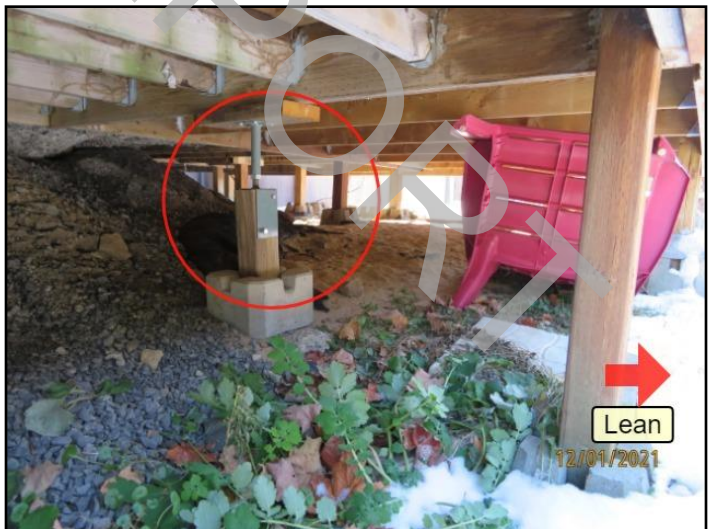
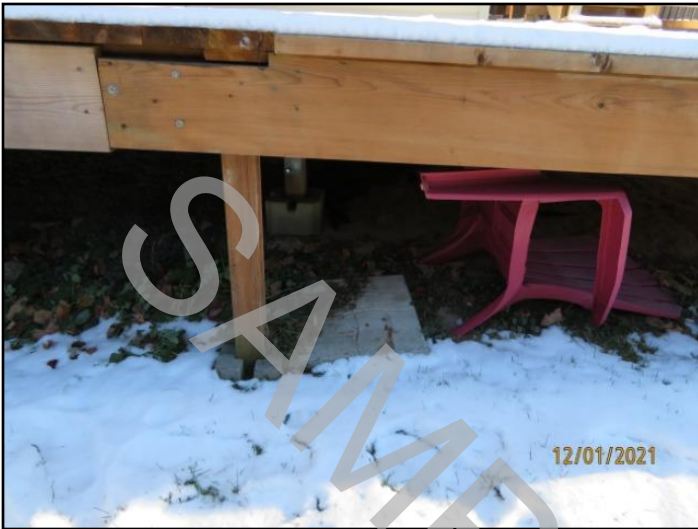
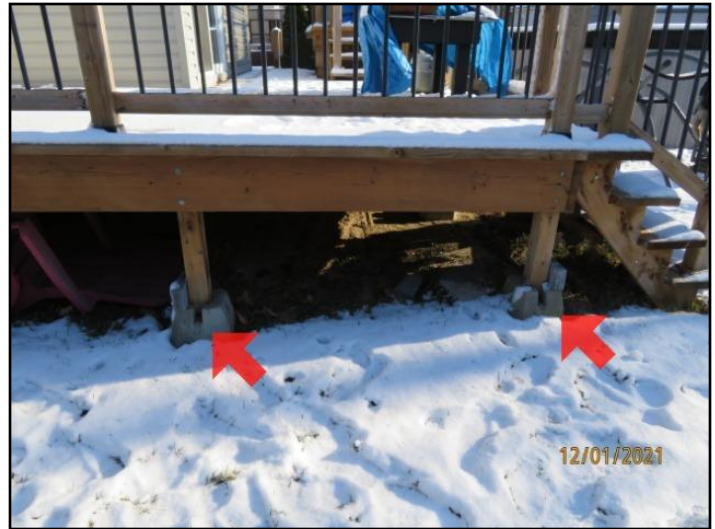
11. Poorly secured at top & bottom:At the...

12. Poorly secured at top & bottom:At the...

13. Poorly secured at top & bottom:At the...

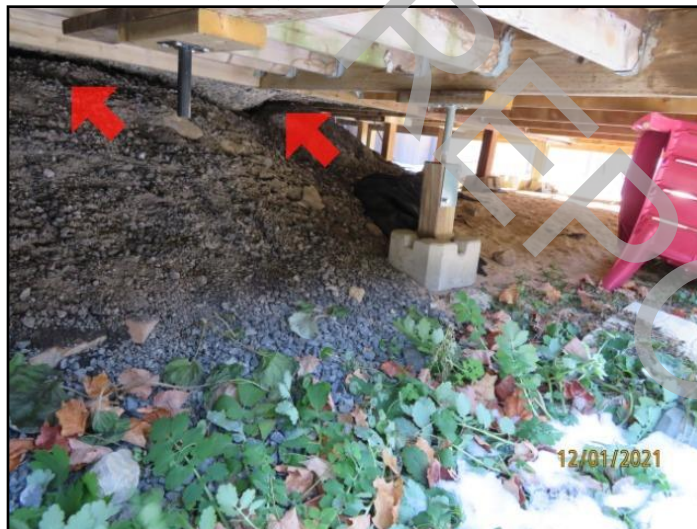
19. Condition: • [Wood/soil contact](#)

Implication(s): Rot | Insect damage

14. Wood/soil contact

Task: Improve

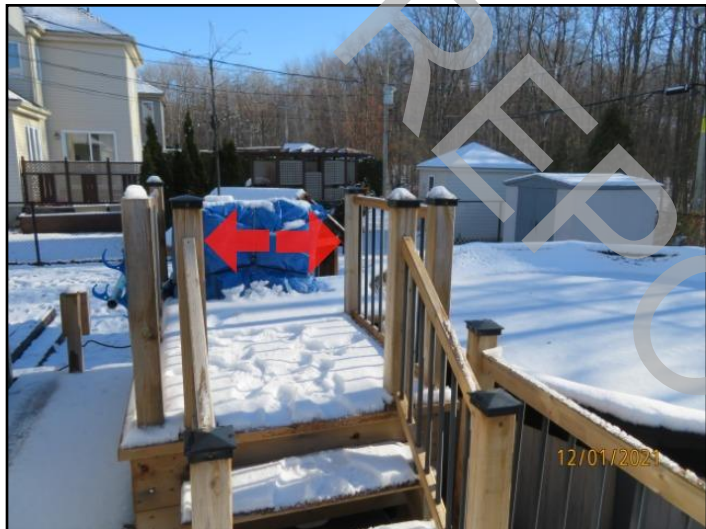
20. Condition: • [Missing](#)

Implication(s): Fall hazard

15. Missing

Task: Provide

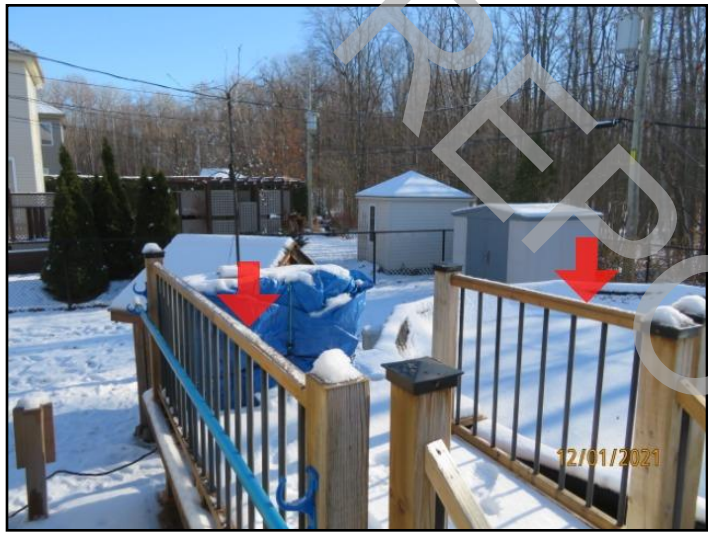
21. Condition: • [Too low](#)
Implication(s): Fall hazard
Location: Exterior Yard
Task: Improve
Time: Immediate

16. Too low

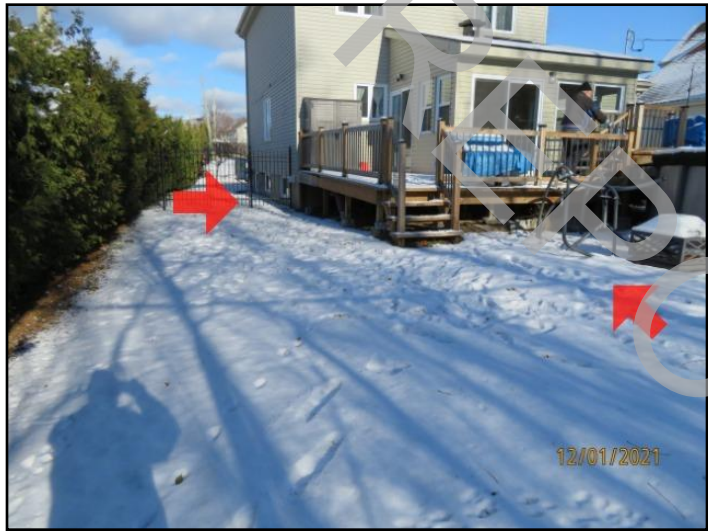
22. Condition: • [Improper slope or drainage](#)

Implication(s): Chance of water damage to structure, finishes and contents

17. Lot slop Toward Building

Task: Improve

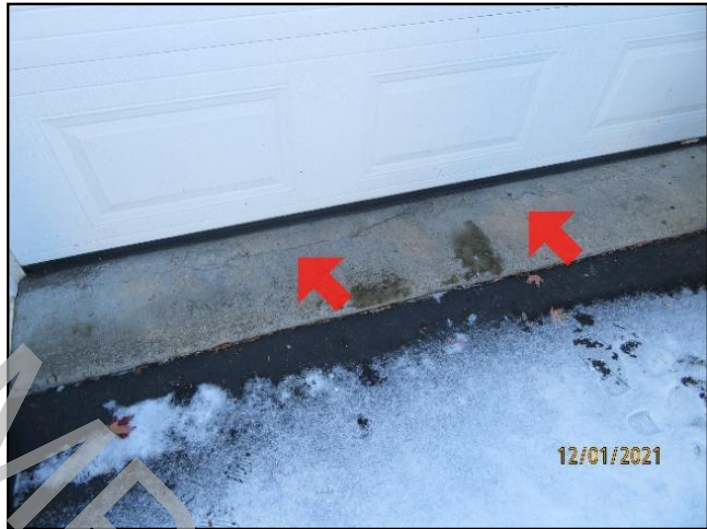
23. Condition: • [Cracked](#)

Implication(s): Uneven floors

18. Cracked

Task: Repair

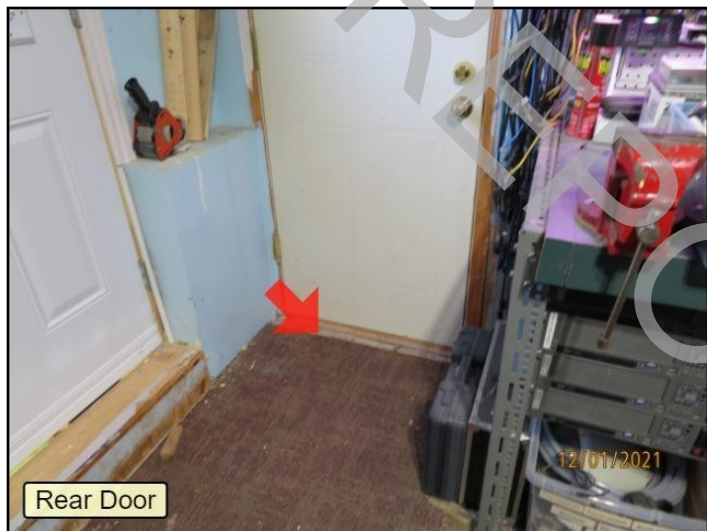
24. Condition: • [No step up into building](#)

Implication(s): Increased fire hazard

19. No step up into building

Task: Improve

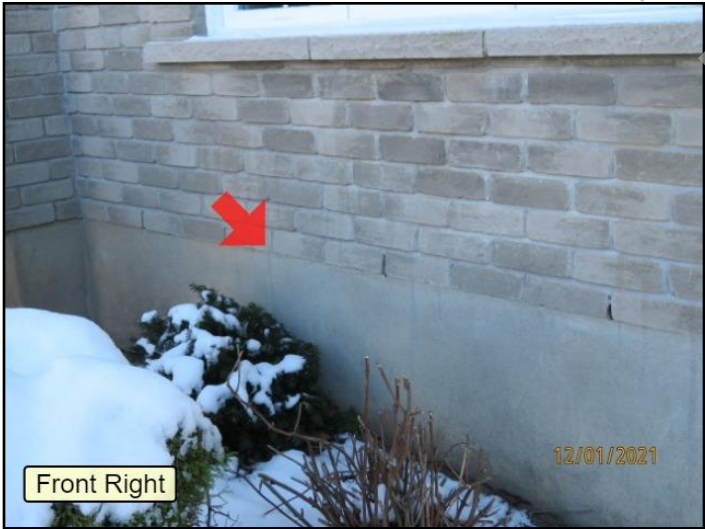
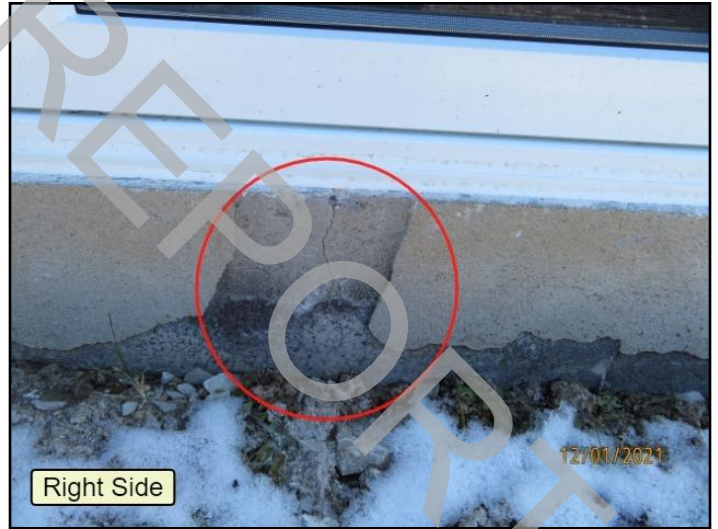
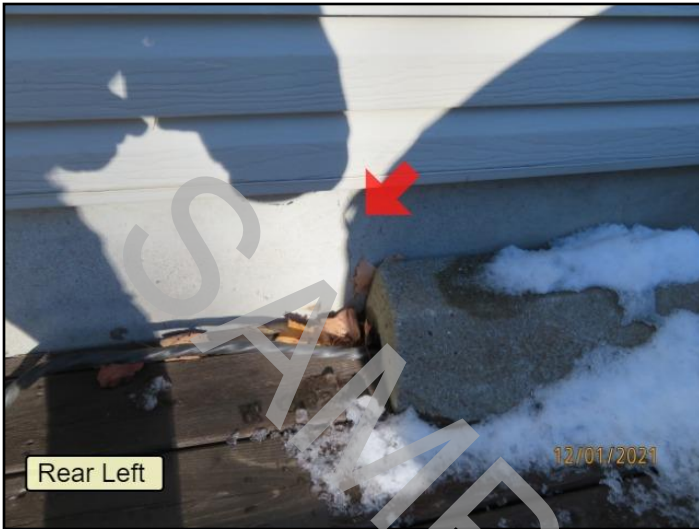
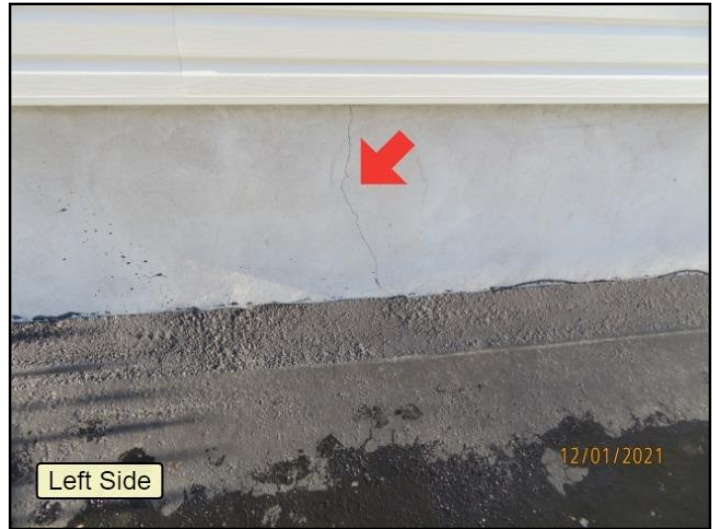
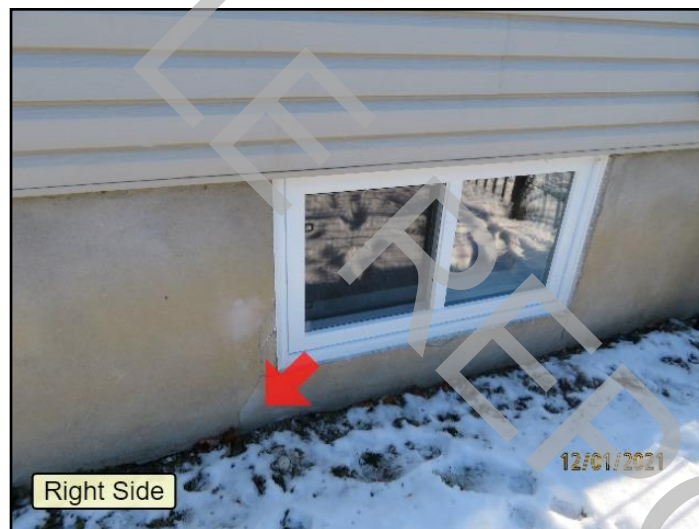
- 28. Condition:** • Typical minor cracks
Repair if needed
- Implication(s):** Chance of water entering building
- Location:** Various Exterior
- Task:** Further evaluation Monitor
- Time:** Regular maintenance

20. Crack

21. Crack

22. Crack

23. Crack

24. Cracked

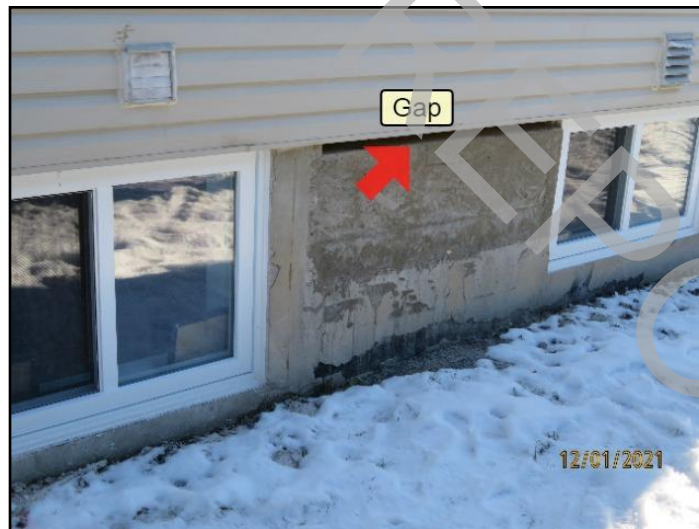
29. Condition: • [Not well secured](#)

According to seller, part of foundation reworked to re-position basement windows, addition section seems has cold joints, voids and may not secured well, upper part of foundation wall need to be filled and bare wall to be covered with parging. please ask seller for documentation.

25. Foundation rework

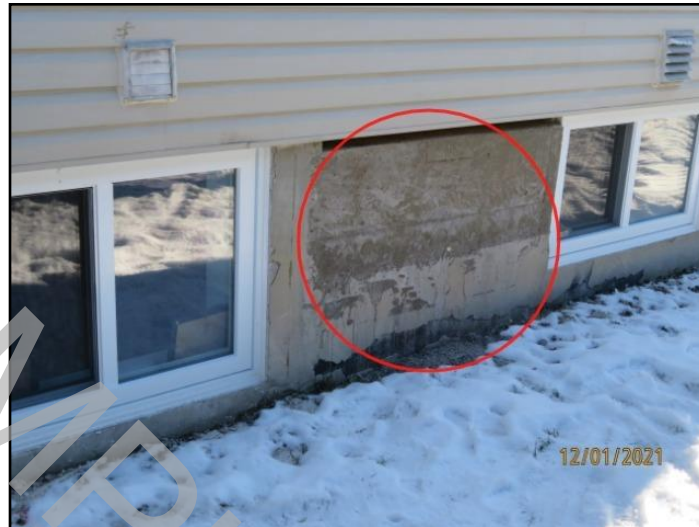
30. Condition: • [Prior repairs](#)

Part of foundation wall cut and re-constructed to accommodate new basement window arrangement. Ask seller for permission and any structural evaluation.

26. *Plarging missing- prior repair*

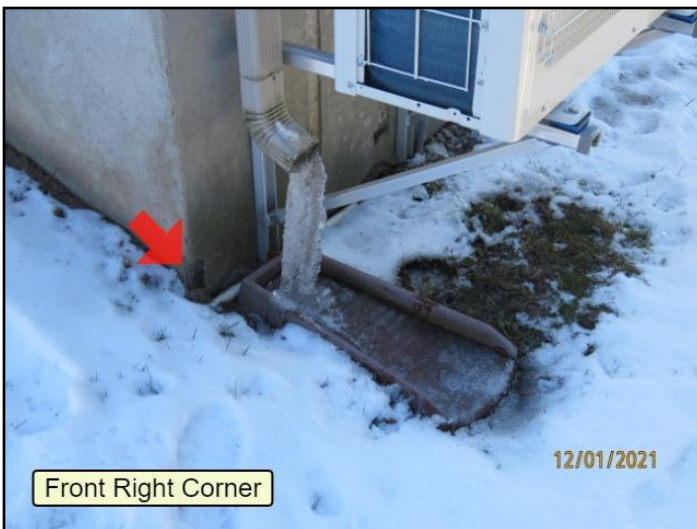
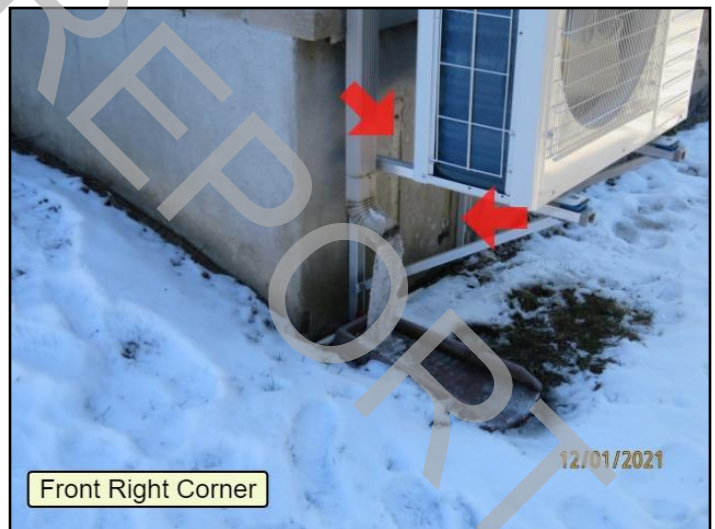
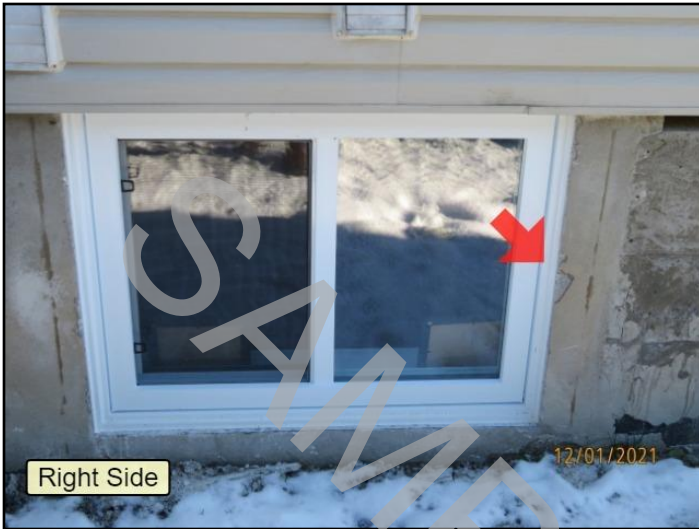
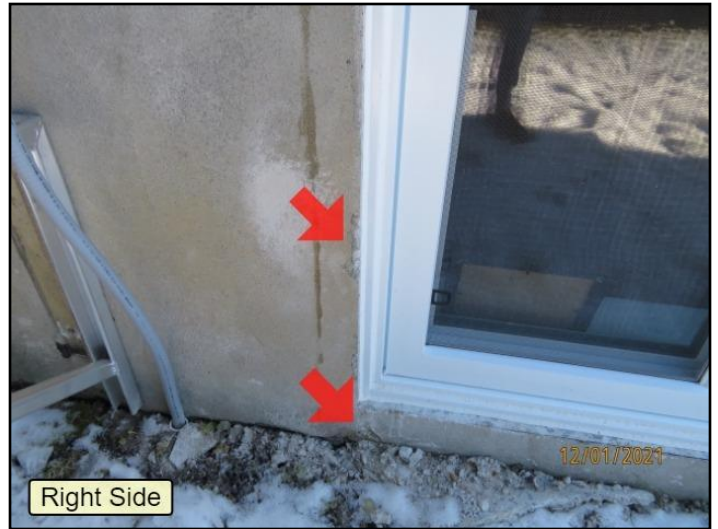
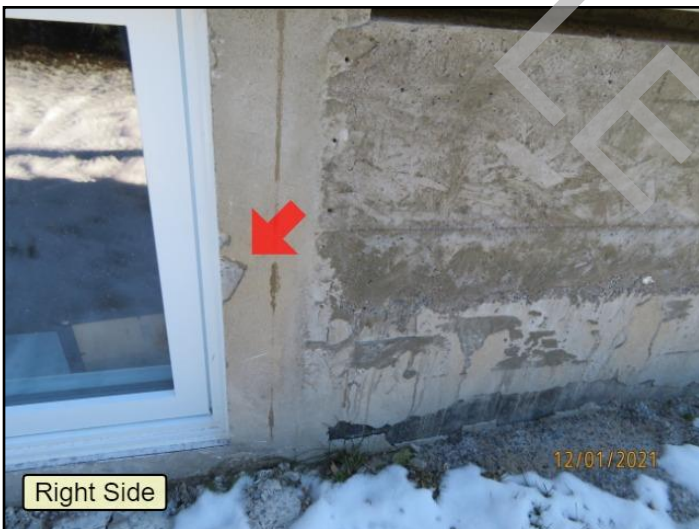
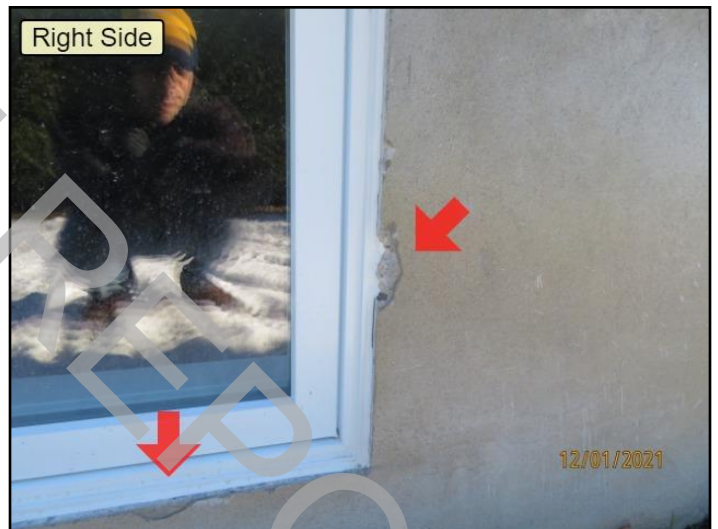
31. Condition: • [Plarging damaged or missing](#)

Implication(s): Chance of damage to structure | Shortened life expectancy of material

27. *Plarging damaged or missing*

28. *Plarging damaged or missing*

29. *Parging damaged or missing*

30. *Parging damaged or missing*

31. *Parging damaged or missing*

32. *Parging damaged or missing*

Task: Repair

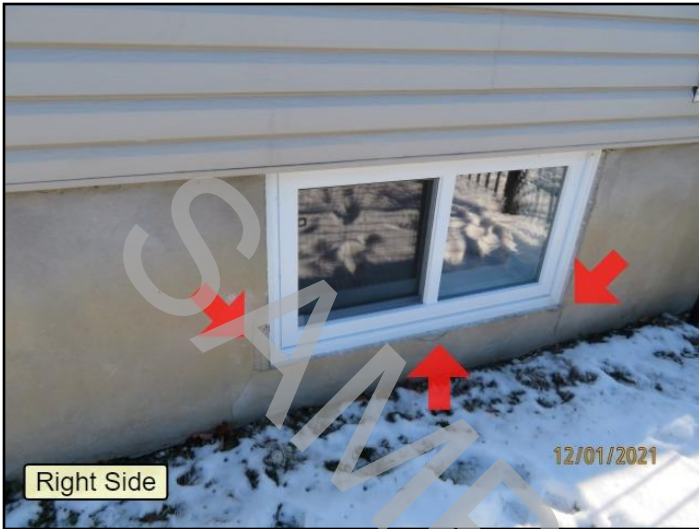
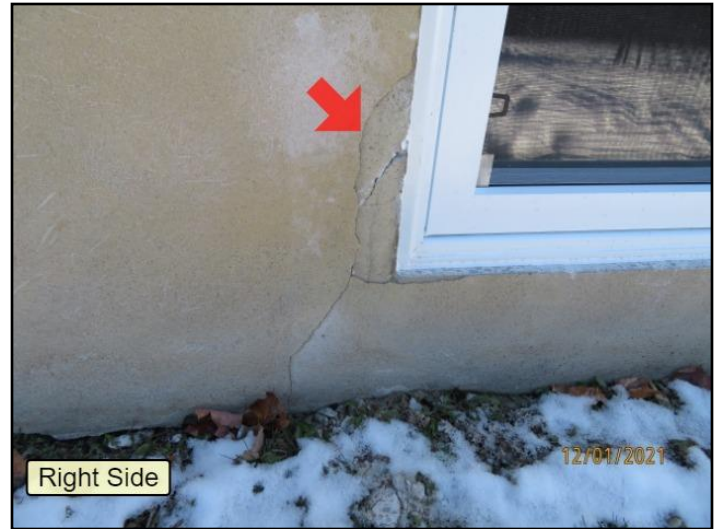
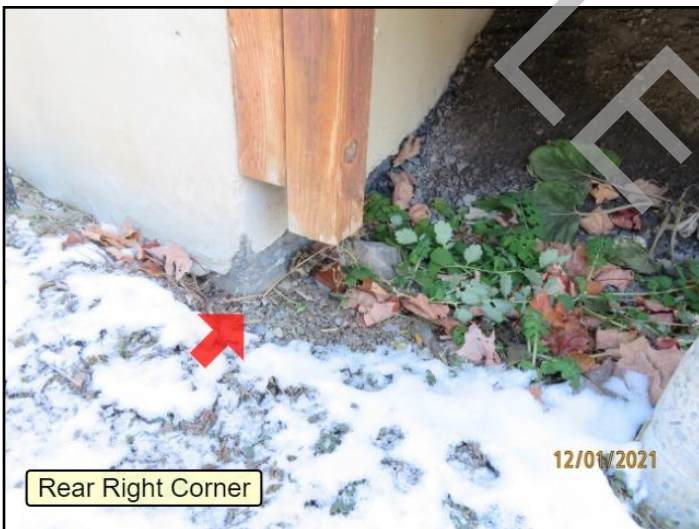
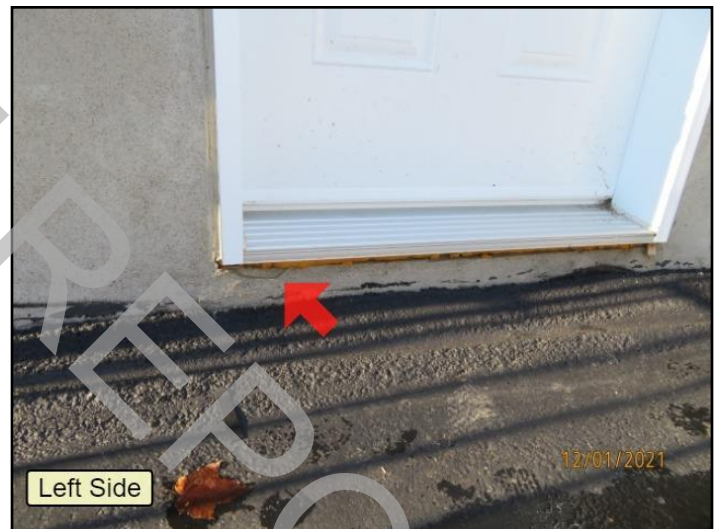
33. *Grouting damaged or missing*

34. *Grouting damaged or missing*

35. *Grouting damaged or missing*

36. *Grouting damaged or missing*

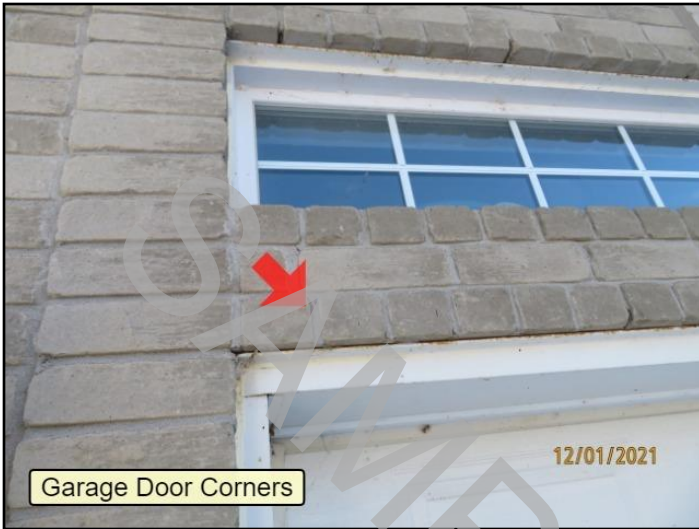
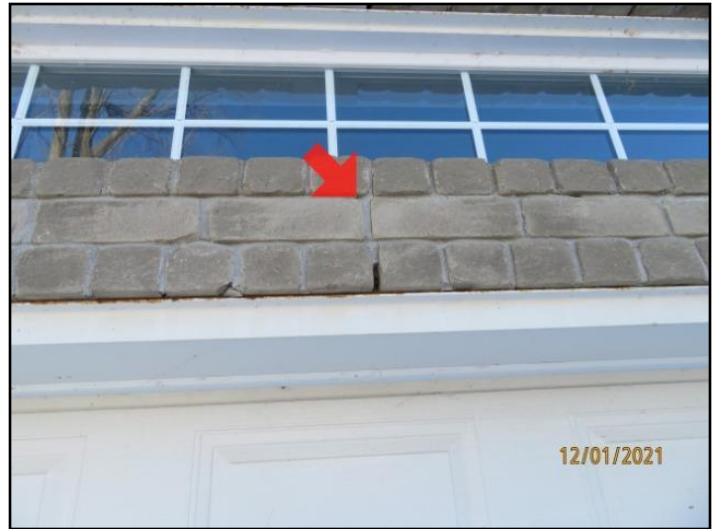
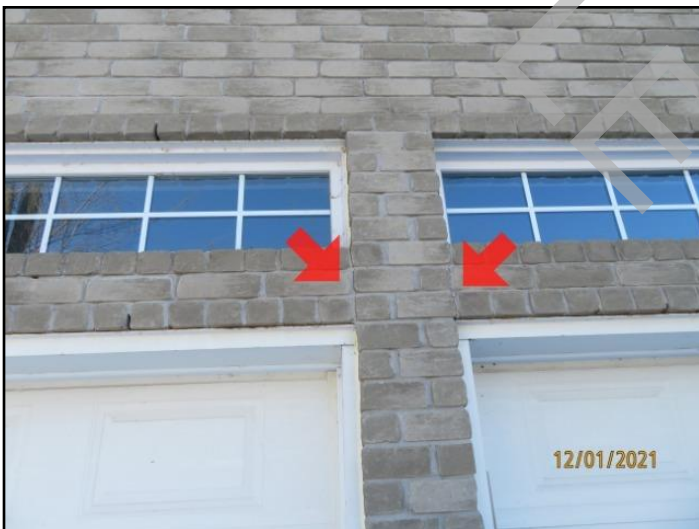
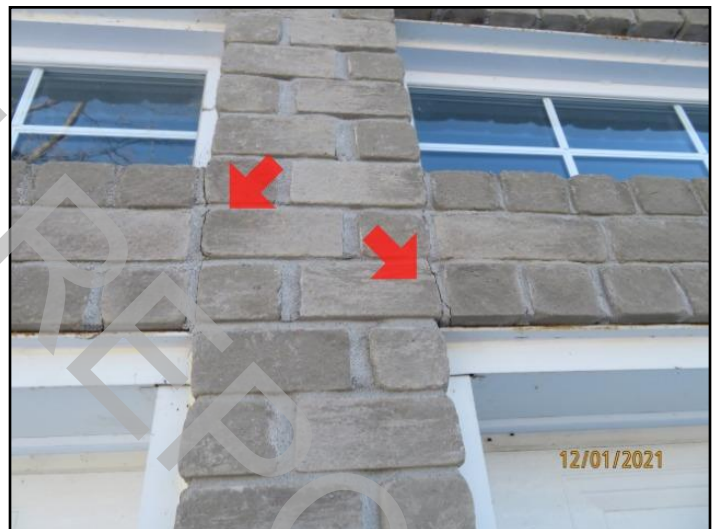
32. **Condition:** • Typical minor cracks

37. Typical minor cracks

38. Typical minor cracks

39. Typical minor cracks

40. Typical minor cracks

Task: Repair

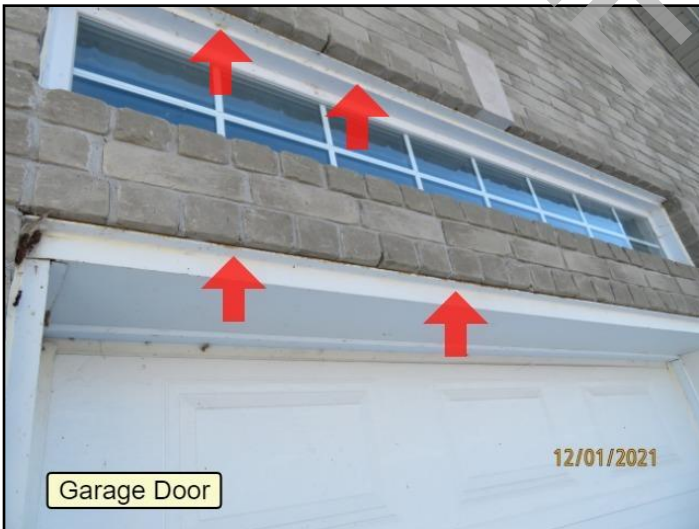
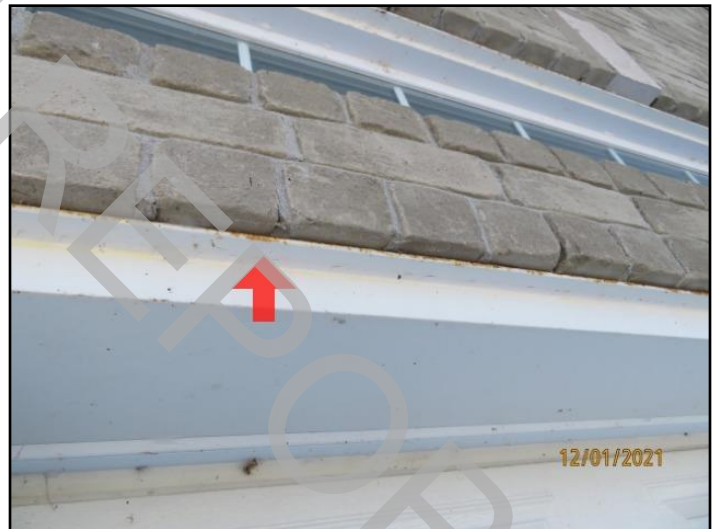
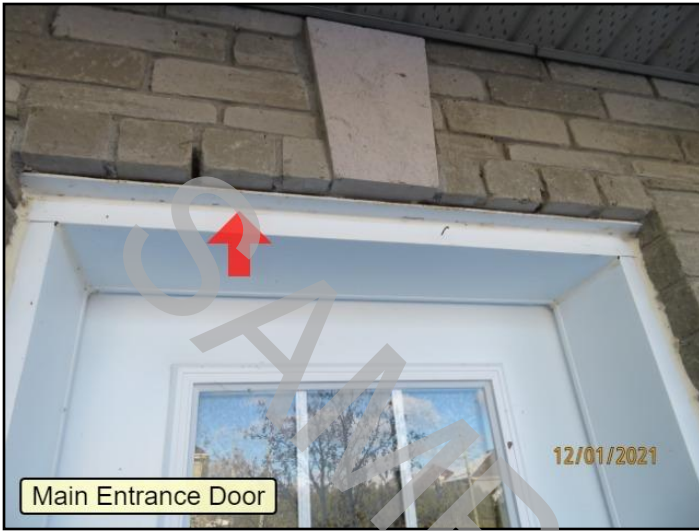
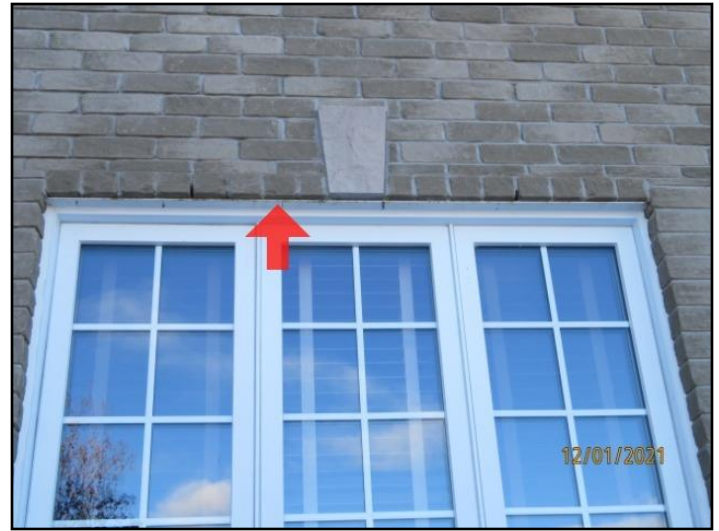
33. Condition: • [Rust](#)

41. Rust

42. Rust

43. Rust

44. Rust

Task: Repair

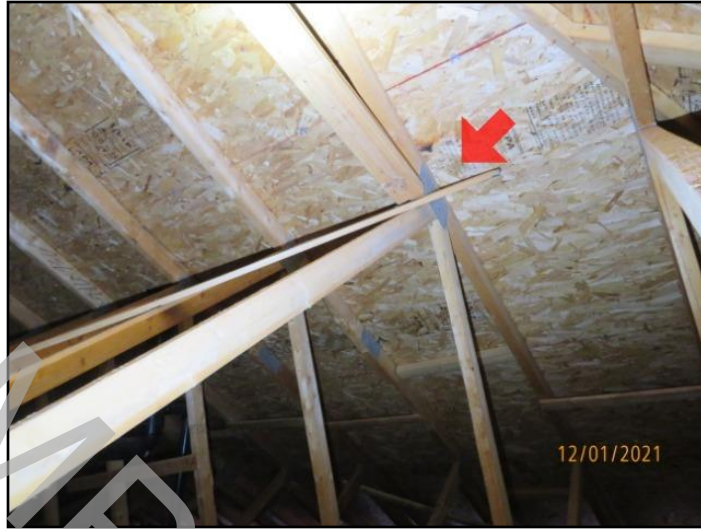
34. Condition: • [Poor connections](#)

45. *Poor connections*
