Home Inspection Report

Prepared for: Tommy Condo
Date: 9/8/2010

Property address: 789 Palmetto Blvd. Unit 36
Charleston SC 29412

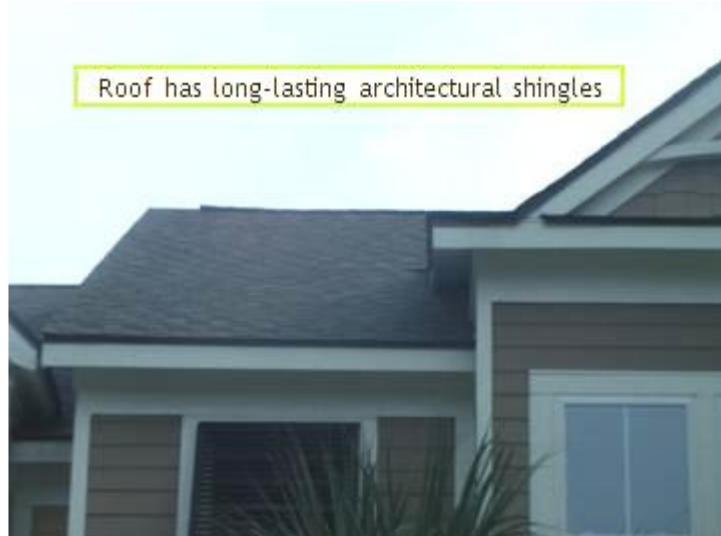
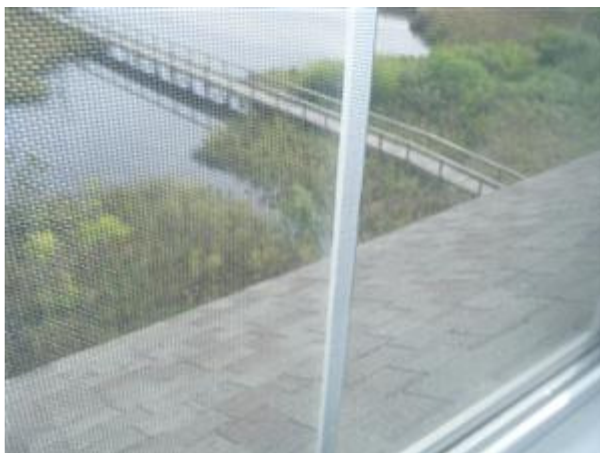
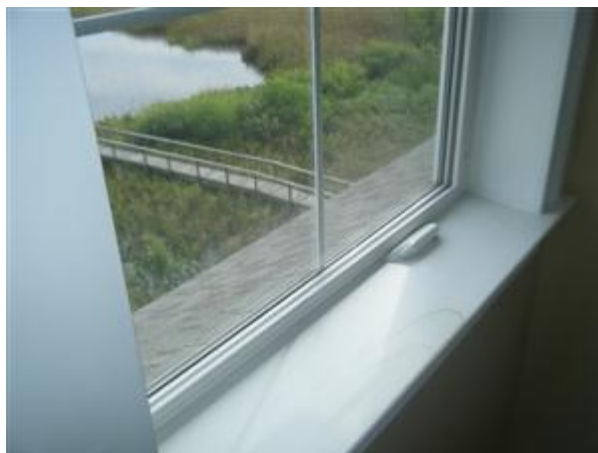
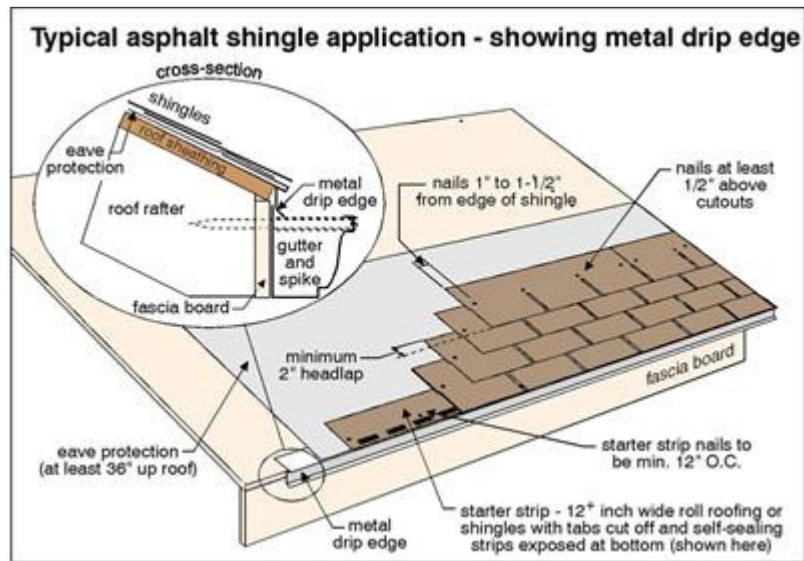
(1) Observed that this home has architectural shingles which are estimated to be 2 years old. For your reference, the average roof with this type of shingles can last up to 35 years and possibly longer depending on the local climate and roof ventilation. Please note that due to the height and design of the home, I was not able to walk-on the roof. However, I was able to inspect parts of the roof from the ground with binoculars and from the windows.

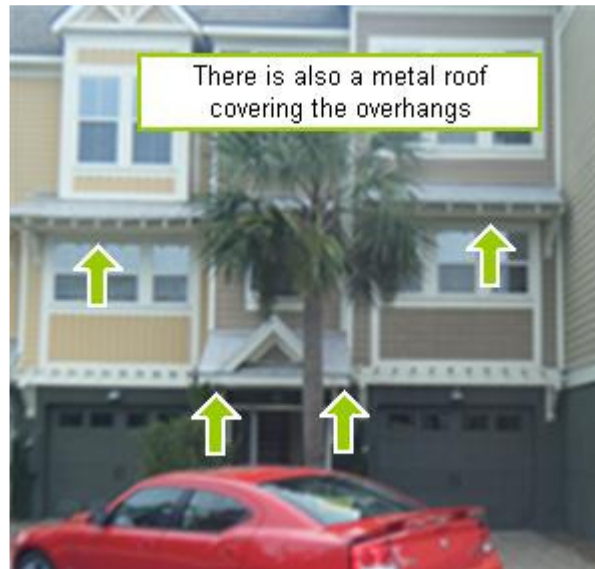
(2) Observed that this home has a metal roof which is estimated to be 2 years old and in good condition. For your reference, the average metal roof can last up to 50 to 70 years and possibly longer depending on maintenance.

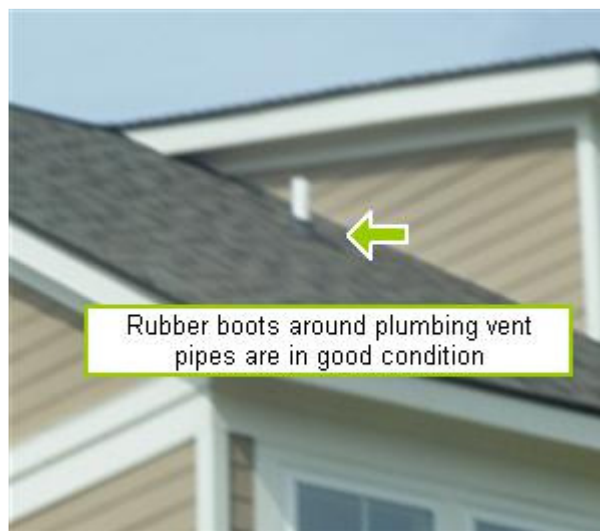
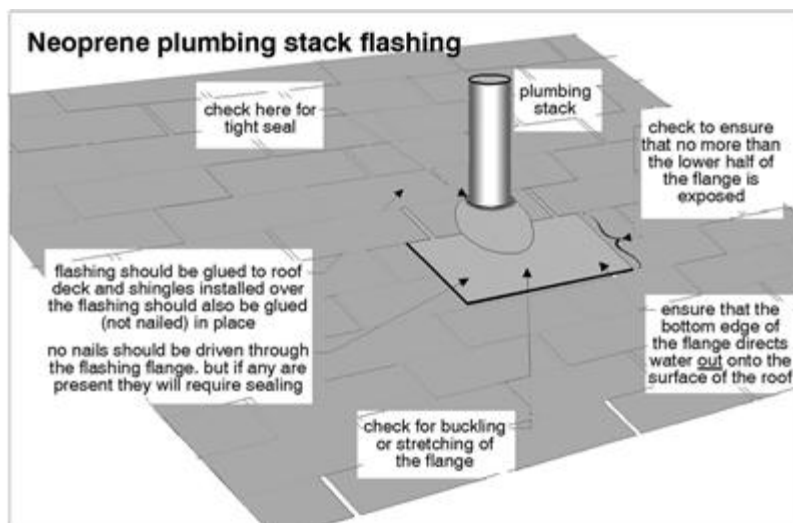
Observed that the flashings are in good condition. For your reference, flashing is a sheet of metal or Neoprene which is installed around pipes and chimneys traveling through the roof to ensure these areas are water tight. Also, flashing is applied along the sidewalls where different parts of the roof come together as well.

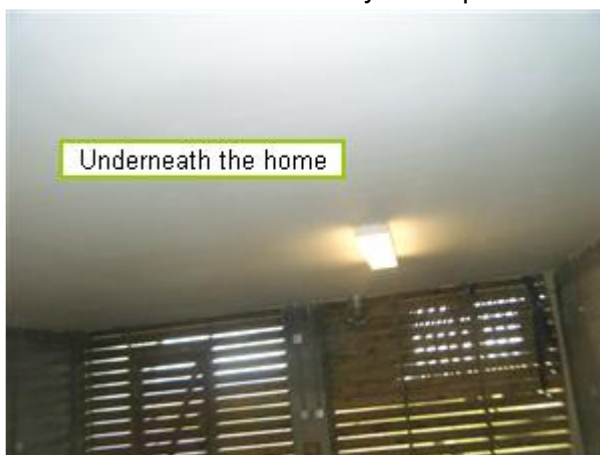
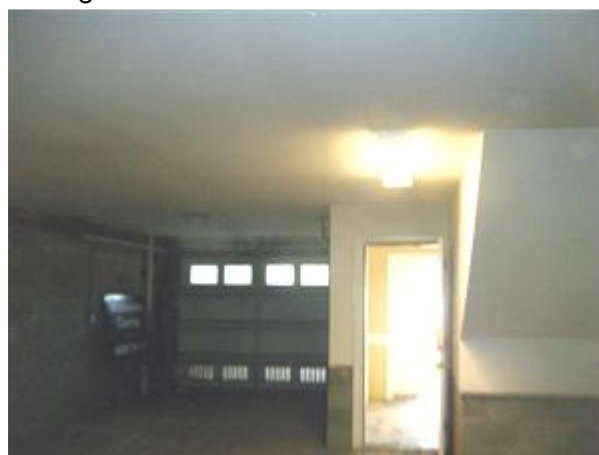
Observed that this is a beach home with parking directly underneath the house. As a result, this home is built on a system of piers -- there is a gravel area used for parking, there are 4 walls which are screened and open in case of a flood. The home appears to be strapped to the cement filled masonry block piers in case of high winds or flood.

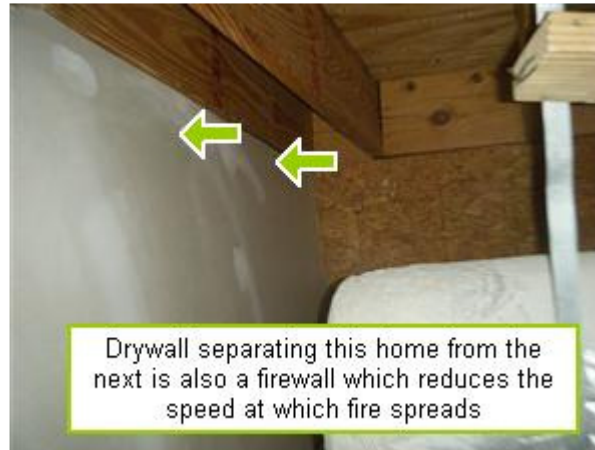
(2) Observed that there is drywall in the attic which separates this home from the next -- a positive. For your reference, drywall will help reduce the speed at which fire spreads from one home to the next.

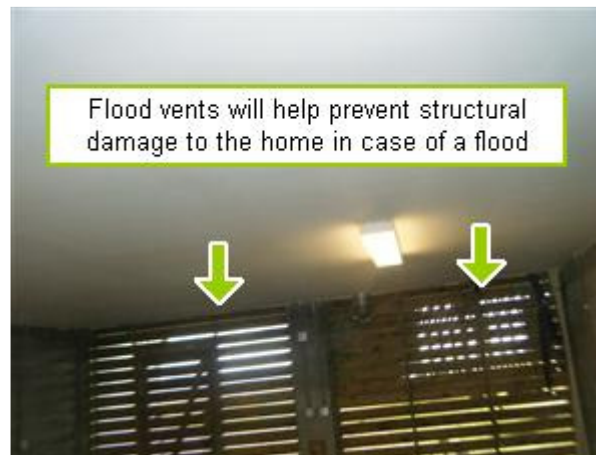
Observed that there are flood vents/breakaway walls around the perimeter of the home. For your reference, homes built in floodplains are designed so that the exterior walls of the foundation allow for the free flow of floodwater in and out (in the event of a flood) in order to minimize structural damage that unbalanced water levels impose on foundation walls. In other words, if floodwater constantly applies pressure to your foundation, there is a great chance that it will break the foundation walls. By equalizing the water level in the foundation via flood vents, less pressure is placed transversely on the wall, reducing the chance it will collapse under the water pressure.

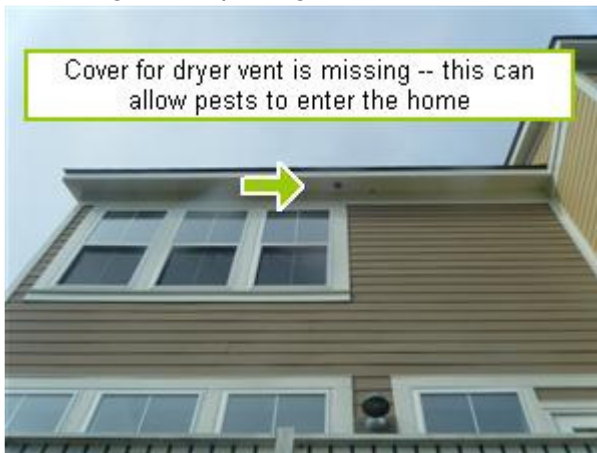
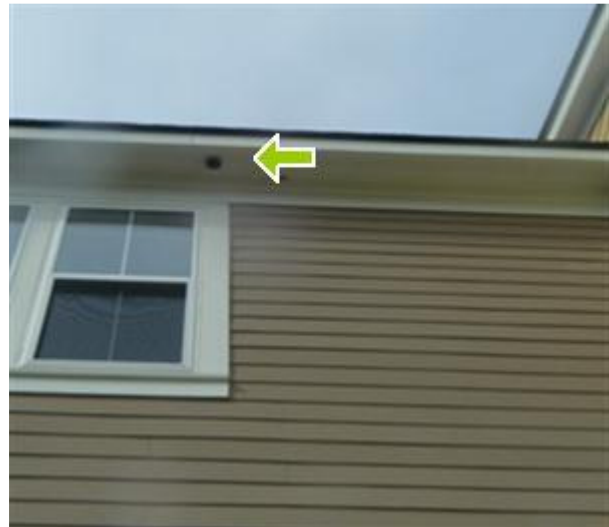
Observed that the vent for the dryer is missing its cover on the exterior of the home. Recommend having a handyman install a cover to prevent pests from entering the home through this opening.

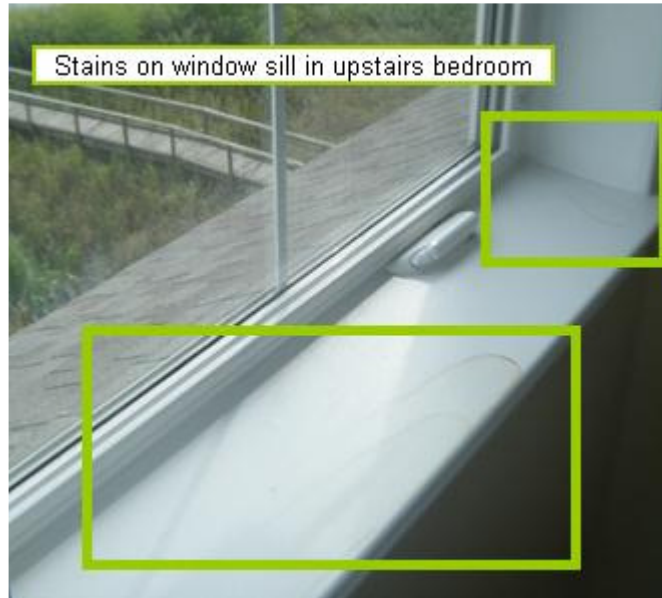
In one of the upstairs bedrooms, there are a couple of stains on the window sill. Please note it was not raining at the time of the inspection and there are no other indications of a leak from this window other than these couple of stains. Recommend monitoring this window during a heavy rain just to ensure water is not finding its way in from high winds.

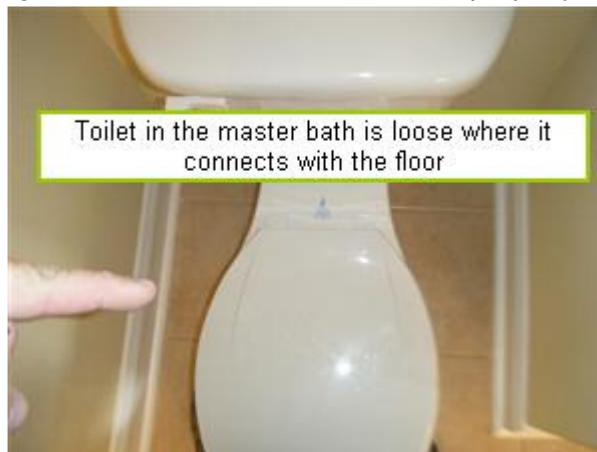
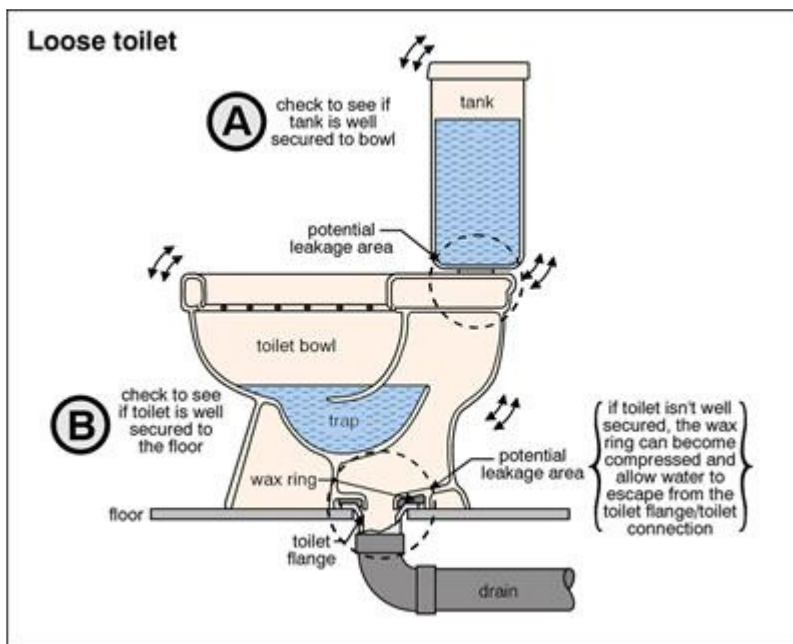
Observed that the toilet in the master bath is loose where it connects to the floor -- this is very common. For your reference, a loose toilet bowl may result in a leak at the wax ring and/or at the supply piping connection which can damage the floor and sub-floor below. Recommend having a handyman tighten the floor bolts so the toilet is properly secure.

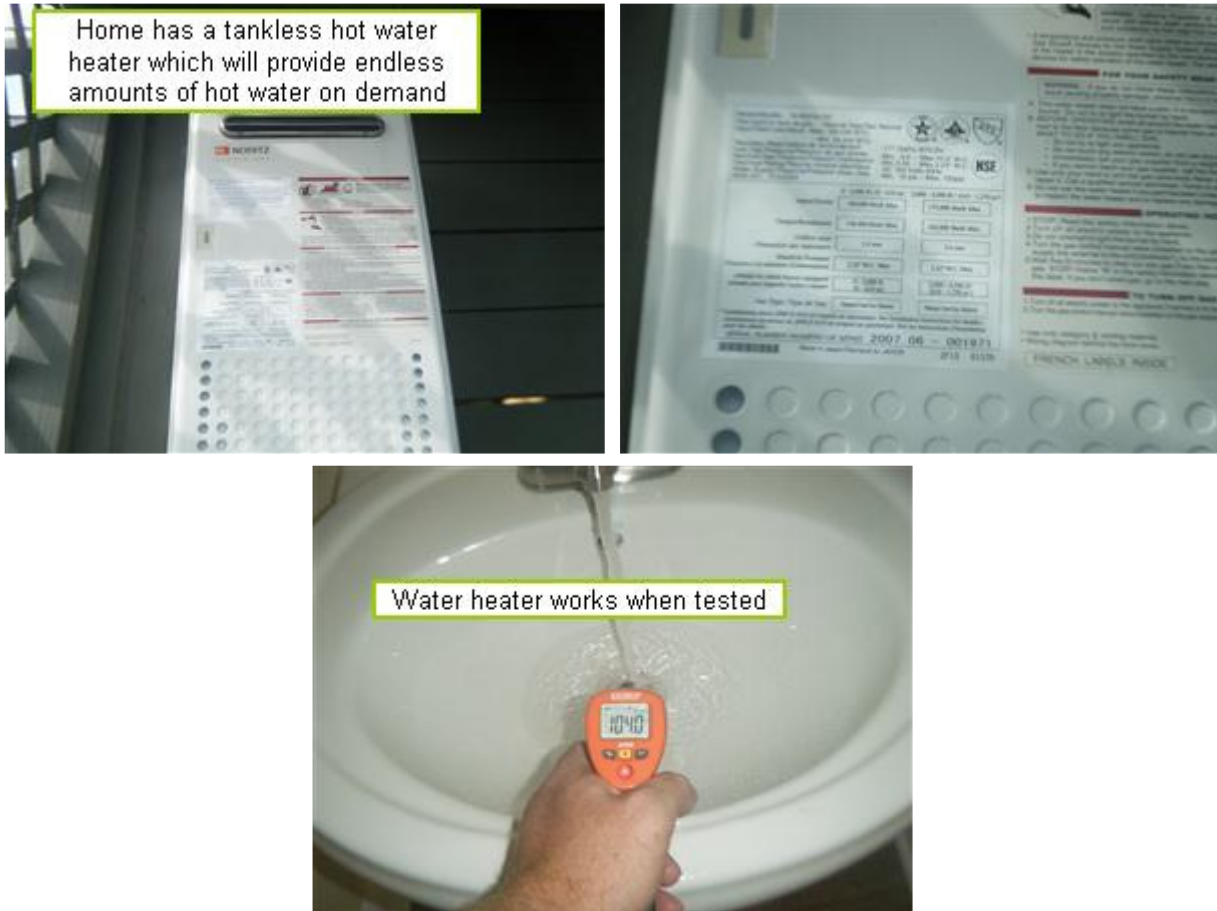
Observed that this home has a gas-powered, tankless hot water heater which is two years old. For your reference, a tankless hot water heater heats water on-demand and delivers an endless supply of hot water for as long as you need it. This type of unit has a heating device that is activated by the flow of water when a hot water valve is opened. Once activated, the heater delivers a constant supply of hot water. Tankless hot water heaters save energy and money because it does not heat water 24 hours a day -- only when you need it. For your reference, the average tankless hot water heater should last about 20 years.

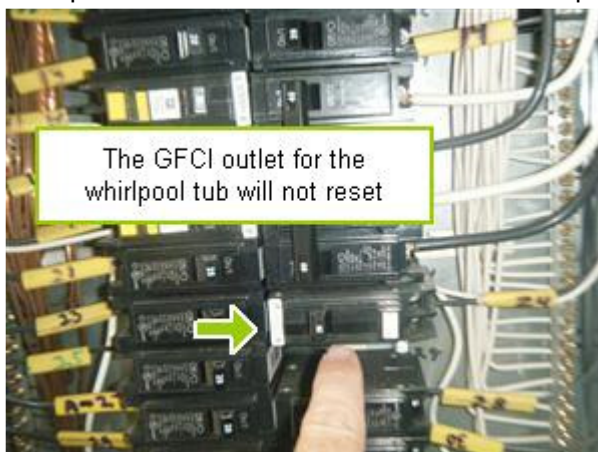
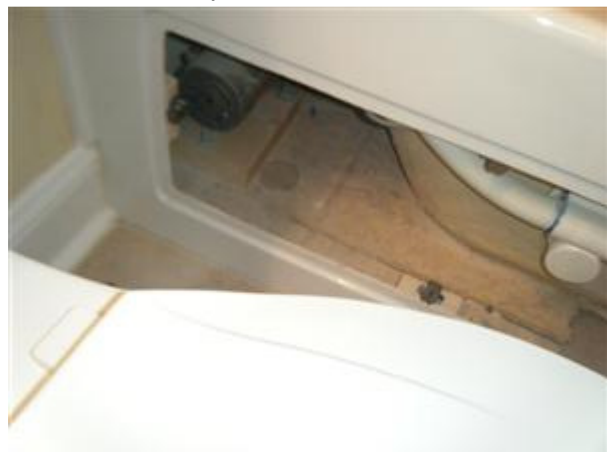
(1) Observed that the GFCI outlet for the whirlpool tub will not reset (which is found in the electrical panel) -- this means the whirlpool has no power. Recommend having the builder replace the GFCI breaker so the tub has power and GFCI trips and resets and it should.

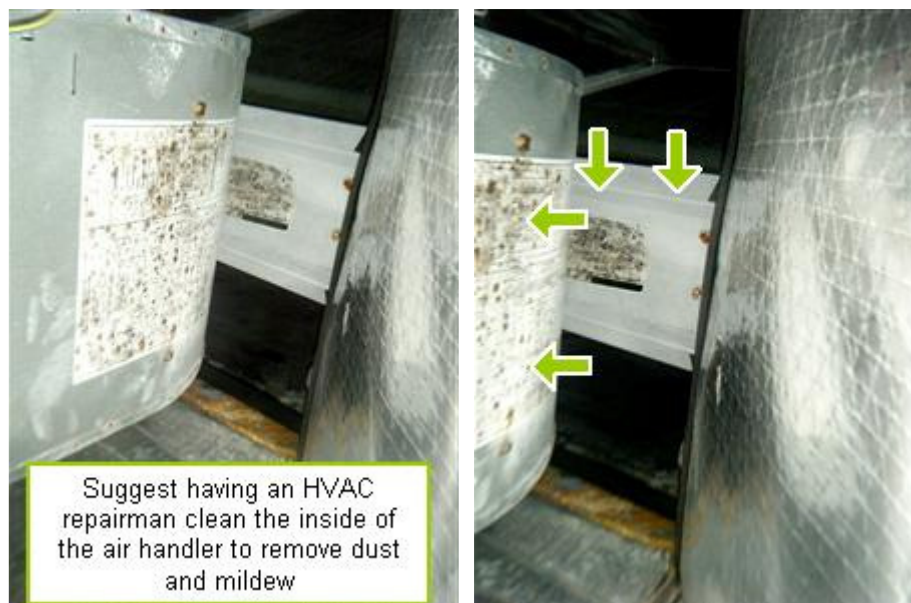
(3) Please note the inside of the air handler has dust and mildew -- this is very common. Recommend having an HVAC repairman service and clean the air handler to help keep it in good condition.

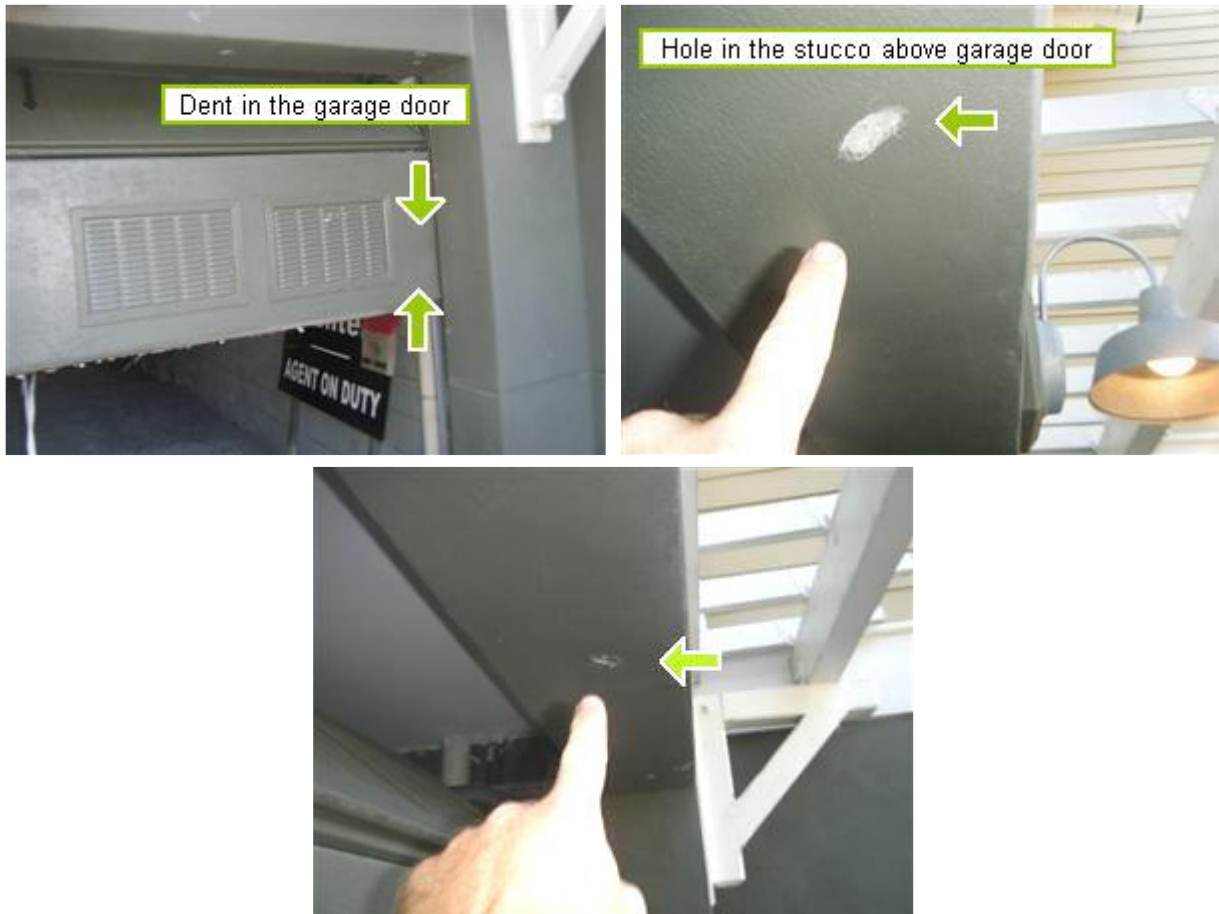
Upon my return visit to the home to inspect the plumbing system on 9/20, observed that there is a dent in the bottom panel of the garage door on each side. Also, there are two holes in the stucco above the garage door. Recommend having a contractor make the needed repairs to the door and stucco.
