# Inspection Report

Prepared for Robert Redford  
111 State Line Road  
Burbank, NY 54321

Robert Redford  
111 State Line Road

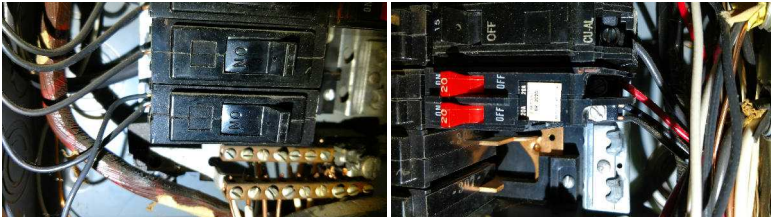
Breakers: CU/AL, Assessment: **Double taps are present at breakers. These circuits need to be moved to their own circuit breaker and cannot share a breaker. It is recommended that a qualified electrician inspect the new circuits and properly connect them to an individual breaker for each circuit**

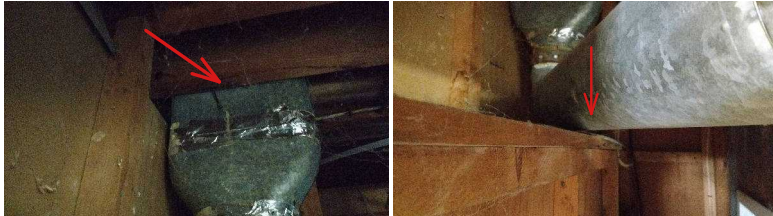
Flue Pipe: Single wall, Double wall, Assessment: **Pipe does not meet the minimum clearances requirements to combustibles.**

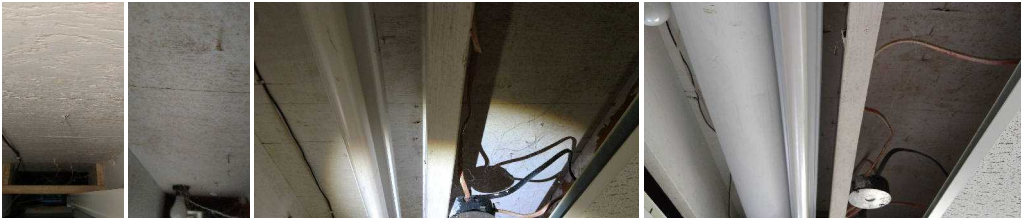
Subfloor: Plywood, Assessment: **There where some brown spots on the floor joists and subfloor in the areas of the lights were they painted the areas white to illuminate the lighting. These spots are suspected mold from basement moisture entering the heated light area. I recommend spraying the areas with a moldicide available at any local building supply center.**

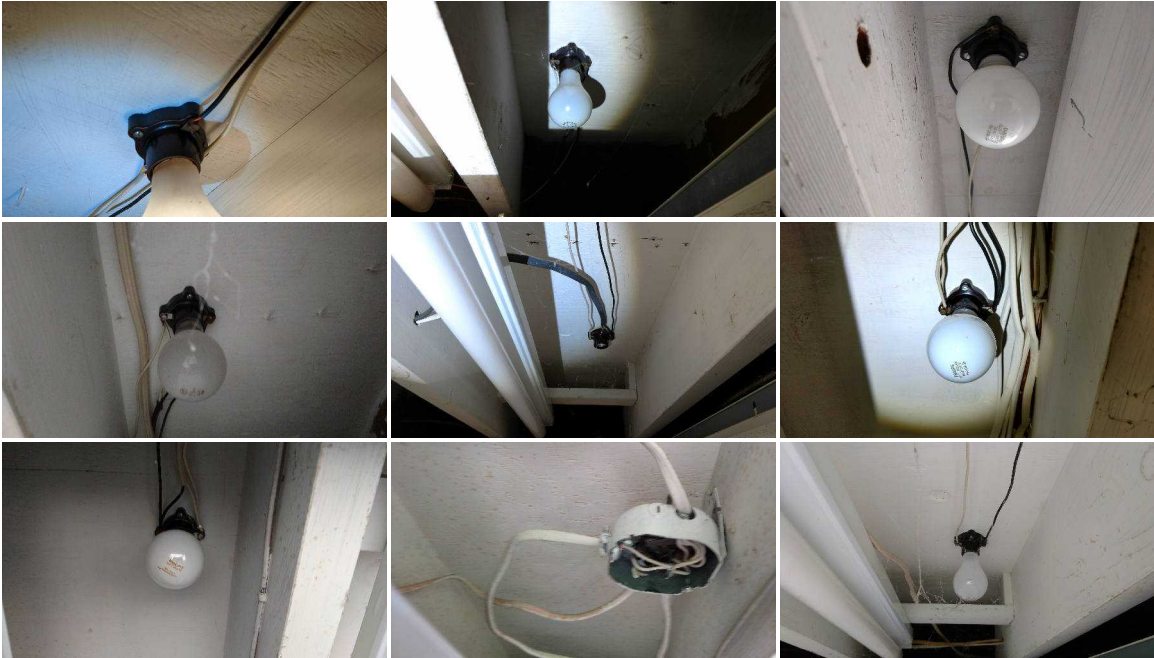
Electrical: 120, Assessment: **The older style light needs replacing.**

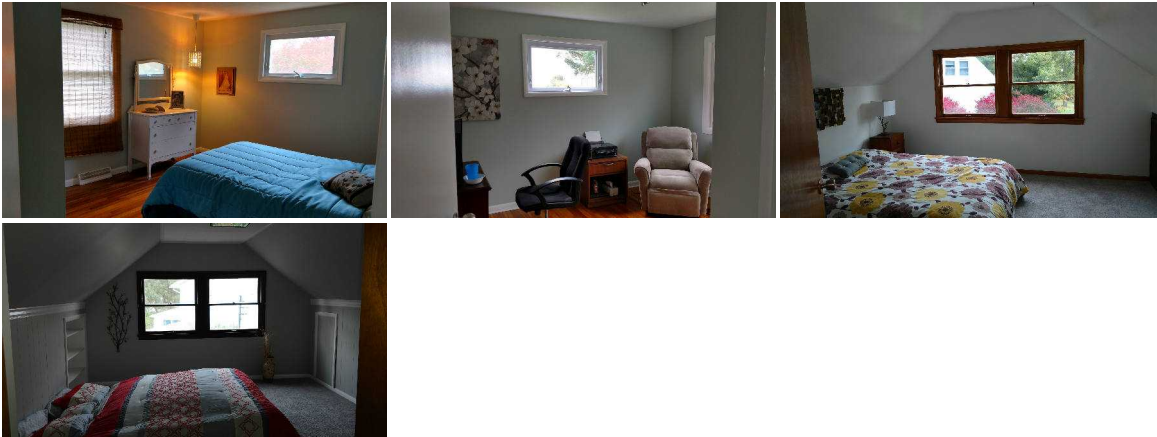
Windows: Vinyl, Assessment: The vinyl trim on the rear window is not properly manufactured.

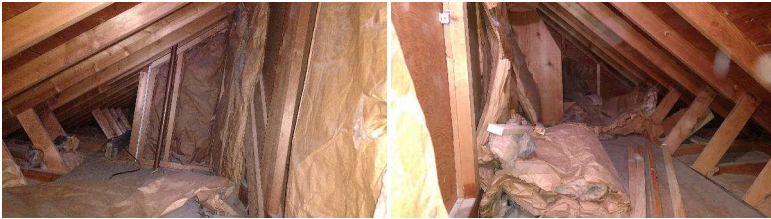
Insulation: Fiberglass, Assessment: Insulation has been damaged and is falling out of place.

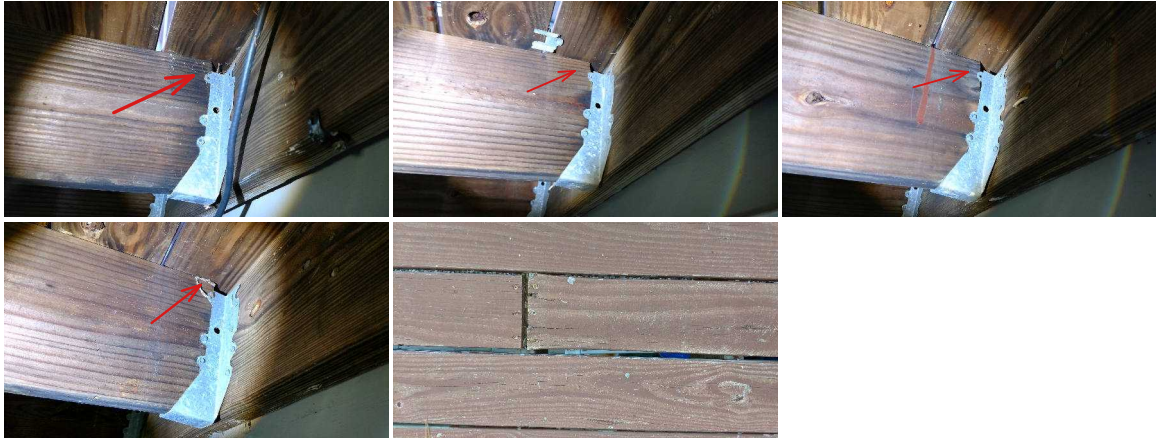
Deck: Treated wood, Assessment: The ledger wasn't properly attached to the home.

The ledger is missing the appropriate lag bolts securing it to the home. They should be installed every 16" . Missing ledger flashings.

18 of the 21 rafters weren't fitted properly to the ledger and are improperly fastened. The deck is a safety hazard in it's current condition and shouldn't be used until repaired properly.

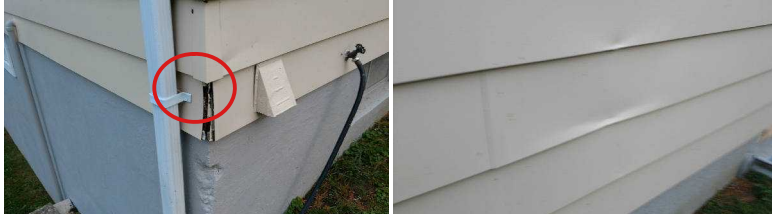
Type: Aluminum siding, Assessment: [The missing corner trim should e replaced.](#)

[Two dented areas were noted.](#)

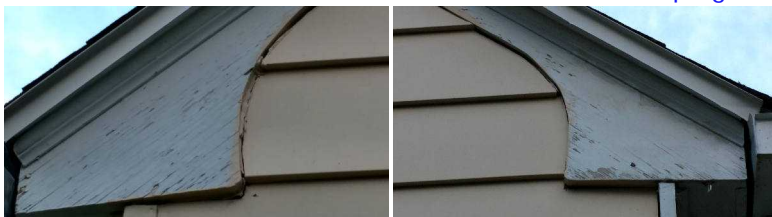
Fascia: Wood, Assessment: [The fascia will need scraping and painting.](#)

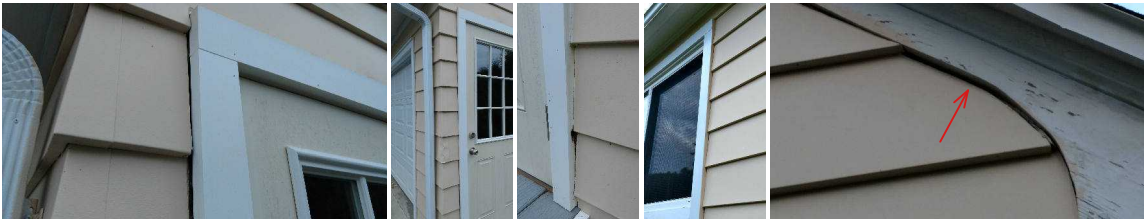
Window and Door Trim: Wood, Assessment: The trim needs caulking where the siding meets the windows and doors.  
Exterior polyurethane caulking is my choice for longevity.

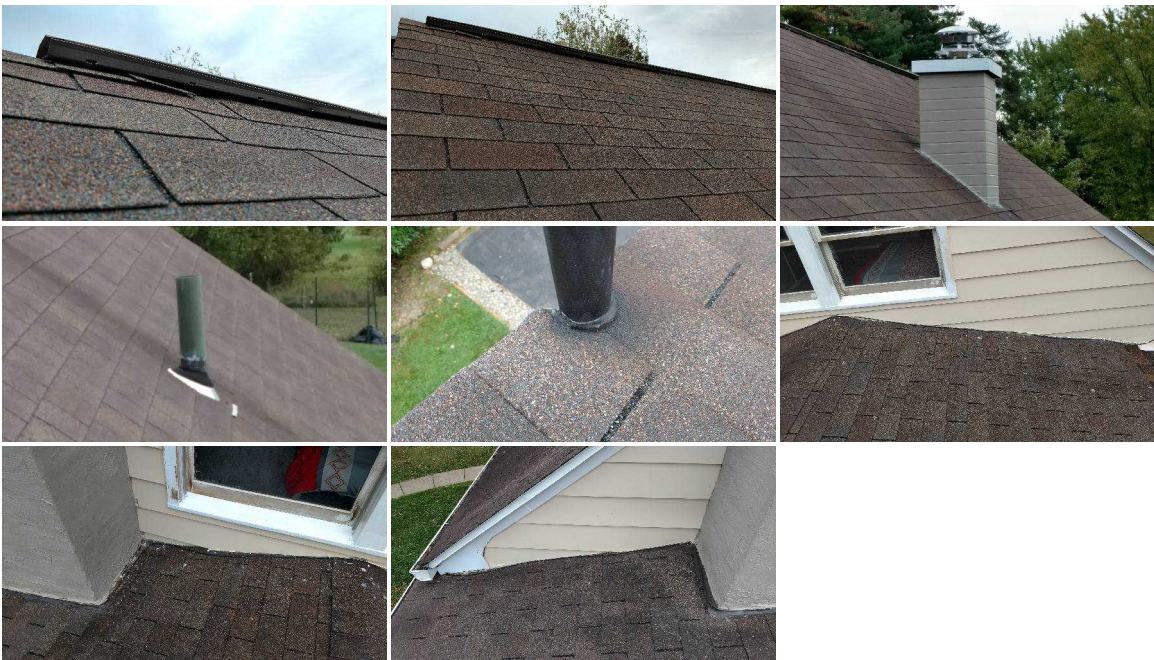
Flashing: Aluminum, Assessment: [The ridge vent is loose and may allow moisture to enter the attic space. Corrections are needed.](#)

[The garage roof doesn't appear to be properly step flashed against the house.](#)

[Improperly flashed metal chimney and plumbing vent. These areas could develop leaks over time if not properly sealed with tar.](#)

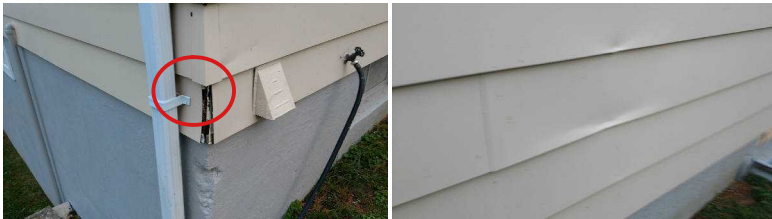
13. All Areas Exterior Surface Type: Aluminum siding, Assessment: [The missing corner trim should be replaced. Two dented areas were noted.](#)

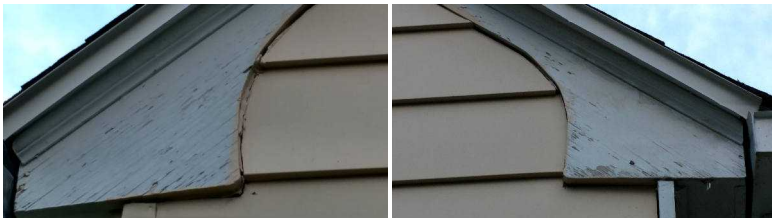
14. All Areas Exterior Surface Fascia: Wood, Assessment: [The fascia will need scraping and painting.](#)

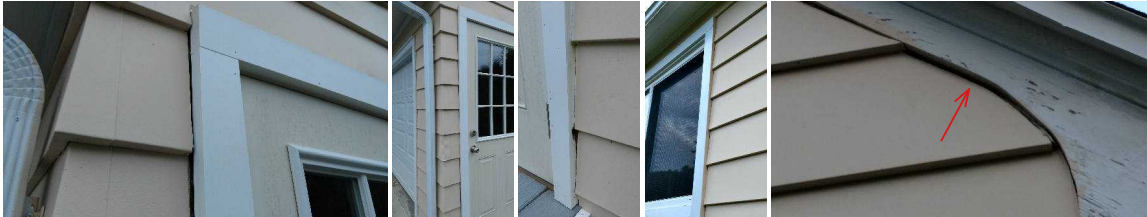
15. All Areas Exterior Surface Window and Door Trim: Wood, Assessment: [The trim needs caulking where the siding meets the windows and doors. Exterior polyurethane caulking is my choice for longevity.](#)

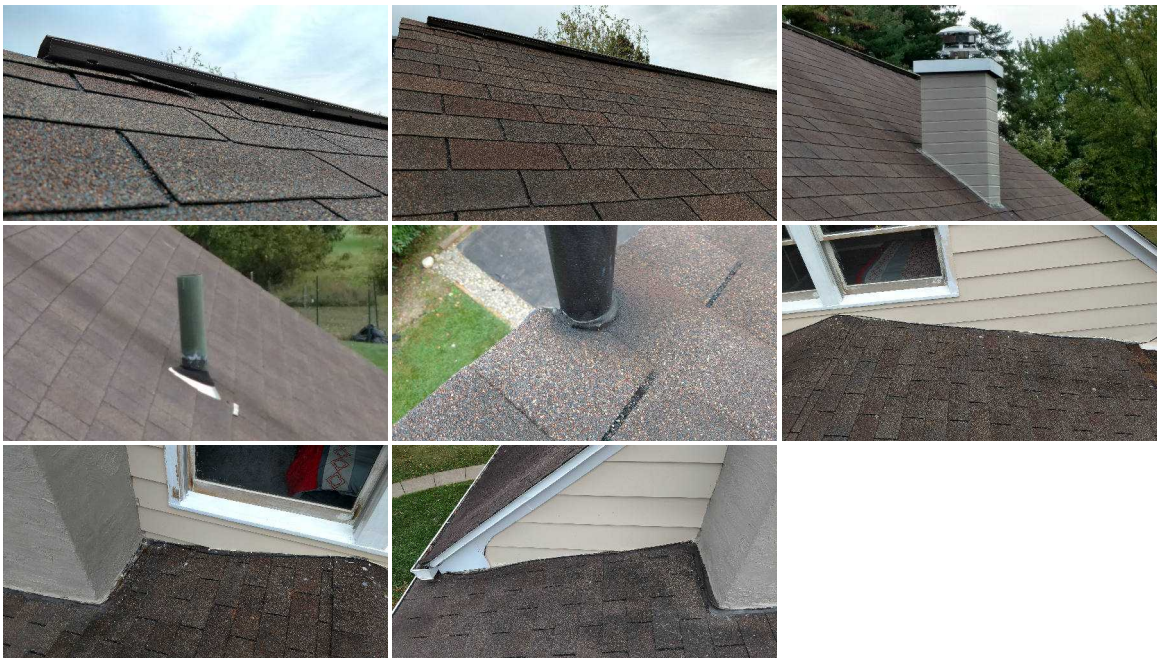
16. Flashing: Aluminum, Assessment: The ridge vent is loose and may allow moisture to enter the attic space. Corrections are needed.

The garage roof doesn't appear to be properly step flashed against the house.

Improperly flashed metal chimney and plumbing vent. These areas could develop leaks over time if not properly sealed with tar.

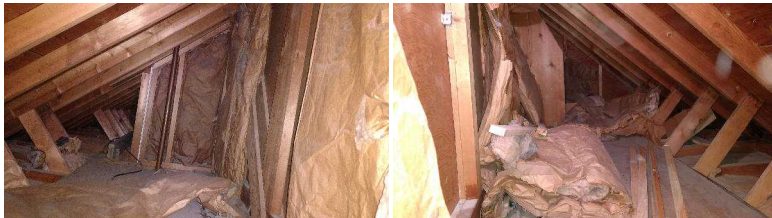
4. Knee walls Attic Ventilation: No ventilation, Assessment: **Vents covered or blocked. Recommend additional ventilation be installed or that the areas be spray foamed.**
5. Knee walls Attic Insulation: Fiberglass, Assessment: **Insulation has been damaged and is falling out of place.**

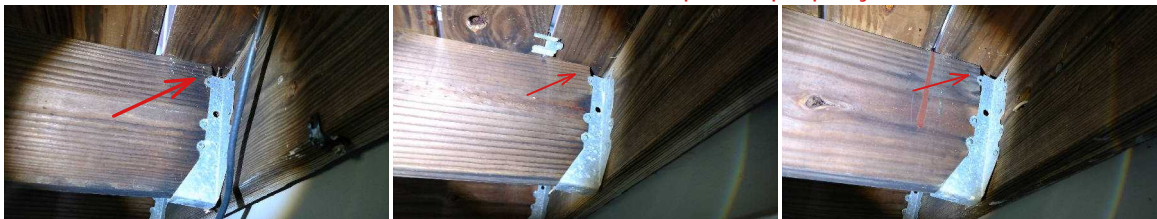
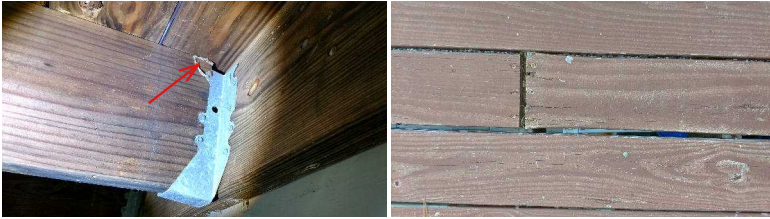
8. Deck: Treated wood, Assessment: **The ledger wasn't properly attached to the home. The ledger is missing the appropriate lag bolts securing it to the home. They should be installed every 16". Missing ledger flashings. 18 of the 21 rafters weren't fitted properly to the ledger and are improperly fastened. The deck is a safety hazard in it's current condition and shouldn't be used until repaired properly.**

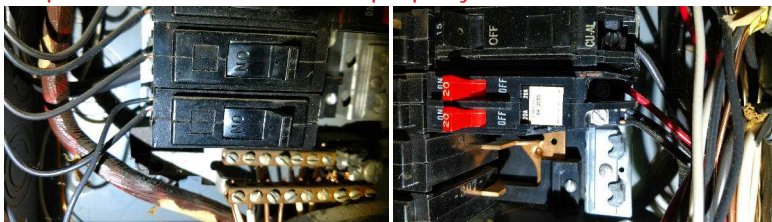
1. Garage Electric Panel Breakers: CU/AL, Assessment: Double taps are present at breakers. These circuits need to be moved to their own circuit breaker and cannot share a breaker. It is recommended that a qualified electrician inspect the new circuits and properly connect them to an individual breaker for each circuit

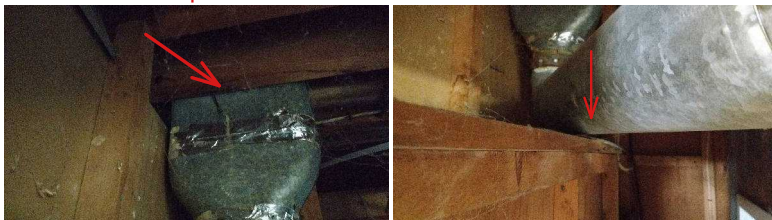
2. Basement Heating System Flue Pipe: Single wall, Double wall, Assessment: Pipe does not meet the minimum clearances requirements to combustibles.

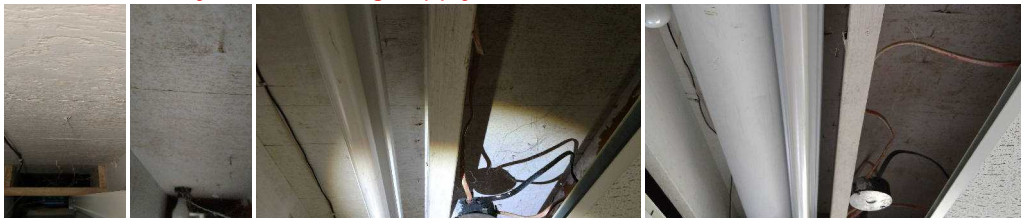
3. Main Basement Subfloor: Plywood, Assessment: There where some brown spots on the floor joists and subfloor in the areas of the lights were they painted the areas white to illuminate the lighting. These spots are suspected mold from basement moisture entering the heated light area. I recommend spraying the areas with a moldicide available at any local building supply center.

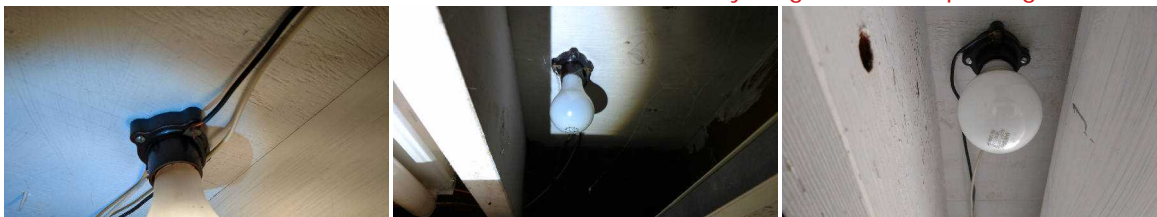
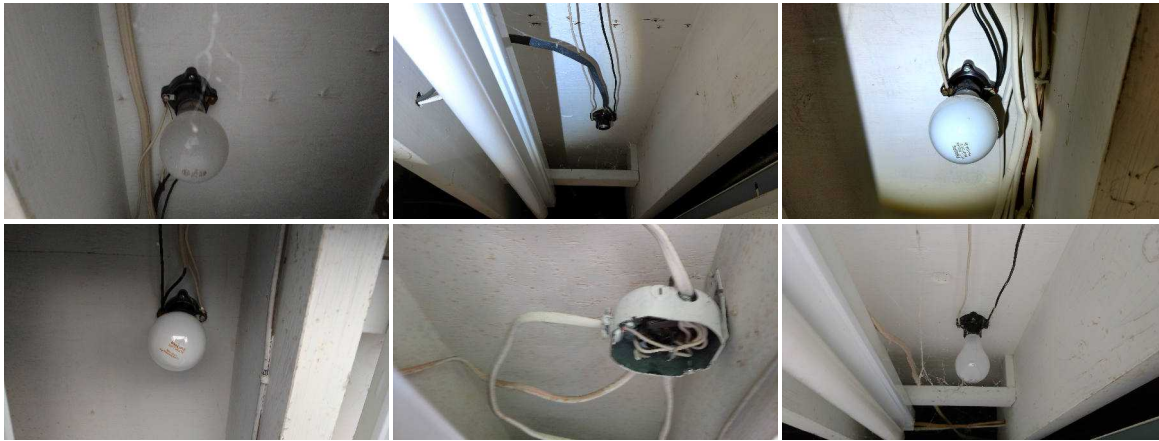
4. Main Basement Electrical: 120, Assessment: The older style light needs replacing.

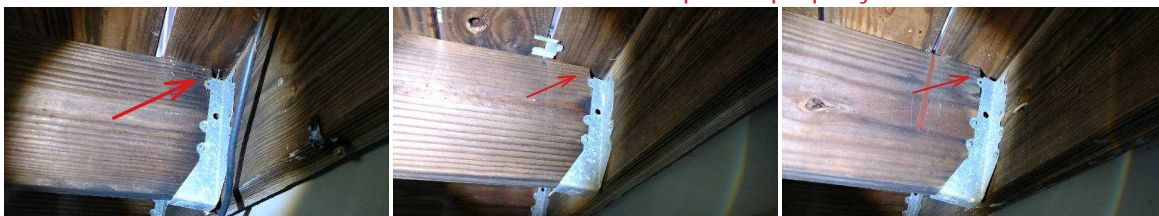
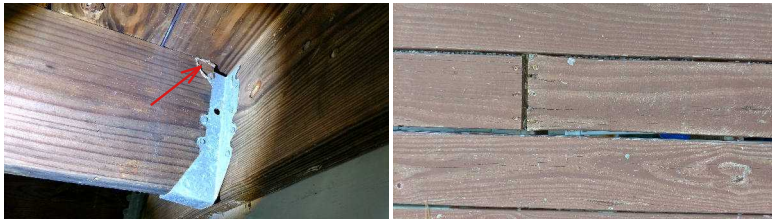
9. Deck: Treated wood, Assessment: **The ledger wasn't properly attached to the home. The ledger is missing the appropriate lag bolts securing it to the home. They should be installed every 16" . Missing ledger flashings. 18 of the 21 rafters weren't fitted properly to the ledger and are improperly fastened. The deck is a safety hazard in it's current condition and shouldn't be used until repaired properly.**
