INVESTIGATION REPORT

FIM nr.: 1903957

REFINERY SHUTDOWN AFTER POWER FAILURE IN 25 KV STATION 4

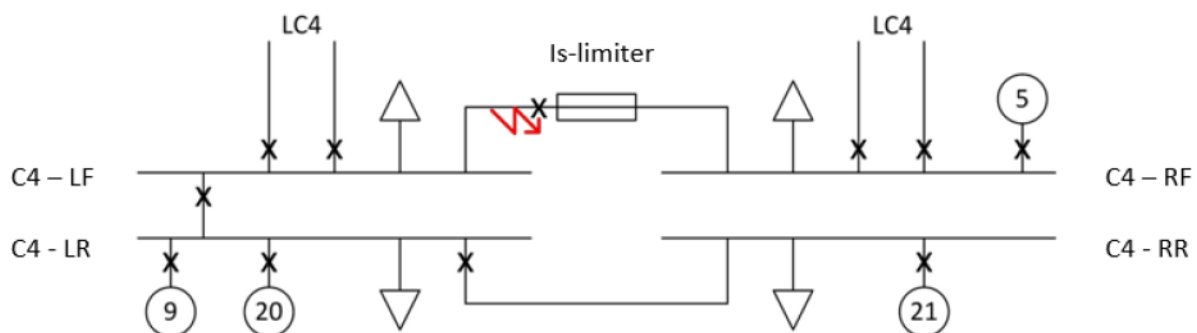
Fig.2: Fault location Centrale 4

From the Electrical Network Monitoring and Control (ENMC) system, it has been established that the loud bang was a two-phase earth fault/short circuit (23:19:06:156 h (Hour: Minute: Seconds: Millisecond)) at the [REDACTED] bus duct behind the 25 kV switchboard feeder L2506.

Figure 2 shows the fault location in the Centrale 4 in a simplified single line diagram.

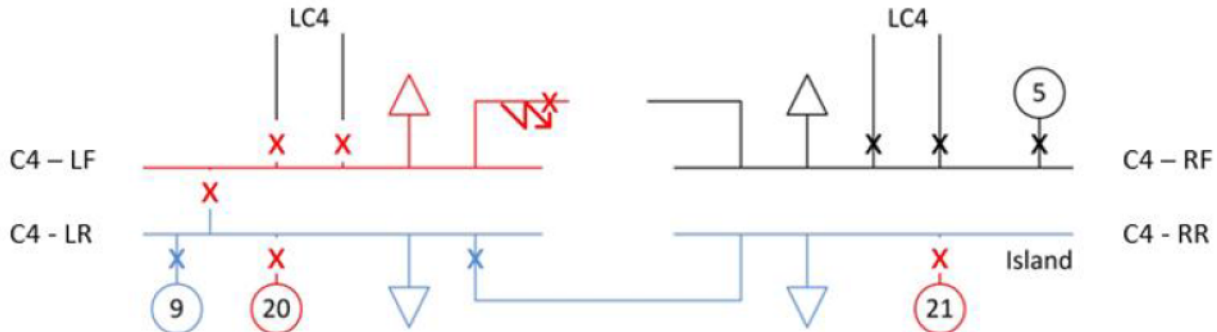
Fig.5: Left Front section disconnected on over-current protection

Due to a phase unbalance the differential protection tripped the supplies to ■ (23:19:07:573 h) and ■ (23:19:07:581 h) as well as ■ (23:19:08:307 h) resulting in substation TS40 being de-energized (tripping HDS-6) and substation TS29 being fed only via TR2 from the C4 island.

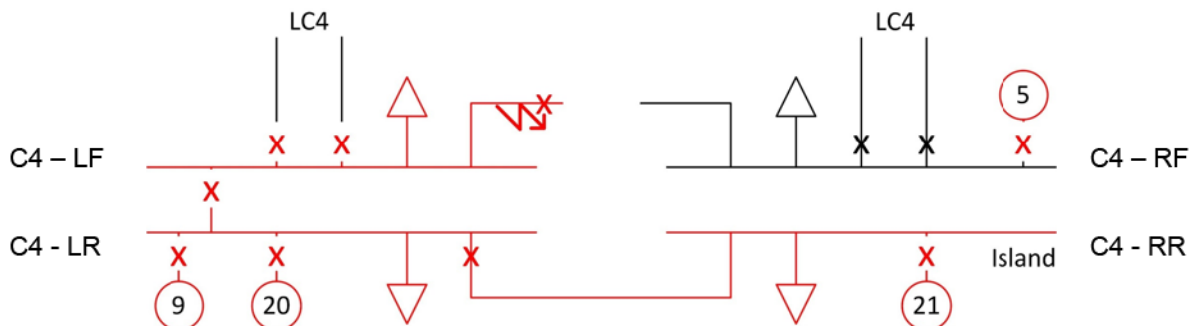
Fig.6: Island de-energized after G9 trip

Approximately 12 seconds after the island was initiated, Generator G9 tripped (23:19:18:117 h). Because G9 was the last remaining generator feeding the island, the island (switchgear sections Left Rear and Right Rear) were de-energized, see Figure 6.

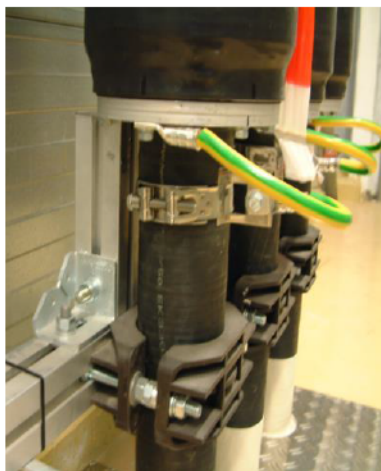
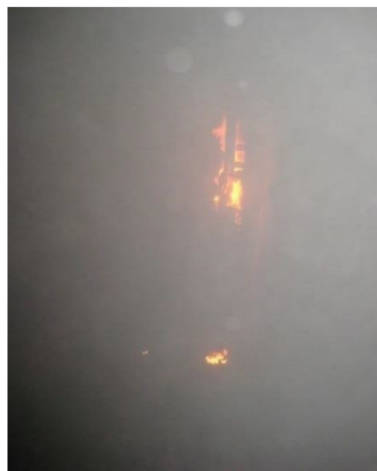
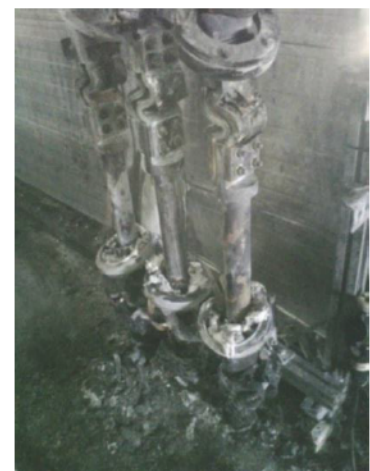
Fig.7: [REDACTED] bus bar system during the installation in 2007, during the fire and after the fire

During further visual inspections, sparks and crackling sounds were noticed at the location of the 25 kV [REDACTED] bus bars on the east side of the building behind the perforated coving. A first attempt was taken to cool the perforated coving with a CO₂ extinguisher. A CIN notification was raised at 22:45 h.

Further inspections between 23:20 h and 23:45 h revealed the absence of the perforated coving. A first attempt was done to extinguish the burning bus bar system with CO₂. Two bottles were used unsuccessfully.

At approximately 02:30 h, Centrale 4 was entirely de-energized, but earthing was not possible. Using foam, the fire brigade attempted to extinguish the fire from a safe distance between 02:38 h and 03:06 h. They were unsuccessful. A third attempt was made between 03:06 h and 03:23 h, with blankets and powder, but was again unsuccessful. Finally, between 04:10 h and 04:22 h, the burning isolation material was removed from the bus bar system and the fire was successfully extinguished with water and monnex powder.

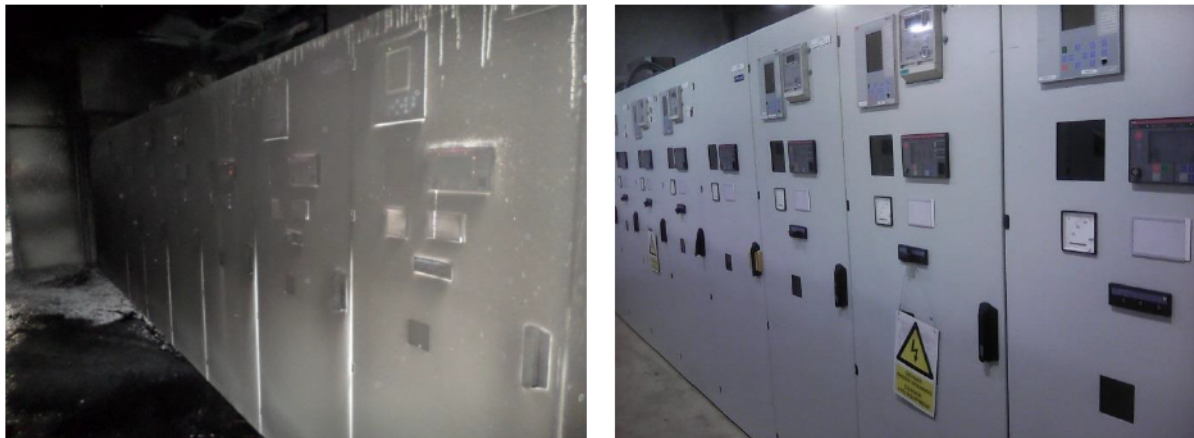
Fig.8: Centrale 4 switchgear before and after cleaning

As the West switchgear room was least polluted switchgear room, the first focus was on this side, together with the required auxiliary room and cable cellar. The cleaning of this side was a significant job as the fire produced a large amount of smoke and thus soot [REDACTED]. The soot was not only found on the interior of the building and on the switchgear panels, but also inside the switchgear panels and secondary systems, such as servers and protection relays. The photos in Figures 8 and 9 give an impression of the situation in Centrale 4 after the fire.

A specialized company was contracted to recondition the 25 kV switchgear, the protection and control systems, all other equipment in the building (e.g. servers) and the building itself. The building has a cable cellar, two switchgear rooms (East and West) and a second floor with an Auxiliary room and the Is-limiter room. The East switchgear room was the most heavily polluted with soot and extinguishing fluids as the fire was in this part of the building. The West switchgear room was less polluted, mainly with soot. The second floor had light pollution from soot and the cable cellar was polluted with extinguishing fluids, leaking through the ceiling from the switchgear rooms.

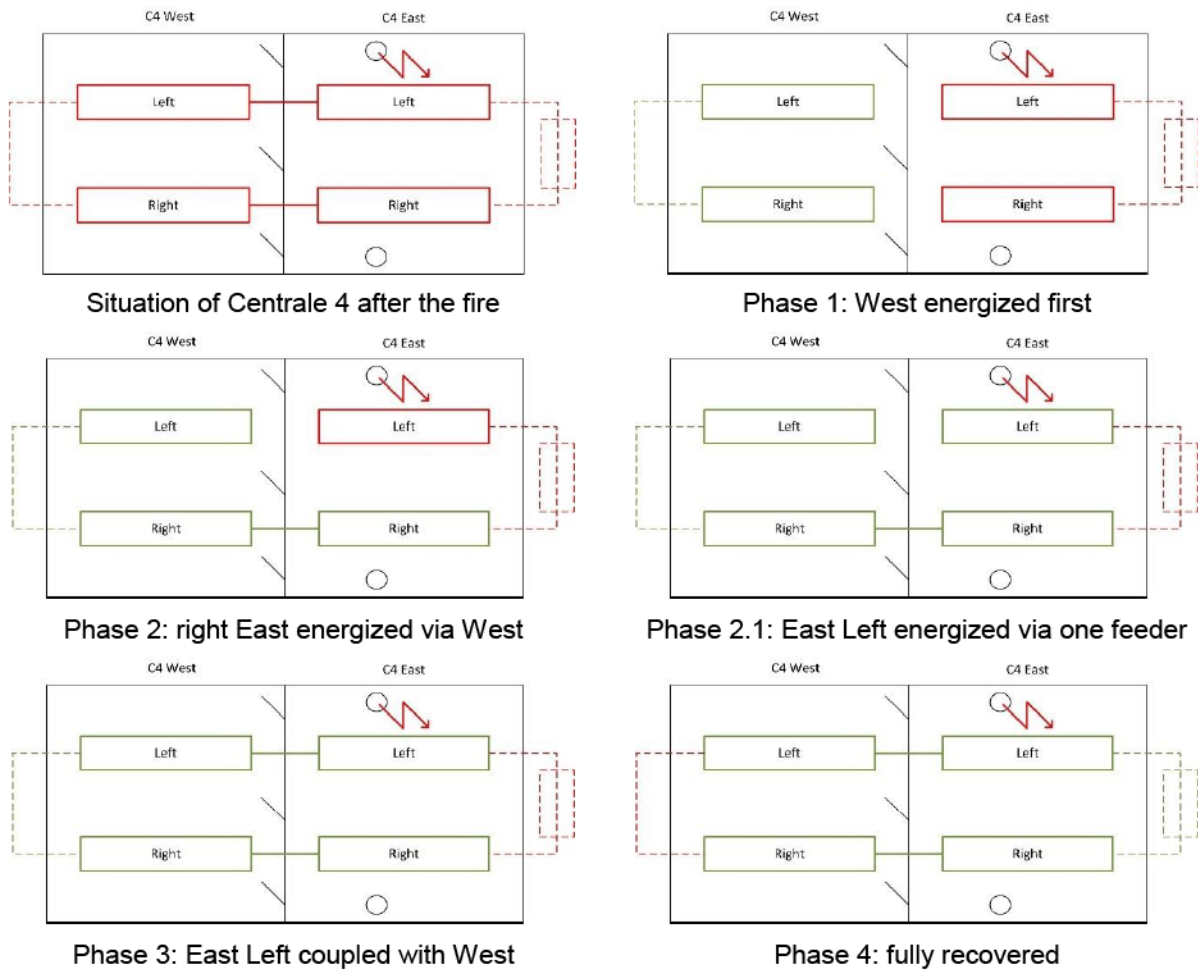
Fig.10: All phases of Centrale 4 recovery, red is de-energized, green is energized

During internal inspection of the Left section of the East side, several damaged parts were found. As there was a delivery time for these parts of [REDACTED], a Phase 2.1 was required to energize only the bus bar of Left West section and using this to only energize the second, redundant, power supply to Water Pump House 4. After delivery and installation of the parts it was possible to re-connect Left East to Left West in Phase 3 (see Figure 10). [REDACTED] [REDACTED] [REDACTED].

In Phase 2 (see Figure 10) a tent was placed over the Right section of Centrale 4 East to clean, inspect, re-commission and re-energize this section, without having to clean the rest of the East side. Maximum effort was focused on the Right section as it was expected that the Left section was polluted most severely and damage to the switchgear could be expected as the fire was closest to this section. After re-energizing the Right East section, more capacity was available and all process plants could be restarted.

In Phase 4 (see Figure 10) the bus duct to the Is-limiter between the Left and Right section will be rebuilt. When this is completed, the Is-limiter can be used again, allowing all generation capacity to be reconnected to Centrale 4 and thus restoring Centrale 4 to its normal configuration.

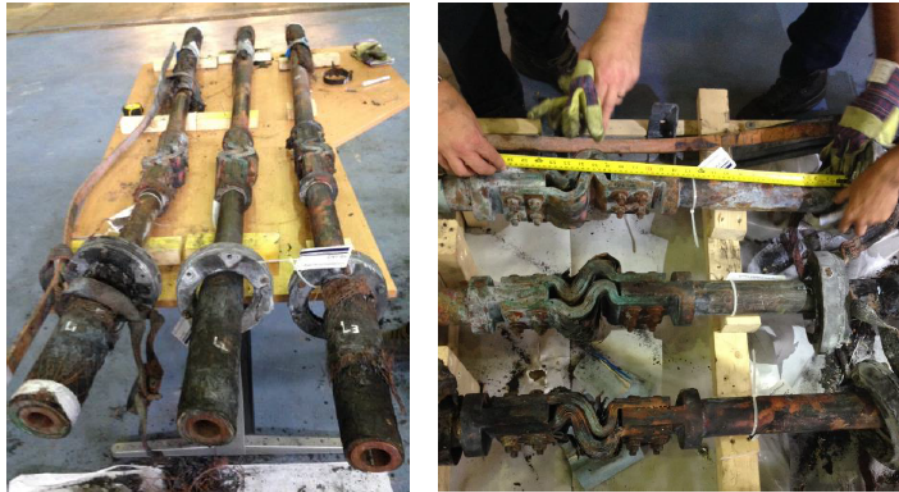
Fig.12: Dissection as part of the Forensic Investigation at DNV GL in Arnhem

- 4) **Dissection of the failed bus ducts.** Although the failed bus ducts have been largely destroyed by the resulting fire, the upper connection tubes are damaged but still intact. DNV GL opened these tubes carefully to inspect the inside of the tubes, the sliding contacts, the bus bar insulation, the connecting tube flanges and sealing (See Figure 12 for photos taken during this dissection).

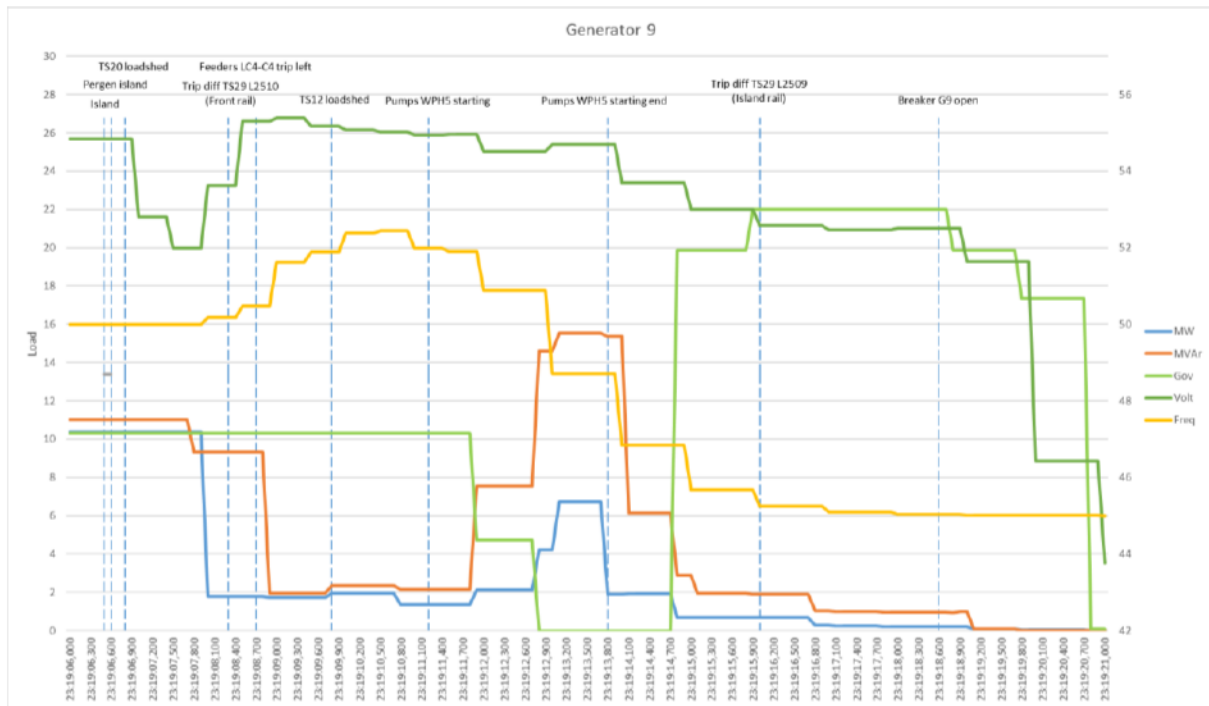
Fig.17: Generator 9 (sampling is based on rate of change in value)

In Figure 17, the output power of G9 in actual power (MW) and reactive power (MVar) is plotted as well as the bus bar voltage and frequency of the Left Rear (Island) bus bar where G9 was connected to during the incident. The frequency and voltage of the Left Rear bus bar after Island initiation at 23:19:06:555 h and subsequently disconnection of G20 and G21 at 23:19:06:617 h, was equal to the frequency of G9, as this was the only connected generator to the Island at that time.

Directly after Island initiation and load shedding of [REDACTED] by the fast load shedding system, the voltage shortly dips to a minimum of 20 kV, where after quickly restoring to nominal value around 25,5 to 26 kV. In the same period the frequency starts to rise to a maximum of 52,5 Hz. At the moment of load shedding [REDACTED] at 23:08:19:882 h by frequency load shedding, the frequency of the bus bar is approximately 52 Hz. At this frequency, the load shedding system should never operate as this will only worsen the over-frequency, i.e. increasing load is decreasing frequency and vice-versa.

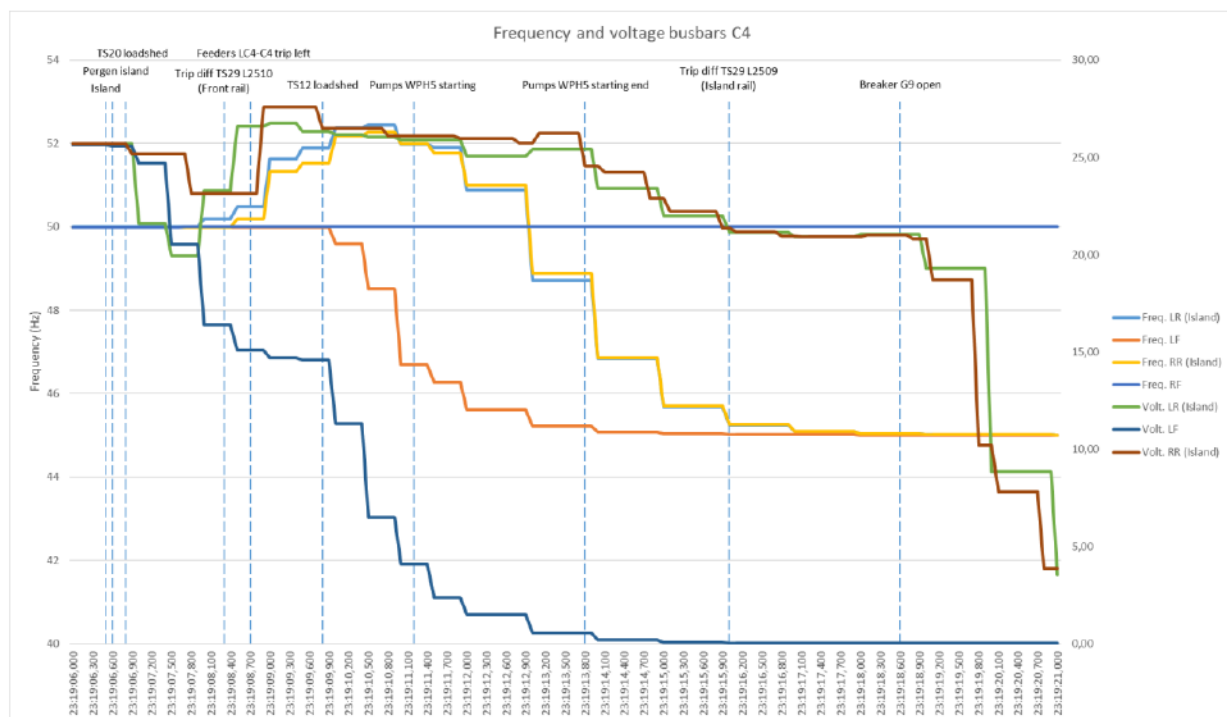
Fig.18: Bus bar frequency and voltages of all C4 bus bars

Conclusion is that the frequency load shedding system did not work correctly and that [REDACTED] should not have been shed. The malfunctioning of the frequency load shedding could be caused by incorrect settings or alternatively that the wrong bus bar measurement is used. The relays and hence the settings are regularly tested. During testing immediately after the incident, the relays worked as intended. Therefore, a setting problem is not likely.

The bus bar measurement used by the RET relays is selected by a manual selector switch in Centrale 4 auxiliary room. This should be selected on one of the two Island (Rear) bus bars as to work in Island mode. As can be seen in Figure 18, the frequency of the Left Front bus bar (bus bar connected to the failed bus duct) falls away at the time of the [REDACTED] load shedding. As the Left Front bus bar de-energized at 23:19:08:738 h, roughly one second earlier, the voltage and hence the frequency had fallen away from that bus bar section. Although this measurement shows that the frequency only starts to drop exactly at the point where [REDACTED] is load shedded, it is very likely that this happened earlier. This could be a time synchronization issue. As there is no time delay on the under-frequency settings of the load shedding system, a very short under-frequency will already shed the loads. It is likely that the bus bar measurement was manually selected on the Front bus bar or that there is a cross wiring between the measurement on the bus bars and the selector switch. This will be topic for further investigation.
