YOUR INSPECTION REPORT

505 Pemberton Place
Picayune, MS 39466

Friday, December 9, 2016

Lochard Home Inspection
118 Dogwood Valley
Picayune, MS 39466

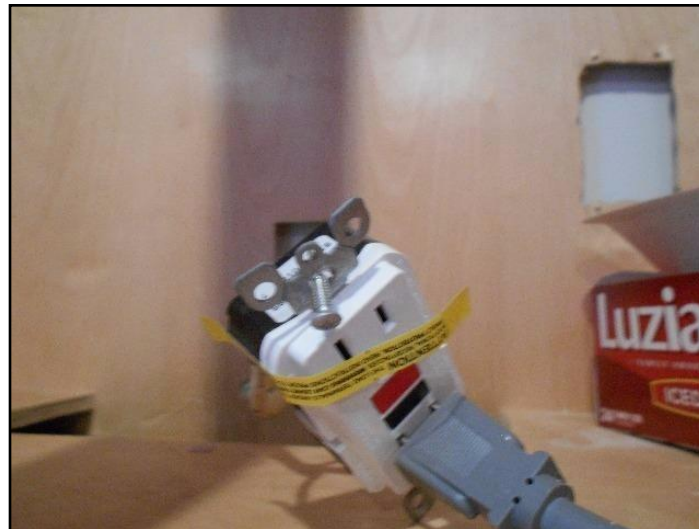
1. Reversed polarity

Condition: • [Reversed polarity](#)

The following outlets have the hot and neutral wires reversed: the east outlet on the north wall in the informal dining room, the east outlet on the north wall in the master bedroom and the microwave oven outlet. Also, the microwave oven outlet is not mounted properly and does not have a cover.

Implication(s): Electric shock

Task: Repair

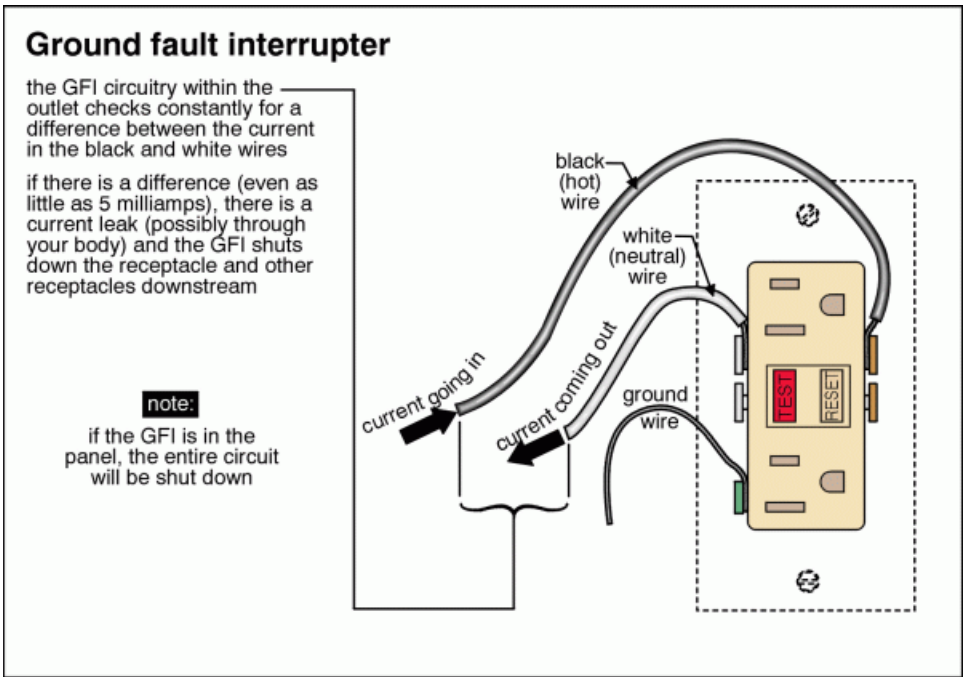
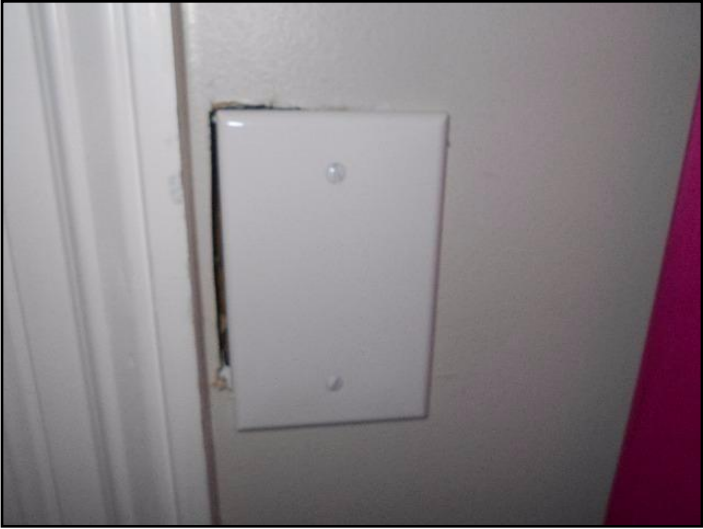
2. GFCI/GFI needed (Ground Fault Circuit...

Condition: • [GFCI/GFI needed \(Ground Fault Circuit Interrupter\)](#)

The master bathroom jetted tub is not GFCI protected. Also, the outlets on the east wall in the kitchen, the outlets in the garage and the exterior outlets are not GFCI protected. The age of the structure (2006) does not predate the adoption of the requirement in the areas noted (1973 - exterior outlets, 1975 - bathroom outlets, 1978 - garage outlets, 1986 - kitchen outlets).

Implication(s): Electric shock

Task: Replace

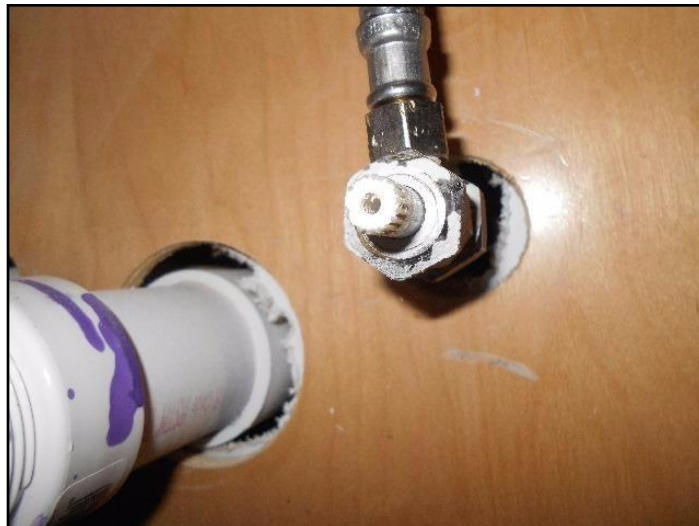
3. Missing or cannot be located

Condition: • [Missing or cannot be located](#)

The shut off valves are missing under the hallway and master bathroom sinks.

Implication(s): Chance of water damage to contents, finishes and/or structure | Difficult to service

Task: Replace

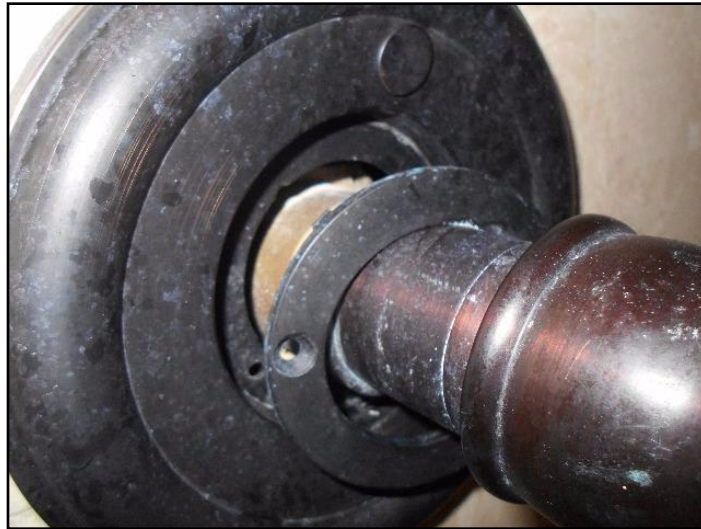
4. Missing

Condition: • Missing

The cover is missing on the master bathroom shower faucet, which could allow water penetration behind the wall.

Task: Replace

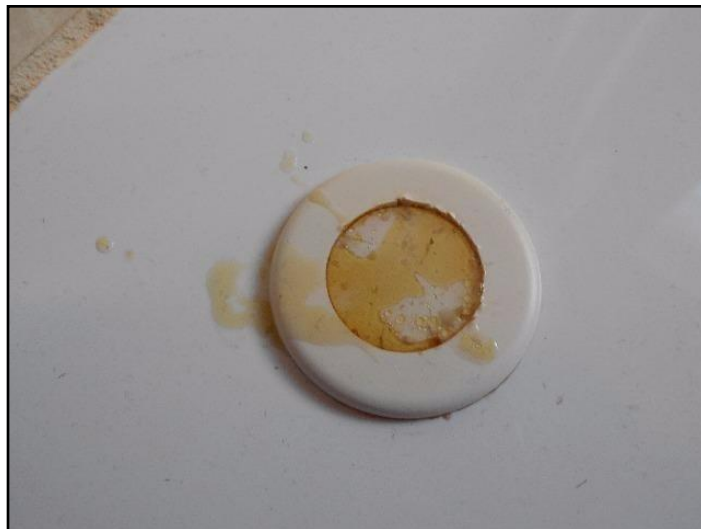
5. Leak

Condition: • [Leak](#)

The master bathroom jetted tub leaked around the on/off button when the inspector tested the tub. The inspector recommend a plumber to repair the leak.

Implication(s): Chance of water damage to contents, finishes and/or structure

Task: Repair

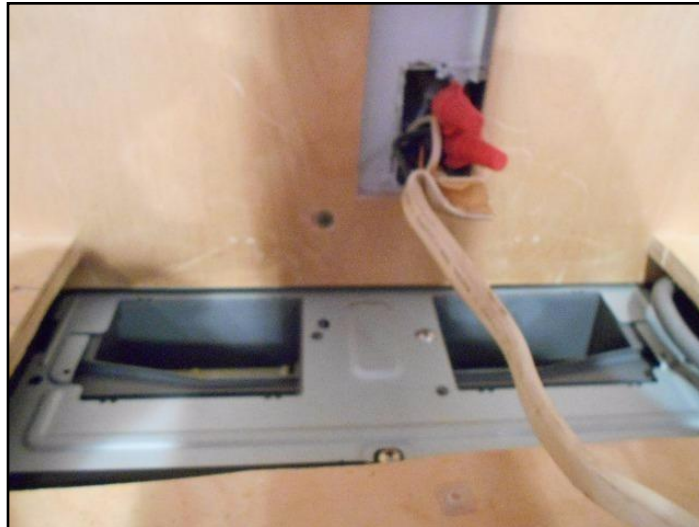
6. Not vented to exterior

Condition: • Not vented to exterior

The kitchen exhaust fan does not vent to the exterior.

Implication(s): Chance of condensation damage to finishes and/or structure

Task: Repair

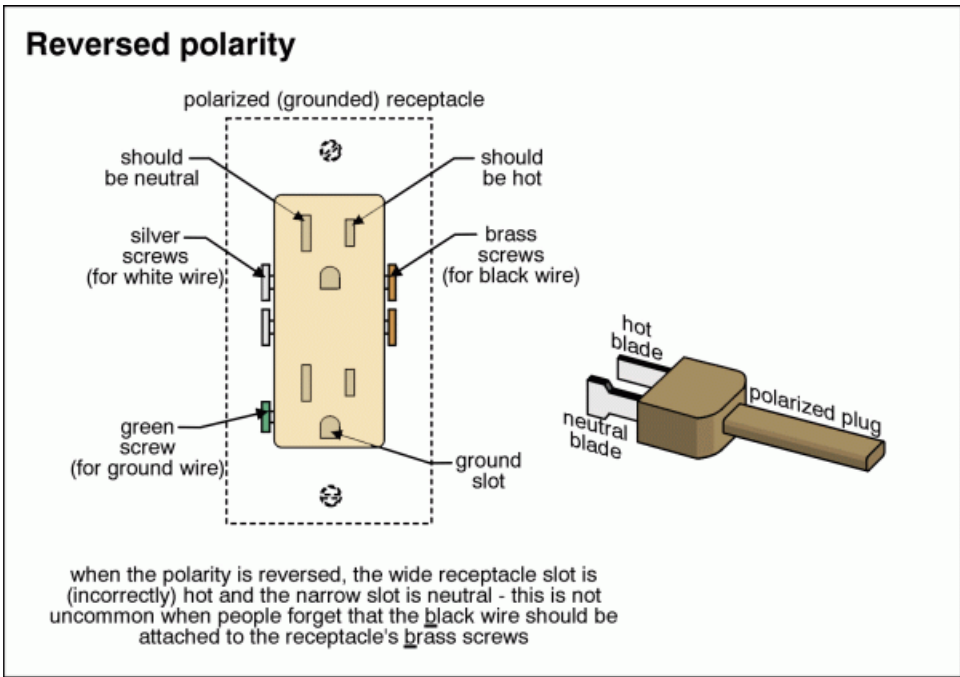
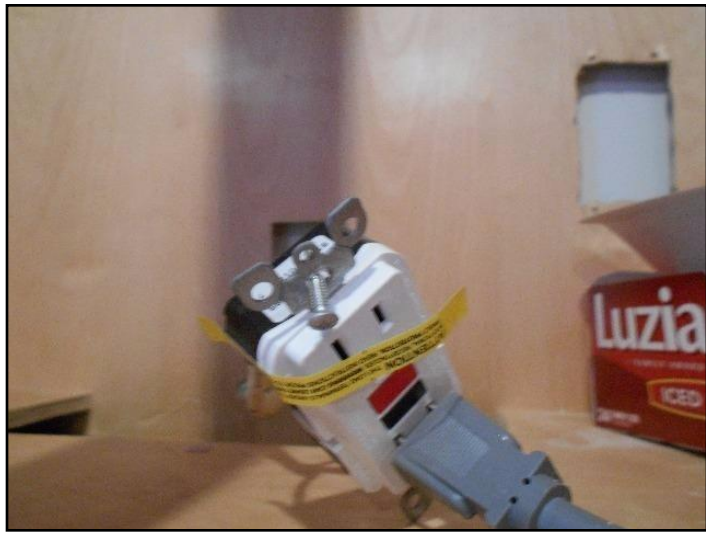
7. Reversed polarity

6. Condition: • [Reversed polarity](#)

The following outlets have the hot and neutral wires reversed: the east outlet on the north wall in the informal dining room, the east outlet on the north wall in the master bedroom and the microwave oven outlet. Also, the microwave oven outlet is not mounted properly and does not have a cover.

Implication(s): Electric shock

Task: Repair

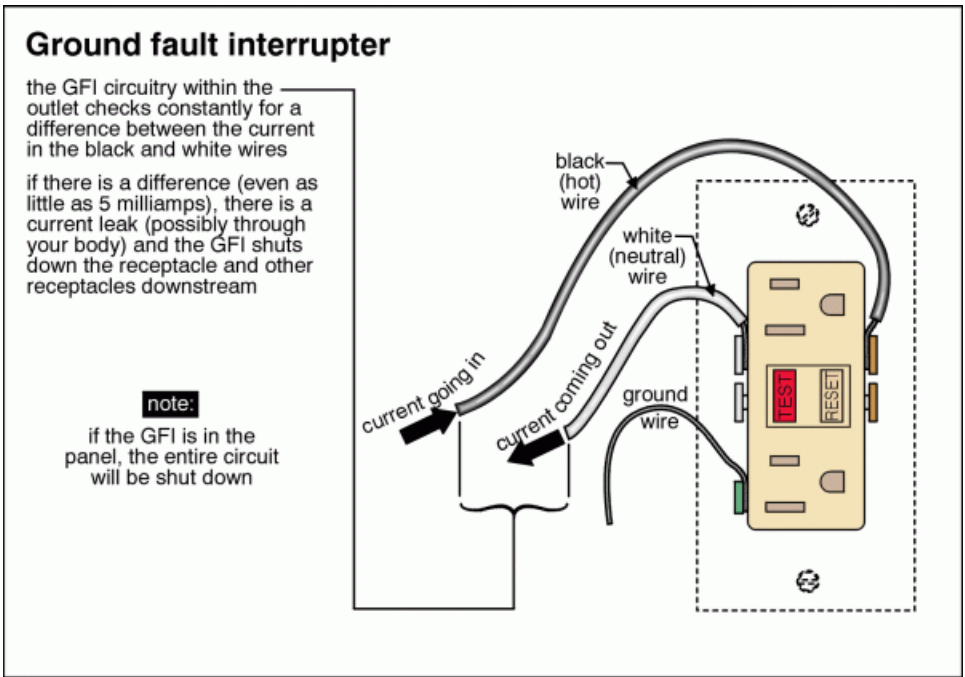
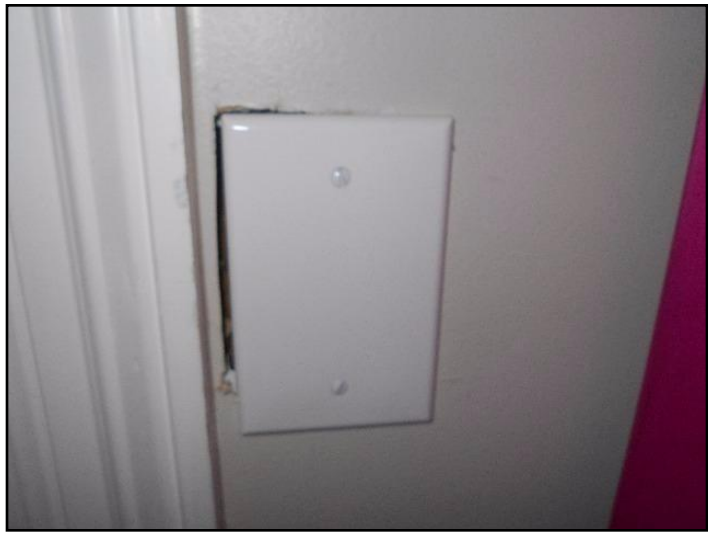
8. GFCI/GFI needed (Ground Fault Circuit...

7. Condition: • [GFCI/GFI needed \(Ground Fault Circuit Interrupter\)](#)

The master bathroom jetted tub is not GFCI protected. Also, the outlets on the east wall in the kitchen, the outlets in the garage and the exterior outlets are not GFCI protected. The age of the structure (2006) does not predate the adoption of the requirement in the areas noted (1973 - exterior outlets, 1975 - bathroom outlets, 1978 - garage outlets, 1986 - kitchen outlets).

Implication(s): Electric shock

Task: Replace

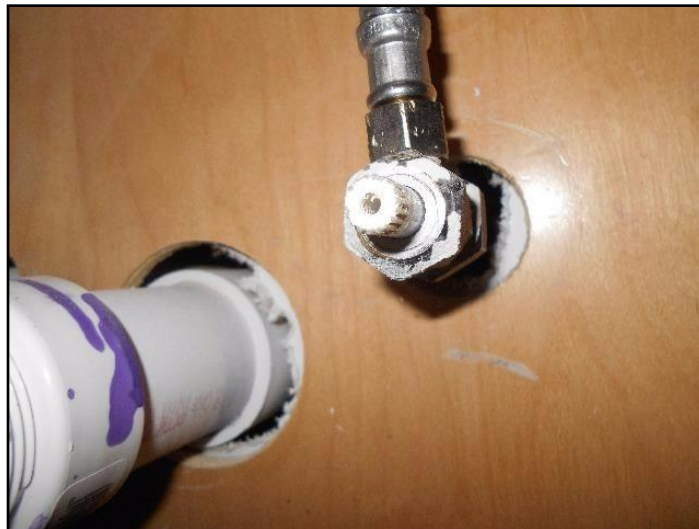
9. Missing or cannot be located

10. Condition: • [Missing or cannot be located](#)

The shut off valves are missing under the hallway and master bathroom sinks.

Implication(s): Chance of water damage to contents, finishes and/or structure | Difficult to service

Task: Replace

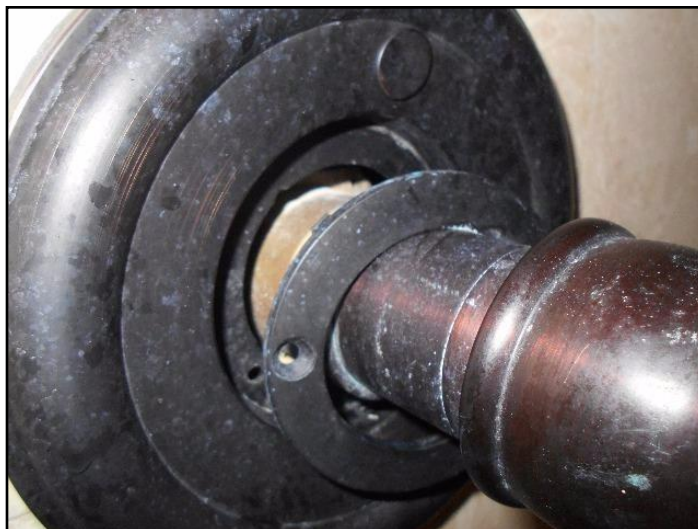
10. Missing

12. Condition: • Missing

The cover is missing on the master bathroom shower faucet, which could allow water penetration behind the wall.

Task: Replace

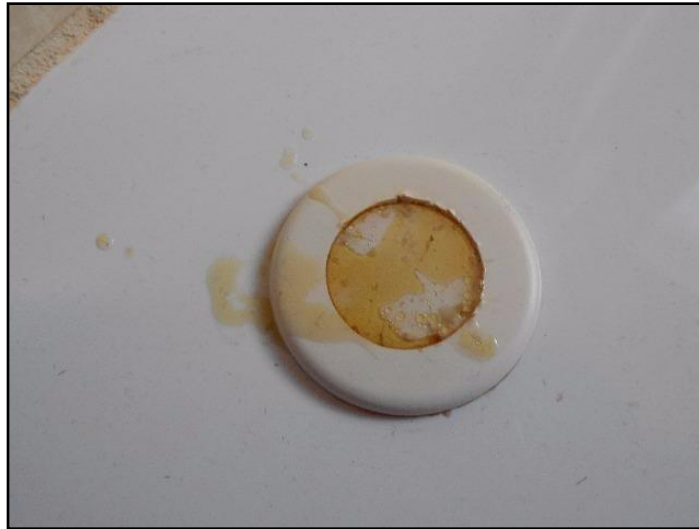
11. Leak

13. Condition: • [Leak](#)

The master bathroom jetted tub leaked around the on/off button when the inspector tested the tub. The inspector recommend a plumber to repair the leak.

Implication(s): Chance of water damage to contents, finishes and/or structure

Task: Repair

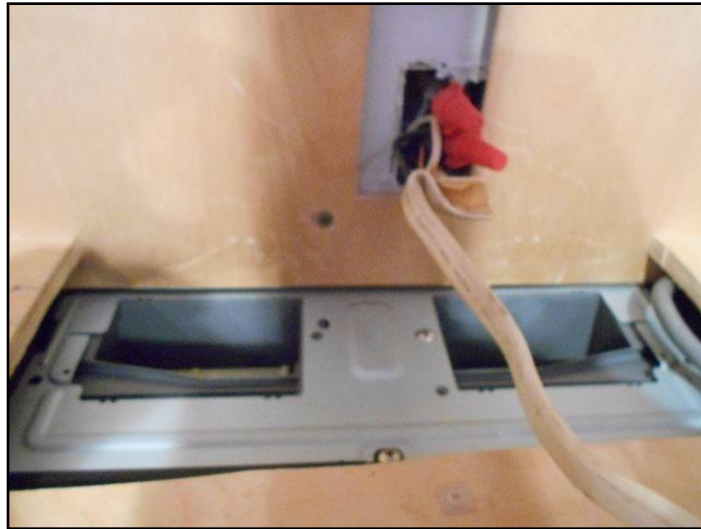
12. *Not vented to exterior*

18. Condition: • Not vented to exterior

The kitchen exhaust fan does not vent to the exterior.

Implication(s): Chance of condensation damage to finishes and/or structure

Task: Repair
