# Home Inspection Report

Prepared for: Janie Johnson  
Date: 7/6/2010

Property address: 350 Summer Lane  
North Charleston SC 29420

Inspected by: Stephen Houmard  
South Carolina License #2046  
Solid Ground Home Inspections, LLC  
Professional Member:  
-American Society of Home Inspectors  
(ASHI)

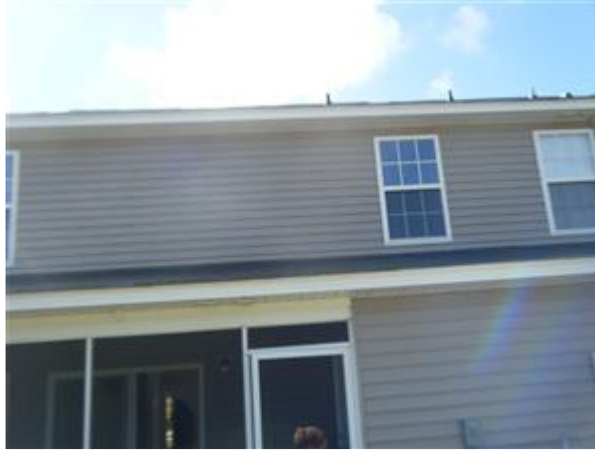
(2) Observed that a section of siding on the screen porch is loose. Recommend notifying the builder so it can be repaired.

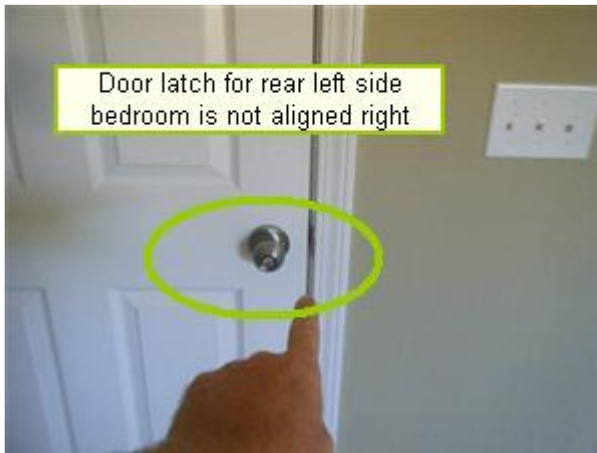
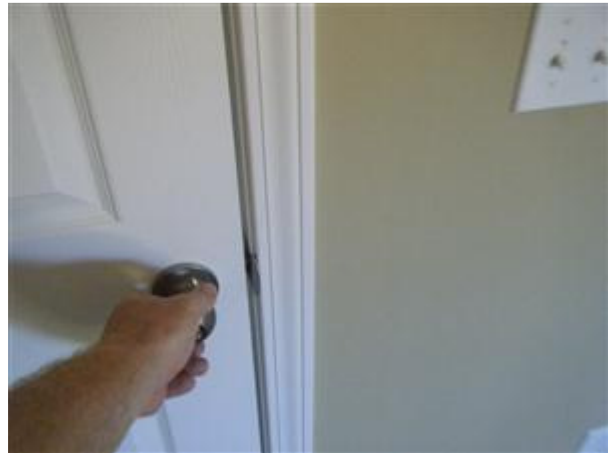
Observed that the door latch for the rear left side bedroom ( rear the steps) is not aligned right. Recommend notifying the builder so repairs can be made.

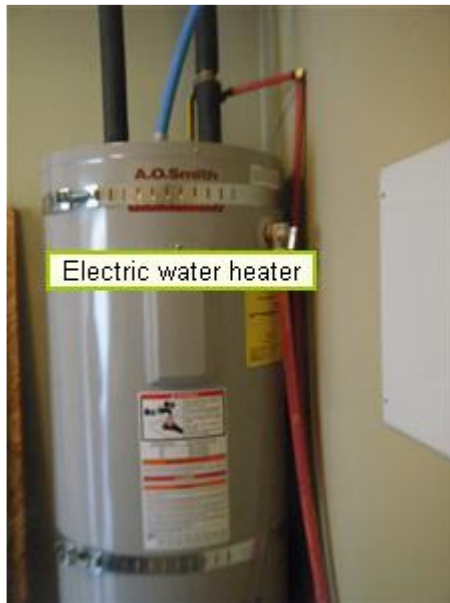
Electric water heater

Observed that the electric water heater is estimated to be 1 year old. For your reference, the average hot water heater can generally last up to 12 years and possibly longer.

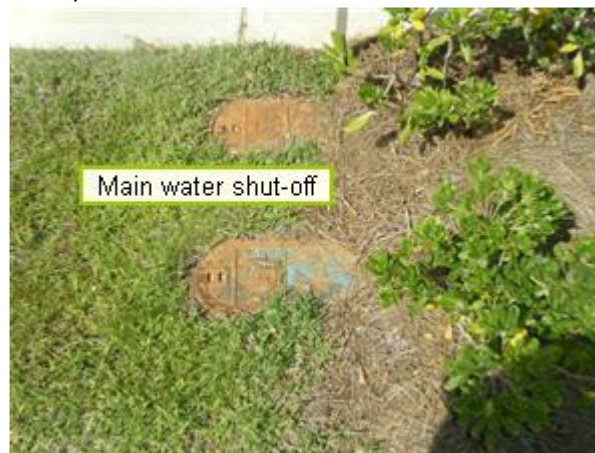
Main water shut-off

Observed that the main water shut-off is located in the front yard at the meter. If you need to do any plumbing work in the house, or if one of your pipes breaks, you'll need to know where to shut-off the water so repairs can be made.

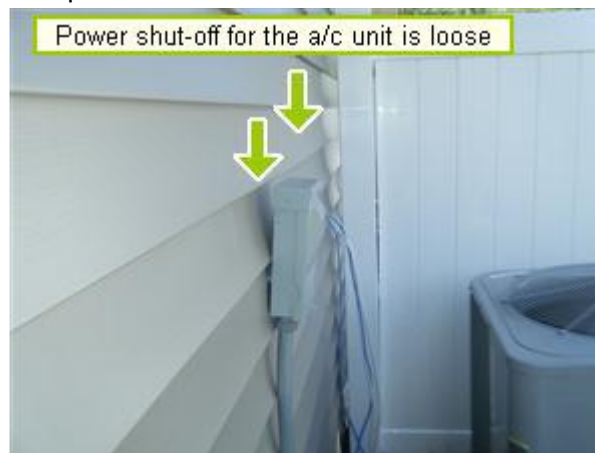
Observed that the power shut-off for the outdoor a/c compressor is loose. Recommend notifying the builder so repairs can be made.

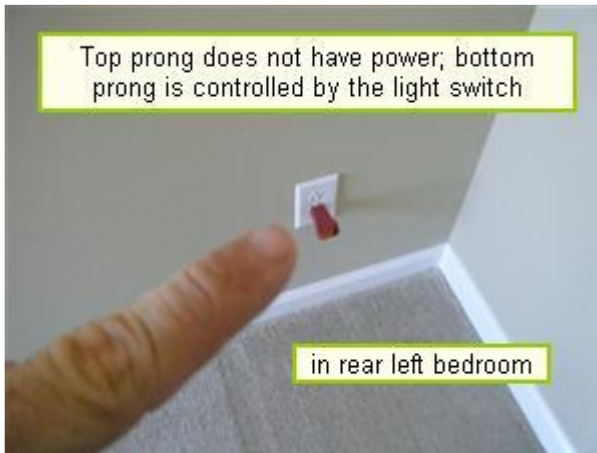
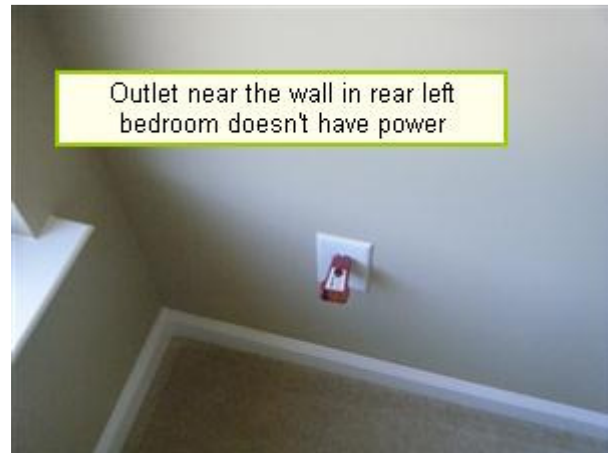
(1) Observed that the upside down outlet in the rear left bedroom has an outlet where the top has no power, the bottom is controlled by a switch and is powered. Also, the outlet near the wall is also without power. Recommend notifying the builder so repairs can be made.

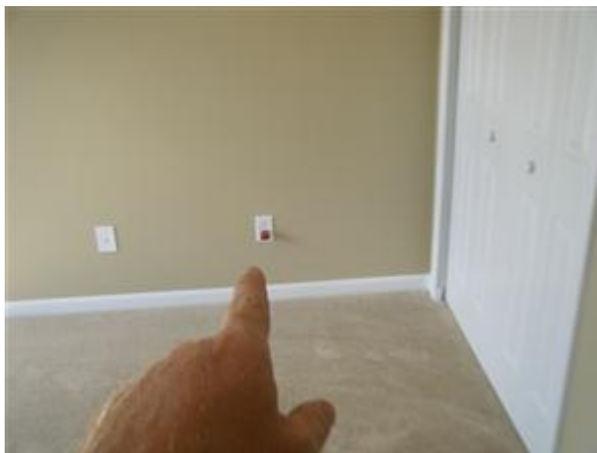
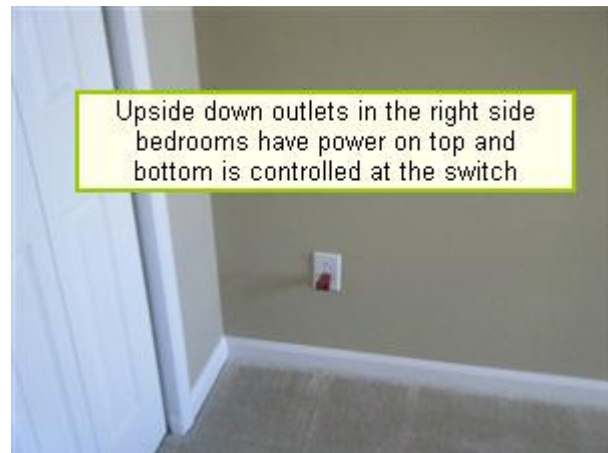
(2) Observed that the two right side bedrooms have upside down outlets which are installed upside down. In this case, the continuous power is on top prong and the bottom prong is controlled by a switch. This should be reversed. Recommend notifying the builder so repairs can be made.
