Property Address: 1804 South Broad Street
Hamilton NJ 08610
Municipality: Hamilton
County: Mercer
Purpose: Evaluation of Collapse

Structural Evaluation
For
Cause Of Collapse
Of Single-Family House
July 23, 2018

1804 South Broad Street
Hamilton NJ

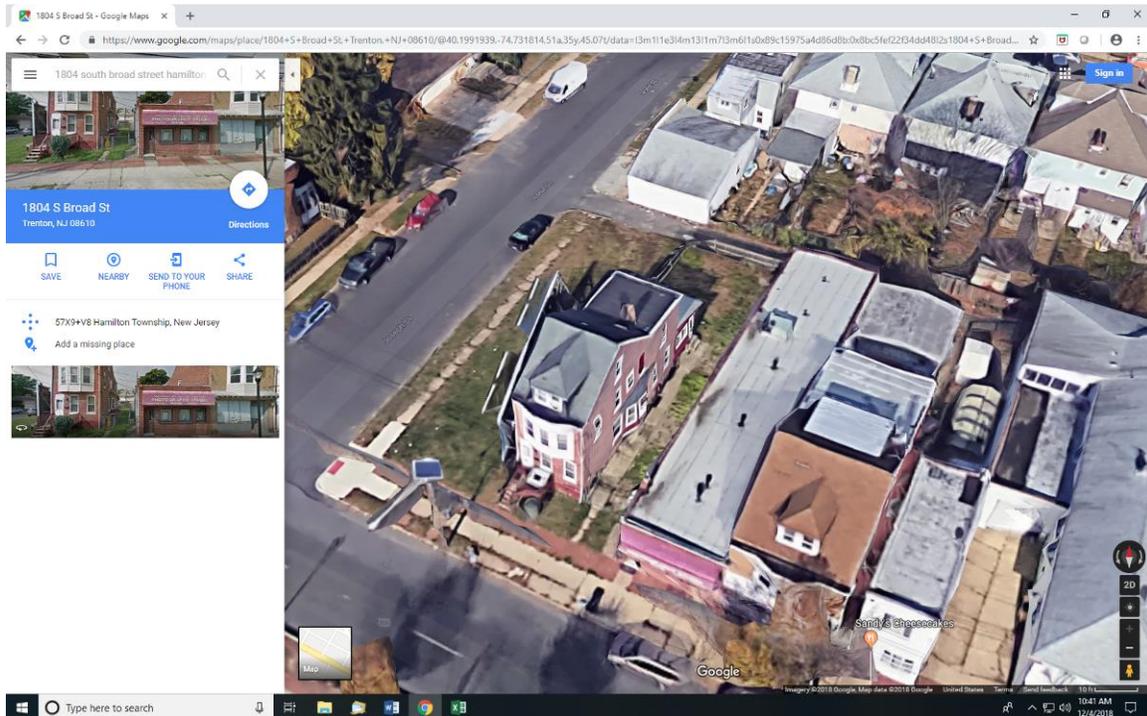
Photo 2 – Google Maps

Aerial view showing front and right side of house, on corner property; June 2018.
Front wall faces South Broad Street.

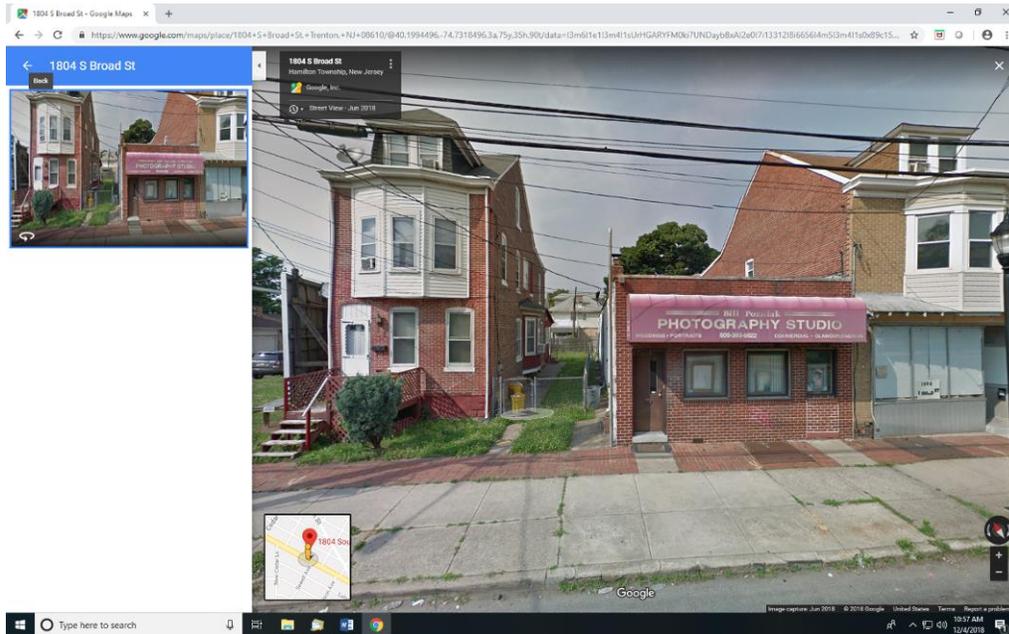
Photo 3 – Google Maps
Front and right side of house; June 2018.

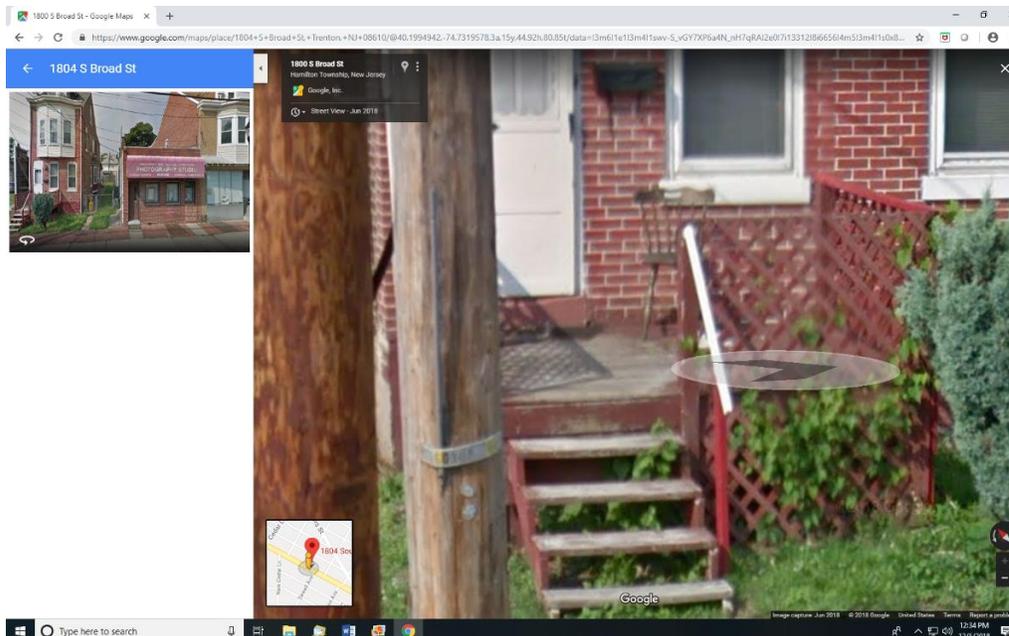
Photo 3A – Google Maps
Wood-framed porch deck outside front door; June 2018.
Surface of porch deck is about 7 inches below first floor.

Considering that first floor was about 7 inches above top of block foundation wall (Photos 3A, 3B), ends of first floor joists (reported as 9-5/8 inches deep by Mr. Busch) were likely supported directly on top of block foundation wall (perhaps with notch at end of joist), without wood sill plate, and were effectively embedded within base of brick wall. Hollow cores of top course of block foundation wall may have been filled solid with grout or concrete.

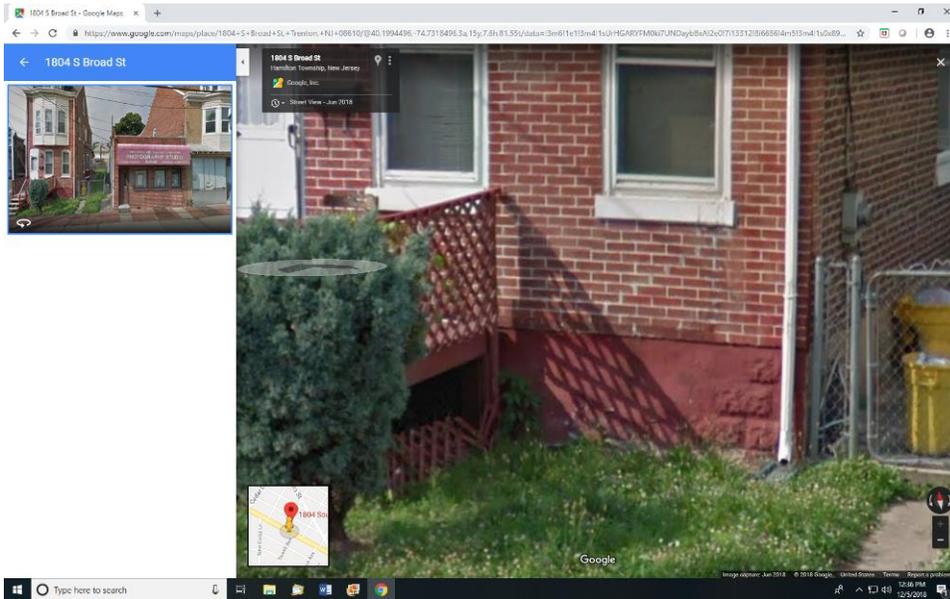
Photo 3B – Google Maps

Brick wall on block foundation wall; June 2018.

Surface of porch deck is flush with top of block foundation wall.

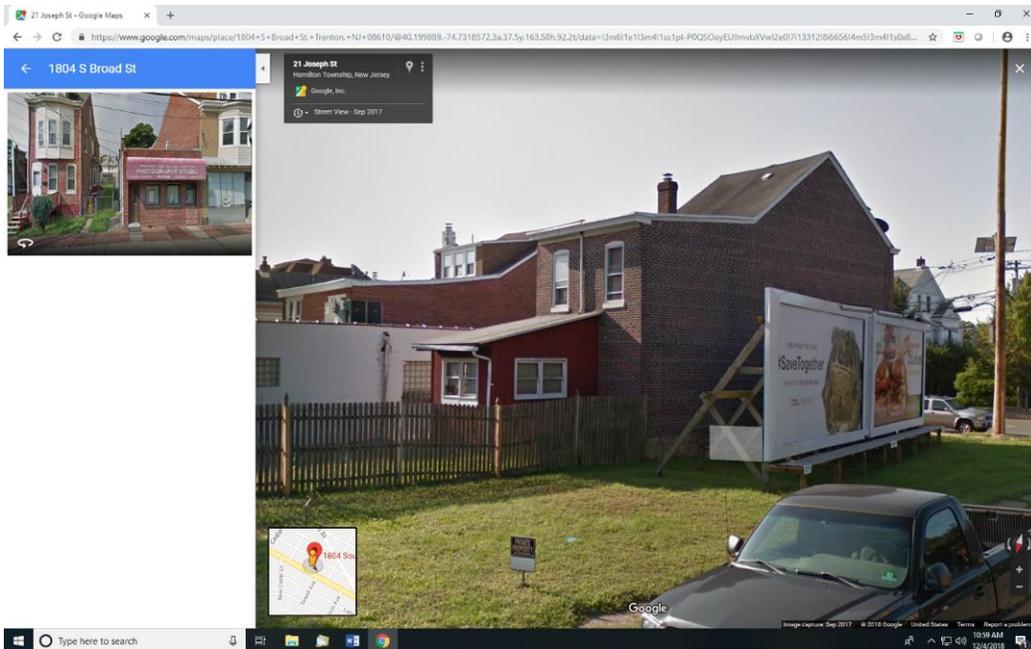
Photo 4 – Google Maps

Back and left side of house.

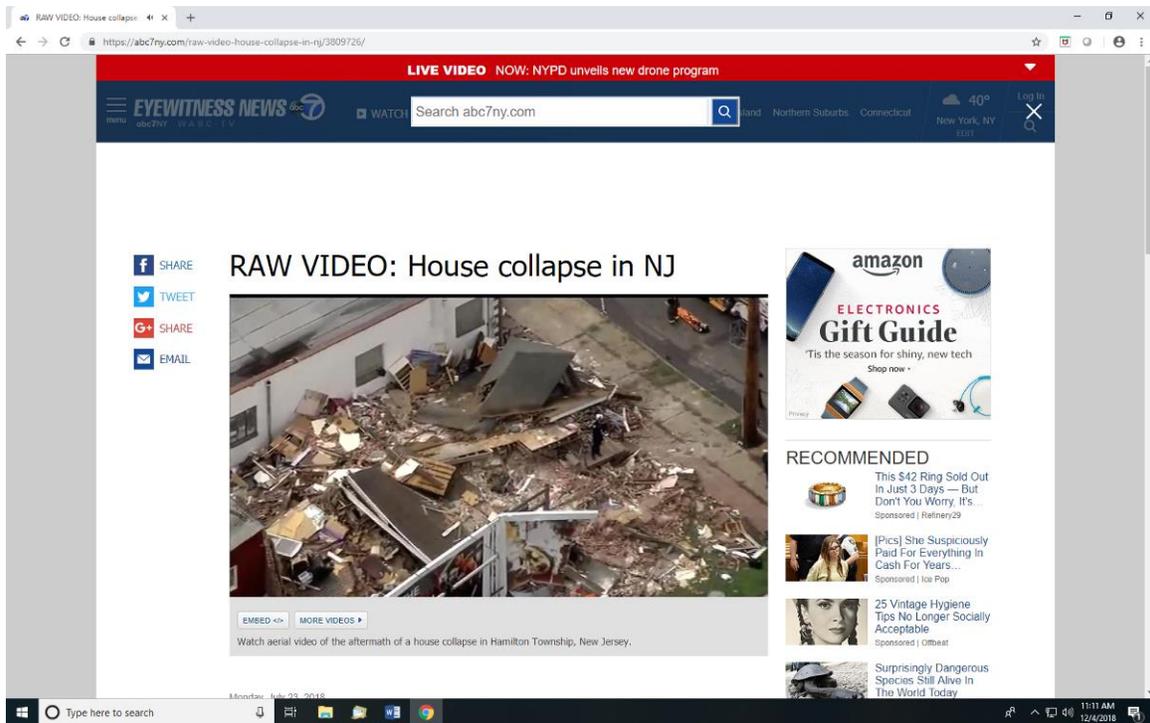
Photo 101 – ABC 7 New York
Aerial view of collapsed house, July 23, 2018

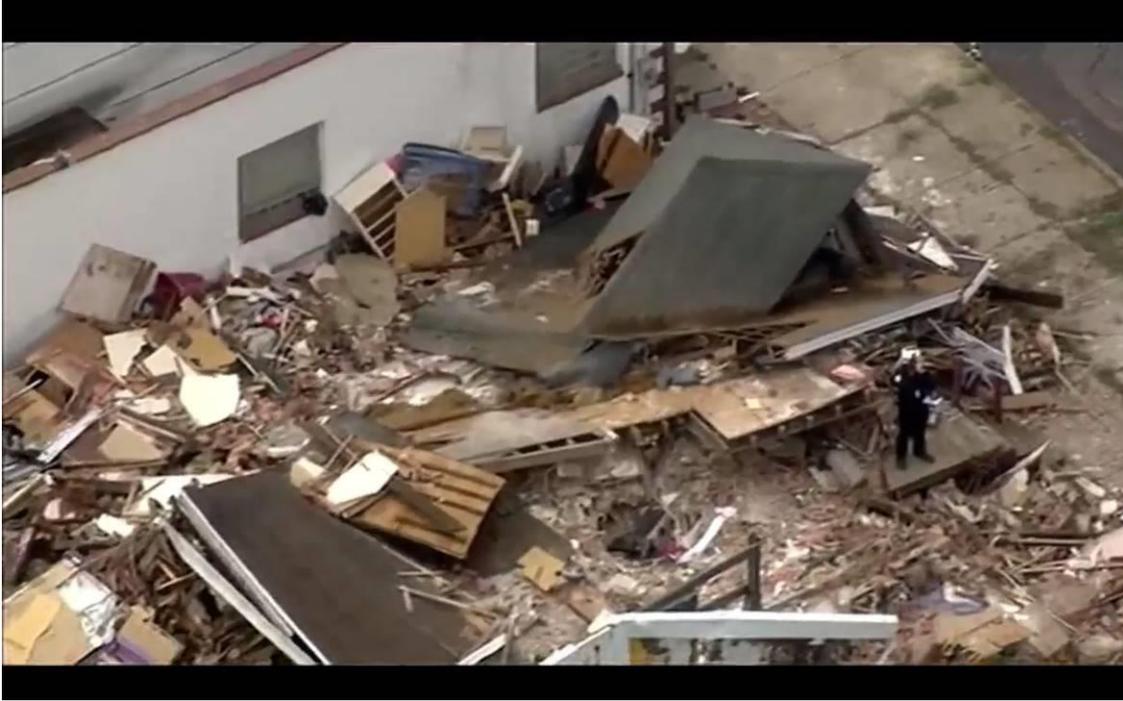
Photo 101A – ABC 7 New York

Front part of collapsed house.

Attic floor joists appear to have spanned side-to-side across width of house.

Former back slope of gable roof is not seen and may have been moved during rescue operations. However, see discussion for Photo 102C.

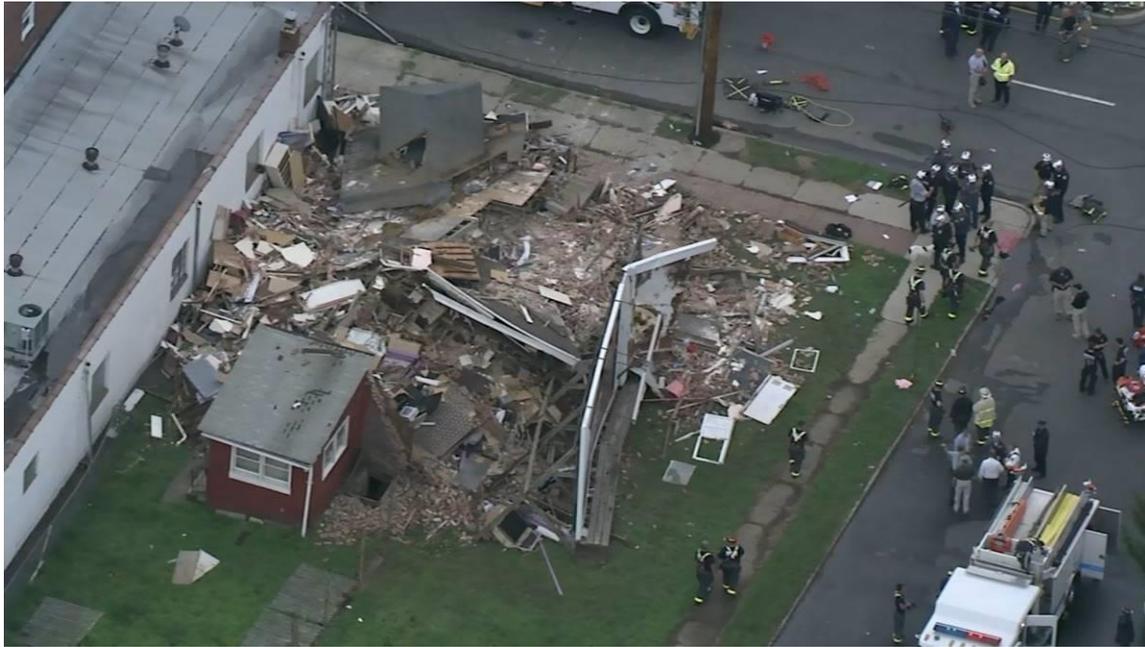
Photo 102 – ABC 7 New York

Aerial view of collapsed house, looking towards South Broad Street.
One-story Section 2 that had been behind two-story Section 1 remains standing.

Front part of former large sign (billboard) has been destroyed, apparently by left-side brick wall falling outward.

Opening for access into basement seen adjacent to left side of one-story section (to right of one-story section in photo); see Photo 102C. In other videos, steel hatch door are seen in closed position over this opening.

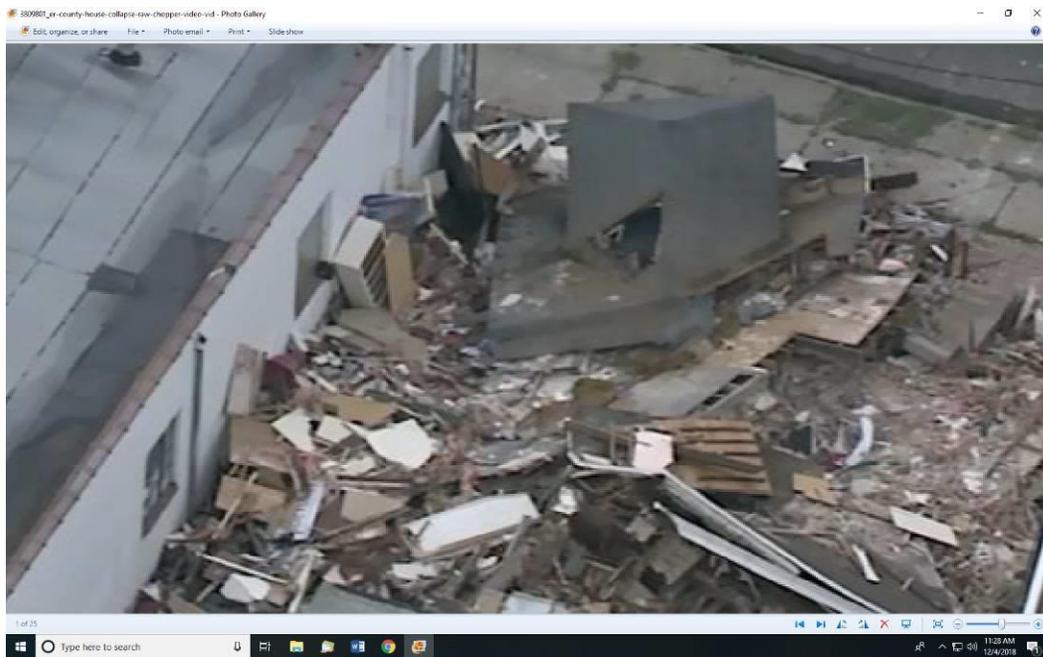
Photo 102A

Closeup (zoomed in) of Photo 102 showing front of collapsed house.
Opening in dormer roof was made by rescue persons, as seen in other videos.

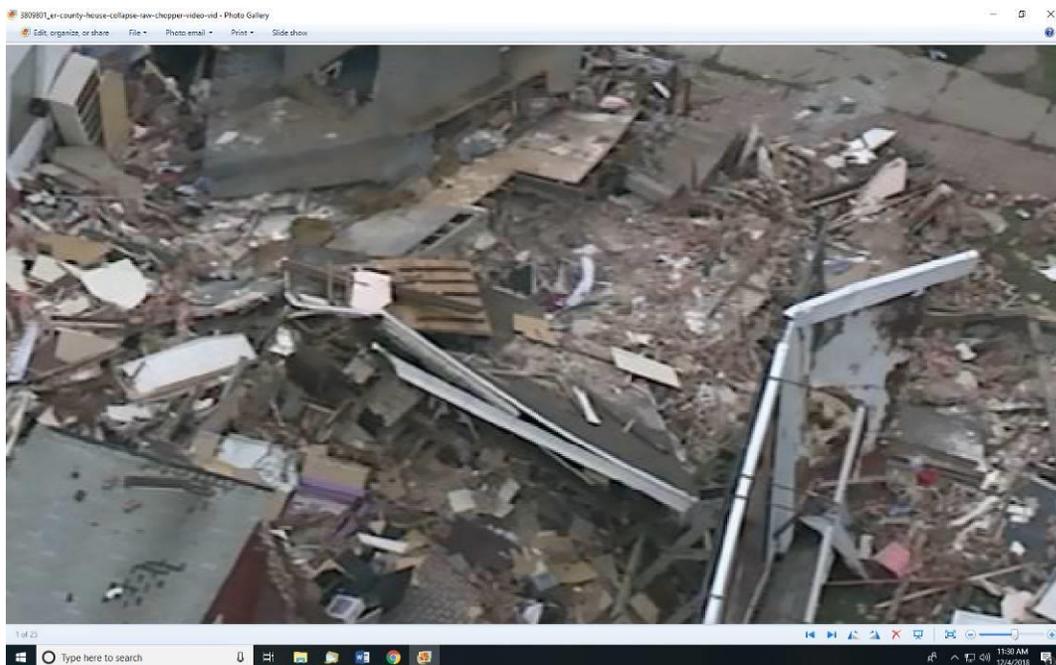
Photo 102B

Closeup (zoomed in) of Photo 102 showing center of collapsed house.

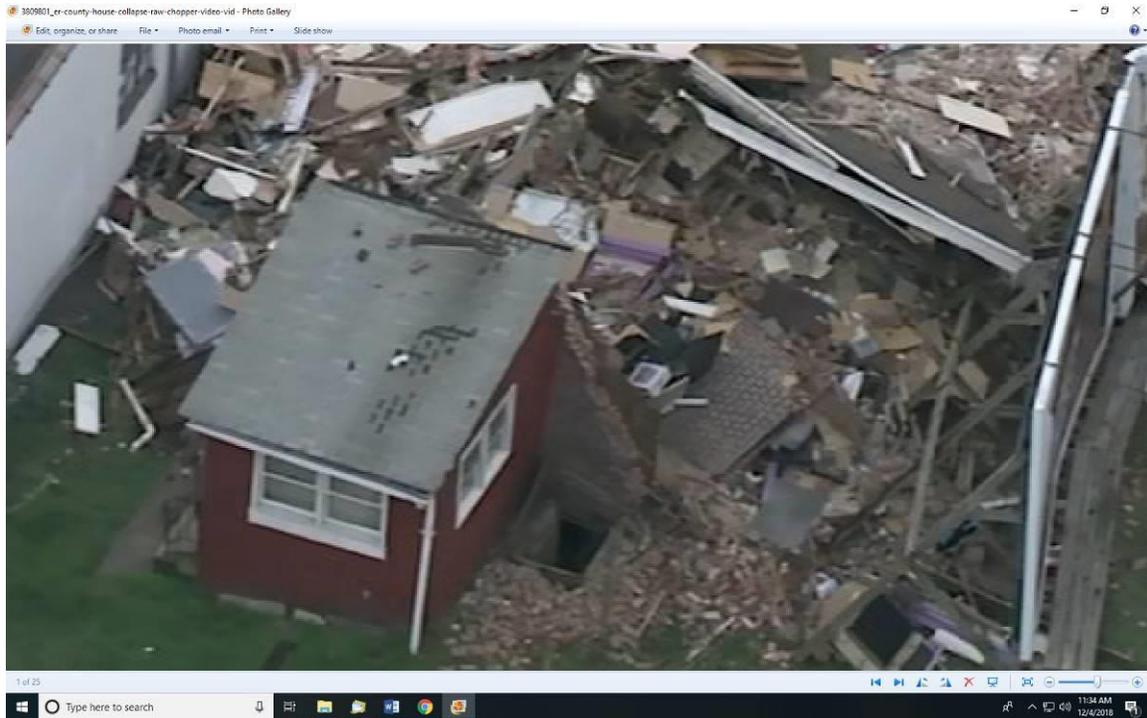
Photo 102C

Closeup (zoomed in) of Photo 102 showing back of collapsed two-story Section 1 and one-story Section 2 remaining.

Part of brick wall at back of Section 1 remains against and adjacent to front of Section 2.

Rectangular panel at center of photo, with apparent shingles, appears to be part of former back slope of gable roof. This panel may have been moved during rescue operations from position just after collapse. However, it might also be in this position due to sudden lateral movement (towards back of house) of back slope of gable roof.

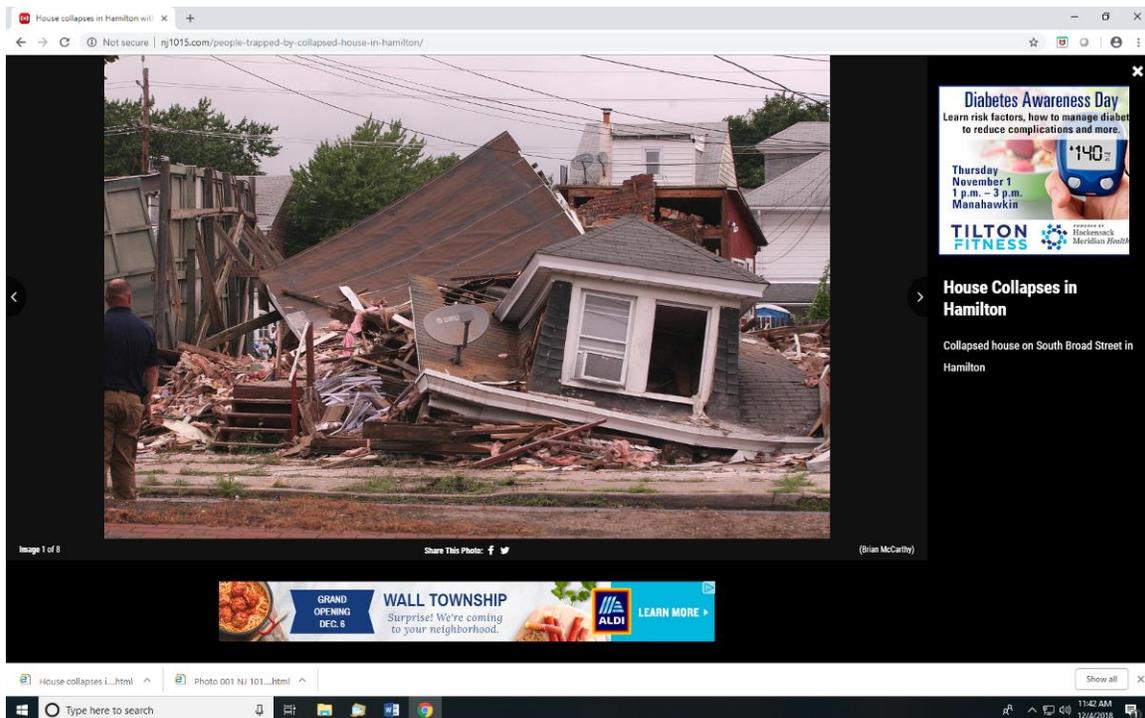
Photo 103 – NJ1015.com

Front view of collapsed house.

Foreground – Dormer on front slope of former gable roof.

Background, center of photo - Monoslope roof (with roll-roofing) that had been over back part of two-story Section 1, with former back right corner up high.

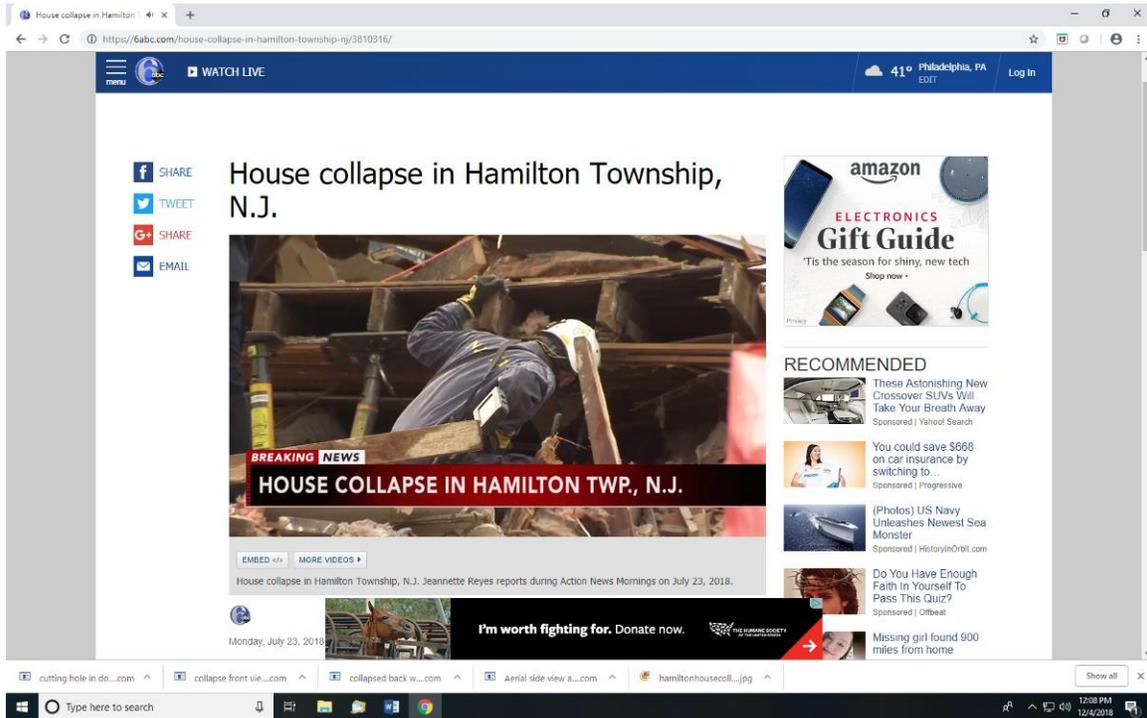
Photo 104 – ABC 6 Philadelphia

Ends of floor joists, which appear to be former attic floor joists.

Jacks to left of rescue person used to lift floor platform during rescue operations.

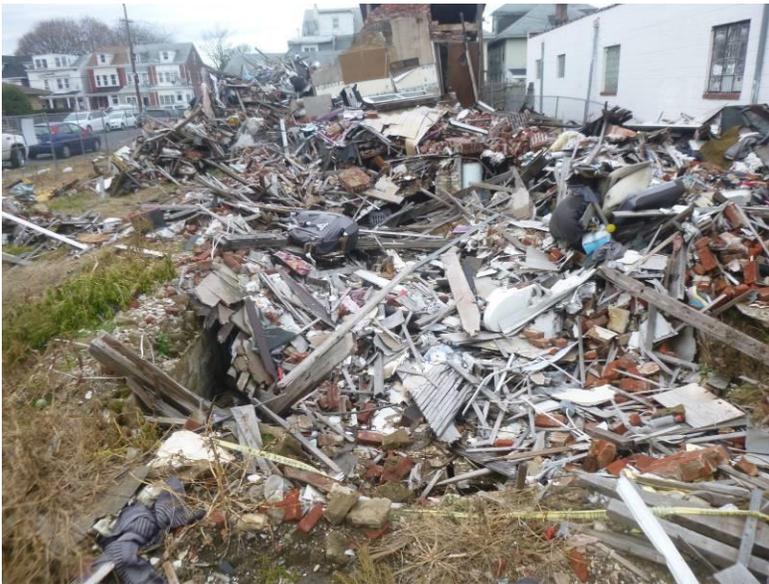
Photo 202

Front of collapsed house.
First floor collapsed into basement.

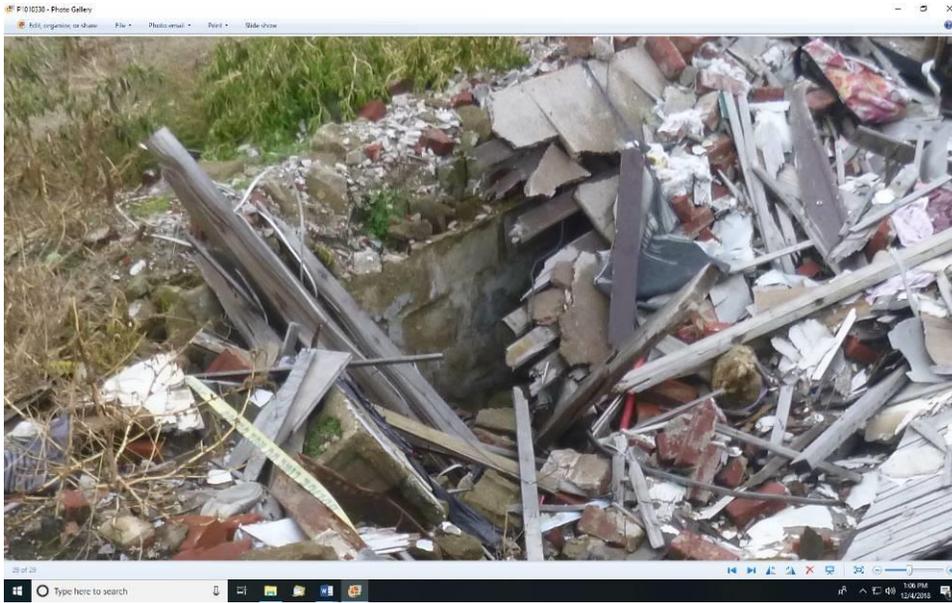
Photo 203

Remaining block at front end of left-side foundation wall.
Original courses of block that had been above grade are missing.
Gray patching mortar on inside face of block.

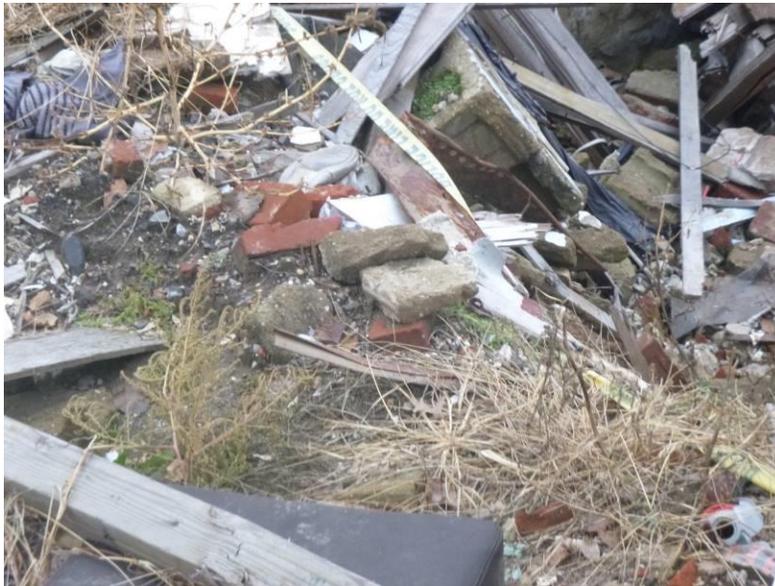
Photo 204

Top of photo – Concrete block, along top of remainder of front foundation wall, tilted outward. Block is otherwise in good condition.
This block is also seen in Photo 203.

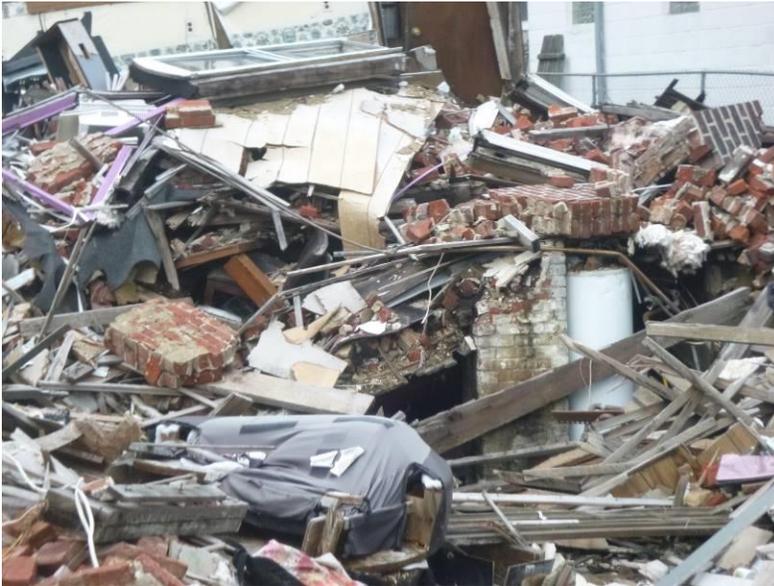
Photo 205

Center of photo – Remainder of brick chimney (in former basement) and water heater (white, to right of chimney).

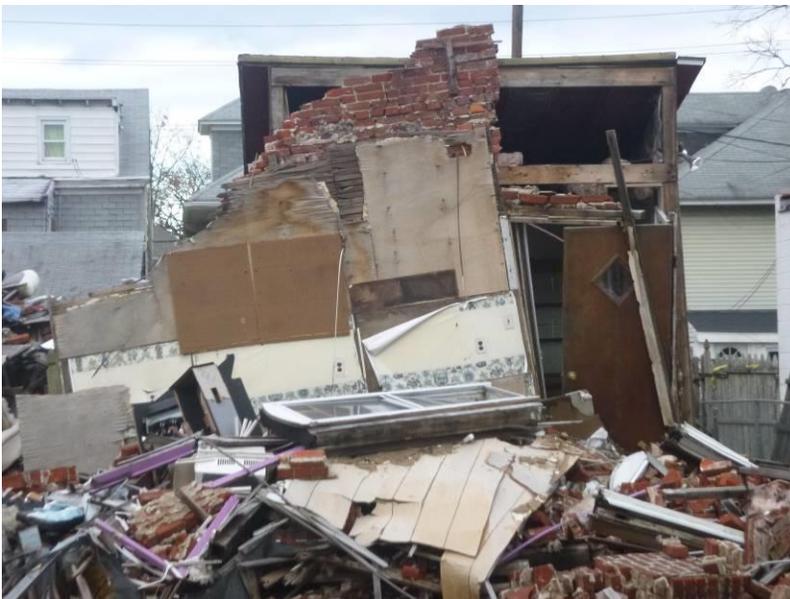
Photo 206

Reminder of brick back wall against front of one-story Section 2.
