# A. T. DESIGNS, INC.

CIVIL / STRUCTURAL ENGINEERING AND PROJECT MANAGEMENT SERVICES

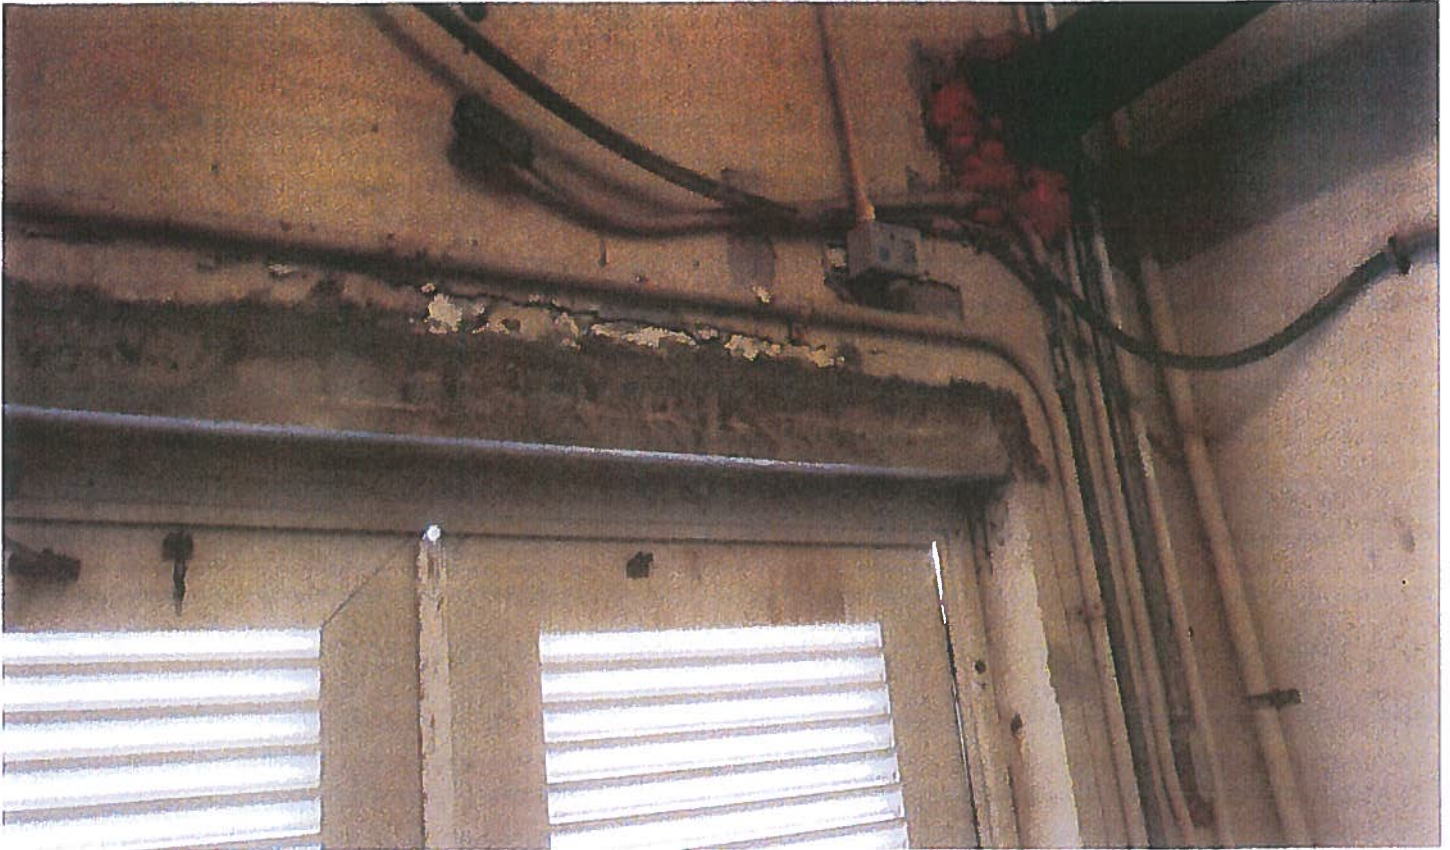
Photo 1: Cracking and spalling of the concrete header of the ground floor equipment room.

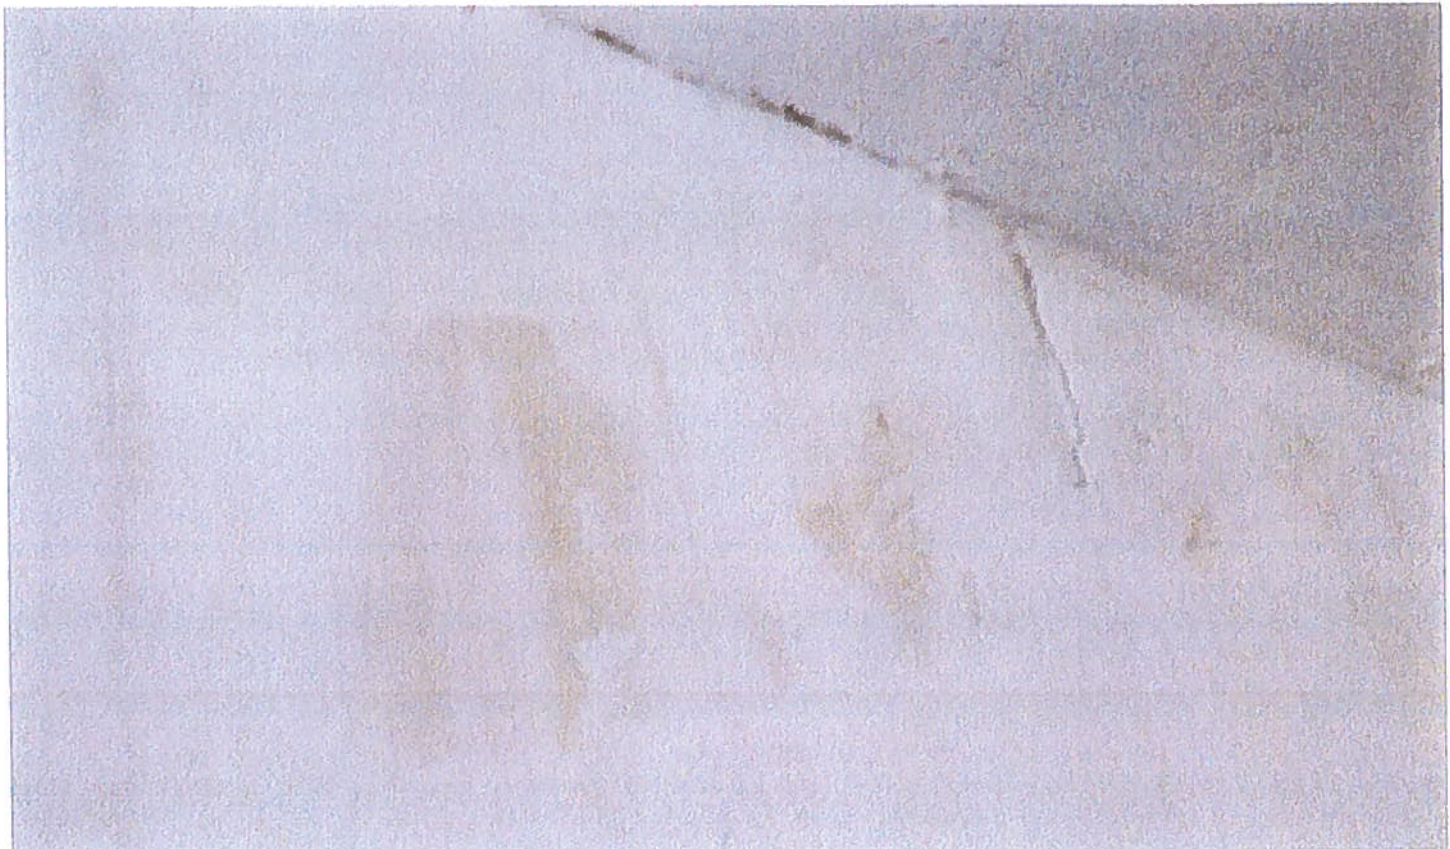
Photo 2: Apparent moisture staining on the perimeter wall of the stairwell.

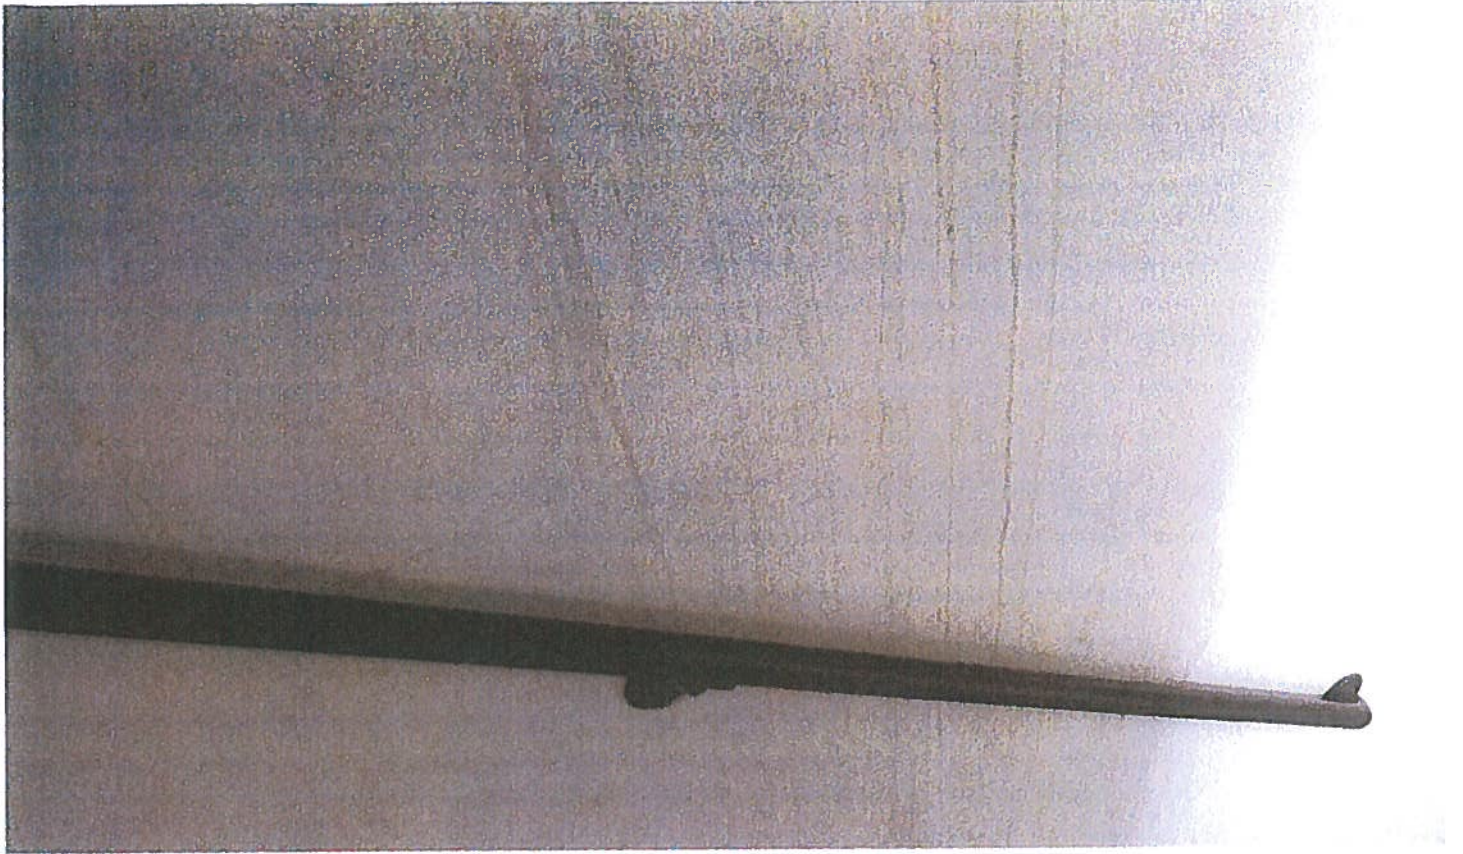
Photo 3: Apparent moisture staining on the perimeter wall of the stairwell.

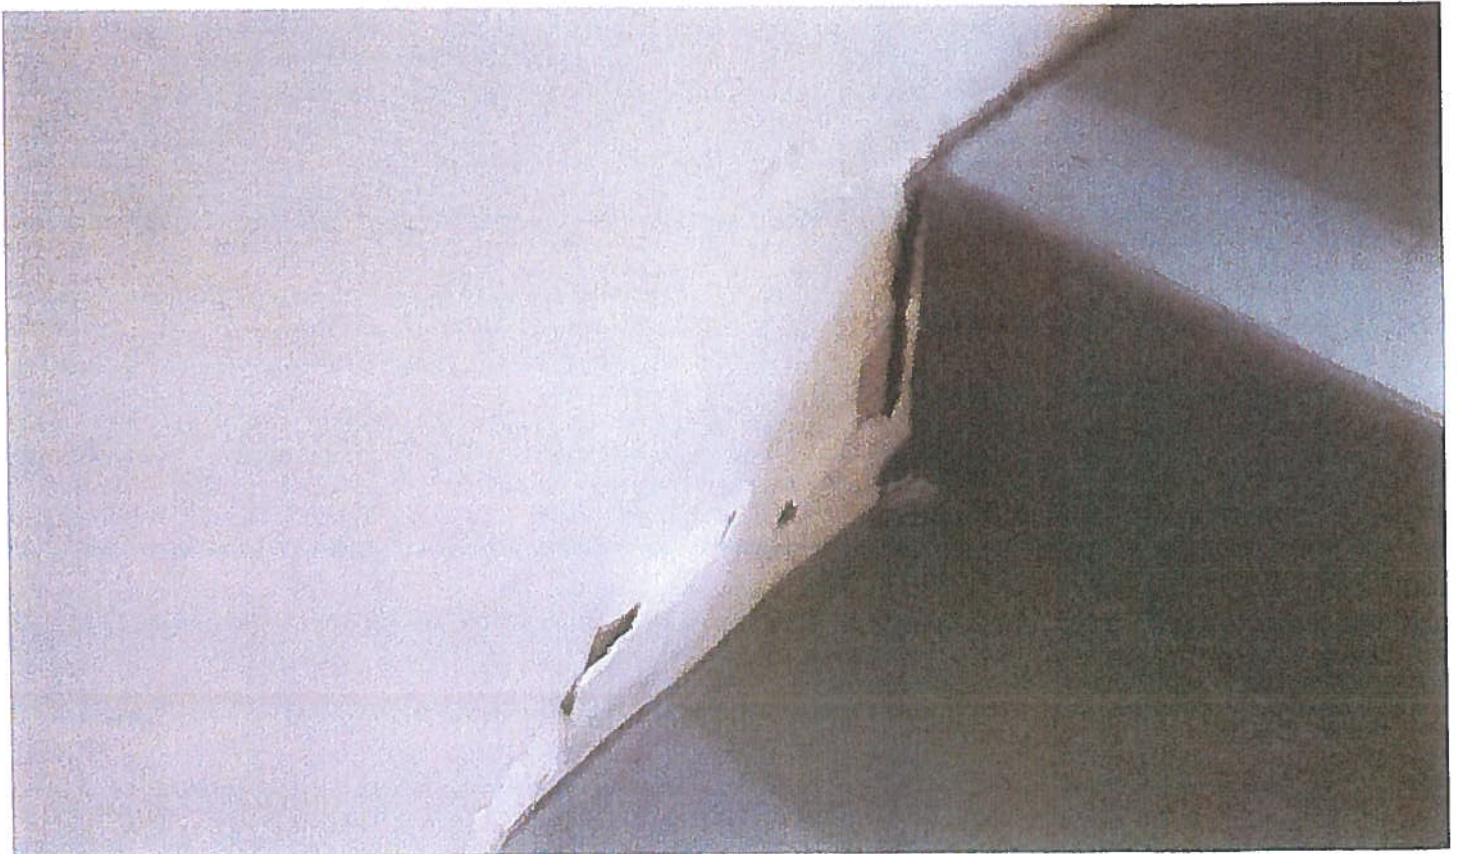
Photo 4: Cracking and slight displacement of the stairs adjacent to the masonry wall.

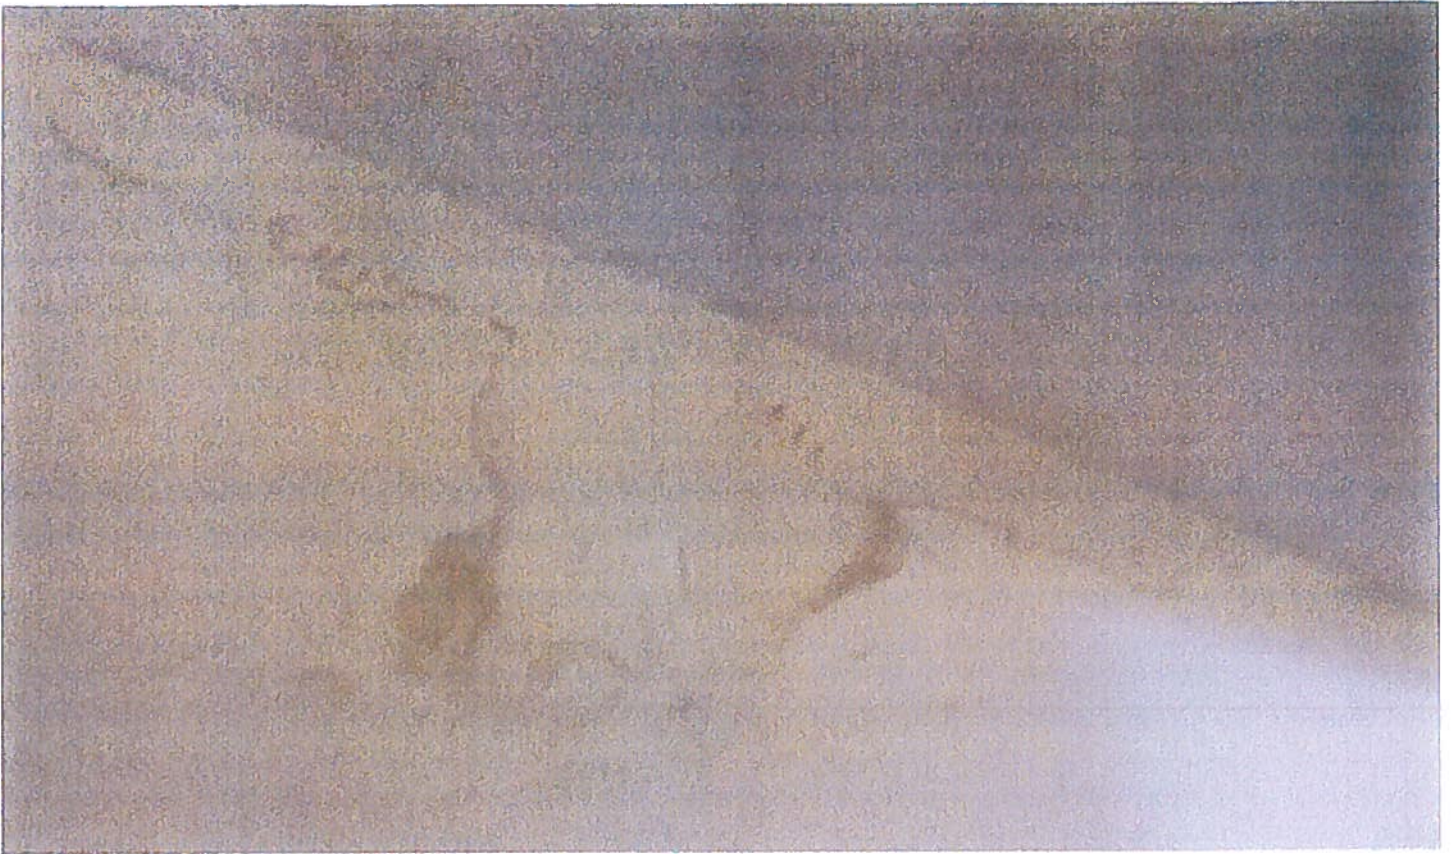
Photo 5: Apparent moisture staining on the perimeter wall of the stairwell.

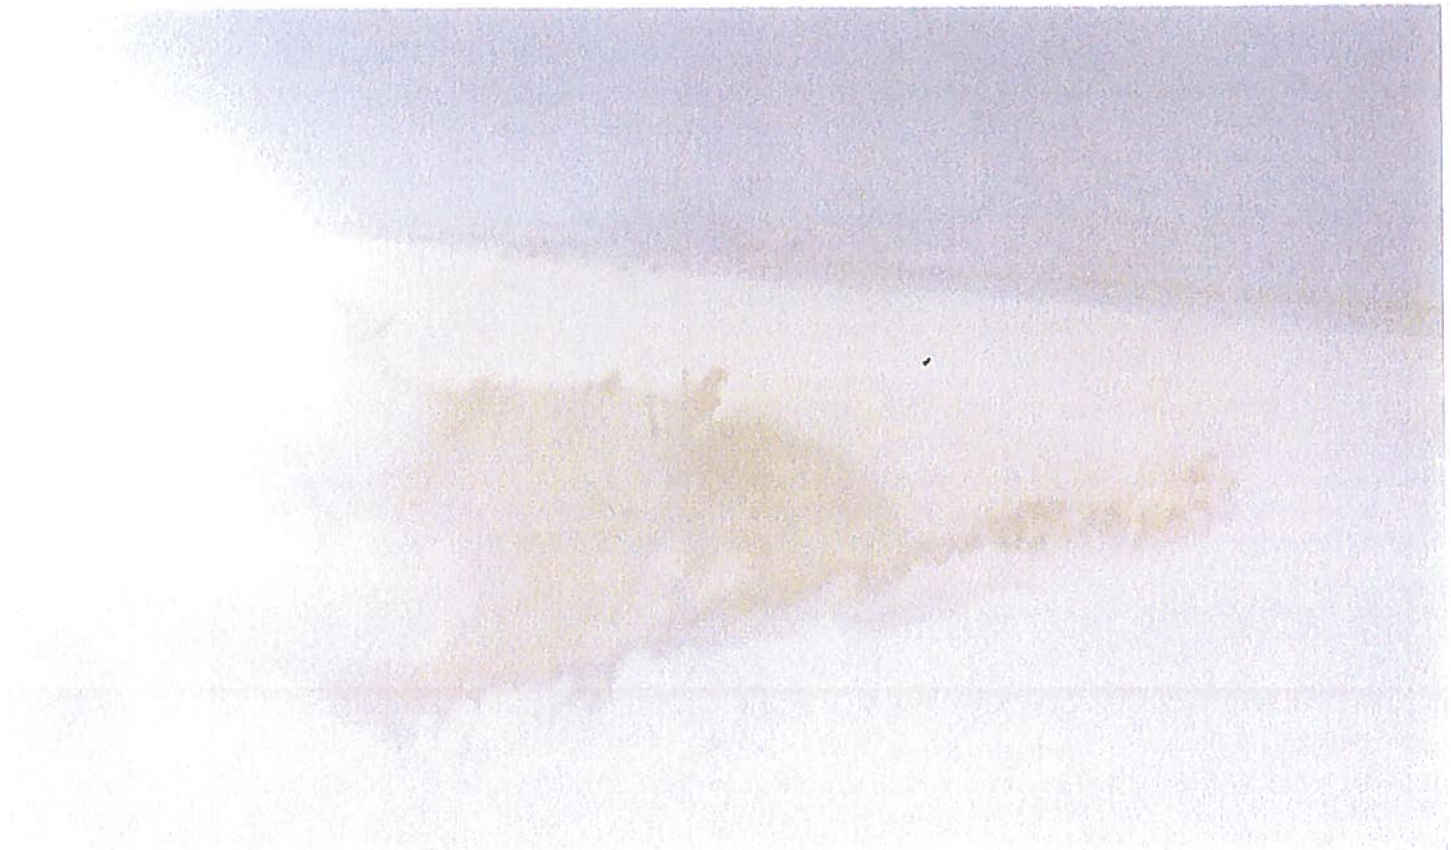
Photo 6: Apparent moisture staining on the perimeter wall of the stairwell.
