Water Glades T300

Riviera Beach, FL • November 30, 2022

Water Glades T300 Riviera Beach, Florida

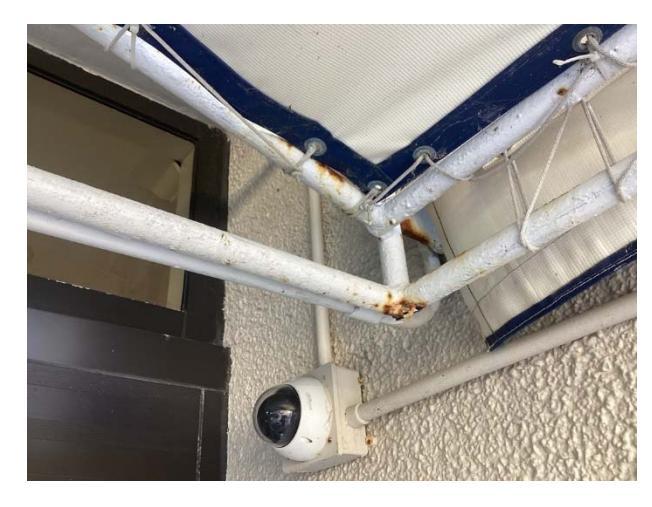
Frame rust at entrance awning

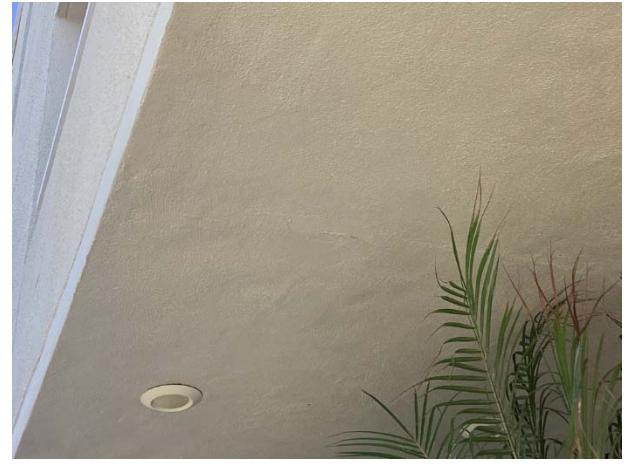
Previous repair under second floor balcony

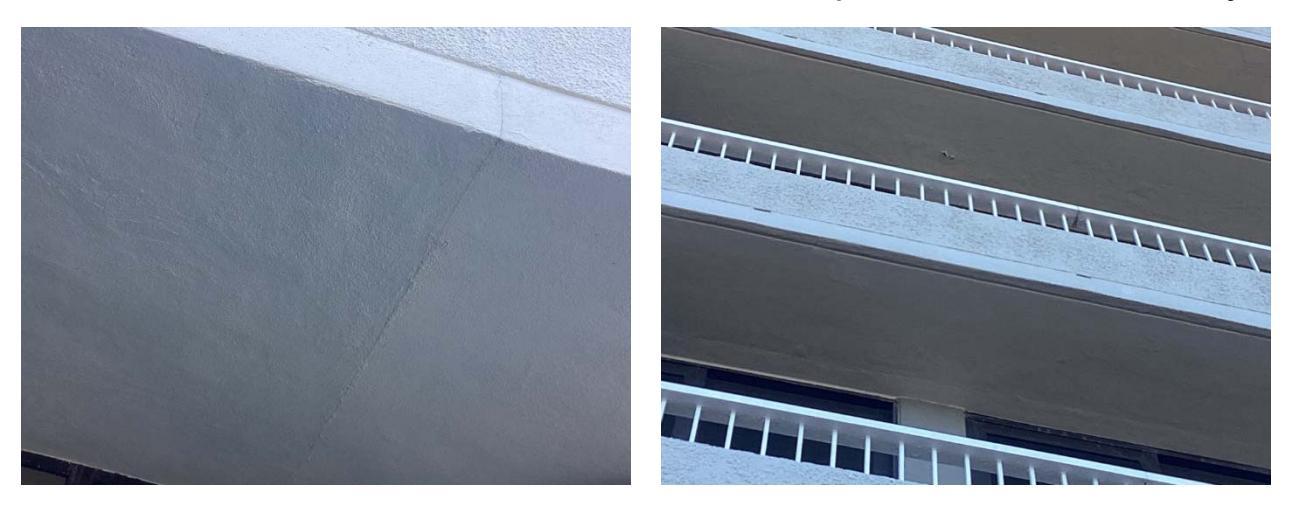
Crack with rust stain below second floor balcony Signs of water intrusion under balconies at floors four and five

- Partial depth replacement of less than one percent (<1%) of the concrete topsides, edges and undersides
- Crack repairs as necessary
- Repairs to the railings as necessary
- Replacement of perimeter sealants as needed
- Application of a waterproof coating (Urethane based elastomeric)

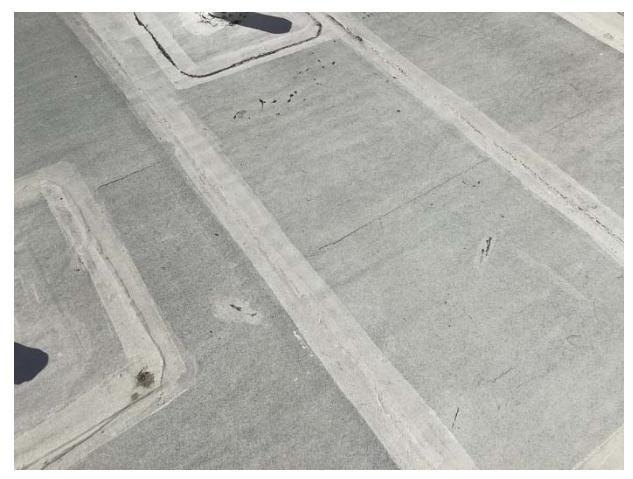
Condition: Fair overall with periodic evidence of standing water, bulges in the coating and patches evident. Management does not report history of leaks

Cracks in coating

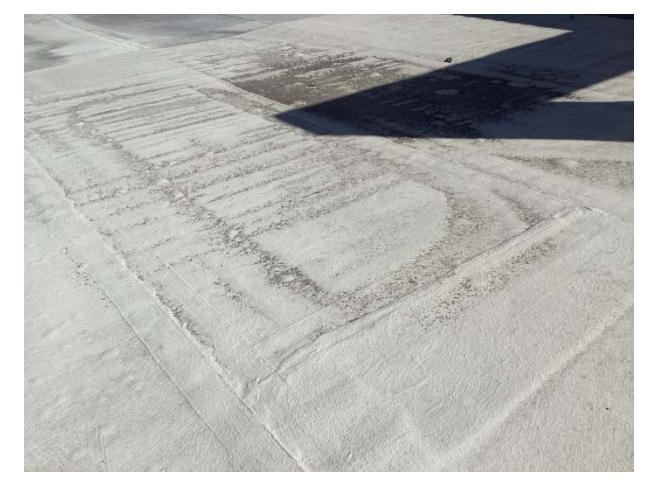
Bulges in coating

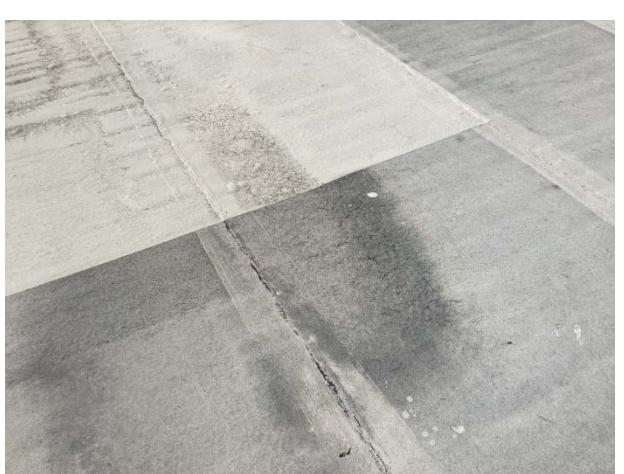
Cracks, bulges and previous repairs

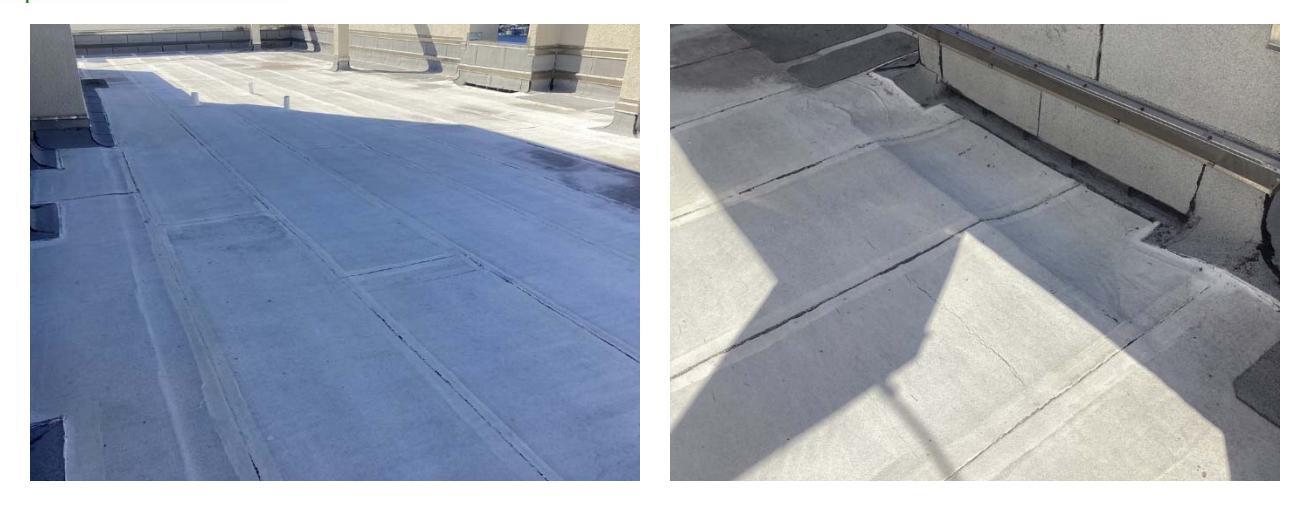
Coating cracks

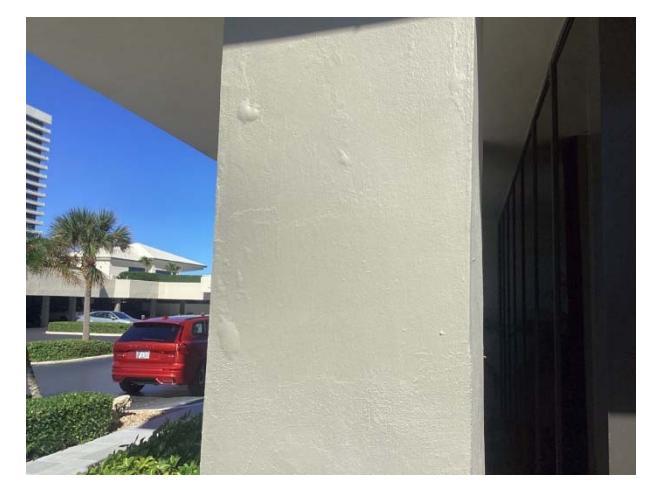
Condition: Fair overall with isolated bulges, cracks, previous repairs and rust evident.

Paint bulges at first floor column

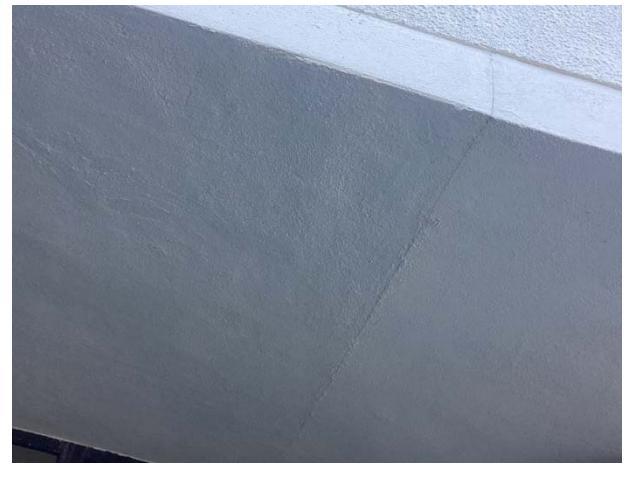
Stucco crack with minor rust stain below second floor balcony

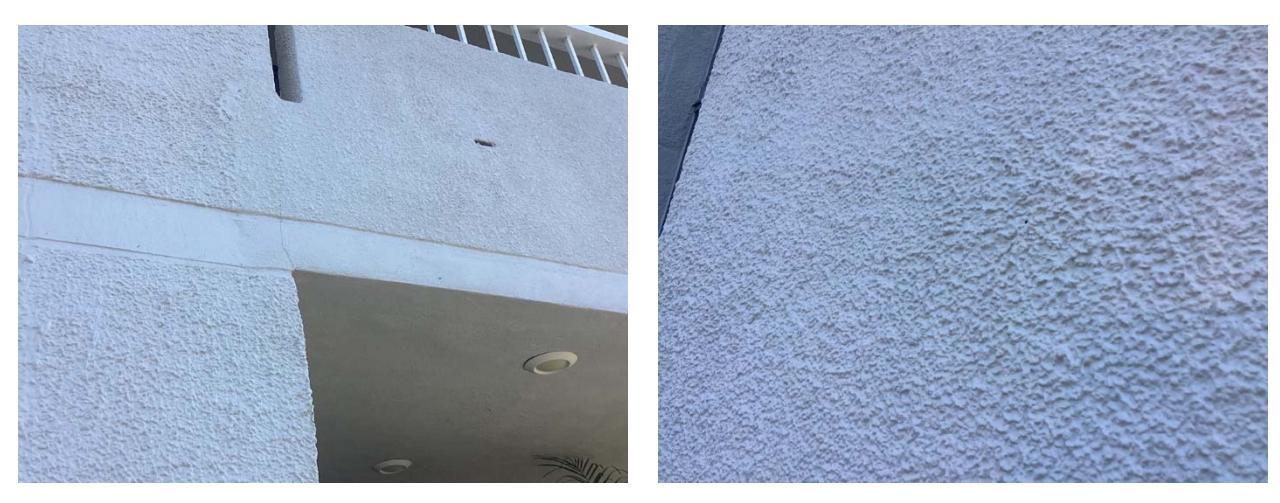
Stucco crack

Small hole in stucco

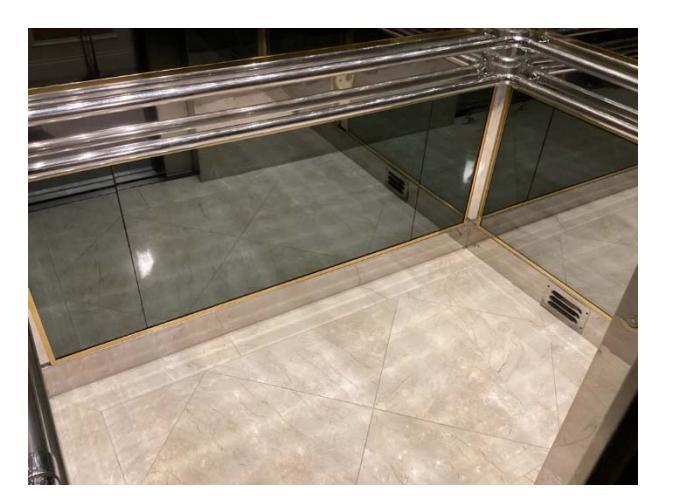
Condition: Unsatisfactory overall

Elevator cab finishes

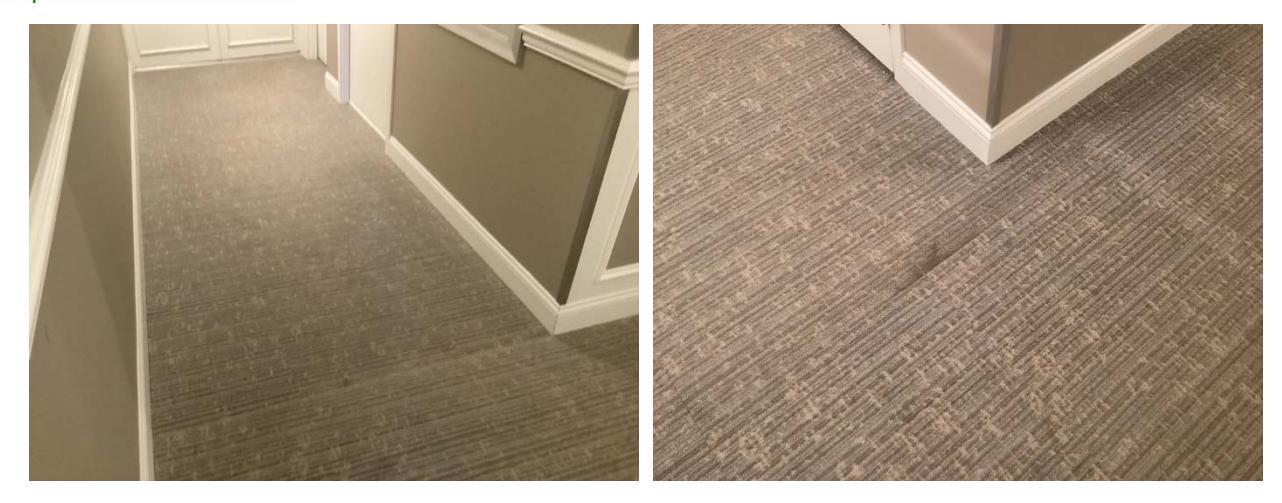
Carpet stain at floor 12

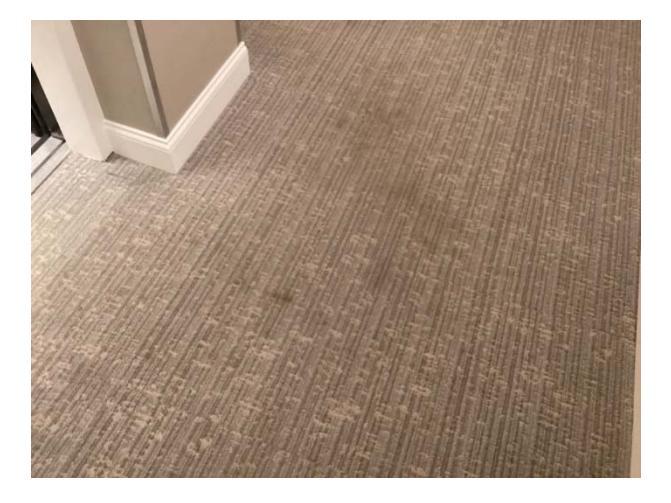
Carpet stains at floor 26

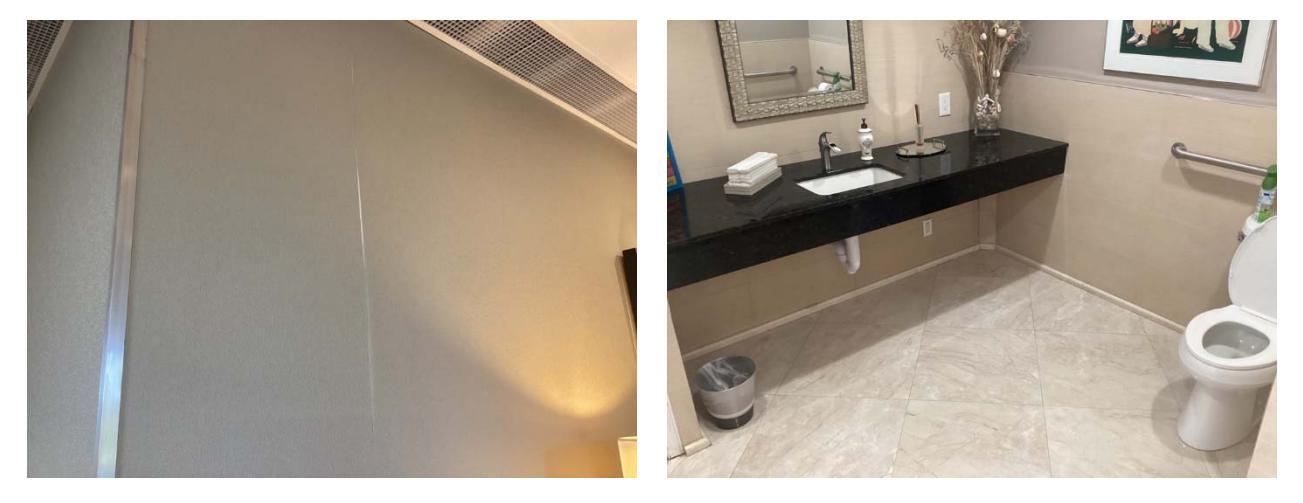
Wall covering separation at lobby

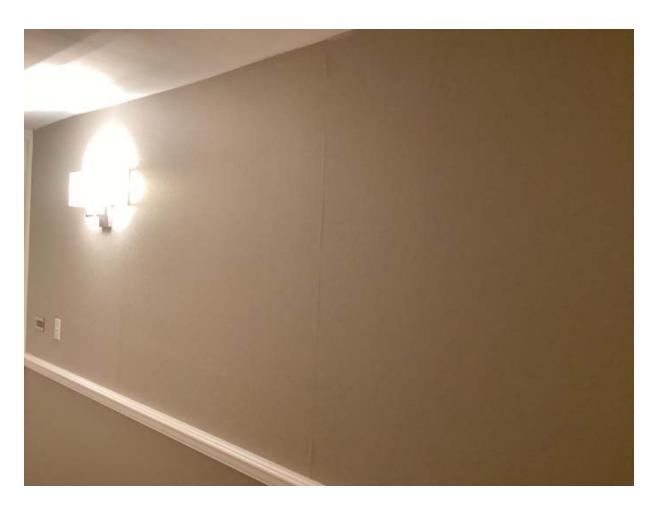
Condition: Fair overall with isolated peeling seams evident.

Peeling seem at floor 12

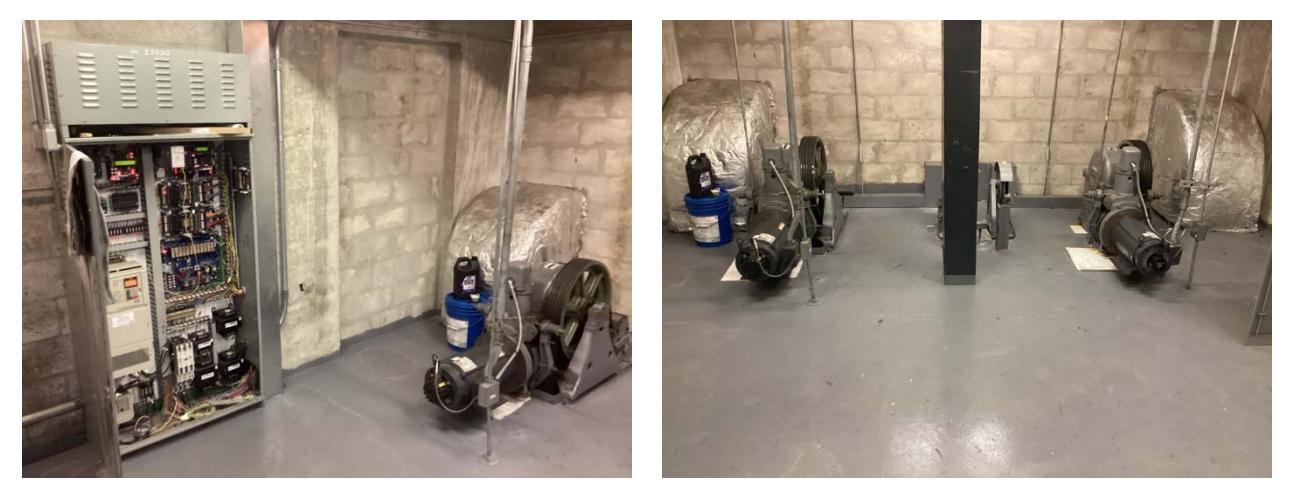
Condition: Reported unsatisfactory

Traction elevator equipment

Traction elevator hoists and motors

History: The elevators are planned to be replaced in 2023. The cost of the replacements is accounted for in the projected year-end reserve balance.

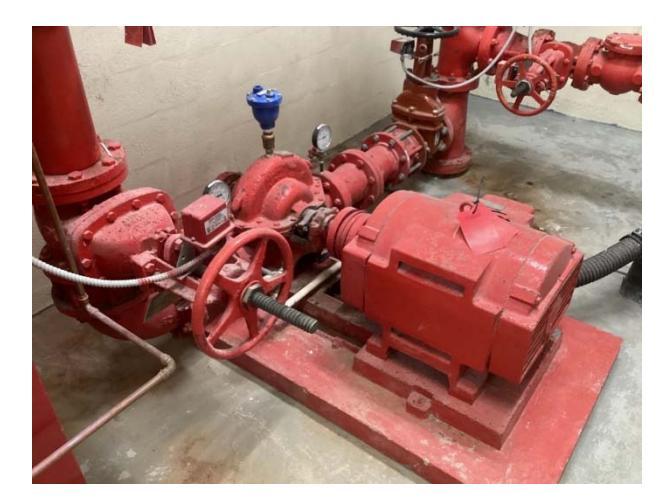
Condition: Reported unsatisfactory with operational deficiencies.

Fire suppression pump Useful Life: Up to 50 years

History: Original; The Association plans to replace the fire suppression pump in the near term.

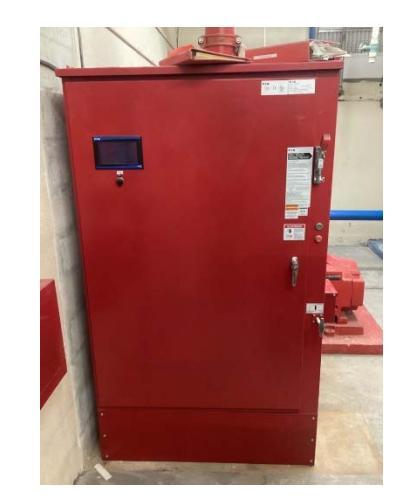
Fire suppression pump controls
