# Inspection Report

## Quakertown Fire Company

**Property Address:**  
2 Perryville Rd  
Union Twp NJ 08867

<b>Date:</b> 12/19/2015	<b>Time:</b> 10:00 AM	<b>Report ID:</b>
<b>Property:</b> 2 Perryville Rd Union Twp NJ 08867	<b>Customer:</b> Quakertown Fire Company	<b>Real Estate Professional:</b> Joanne Schwartz Weidel

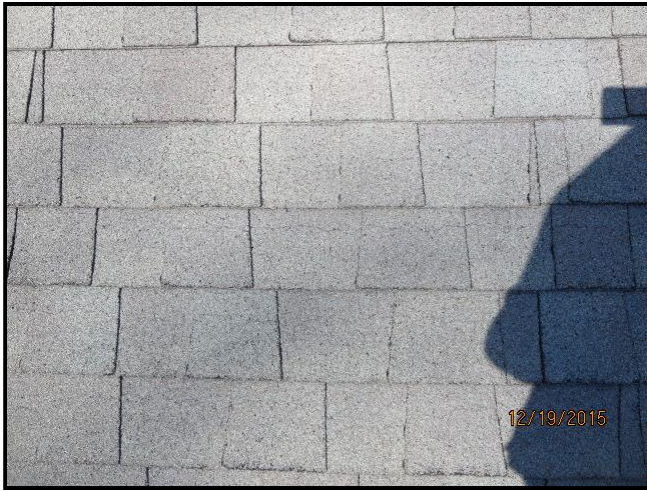
1.0 Item 1(Picture) Cracks

The roof covering is damaged cracks lifts and buckling at the "entire roof". This does not appear adequate. It should be properly repaired or replaced. A qualified roofing contractor should inspect and repair as needed.

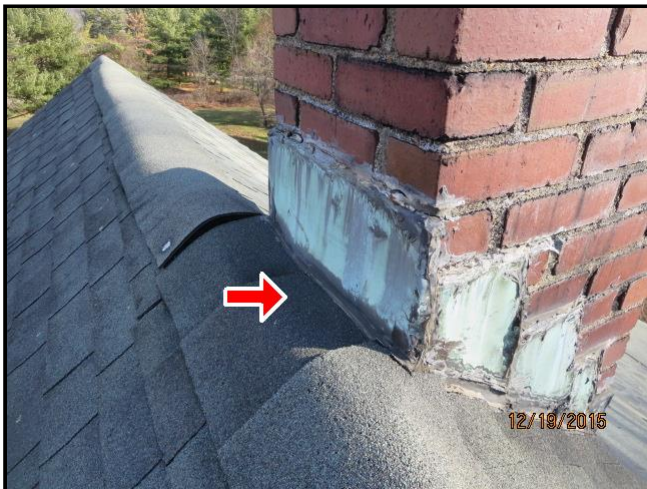
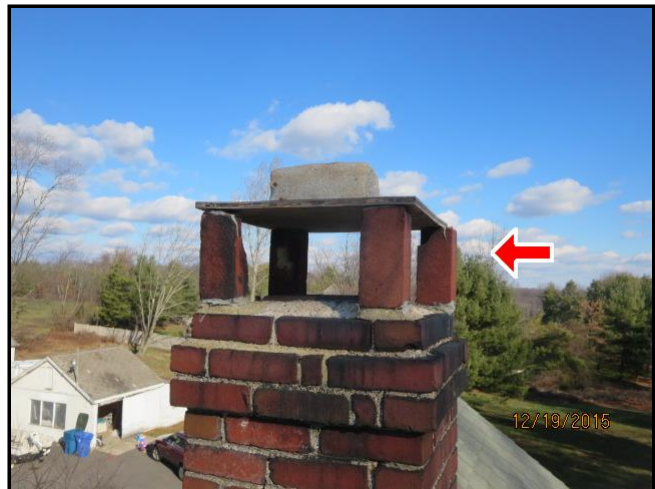
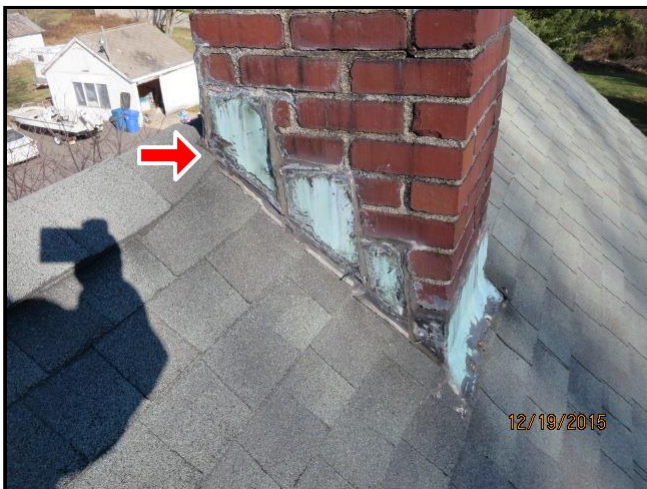
Flashing around chimney is deteriorated and needs sealant. Deteriorated flashing can lead to water intrusion. The chimney is also missing mortar and needs re-pointing. Recommend a chimney specialist further evaluate and repair.

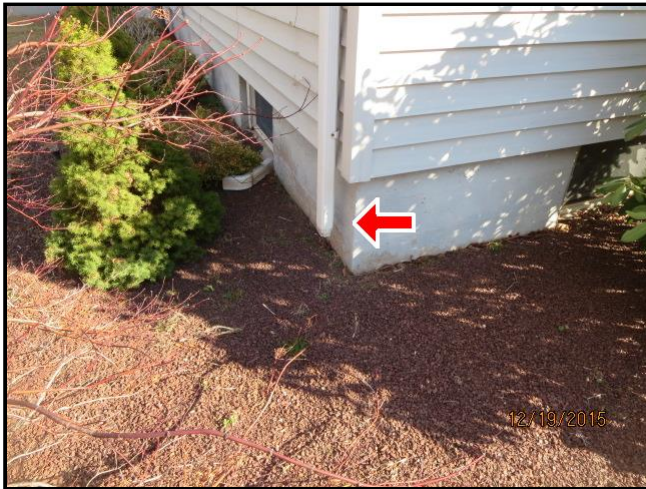
1.2 Item 1(Picture) Needs extension

(1) The downspout needs an extension and a buried drain line to carry water away from the home at the front of home.

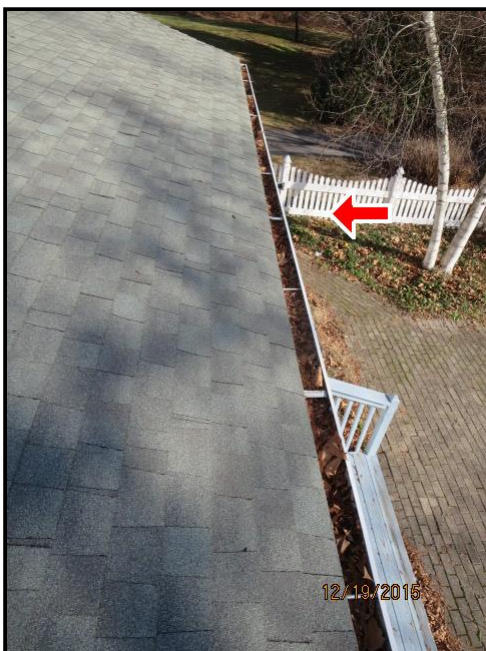
1.2 Item 2(Picture) Clogged Gutters

(2) The gutters are full of debris in areas and needs to be cleaned. The debris in gutters can also conceal rust, deterioration or leaks that are not visible until cleaned, and I am unable to determine if such conditions exist.

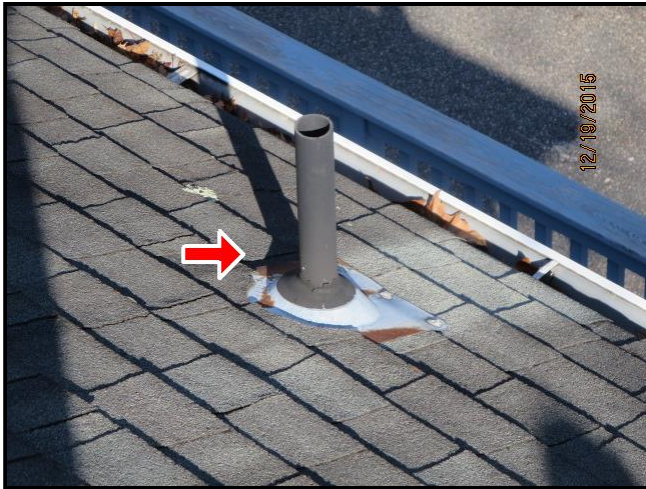
1.3 Item 1(Picture) Failed Boot

The plumbing vent pipes need caulking around the perimeter of pipe and boot where boot flange has failed.

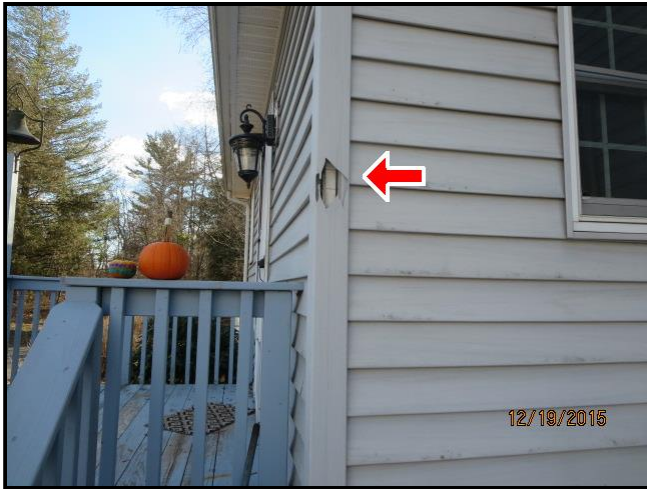
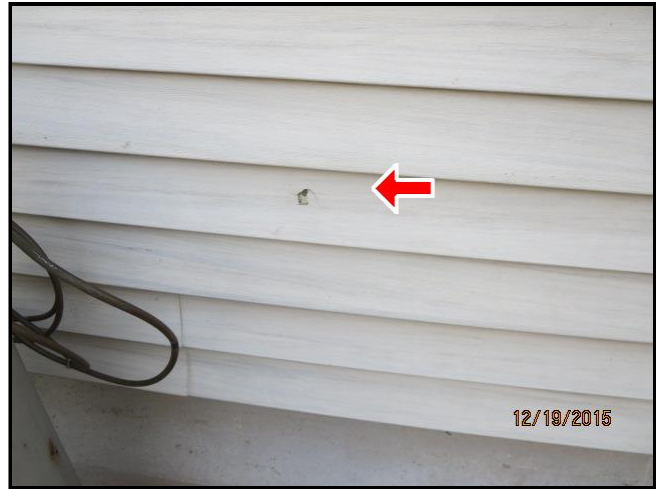
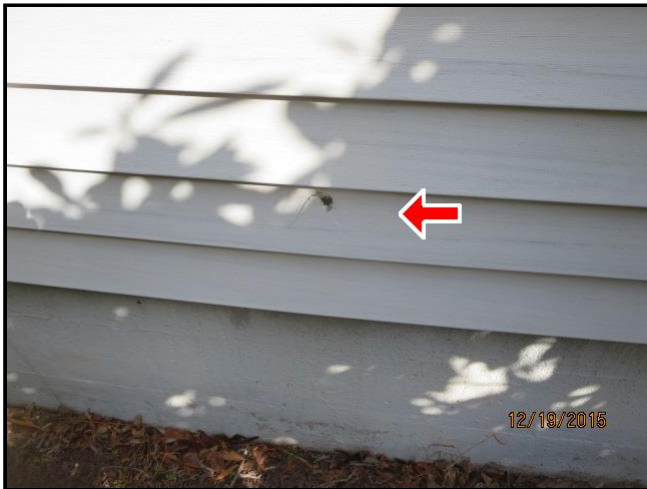
The Vinyl siding at the exterior in areas is damaged with holes. Further deterioration from water and insect intrusion can occur if not corrected. A qualified contractor should inspect and repair as needed.

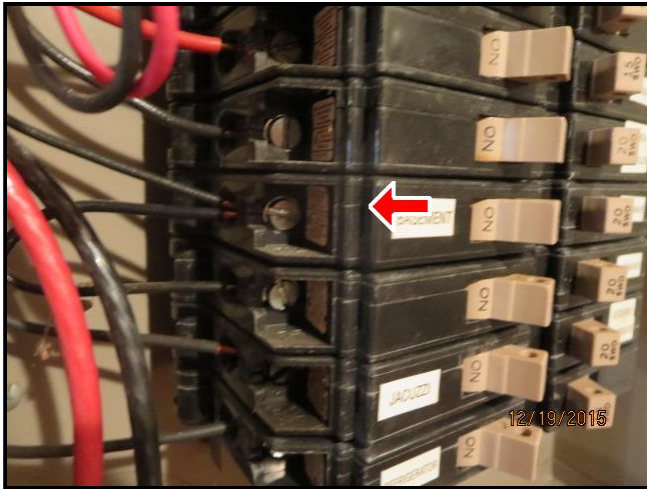
3.1 Item 1(Picture) Double wire

The problem(s) discovered in the panel such as doubled wiring at breakers, and any other problems that an electrical contractor may discover while performing repairs need correcting. Sub Panel is also wire incorrectly Neutral and ground wires are on the same bus bar. I recommend a licensed electrical contractor inspect further and correct as needed.

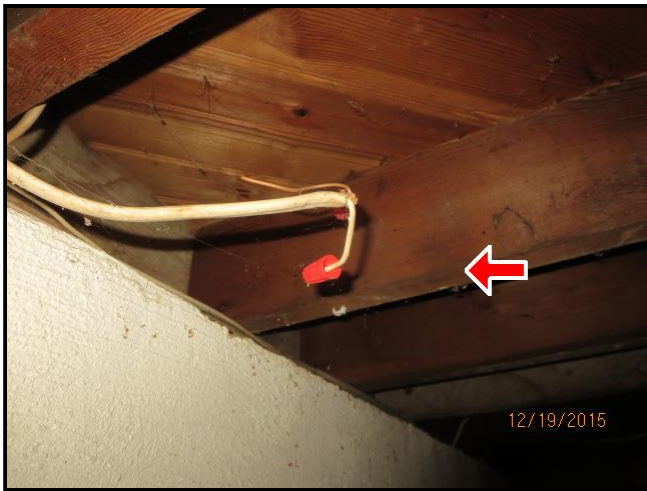
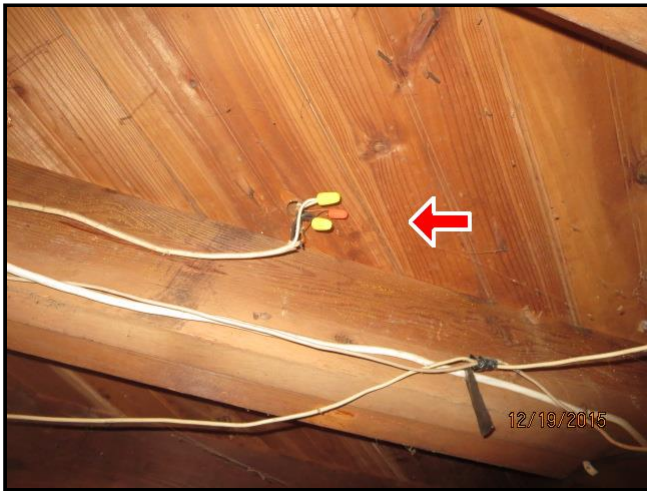
(1) Exposed wiring at the ceiling in the basement. This is a safety issue that needs to be corrected. A qualified licensed electrical contractor should perform repairs that involve wiring.

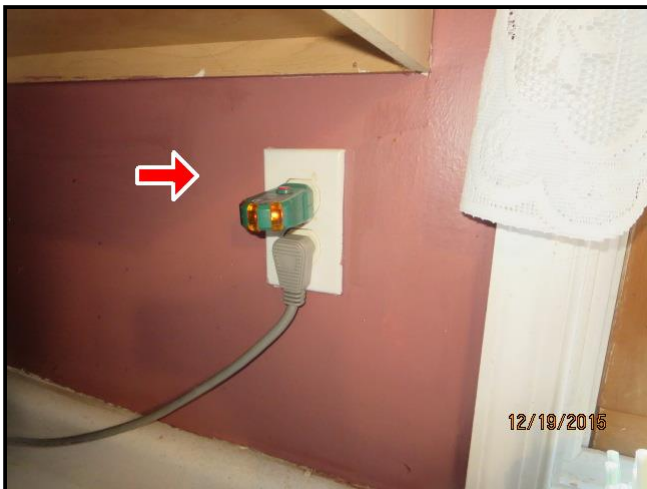
3.3 Item 4(Picture) Non GFCI

(2) Two "three-prong" outlets are outdated and not a three-prong GFCI (Ground Fault Circuit Interrupt) in the second floor kitchen and private bath. This is a safety issue that needs to be corrected. A qualified licensed electrical contractor should perform repairs that involve wiring.

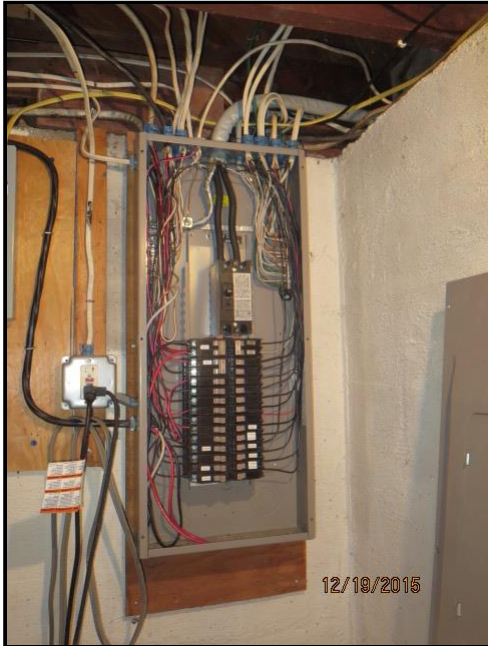
3.6 Item 1(Picture) Main Panel

The main panel box is located at the basement.

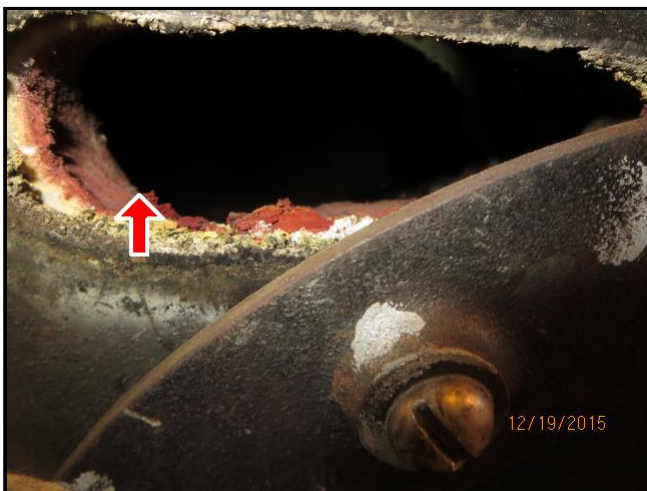
4.0 Item 1(Picture) Firewall cracks

(1) The oil-fired boiler is deteriorated with cracks at the fire wall. This is a safety issue and should be repaired, or replaced by A licensed HVAC contractor should service or repair unit.

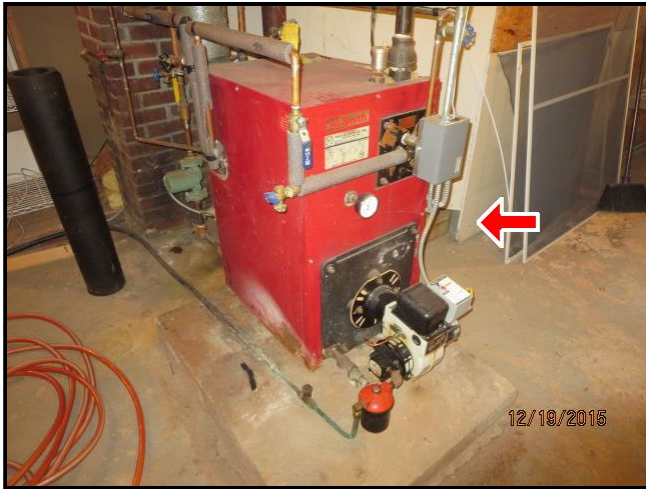
4.0 Item 2(Picture) Boiler

(2) Heating System was working at time of inspection, Boiler is from 1986, life expectancy is 15-25 years

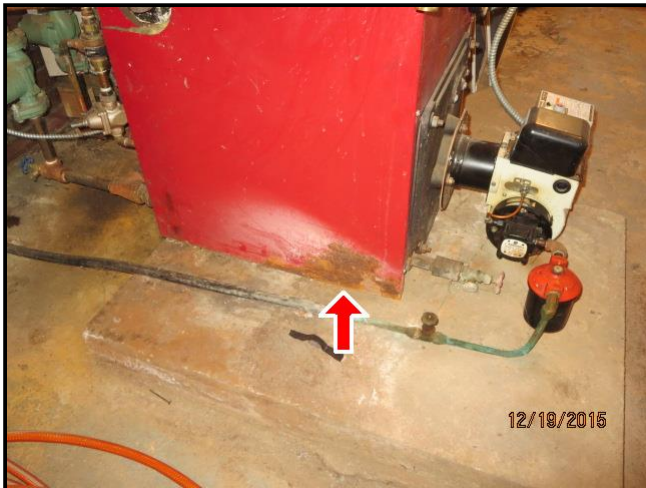
4.0 Item 3(Picture) Boiler Rust

(3) Rust was observed outside at bottom of boiler, could not determine if this effected the inside heat exchanger. Recommend an HVAC contractor further evaluate

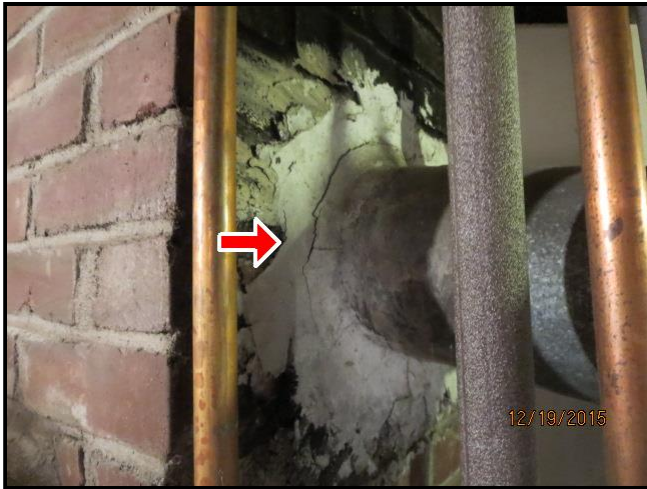
4.5 Item 1(Picture) Needs sealant

(2) The vent pipe for oil fired boiler needs mastic sealed around pipe where it enters chimney. This is a safety issue and should be repaired. I recommend a qualified licensed heat contractor inspect further and repair as needed.

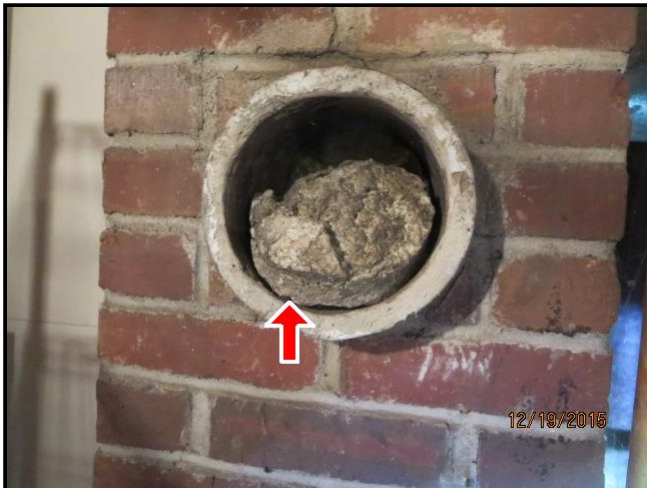
4.5 Item 2(Picture) Possible asbestos

(3) Insulation at the chimney at basement maybe asbestos. Asbestos is a health hazard, recommend a specialist further evaluate.

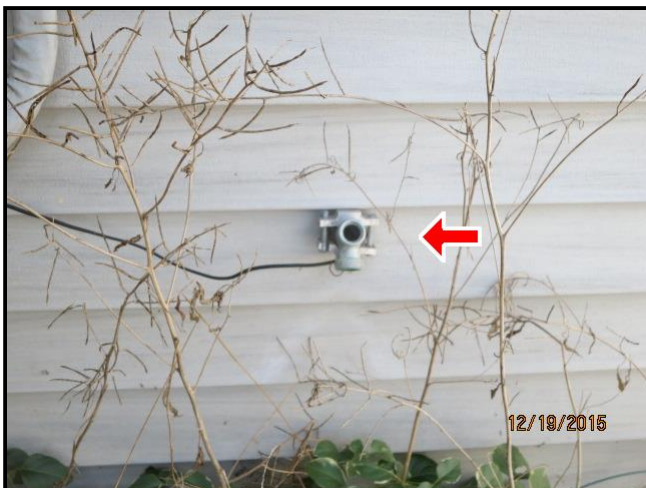
5.1 Item 1(Picture) Spigot

(1) The outside water faucets did not work at the rear of home. This is not considered up to today's standard. A qualified licensed plumber should repair or correct as needed.

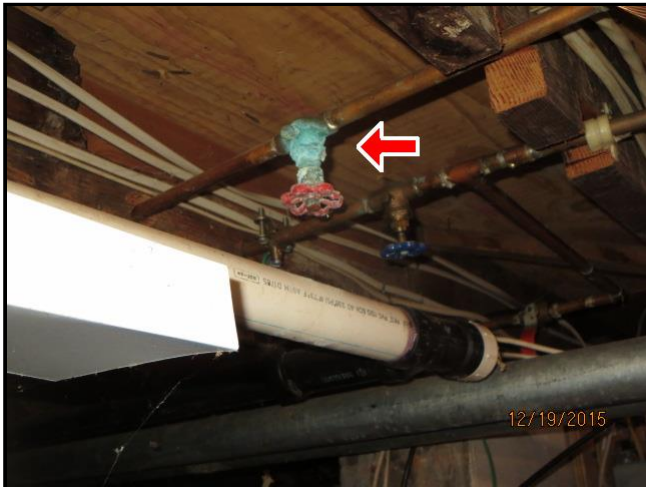
5.1 Item 2(Picture) Corroded valve

(2) The shut-off valve is corroded. Repairs are needed before a leak occurs . A qualified licensed plumber should repair or correct as needed.

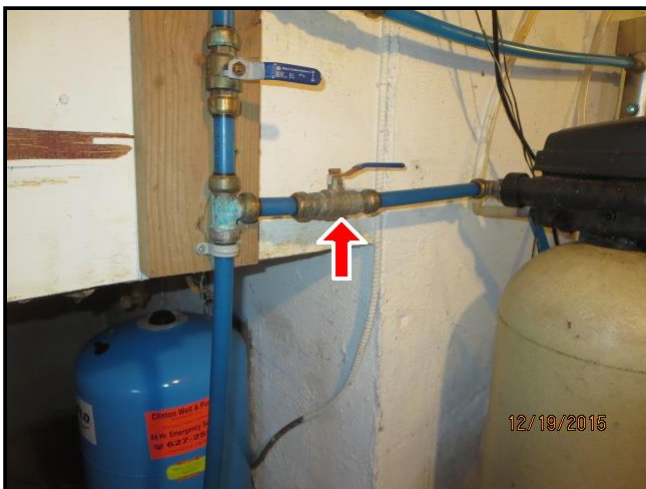
5.3 Item 1(Picture) Main water shut off

The main shut off is the lever located in the basement. This is for your information.

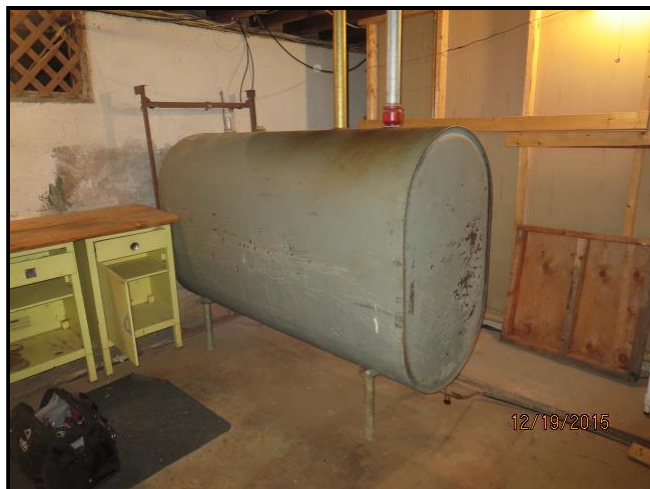
5.5 Item 1(Picture) Oil Barrel

The main shut off for oil is at oil barrel inside.

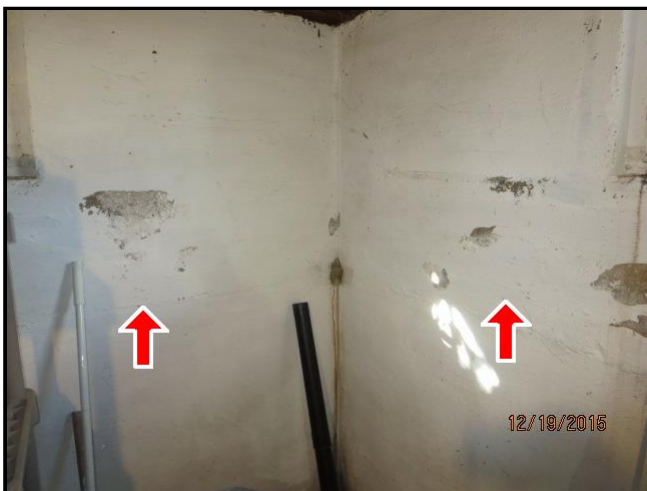
6.0 Item 1(Picture) Efflorescence

White efflorescence (powder substance) on block wall indicates moisture is in contact with the masonry. This does not necessarily indicate that intrusion will occur. I recommend checking the gutters and the downspout drain lines for proper operation. Also, a water proofing paint could be applied to the interior side of the block if necessary. Efflorescence is found on many homes without water intrusion occurring inside the home. But, it should alert you to the possibility that future steps may be needed.

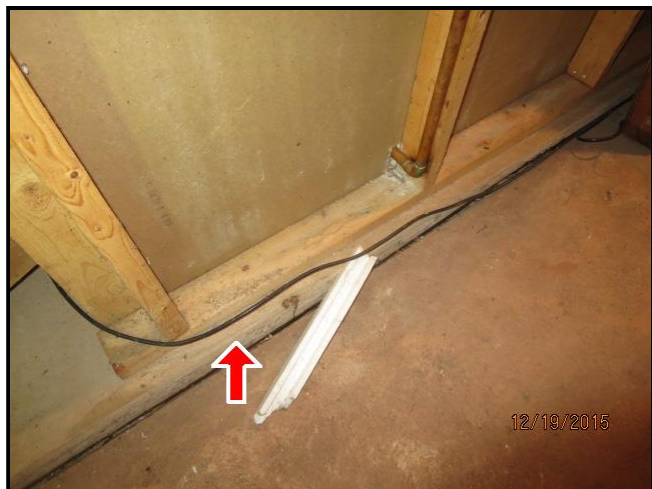
6.1 Item 1(Picture) Base wood

The wood for the base of the wall in basement is not pressure treated. Wood rot can occur if not corrected. Recommend a GC further evaluate and check for permits.

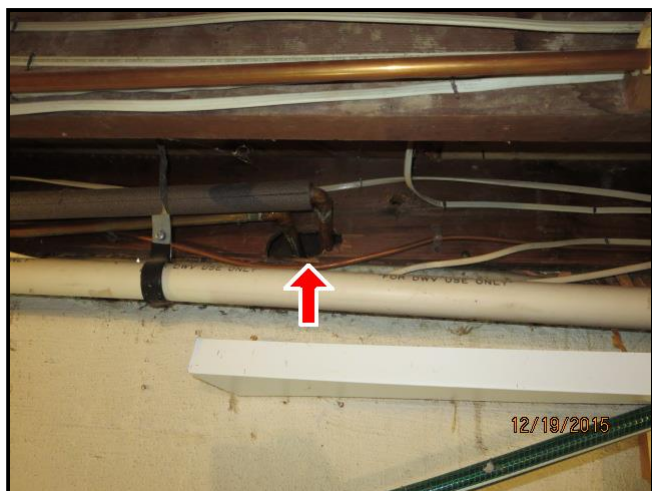
6.2 Item 1(Picture) Support Beam

The support beam at right side basement has a large hole. It could not be determined if the support beam was compromised. Recommend a GC further evaluate

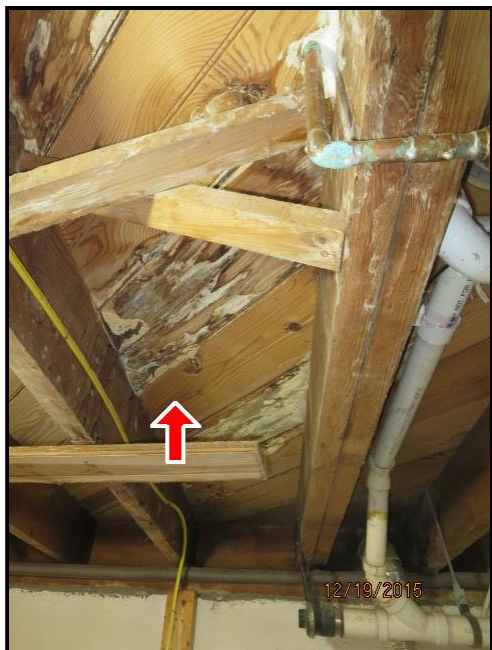
6.3 Item 1(Picture) Water stains

Wood rot and water stains were observed at basement ceiling. A moisture meter was used and indicated that the stain is not active. Recommend repairs be made to the area.

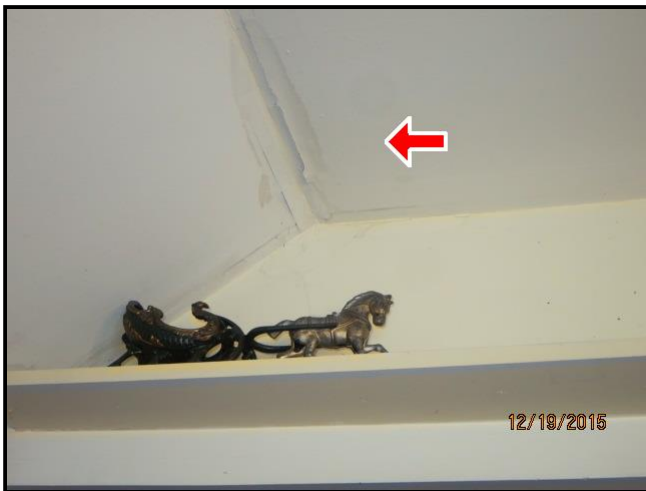
7.0 Item 1(Picture) Water stain

Water stain at second floor ceiling was observed at time of inspection. A moisture meter was used and indicated that the stain was not active. Recommend monitor area and repair as needed.

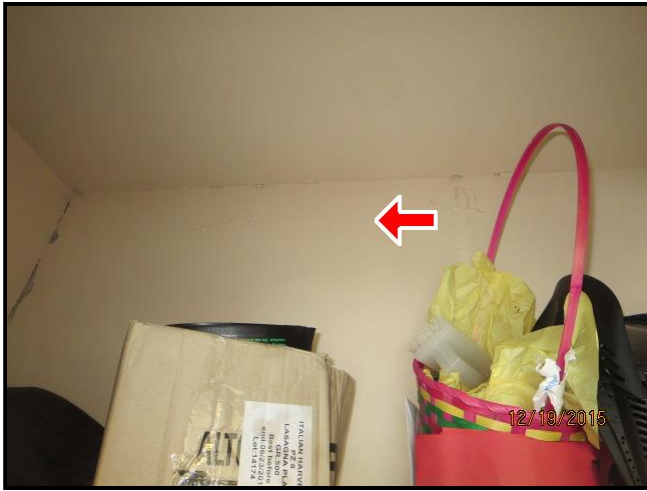
7.1 Item 1(Picture) Possible Led paint

(1) Possible lead paint observed in closet at first floor bedroom, Recommend further evaluation by a lead specialist and removed as needed

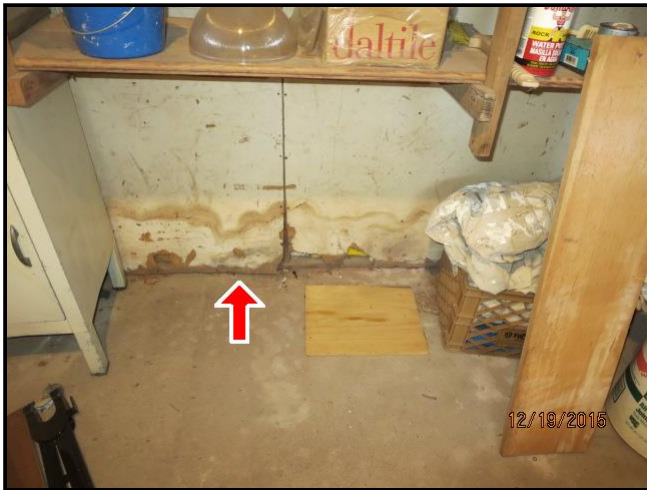
7.1 Item 2(Picture) Water Stain wall

(2) Water damage at basement wall was observed at time of inspection. A moisture meter was used and indicated that the water was not active. Recommend the wall be checked for mold.

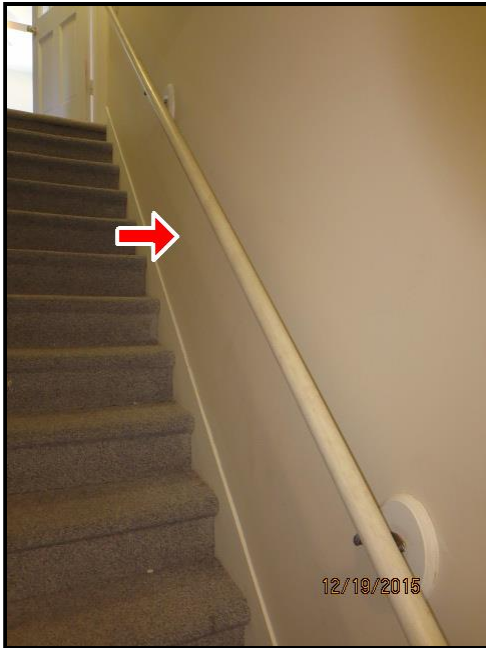
7.3 Item 1(Picture) Loose rail

The hand/guard rail for the second story stairs is loose. A fall or injury could occur if not corrected. A qualified contractor should repair or replace as needed.

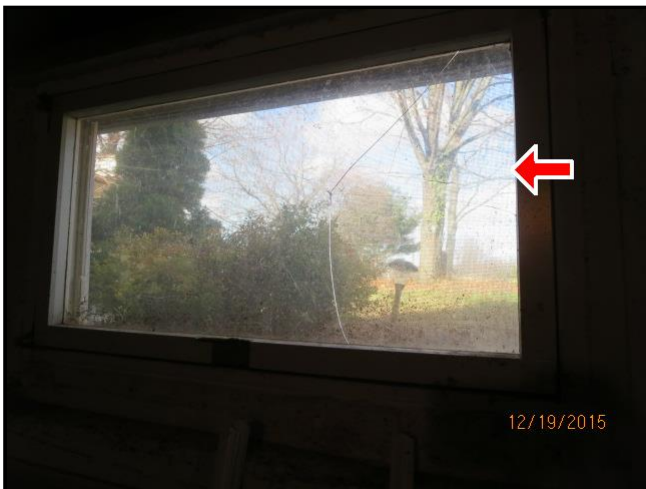
7.6 Item 1(Picture) Cracked glass

One window cracked at glass pane at the basement. Cracked glass should be replaced to prevent injury or damage. A qualified contractor should inspect and repair as needed.

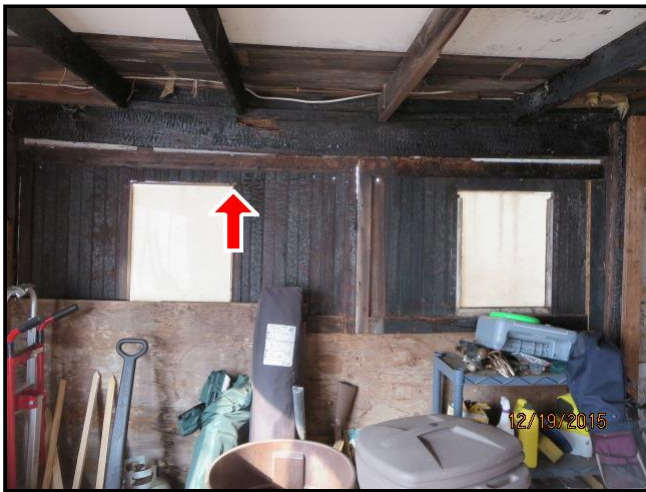
9.0 Item 1(Picture) Burnt beams

The entire garage is considered unsafe with burnt support beams and posts, Termite infested wood and possible electrical issues. Recommend that the garage be shut down and off limits, till a structural engineer can further Evaluates

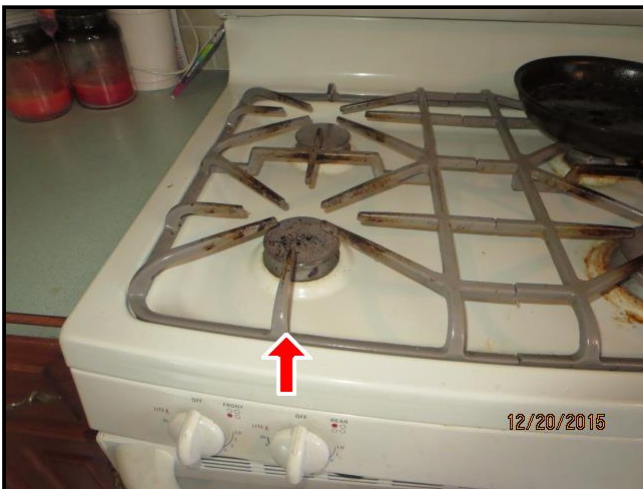
10.1 Item 1(Picture) Not working burner

The front left burner for range did not work when tested. I recommend repair as needed.

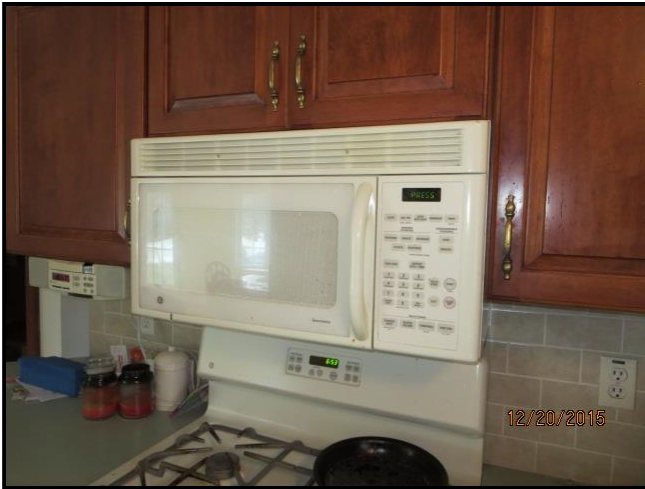
10.5 Item 1(Picture) Microwave

The microwave did not work at time of inspection. I recommend repair as needed.

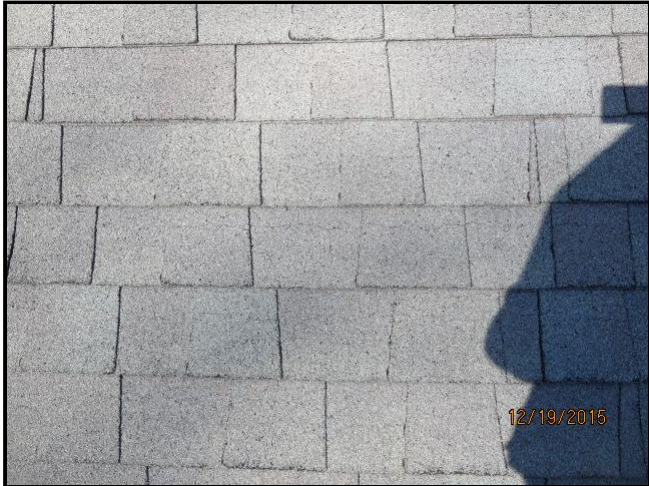
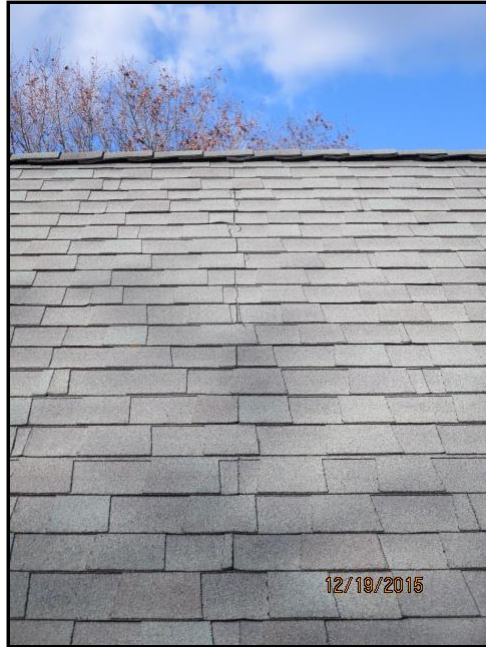
The roof covering is damaged cracks lifts and buckling at the "entire roof". This does not appear adequate. It should be properly repaired or replaced. A qualified roofing contractor should inspect and repair as needed.

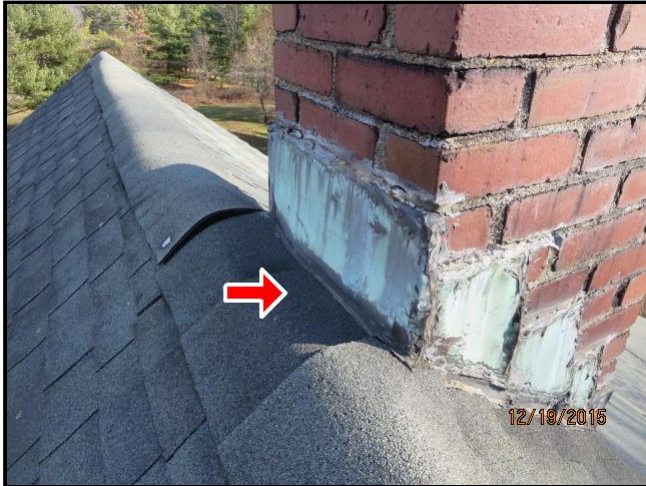
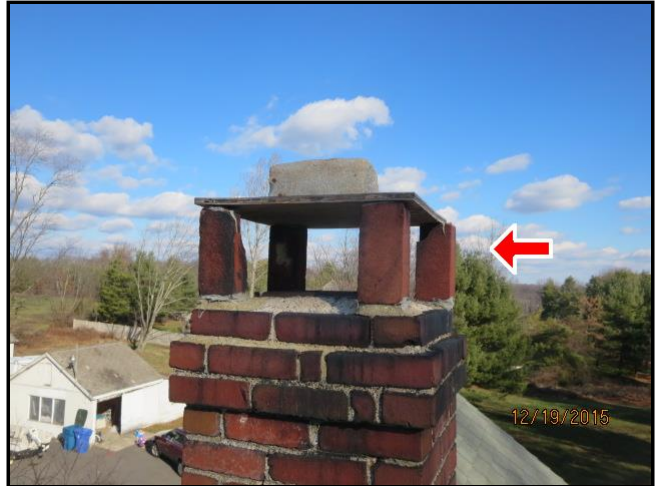
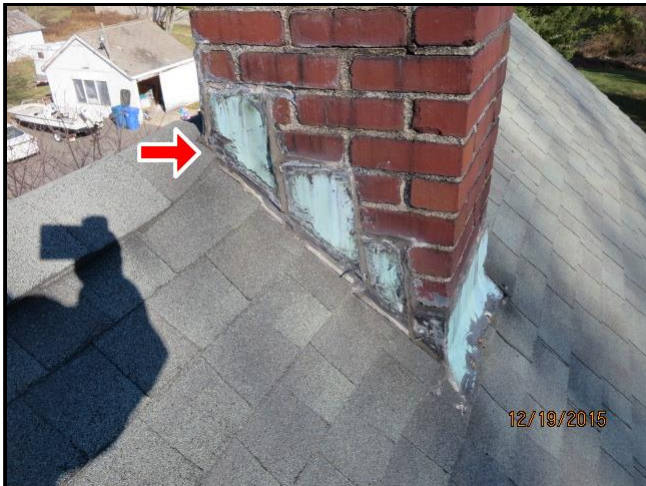
Flashing around chimney is deteriorated and needs sealant. Deteriorated flashing can lead to water intrusion. The chimney is also missing mortar and needs re-pointing. Recommend a chimney specialist further evaluate and repair.

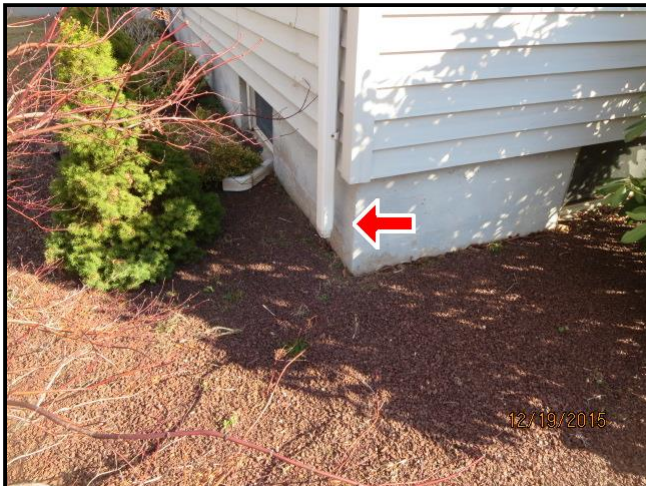
1.2 Item 1(Picture) Needs extention

(1) The downspout needs an extension and a buried drain line to carry water away from the home at the front of home.

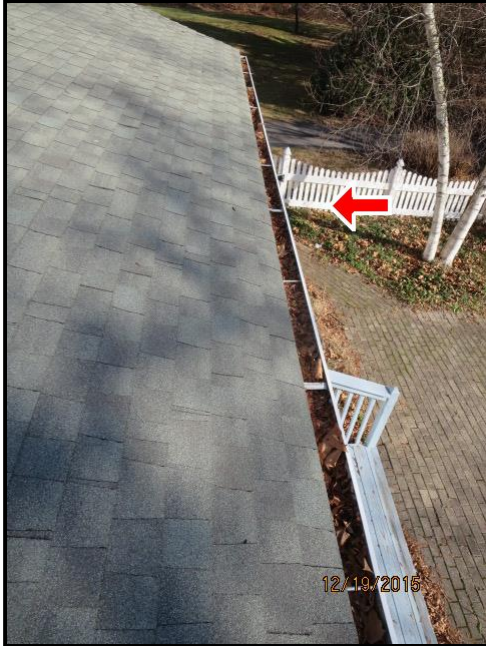
1.2 Item 2(Picture) Clogged Gutters

(2) The gutters are full of debris in areas and needs to be cleaned. The debris in gutters can also conceal rust, deterioration or leaks that are not visible until cleaned, and I am unable to determine if such conditions exist.

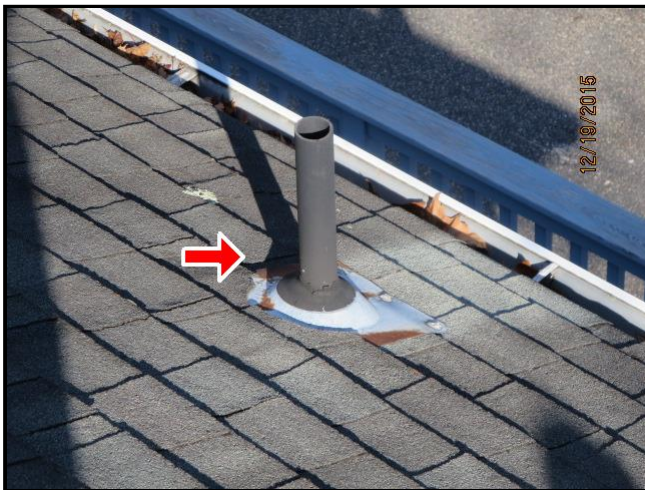
1.3 Item 1(Picture) Failed Boot

The plumbing vent pipes need caulking around the perimeter of pipe and boot where boot flange has failed.

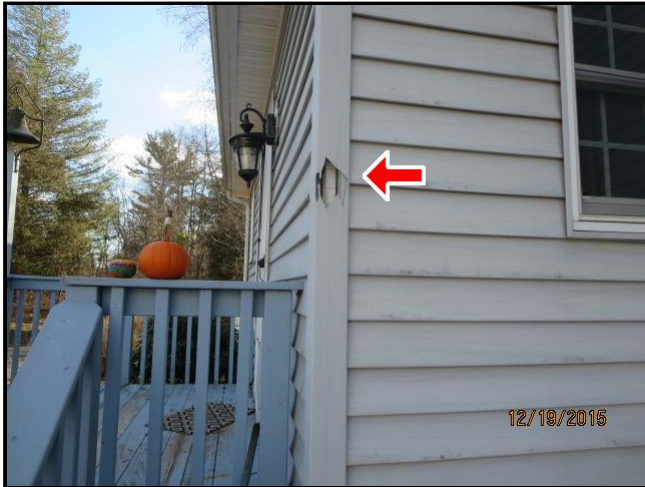
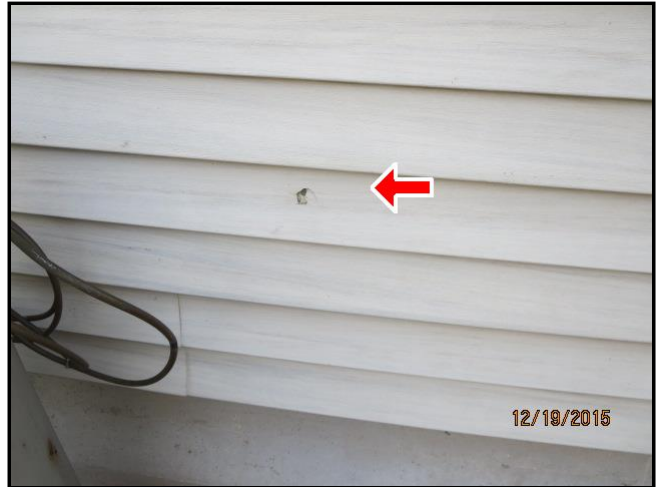
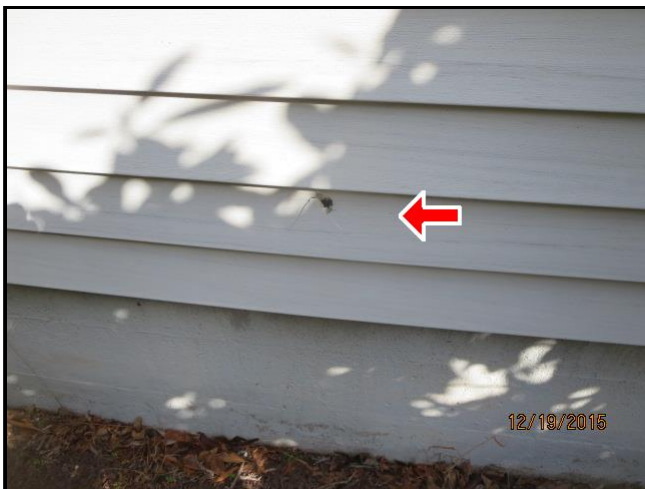
The Vinyl siding at the exterior in areas is damaged with holes. Further deterioration from water and insect intrusion can occur if not corrected. A qualified contractor should inspect and repair as needed.

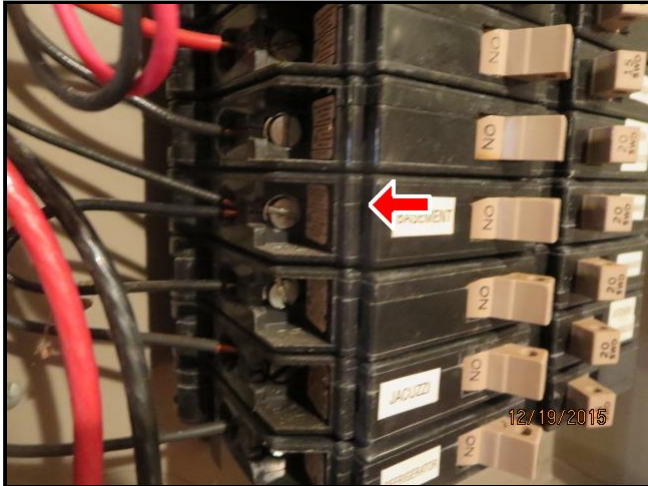
3.1 Item 1(Picture) Double wire

The problem(s) discovered in the panel such as doubled wiring at breakers, and any other problems that an electrical contractor may discover while performing repairs need correcting. Sub Panel is also wire incorrectly Neutral and ground wires are on the same bus bar. I recommend a licensed electrical contractor inspect further and correct as needed.

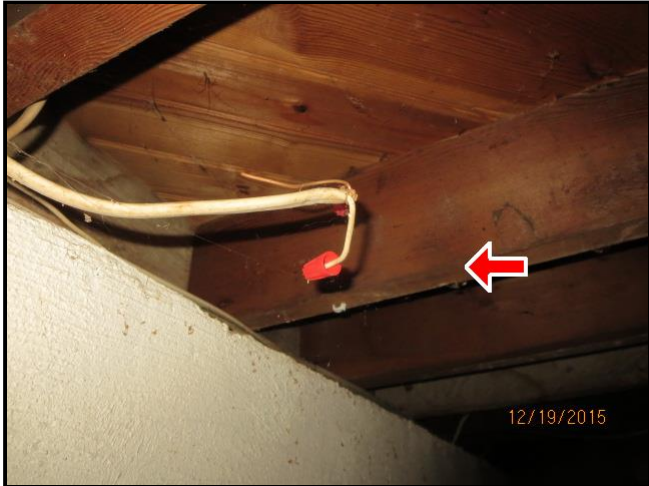
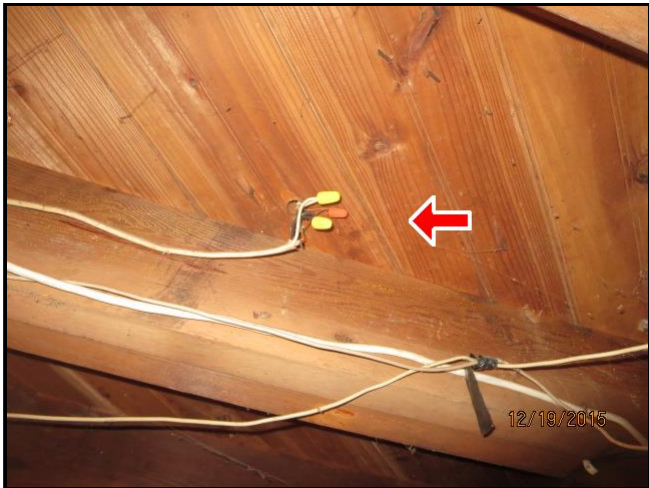
(1) Exposed wiring at the ceiling in the basement. This is a safety issue that needs to be corrected. A qualified licensed electrical contractor should perform repairs that involve wiring.

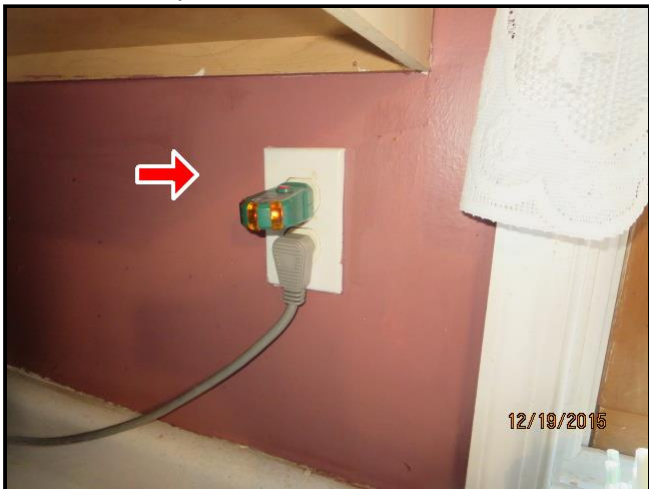
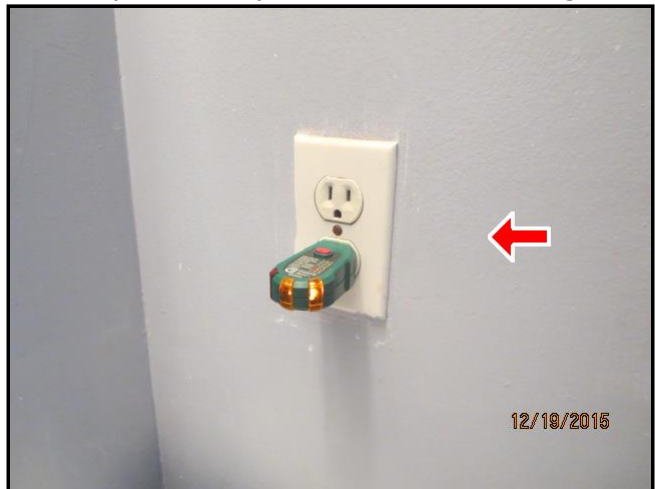
(2) Two "three-prong" outlets are outdated and not a three-prong GFCI (Ground Fault Circuit Interrupt) in the second floor kitchen and private bath. This is a safety issue that needs to be corrected. A qualified licensed electrical contractor should perform repairs that involve wiring.

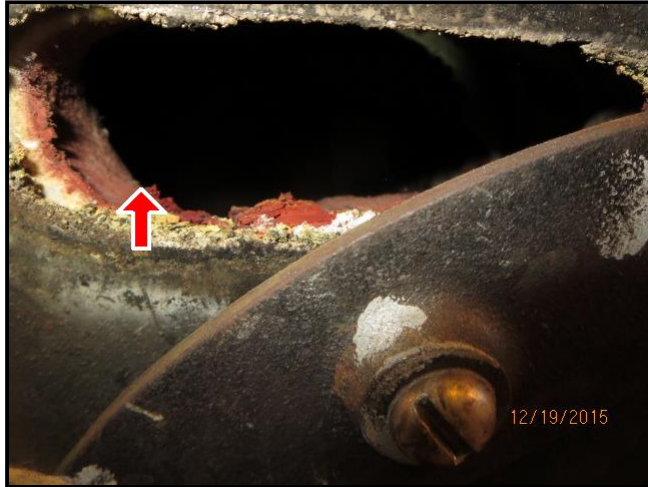
4.0 Item 1(Picture) Firewall cracks

(1) The oil-fired boiler is deteriorated with cracks at the fire wall. This is a safety issue and should be repaired, or replaced by A licensed HVAC contractor should service or repair unit.

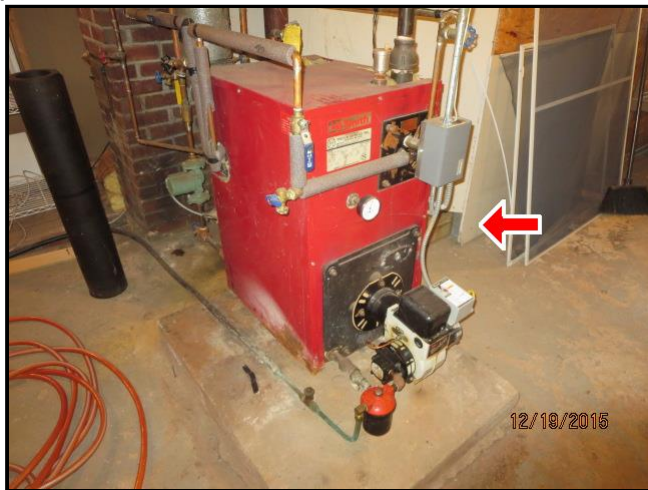
4.0 Item 2(Picture) Boiler

(2) Heating System was working at time of inspection, Boiler is from 1986, life expectancy is 15-25 years

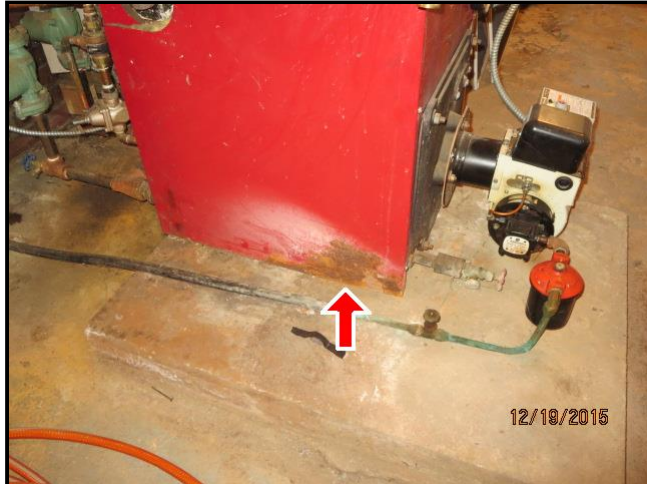
4.0 Item 3(Picture) Boiler Rust

(3) Rust was observed outside at bottom of boiler, could not determine if this effected the inside heat exchanger. Recommend an HVAC contractor further evaluate

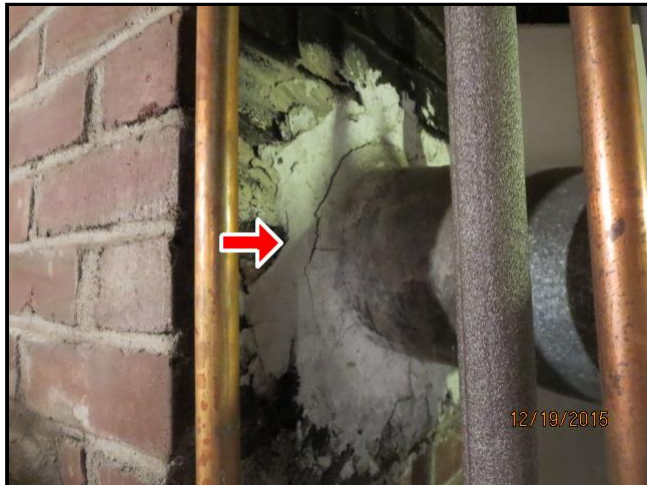
4.5 Item 1(Picture) Needs sealant

(2) The vent pipe for oil fired boiler needs mastic sealed around pipe where it enters chimney. This is a safety issue and should be repaired. I recommend a qualified licensed heat contractor inspect further and repair as needed.

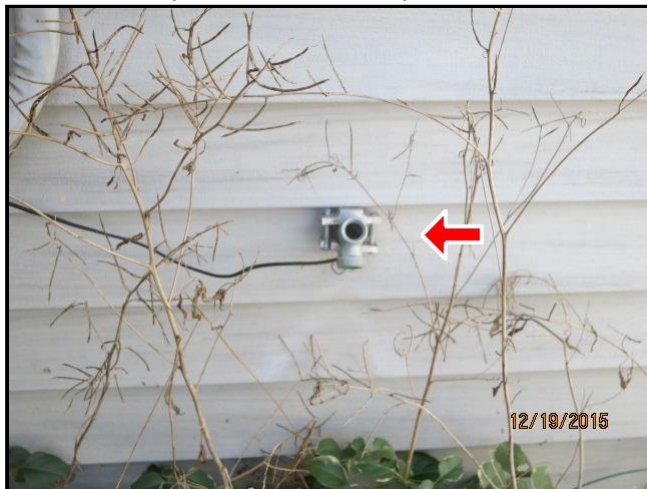
5.1 Item 1(Picture) Spigot

(1) The outside water faucets did not work at the rear of home. This is not considered up to today's standard. A qualified licensed plumber should repair or correct as needed.

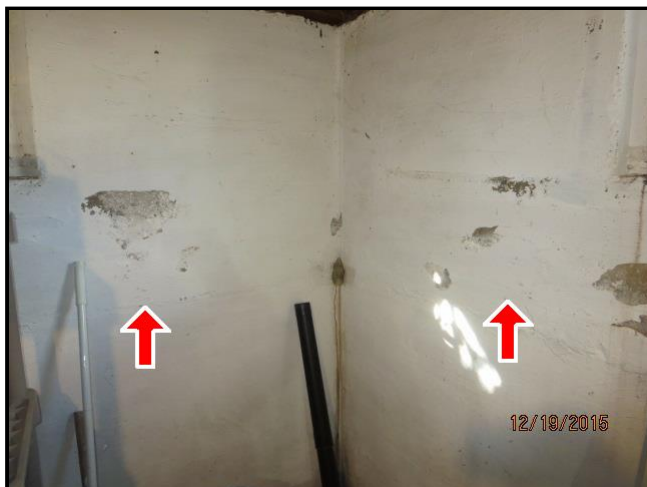
6.0 Item 1(Picture) Efflorescence

White efflorescence (powder substance) on block wall indicates moisture is in contact with the masonry. This does not necessarily indicate that intrusion will occur. I recommend checking the gutters and the downspout drain lines for proper operation. Also, a water proofing paint could be applied to the interior side of the block if necessary. Efflorescence is found on many homes without water intrusion occurring inside the home. But, it should alert you to the possibility that future steps may be needed.

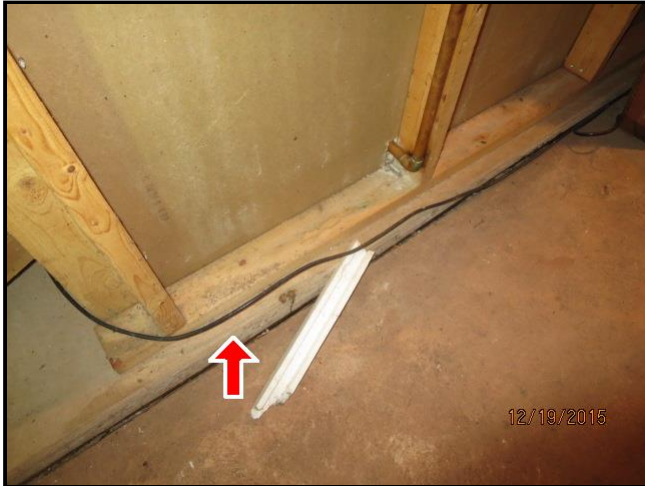
6.1 Item 1(Picture) Base wood

The wood for the base of the wall in basement is not pressure treated. Wood rot can occur if not corrected. Recommend a GC further evaluate and check for permits.

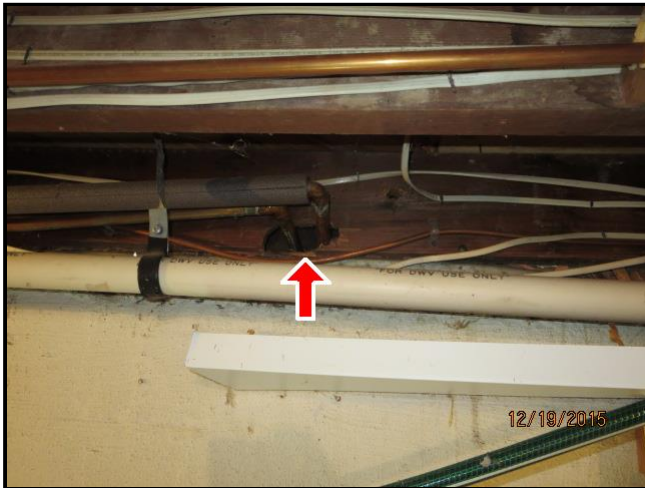
6.2 Item 1(Picture) Support Beam

The support beam at right side basement has a large hole. It could not be determined if the support beam was compromised. Recommend a GC further evaluate

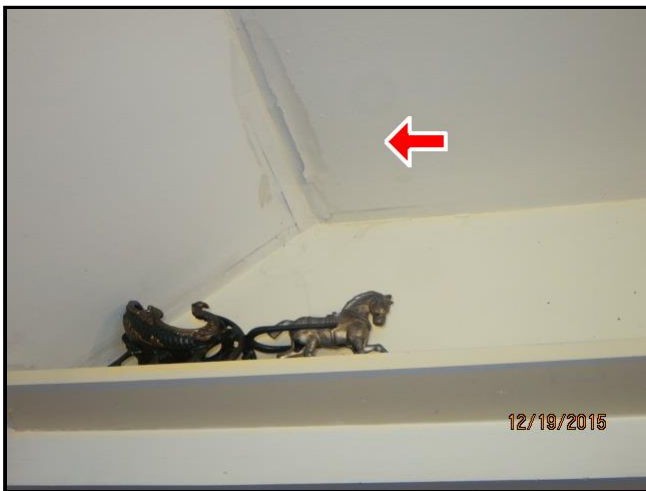
7.0 Item 1(Picture) Water stain

Water stain at second floor ceiling was observed at time of inspection. A moisture meter was used and indicated that the stain was not active. Recommend monitor area and repair as needed.

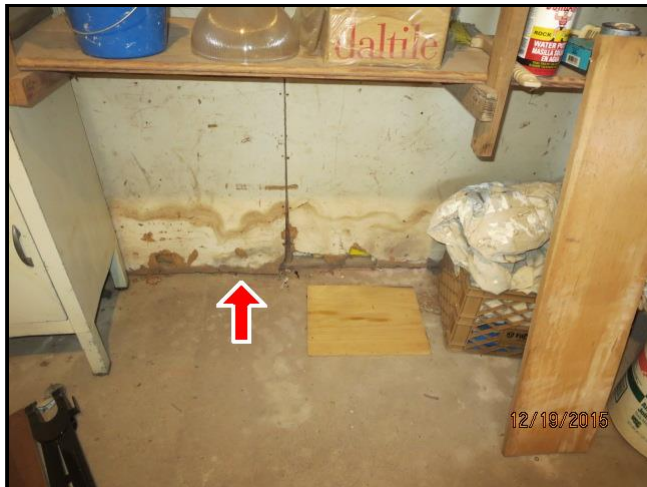
7.1 Item 2(Picture) Water Stain wall

(2) Water damage at basement wall was observed at time of inspection. A moisture meter was used an indicated that the water was not active. Recommend the wall be checked for mold.
