# Inspection Report

## Quakertown Fire Company

**Property Address:**  
2 Perryville Rd  
Union Twp NJ 08867

<b>Date:</b> 12/19/2015	<b>Time:</b> 10:00 AM	<b>Report ID:</b>
<b>Property:</b> 2 Perryville Rd Union Twp NJ 08867	<b>Customer:</b> Quakertown Fire Company	<b>Real Estate Professional:</b> Joanne Schwartz Weidel

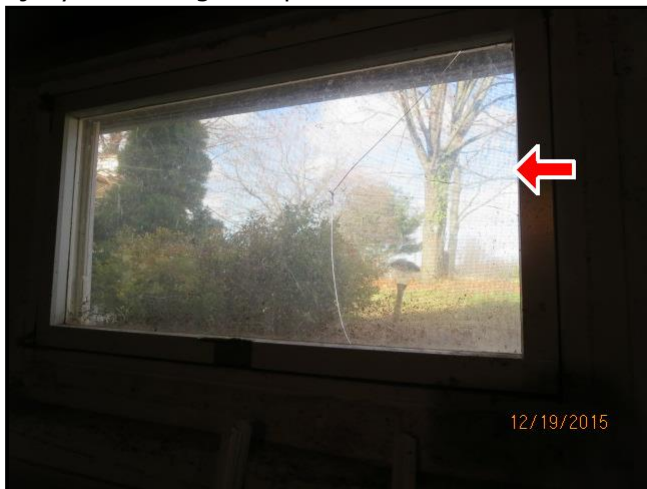
7.6 Item 1(Picture) Cracked glass

One window cracked at glass pane at the basement. Cracked glass should be replaced to prevent injury or damage. A qualified contractor should inspect and repair as needed.

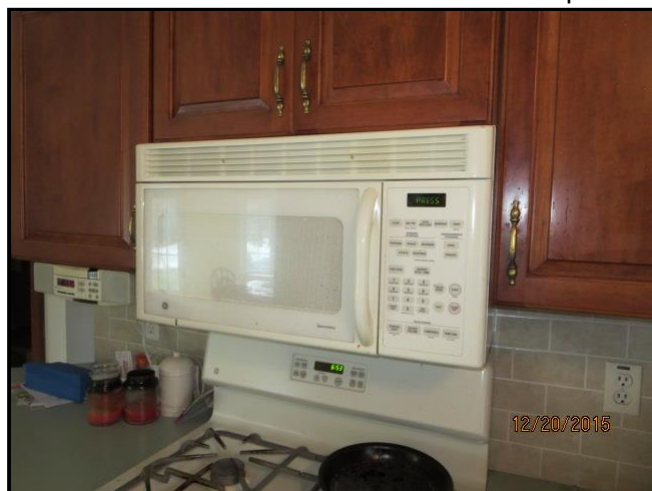
10.5 Item 1(Picture) Microwave

The microwave did not work at time of inspection. I recommend repair as needed.
