# South Laughery Creek Watershed Management Plan

The South Laughery Creek Watershed Project  
December 2005

Dearborn County Soil and Water Conservation District  
10729 Randall Avenue Suite 2  
Aurora, IN 47001

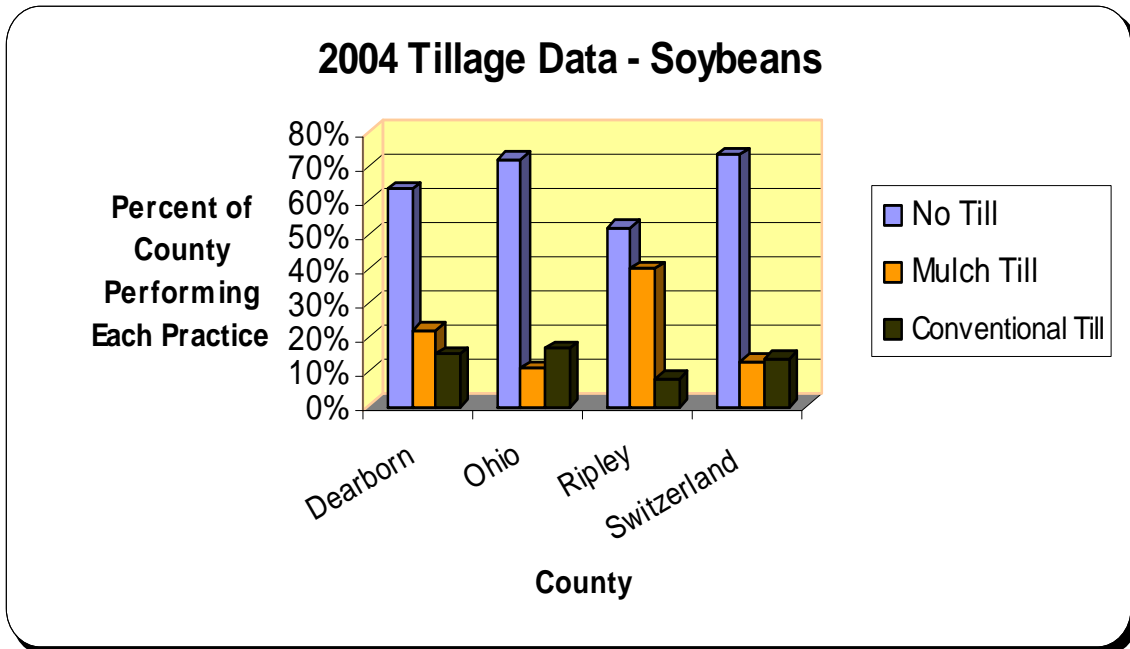
There seems to be a significant gap within the amount of corn and soybeans produced with no-till practices. Several factors may contribute to these gaps. No-till corn is a concern for some farmers because planting is typically later than conventional tillage. Machinery may be another reason for the decrease conservation tillage practices. Many of the Soil and Water Districts have no-till drills for soybeans but not for corn. Many farmers do not have the financial means for equipment upgrades. It is thought that no-till beans are higher in no-till acres since beans do not have to be planted as early and no-till beans seem to have better resistance to weather related stress, unlike no-till corn. (Figures 16-18 illustrate tillage practices by county for 2004.)
