# Inspection Report

## Grand Depot Partners

**Property Address:**  
32-34 North Union St.  
Lambertville NJ 08530

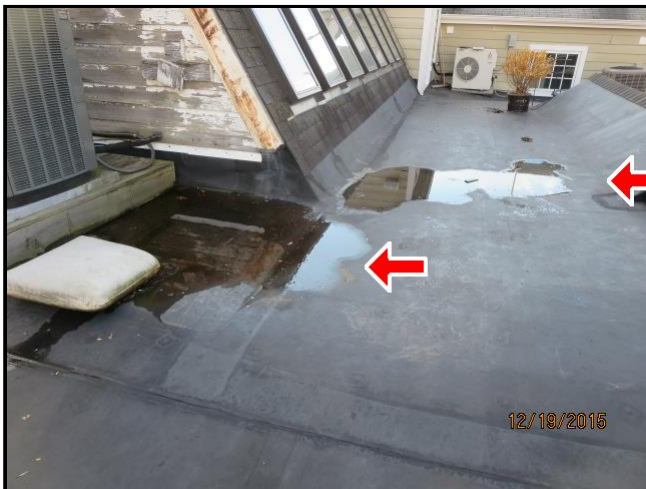
(1) Roof was observed with standing water (ponding) this can lead to water leaks if not corrected. Recommend a roofing company evaluate and repair.

1.0 Item 1(Picture) Standing water

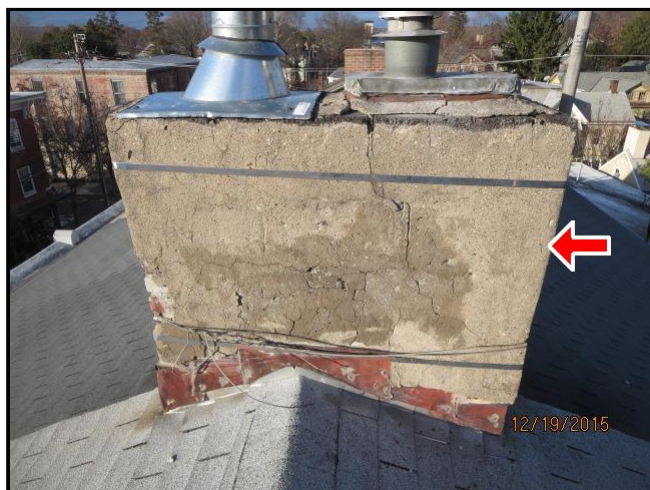
The masonry chimney is damaged with cracks. Further deterioration may occur if not repaired. A qualified contractor should inspect and repair as needed.

1.2 Item 1(Picture) Needs re-pointing

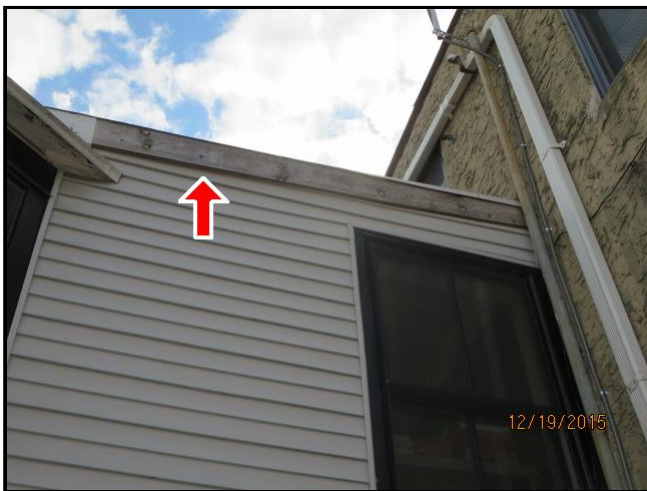
The Wood trim at the rear of building is exposed . Further deterioration can occur if not corrected. A qualified contractor should inspect and repair as needed.

2.0 Item 1(Picture) Exposed trim

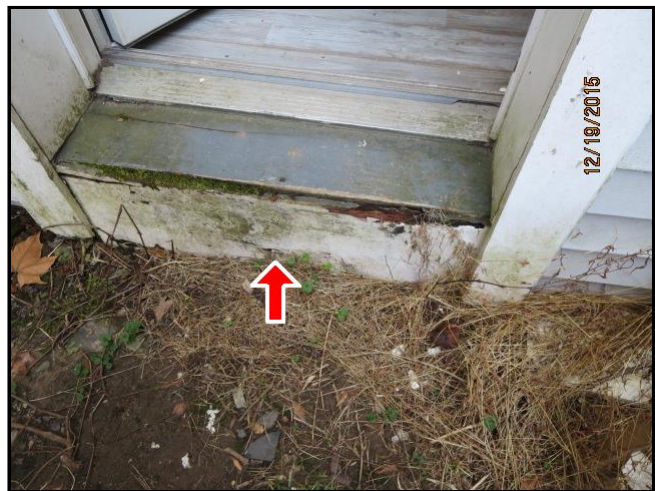
2.0 Item 2(Picture) Damaged wood

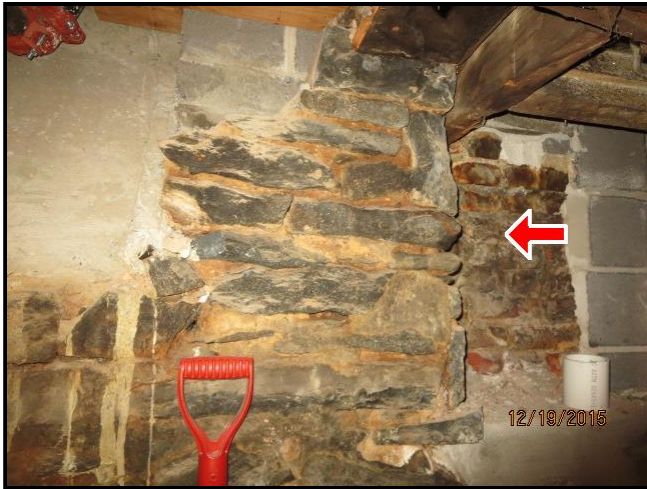
(1) The foundation wall at the front, rear and sides of building are deteriorated with loose and missing mortar. Repairs are needed and The wall(s) may need reinforcement. A skilled masonry contractor should perform the repairs.

3.1 Item 1(Picture) Loose Mortar

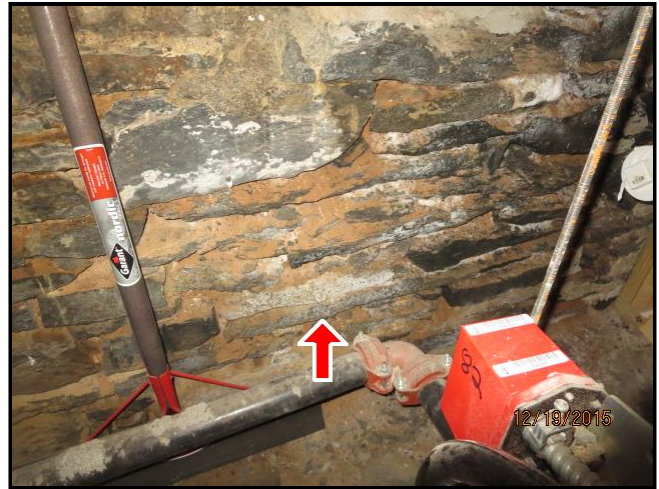
3.1 Item 2(Picture) Loose mortar

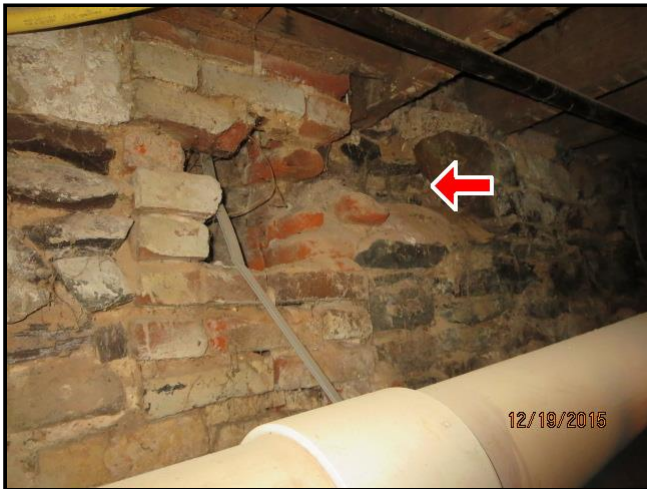
3.1 Item 3(Picture) Loose bricks

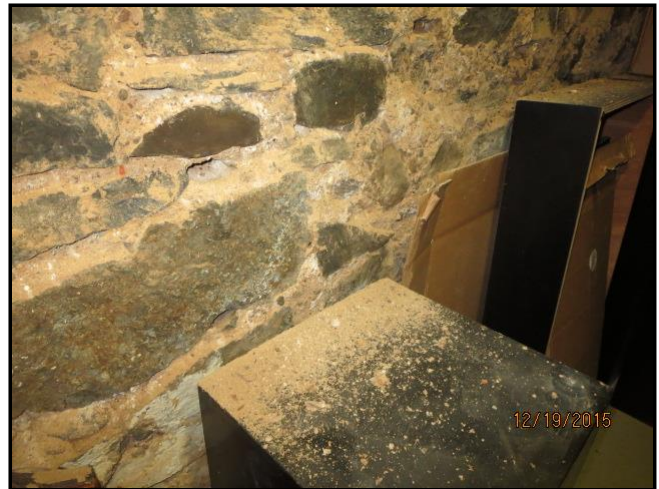
3.1 Item 4(Picture) Loose mortar

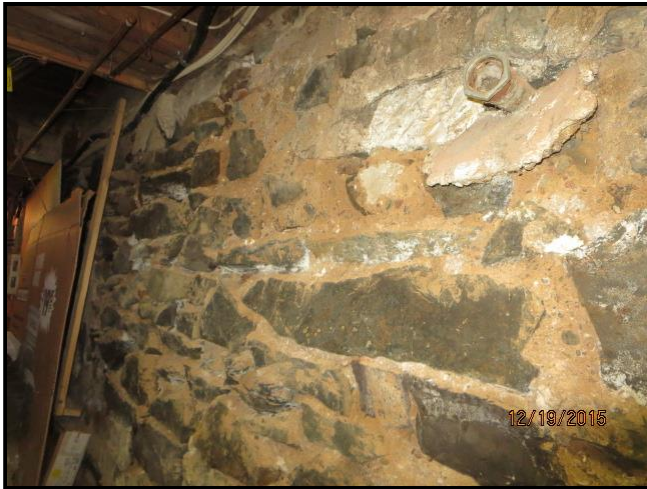
3.1 Item 5(Picture) Loose mortar

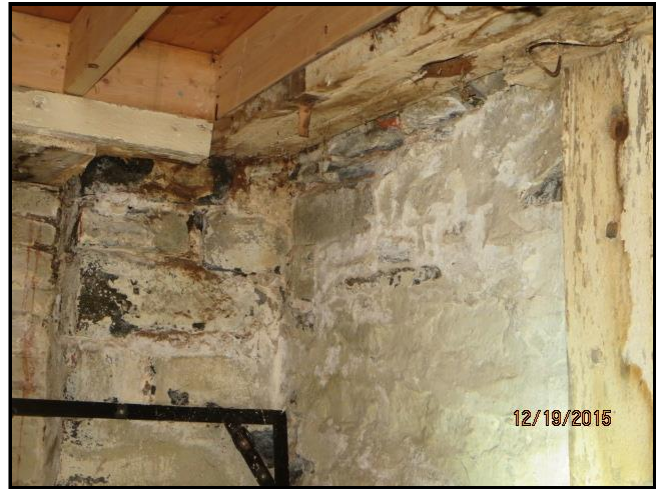
3.1 Item 6(Picture) Loose rock

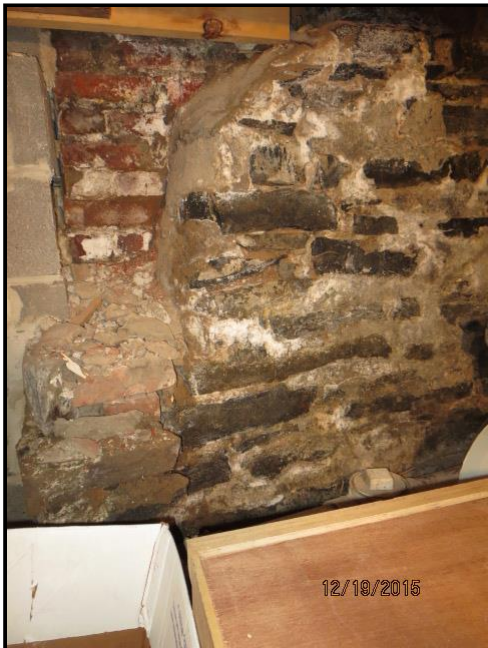
3.1 Item 7(Picture) Loose mortar

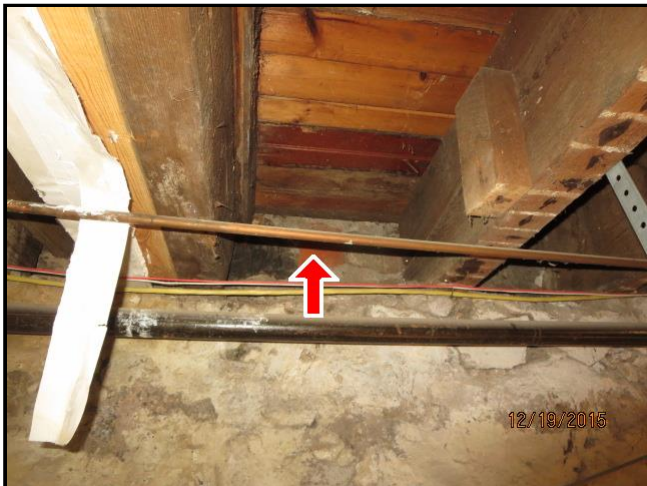
(2) Some tops of basement walls are missing Fire block insulation. Fire blocks help to prevent fire and smoke from traveling up the walls. Recommend a qualified person further evaluate and install

3.1 Item 8(Picture) Missing fire block

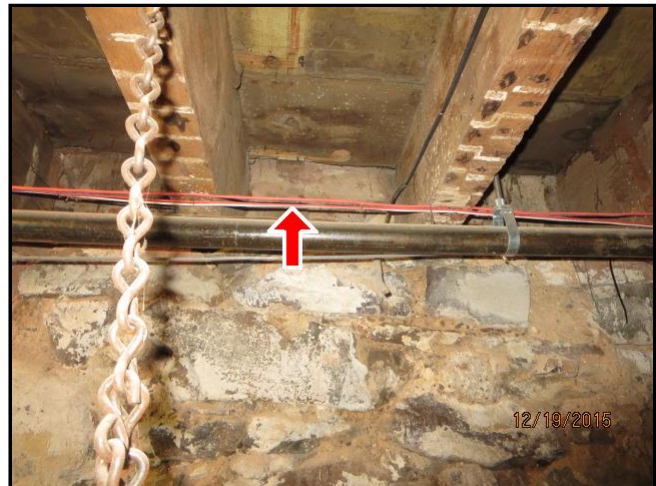
3.1 Item 9(Picture) Missing fire block

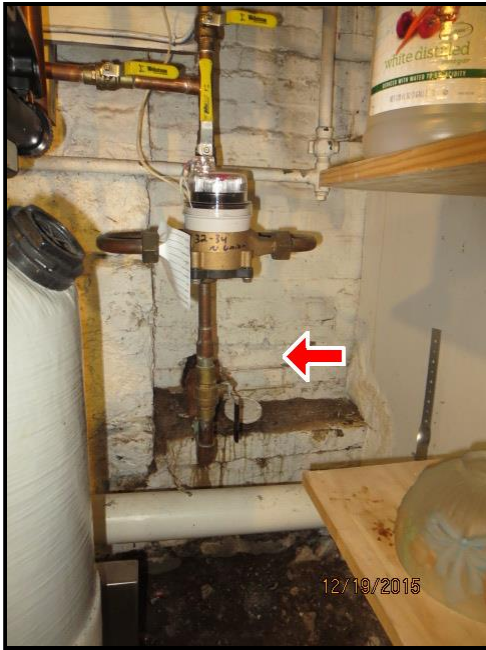
The main shut off is the lever located in the basement. This is for your information.

4.3 Item 1(Picture) Main water shut off

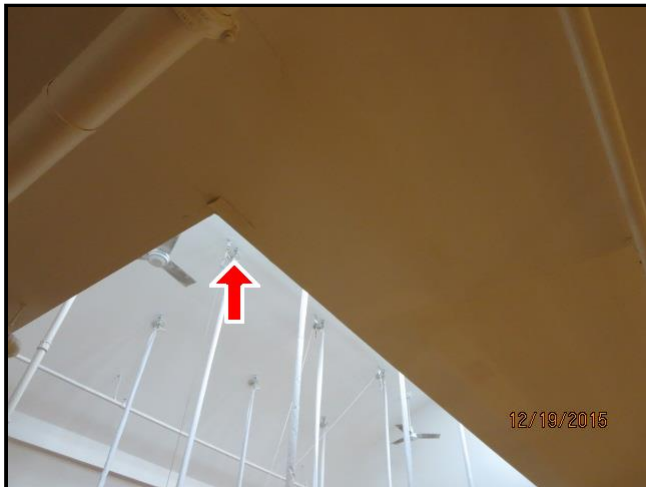
The Sheetrock on the ceiling reveals a water stain indicating a leak still exists at the 2nd floor ceiling . The moisture meter was used and it recorded 19% or higher, which indicates the leak has not been corrected. A qualified contractor should inspect and repair as needed. This leak maybe the results from standing water on the roof.

5.0.B Item 1(Picture) Water stain

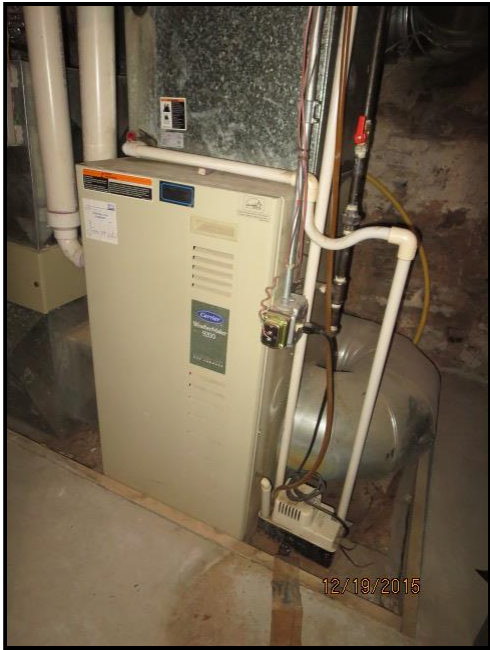
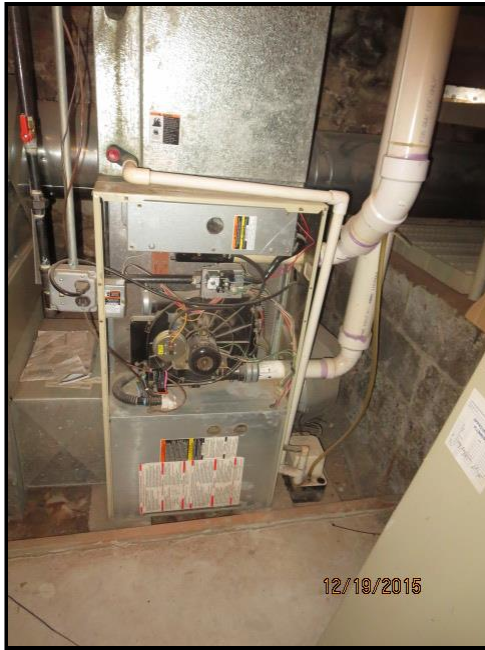
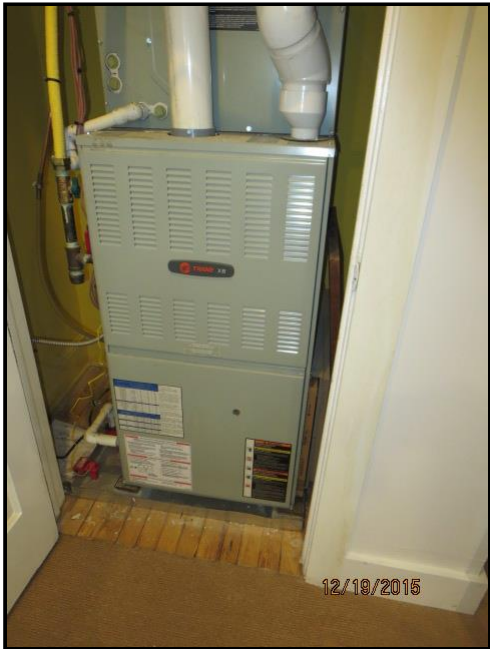
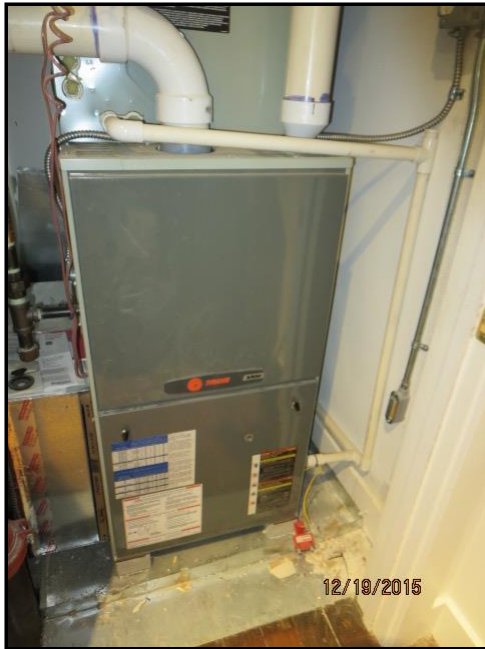
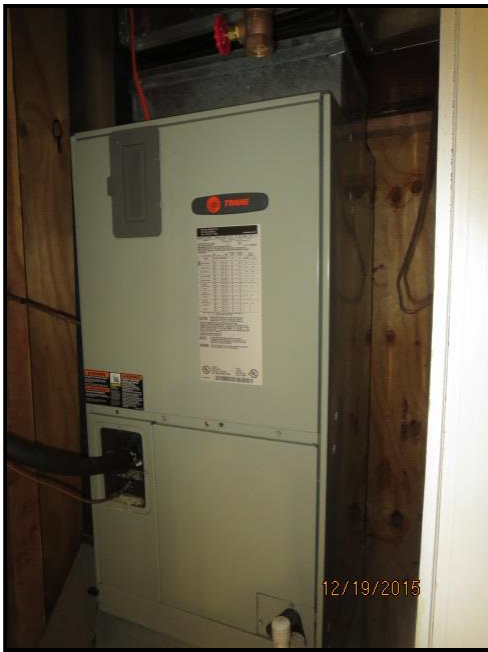
All five Heating systems were working at time of inspection. The age of the furnaces range from 2000-2009, life expectancy is 15-25 years.

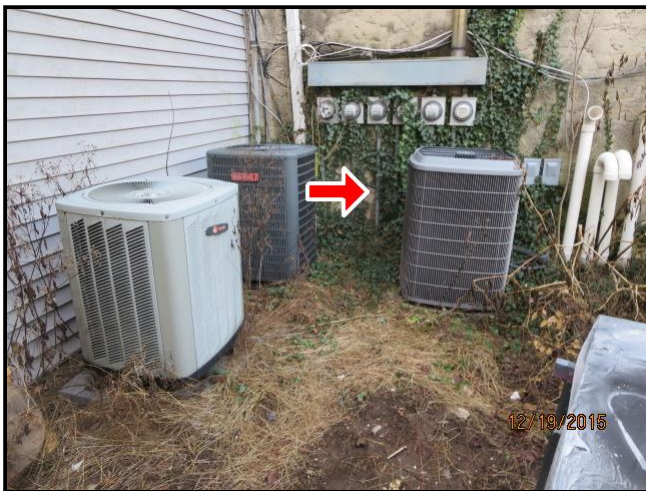
The A/C was not tested for proper operation due to the outside air temperature is 65 degrees or less. We did not inspect this unit(s). There are 5 condensers 4 are within the life expectancy of 8-15 years, 1 Condensers is from 2000 and will need to be replaced in the next 2-5 years cost will be around \$4,000

8.2 Item 1(Picture) Old unit

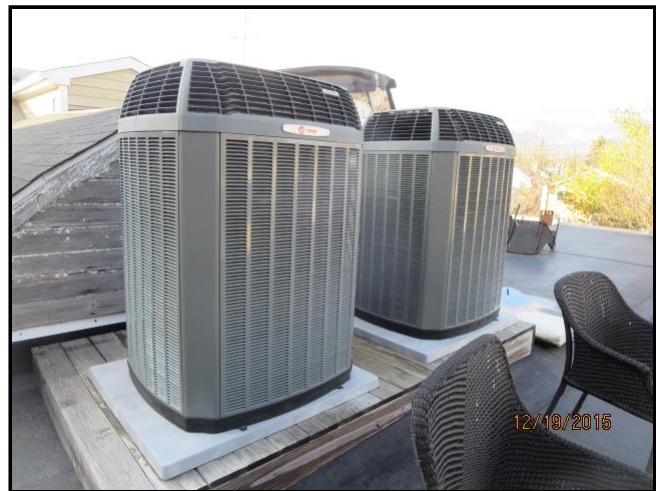
8.2 Item 2(Picture) Roof top units

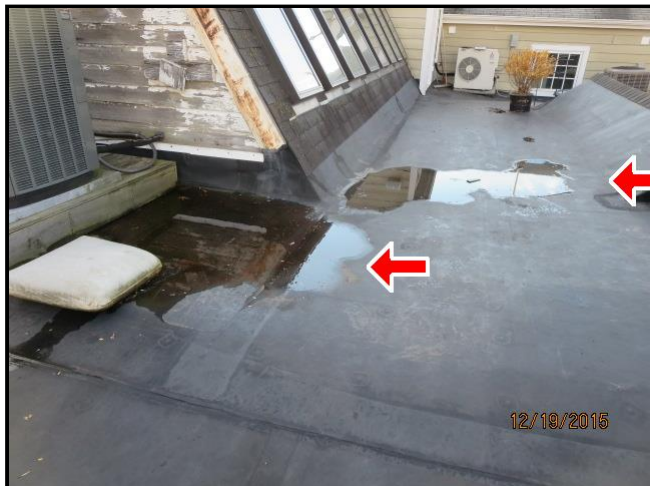
(1) Roof was observed with standing water (ponding) this can lead to water leaks if not corrected. Recommend a roofing company evaluate and repair.

1.0 Item 1(Picture) Standing water

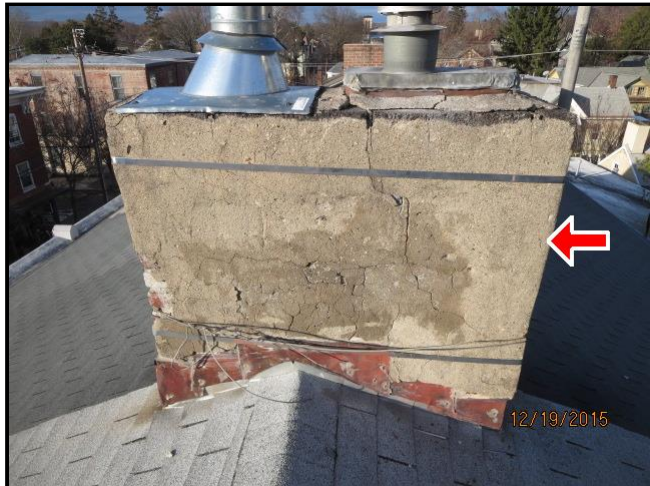
The masonry chimney is damaged with cracks. Further deterioration may occur if not repaired. A qualified contractor should inspect and repair as needed.

1.2 Item 1(Picture) Needs re-pointing

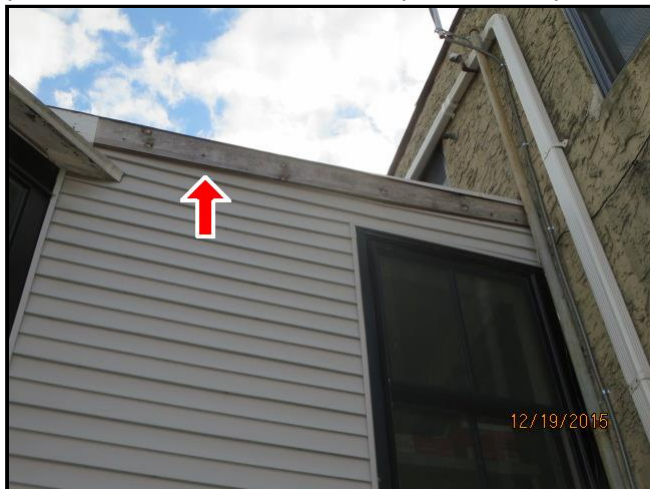
The Wood trim at the rear of building is exposed . Further deterioration can occur if not corrected. A qualified contractor should inspect and repair as needed.

2.0 Item 1(Picture) Exposed trim

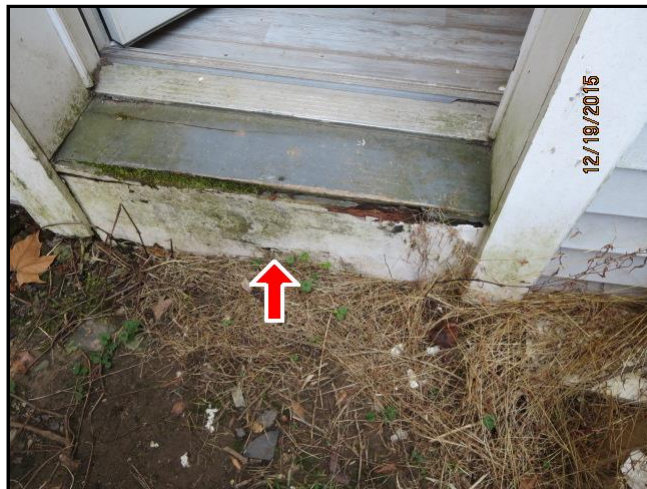
2.0 Item 2(Picture) Damaged wood

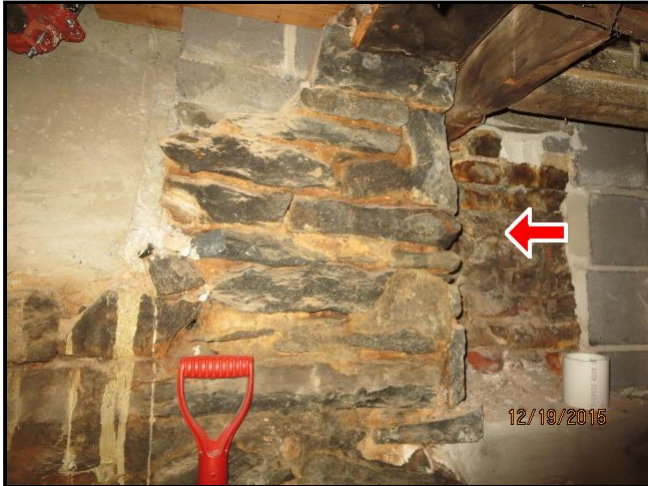
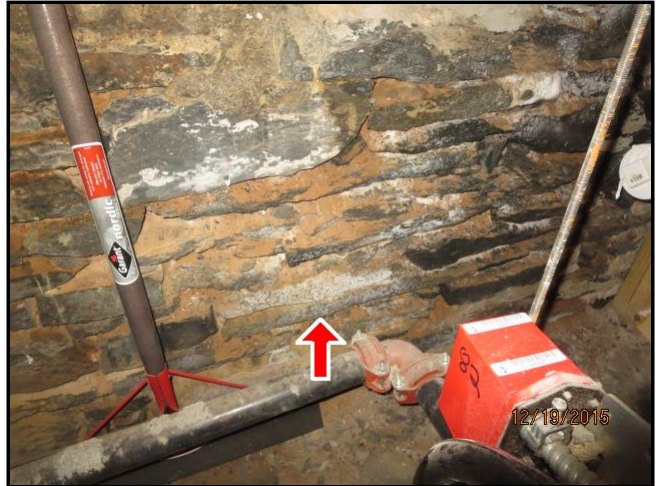
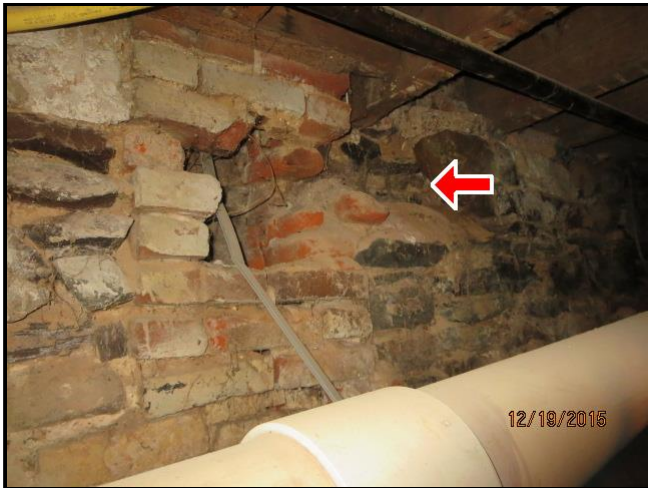
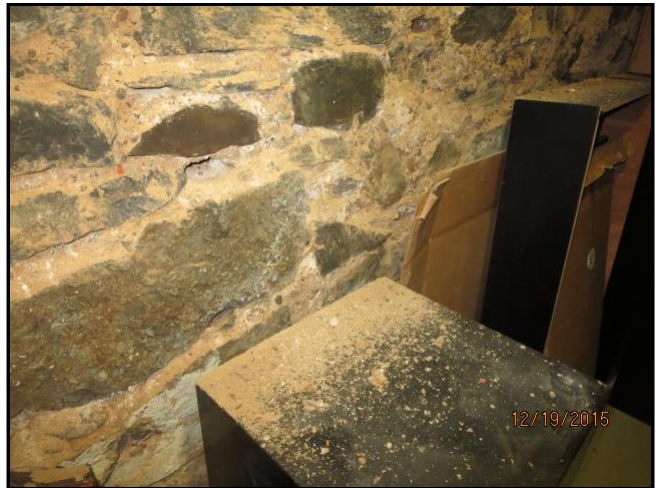
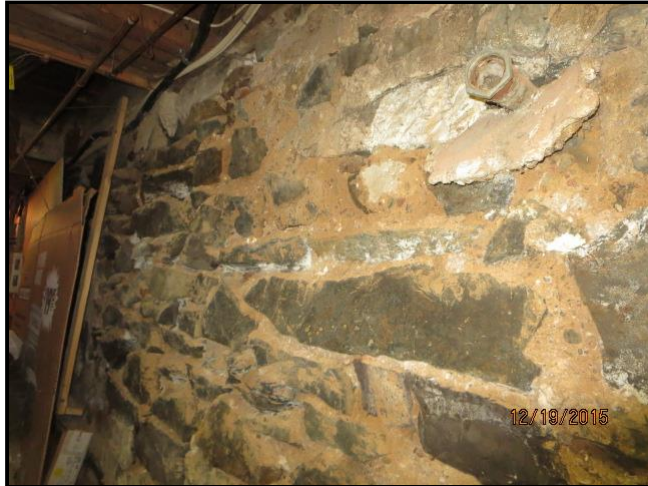
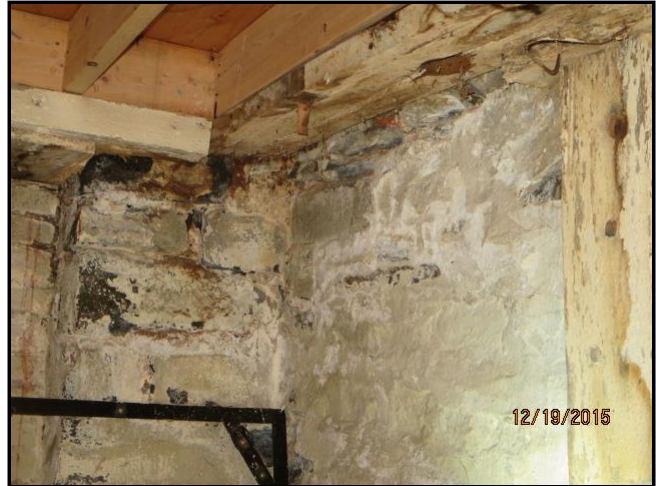
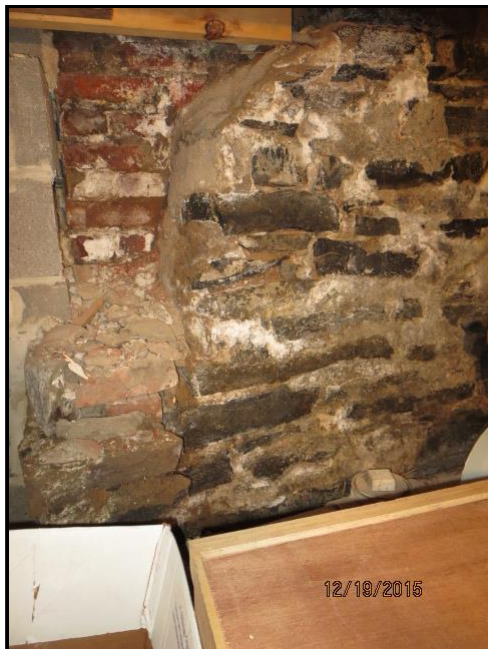
(1) The foundation wall at the front, rear and sides of building are deteriorated with loose and missing mortar. Repairs are needed and The wall(s) may need reinforcement. A skilled masonry contractor should perform the repairs.

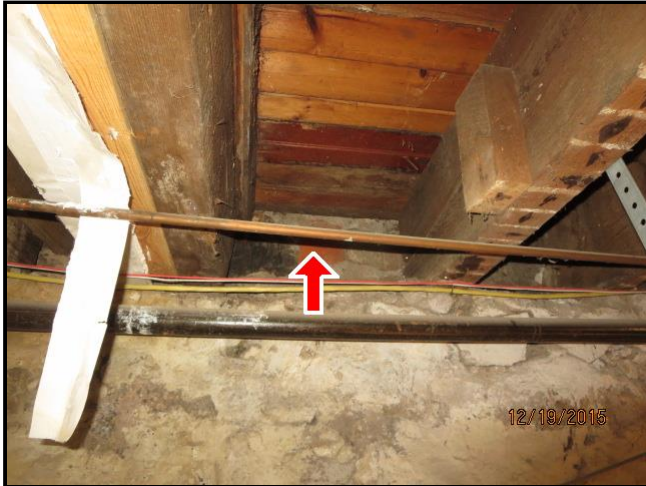
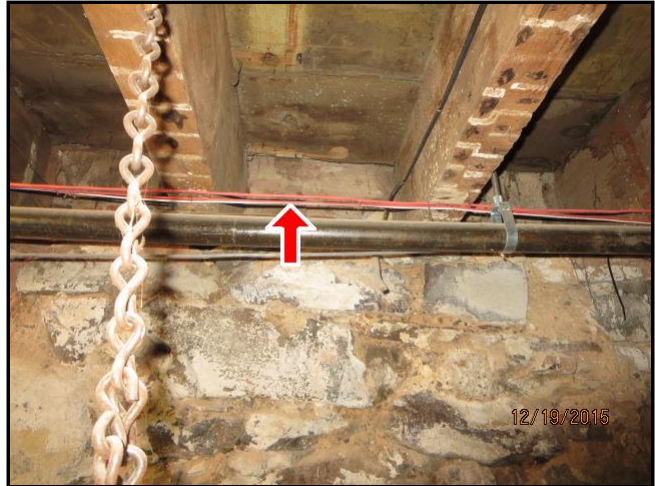
(2) Some tops of basement walls are missing Fire block insulation. Fire blocks help to prevent fire and smoke from traveling up the walls. Recommend a qualified person further evaluate and install

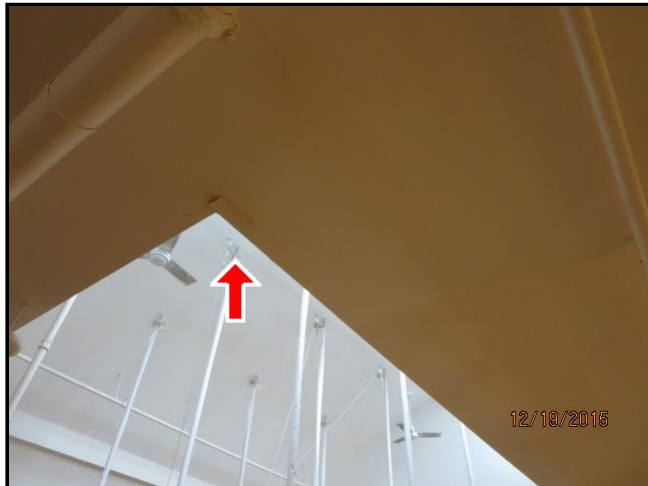
The Sheetrock on the ceiling reveals a water stain indicating a leak still exists at the 2nd floor ceiling . The moisture meter was used and it recorded 19% or higher, which indicates the leak has not been corrected. A qualified contractor should inspect and repair as needed. This leak maybe the results from standing water on the roof.

5.0.B Item 1(Picture) Water stain

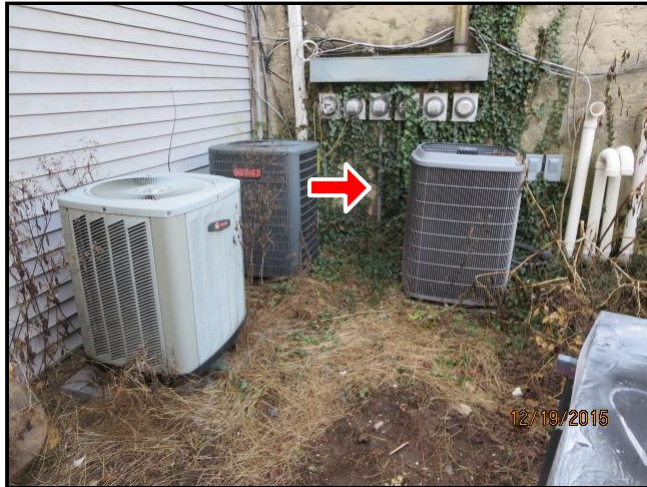
1 Condensers is from 2000 and will need to be replaced in the next 2-5 years cost will be around \$4,000

8.2 Item 1(Picture) Old unit

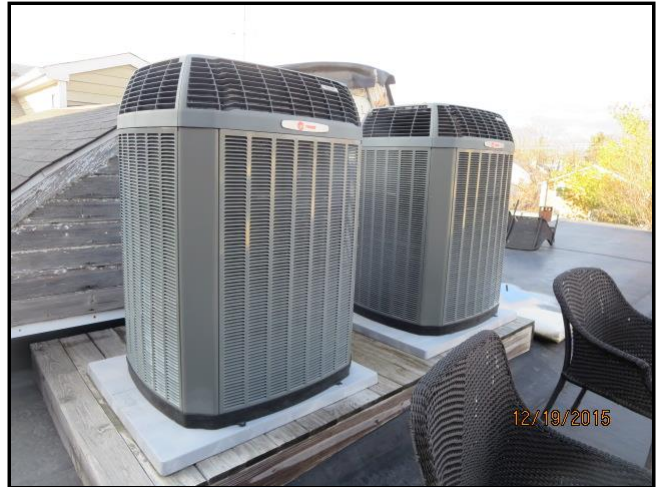
8.2 Item 2(Picture) Roof top units
