# *Pacific Homes Inspection*

## Property Inspection Report

xxxxxxx, xxxxx, CA 94534

Date of Inspection: 8/13/2019 Time: 1:00

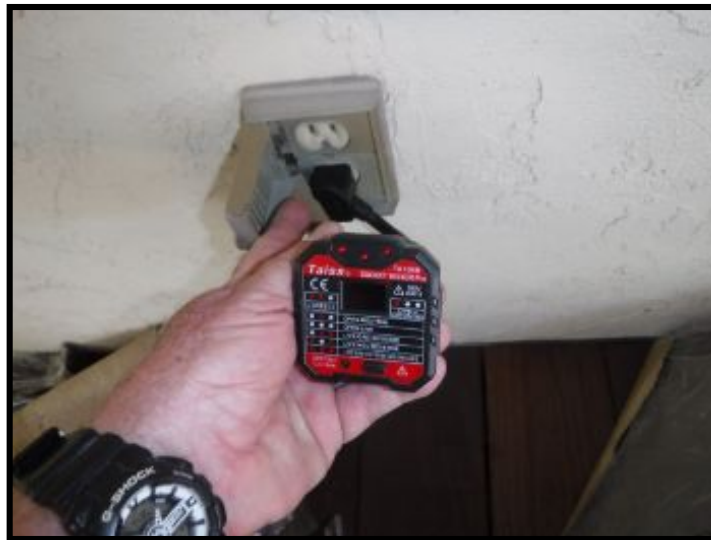
- 5.1. An inoperable electrical outlet was located in the deck area. See pic. This outlet should be corrected by a qualified electrical contractor.

Outlet not operational at deck area.

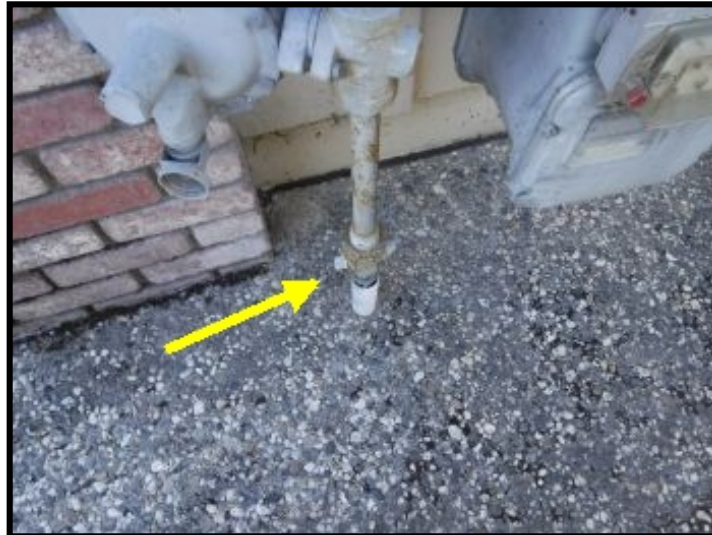
7.4. Suggest adding gas shutoff wrench to gas meter in case of emergency.

Main gas shut off. To turn of main gas shut off, turn valve so that flat area of the valve is perpendicular to the pipe. Make sure special wrench is always available in emergency.

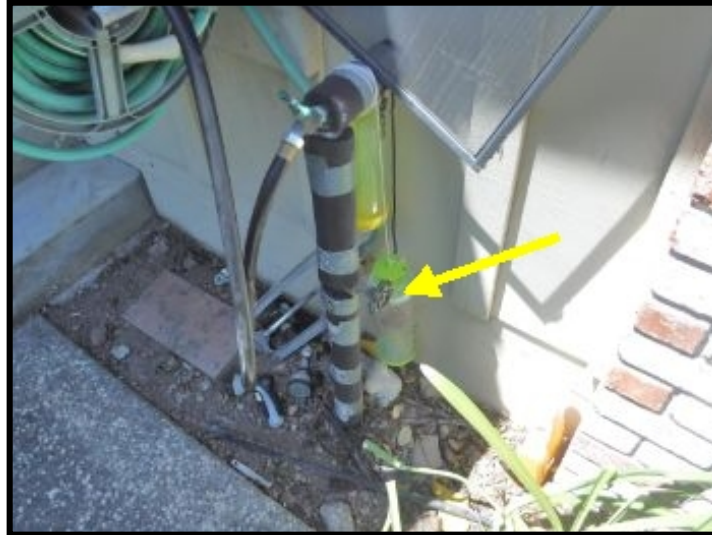
8.2. Although the main water supply shut-off valve was not operated at the time of the inspection it was visually inspected and appeared to be in serviceable condition.

Main water shut off.

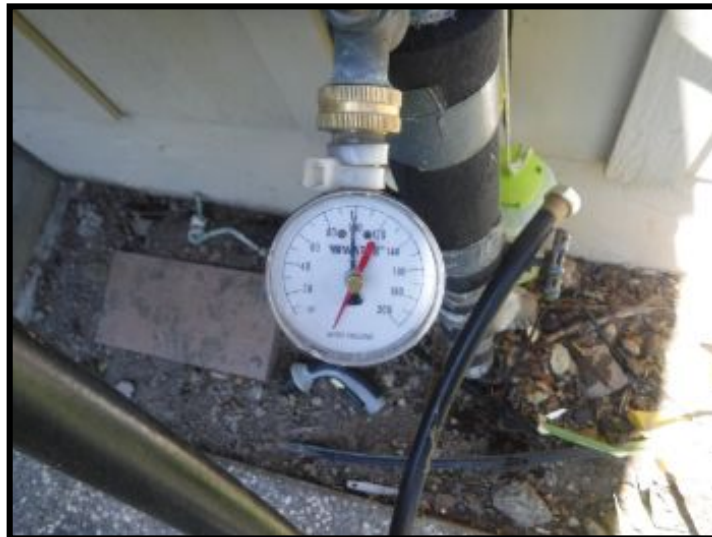
10.1. Home water supply pressure was slightly above the 80 pounds per square inch (PSI) limit considered the maximum allowable by generally-accepted current standards.

10.2. 100 p.s.i.

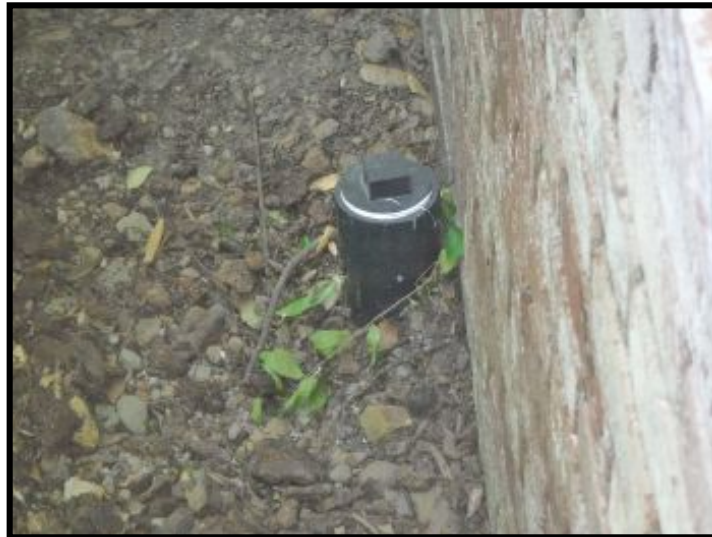
11.2. A waste pipe clean-out was located at the front of the home.

Sewer cleanout

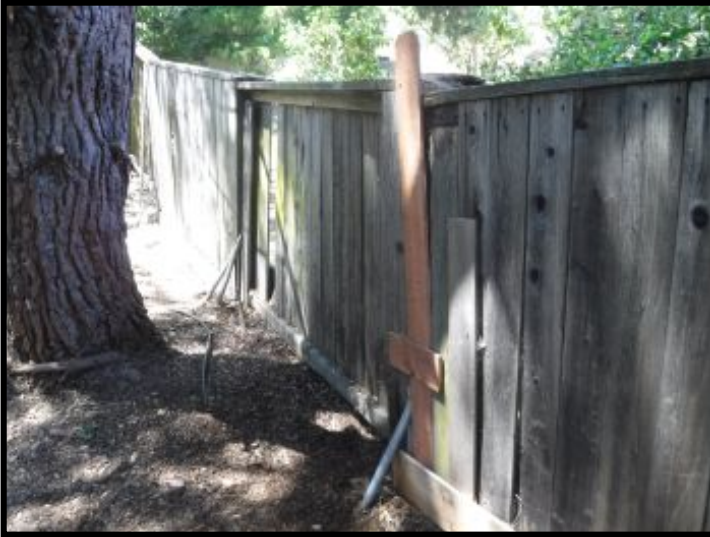
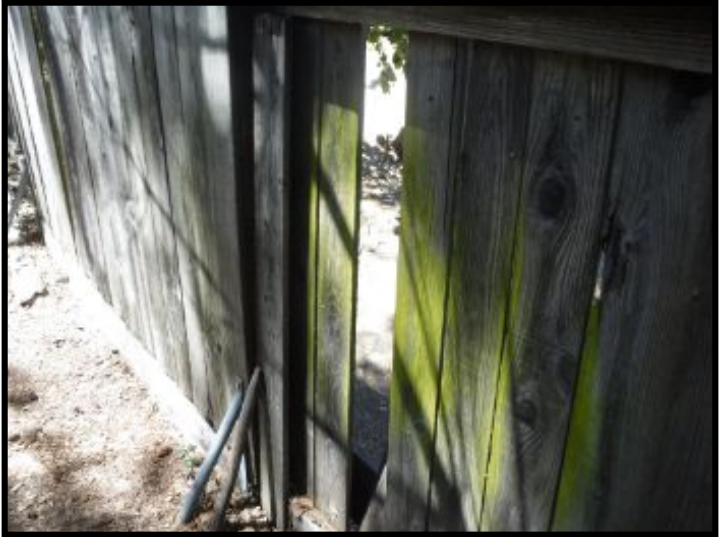
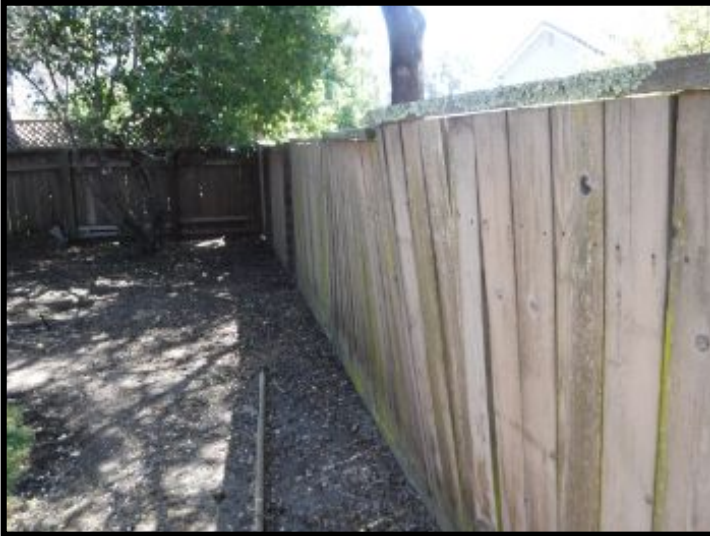
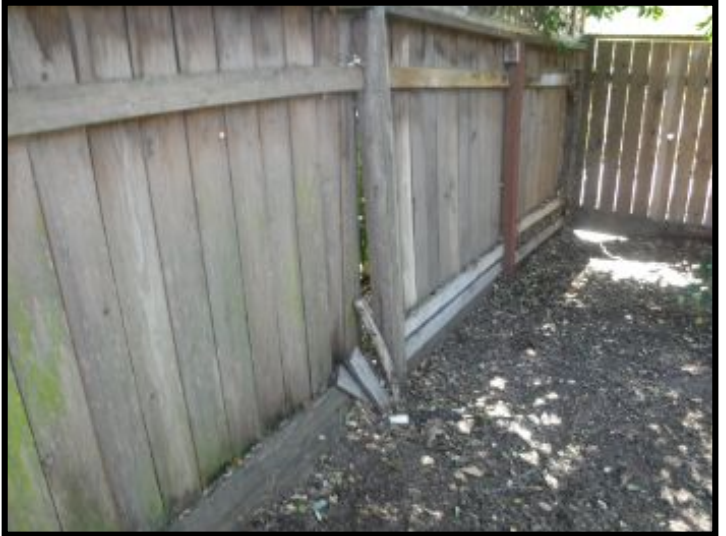
12.2. Some wood boards forming the fence barrier were damaged and in need of repair at the time of the inspection.

Fence leaning.

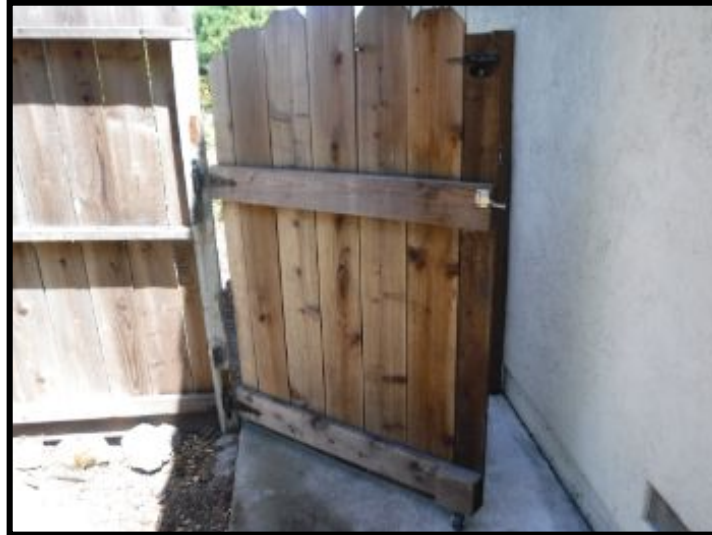
13.1. Gate is sagging. see pic.

Gate sagging.

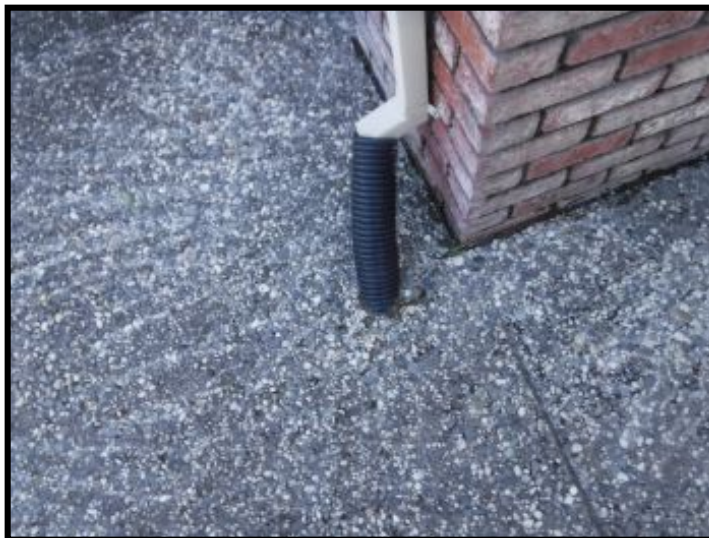
6.2. Ends of downspouts not visible under deck/concrete area/ground area; cannot determine if water is drained sufficiently away from foundation.

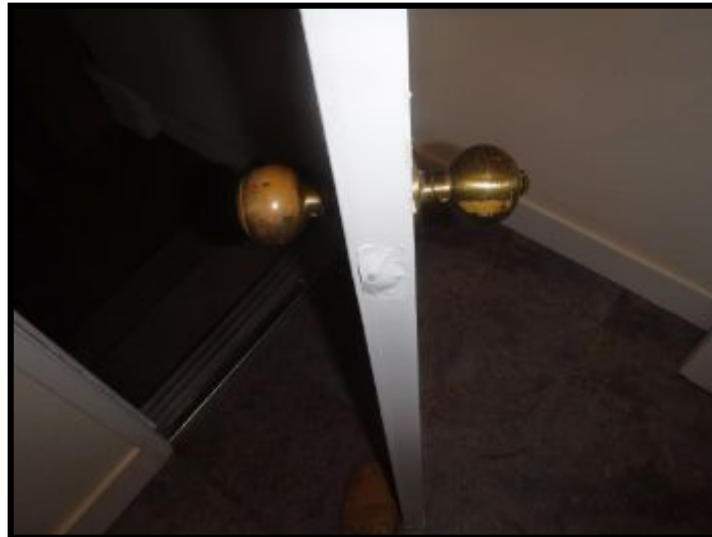
- 8.1. The door appears to be fire rated.
- 8.2. Auto closure present and operating.
- 8.3. Door does not close, needs adjustment.

Lock taped.

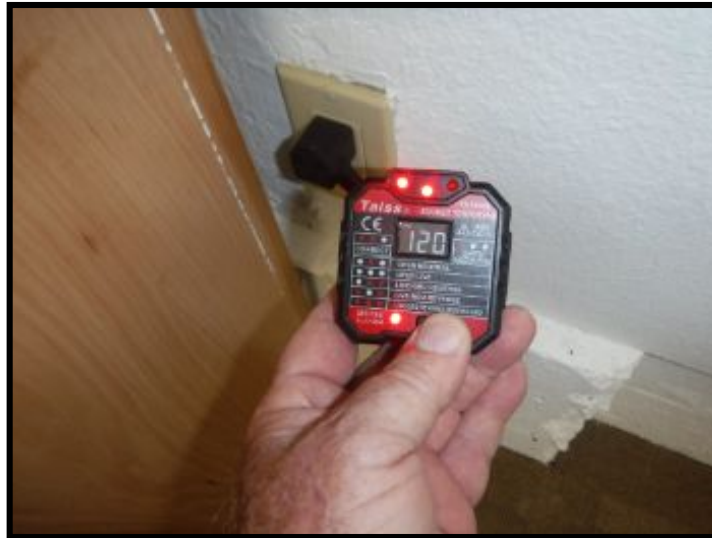
12.1. GFCI did not respond to test, suggest replacing for safety.

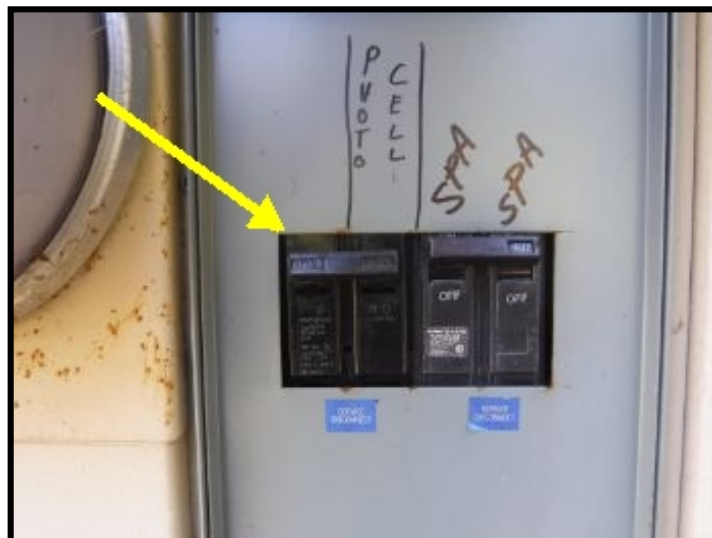
Main electrical shut off.

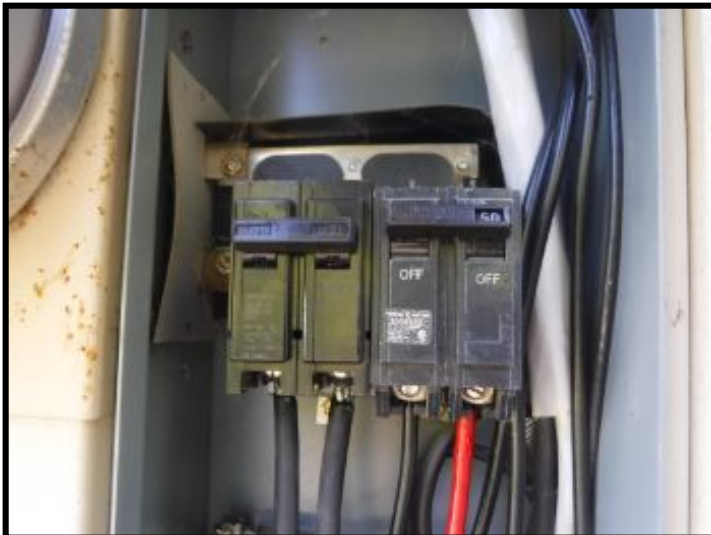
Main electrical panel.

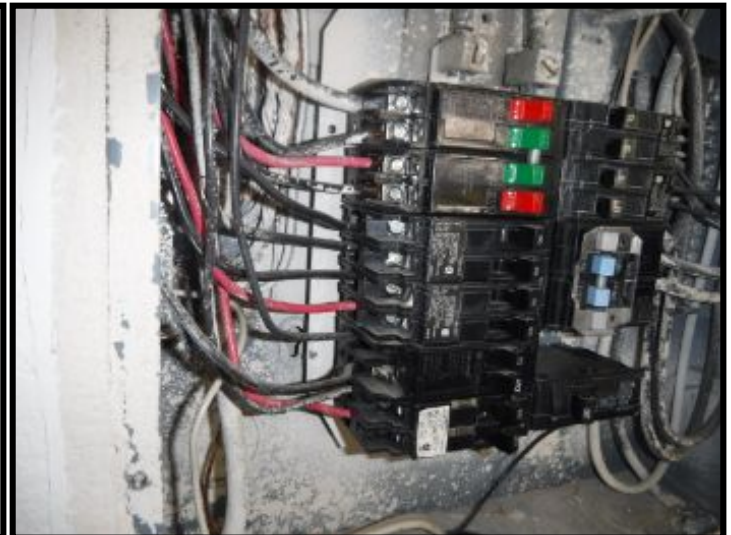
Sub electrical panel.

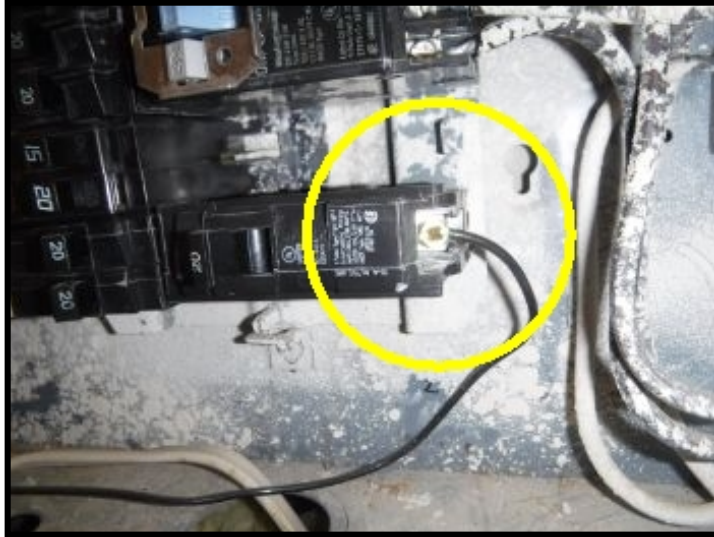
6.2. In the sub electrical service panel, a branch conductor was connected to a circuit breaker for which the wire size was insufficient. 14 gauge wire should be 12 gauge. This is a defective condition which should be corrected by a qualified electrical contractor.

Wire size insufficient for breaker.

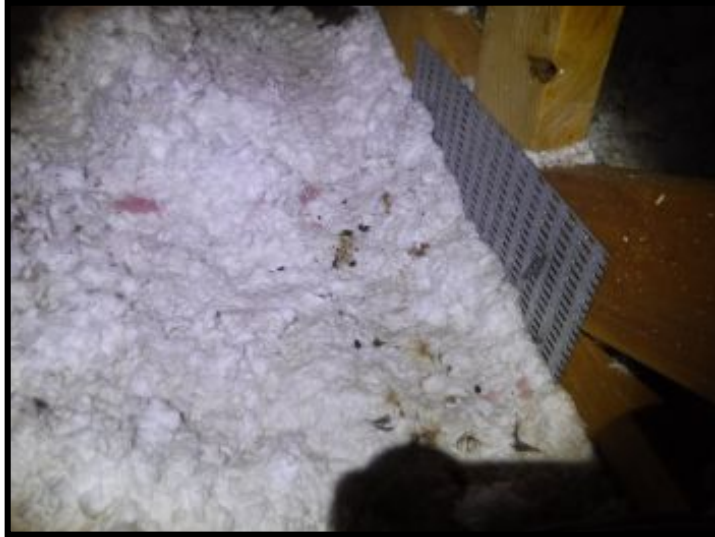
- 8.1. The attic had minor amounts of rodent feces visible. You should consider setting traps for mice and closing off avenues of entry.

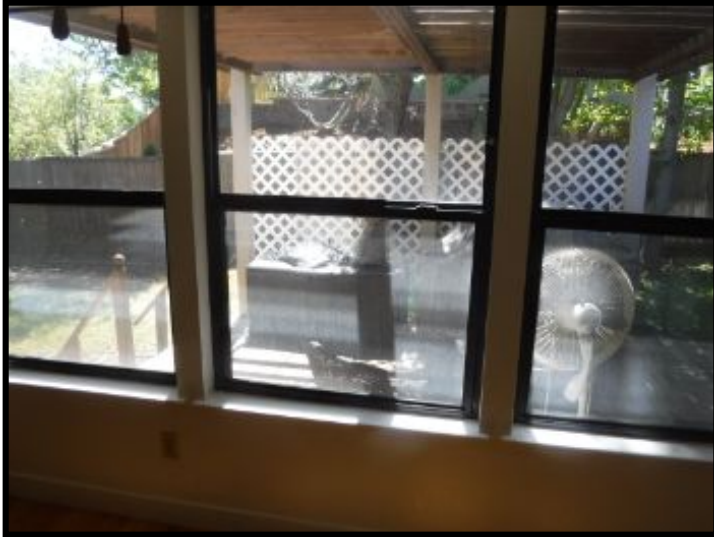
7.7. The windows in the breakfast/dining area had damaged travelers which made the window difficult to operate.

Damage noted.

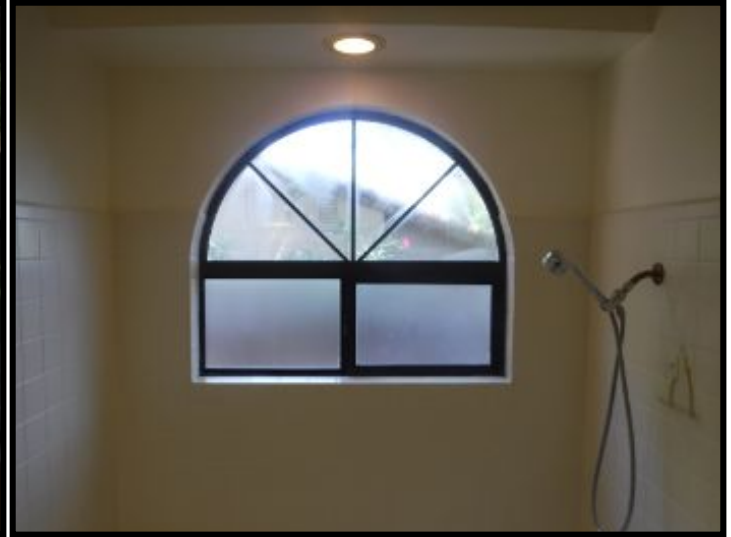
7.6. One window in the bathroom showed sign of loss of seal/condensation, recommend repair or replace to provide energy savings and prevent hazed window from limiting view out of window.

Loss of seal/condensation.

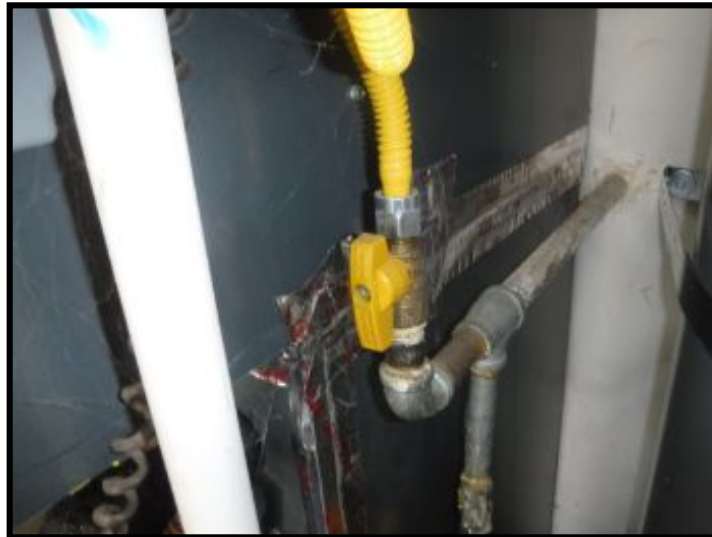
5.1. Gas shut off valves were present and functional.

Furnace gas shut off.

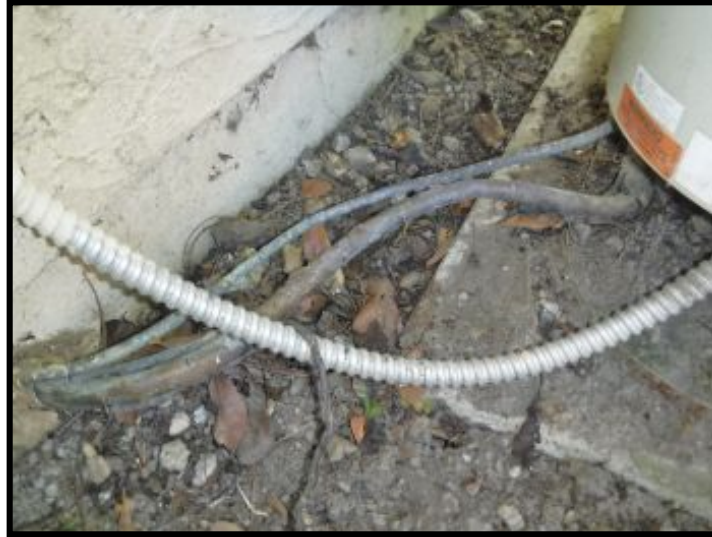
8.1. Missing insulation at A/C unit.

Missing insulation noted.

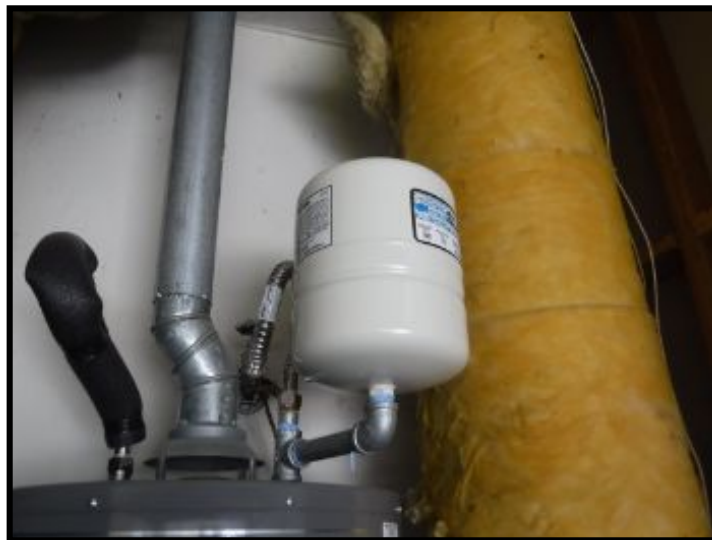
1.4. The water heater had an expansion tank installed to allow for thermal expansion of water in the plumbing pipes. The expansion tank appeared to be properly installed and in serviceable condition.

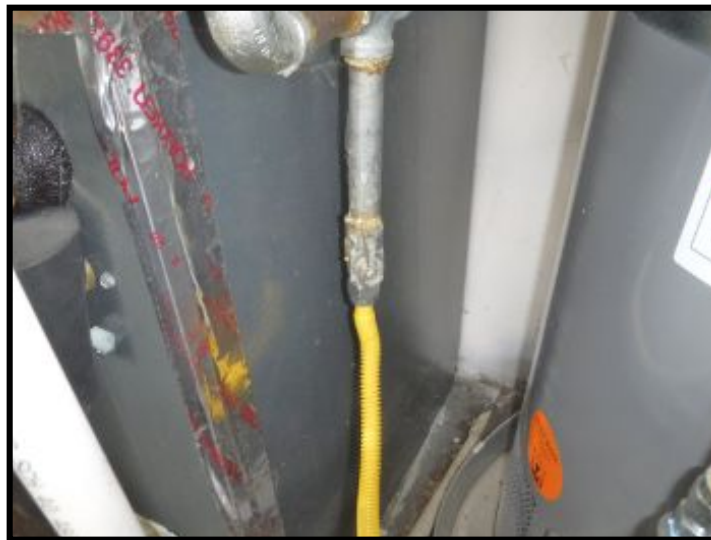
8.1. The gas shut-off appeared to be in serviceable condition at the time of the inspection. It was not operated but was visually inspected.

Water heater gas shut off.

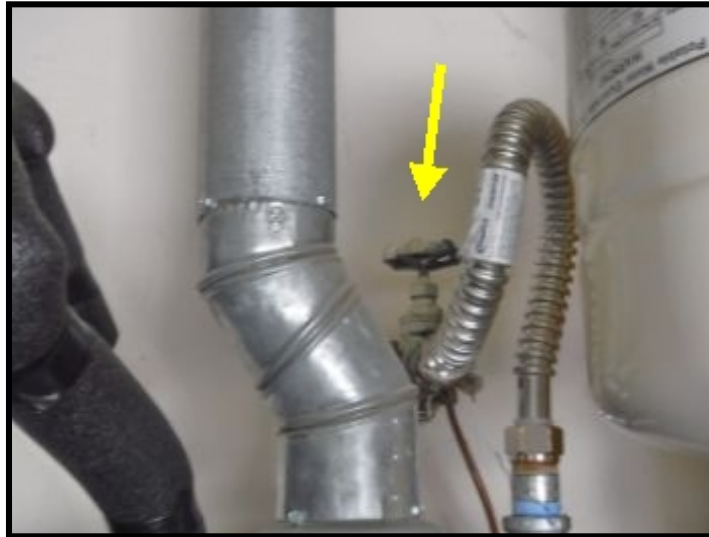
9.1. The water shut-off appeared to be in serviceable condition at the time of the inspection. It was not operated but was visually inspected.

Water heater water shut off.
