BUCKEYE HOME INSPECTIONS OF NEO

RESIDENTIAL REPORT & WELL SYSTEM INSPECTION

1234 Main St.
Geneva, OH 44041

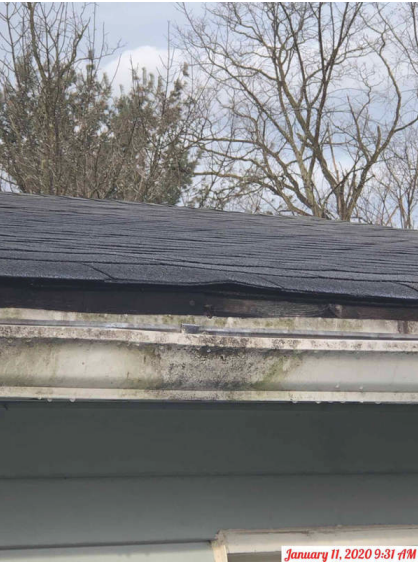
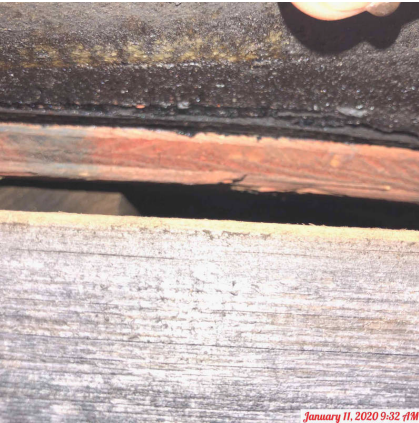
MISSING FLASHING

I observed areas where flashing was missing. Not installed. These areas of missing flashing are prone to water penetration. Flashing is installed to provide protection against roof leaks and to divert water away from certain areas. This absence could lead to a material defect if not corrected as soon as possible.

Recommendation

Contact a qualified roofing professional.

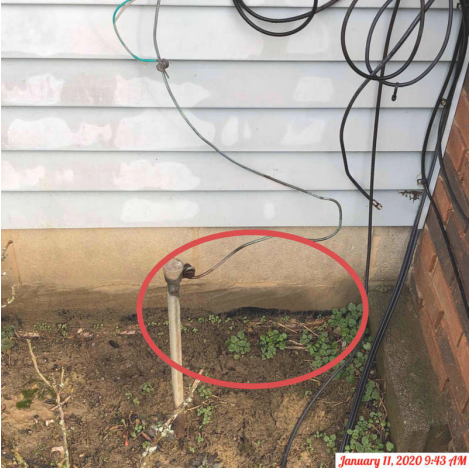
7.1.1 Wall-Covering, Flashing & Trim

DETERIORATION AT MASONRY EXTERIOR

I observed indications of masonry deterioration at the time of my inspection. Recommend correction.

Recommendation

Contact a qualified masonry professional.

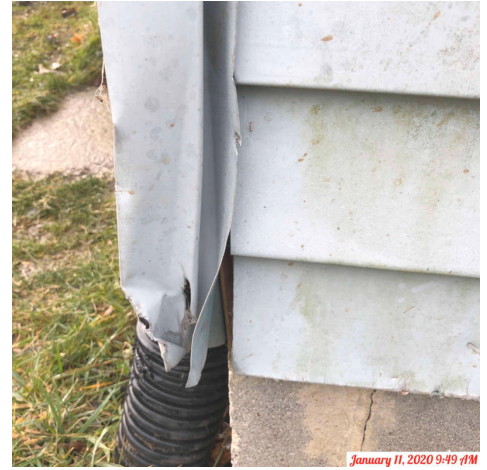
7.1.2 Wall-Covering, Flashing & Trim

CRACKING - MINOR

Siding showed cracking in one or more places. Recommend monitoring.

Recommendation

Contact a handyman or DIY project

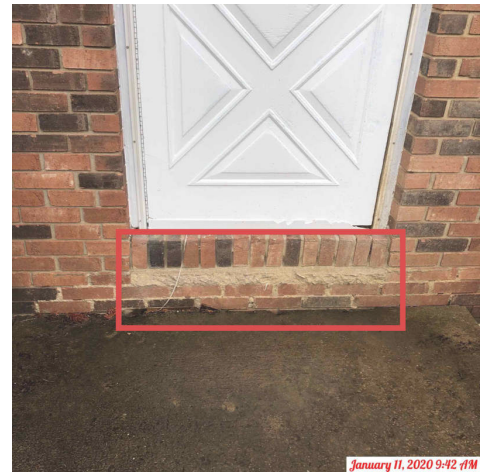
7.6.1 Stairs, Steps, Stoops, Stairways & Ramps

TRIP HAZARD AT STEP

I observed a trip hazard at a step. This condition is a safety hazard. Correction and further evaluation is recommended.

Recommendation

Contact a qualified masonry professional.

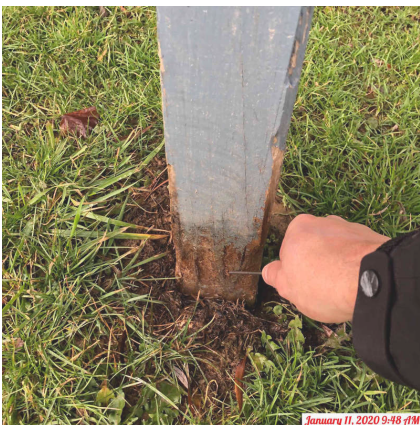
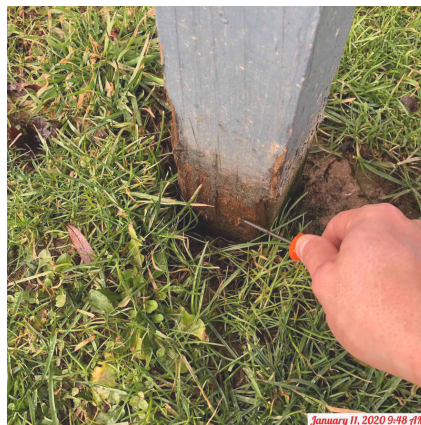
7.8.1 Porches, Patios, Decks, Balconies & Carports

DETERIORATED CONDITION AT DECK

I observed indications of deteriorated conditions at the deck components. Precautions should be made to cause no further damage to these areas while caring for your lawn. Recommend using products to apply and preserve the life of the wood in this area.

Recommendation

Contact a handyman or DIY project

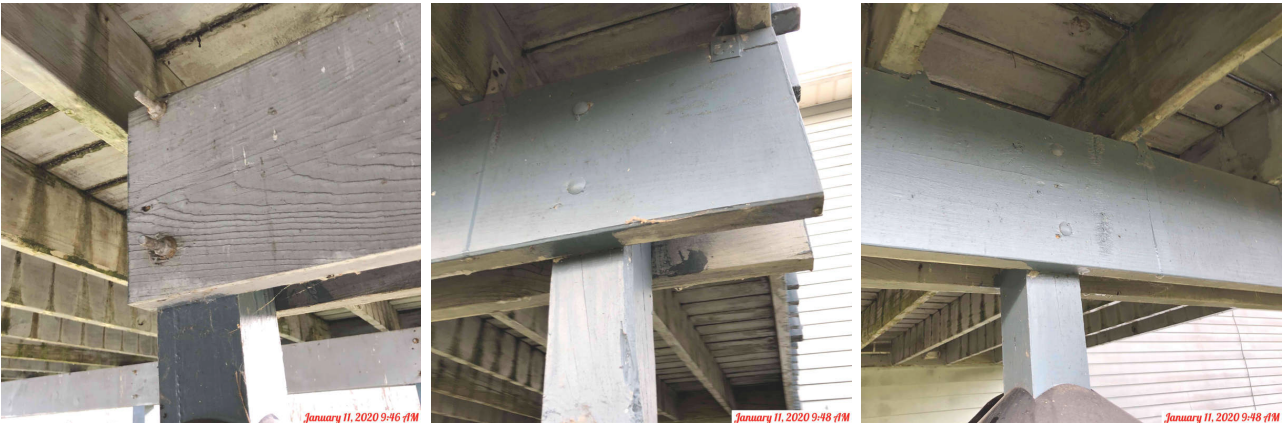
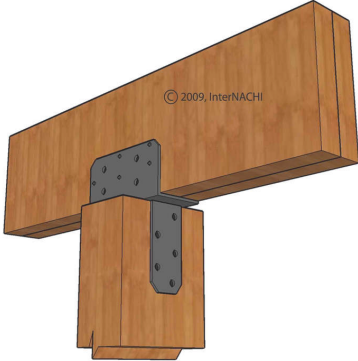
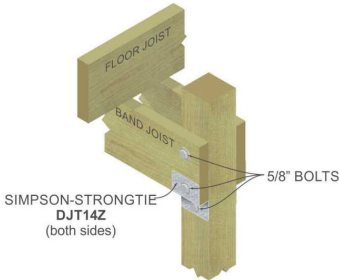
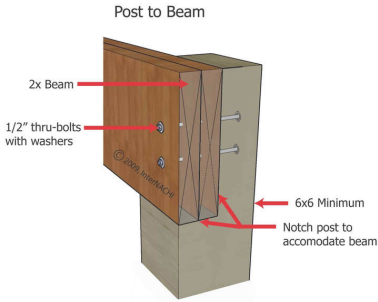
7.8.2 Porches, Patios, Decks, Balconies & Carports

I observed deck girders being held together by bolts. Bolts are usually not intended to support the entire weight of the deck structure. Ledger board attached to home appears to be installed appropriately. Recommend further evaluation by a deck contractor.

Post to Beam Attachment

Recommendation

Contact a qualified deck contractor.

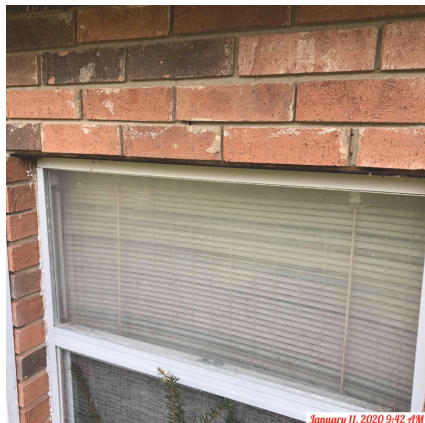
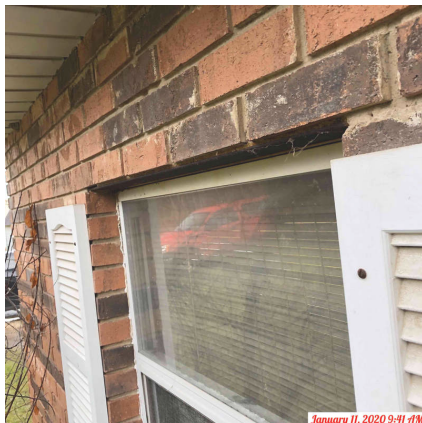
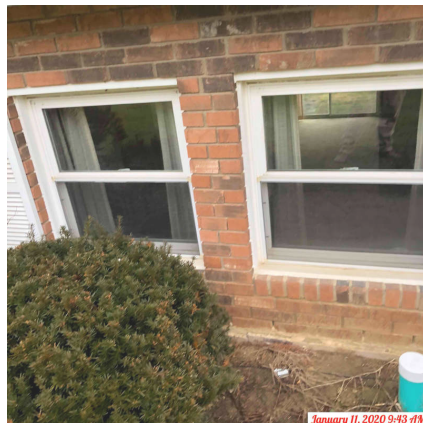
7.10.1 Windows

MISSING FLASHING

I observed missing flashing on exterior windows. This can lead to water intrusion and rusting of the lintels. Recommend installation. You can compare the pictures to see proper installation at your other windows.

Recommendation

Contact a qualified window repair/installation contractor.

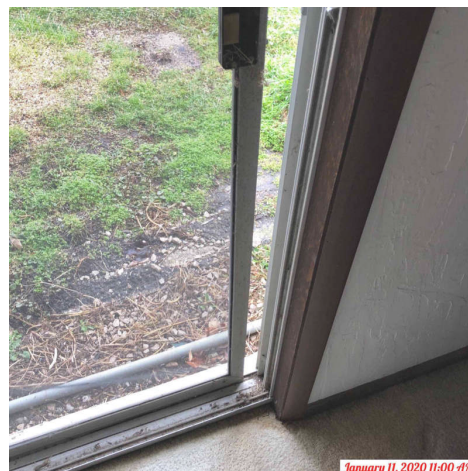
7.11.2 Exterior Doors

SCREEN DOOR DEFECT

I observed a defect at the screen door.

Correction and further evaluation is recommended.

Recommendation

Contact a handyman or DIY project

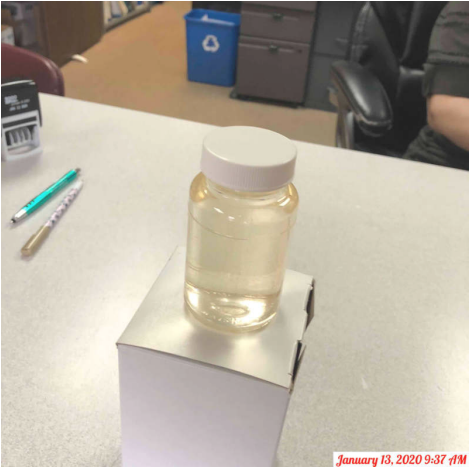
The water sample taken from the well was discolored. Discoloration may occur for a variety of reasons. Recommended to monitor because this sample came directly from well with no filtration, and the well is unused (per the homeowner).

Recommendation
Recommend monitoring.

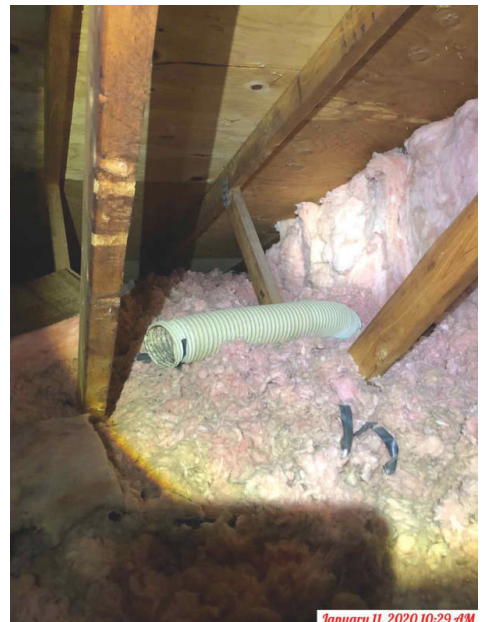
11.4.1 Ventilation in Attic

IMPROPER VENTILATION

Recommendation

Contact a qualified professional.

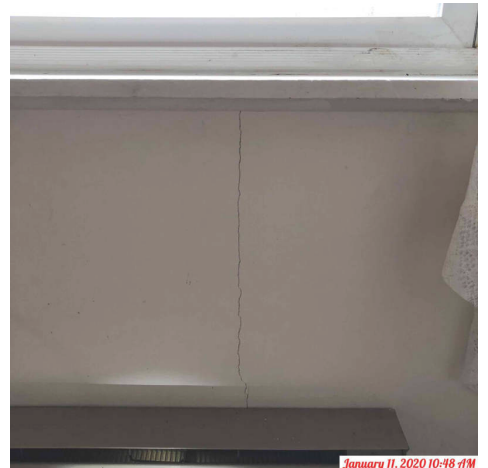
12.4.1 Floors, Walls, Ceilings

MINOR CRACK

Recommendation

Recommend monitoring.

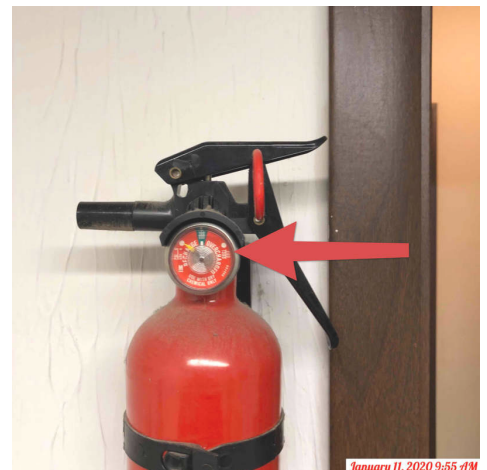
15.4.1 Fire Extinguishers

NEED REPLACED

I observed a fire extinguisher that needed recharged. Recommend replacement.

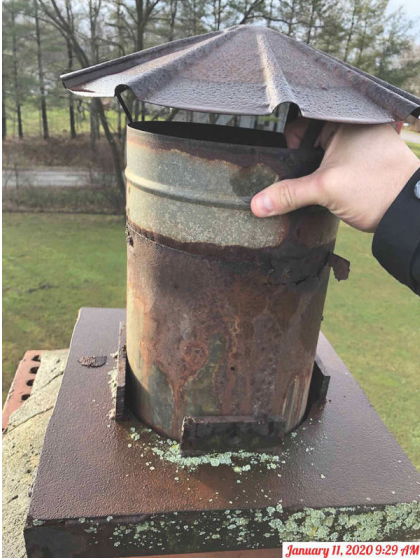
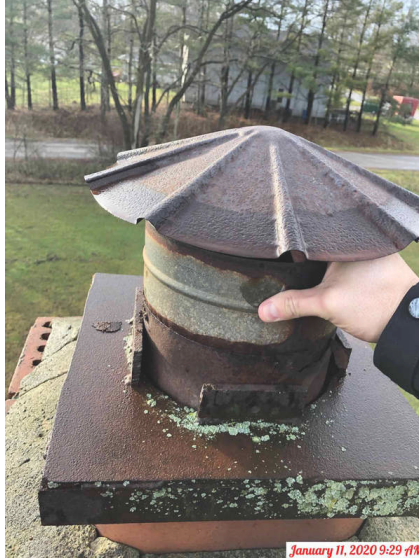
19.1.2 Masonry Chimney

LOOSE INTERIOR AND CORROSION OF FLUE LINER

Recommendation

Contact a qualified chimney contractor.

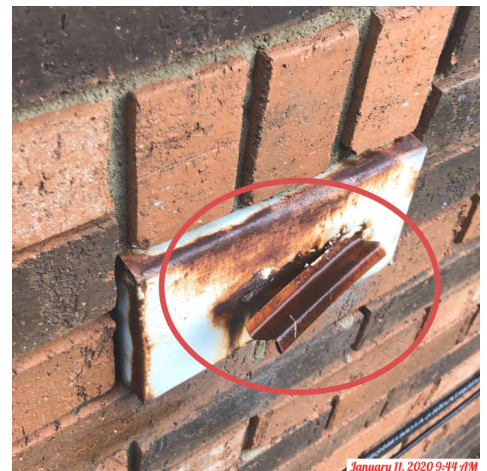
19.1.3 Masonry Chimney

CHIMNEY CLEAN OUT DEFECT

Recommendation

Contact a qualified chimney contractor.
