CNM
Inspection Services
Construction & Remodeling

Client(s): John Doe
Inspection Date: 8/29/2014

Date: 8/29/2014	Time: 12:30:00 PM	Report ID: 201408291
Property: 1234 Anywhere Dr, Rochester Hills, MI 48309		Prepared By: CNM

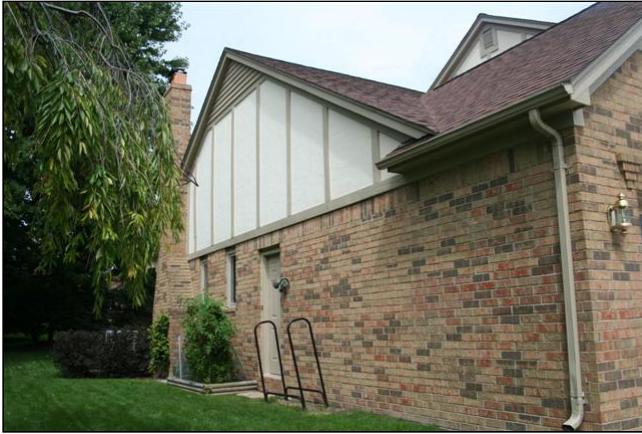
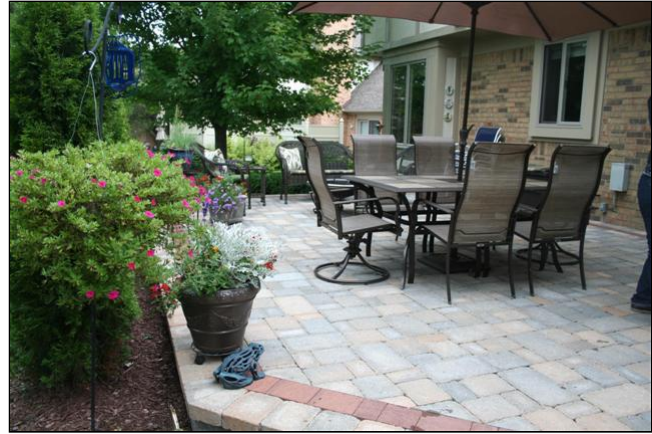
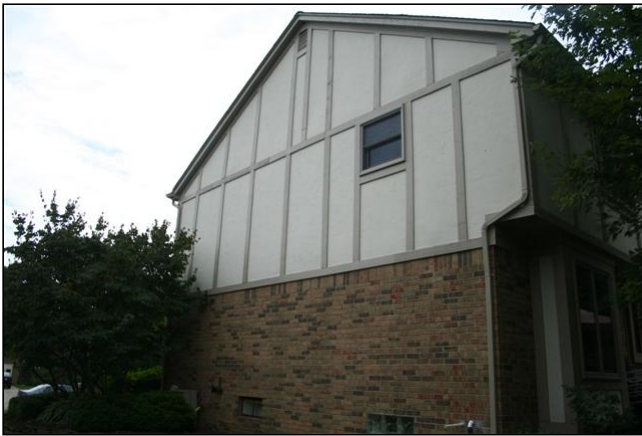
EXTERIOR PHOTO(S)

- ◆ Some brick cracking is visible at garage and right side of house; these areas should be repaired by a qualified mason to help prevent water intrusion and further damage.

We suggest caulking/sealing the exterior as needed to help shed water and to maximize energy efficiency. Pay attention to all openings and gaps as well as old caulk that has deteriorated.

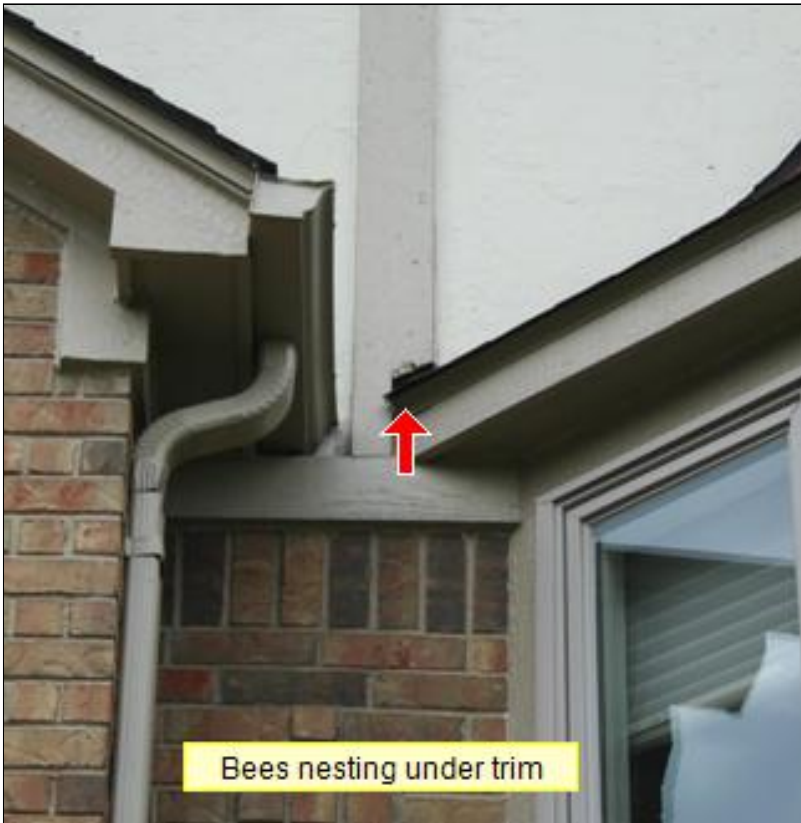
TRIM [Inspected]
 ♦ Gaps/holes should be sealed against the weather birds and pest.

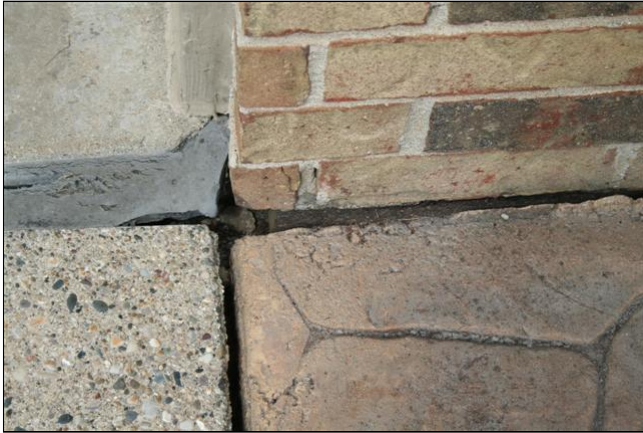
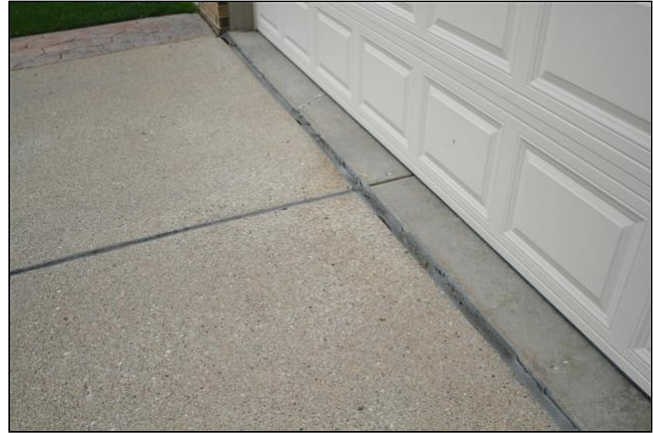
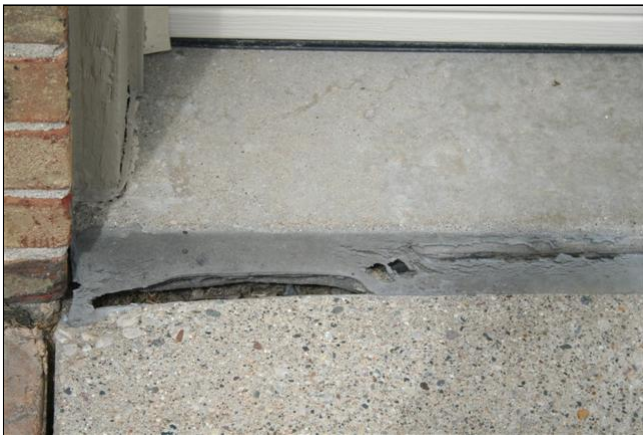
DRIVEWAYS/WALKS/PATIOS LEADING TO ENTRANCE(S) [Inspected]

- ◆ Common cracking and minor settlement noted. Sealing the cracks and gaps between slabs can help reduce the chances of settlement from water intrusion. If the settlement threatens to become a trip hazard it should be corrected.

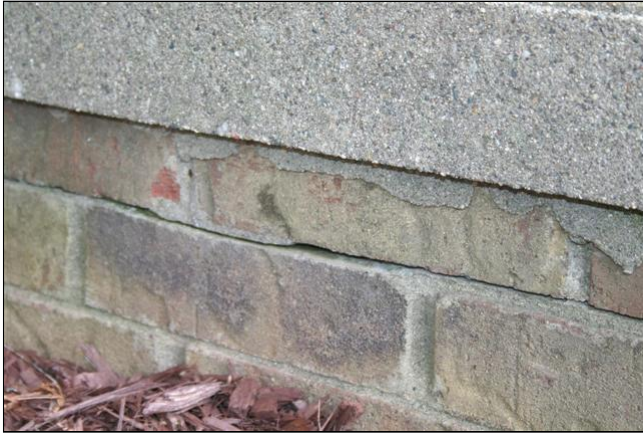
- ◆ Some tuckpointing needed under front porch slab to prevent further damage.

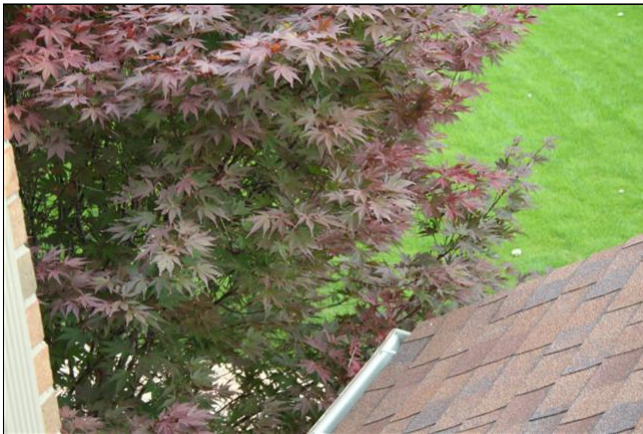
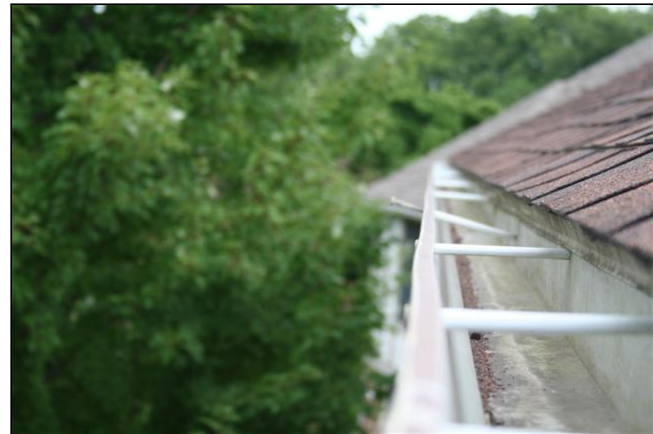
- ◆ We suggest trimming vegetation well away from the structure to provide free airflow, reduce chances of damage and allow for routine observation and maintenance.

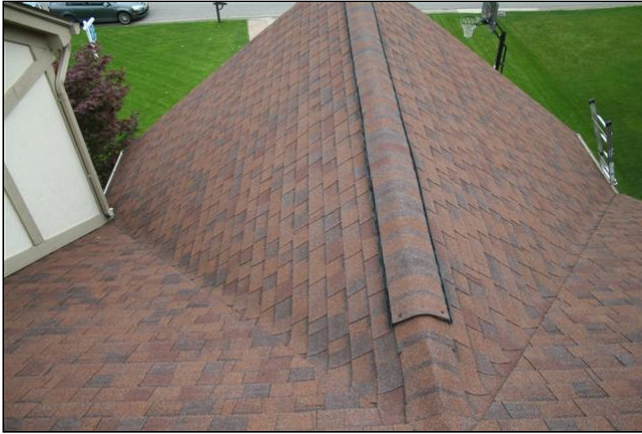
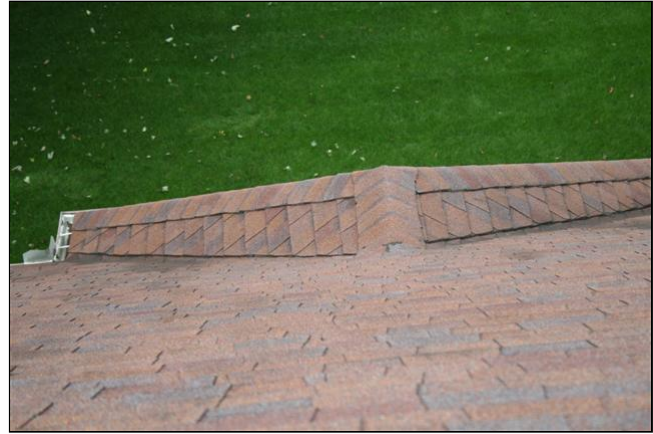
ROOF PHOTO(S)

- ❌ ♦ Damaged shingles should be replaced to reduce risk of leaks.

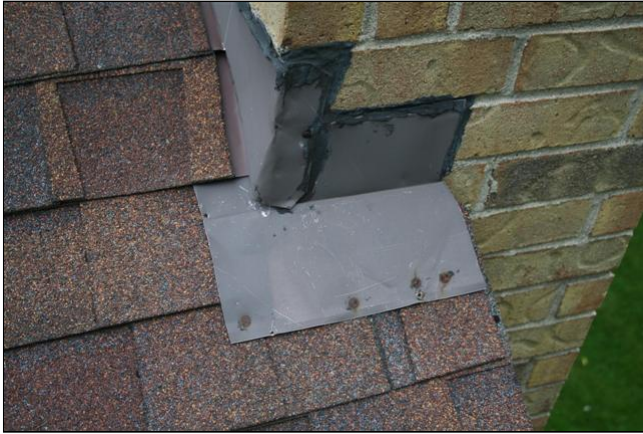
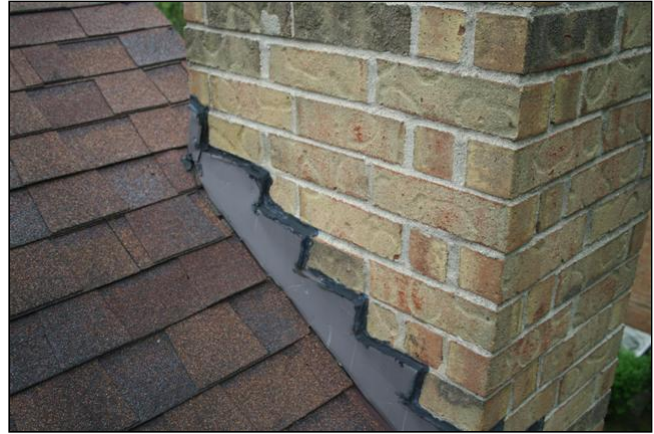
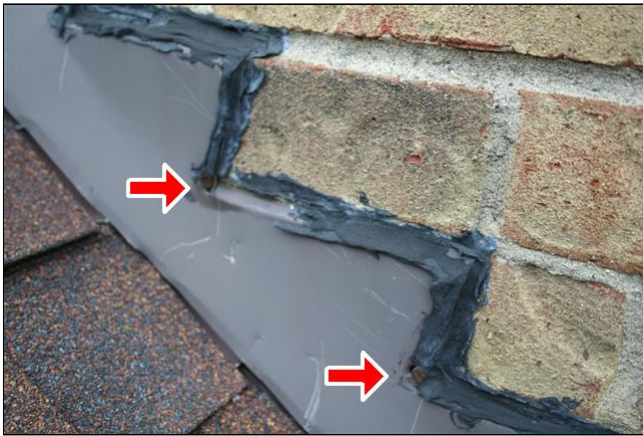
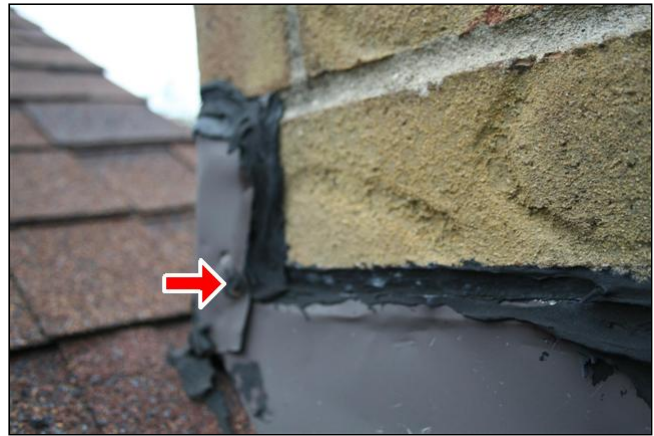
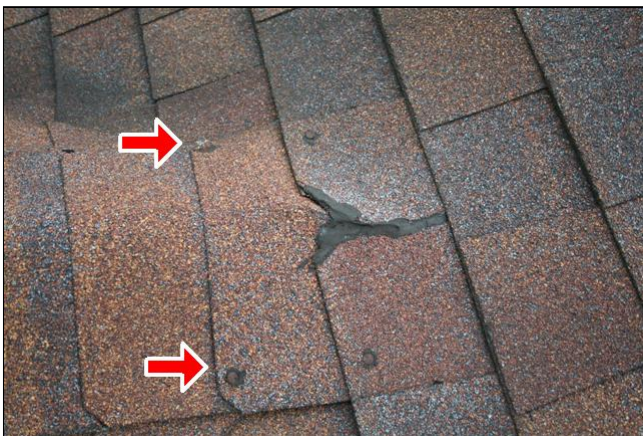
FLASHINGS [Inspected]

- ⚠️ ♦ We advise sealing all exposed fasteners to reduce the chances for moisture penetration. As part of routine maintenance, caulking around the fasteners should be periodically checked and resealed as needed.

Counter flashing need to resealed to prevent water intrusion.

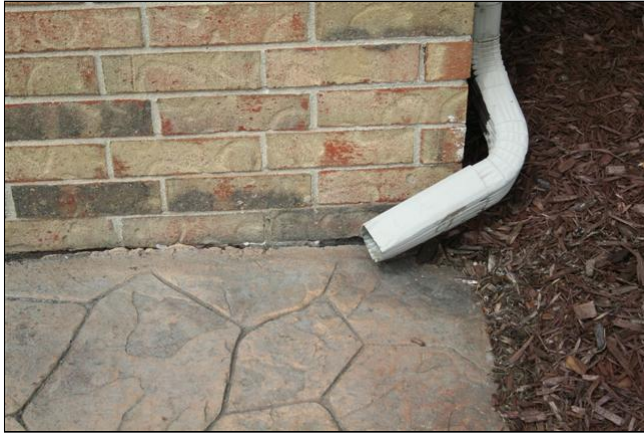
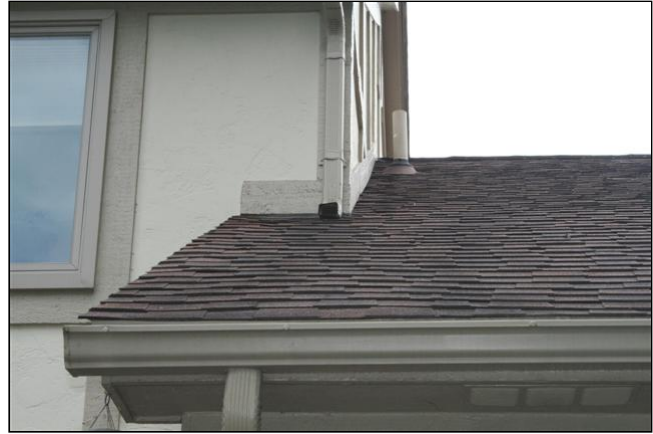
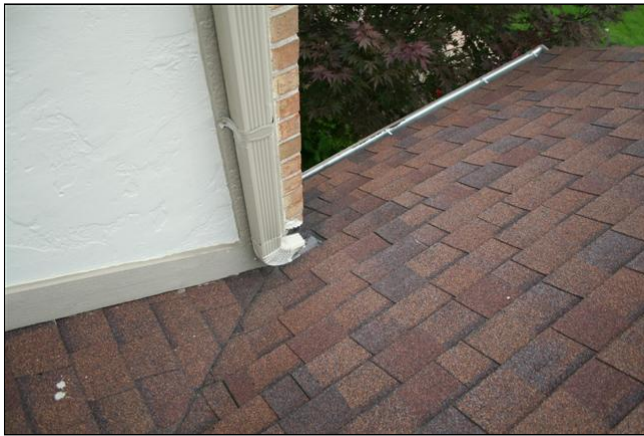
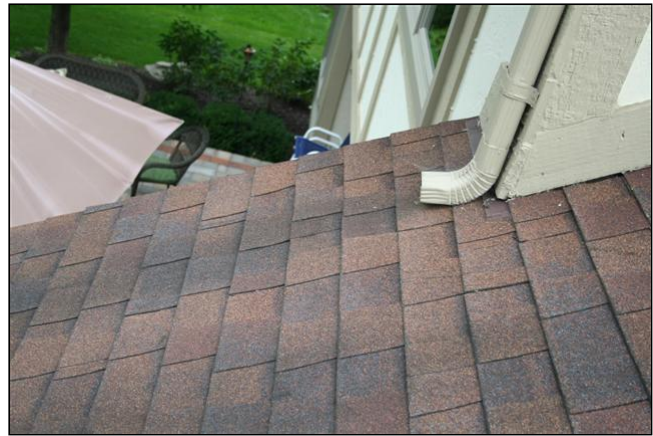
♦ Gutters that drain onto walks/drives can create a slip and fall hazard. Advise having re-routed away from the home to an alternate location

Downspout(s) drain onto the roof surface. Although a common practice, we suggest alternate drainage (directly to gutters or grade) to reduce the chances of roof leaks and accelerated roof wear.

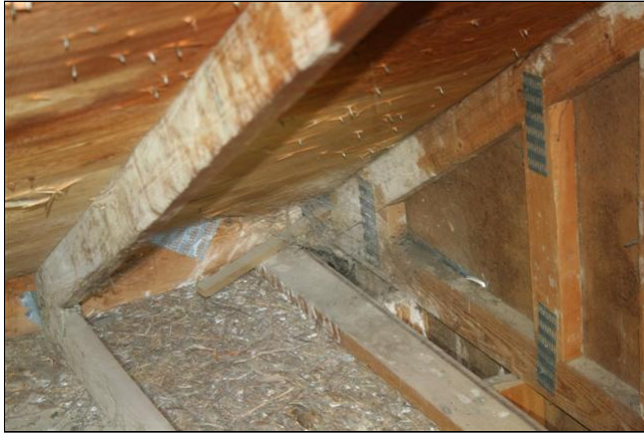
- ☒ ◆ Bird nest material noted in the attic. We suggest having removed and the attic appropriately sealed against pest intrusion.

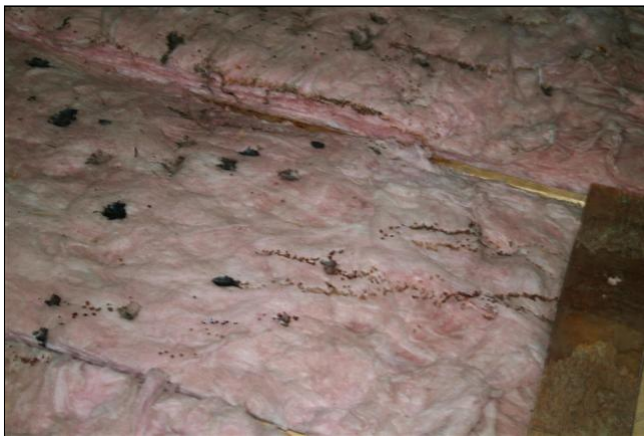
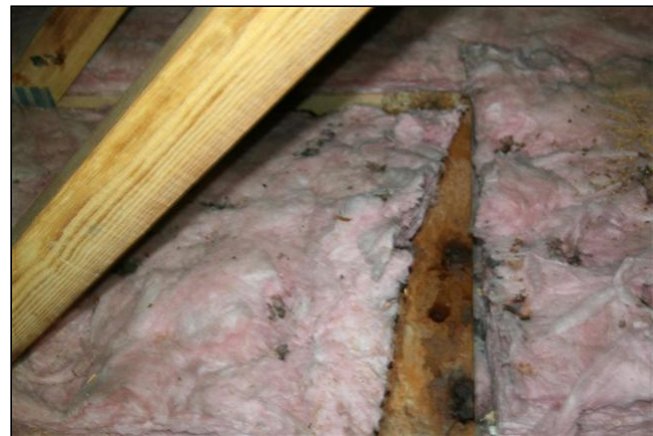
- ❌ ♦ Rodent droppings were noted in the attic. We suggest obtaining the history of any pest activity and having evaluated and treated as needed by a qualified pest control operator.

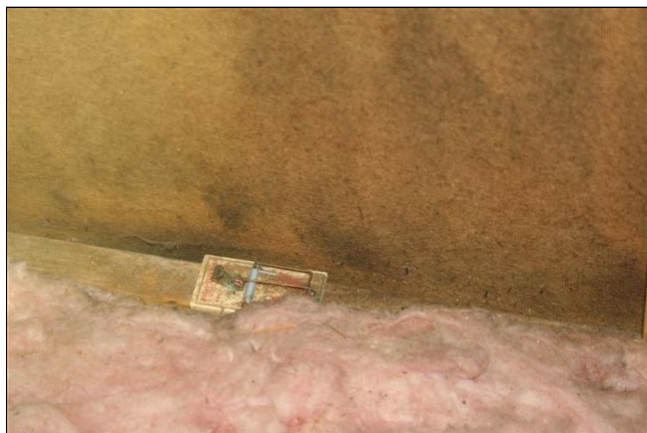
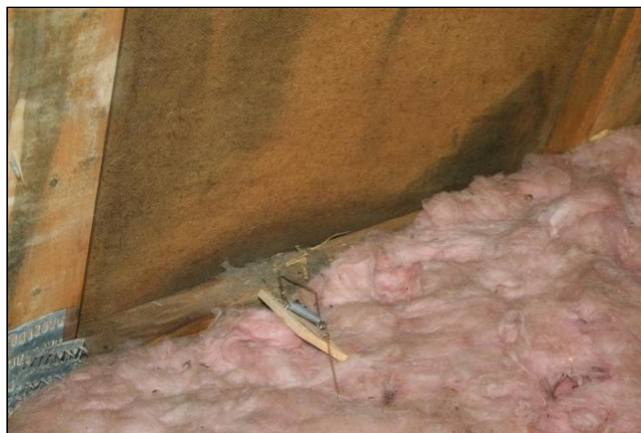
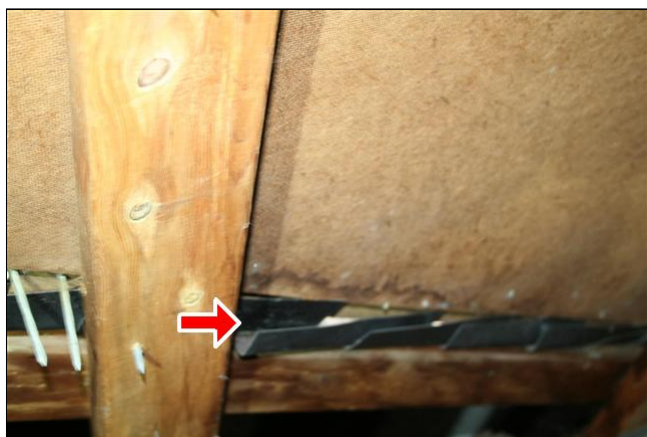
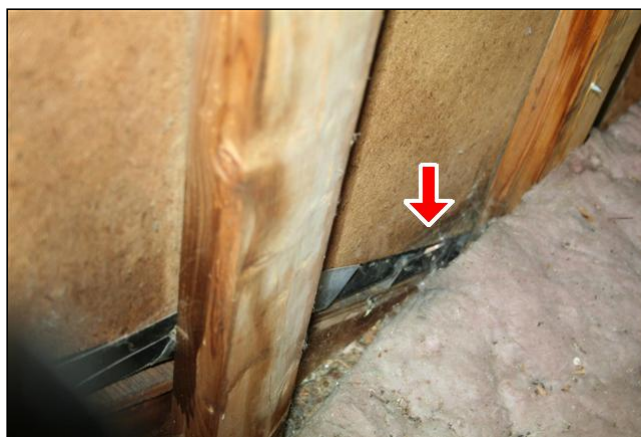
- ❌ ♦ There is a gap large enough for animal entry in the attic and signs that pests have entered the attic. The opening should be appropriately sealed and the attic checked for pests.

Rodent bait traps noted; we suggest obtaining history of any pest activity and having treated as needed by a qualified pest control company.

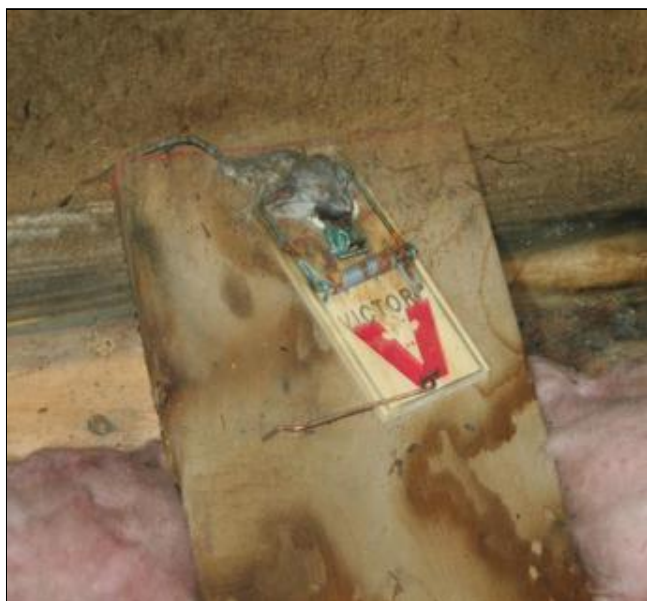
- ◆ Dead mouse noted in the attic. We suggest having removed and the attic appropriately sealed against pest intrusion.

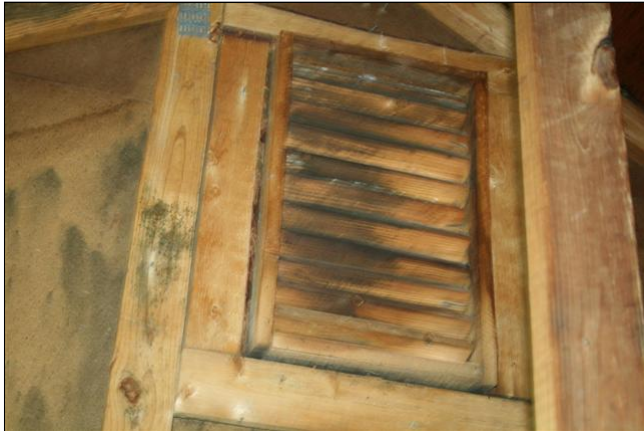
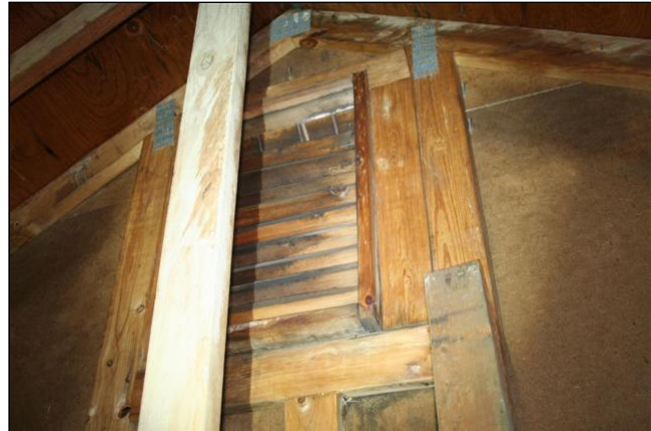
ATTIC VENTILATION [Inspected]

- ☒ ♦ In addition to ridge and soffit vents, there are Two gable vent serving the attic space. In recent years, it has been discovered that mixing ventilation systems can sometimes cause problems, ranging from short-circuiting ventilation patterns (and thus making them less effective) to increasing the risk of water intrusion. We suggest having corrected as needed and assuring balanced ventilation system. One manufacturer's site with good information is www.airvent.com .

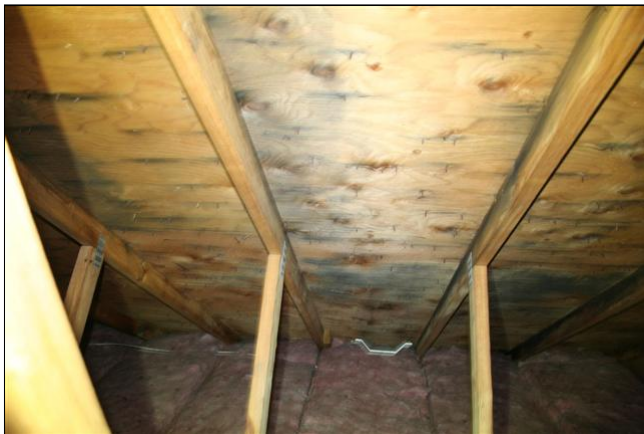
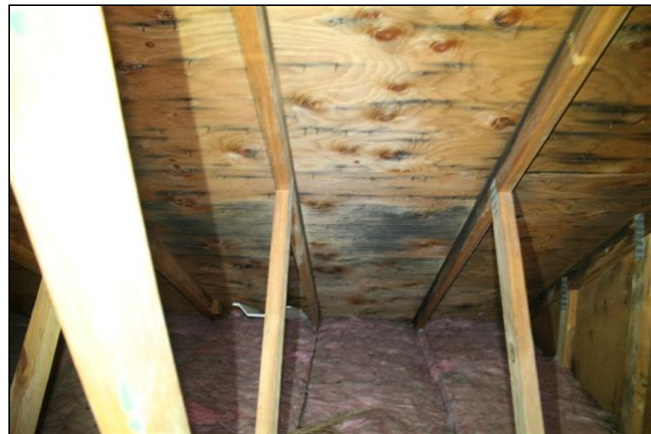
ATTIC MOISTURE CONDITIONS [Inspected]

- ☒ ♦ Possible mold growth noted. Mold can only grow if there is excess moisture. Steps should be taken to eliminate the source of moisture and to clean/remove the mold as needed. Experts advise hiring a contractor for areas over 10 square feet. Guidance is available from the EPA by searching the web for "EPA" and "Mold guidelines". The most recent link we have for the guide is <http://www.epa.gov/iedmold1/moldguide.html>. Another useful private website is www.buildingscience.com.

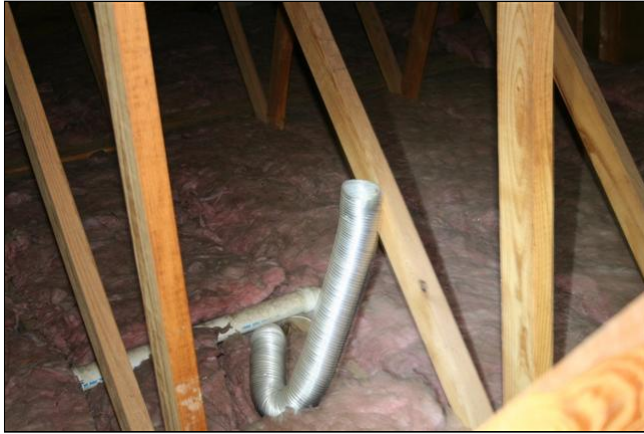
EXHAUST FANS [Inspected]

- ☒ ♦ The bath fan exhausts into the attic; we advise having corrected to discharge to the exterior to reduce the chances of moisture related problems.

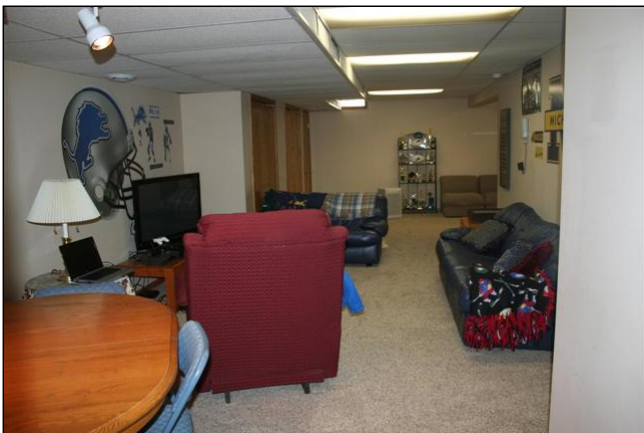
Basement photo(s)

◆ Typical rod hole water stains noted. These are common areas of seepage left over from the original construction. In many cases no further leaking occurs. When needed, repairs are usually simple to accomplish.

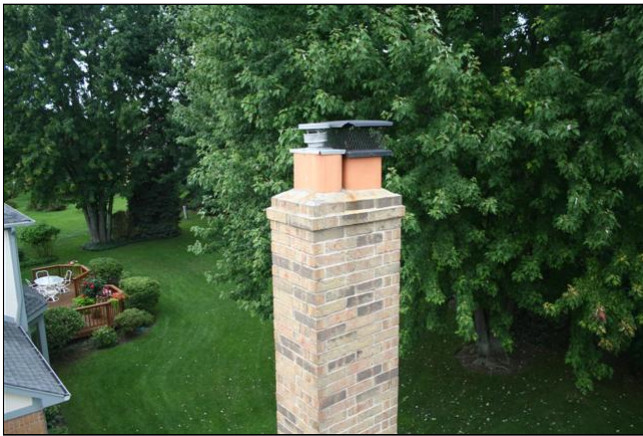
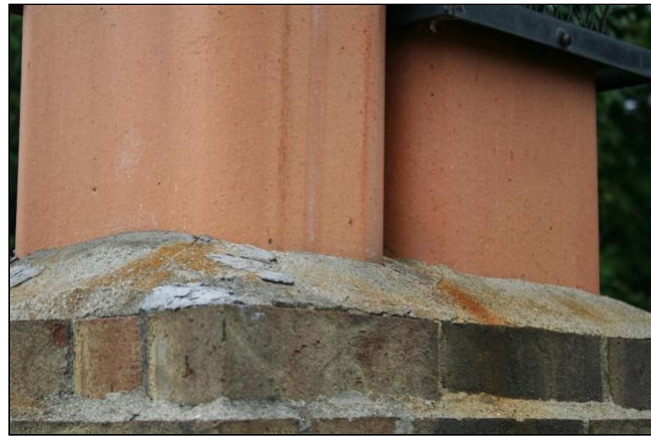
CHIMNEY CONDITION [Inspected]

- ✘ ◆ The cement chimney cap at the chimney should be sealed as part of routine maintenance. For longer term performance, client may wish to consider upgrading to a full overhanging crown with a sloping top and drip slot at the overhang.

Glazed creosote build-up in the chimney. Creosote is a naturally produced flammable by product of combustion. Its presence is a limiting factor on a visual review. We suggest having cleaned and evaluated (request an NFPA Level II inspection) by a qualified fireplace and chimney specialist. Glazed creosote can be difficult to correct and cleaning is typically much more expensive with such deposits.

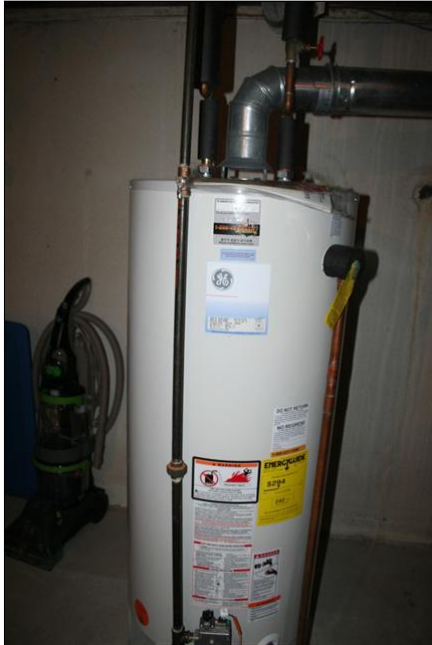
WATER HEATER [Inspected]

SERIAL NO. GELN0511D06273 MFG. DATE: 05/2011
MODEL NO. SG50T12AVG00 Cap. U.S. Gals. 50
Input BTUH 40,000 TYPE GAS - NATURAL
Gas PRESS. IN. W.C. - Manifold - 4.0
Max. Inlet - 10.5 Min. Inlet - 5.0
ANS Z21.10.1*CSA 4.1-2009
Manufactured under trademark license by Rheem Mfg. Co., Mont

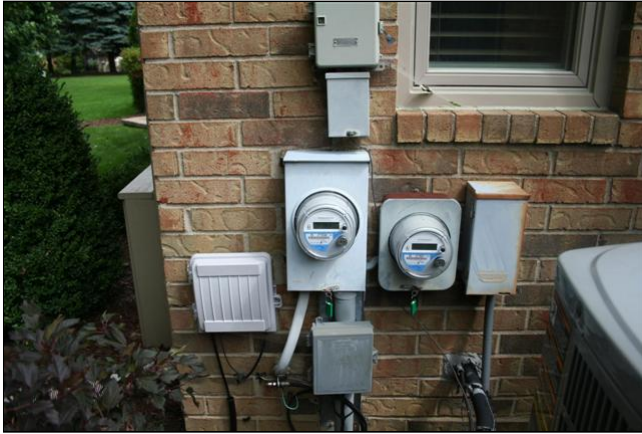
SERVICE ENTRANCE CONDUCTORS/ELECTRIC METER/EXTERIOR DISCONNECT [Inspected]

- ❌ ♦ One GFCI outlet(s) at the front porch would not trip. GFCI's are an important and, fortunately, inexpensive safety device. Repair or replacement by a qualified person is needed.

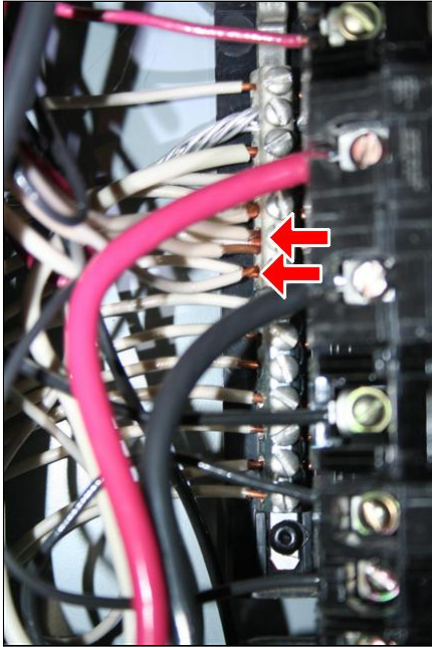
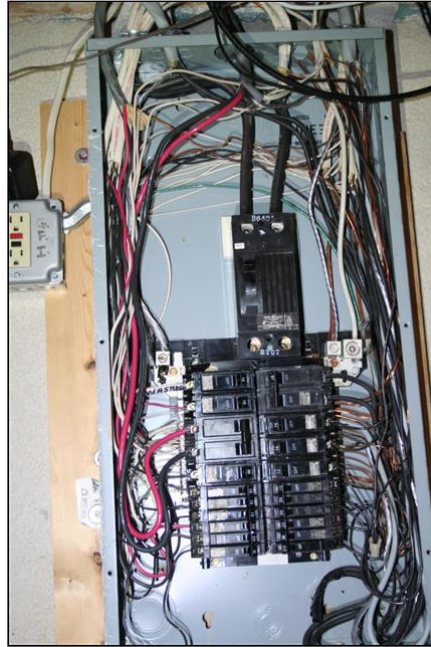
MAIN PANEL BRANCH CIRCUIT CONDUCTORS & OVERCURRENT DEVICES [Inspected]

- ❌ ♦ Doubled up neutral terminals noted. Panel manufacturers prohibit this practice as this can cause loose connections and arcing. This can typically be fixed with a minor wiring change. This wiring guideline was not widely enforced until recently.

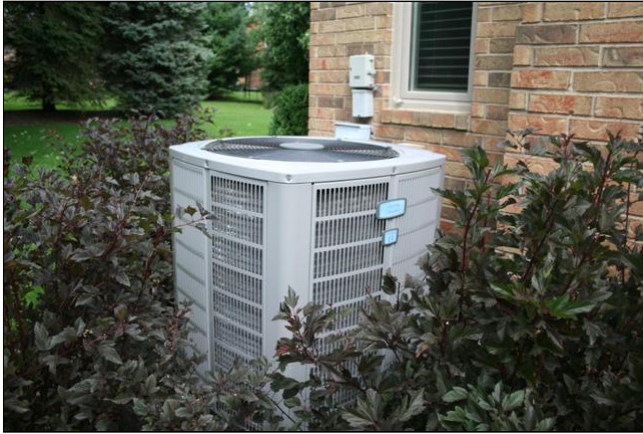
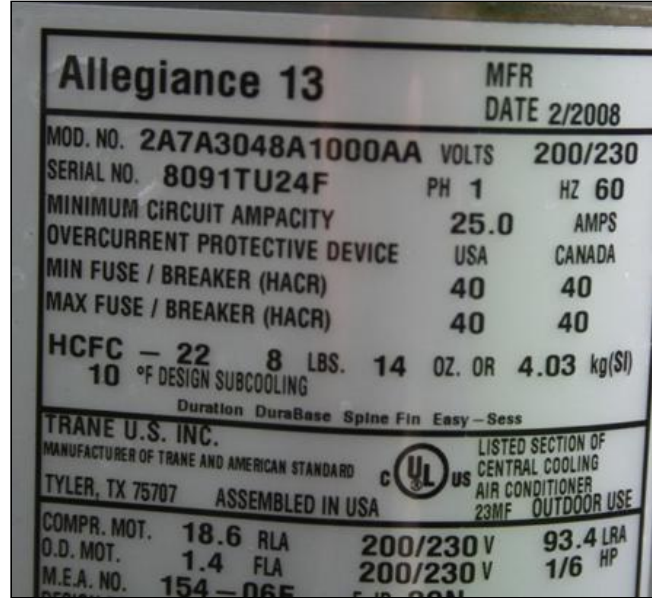
AIR CONDITIONER (A/C) OPERATION [Inspected]

♦ Vegetation should be trimmed at least two feet away from the exterior air conditioning unit(s) to avoid excess wear and increase efficiency.

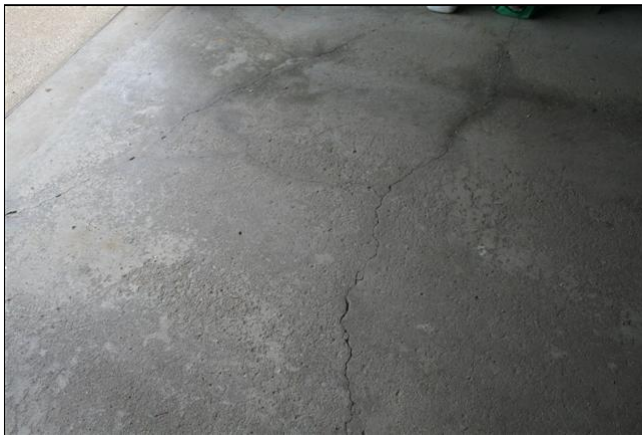
GARAGE FLOOR [Inspected]

- ◆ Minor cracking is evident in the floor slab, but there is no noticeable vertical displacement.

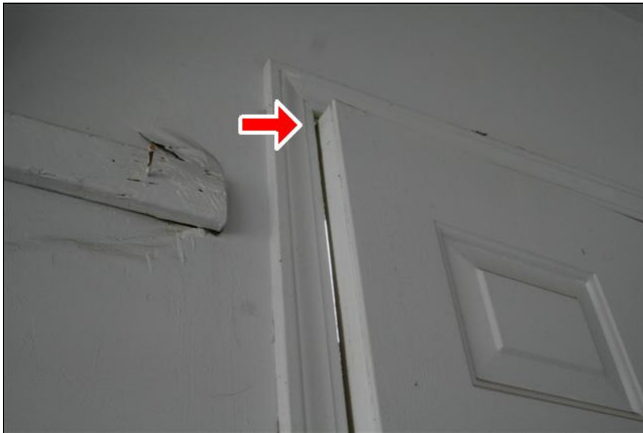
PEDESTRIAN DOOR INTO GARAGE [Inspected]

- ◆ Door sticks minor adjustments needed.

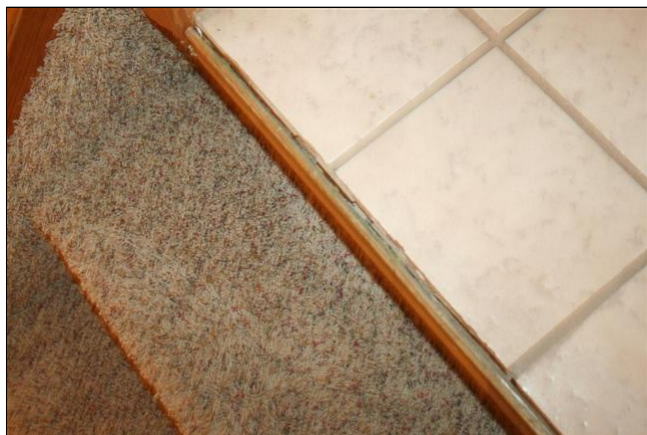
STEPS, STAIRWAYS, BALCONIES AND RAILINGS [Inspected]

♦ There is no stair nosing (slight overhang) in the stairs to basement. This increases the risk of tripping.

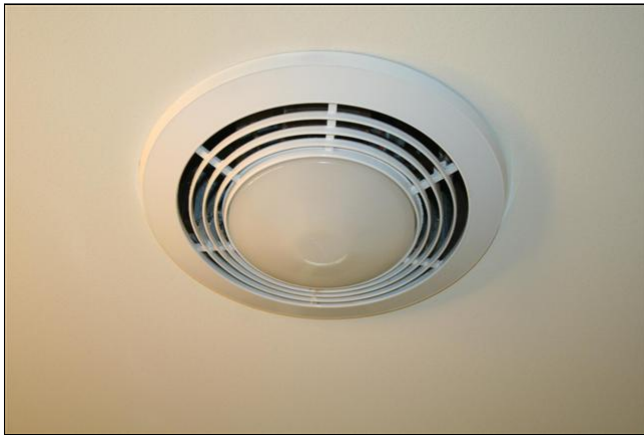
♦ Fan is noisy: may be wearing out in upstairs hall bath.
