Inspection Report

Property Address:
3 Proprietor Lane
Whitehouse Station NJ 08889

New Jersey Property Inspections

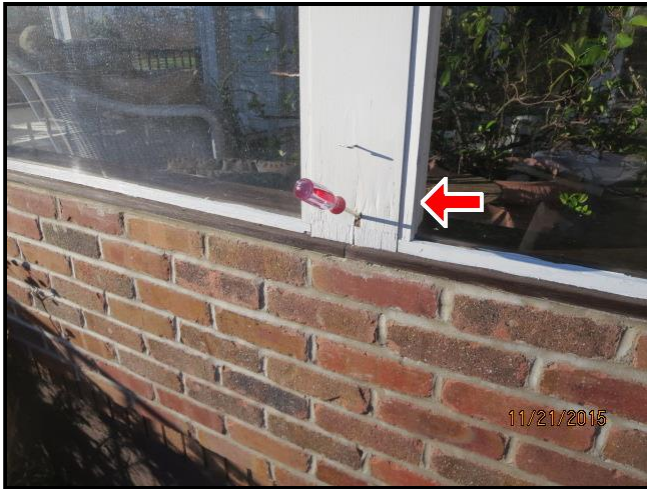
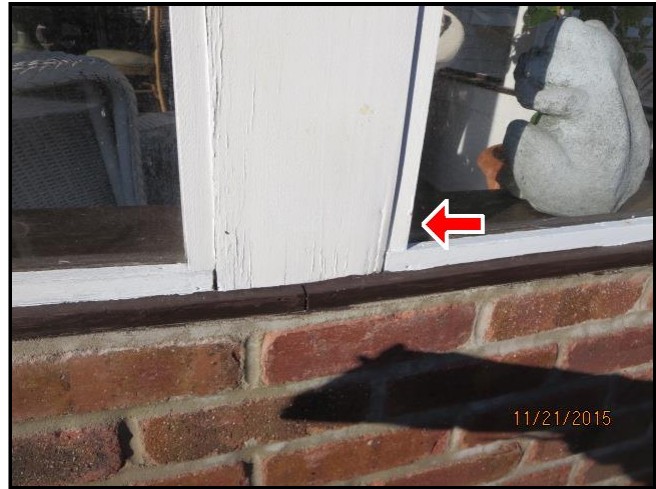
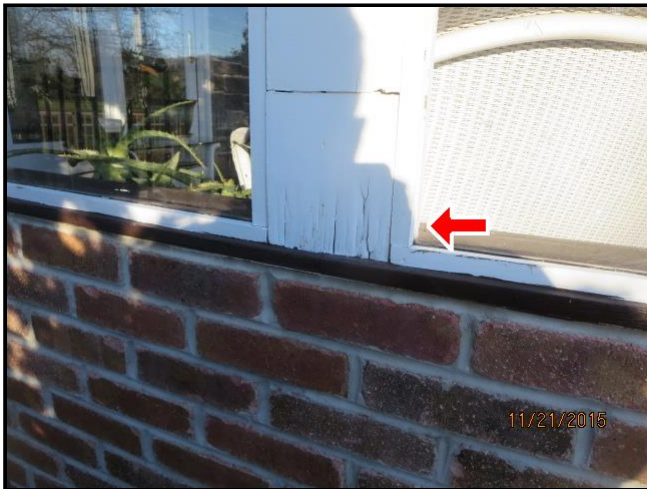
2.0 Item 1(Picture) Wood Rot

(1) The wood trim at the rear of home deteriorated with rot. Further deterioration can occur that can lead to costly water intrusions if not corrected. A qualified contractor should inspect and repair as needed.

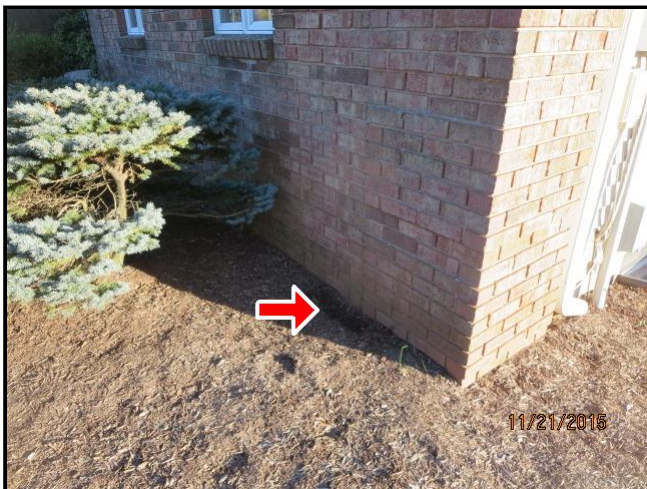
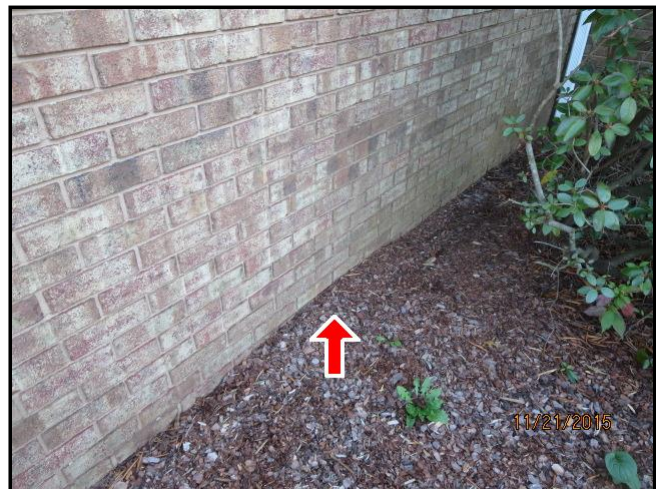
2.0 Item 4(Picture) Missing or buried weep holes

(2) The weep holes for the brick veneer siding at the front of home are either missing or buried below the grading. Weep holes are need for air venting the walls behind the brick keeping them dry. Improper or no ventilation can cause moisture leading to wood rot and mold. It is recommended that a G.C. or mason further evaluate and repair or replace as needed.

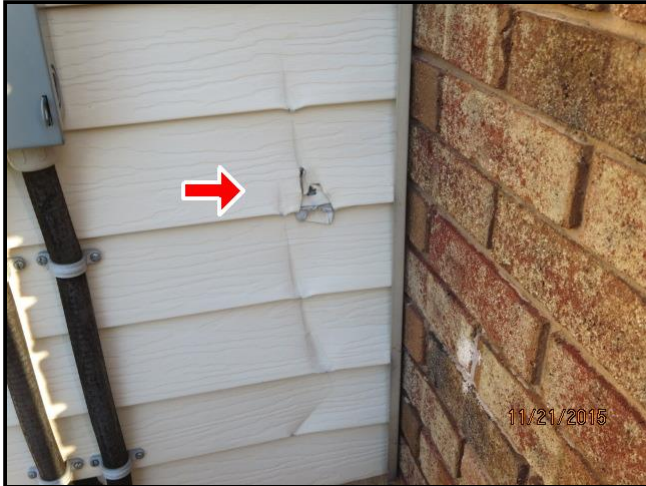
2.0 Item 6(Picture) Damaged siding

(3) The Vinyl siding at the right side (facing front) is damaged. Further deterioration can occur that can lead to water and insect intrusion if not corrected. A qualified contractor should inspect and repair as needed.

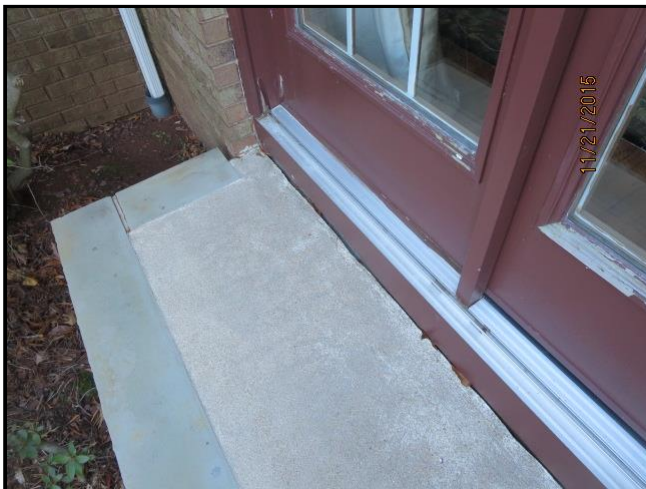
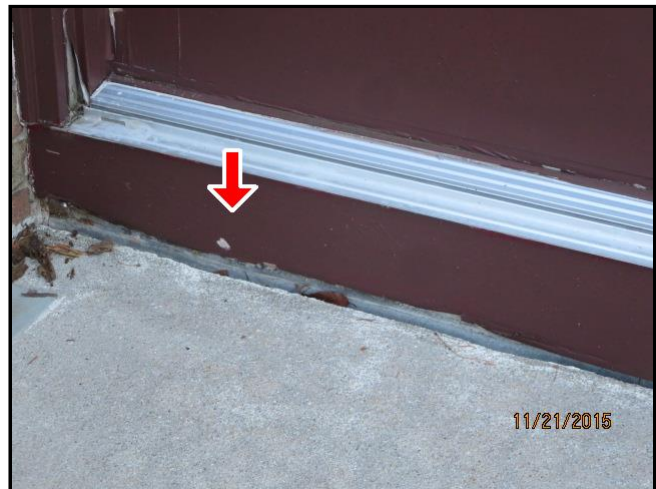
2.3 Item 1(Picture) Front step

The front step at entrance to dining room is damaged and pulling away from home. Further deterioration can occur if not repaired. Recommend a GC further evaluate and repair

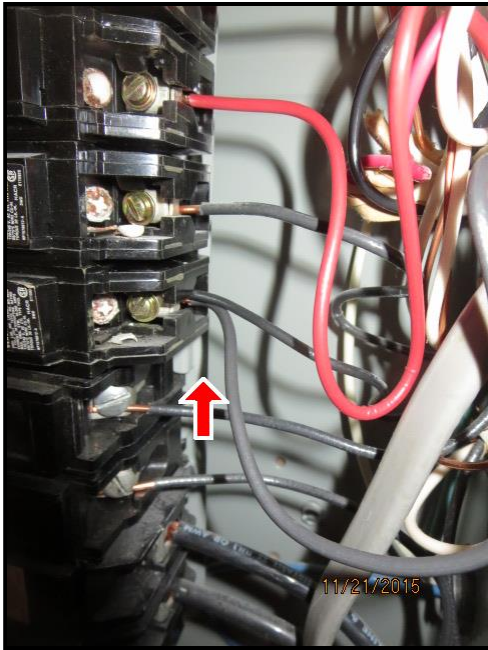
3.1 Item 1(Picture) Double wire

The problem(s) discovered in the panel such as doubled wiring at breaker, and any other problems that an electrical contractor may discover while performing repairs need correcting. I recommend a licensed electrical contractor inspect further and correct as needed.

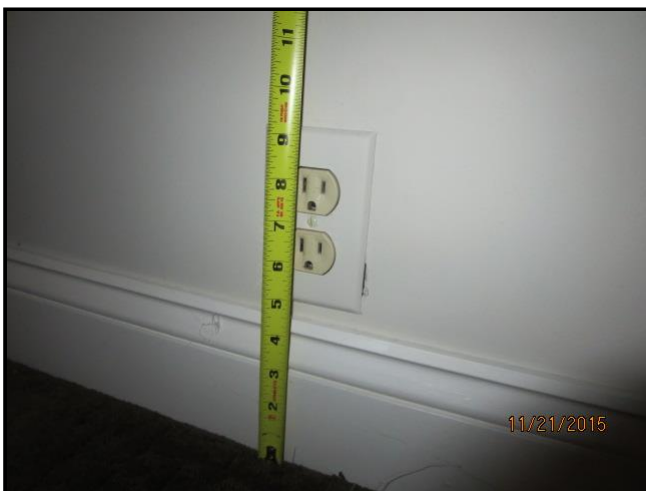
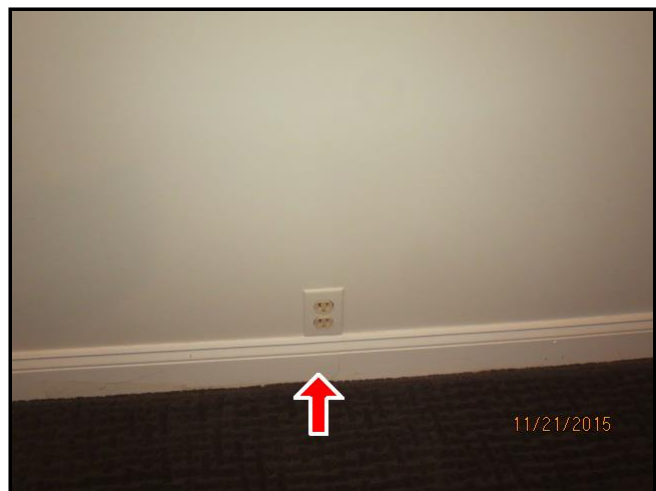
3.3 Item 1(Picture) Low outlet

(1) The "three-prong" outlets may not be at the proper height in the basement. If so, this is a safety issue that needs to be corrected. A qualified licensed electrical contractor should perform repairs that involve wiring. It is also recommended that all wiring in the basement be evaluated and check for permits.

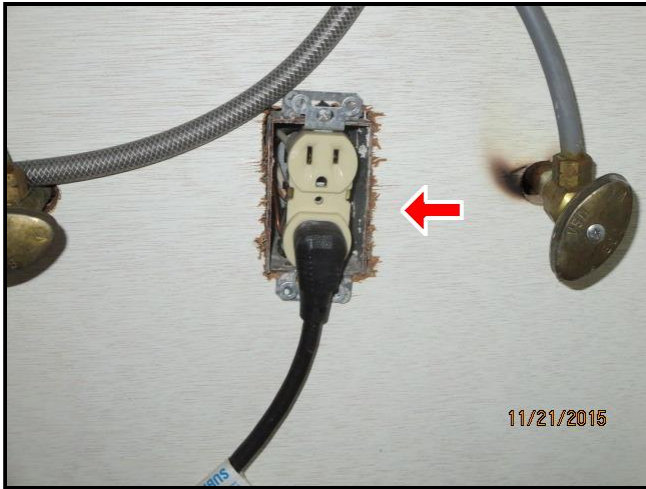
3.3 Item 3(Picture) Missing cover plate

(2) The "three-prong" outlet is missing cover-plate under basement sink. This is a safety issue that needs to be corrected. A qualified licensed electrical contractor should perform repairs that involve wiring.

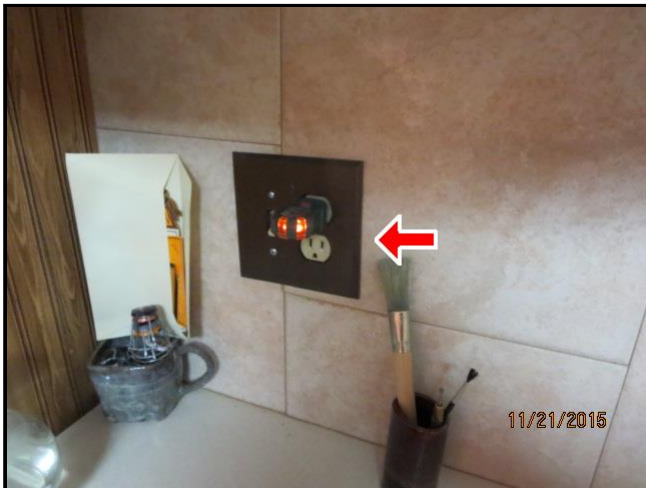
3.4 Item 1(Picture) Non GFCI outlet

The "three-prong" outlet is not a three-prong GFCI (Ground Fault Circuit Interrupter) at the basement sink . This is a safety issue that needs to be corrected. A qualified licensed electrical contractor should perform repairs that involve wiring.

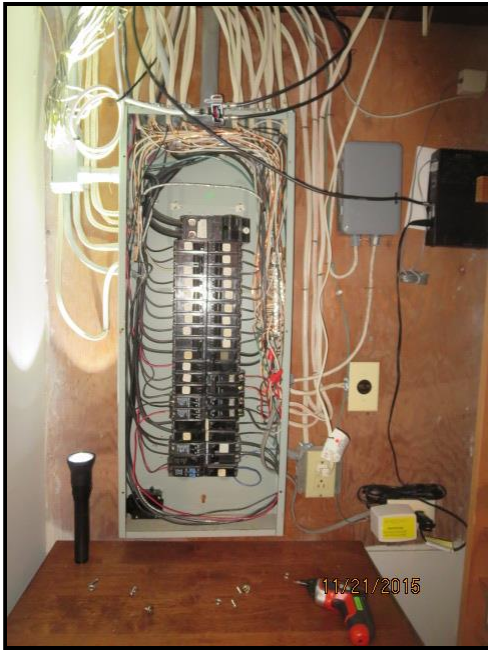
3.6 Item 1(Picture) Main Panel Box

The main panel box is located at the basement.

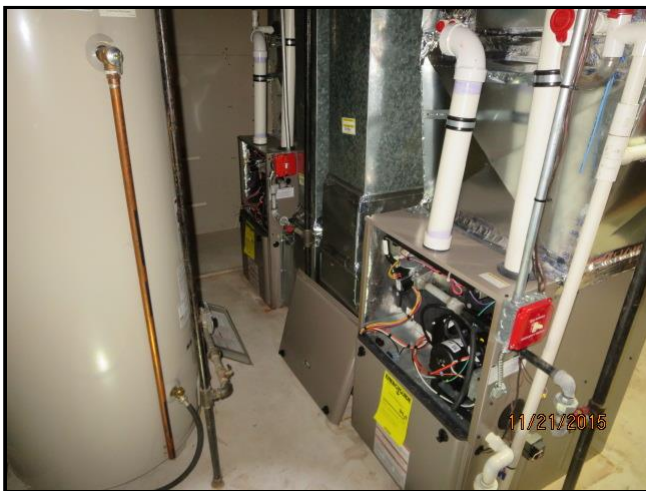
4.0 Item 1(Picture) Furnaces

Heating System was working at time of inspection. Both furnaces are from 2013, life expectancy is 15-25 years

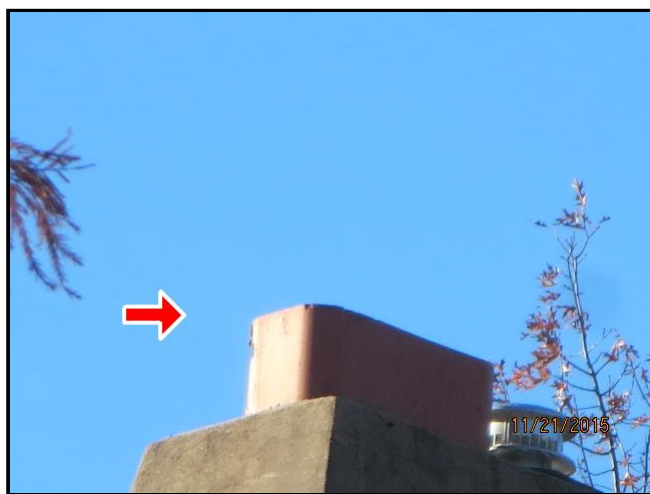
4.5 Item 1(Picture) Missing Rain Cap

(1) Metal rain cap on chimney crown is missing. This helps to prevent water intrusion

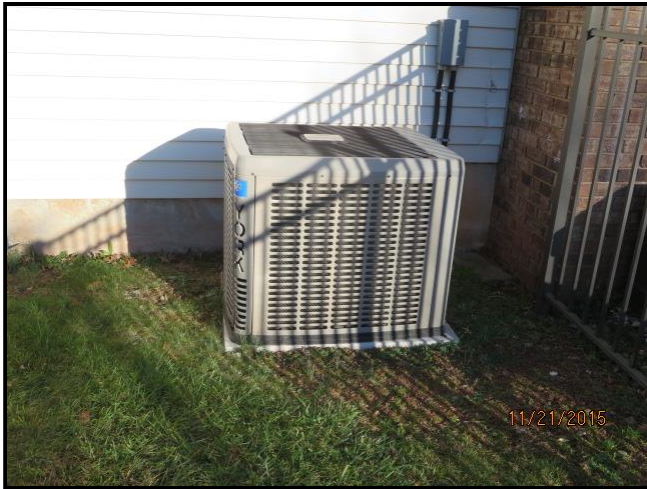
4.8 Item 1(Picture) 2005 condenser

The A/C was not tested for proper operation due to the outside air temperature is 65 degrees or less. We did not inspect this unit(s). Condenser are from 2008 and 2005 life expectancy is 8-12 years

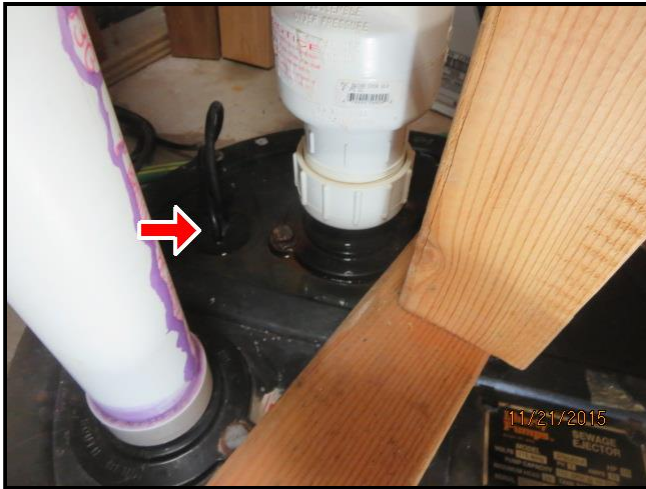
5.1 Item 1(Picture) Pump up system leak

(1) The pump up system for the basement bathroom is leaking. Water intrusion can lead to costly repairs with wood rot and mold. It is recommended that a licensed plumber further evaluate and repair or replace.

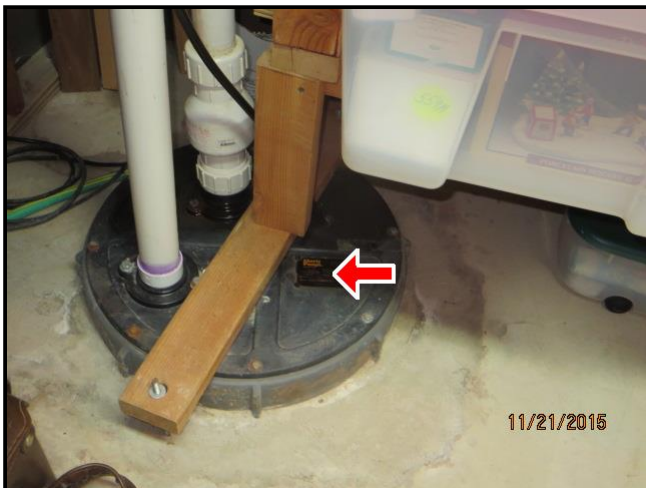
5.1 Item 2(Picture) Shelf Support

(2) It was observed that heavy shelving support is in contact with the pump up system. This will prevent any emergency services to be obtained. Recommend that the restriction be eliminated.

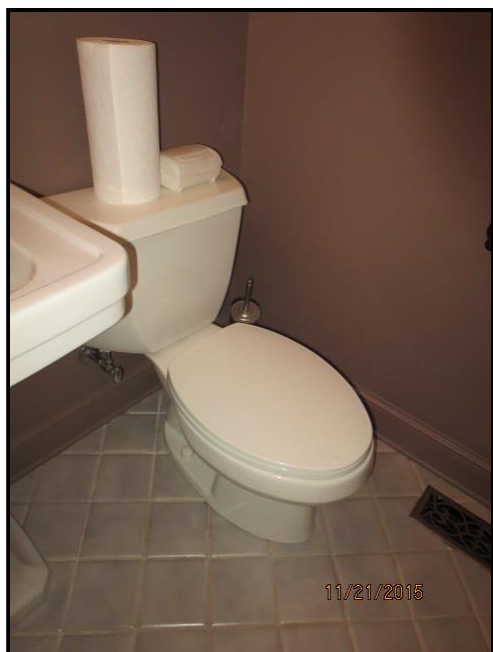
5.1 Item 3(Picture) Loose toilet

(3) The toilet is loose and needs to be secured at the half bath. Repairs are needed to prevent odor from entering home. A qualified licensed plumber should repair or correct as needed.

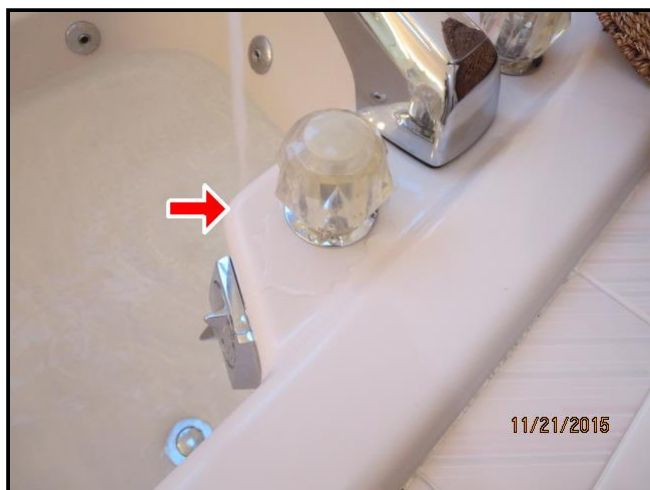
5.1 Item 4(Picture) Valve leak

(4) The water supply valve is leaking at the master bath Jacuzzi . This is not considered up to today's standard Repairs are needed. A qualified licensed plumber should repair or correct as needed.

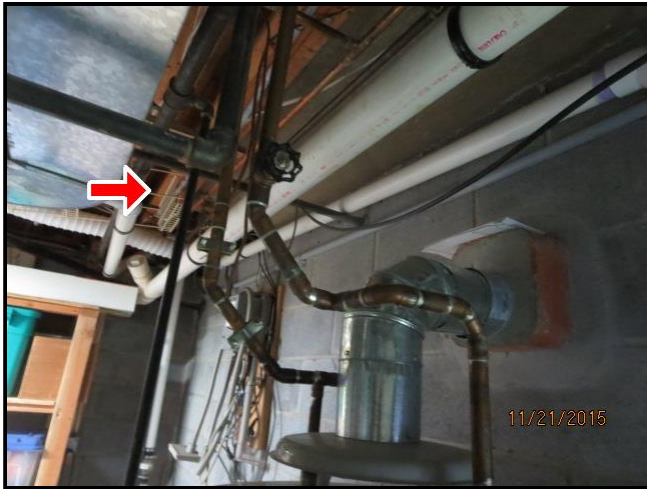
5.2 Item 1(Picture) Missing bond wire

(1) The water heater is missing a bond wire. The bond wire is needed to complete the electrical throughout the home.

It is recommended that a licensed electrician further evaluate and install. Check for installation permits.

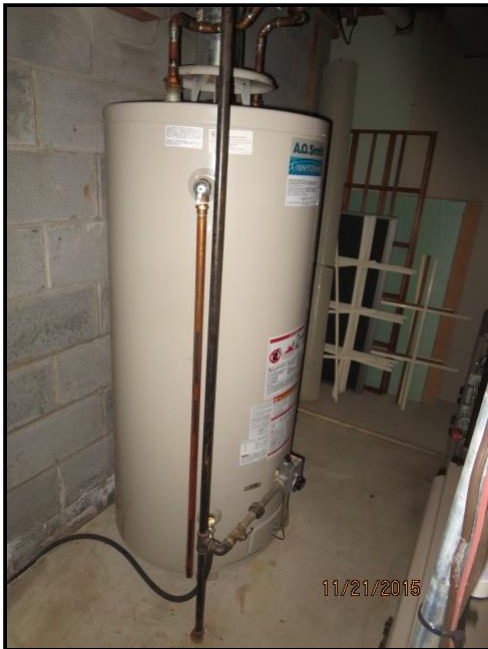
5.2 Item 2(Picture) Water heater

(2) Water heater was working at time of inspection, Water heater is from 2002, life expectancy is 8-12 years.

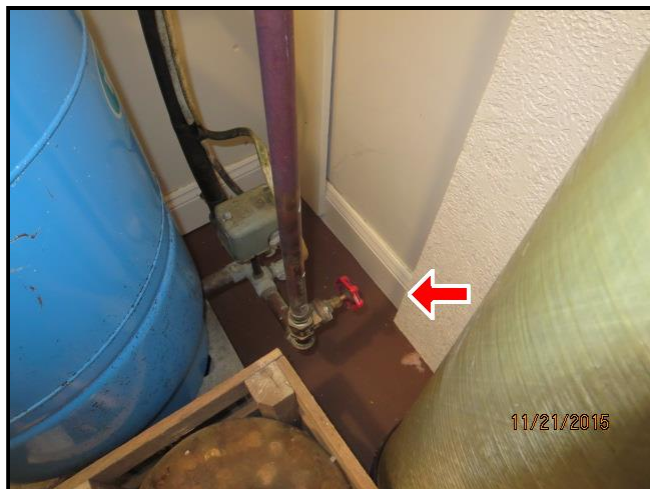
5.3 Item 1(Picture) Main Water shut off

The main shut off is the lever located in the basement. This is for your information.

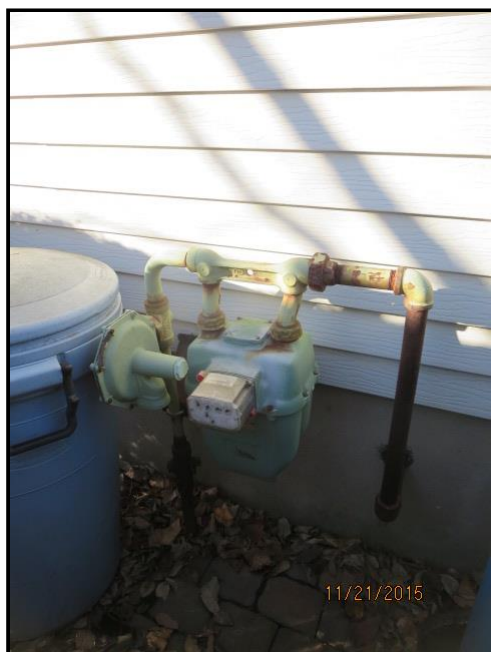
5.5 Item 1(Picture) Gas meter

The main fuel shut off is at gas meter outside

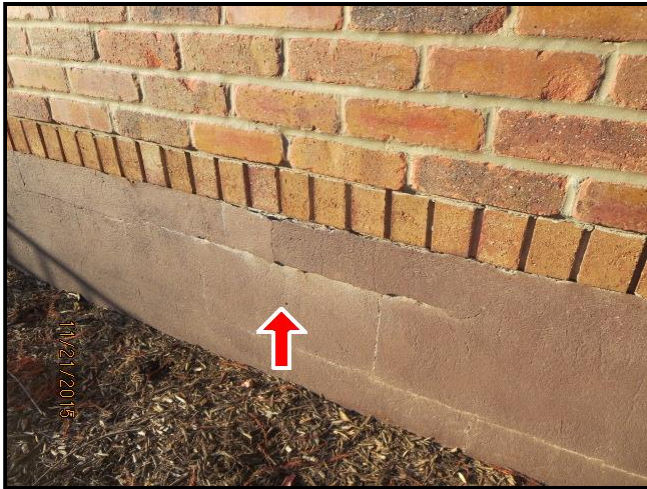
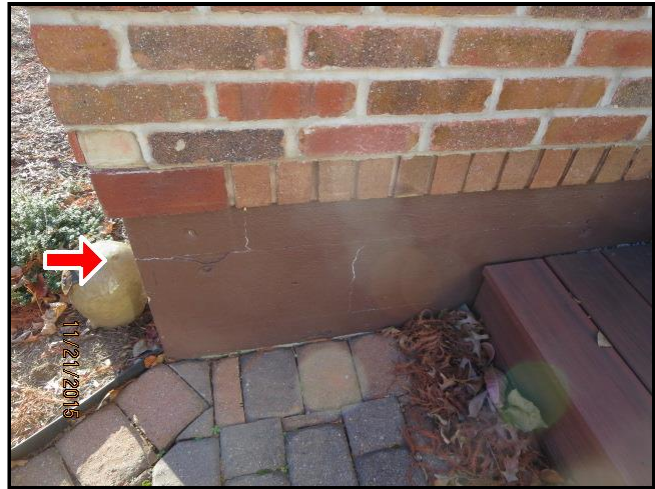
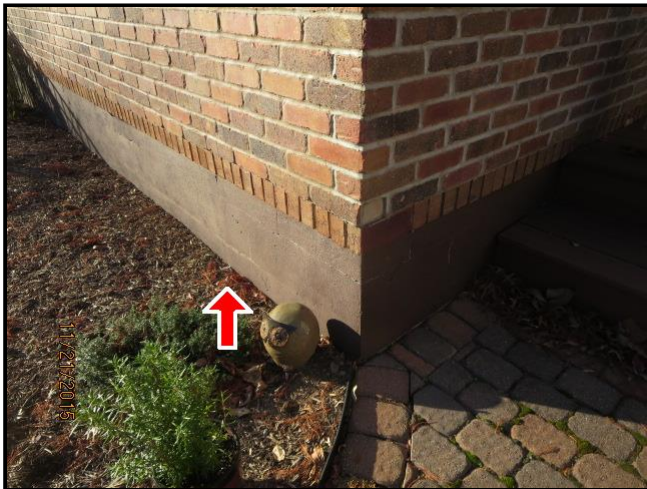
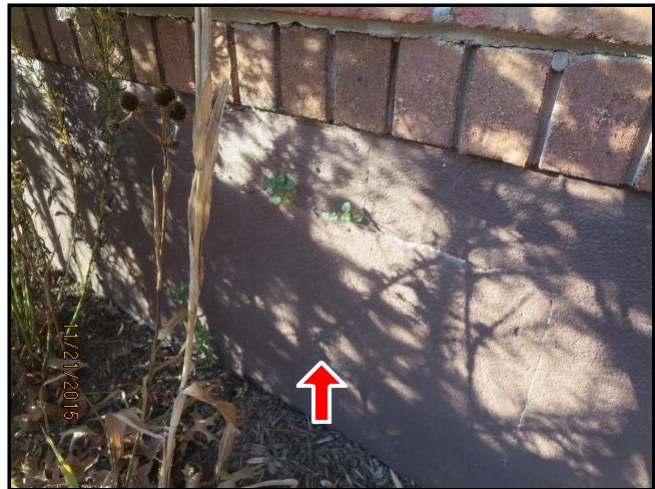
6.0 Item 1(Picture) Wall Cracks

(1) There are structural crack(s) in the foundation wall at the rear of home. The wall(s) may need reinforcement. A qualified structural engineer should inspect and repair or replace as needed.

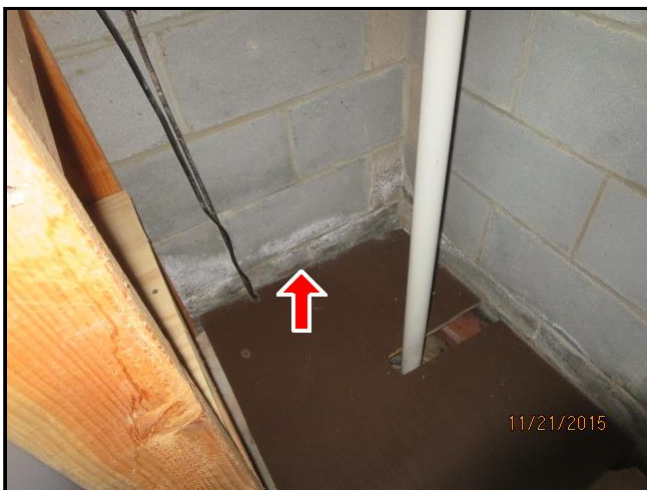
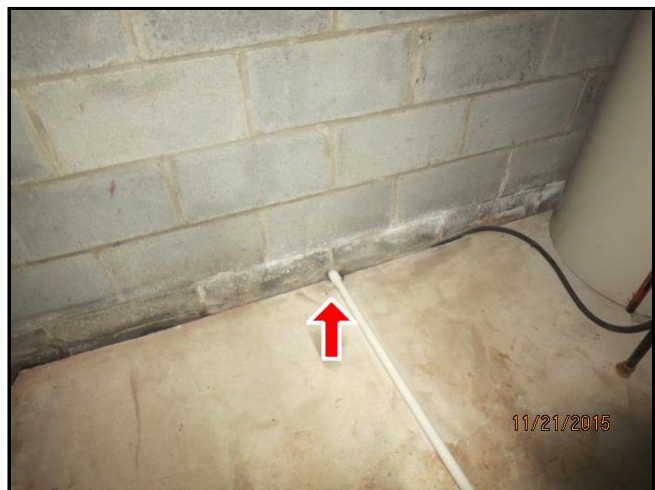
6.0 Item 5(Picture) Efflorescence

(2) White efflorescence (powder substance) on block wall indicates moisture is in contact with the masonry. This does not necessarily indicate that intrusion will occur. I recommend checking the gutters and the downspout drain lines for proper operation. Also, a water proofing paint could be applied to the interior side of the block if necessary. Efflorescence is found on many homes without water intrusion occurring inside the home. But, it should alert you to the possibility that future steps may be needed.

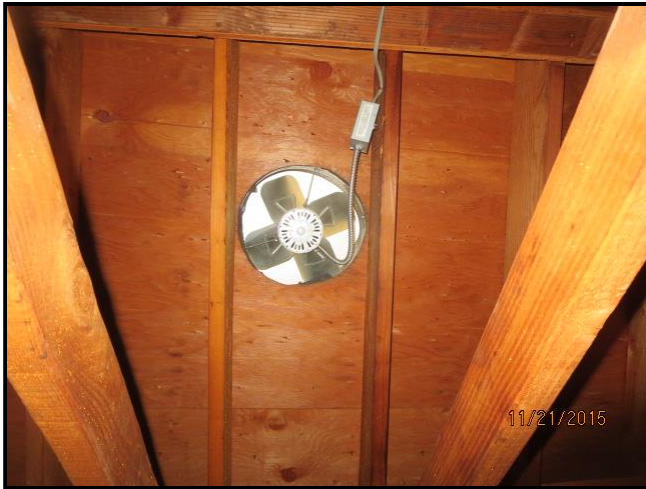
7.5 Item 1(Picture) Thermo Fan

Thermostatic fan was not working at time of inspection. Due to temperatures in the attic being below 60 degree's

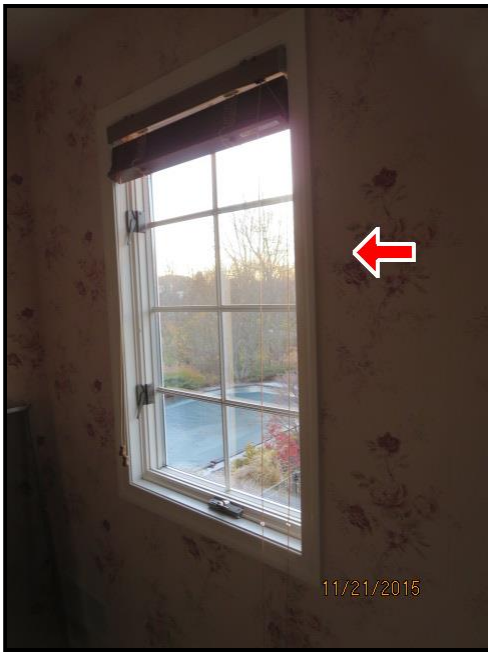
8.6 Item 1(Picture) Bed window

One window difficult to operate at the Bedroom. Further deterioration may occur if not repaired. A qualified contractor should inspect and repair as needed.

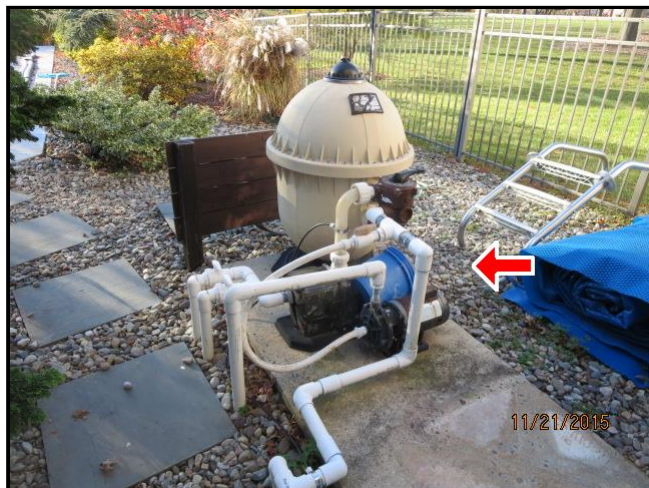
11.0 Item 1(Picture) Pump & Filter

Pool was closed at time of inspection. Pump and filter could not be inspected. Dating on the pump indicates the pump and filter maybe from 1998 this should be verified by the seller. Due to the age of the pump, it is recommend that the pool be opened and a full inspection be completed before closing.

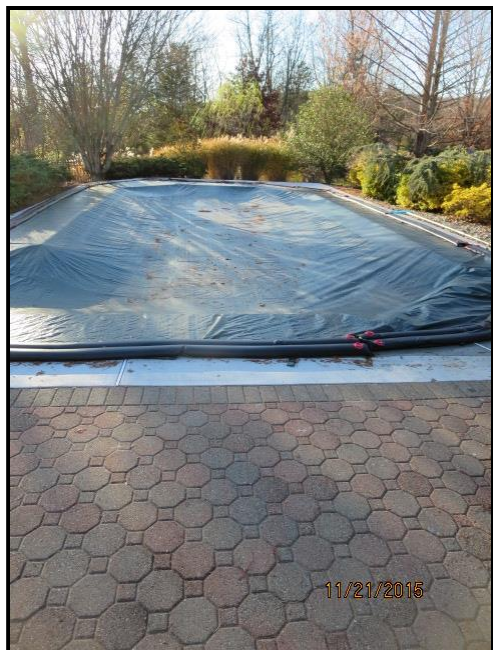
11.1 Item 1(Picture) Pool closed

Pool was closed at time of inspection. Pool liner could not be inspected. It is recommended that the pool be opened an liner be inspected before closing,

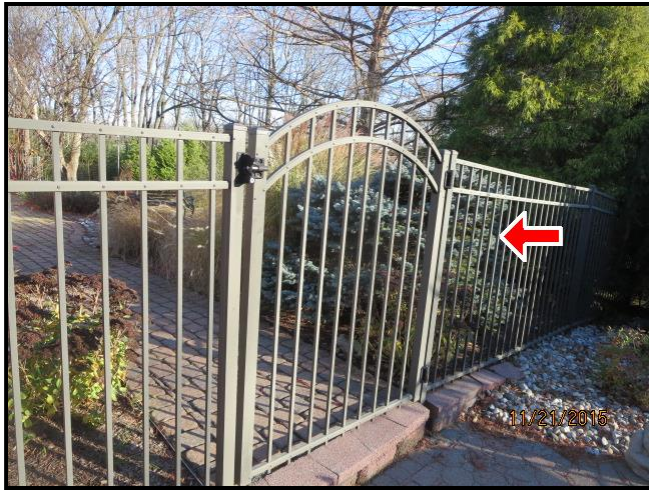
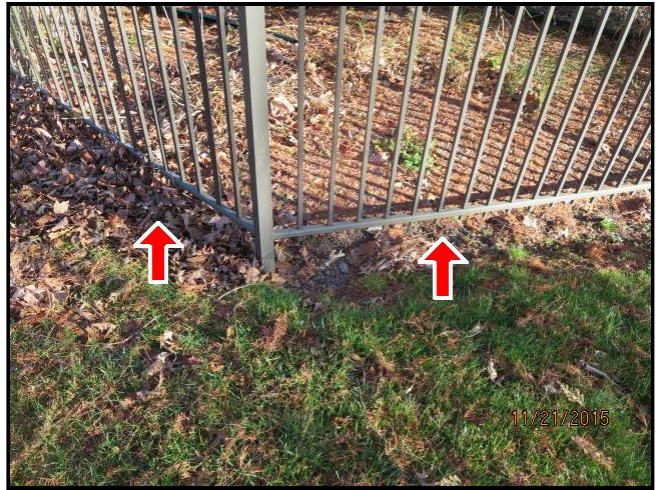
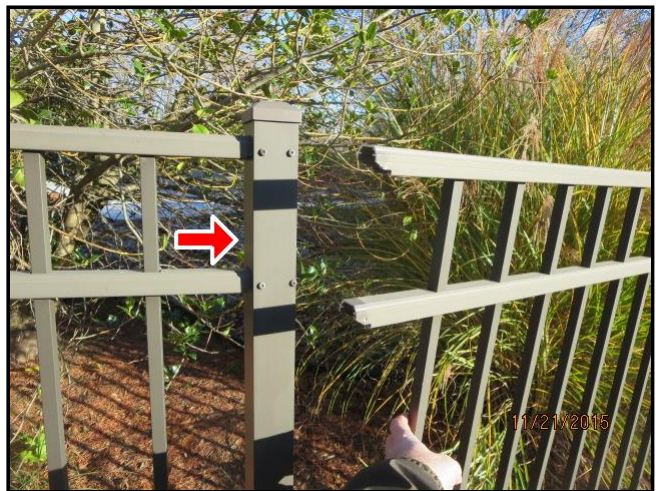
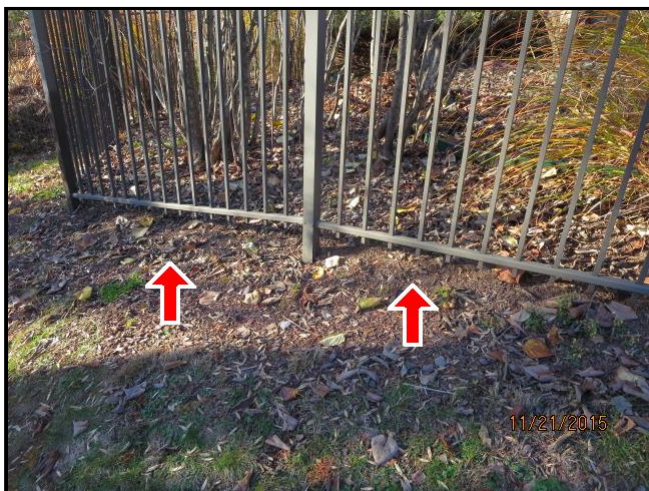
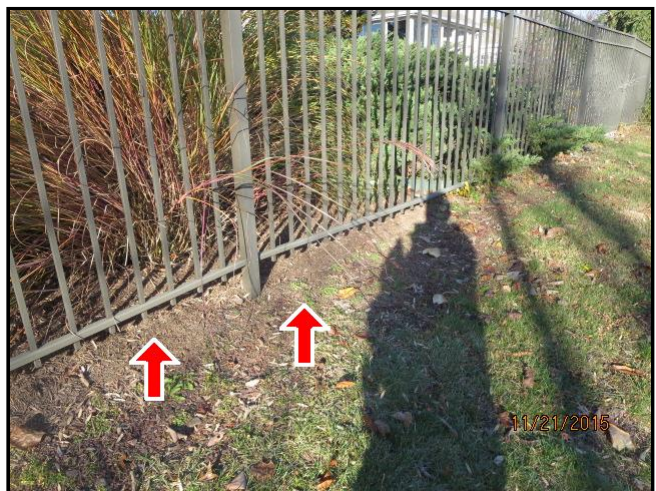
11.15 Item 1(Picture) Gate

The fencing around the pool has safety issues that need to be addressed. The fence gate opens the wrong way, (gate should open outward) there are gaps at the bottom that are more than 3 inches and a damaged section of the fence. It is recommended that a fence company further evaluate and repair.

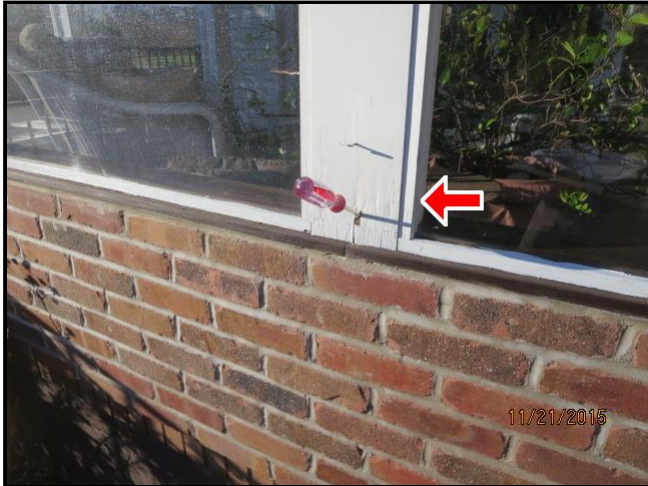
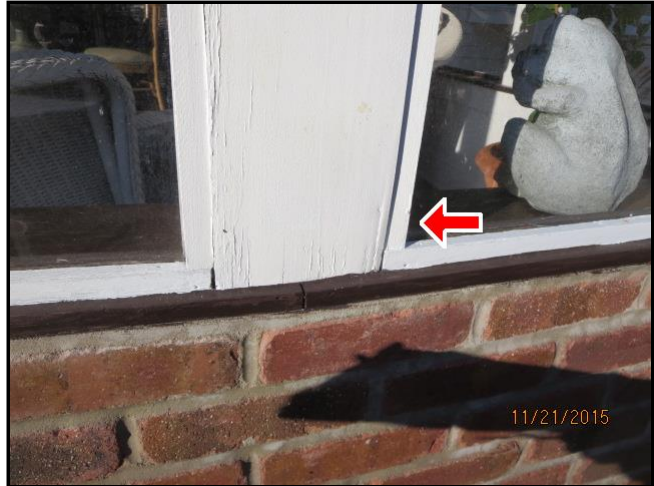
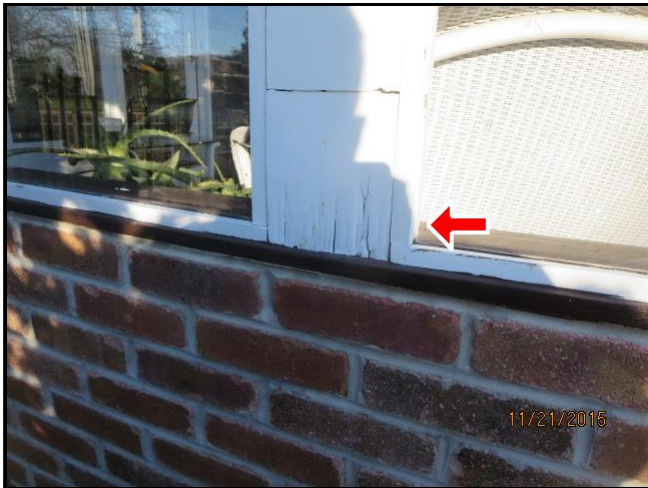
2.0 Item 1(Picture) Wood Rot

(1) The wood trim at the rear of home deteriorated with rot. Further deterioration can occur that can lead to costly water intrusions if not corrected. A qualified contractor should inspect and repair as needed.

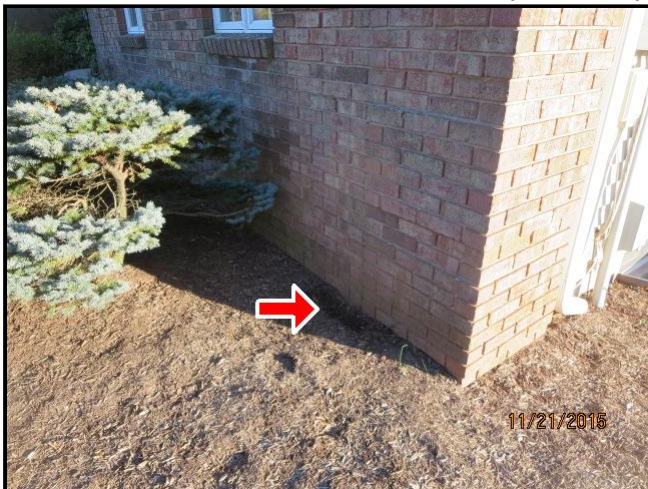
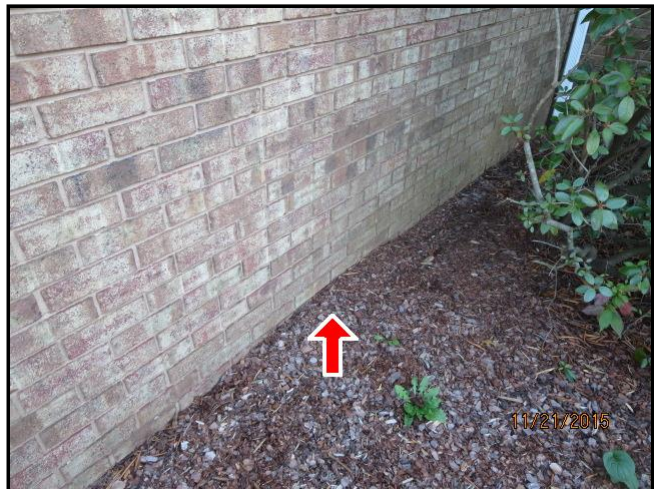
2.0 Item 4(Picture) Missing or buried weep holes

(2) The weep holes for the brick veneer siding at the front of home are either missing or buried below the grading. Weep holes are need for air venting the walls behind the brick keeping them dry. Improper or no ventilation can cause moisture leading to wood rot and mold. It is recommended that a G.C. or mason further evaluate and repair or replace as needed.

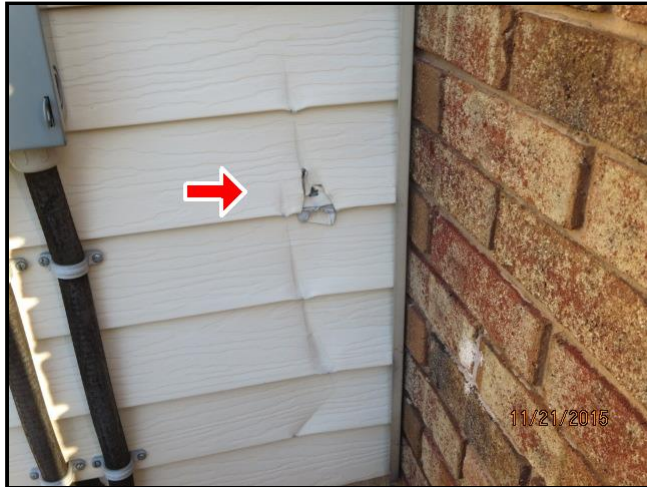
2.0 Item 6(Picture) Damaged siding

(3) The Vinyl siding at the right side (facing front) is damaged. Further deterioration can occur that can lead to water and insect intrusion if not corrected. A qualified contractor should inspect and repair as needed.

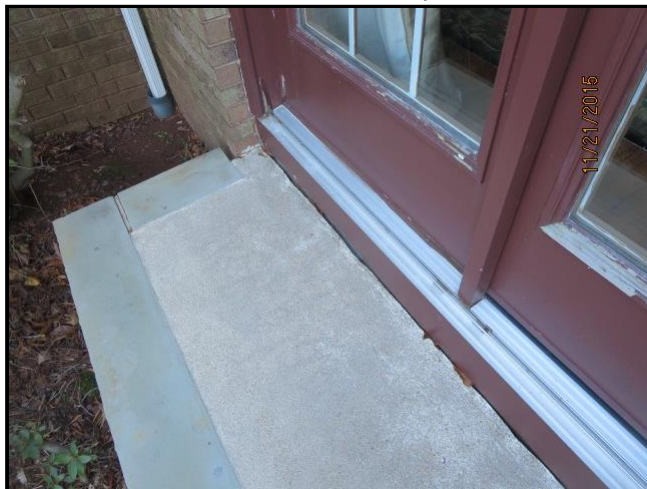
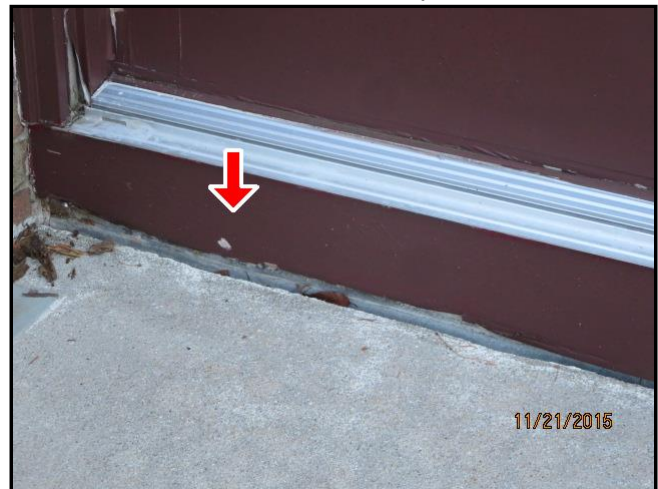
2.3 Item 1(Picture) Front step

The front step at entrance to dining room is damaged and pulling away from home. Further deterioration can occur if not repaired. Recommend a GC further evaluate and repair

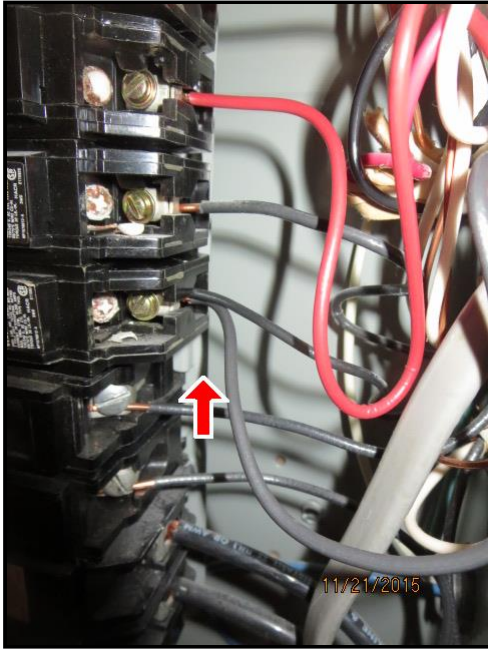
3.1 Item 1(Picture) Double wire

The problem(s) discovered in the panel such as doubled wiring at breaker, and any other problems that an electrical contractor may discover while performing repairs need correcting. I recommend a licensed electrical contractor inspect further and correct as needed.

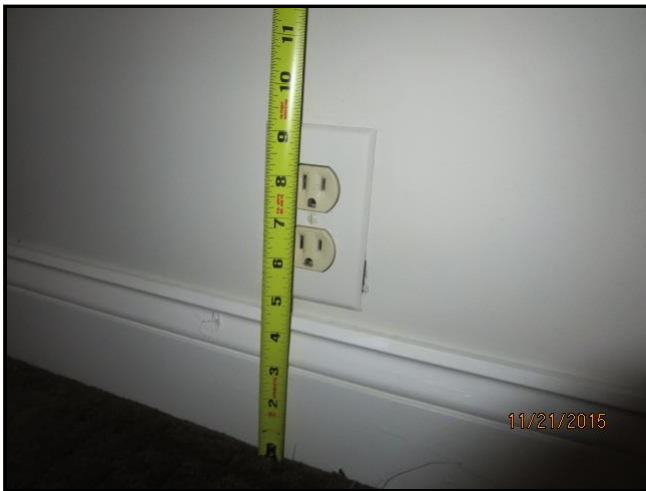
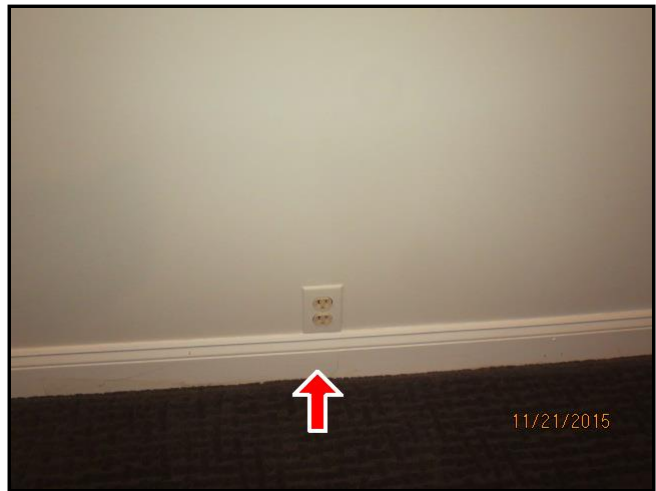
3.3 Item 1(Picture) Low outlet

(1) The "three-prong" outlets may not be at the proper height in the basement. If so, this is a safety issue that needs to be corrected. A qualified licensed electrical contractor should perform repairs that involve wiring. It is also recommended that all wiring in the basement be evaluated and check for permits.

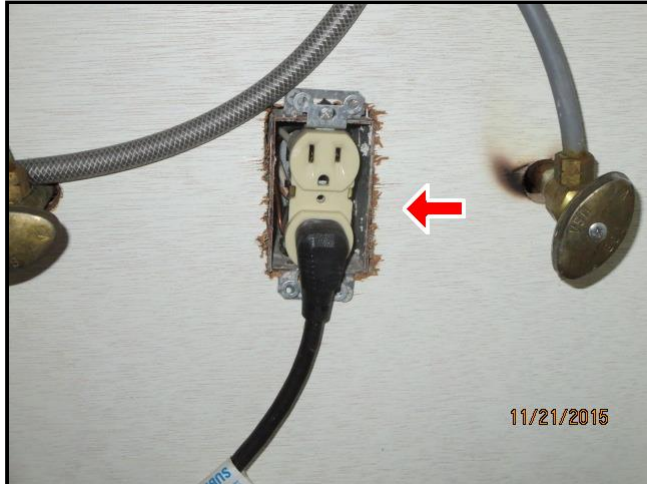
3.3 Item 3(Picture) Missing cover plate

(2) The "three-prong" outlet is missing cover-plate under basement sink. This is a safety issue that needs to be corrected. A qualified licensed electrical contractor should perform repairs that involve wiring.

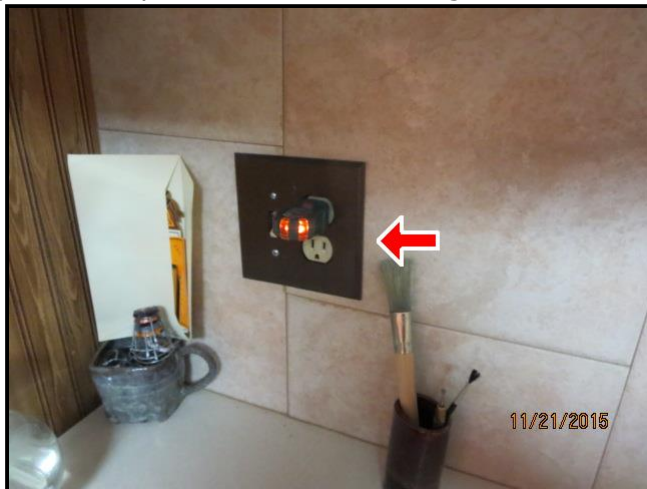
3.4 Item 1(Picture) Non GFCI outlet

The "three-prong" outlet is not a three-prong GFCI (Ground Fault Circuit Interrupt) at the basement sink. This is a safety issue that needs to be corrected. A qualified licensed electrical contractor should perform repairs that involve wiring.

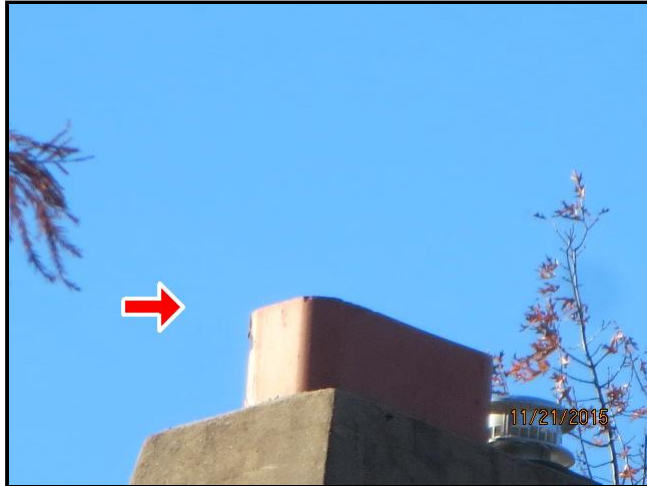
4.5 Item 1(Picture) Missing Rain Cap

(1) Metal rain cap on chimney crown is missing. This helps to prevent water intrusion

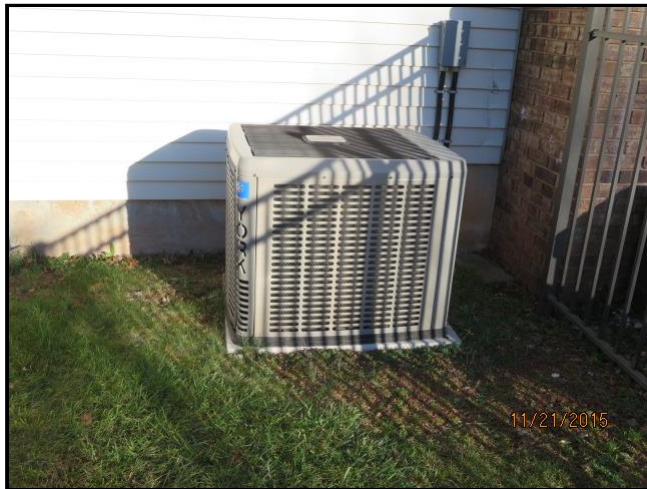
4.8 Item 1(Picture) 2005 condenser

The A/C was not tested for proper operation due to the outside air temperature is 65 degrees or less. We did not inspect this unit(s). Condenser are from 2008 and 2005 life expectancy is 8-12 years

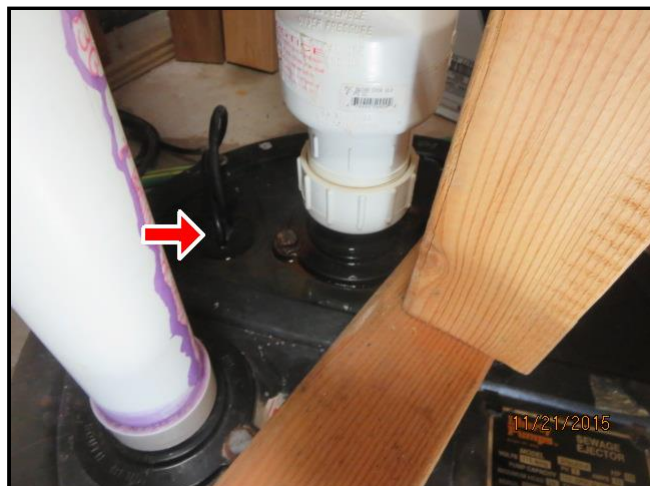
5.1 Item 1(Picture) Pump up system leak

(1) The pump up system for the basement bathroom is leaking. Water intrusion can lead to costly repairs with wood rot and mold. It is recommended that a licensed plumber further evaluate and repair or replace.

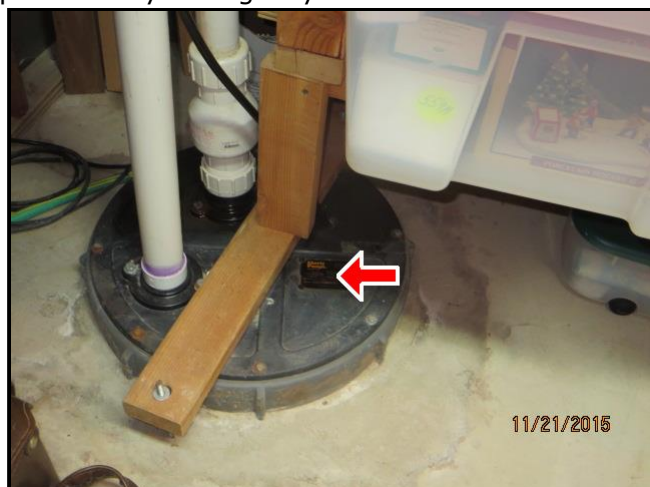
5.1 Item 2(Picture) Shelf Support

(2) It was observed that heavy shelving support is in contact with the pump up system. This will prevent any emergency services to be obtained. Recommend that the restriction be eliminated.

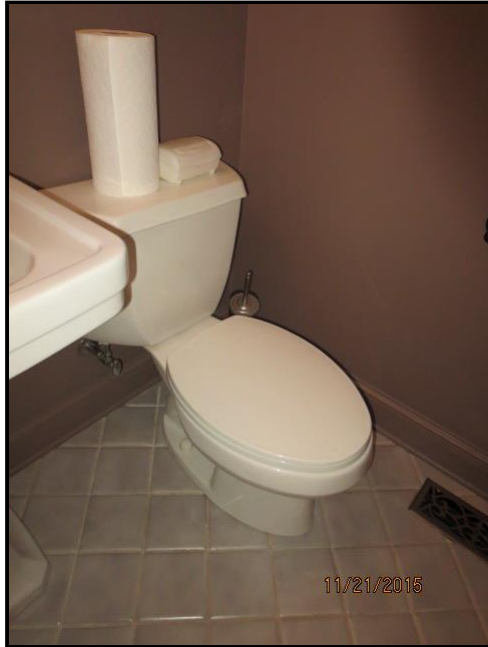
5.1 Item 3(Picture) Loose toilet

(3) The toilet is loose and needs to be secured at the half bath. Repairs are needed to prevent odor from entering home. A qualified licensed plumber should repair or correct as needed.

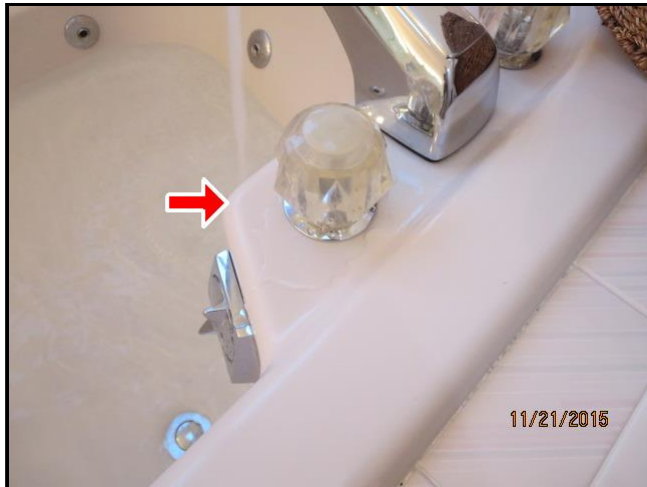
5.1 Item 4(Picture) Valve leak

(4) The water supply valve is leaking at the master bath Jacuzzi . This is not considered up to today's standard Repairs are needed. A qualified licensed plumber should repair or correct as needed.

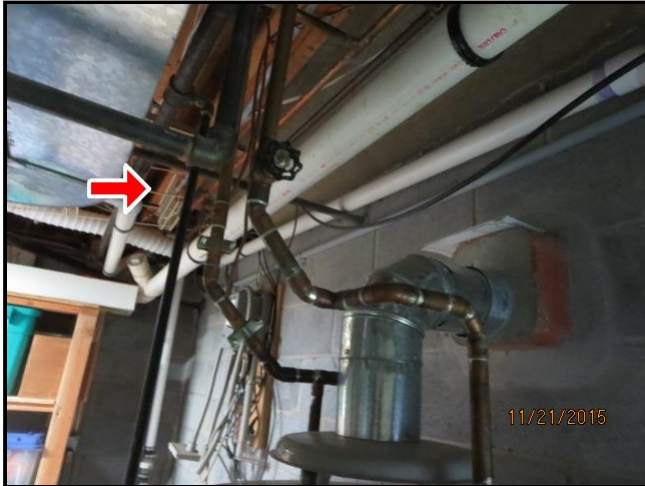
5.2 Item 1(Picture) Missing bond wire

(1) The water heater is missing a bond wire. The bond wire is needed to complete the electrical throughout the home.

It is recommended that a licensed electrician further evaluate and install. Check for installation permits.

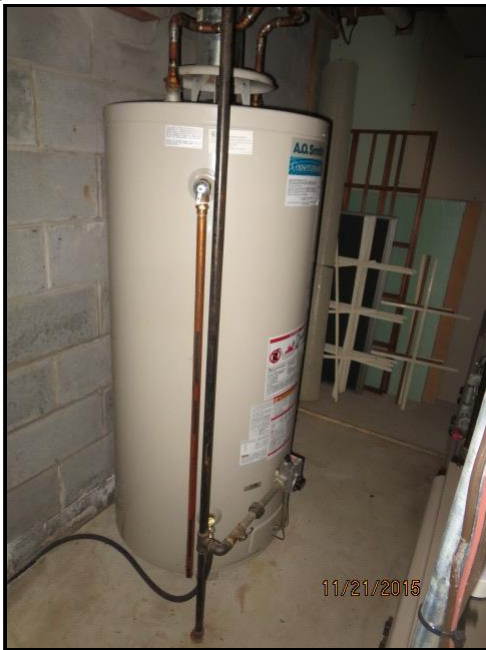
5.2 Item 2(Picture) Water heater

(2) Water heater was working at time of inspection, Water heater is from 2002, life expectancy is 8-12 years.
